**Subject:** Thames Pool Condition Update and Repair Options

**Date:** July 18, 2023

Existing review for City of London

Thames Pool  
15 Ridout Street S.  
London, ON  
N6C 3W6

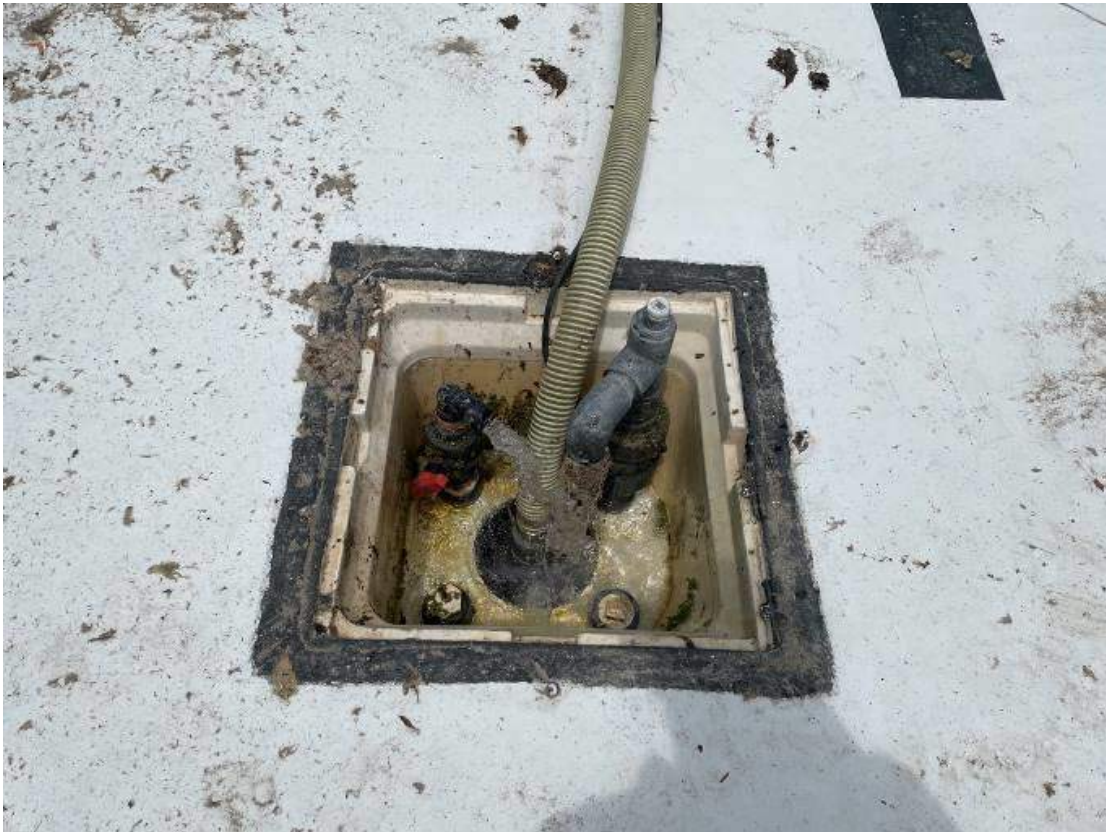
During the initial site meeting to discuss the project, the pool was empty to allow for visual inspection. The hydrostatic relief valve in one of the main drains was open to permit the release of ground water and pressure on the tank. A submersible pump was used to discharge the incoming water as quickly as it was entering the pool tank. See Figure 1.

Figure 1 – Ground water in main drain, with pump

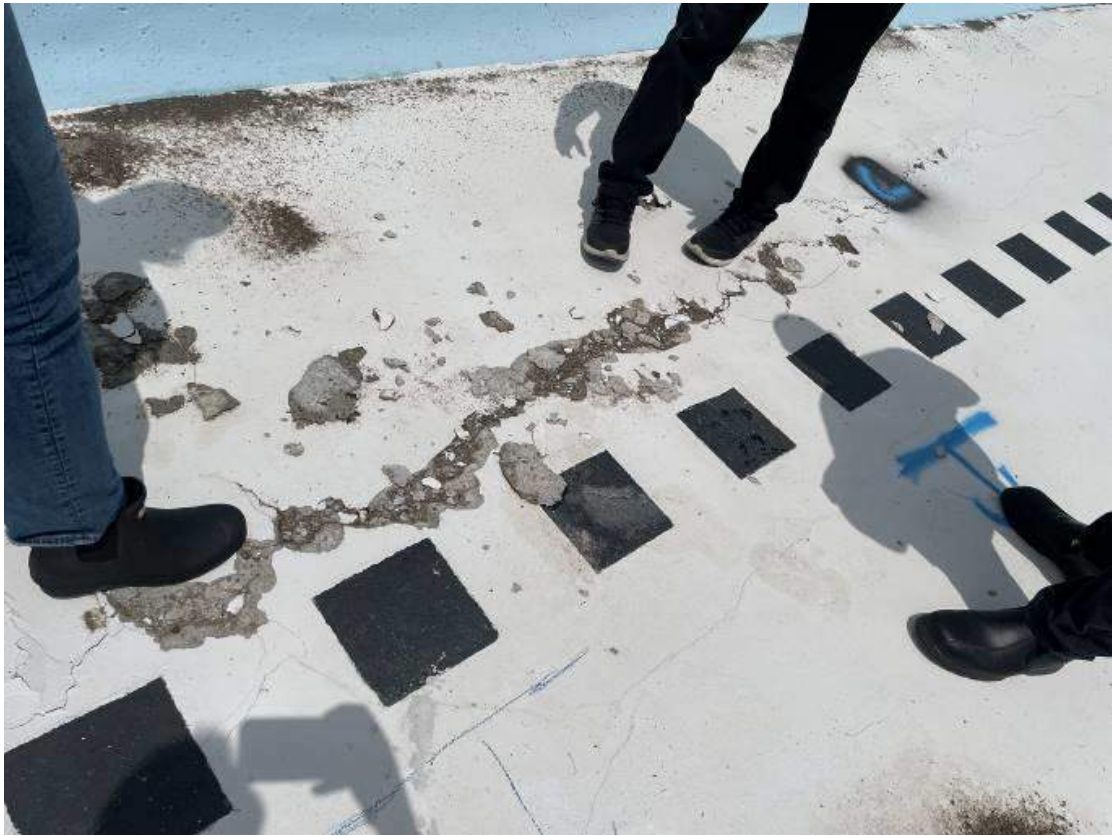
Figure 2 – Significant fracture in lane 1 at break point to deep area

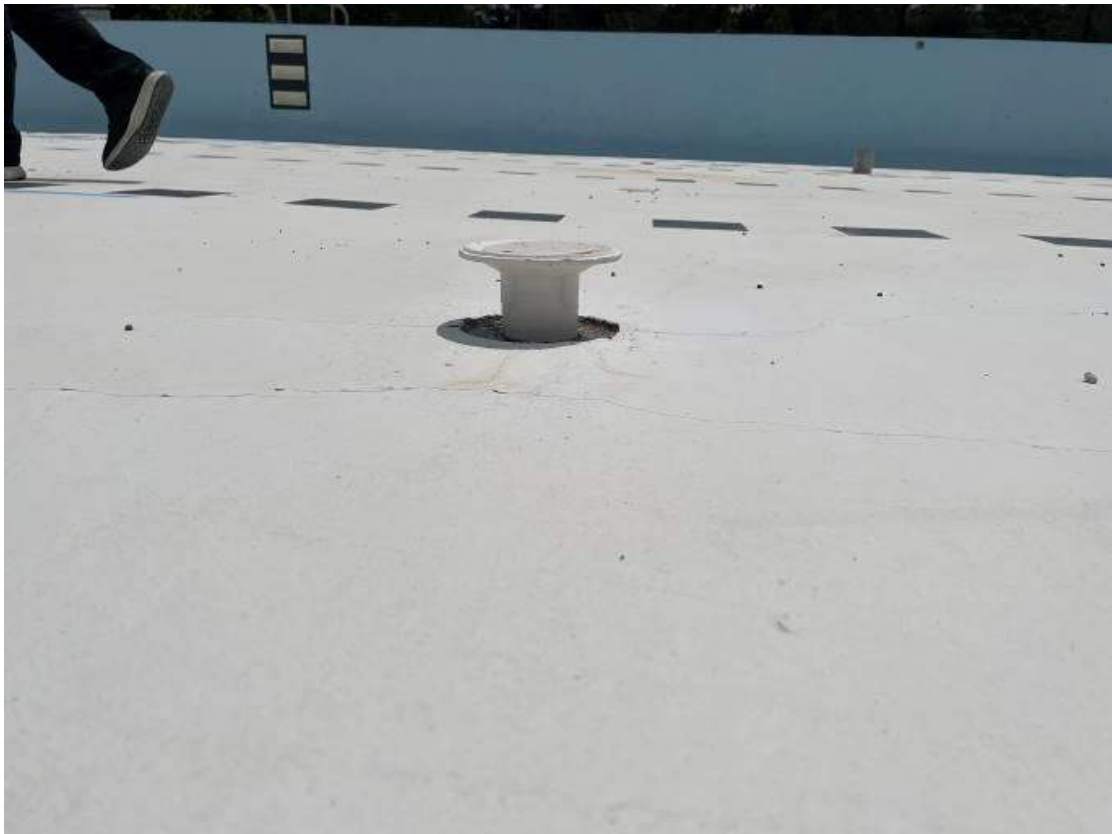
Figure 3 – Floor return protruding from pool floor

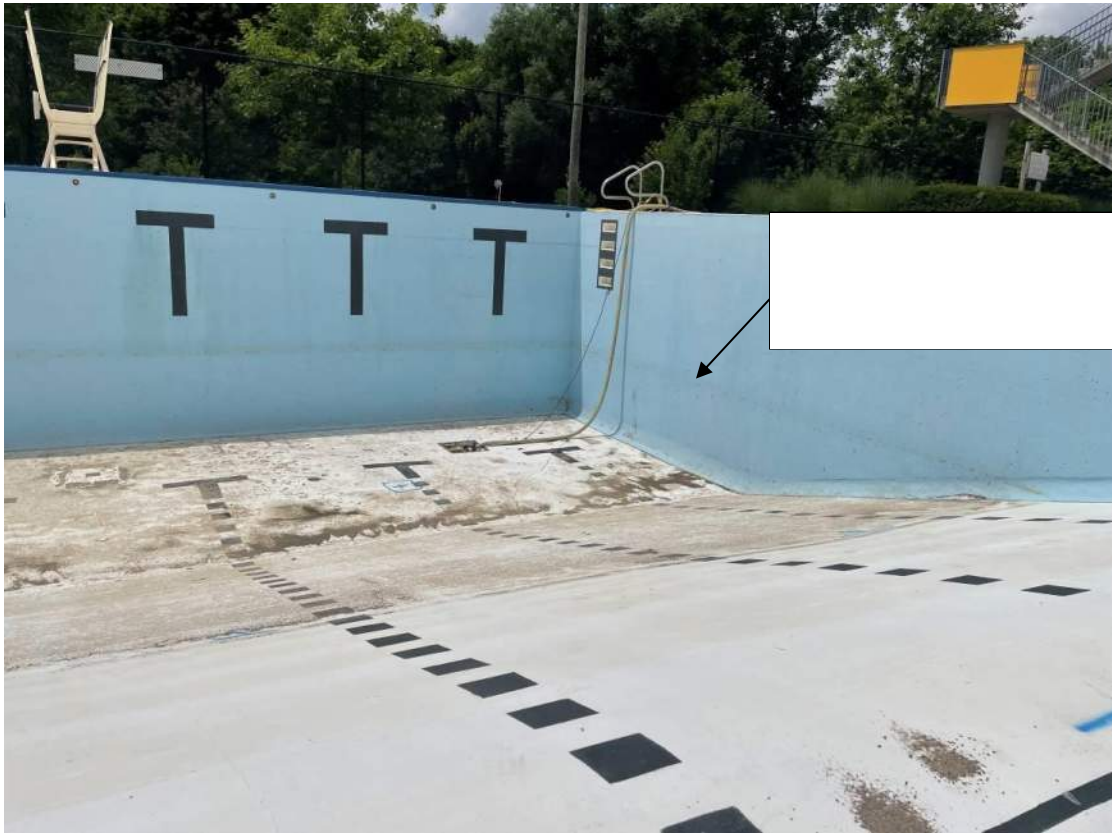
It was also noted during the site meeting at project kick-off that the pool, if left on its own drains down to the silt line as shown on Figure 4. This would indicate that the piping, either from the pool drains or return piping has a break at that level, approximately minus 8 feet (-2500) below pool deck.

Figure 4 – Debris marking water lost line, and pump extracting ground water

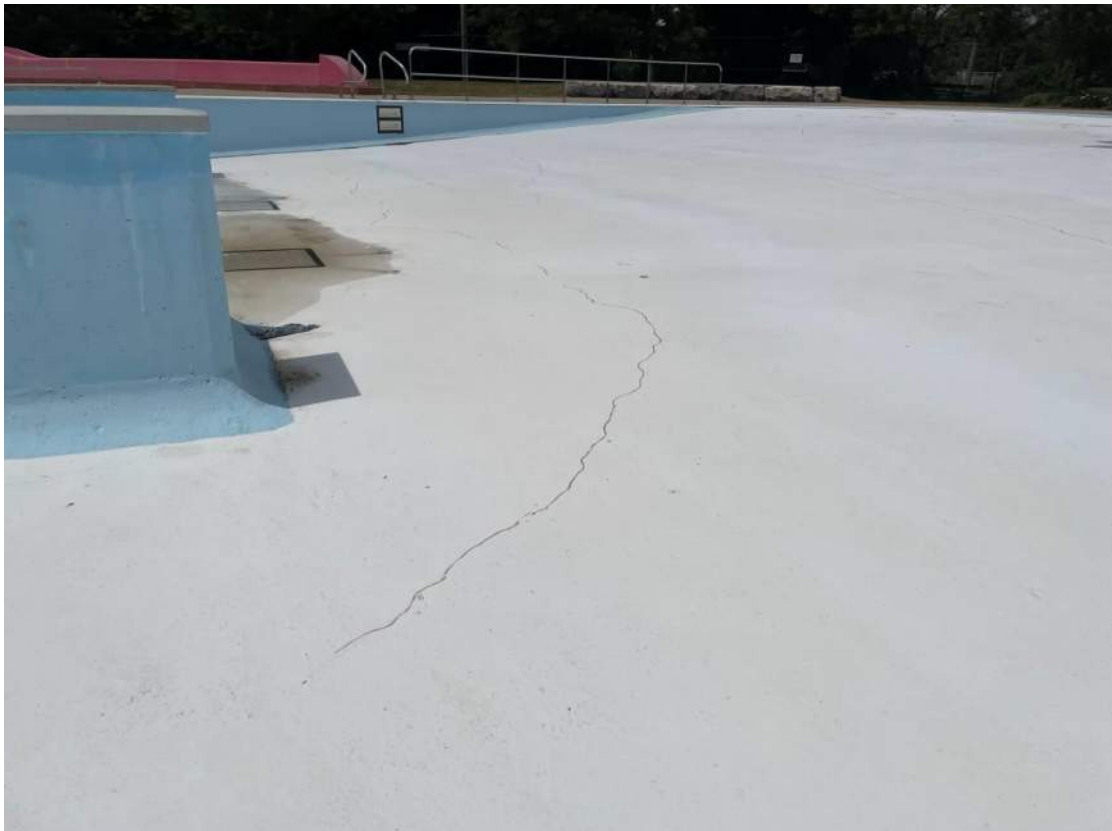
Figure 5 – Cracking within shallow end @ beach entry area

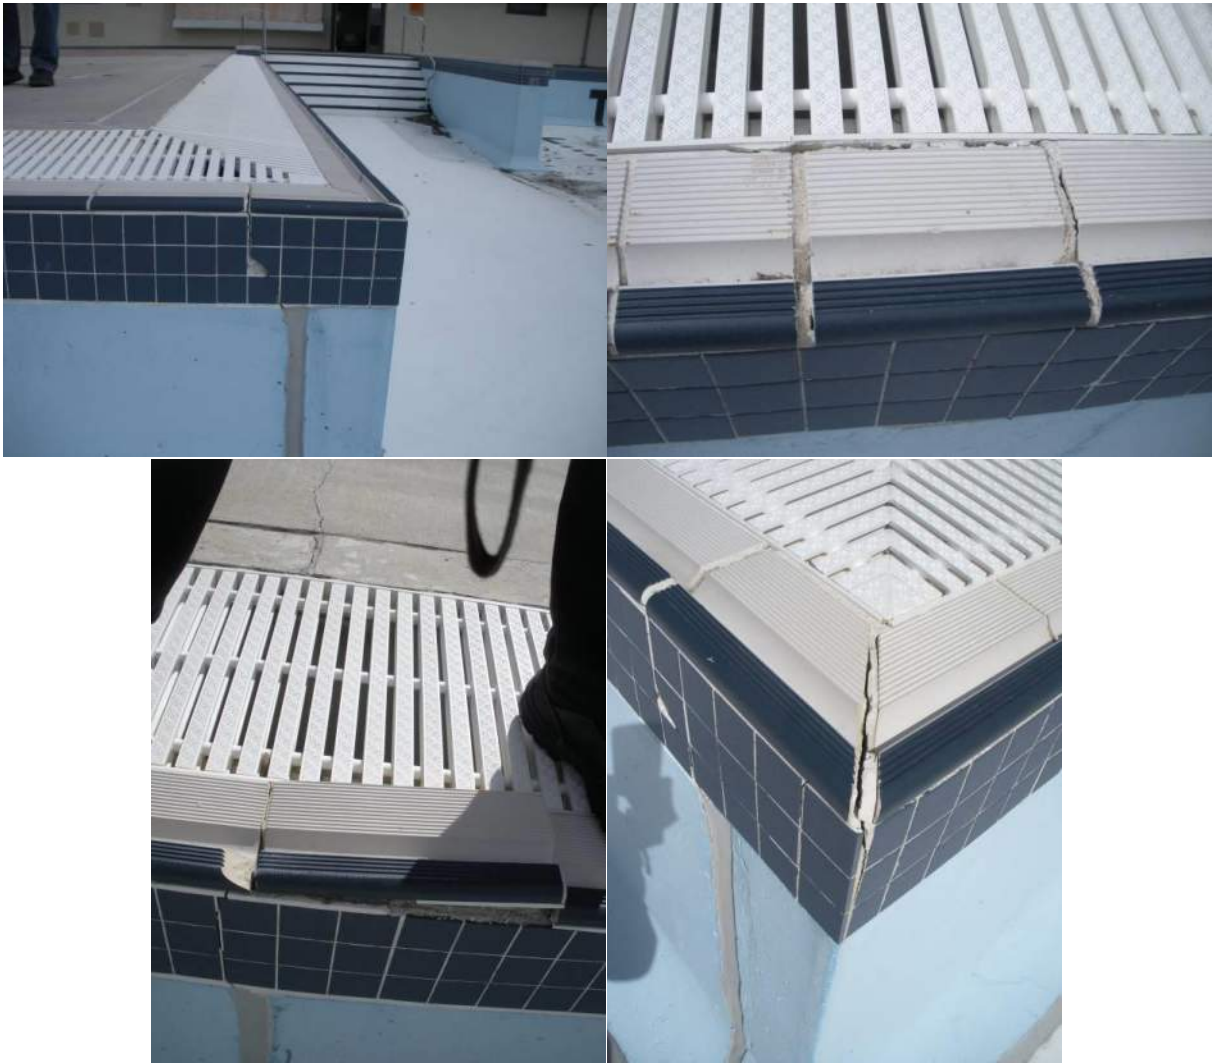
Figure 6 – Original coping damage, prior to recent renovation  
Indication of pool tank / deck movement  
(Photos from 2016)

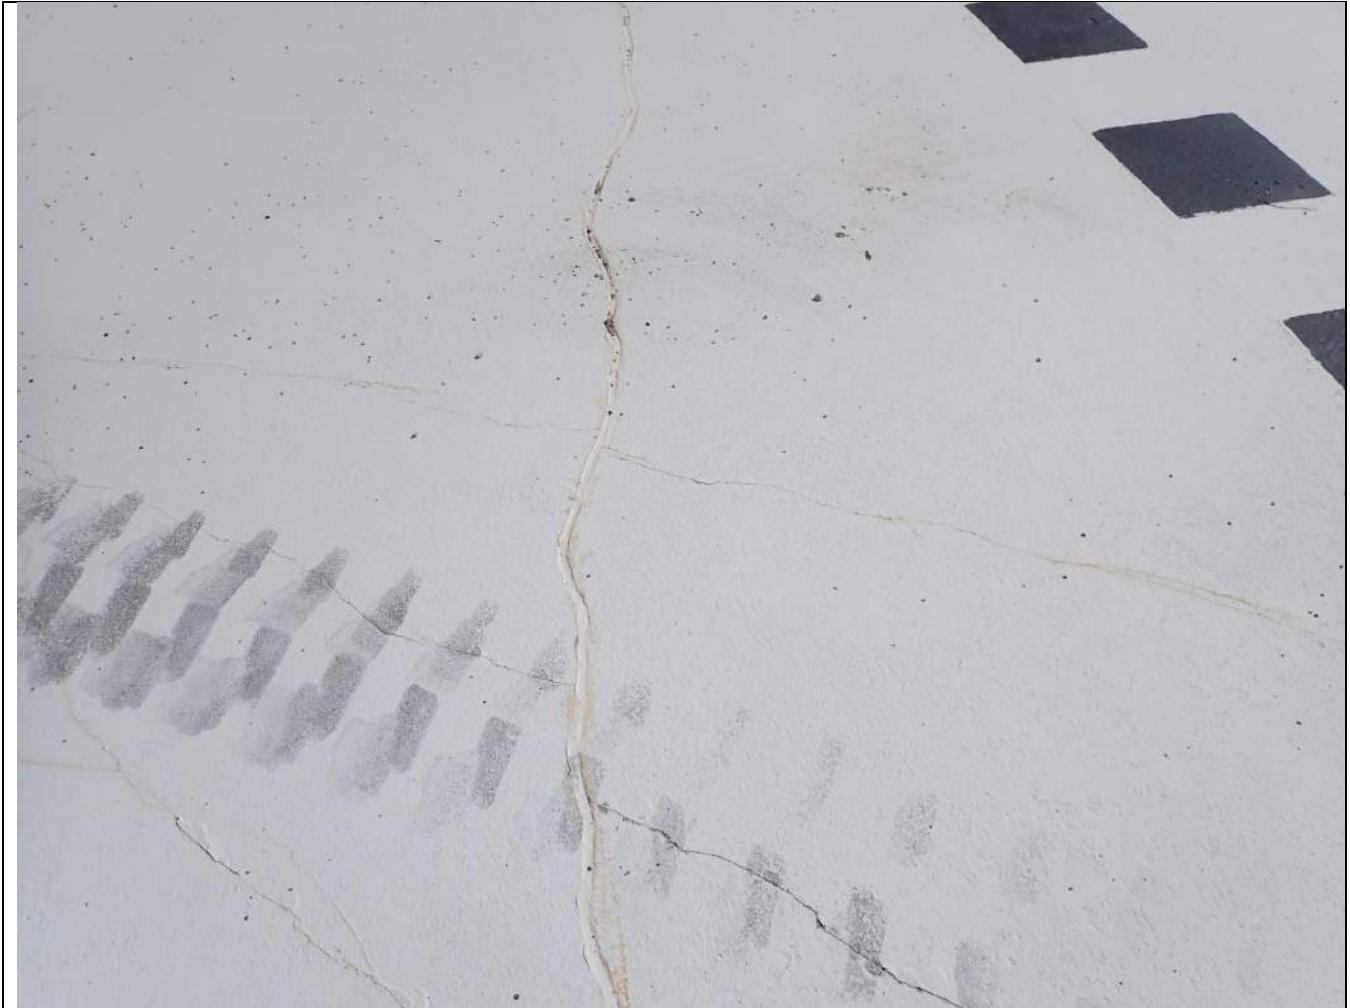
PHOTOGRAPH 7 : Large Size Cracks present in the concrete forming pool floor slab.

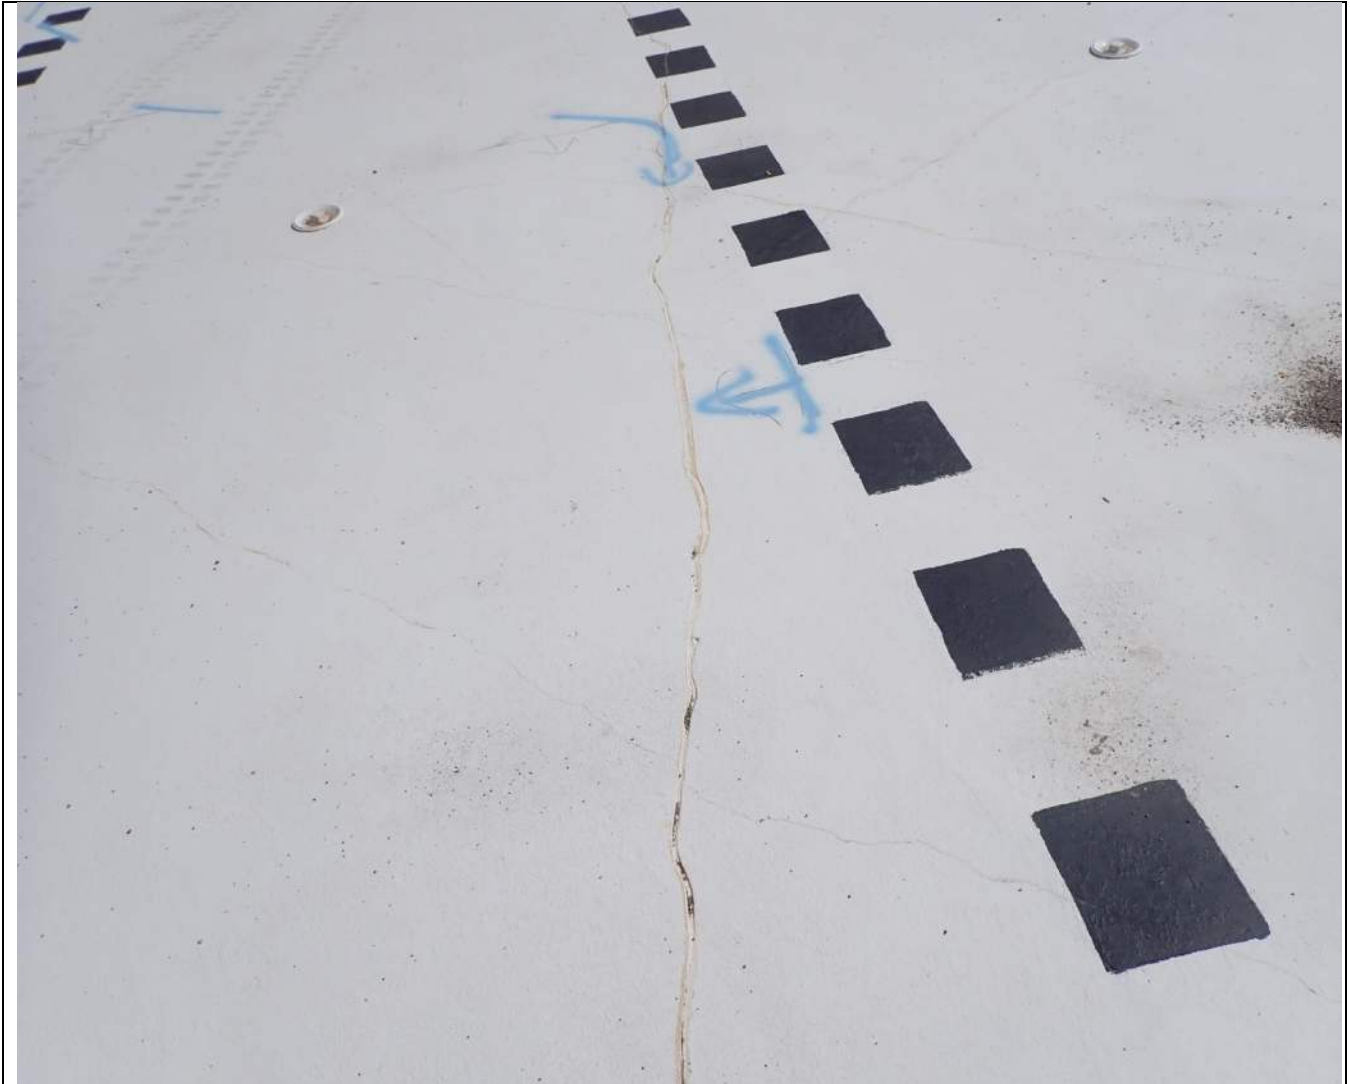
PHOTOGRAPH 8: Large Size Cracks present in the concrete forming pool floor slab.

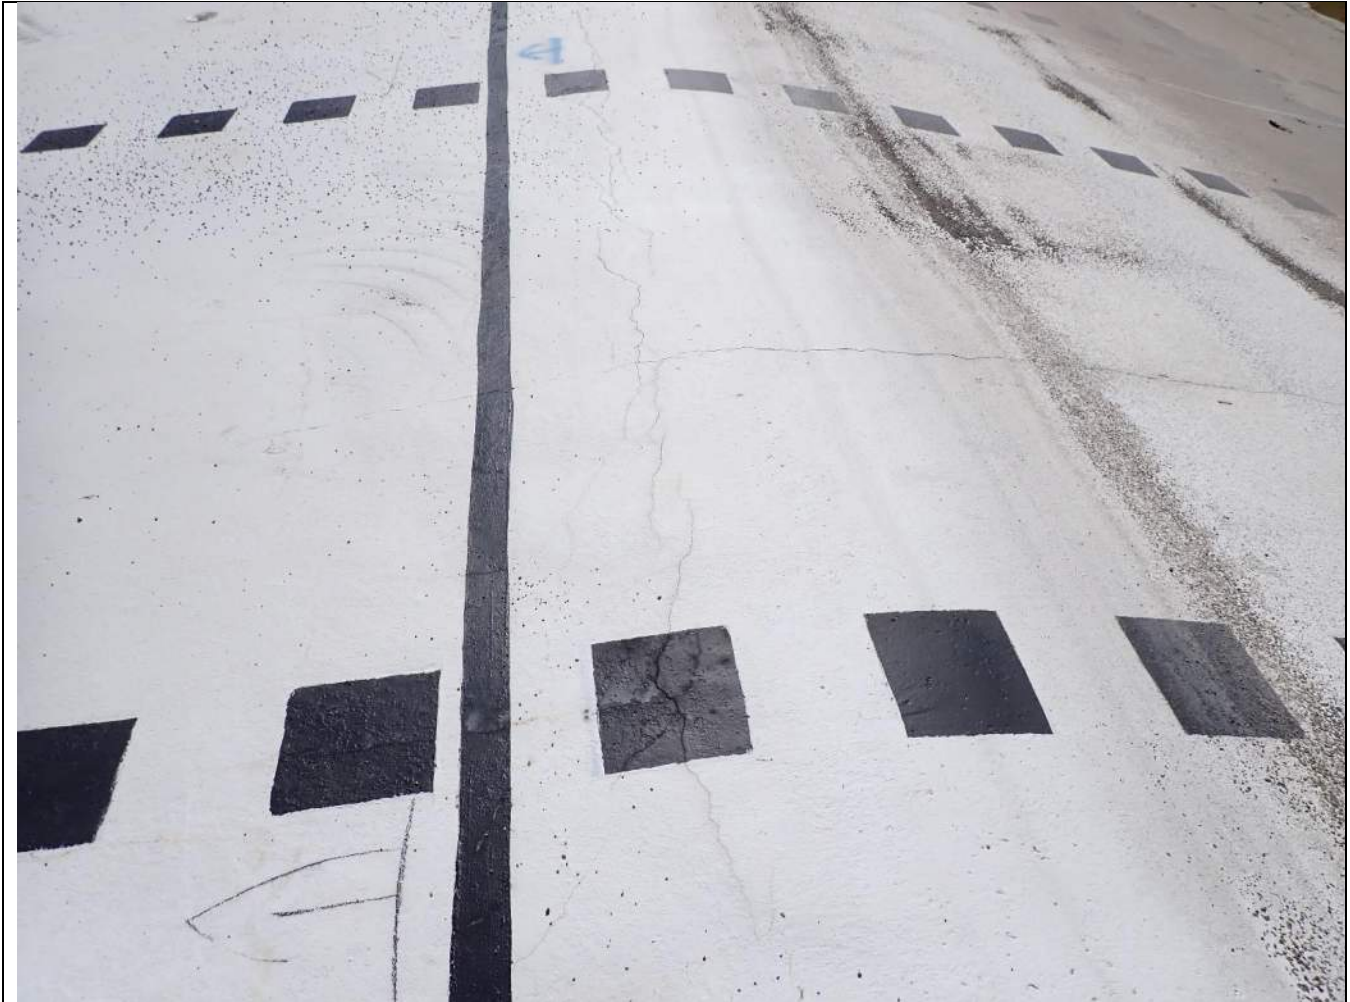
PHOTOGRAPH 9: Narrow Cracks present in the concrete forming pool floor slab.

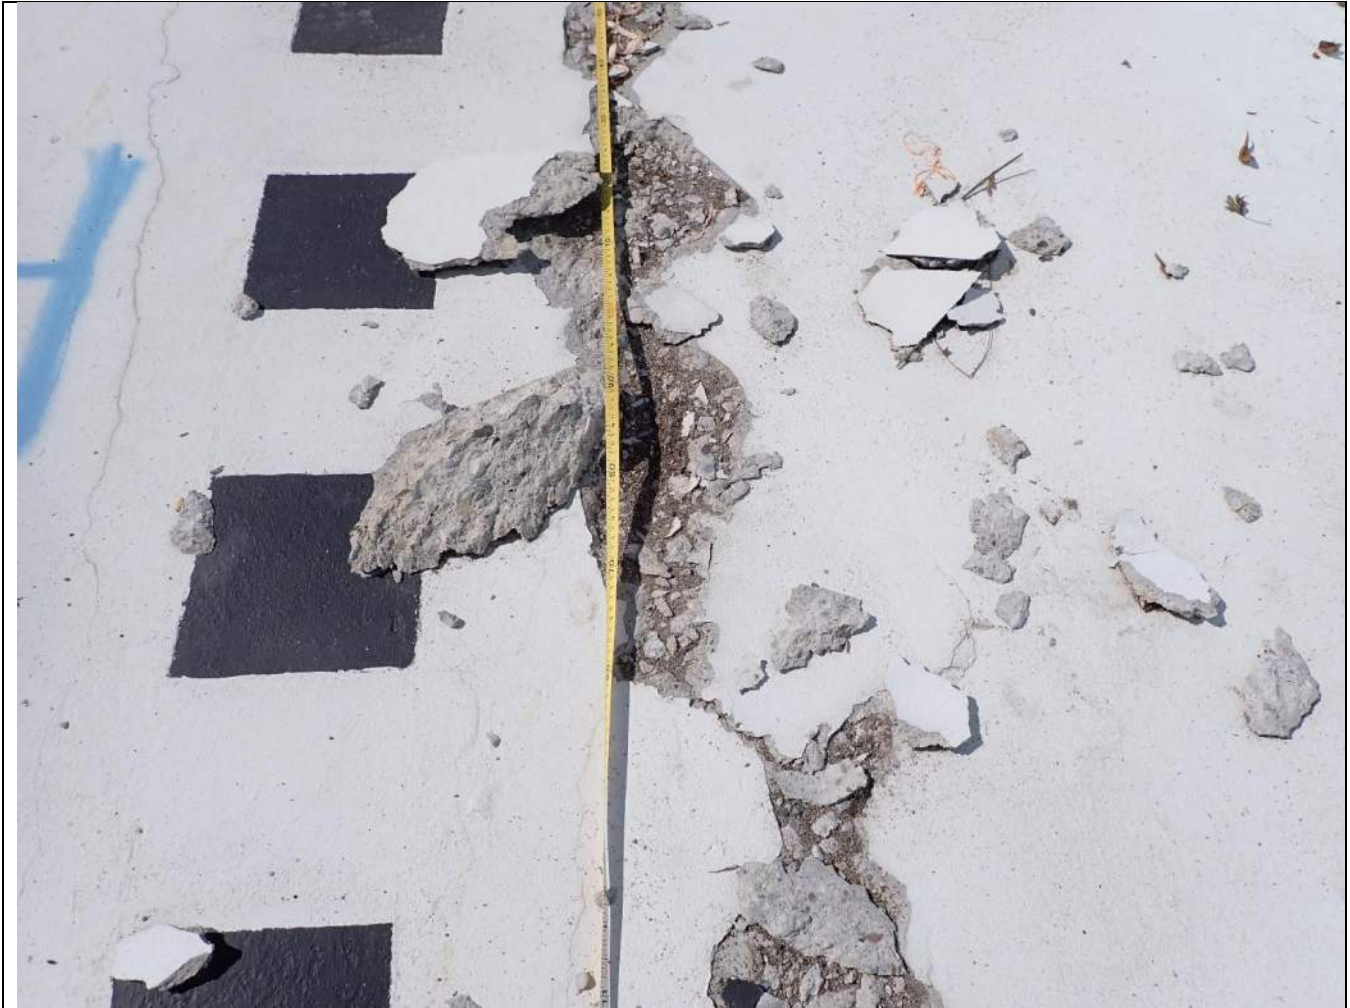
PHOTOGRAPH 10: Spalling of concrete along the crack line evident in the pool slab.

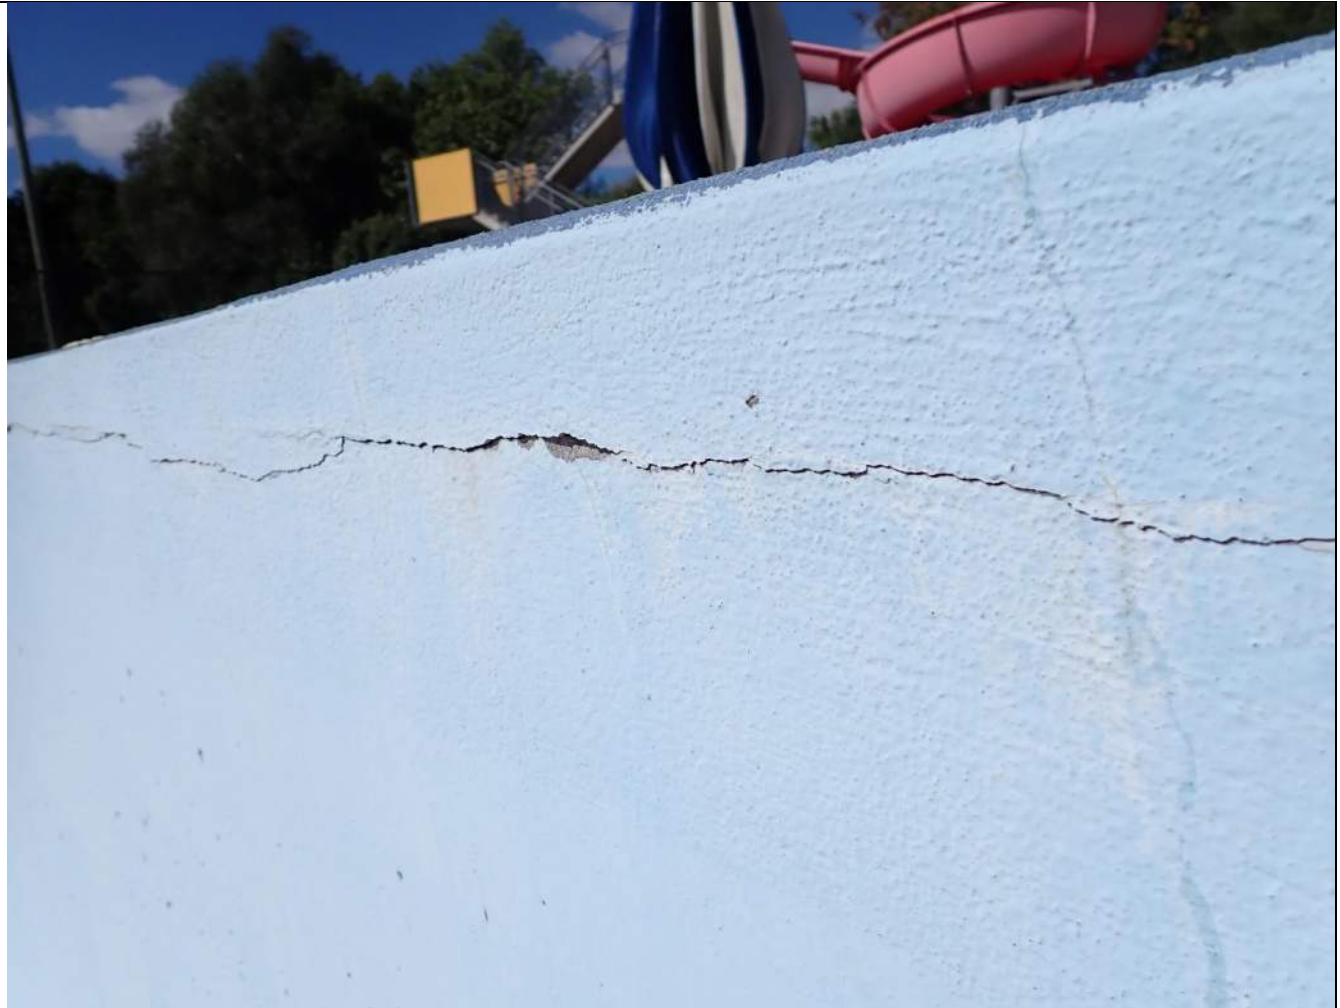
PHOTOGRAPH 11: Longitudinal cracking of the concrete forming pool wall

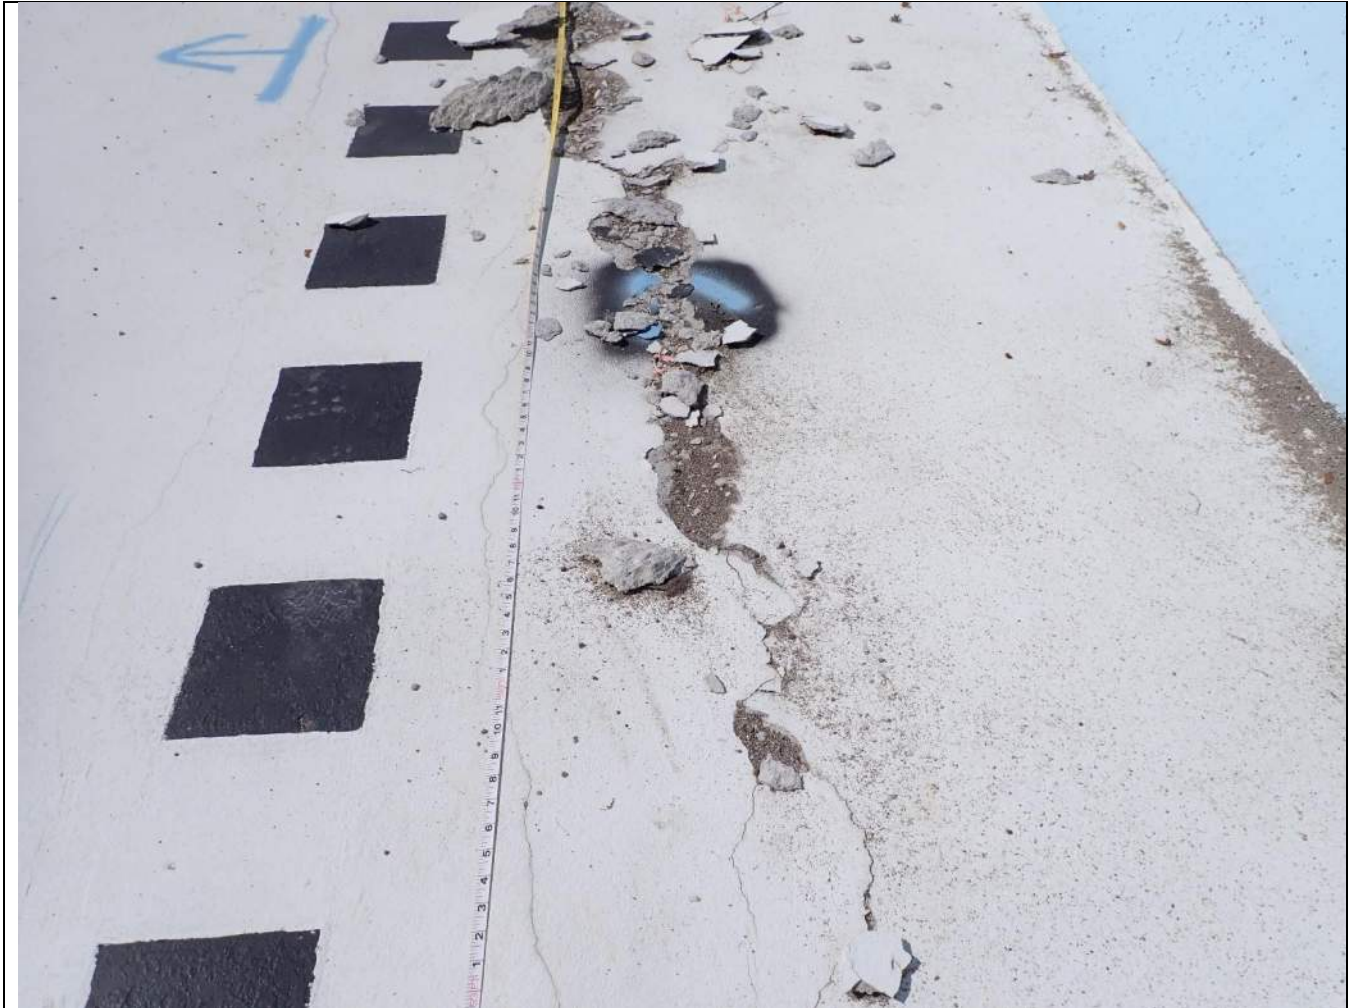
PHOTOGRAPH 12: Hydrostatic pressure evident in the form of subgrade material forced out along the crack line.

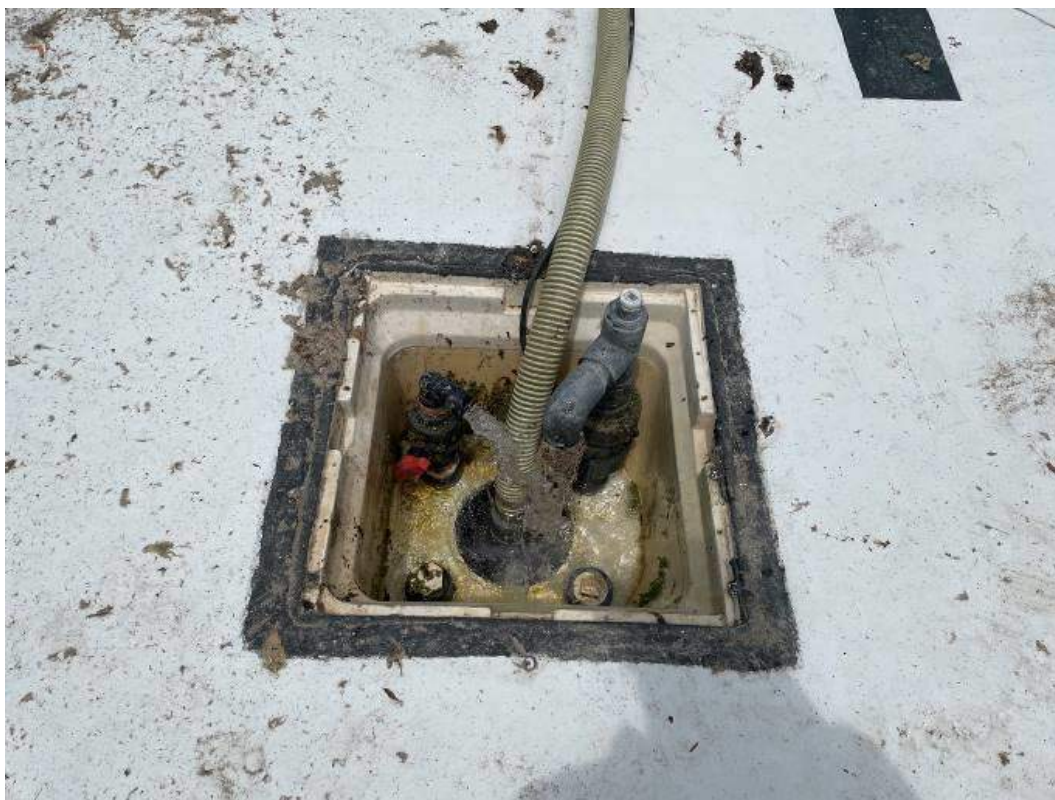
During the initial site meeting in September 2022 to discuss the project, the pool was empty to allow for visual inspection. The hydrostatic relief valve in one of the main drains was open to permit the release of ground water and pressure on the tank. A submersible pump was used to discharge the incoming water as quickly as it was entering the pool tank. See Figure 1.

Report I - Ground water in main drain, with pump, June 2022

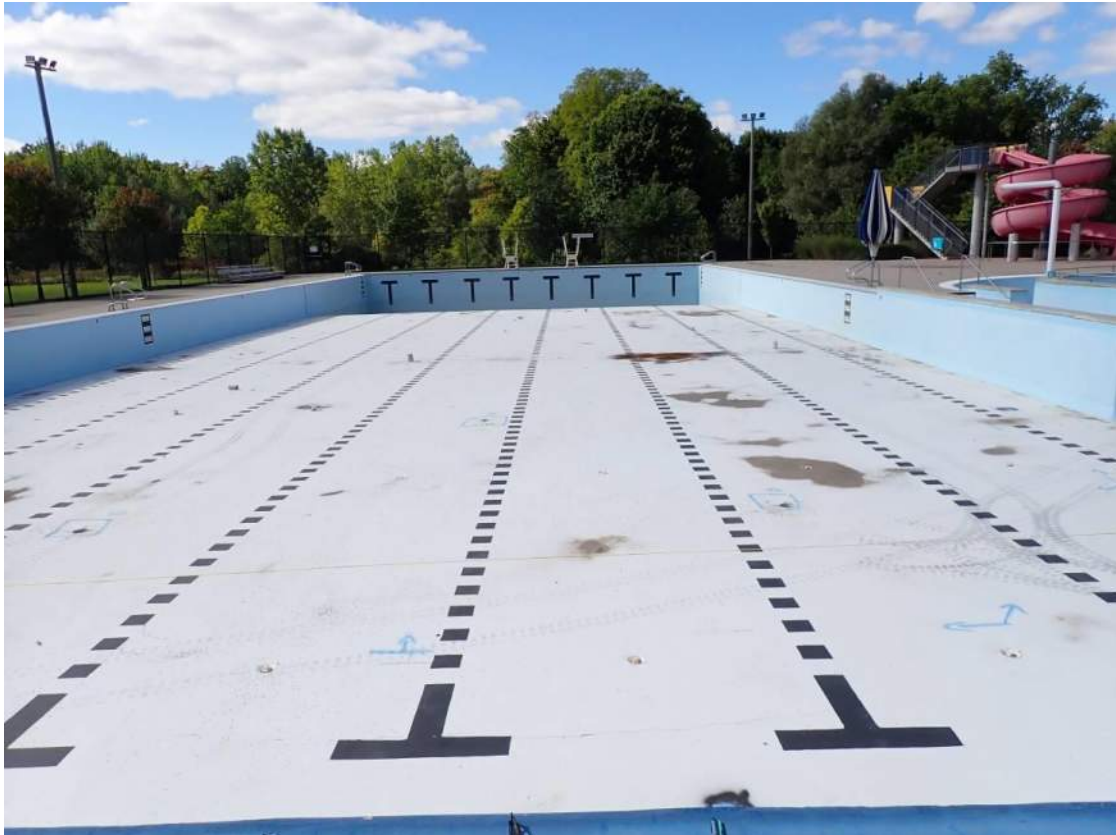
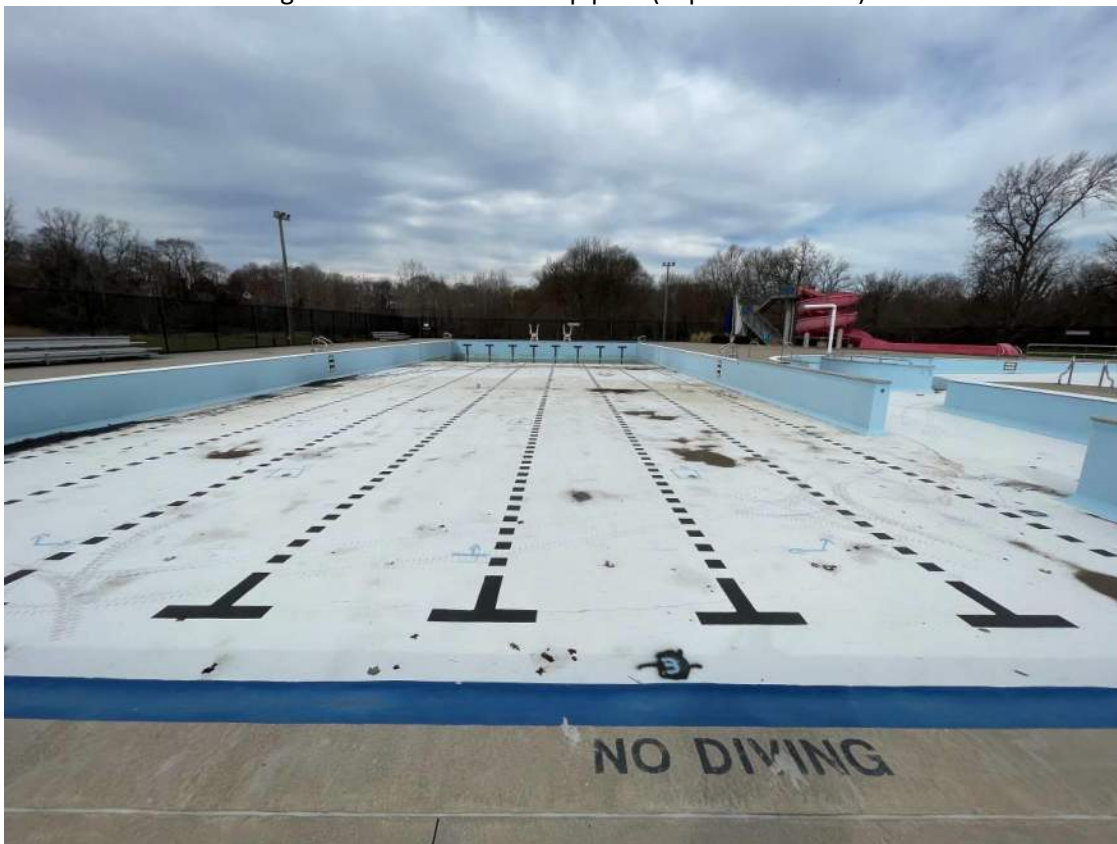
Figure 1a – Overview of lap pool (September 2022)

Figure 1b – Overview of lap pool (April 2023)

Additional sand has accumulated within the pool tank around the core sample openings indicating ground water under the pool forcing granular materials (backfill) from under the pool into the pool tank.

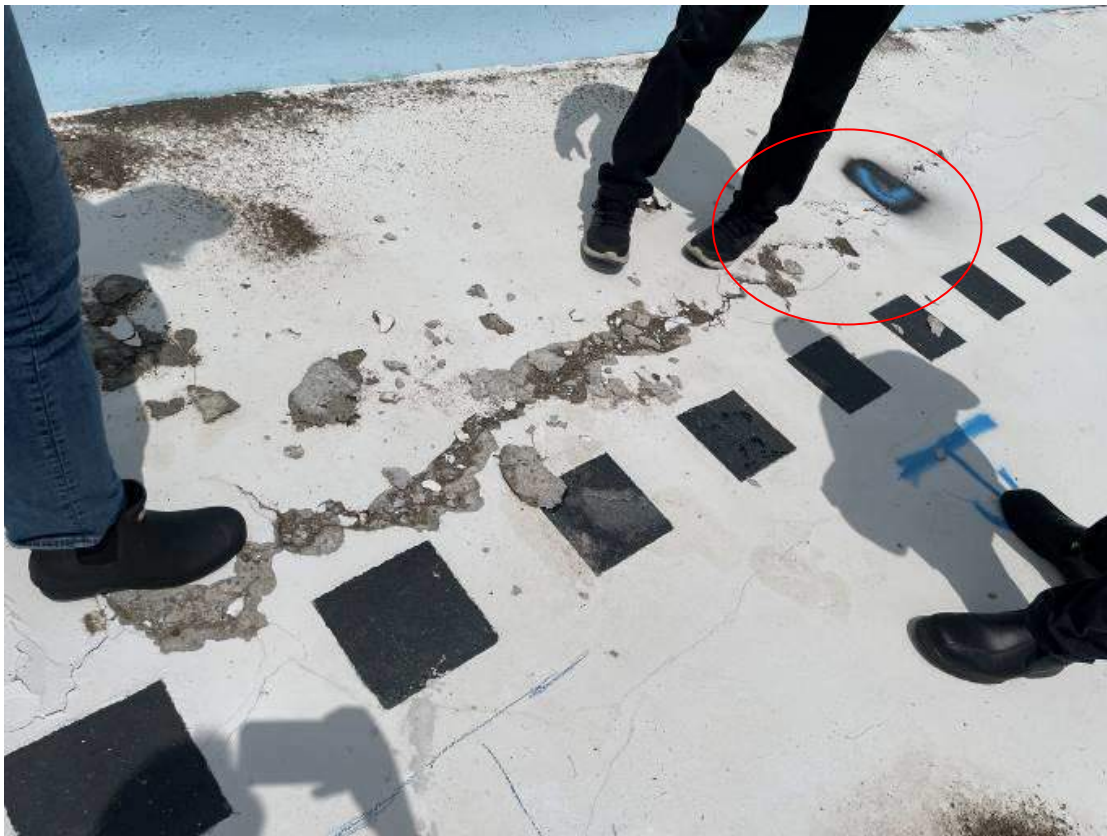
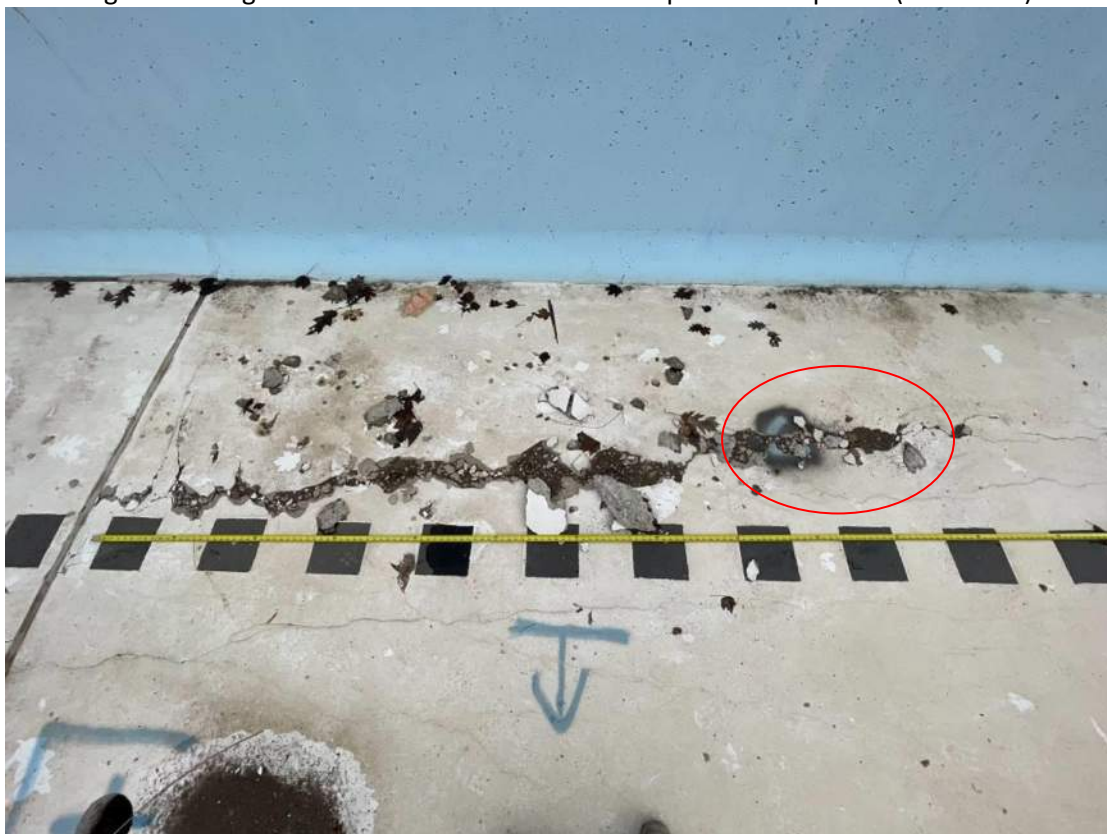
Figure 2a – Significant fracture in lane 1 at break point to deep area (June 2022)

Figure 2b – Significant fracture in lane 1 at break point to deep area (April 2023)

The cracking along lane 1 near the break point has increased and the crack now extends from the break point to the shallow end wall, indicating further stress placed on the tank due to ground water and freeze / thaw conditions.

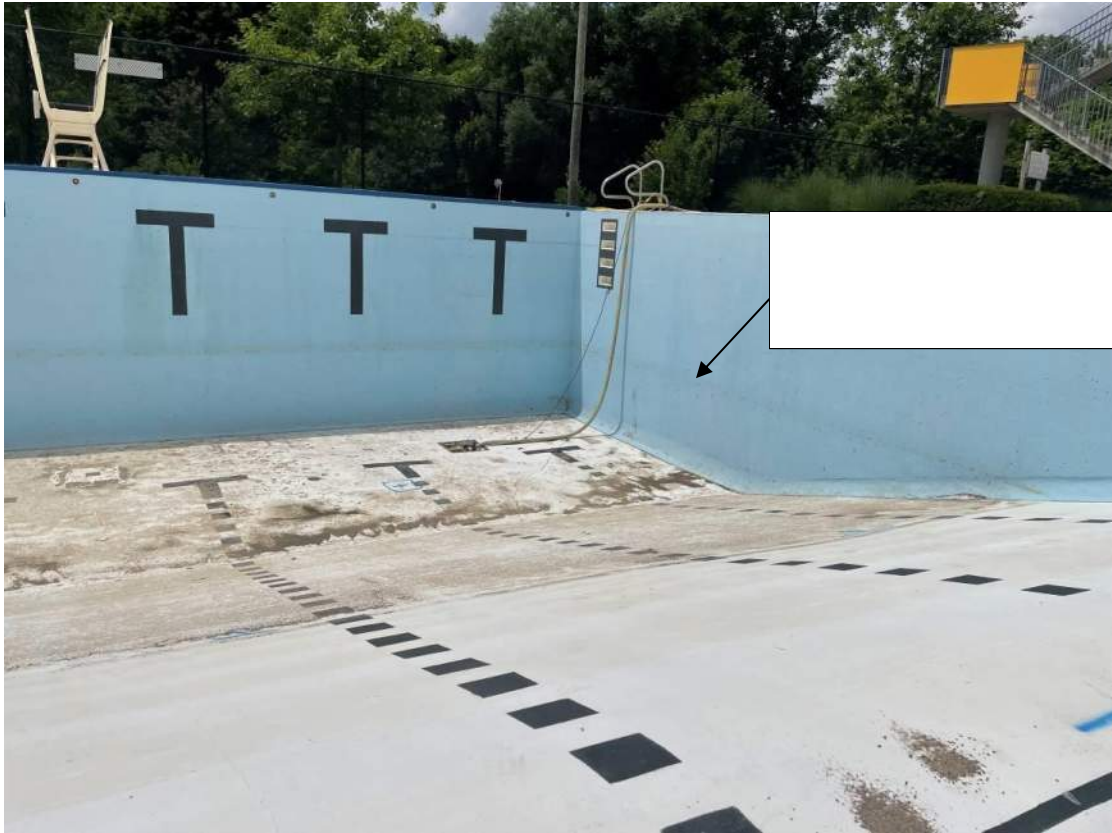
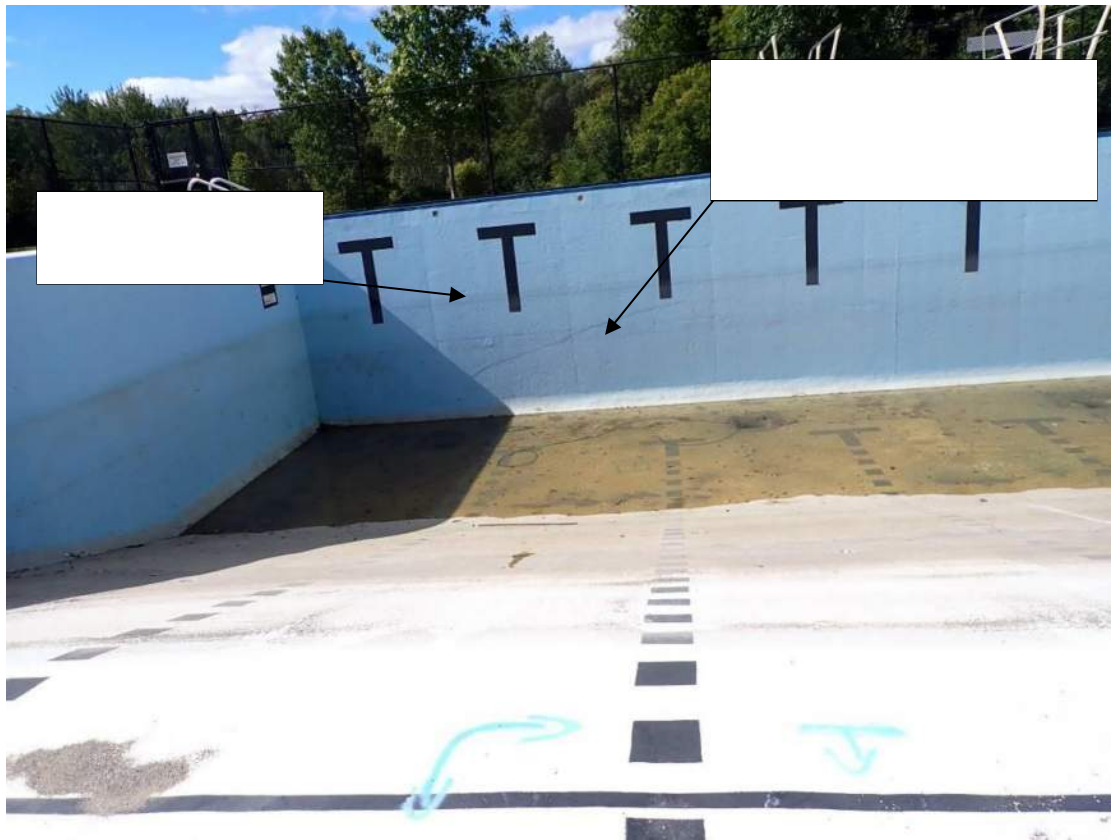
Spring flood conditions occurred in Thames Park in late March 2023. A photo taken April 6, 2023, shows the debris line in Thames Pool consistent with the flood level. (Figure 3b) The water in the tank equalizes with the external hydrostatic pressure of the flood waters.

Figure 3a – Debris marking water lost line, and pump extracting ground water (June 2022)

Figure 3b – Debris marking water flood line and lost water line (April 2023)

Ground water the week prior to site meeting was noted within the flood plain and lower field, approximately at the same level as the debris line on the pool wall.
