**Subject:** Thames Pool Condition Update and Repair Options

**Date:** July 18, 2023

Existing review for City of London

Thames Pool  
15 Ridout Street S.  
London, ON  
N6C 3W6

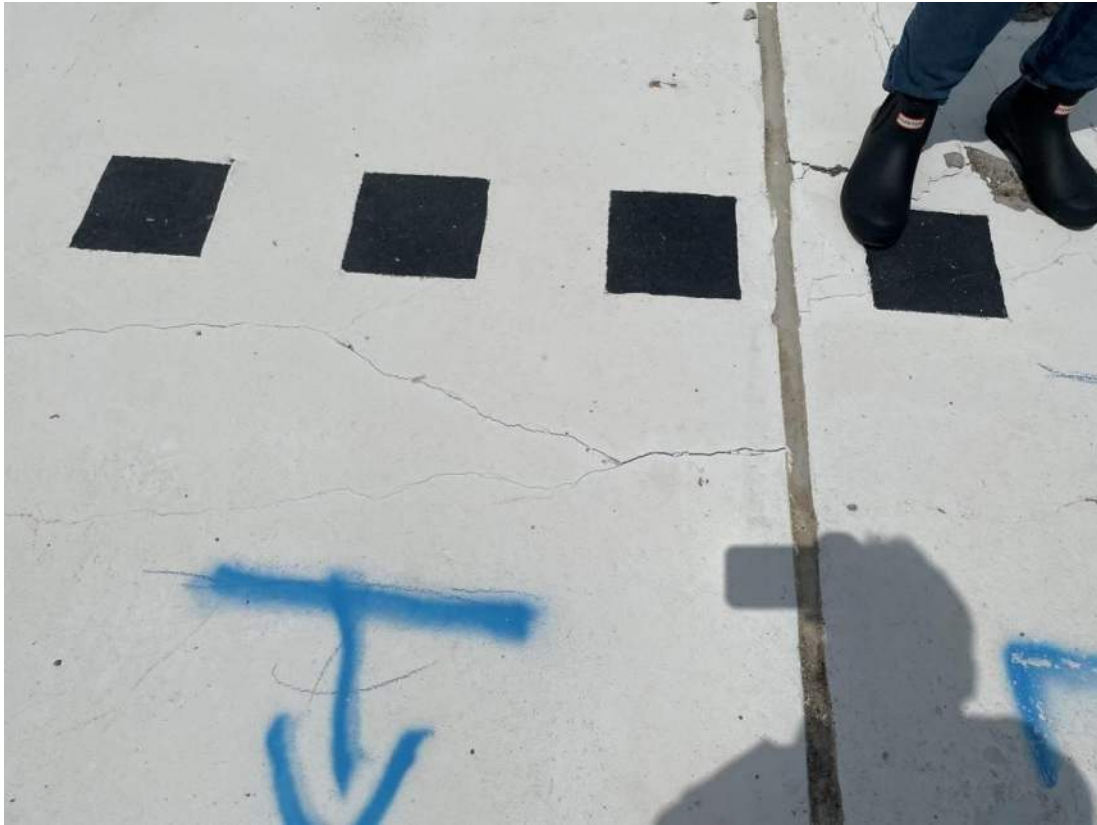
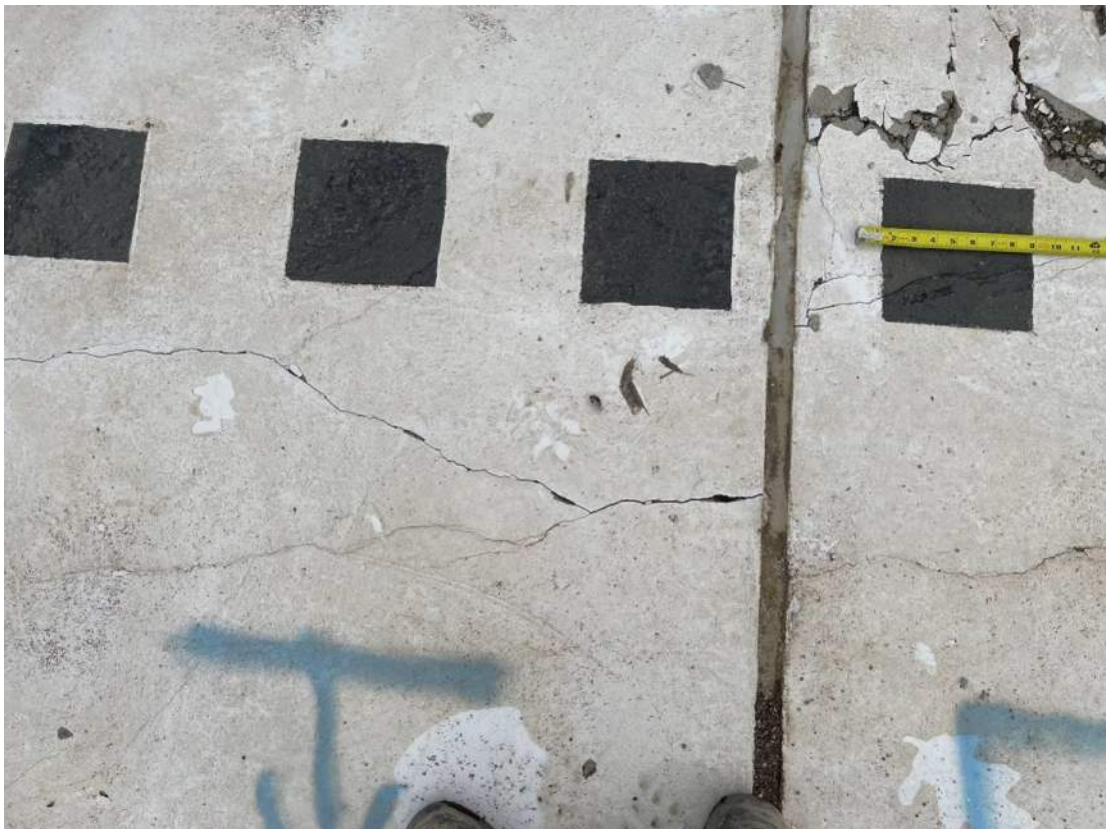
Figure 4a – Fracture in lane 1 at break point to deep area (June 2022)

Figure 4b – Fracture in lane 1 at break point to deep area (April 2023)

Cracking along the lane 1 towards the deep end is increasing in length as well as the crack is opening. (becoming wider)

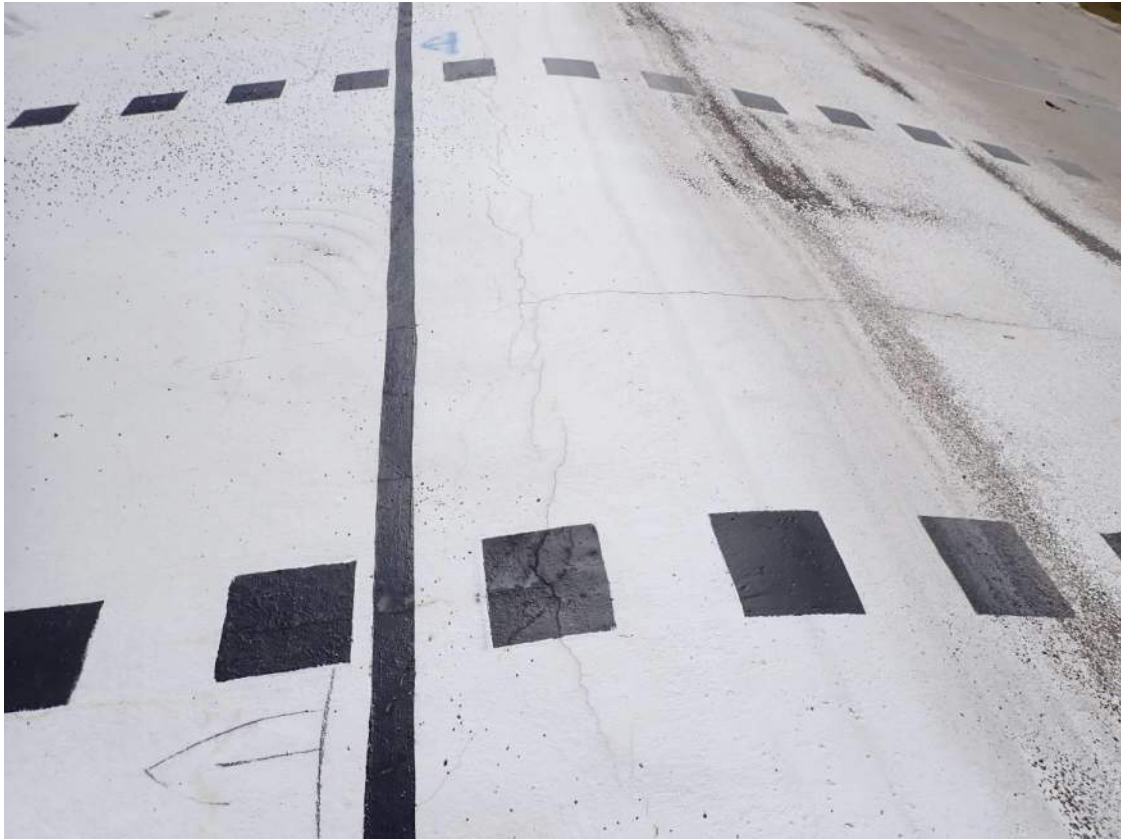
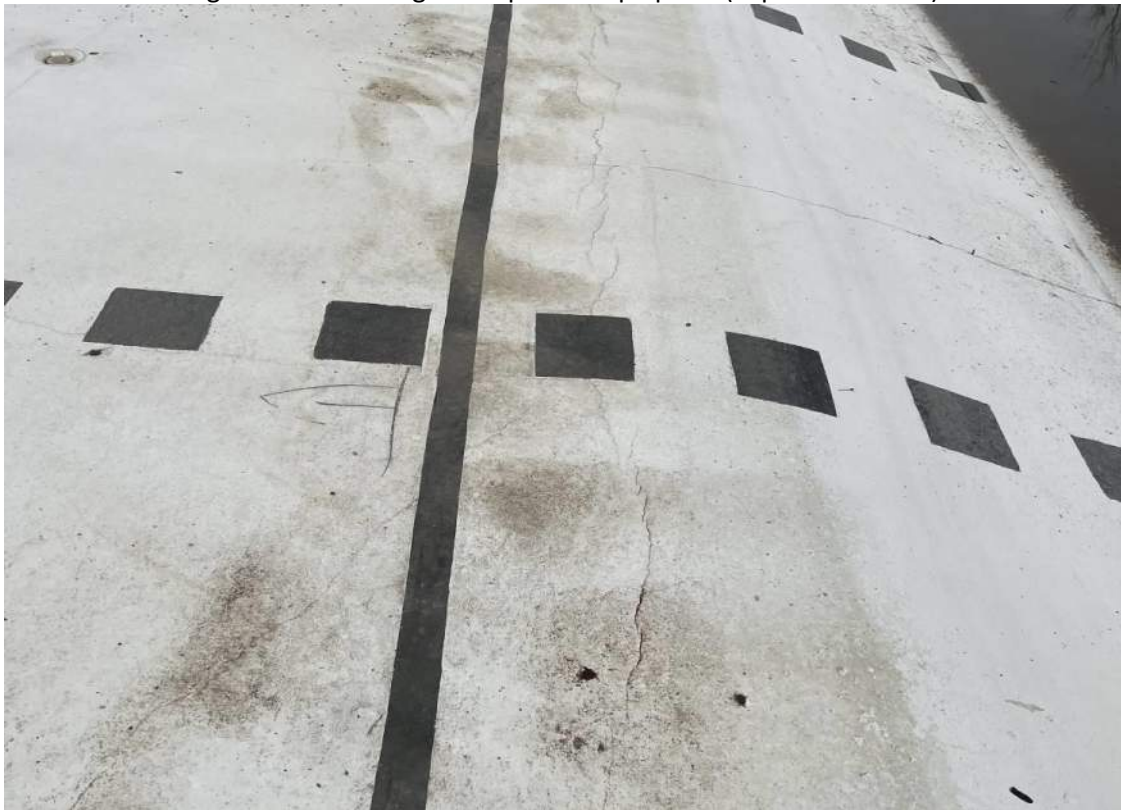
Figure 5a – Cracking at deep-end slope point (September 2022)

Figure 5b – Cracking at deep-end slope point (April 2023)

Cracking along the break point across the pool with the deep end on the right side of the photo is increasing in length as well as the crack is opening (becoming wider) in places.

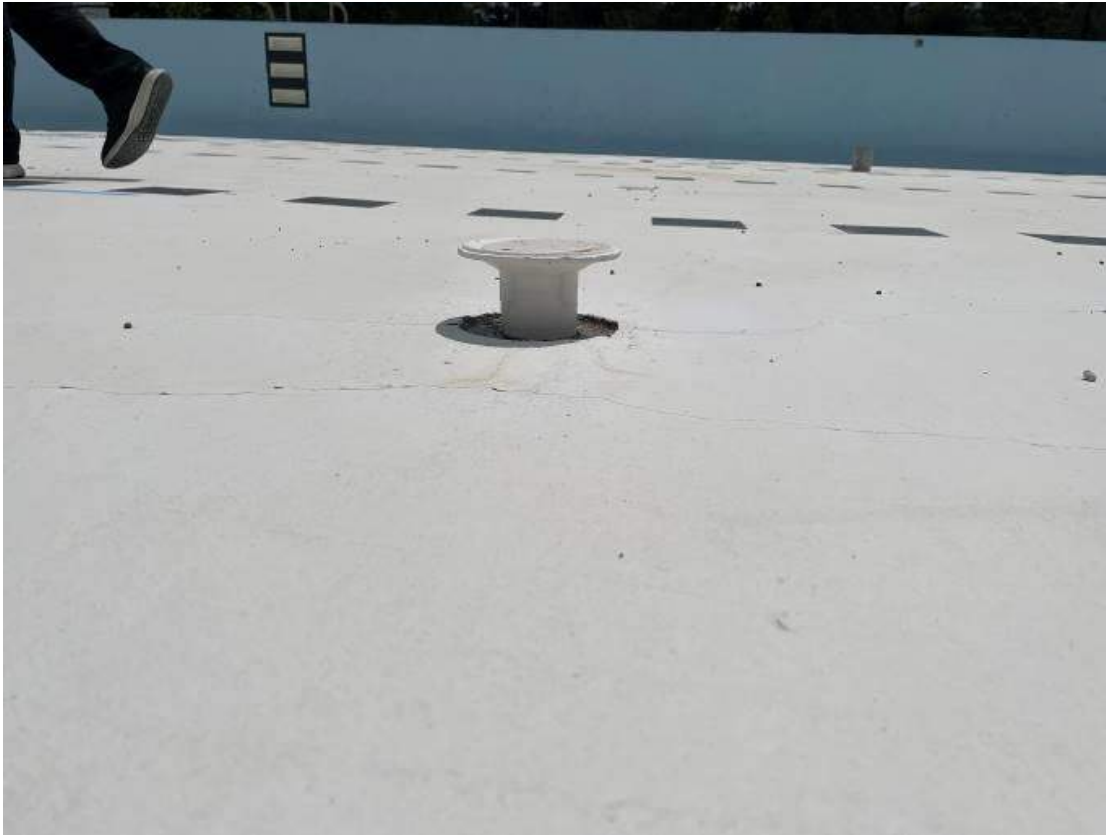
In Thames Pool specifically, both the suction (main drain lines) and the return (supply lines) piping system is below the pool floor. This means the piping is buried in the soil below and around the pool. The Report I – Preliminary Review discusses the breaks and movement in the pipes and how it has shifted. The below photo shows the return water fitting pushing through the concrete floor of the pool.

Figure 7, Report I – Preliminary Review – Floor return protruding from pool floor, June 2022

From this observation the concrete pool floor must be removed to correct the piping.
