REGINA MUNDI CATHOLIC COLLEGE

LONDON, ON | HERITAGE IMPACT ASSESSMENT
AUGUST 15, 2018; REVISED JULY 18, 2023

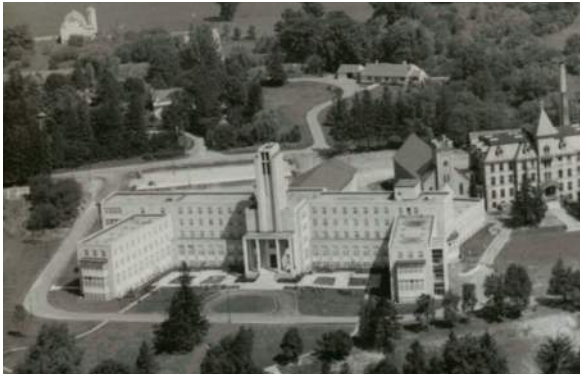
Aerial photo of Mount St. Joseph (Congregation of the Sisters of St. Joseph in Canada Archives, 2014).

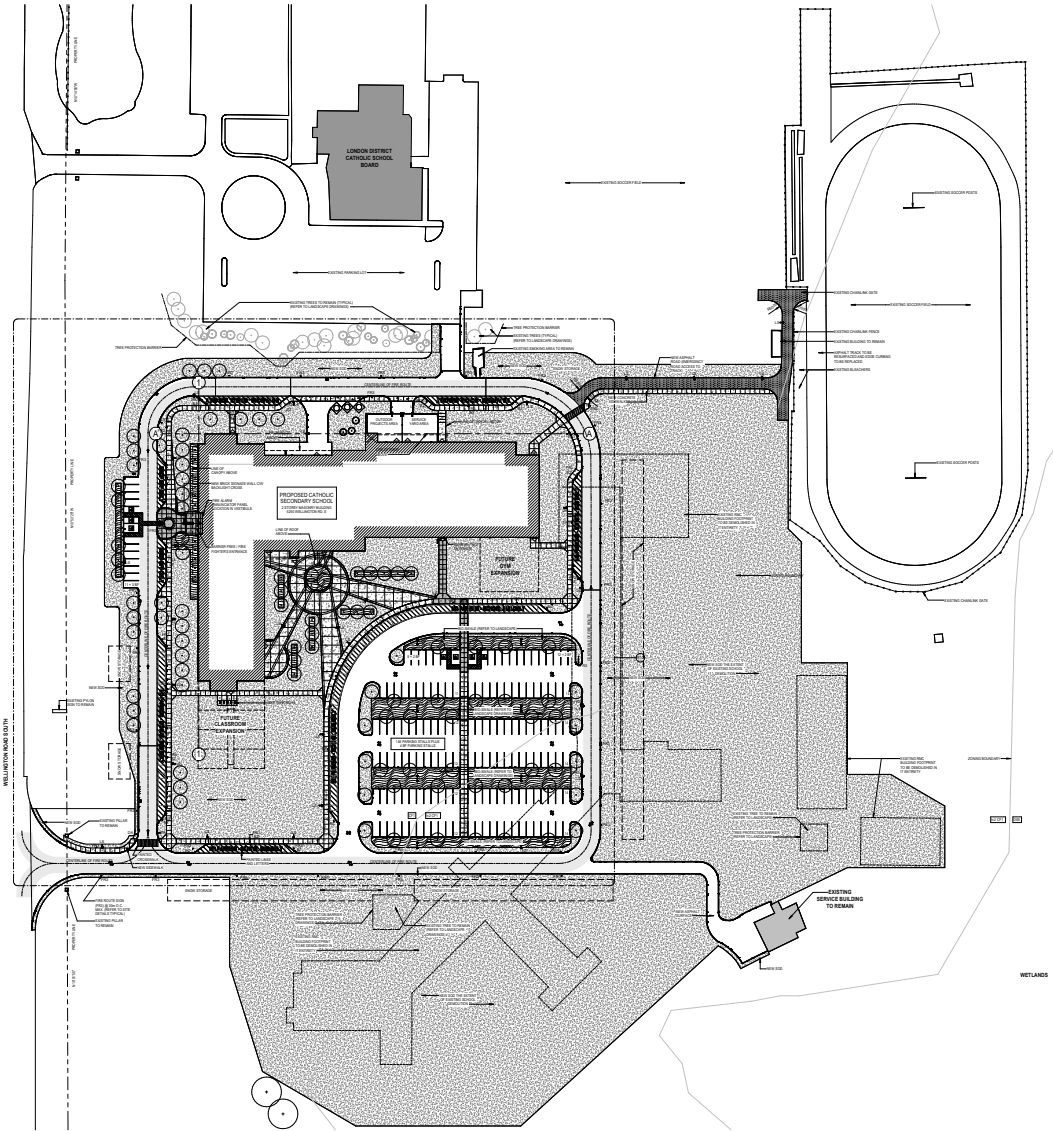
Proposed site plan overlaid with existing Regina Mundi College building footprint (Nicholson Sheffield Architects, 2023).

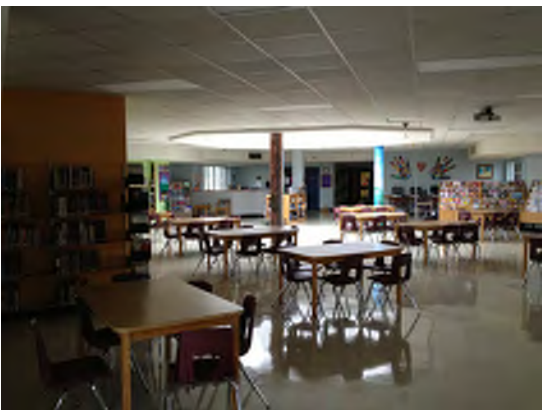
A summary of the costs related to upgrades and refurbishment of RMC can be found at the end of this report.

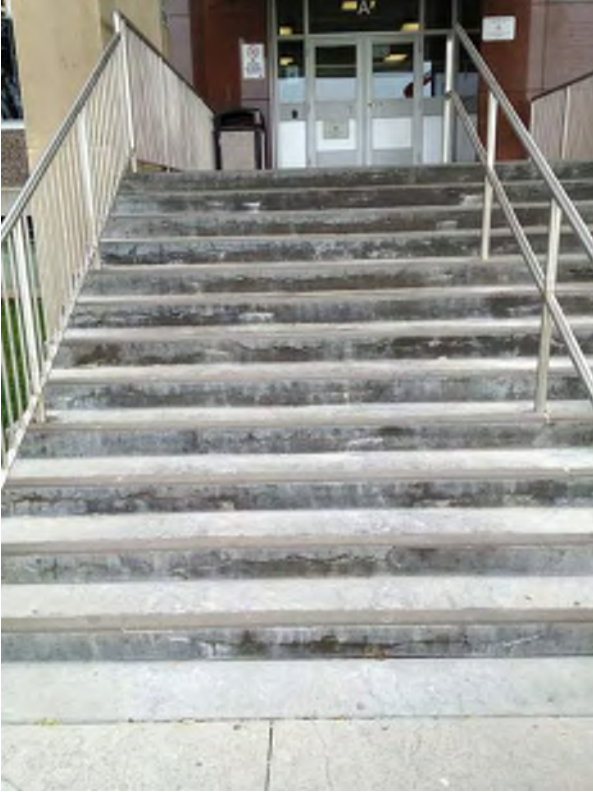
Existing front entry stairs and sidewalks have been replaced in the last decade, yet show signs of damage and wear. Intermediate handrail spacing does not comply with current building code

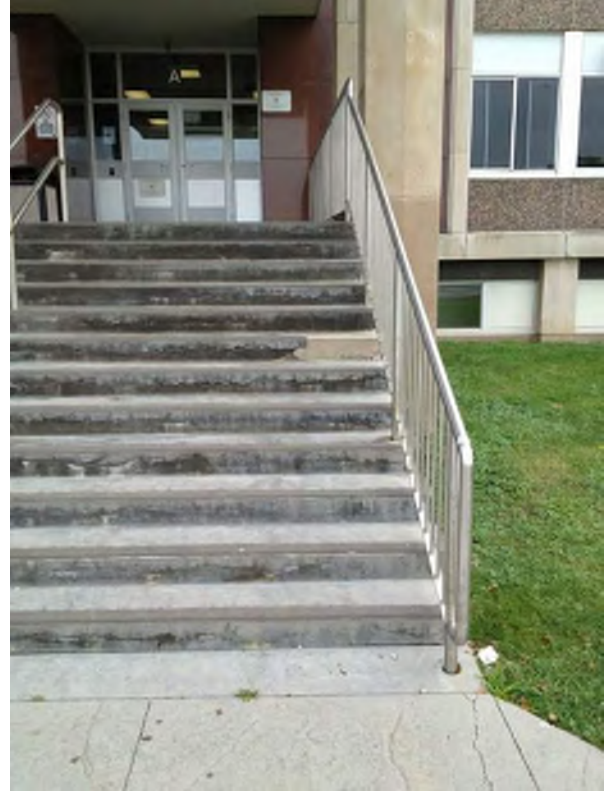
Front entry exterior stairs

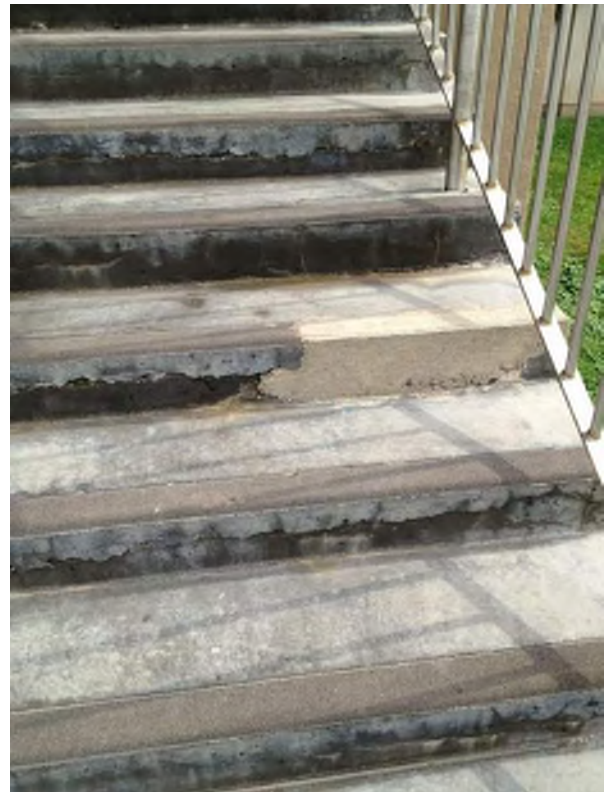
Front entry exterior stairs

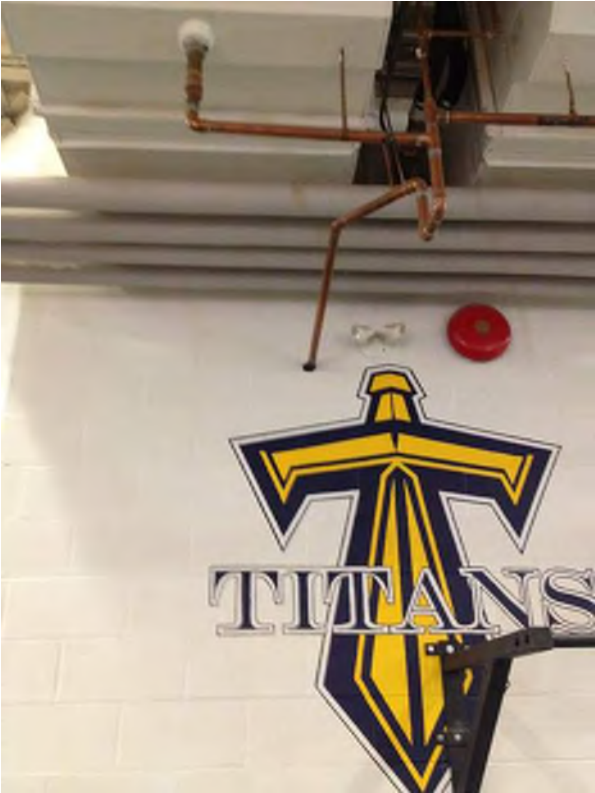
Firestopping missing at pipe penetration.

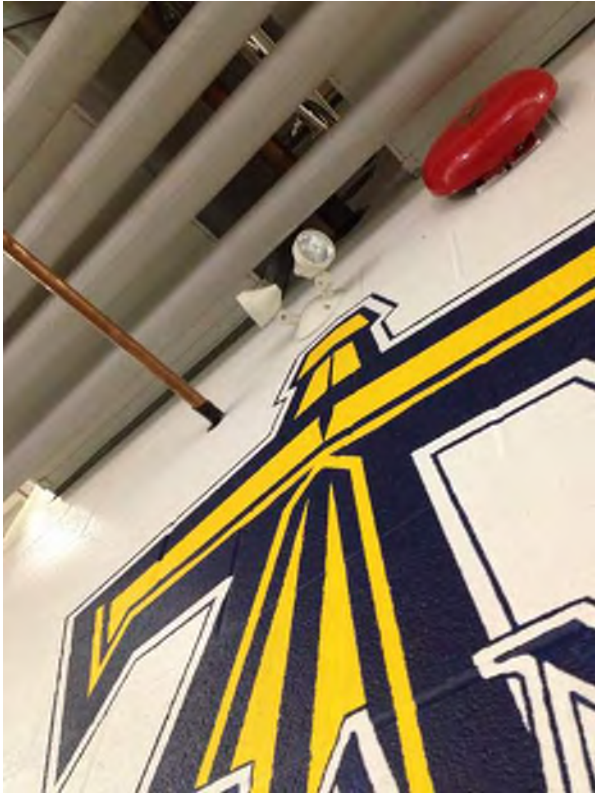
Firestopping missing at pipe penetration.

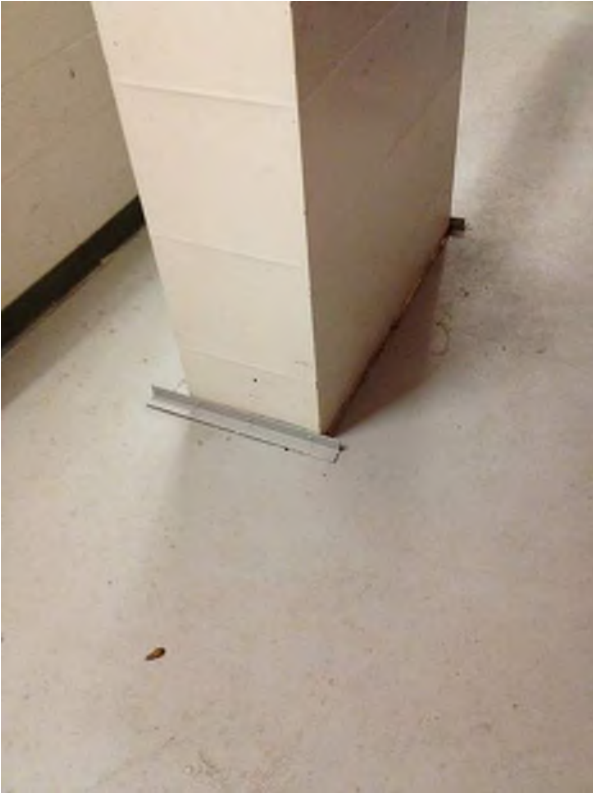
Duct penetration at fire-rated floor not firestopped; damper missing

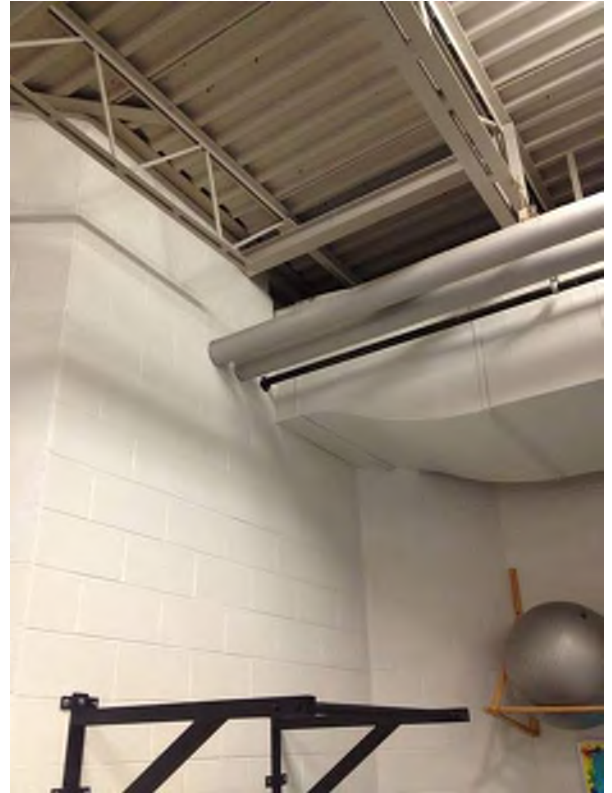
Firestopping missing and fire separation incomplete.

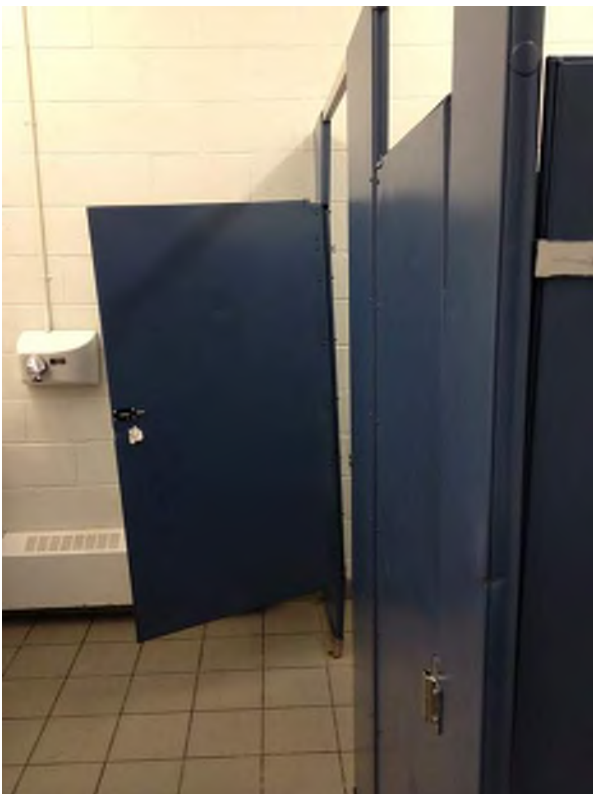
Toilet Partitions beginning to deteriorate

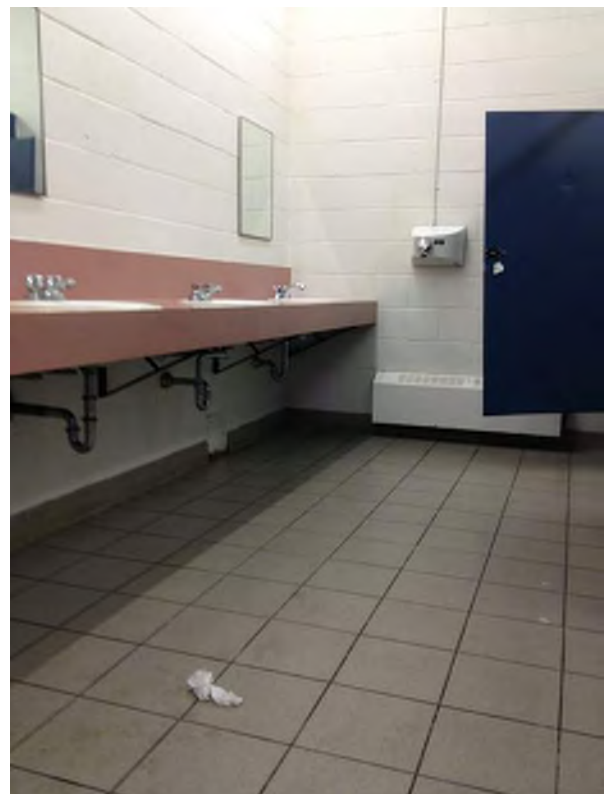
Washroom Vanity not compliant with barrier-free requirements.

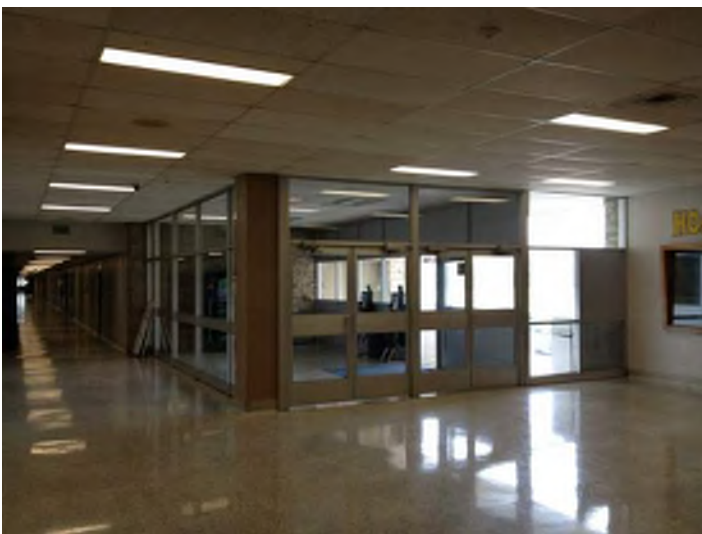
Fire exit sign missing from rear exit

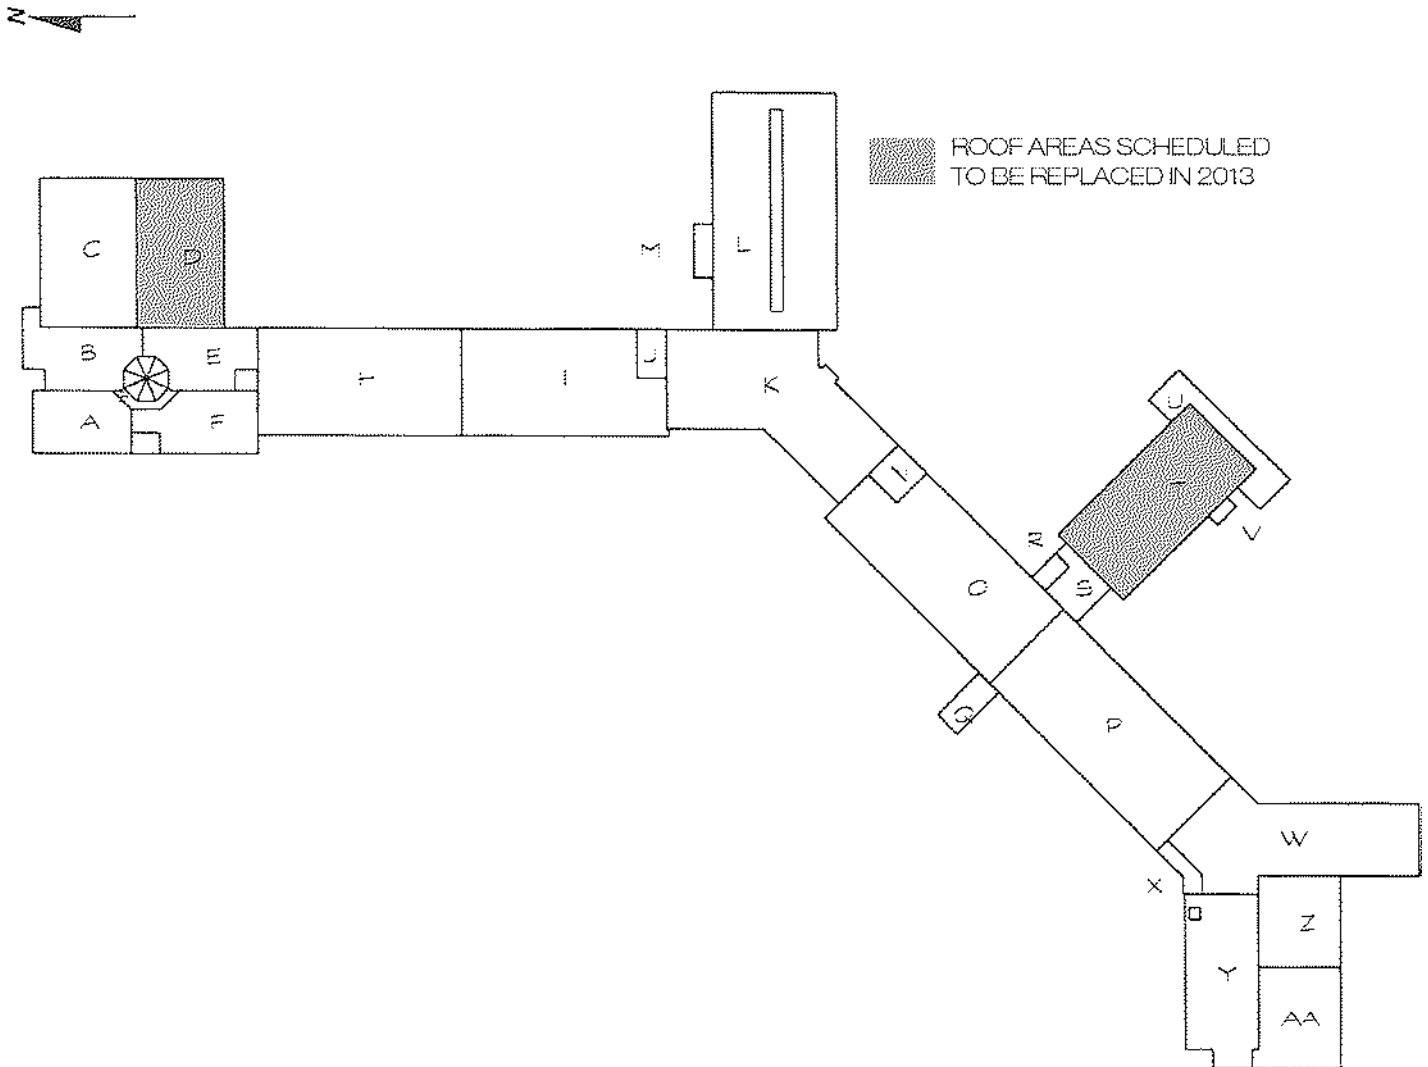
The LDCSB has engaged the services of North American Roof Management Systems Ltd. (NARM) to monitor all roofs within their system. In discussion with Denis Sykora of NARM we have been informed that all roofs at RMC have been replaced except for Roof V located above the side altar of the chapel sanctuary. We are informed that replacement of Roof D (part of 1988 Gym addition) and Roof T (Chapel) are scheduled to be replaced this fall (2013).

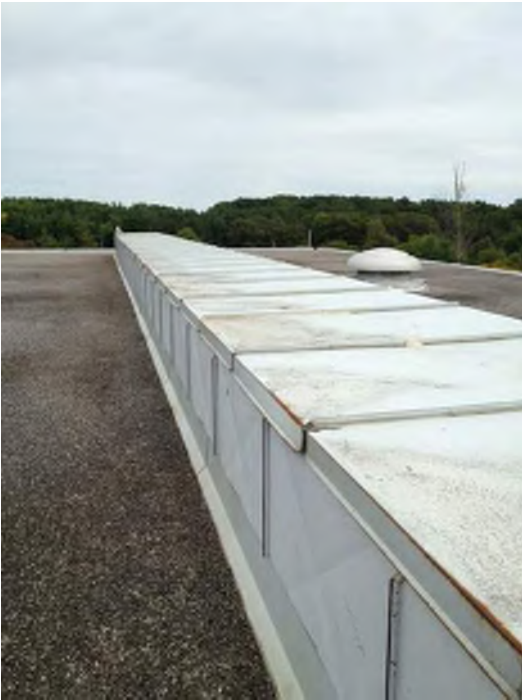
Metal flashing over ductwork above gymnasium beginning to rust - finish has deteriorated

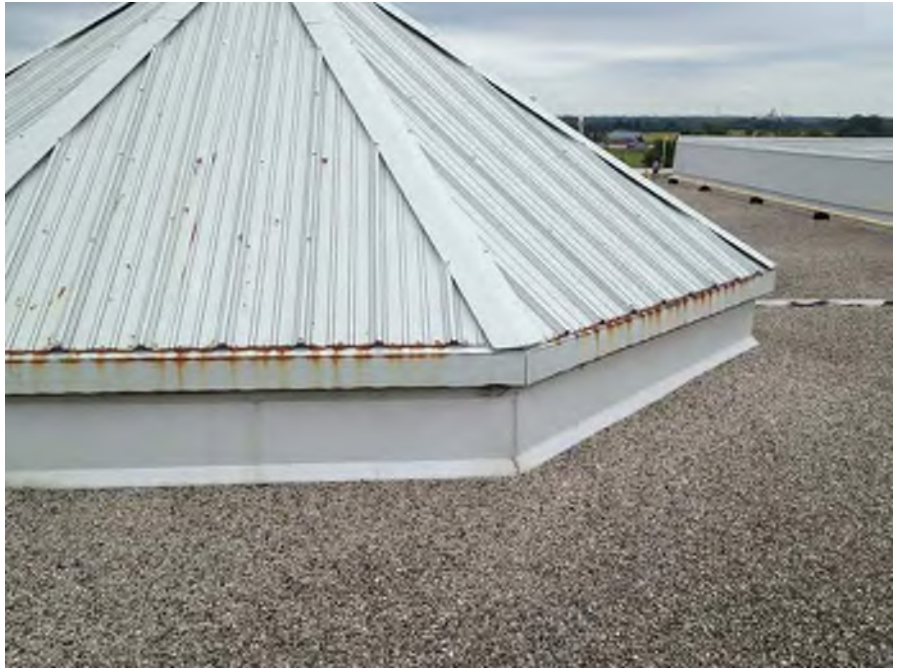
Metal roof over north gymnasium showing rusting

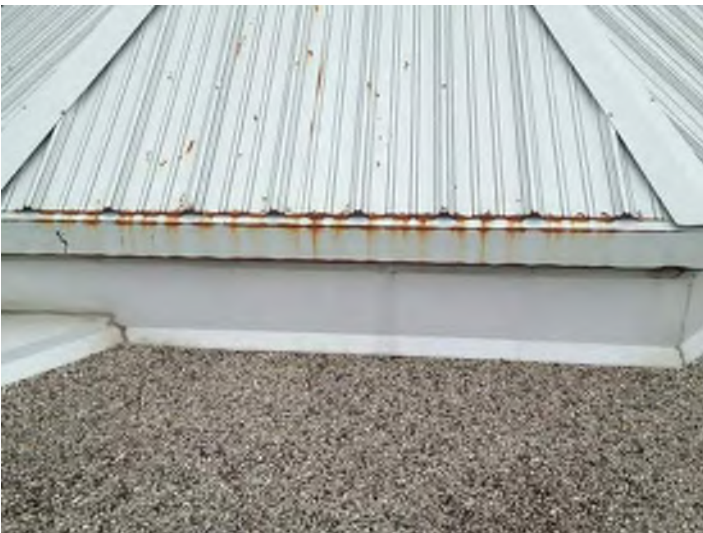
Metal roof over north gymnasium showing rusting

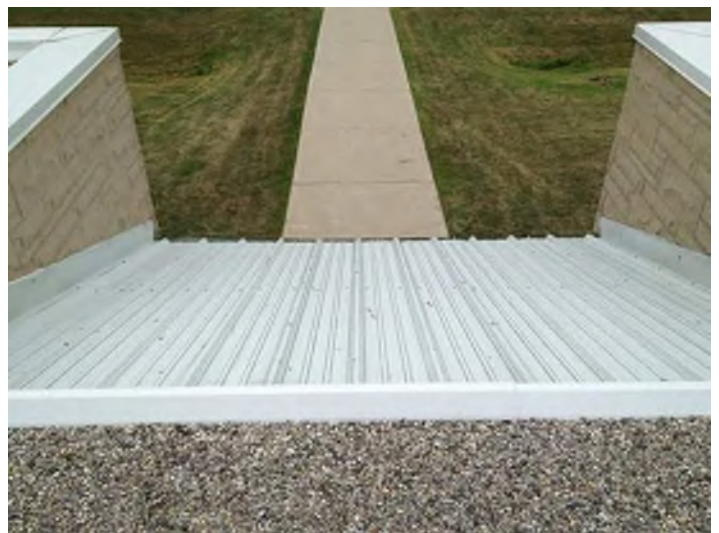
Sloped roof over exit without snow guards

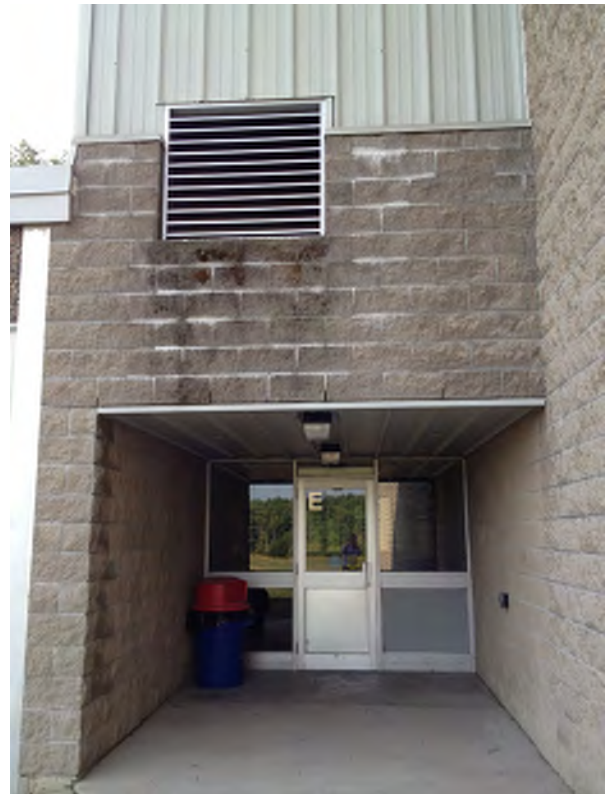
Damage to concrete block masonry from missing metal flashing and sill.

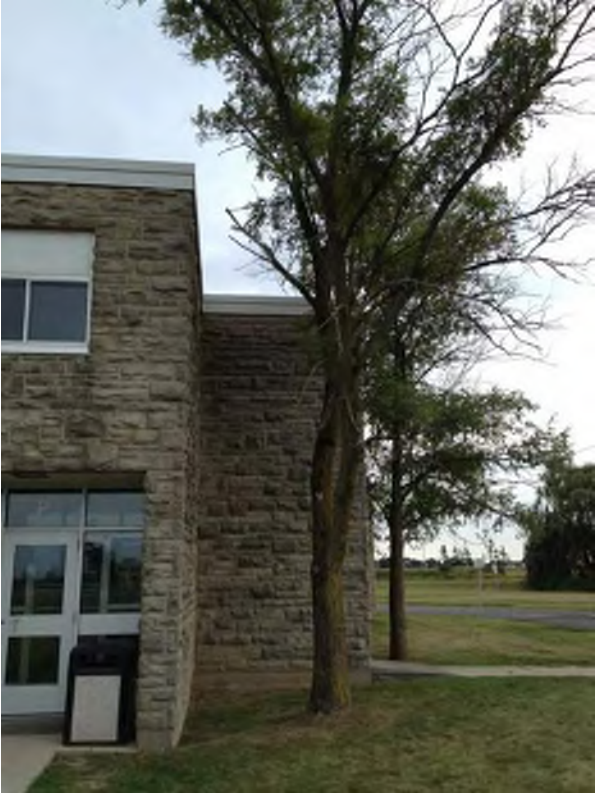
Tree at South Tech Wing beginning to deteriorate causing safety hazard to students

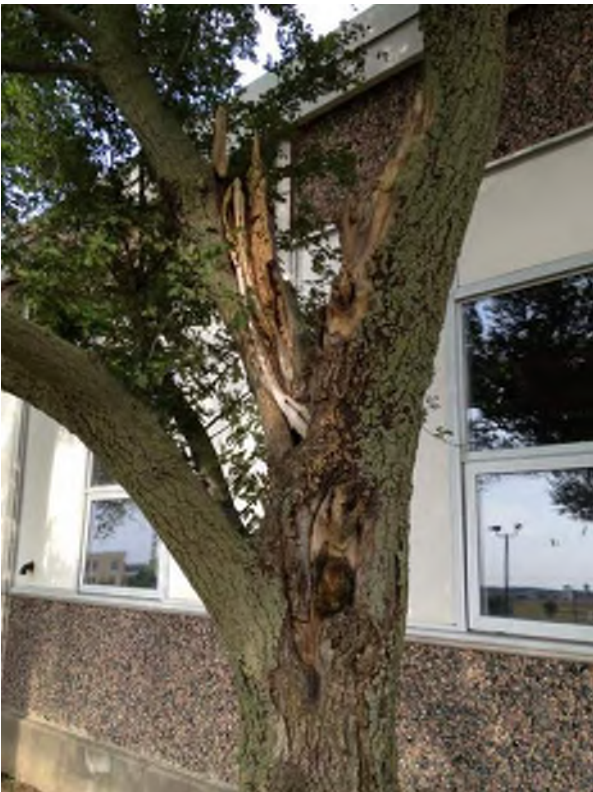
Tree showing signs of rot at West Elevation - danger of limb falling.

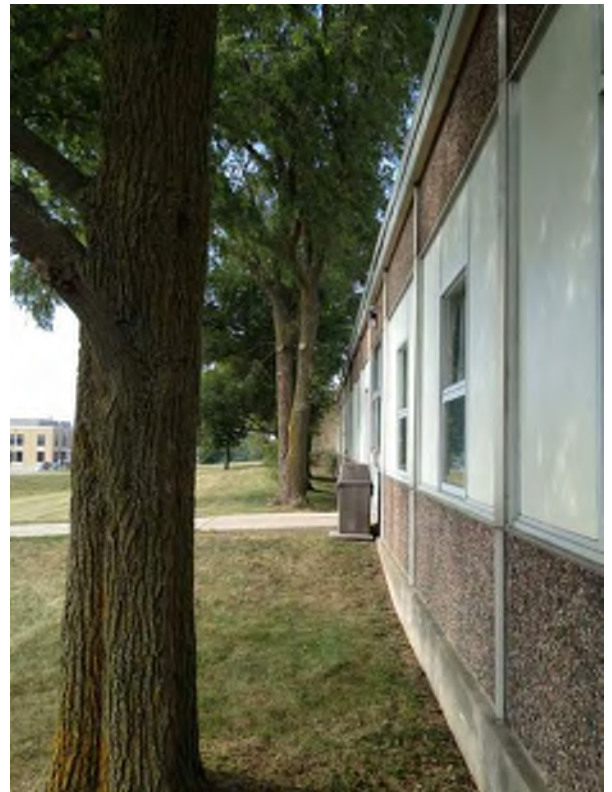
Trees at West Elevation too close to building.

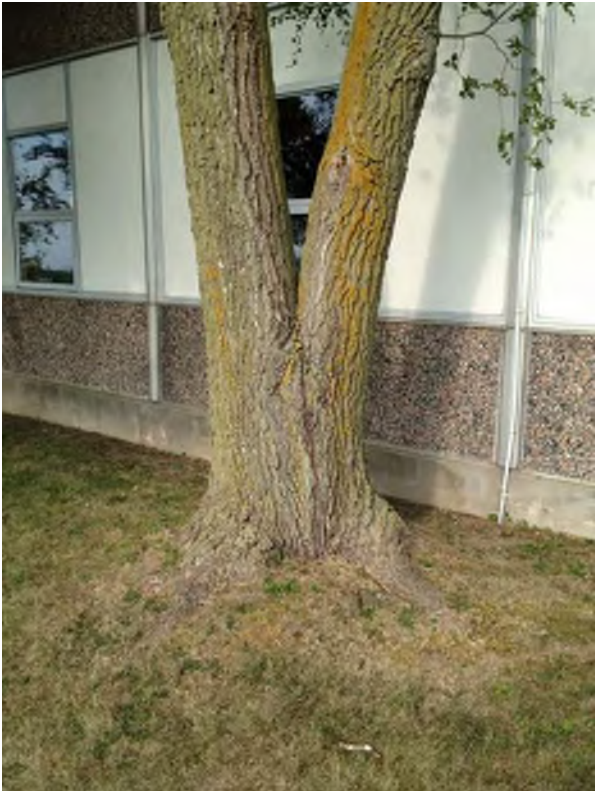
Tree in close proximity to West building wall and notch susceptible to water intrusion and rot.

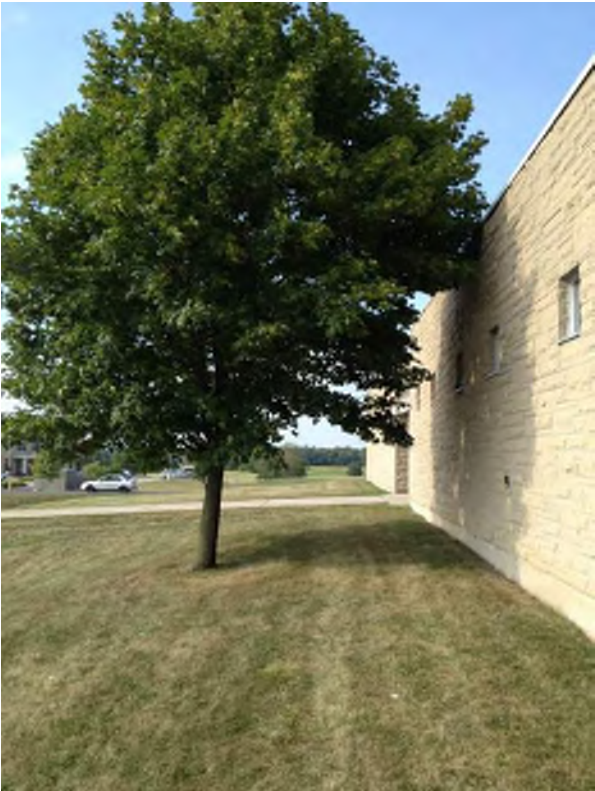
Trees at West elevation of 1988 addition - if not maintained properly will cause similar issues to those of the original building.

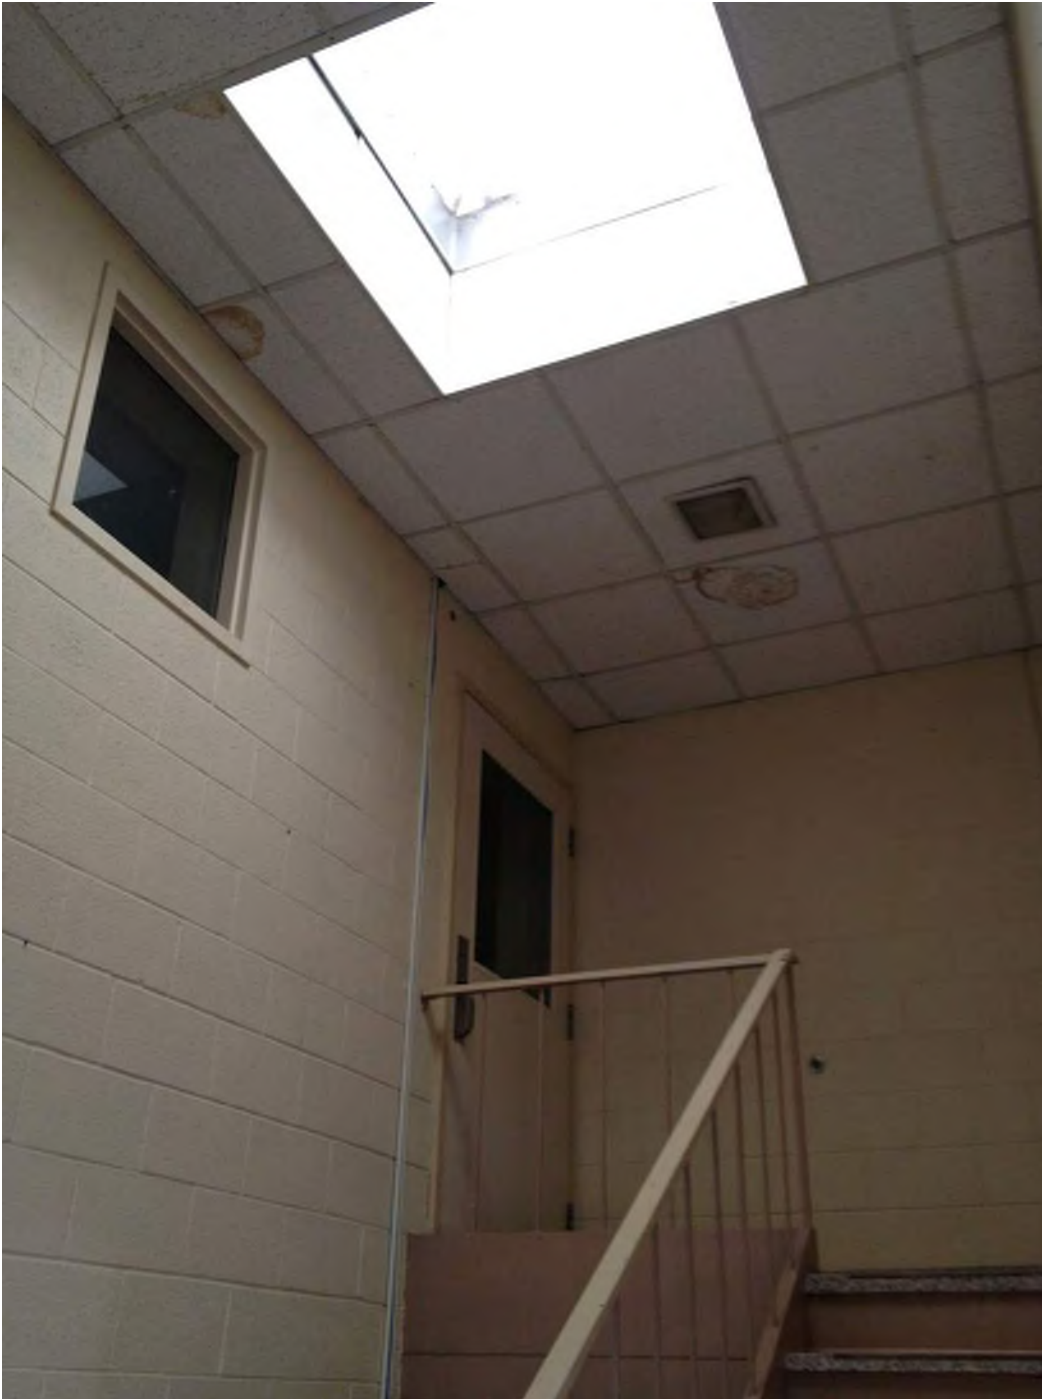
Acrylic Dome Skylight Interior

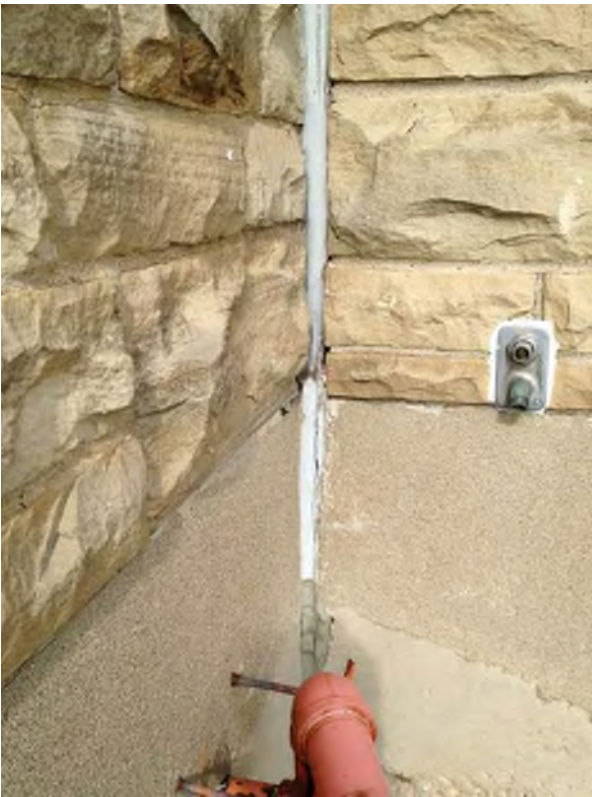
Caulked corner west elevation

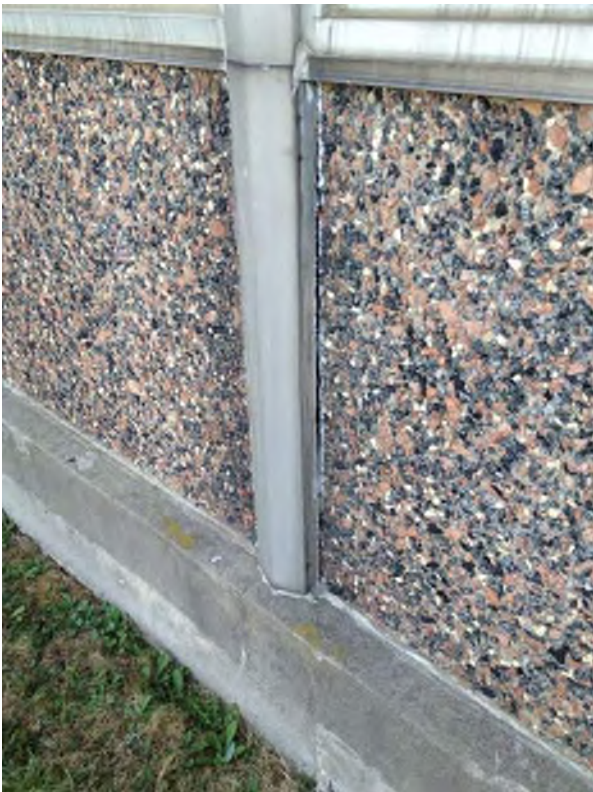
Caulked joint failure on East Elevation

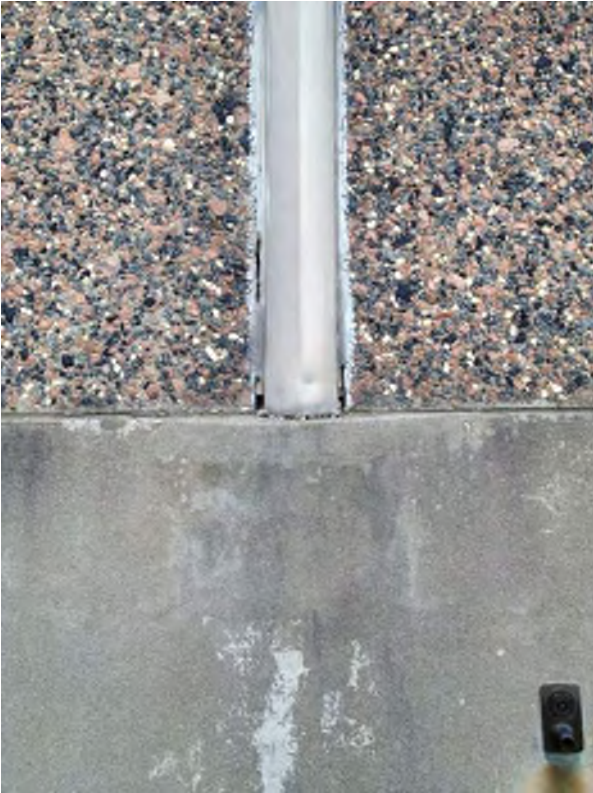
Caulked joint failure on East Elevation.

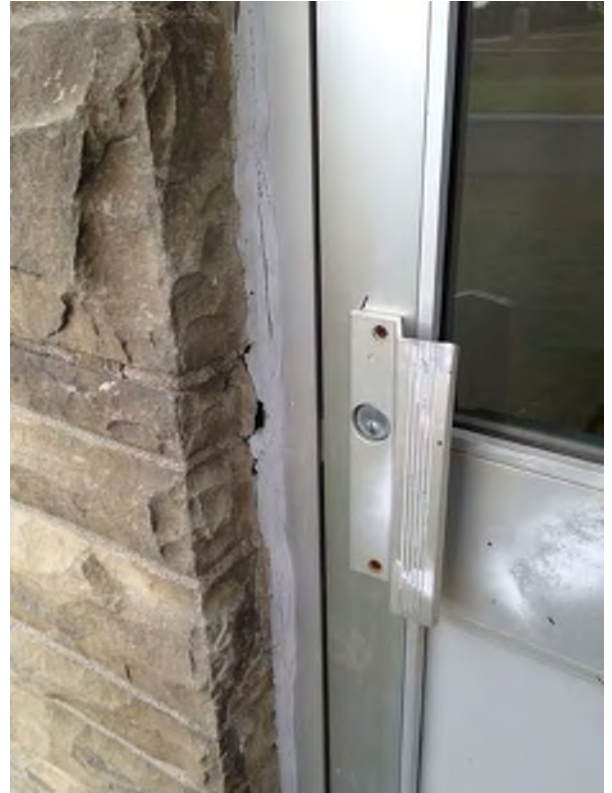
Caulked joint failure at Tech Wing entry.

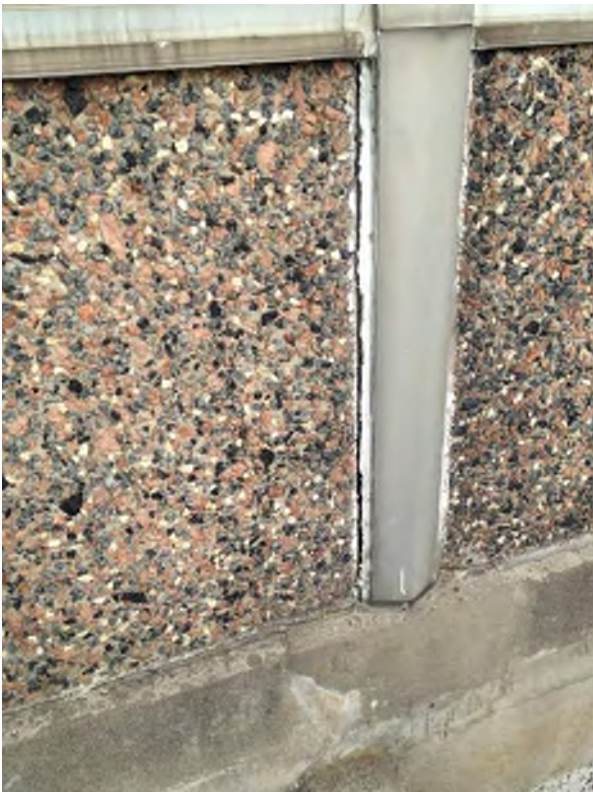
Caulked joint failure on West Elevation.

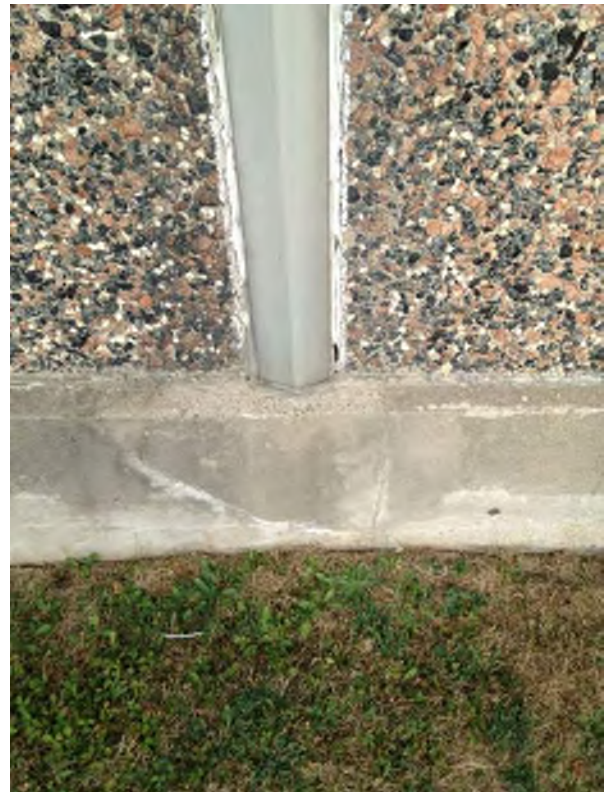
Caulked joint failure on West Elevation.

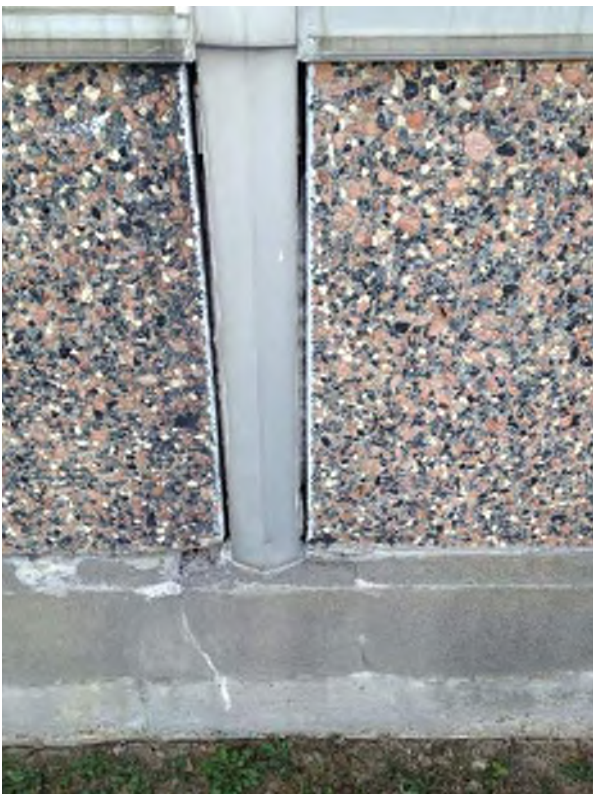
Caulking missing at precast panels - East Elevation

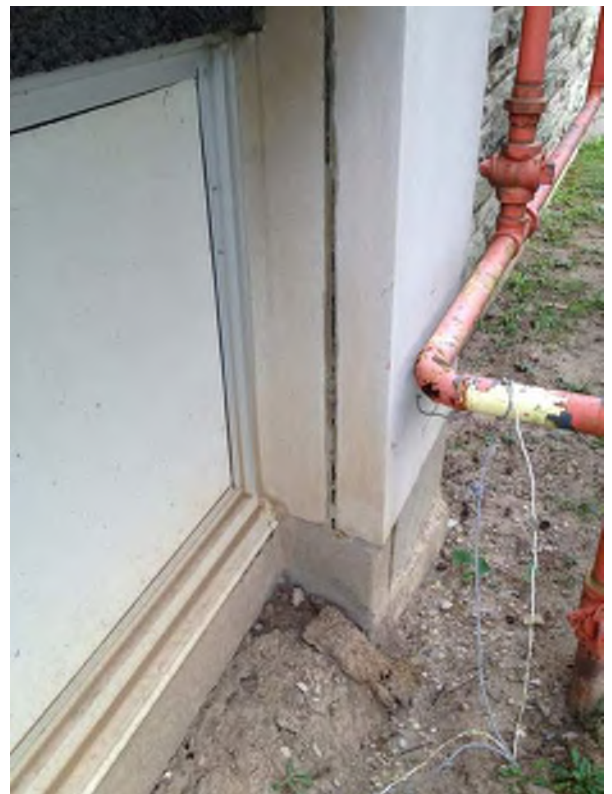
Caulking deteriorated at smooth stone panel - investigation required to view condition of anchors.

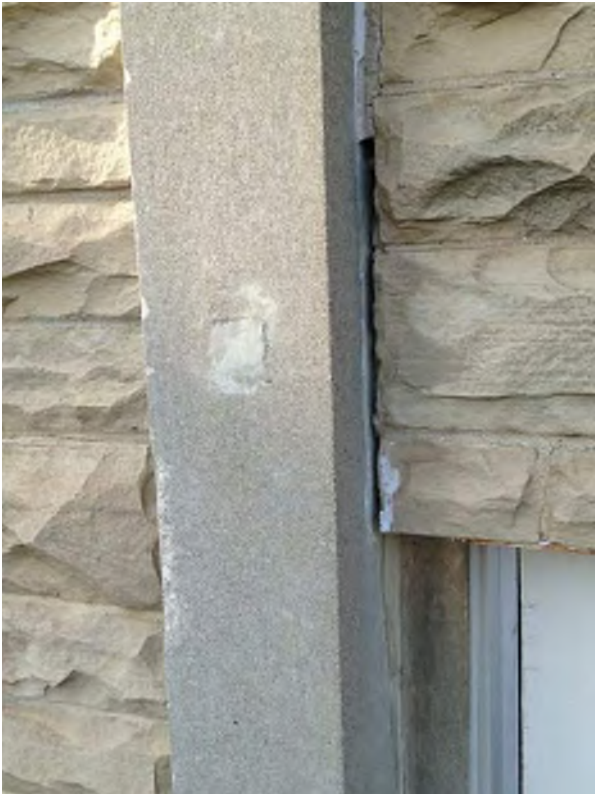
Caulked joint at Gymnasium wall window head - South Elevation.
Note deterioration of mortar joints

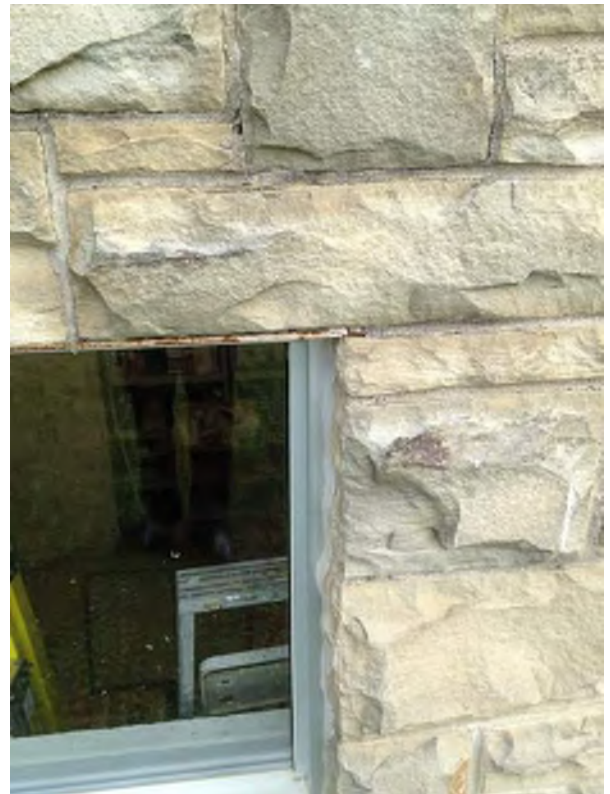
Deteriorated mortar joints and rusting steel lintel at window head.

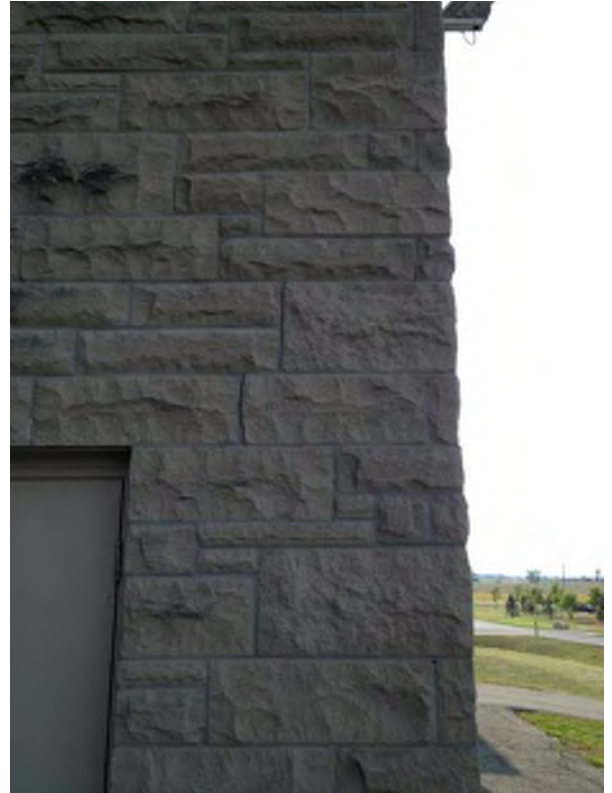
Cracked mortar joints - East Elevation - 1988 addition

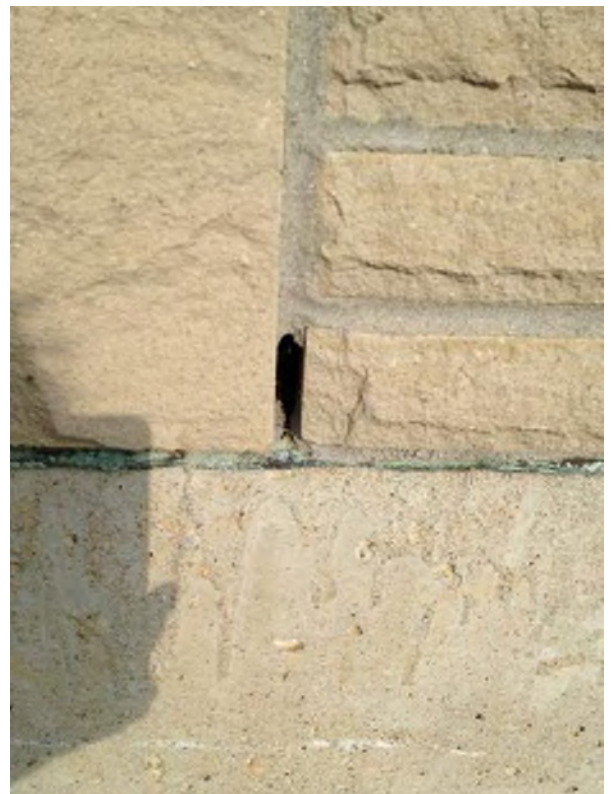
Missing brick vents - 1988 addition

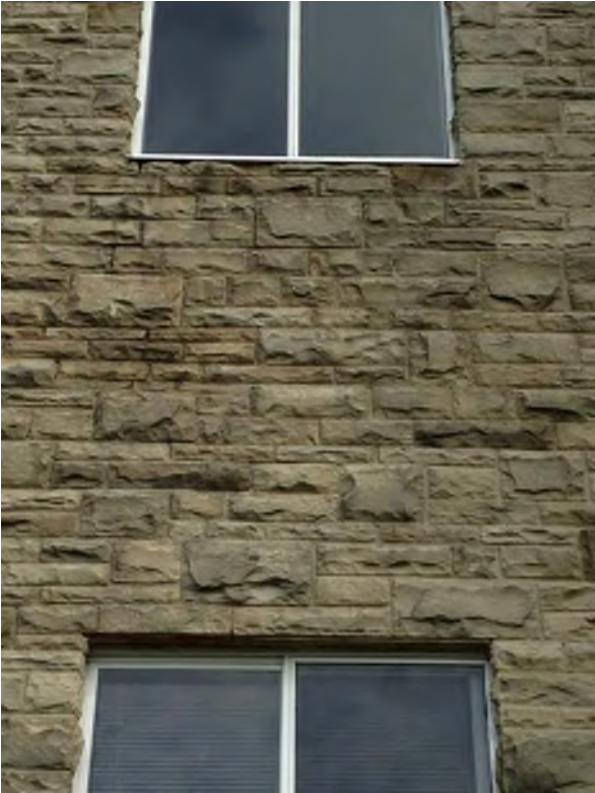
Deteriorated mortar joints below window sill on West Elevation.

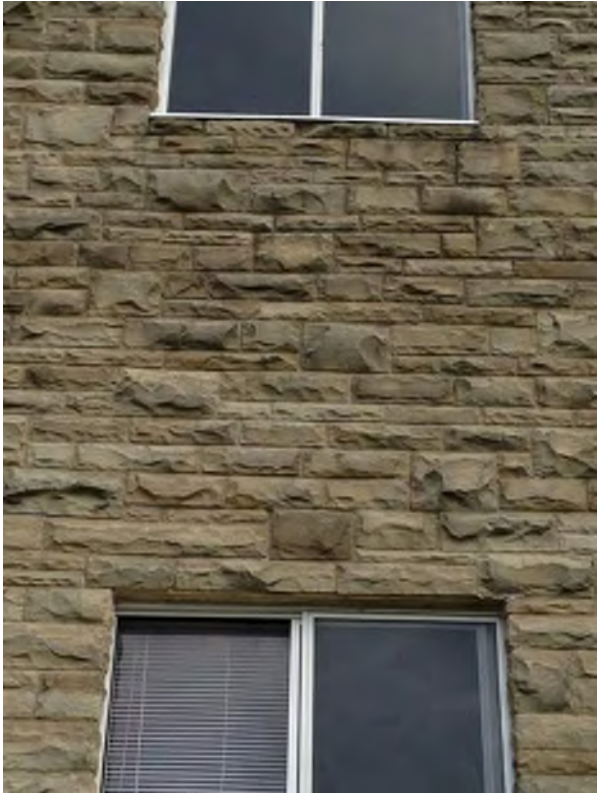
Deteriorated mortar joints below window sill on West Elevation.

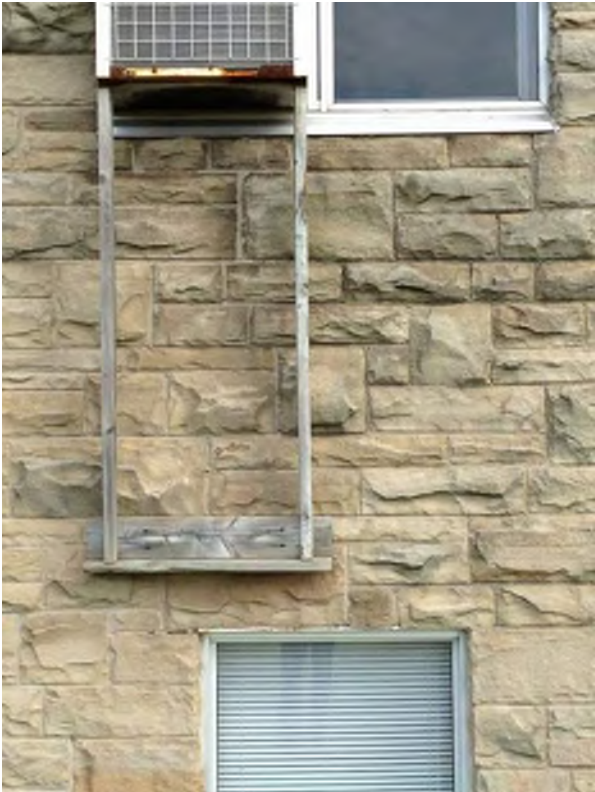
Deteriorated mortar joints below window sill on West Elevation.

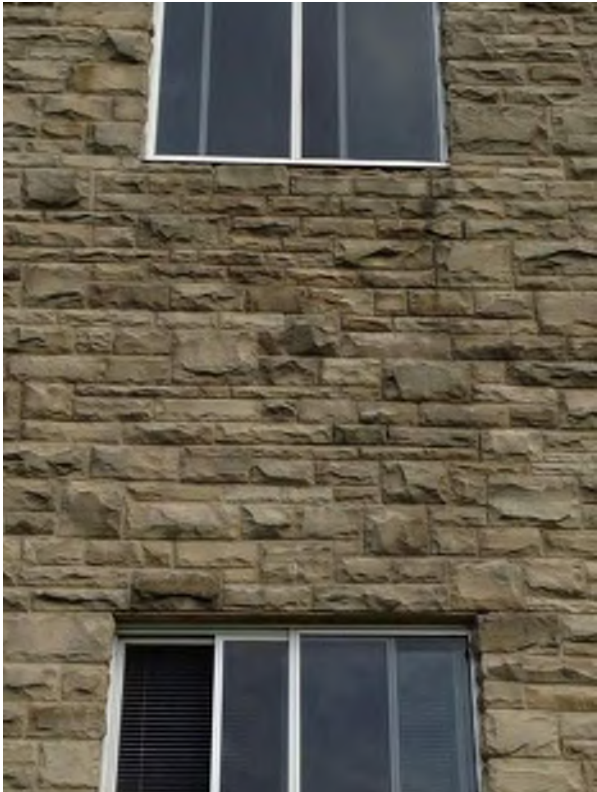
Deteriorated mortar joints below window sill on West Elevation.

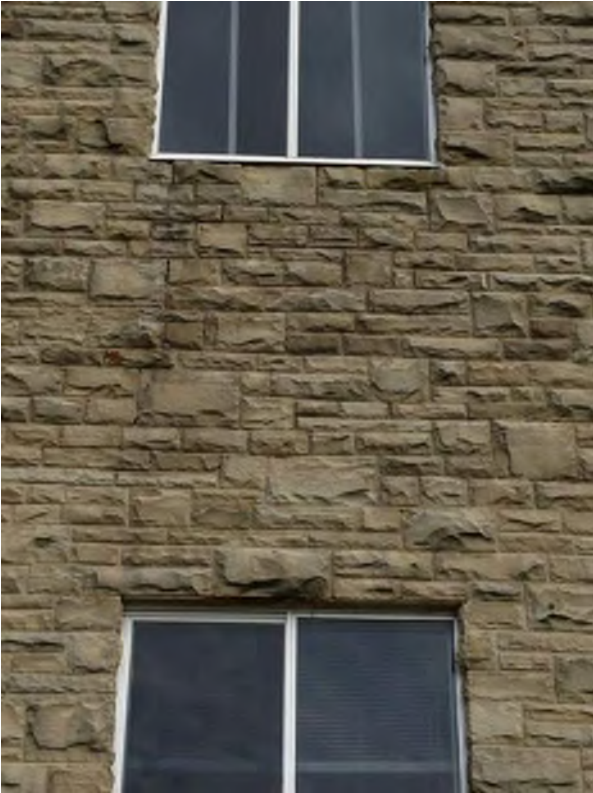
Deteriorated mortar joints below window sill on West Elevation.

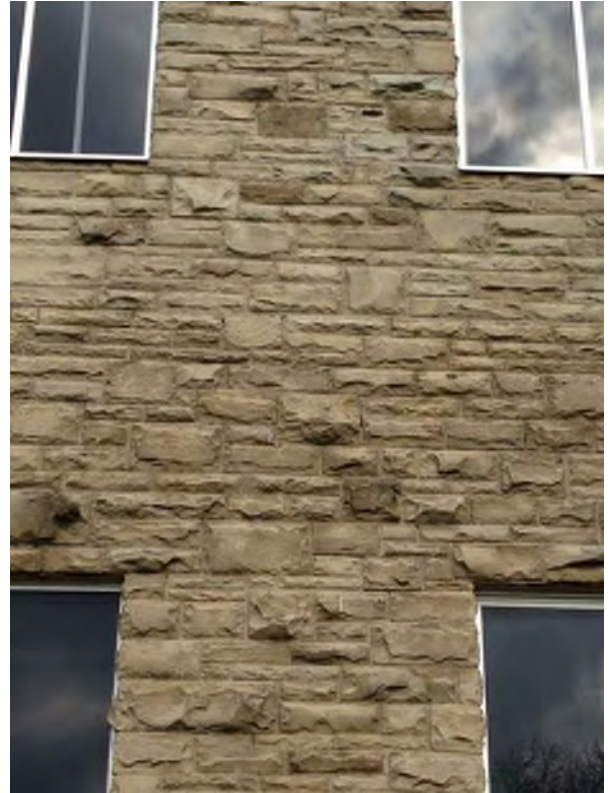
Deteriorated mortar joints below window sill on West Elevation.
