REGINA MUNDI CATHOLIC COLLEGE

LONDON, ON | HERITAGE IMPACT ASSESSMENT
AUGUST 15, 2018; REVISED JULY 18, 2023

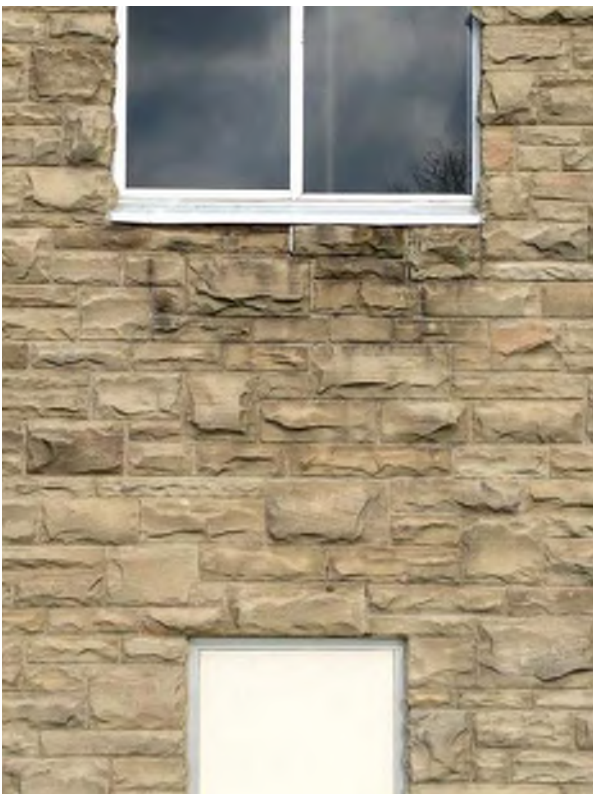
Deteriorated mortar joints below window sill on West Elevation.

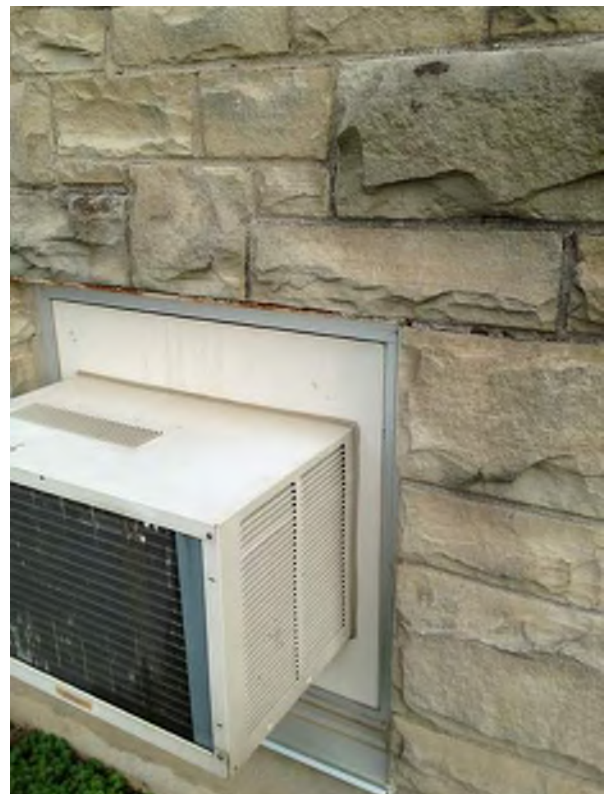
Deteriorated mortar joints on rusting steel lintel at West Elevation.

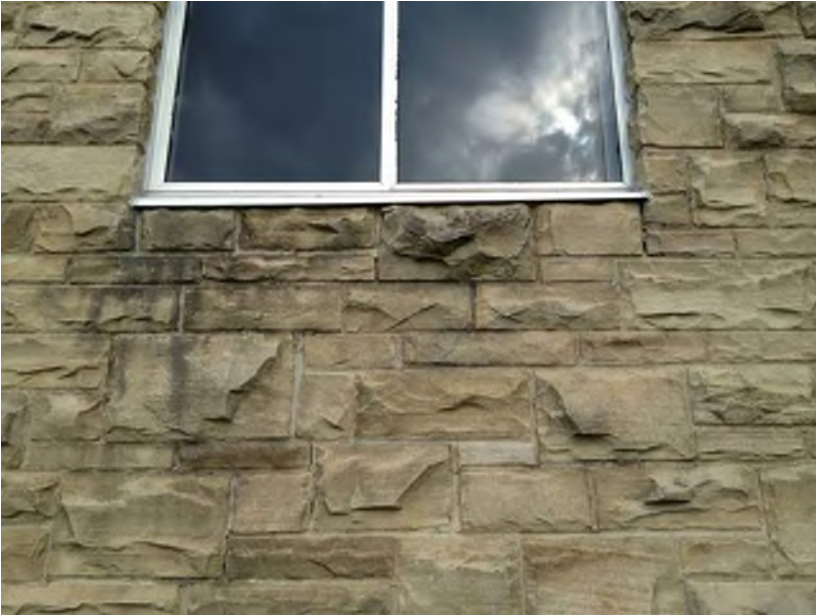
Deteriorated mortar joints below window sill on West Elevation.

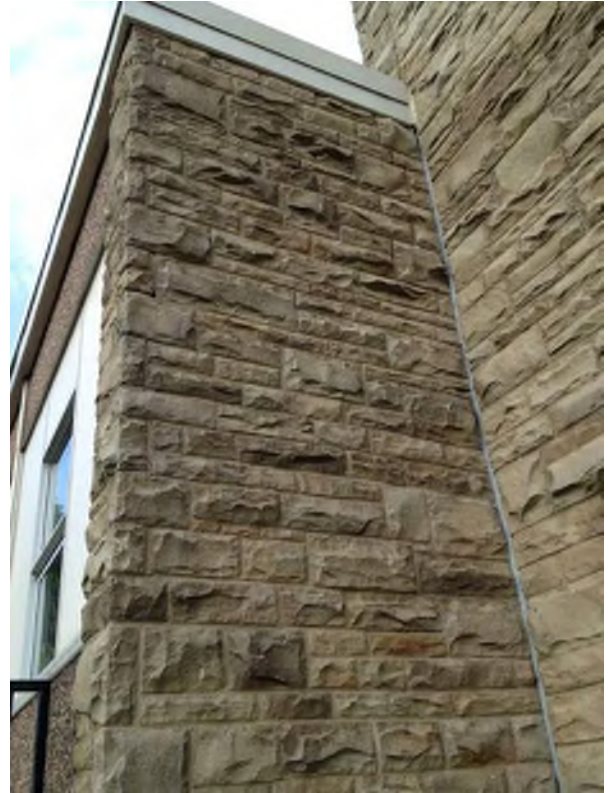
Deteriorated mortar joints on West Elevation.

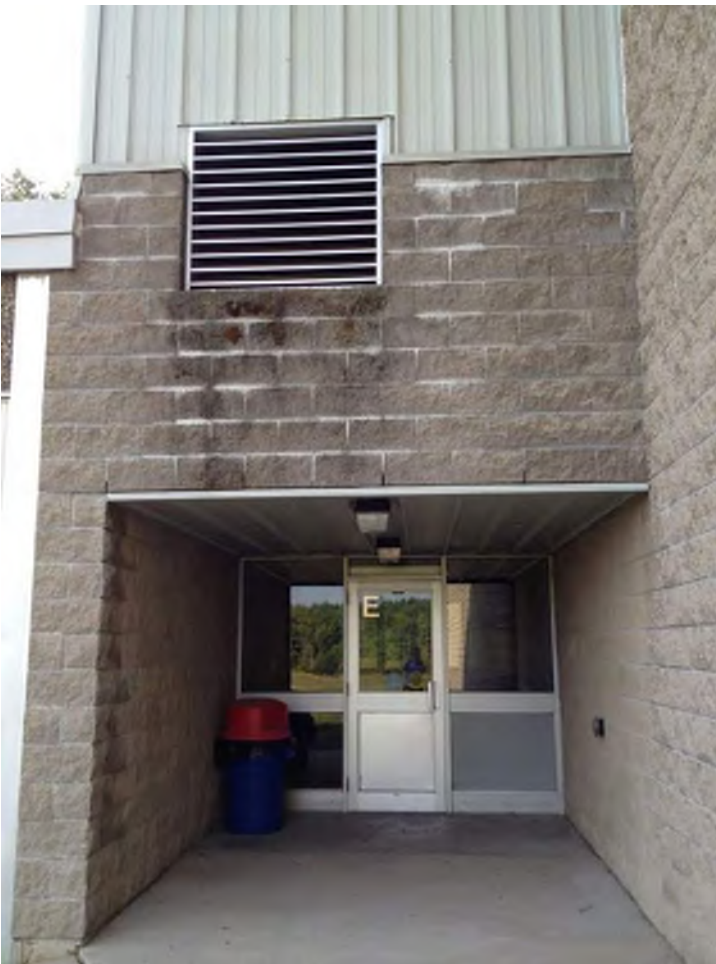
Missing metal sill and flashing at louvre on 1988 addition have caused moisture penetration damaging mortar joints and masonry veneer and growth of moss.

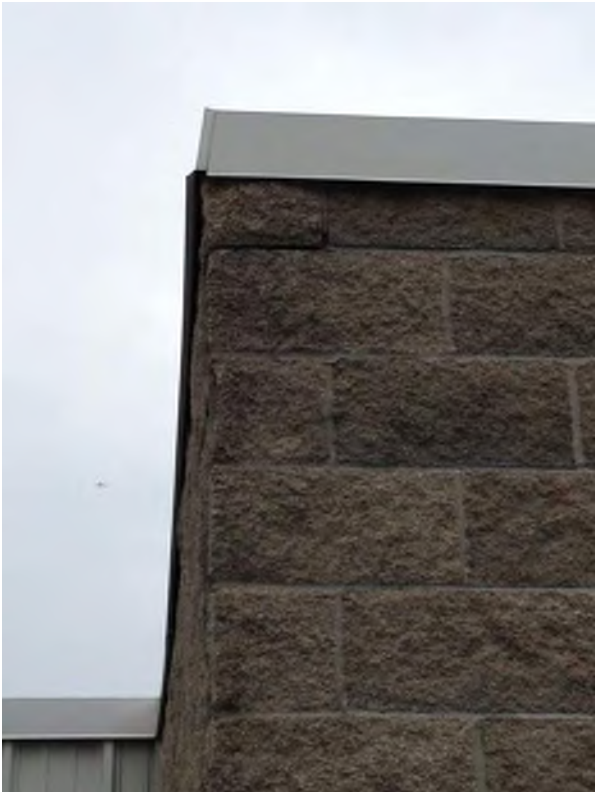
Deteriorated mortar joints at upper corner of 1988 Gymnasium addition.

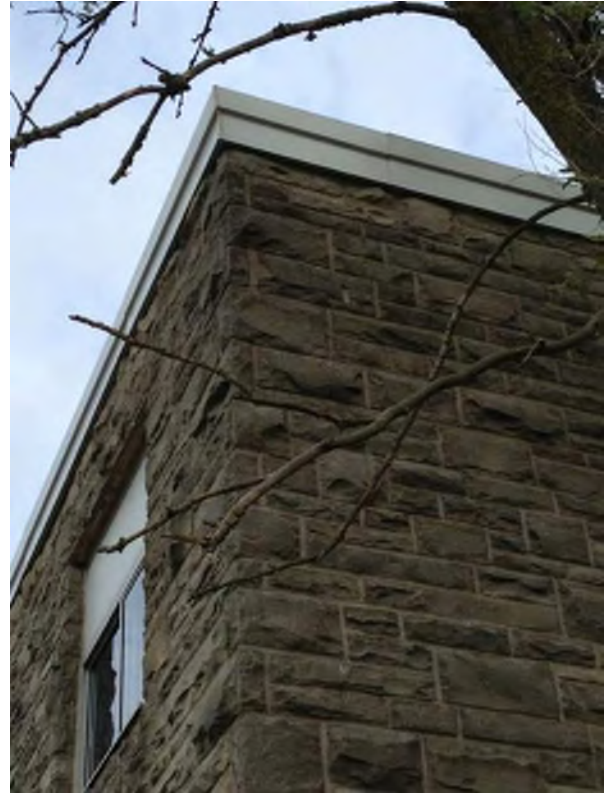
Deteriorated mortar joints at upper stone - Tech Wing

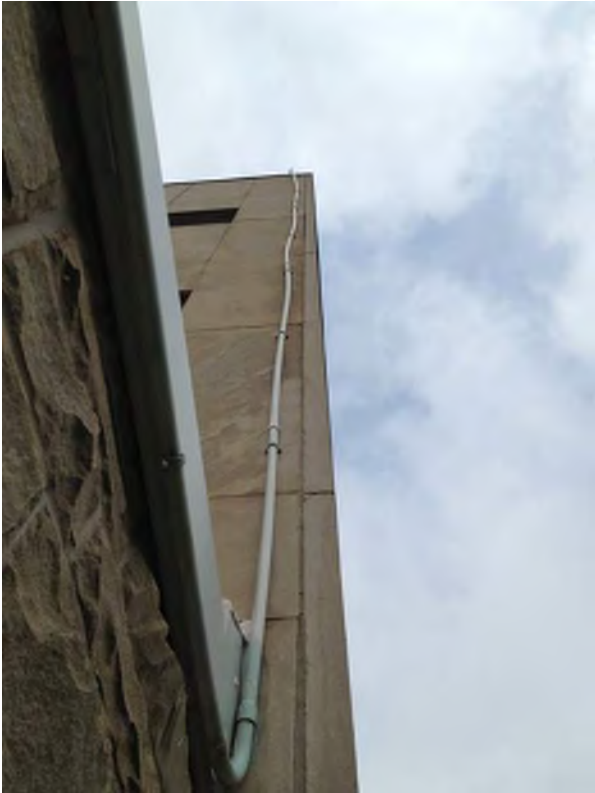
Deteriorated mortar joints at South Elevation

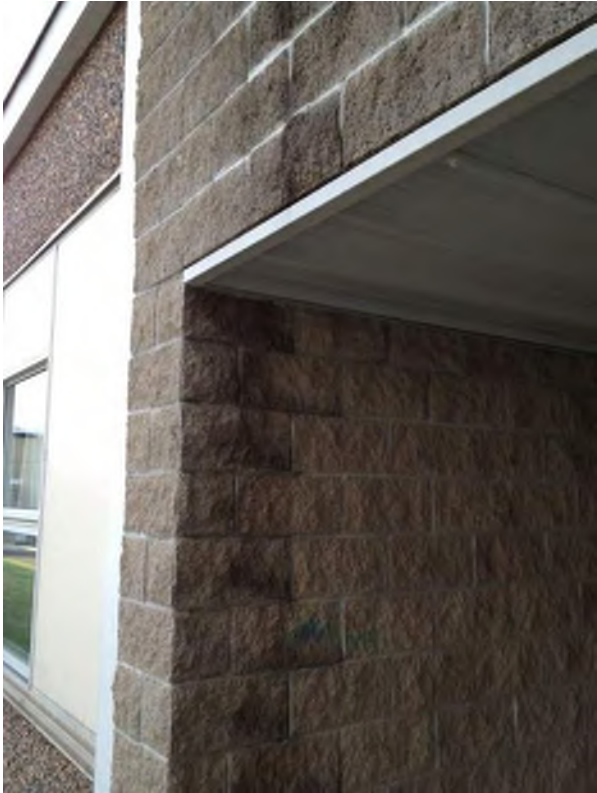
Water damage at soffit - East Elevation 1988 addition

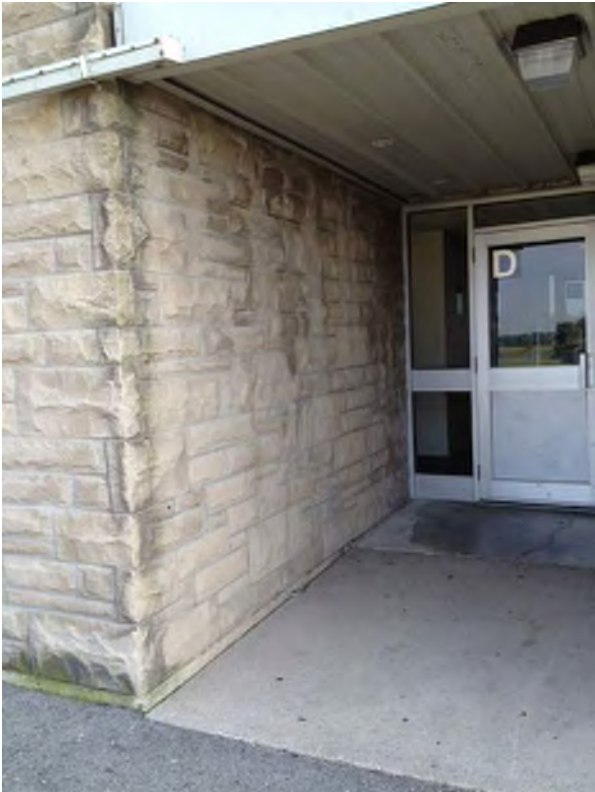
Water damage below soffit - North Elevation 1988 addition

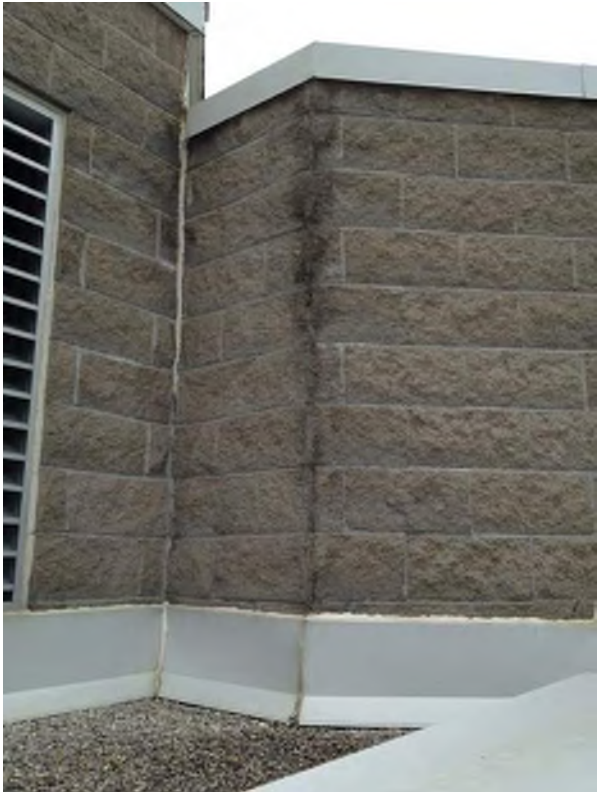
Water damage at concrete block - Upper North Gymnasium Elevation

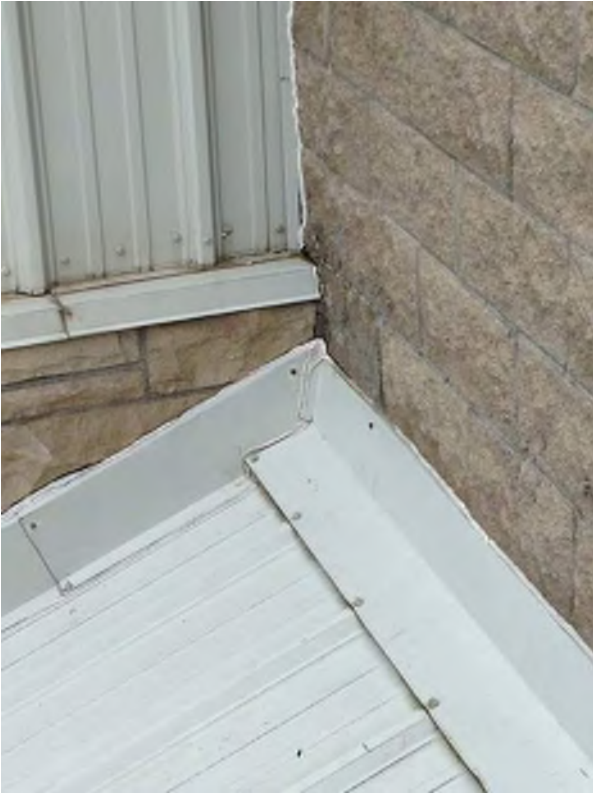
Water damage at concrete block causing deterioration of mortar joints - North Gymnasium Elevation

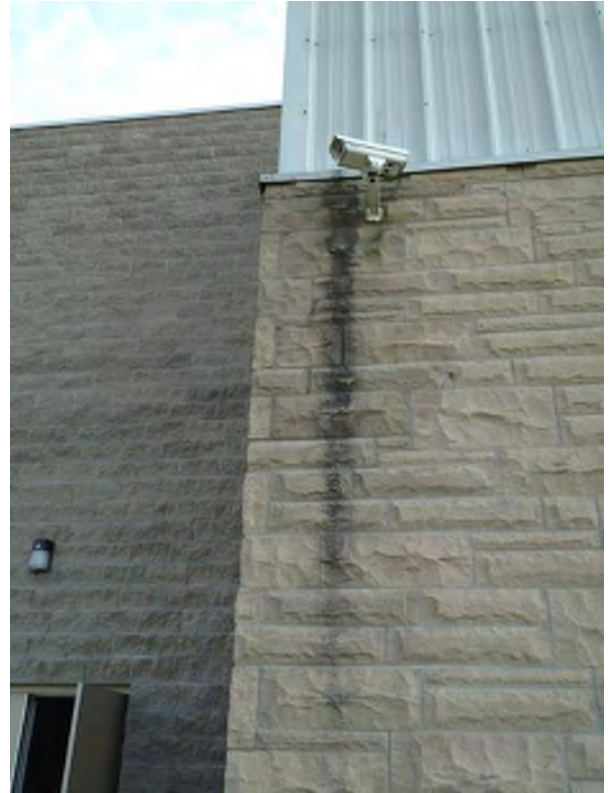
Water Stain from flashing - North Elevation 1988 addition

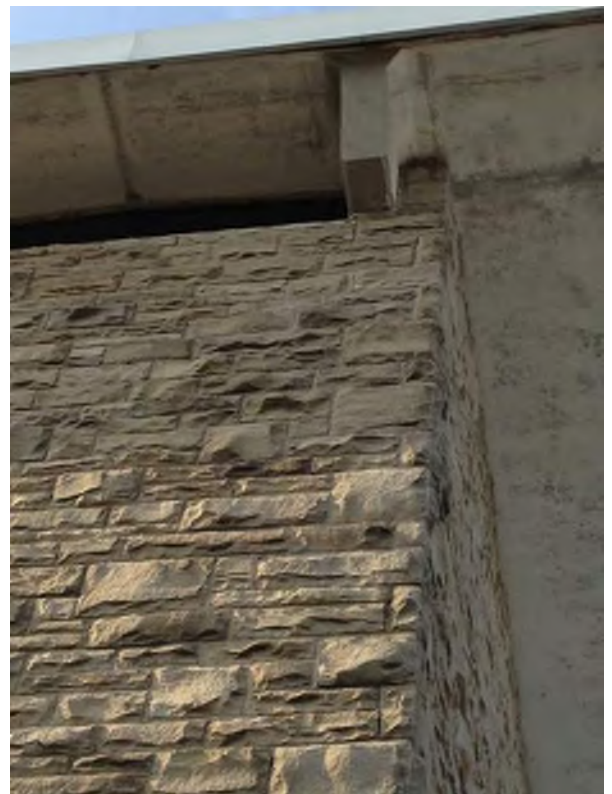
Deteriorated mortar joints - Southeast corner of Gymnasium (Upper)

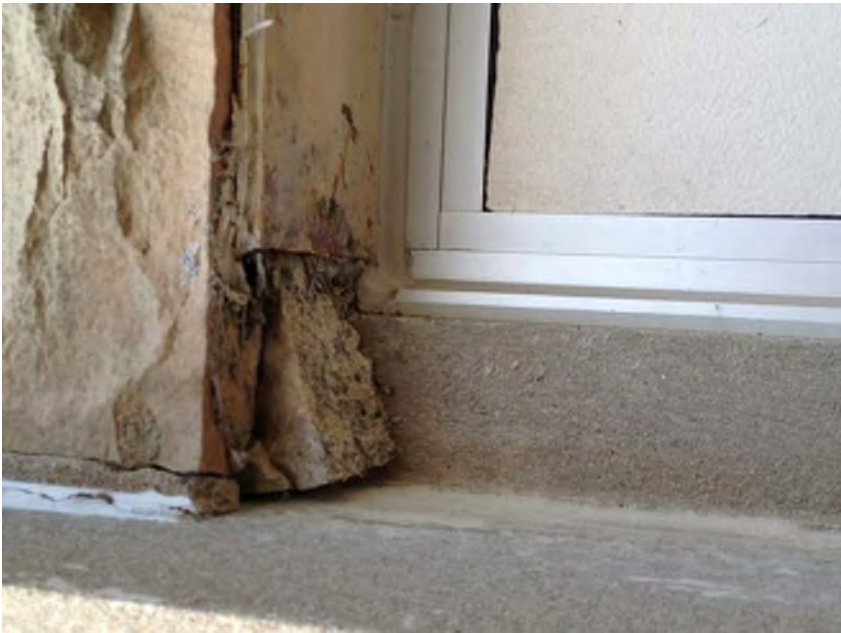
Damage to stone of South Elevation of Gymnasium from moisture at penetration.

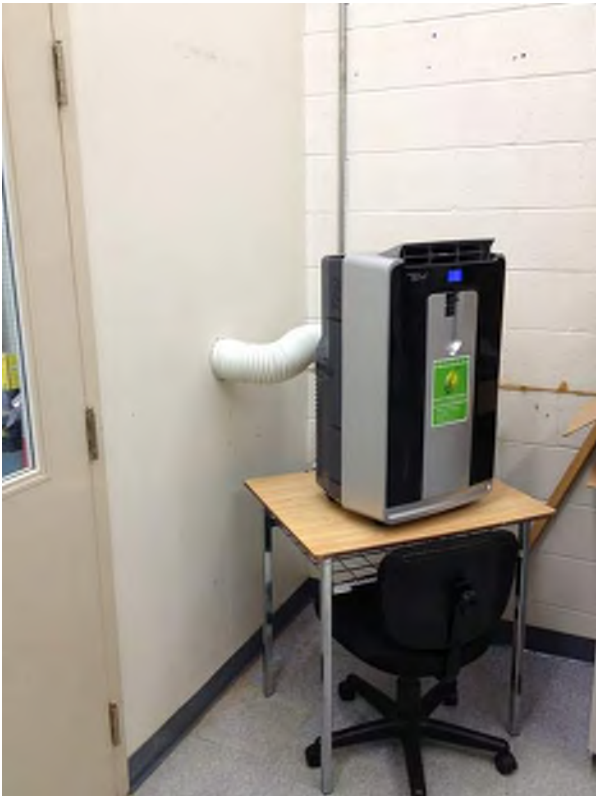
Portable air conditioner

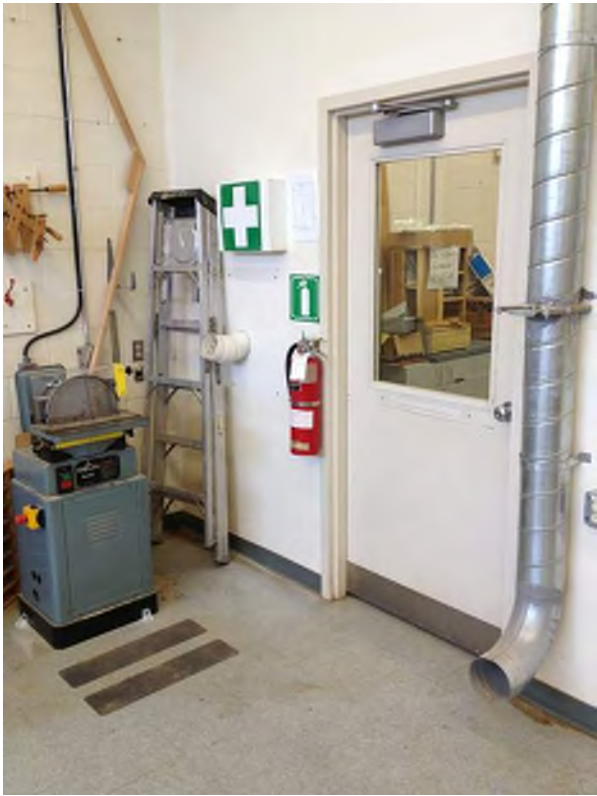
Fabrication Room showing portable air conditioner exhausting into room.

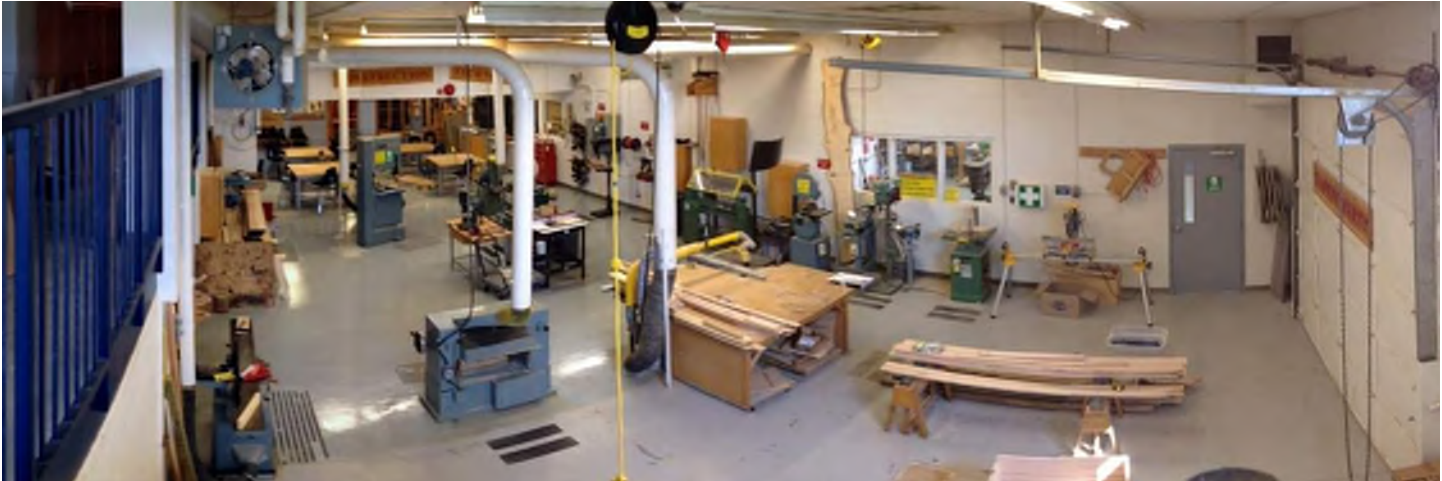
Overall view of Construction Technology Classroom

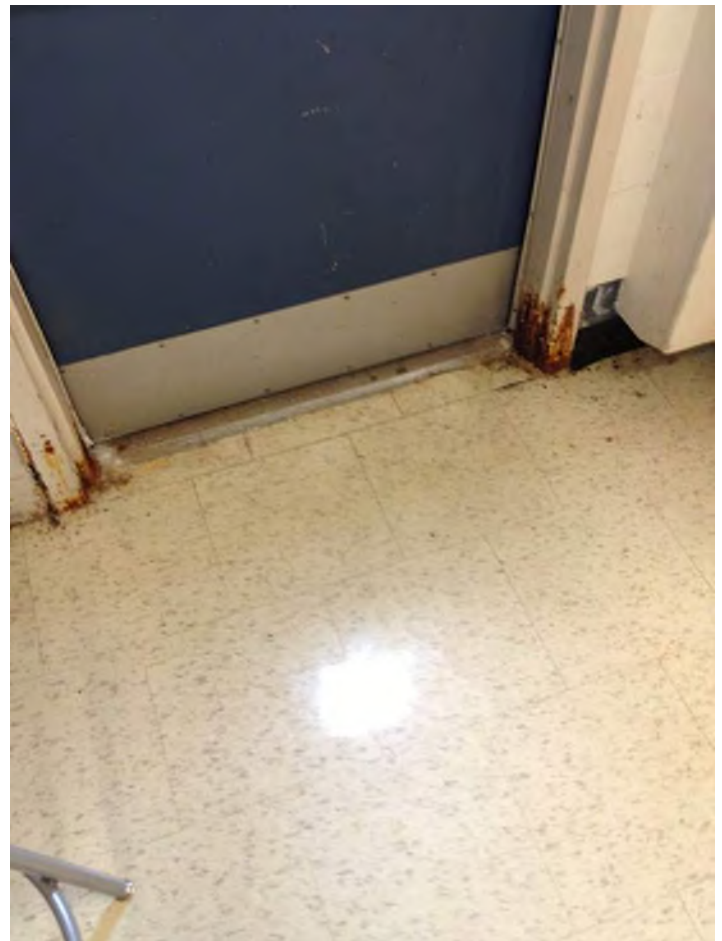
Manufacturing Technology Shop exterior door frame rotting/rusting.

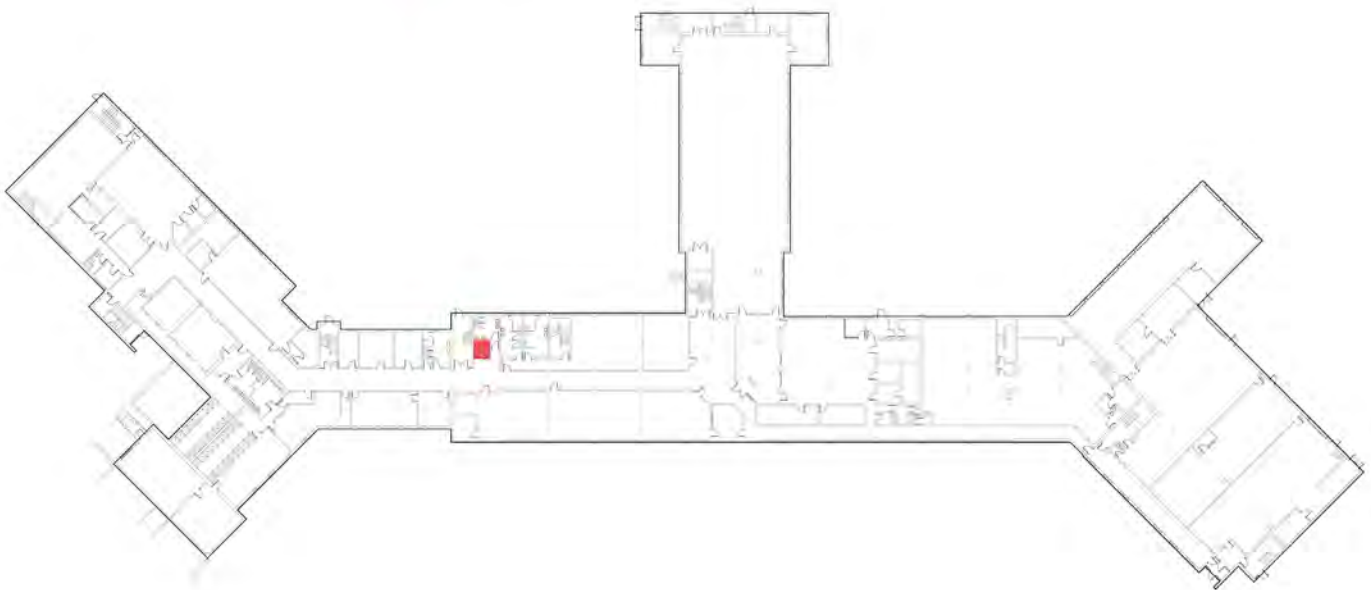
■ LOCATION OF ELEVATOR

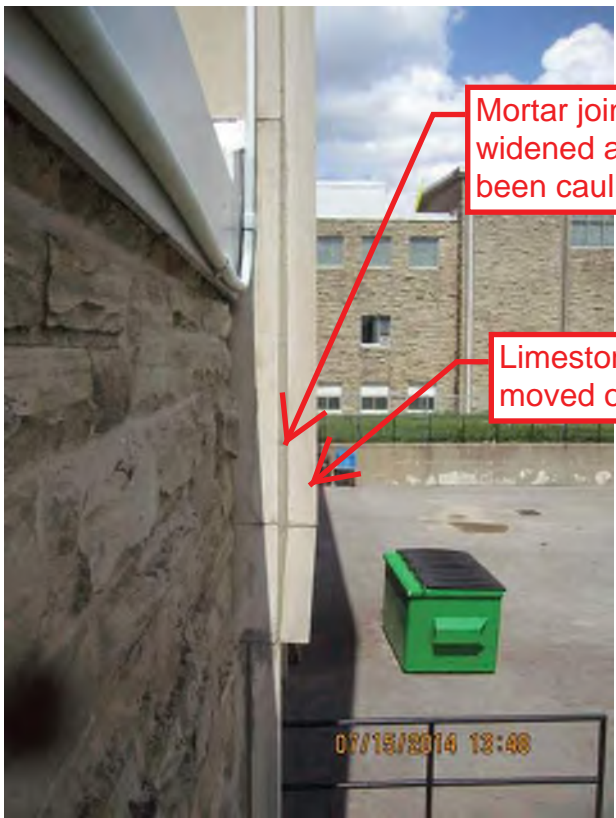
Mortar joint has widened and has been caulked.
