TO:	CHAIR AND MEMBERS PLANNING & ENVIRONMENT COMMITTEE MEETING ON DECEMBER 12, 2011
FROM:	GEOFFREY P. BELCH CORPORATION COUNSEL
SUBJECT	LONDON HEALTH SCIENCES CENTRE SOUTH STREET CAMPUS DECOMMISSIONING

**Re: Building Condition Assessment and
Adaptive Reuse Study for
Colborne Building at
London Hospital, South Street Campus**

This report assesses the condition of the Colborne Building (Building #67) located at the corner of Colborne and South Streets, forming part of the London Health Sciences Centre in the City of London. This assessment focuses on building enclosure and building structure.

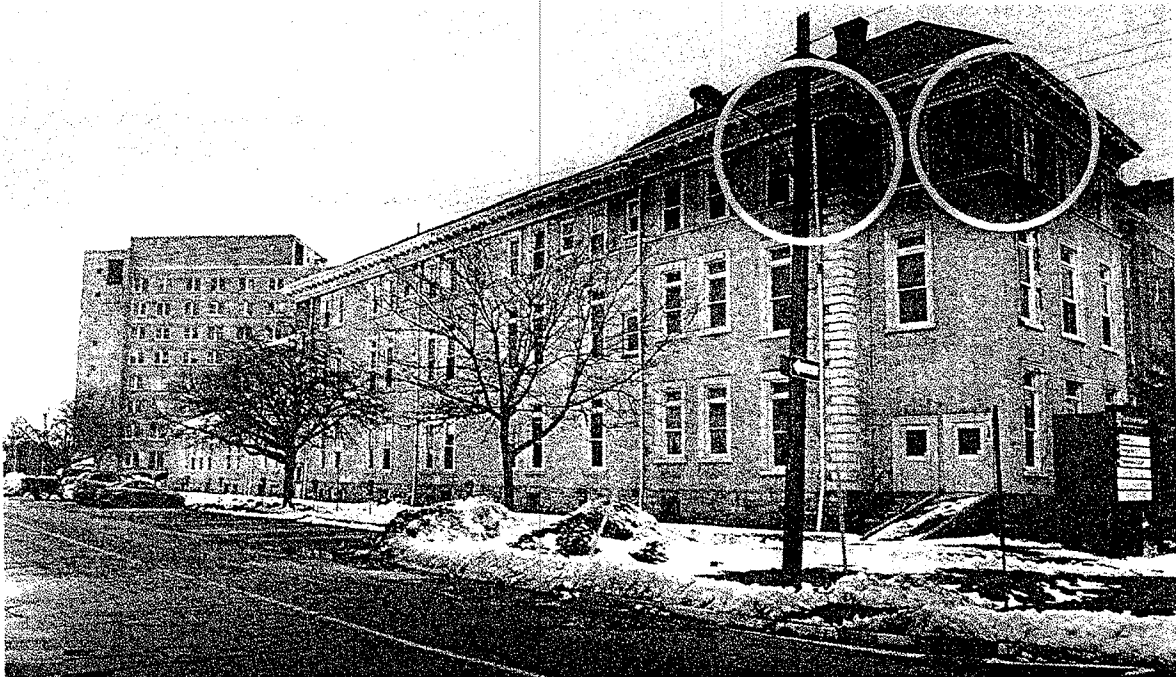
East Façade from Northeast Corner

Staining at corners (yellow circles) is primarily related to leaks at eave gutters, roof flashings and downpipes.

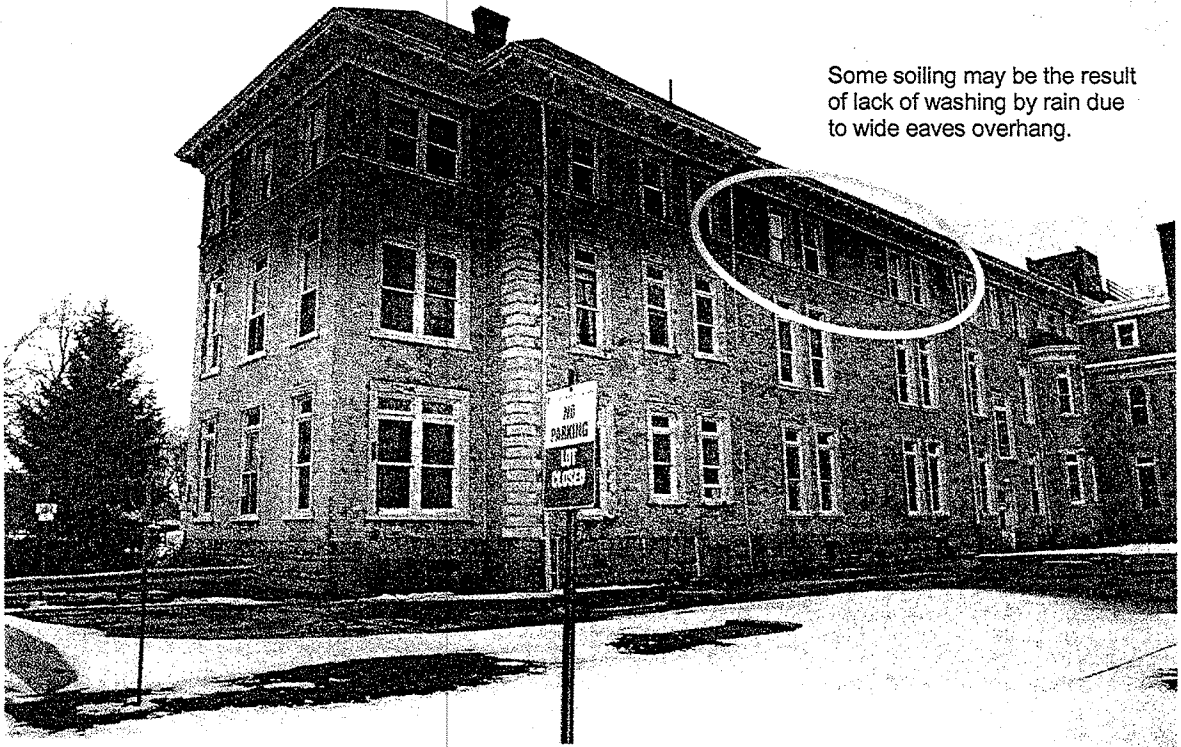
**West Façade from
Northwest Corner**

Some soiling may be the result of lack of washing by rain due to wide eaves overhang.

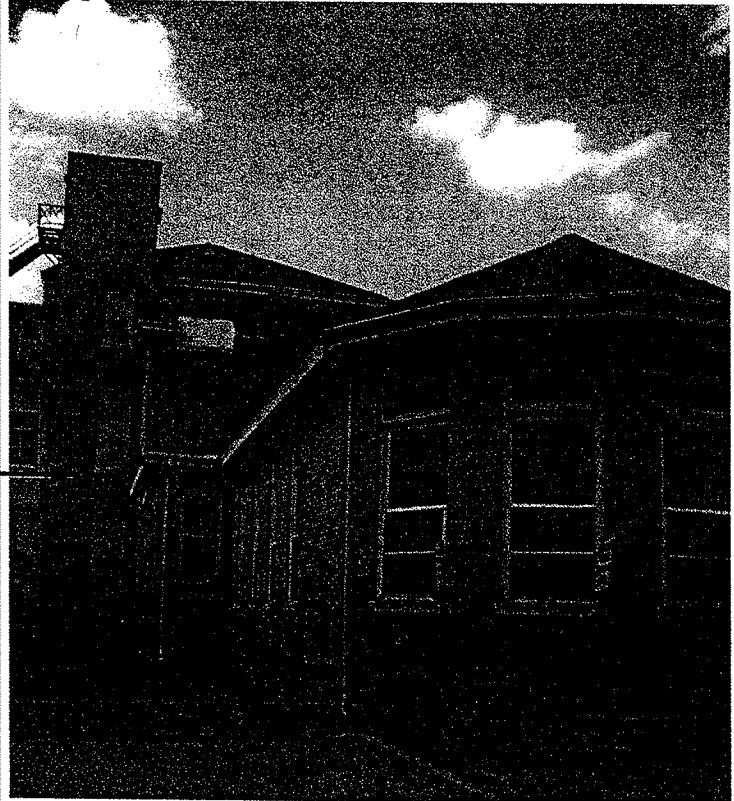
South Façade

Elevator hoistway. Original wall openings have been infilled with painted wood panels.

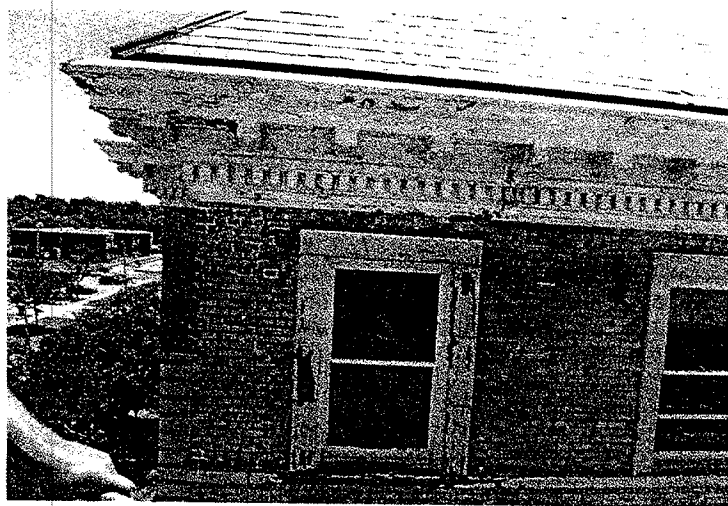
North Façade, Upper Northeast Corner at c1920 Addition

Exterior masonry, at the northeast corner of 1920 Addition, is in poor condition. Mortar joints below eaves are severely weathered and many are void for 1.5" depth. Moss was growing in deeper recessed joints that are protected from the sun. It appears that there has been significant roof leakage at this hipped corner. Surprisingly, notwithstanding the severity of mortar deterioration at this location, the remaining mortar was found to be robust and required force to remove sample brick units. Sampled brick units were found to be sound, intact and in reasonable condition.

Upon further investigation, it was concluded that significant heat loss from the interior has caused melting and ice damming during cold weather. The concrete elevator hoistway located at this corner has an equipment room on top of the hoistway. The concrete ceiling of the equipment room is tight to the underside of the wood roof structure. These concrete structures would contribute to significant heat lost through "stack effect" interior air movement. There is no insulation between the hoistway, equipment room and wood roof structure. In effect, the concrete hoistway and equipment room structure act as a large radiator, causing melting of snow at the slate roof. The absence of an effective roofing underlayment leaves the roof vulnerable to leaks caused by ice damming.

North wall appears to have been regularly saturated by water. Stains at underside of soffit indicate leaks in rain gutter.

It is suspected that heat loss and stack-affect at elevator hoistway inside this corner results in ice damming at roof and this is the primary contributing factor to masonry wall deterioration.

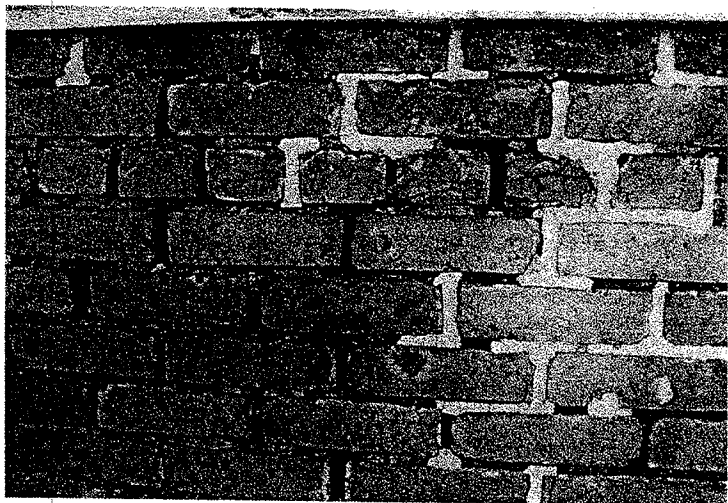
Mortar around this corner is in poor condition, with severely weathered and partially void joints. Previous repair attempts are visible as whiter coloured mortar.

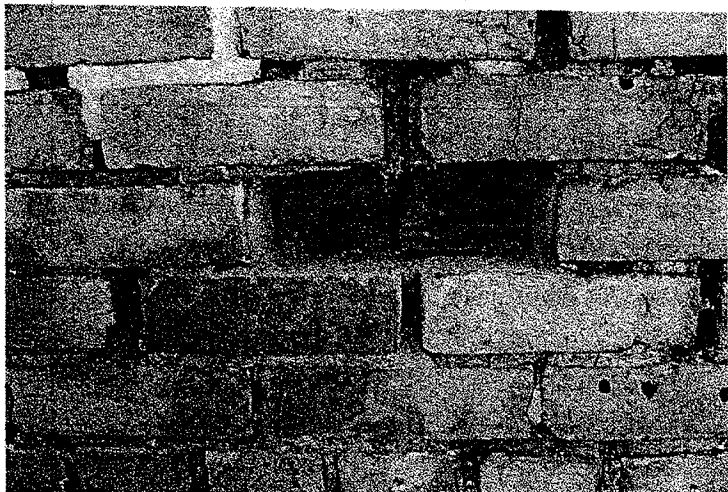
Surprisingly, the surviving mortar still provides resistance to removal, using hammer and chisel. Sampled brick unit was found to be in fair to good condition. Red coloured vitreous clay backup tile is visible beyond.

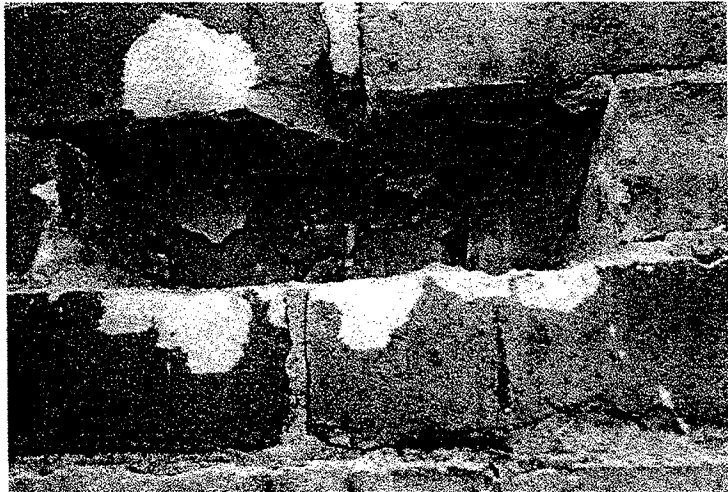
East Façade, Original 1899 Building

Mortar was robust and required mechanical cutting equipment and hammer/chisel to remove brick. Brick units appear to be sound and in good condition as did inner wall core backup brick.

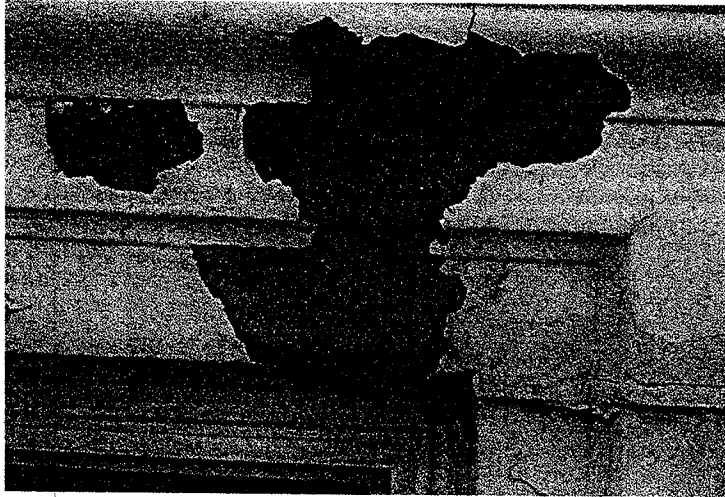
Typical Sandstone Moulding at Exterior of Window

Historic photographs indicate that the sandstone trims were originally exposed in their natural finish, however, they have been covered with multiple coats of paint. Paint systems on sandstone trims have generally failed with large peeling paint fragments falling from the stone units all around the building. This is to be expected since most paint systems are impermeable and moisture from within stone units and wall assembly will typically blow paint films from their substrates as they attempt to exit the stone. The relatively loose sand matrix of the base sandstone unit does not provide for a particularly solid substrate to resist these forces. Layers of sand particles are typically embedded at backside of peeling paint fragments.

Peeling paint reveals underlying red coloured sandstone. Early reports suggested that the mouldings were of terra-cotta but this is not the case as confirmed by sampling stone fragments and drilling of pilot holes at random locations.

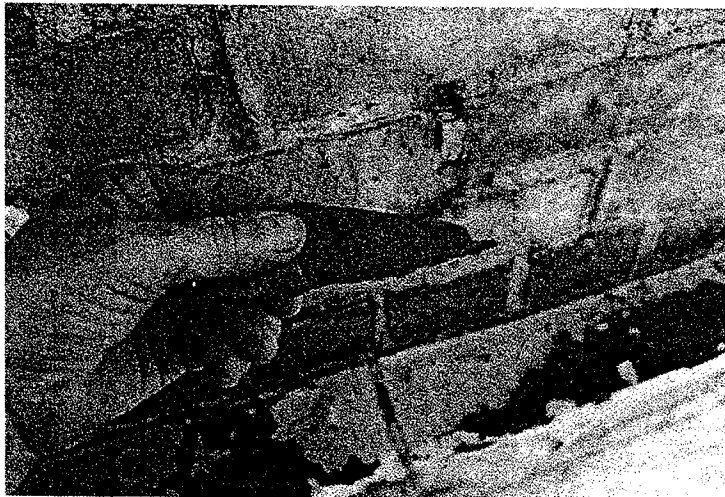
Fragment of peeled paint contains embedded grains of red sandstone at backside of paint.

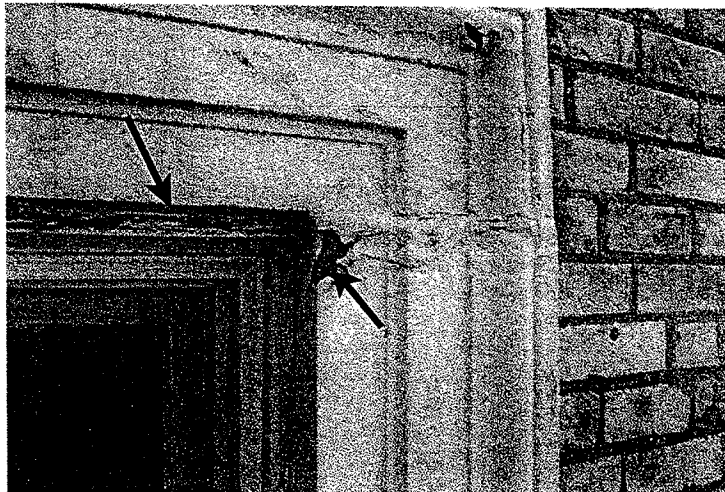
Steel lintels incorporated in 1911 and c1920
Additions are rusting, expanding and causing distress in surrounding stone units. Note diagonal fracture crack at edge of red stone where paint has peeled away.

Sandstone lintels at original 1899 building span window and door openings without assistance of steel support angles. Steel angles are provided at window opening in 1911 and 1920 Additions. The steel lintels have rusted and expanded in dimension, creating stress that has resulted in displacement of mortar from joints and fracture cracks in stone units. It is recommended that steel lintels be removed and replaced with new stainless steel or aluminum units.

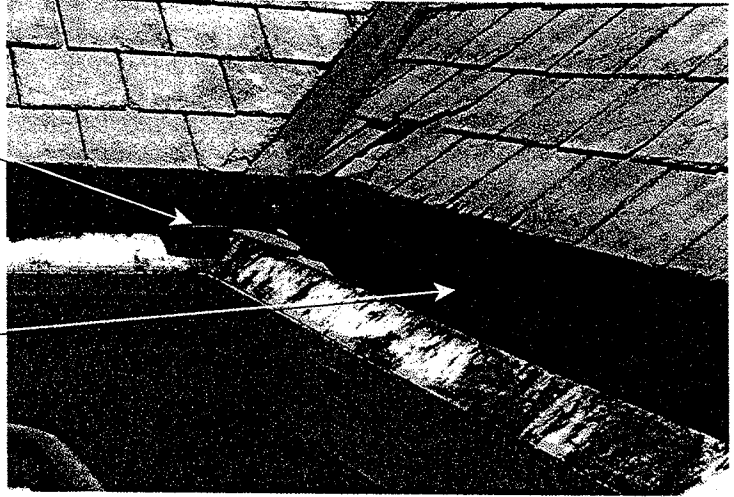
Galvanized metal gutters are built into the eaves. The galvanizing has partially dissipated over time, allowing the base metal to rust and corrode. Multiple applications of roofing mastic have been applied to interior lining of gutters in attempts to counter leaks. Such attempts have been largely unsuccessful as testified by the quantity of peeling paint from underside of soffit and ornate cornice.

Broken shingles and fragments have gather in rain gutter at bottom of valley flashing.

Rain gutter has been coated with roofing mastic at inside of gutter numerous times to address leaks. Leading edge of gutter has rusted through paint finish.

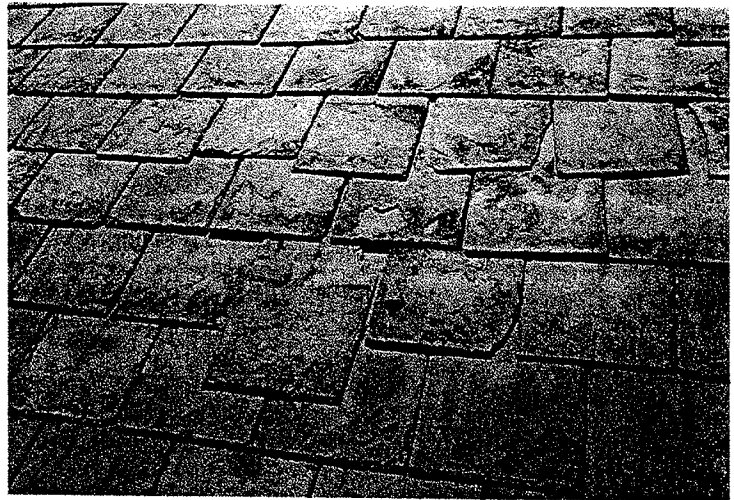
Slate shingle roofing at 1911 and 1920 Additions is in poor condition. Slates have weather and delaminated to substandard thicknesses. Many slate shingles are broken, dislodged or missing, leaving wood sheathing exposed to weather elements. The slate roofing system is at the end of its service life and should be replaced as soon as possible.

Slate shingles are at end of service life. Shingles are severely weathered and delaminated, many are broken or cracked and many are dislodged and are sliding from place.

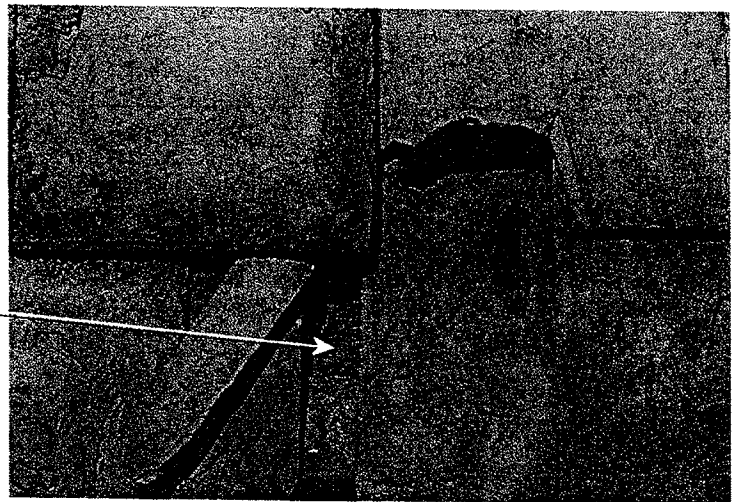
At some locations, missing slates exposed wood sheathing substrate to weather.

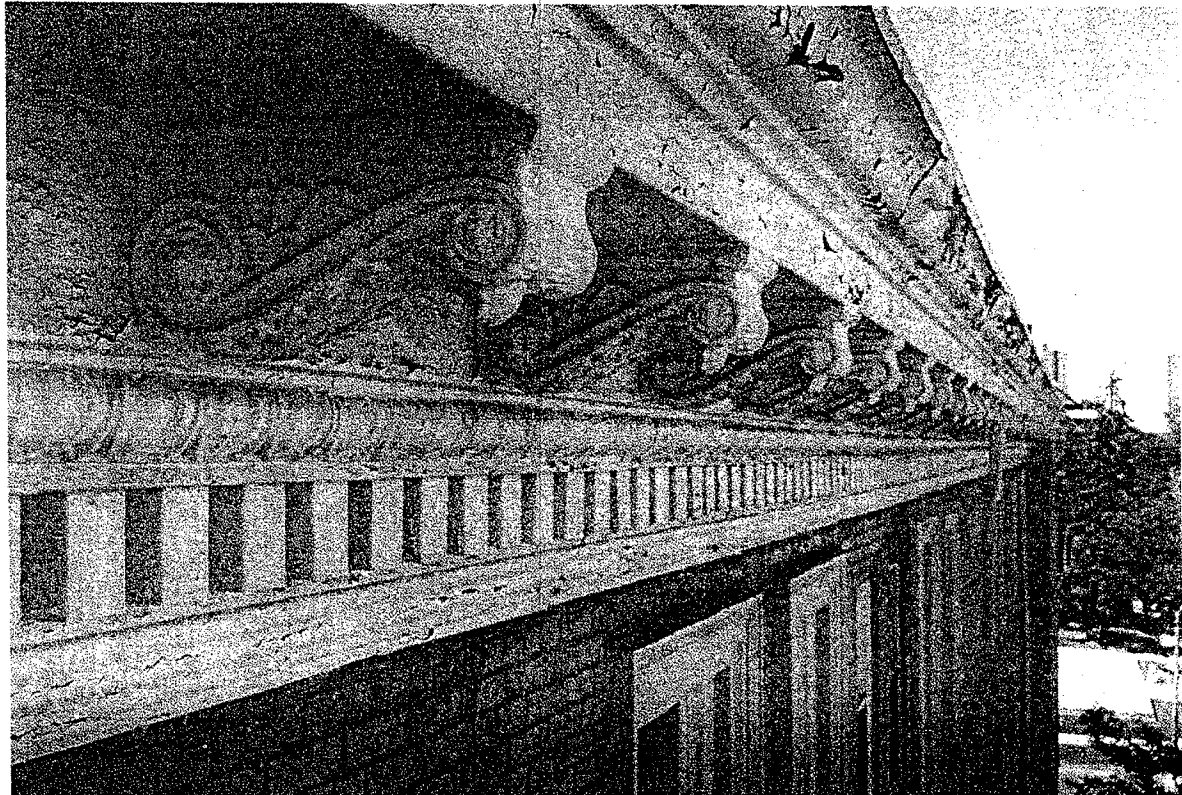
Decorative Metal Cornice, Soffit and Built-in Rain Gutter

The metal cornice generally appears to be sound and in good condition, with some missing dentils and localized areas with staining and corrosion due to water leaks. Paint on metal cornice components has generally failed and it is not feasible to simply repaint these elements. Existing paint films must be removed prior to repainting with an appropriate paint system.

Paint finish on metal components has failed.

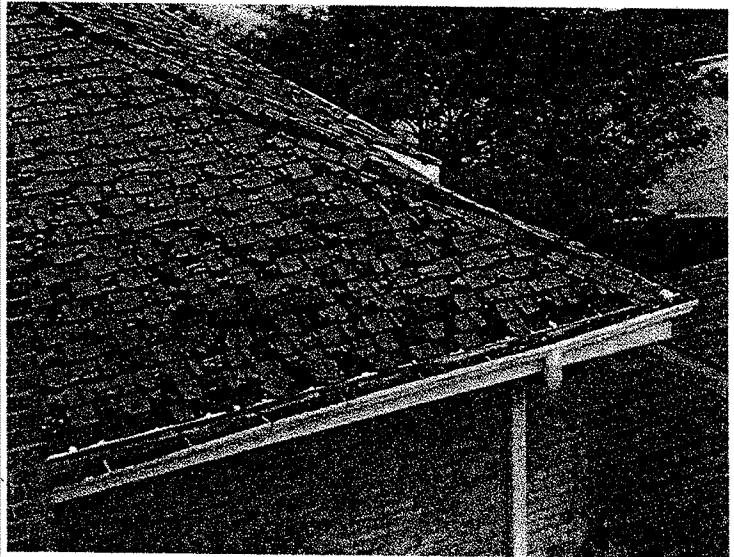
The remainder of roof area is asphalt shingles. Single-tab shingles are provided on the high and low roofs of the 1899 building; 3-tab shingles are provided on the intermediate roof. The high roof appears to be the most recent installation and seems to be in reasonable condition with some remaining service life. The low, south roof and the intermediate roof are older installations that are in poor condition and require replacement as soon as possible.

Asphalt shingle roofing at low and intermediate roofs are in poor condition and require replacement as soon as possible.

Existing asphalt shingle roofing is essentially falling apart and sliding off of the roof.
