**Re: Building Condition Assessment and
Adaptive Reuse Study for
Old War Memorial Children's Hospital at
London Hospital, South Street Campus**

**Old War Memorial Children's Hospital
London Hospital, South Street Campus**

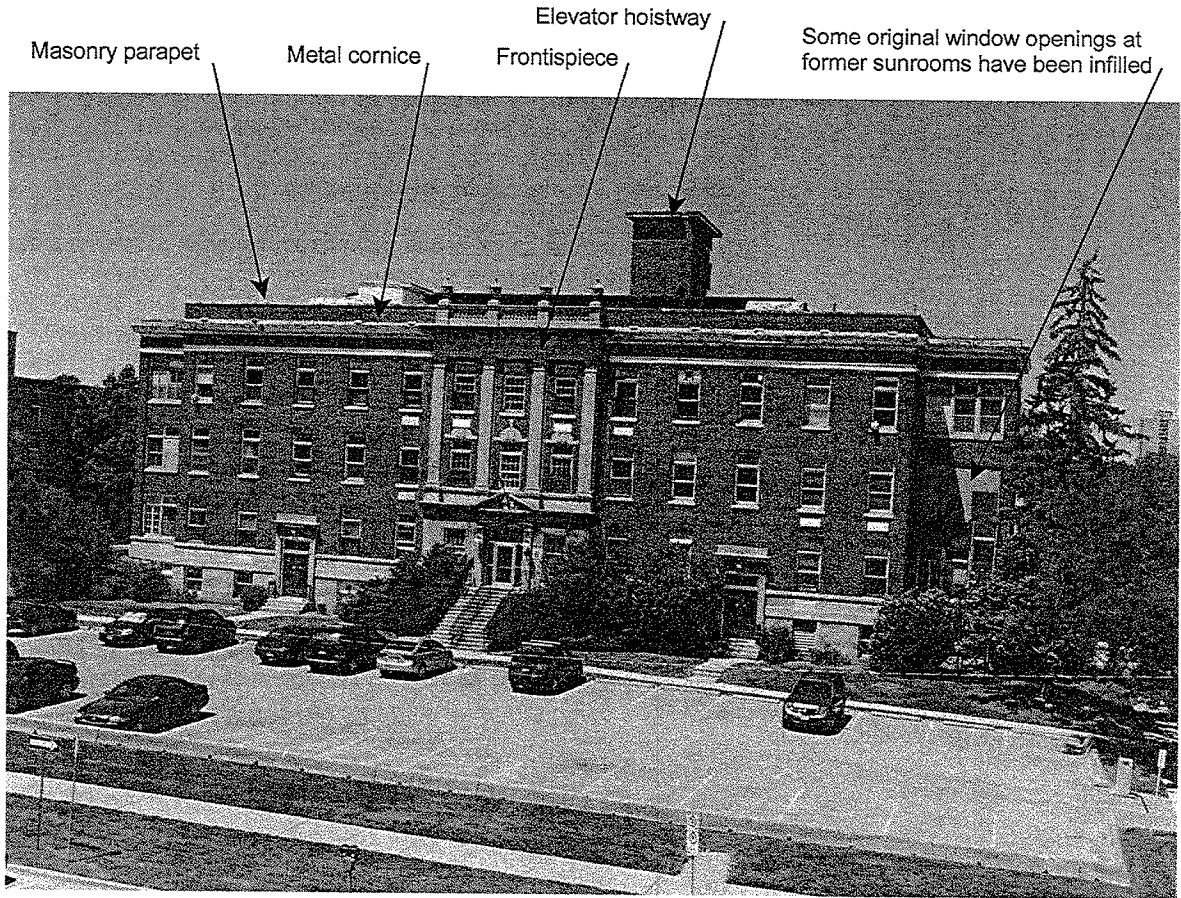
South Facade with Existing Parking Lot in Foreground

Limestone units appear to generally be sound. Potential for ferrous anchors and connectors is a concern, but there is no existing visible evidence of corrosion or oxide-jacking due to rusting of such components.

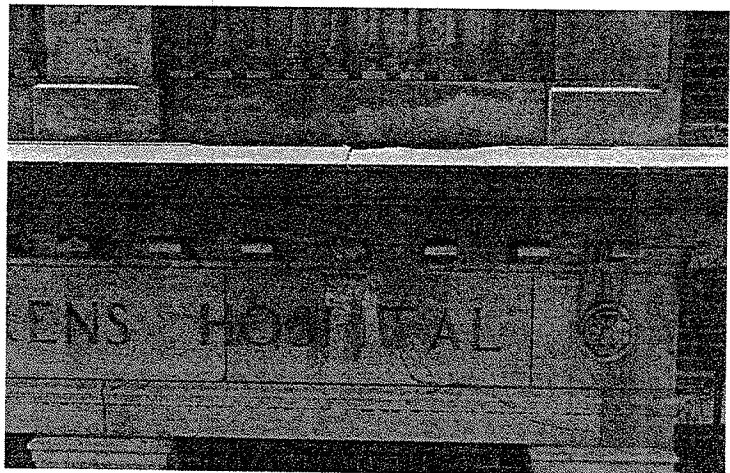
Detail of Entablature in Frontispiece

Wide, horizontal shelf at base of balustrade should be protected with lead-coated copper flashing to prevent erosion of masonry and surface washing, as visible at "P" in carved word "Hospital".

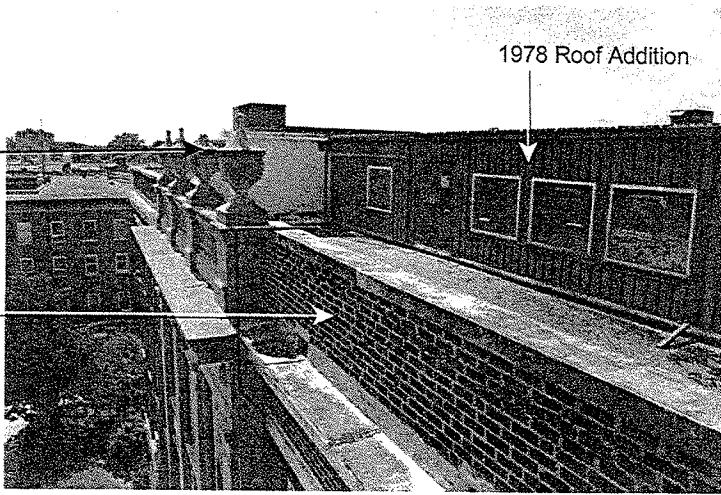
Limestone urns at top of balustrade appear to be sound, although pinnacle of second urn is missing.

Brick masonry parapet is in poor condition and requires disassembly and replacement.

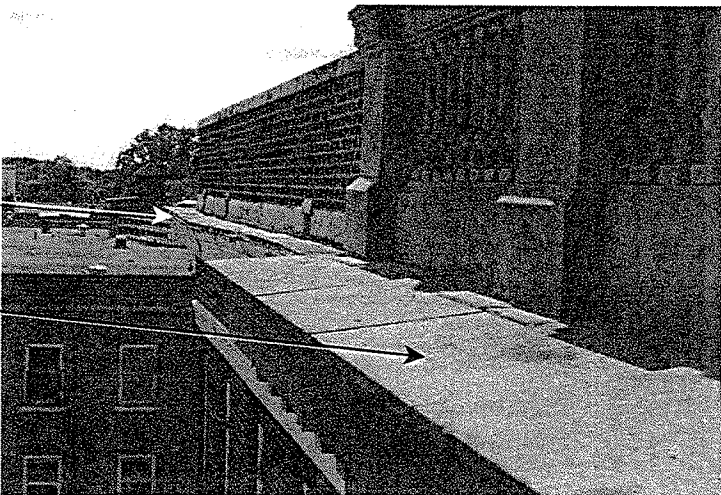
Metal cornice has visible sag, indicating weakness in wood-framed support system.

Lead-coated copper flashing is recommended for deep shelf at top of stone cornice to protect joints between stone units.

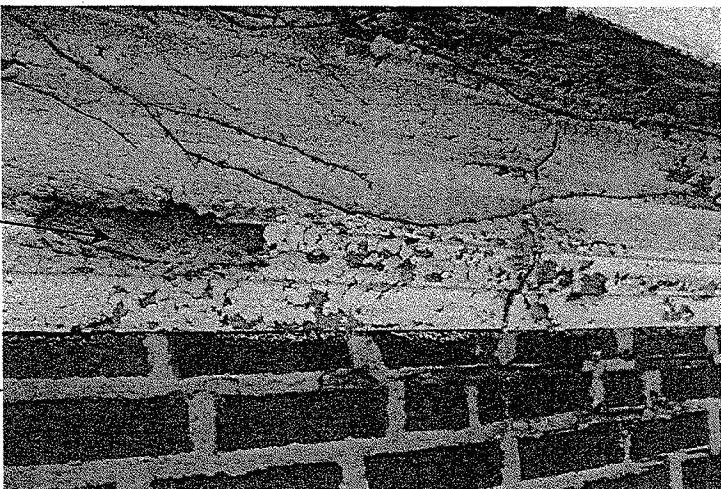
Sections of metal cornice have corroded through the metal. Mortar fines are visible at opening in the cornice.

Flush mortar joint presents as a wide, crude joint because mortar is smeared over irregular shoulders of brick units.

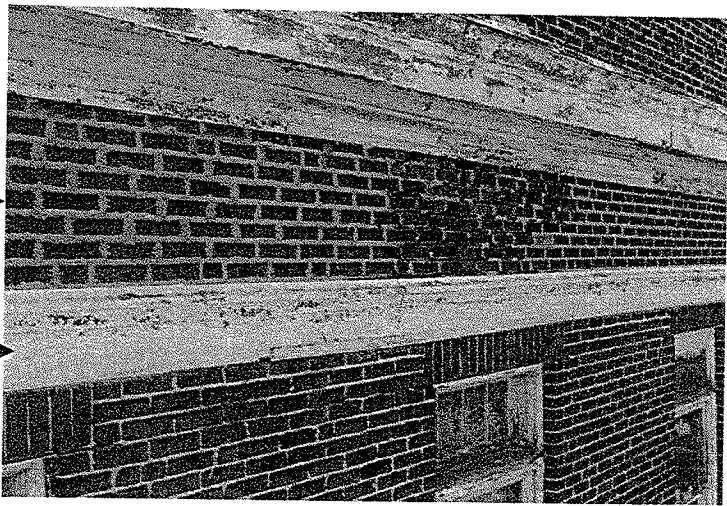
Mortar joints between metal cornice and belt course have previously been repointed. Note area of void and weathered joints above window head.

Metal belt course trim.

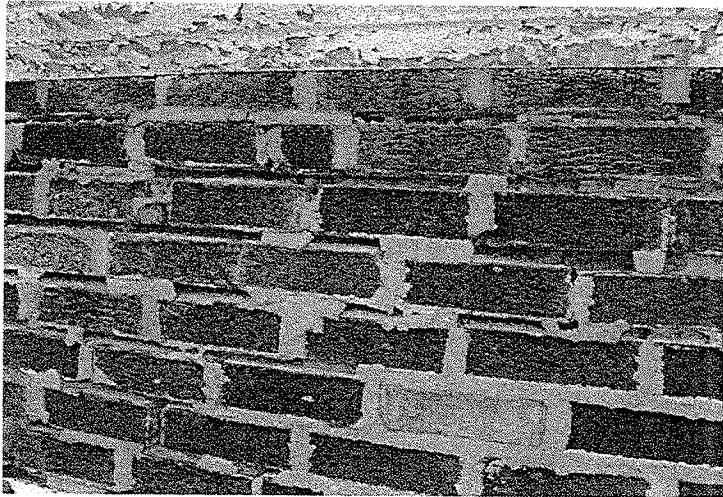
Previous attempts to repair and repoint mortar joints were poorly executed with inappropriate materials.

It is recommended that the masonry parapets be disassembled and reconstructed with all new materials.

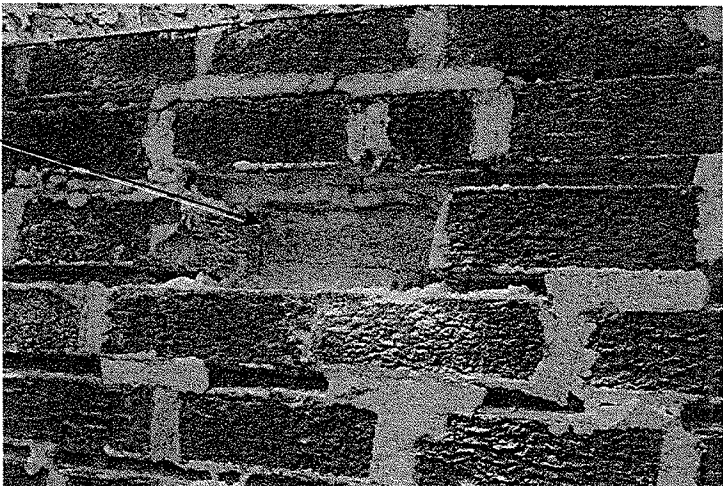
Notwithstanding severe visible mortar joint deterioration, the remaining mortar required power equipment to cut out sample brick. The brick unit was found to be sound.

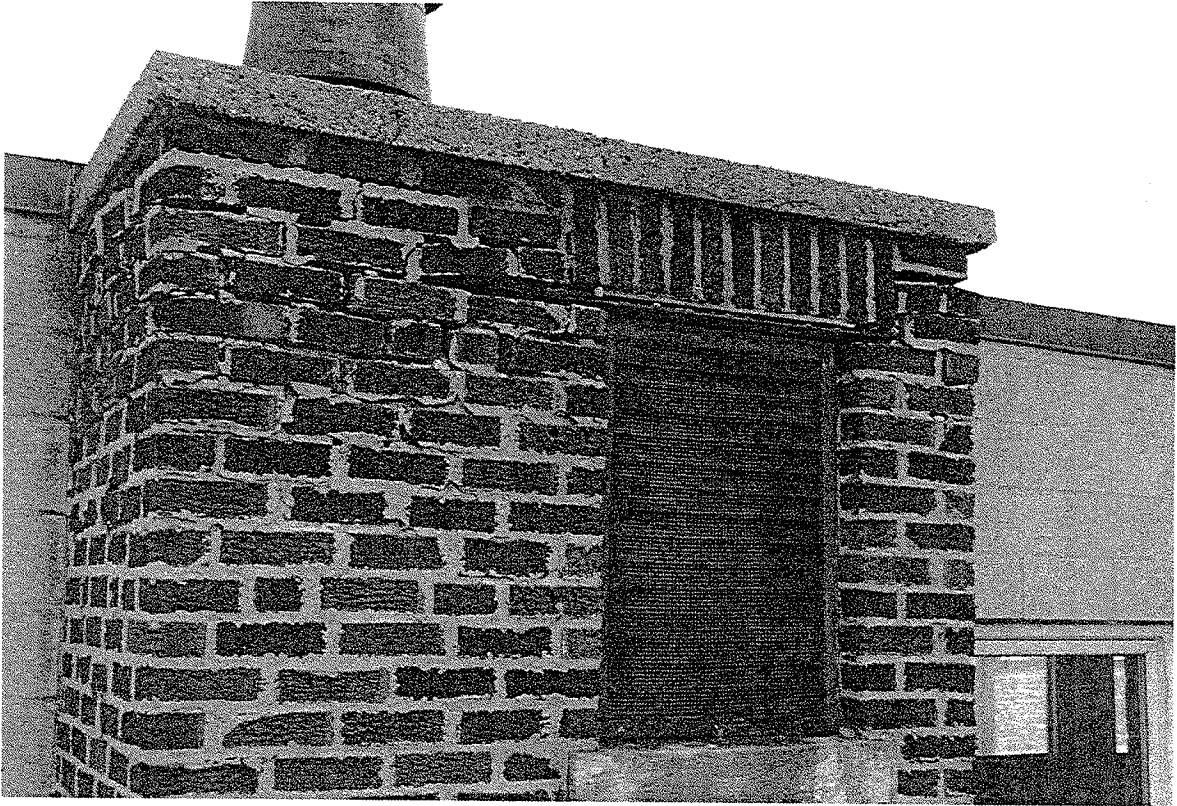
Masonry at top of northeast chimney is in poor condition and require reconstruction.

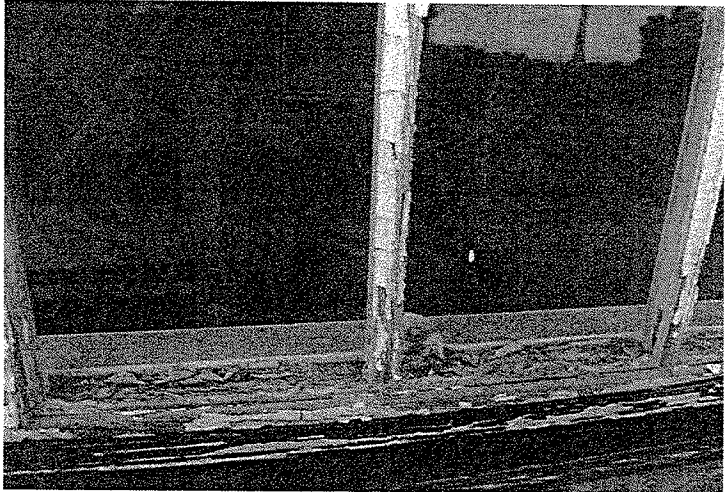
Glazing putty and paint finish is no longer present at some glazing bars. Accumulation of paint fragments at inside of glass is primarily due to condensation on the uninsulated windows.

Paint finish has typically failed on wood sash and sill components leaving raw wood exposed to weather.

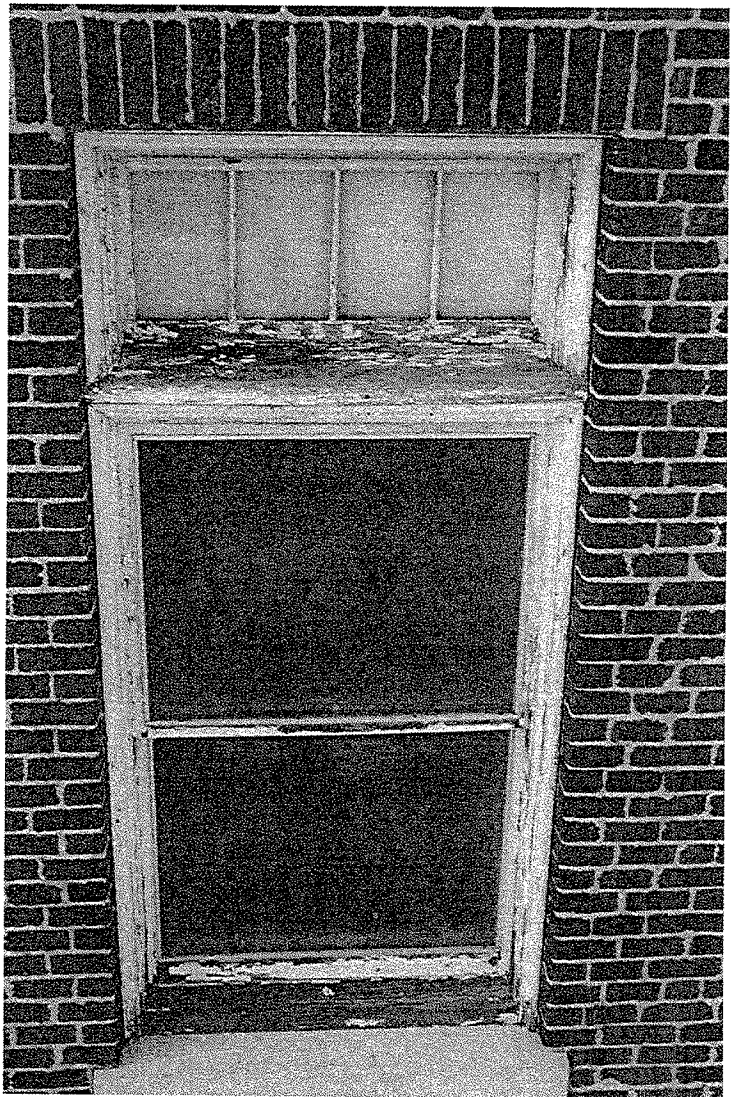
Steel angle lintels supporting brick have rusted and expanded resulting in distress of adjacent brick masonry. All steel should be removed and replaced with new galvanized steel or aluminum units.

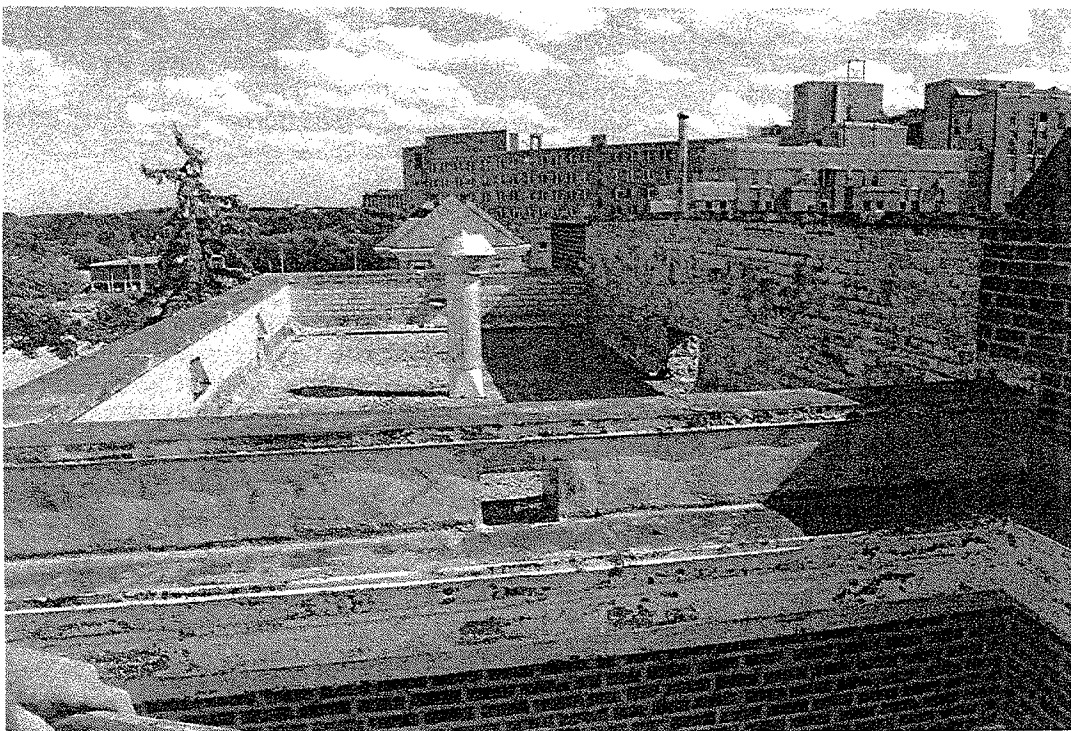
Backside of brick parapets have aluminized paint coating system applied, which is damaging to the masonry. Note scuppers through parapets to drain back-sloped cornice.
