TO:	CHAIR AND MEMBERS BUILT AND NATURAL ENVIRONMENT COMMITTEE PUBLIC PARTICIPATION MEETING MONDAY, SEPTEMBER 26; 7:00 P.M.
FROM:	J. M. FLEMING DIRECTOR, LAND USE PLANNING AND CITY PLANNER
SUBJECT:	DEMOLITION REQUEST FARHI HOLDINGS INC. 764 WATERLOO STREET

Appendix 2: Engineering Assessment – 764 Waterloo Street

Re: Visual Building Assessment for residential building located at 764 Waterloo St., in London, ON

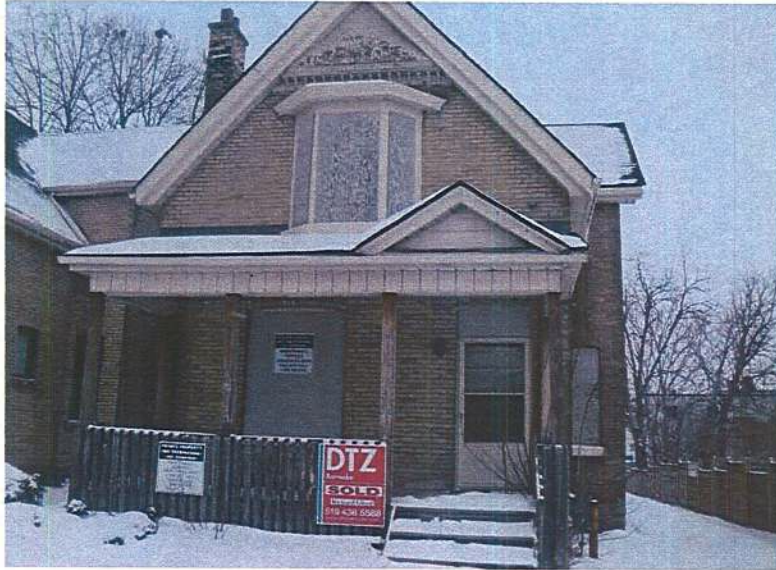
The existing residential building located at 764 Waterloo St.

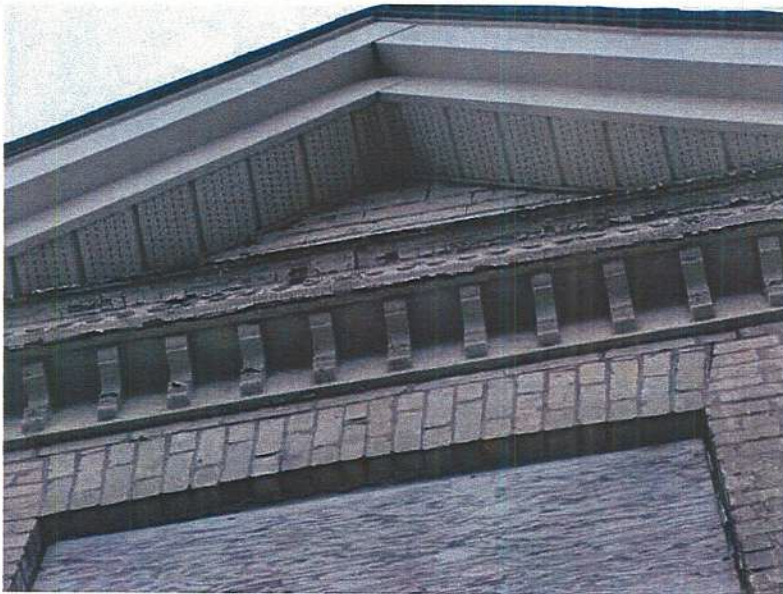
The brick mortar joints specifically below windows, appear to have been repaired at some time. The repair mortar used appears to have been a cement base which is too hard for this type of brick and which will cause more damage to the adjacent brick. New cracks have appeared so these areas require additional repairs. The chimney was noted to have a number of cracks in the brick which require repair. The corner of the building on the south-east has some bricks missing or broken and there is another area at the south-west end where bricks are missing. These areas require repair. Re-pointing of the brick in a number of locations is required because of missing downspouts. The water running over the brick has eroded the mortar.

The exposed wood on the exterior of the building has not been maintained and the paint is peeling away. A close inspection of this was not completed but because of the exposure to the elements the wood may be damaged.

Damage to existing exterior. Metal soffits and fascias are not original.

- The building around the exterior would have to be excavated to properly waterproof the foundations and stop the leaking into the basement.
- The masonry requires re-pointing on the inside basement walls to repair the damage from leaking through the wall. The exterior brick also requires repairs to new damage including cracks, brick replacement and re-pointing. These repairs occur on the chimney, along the areas where the downspouts were, at the corners of the building and in a number of other locations. The existing repairs should be removed and repaired with proper lime based mortar.

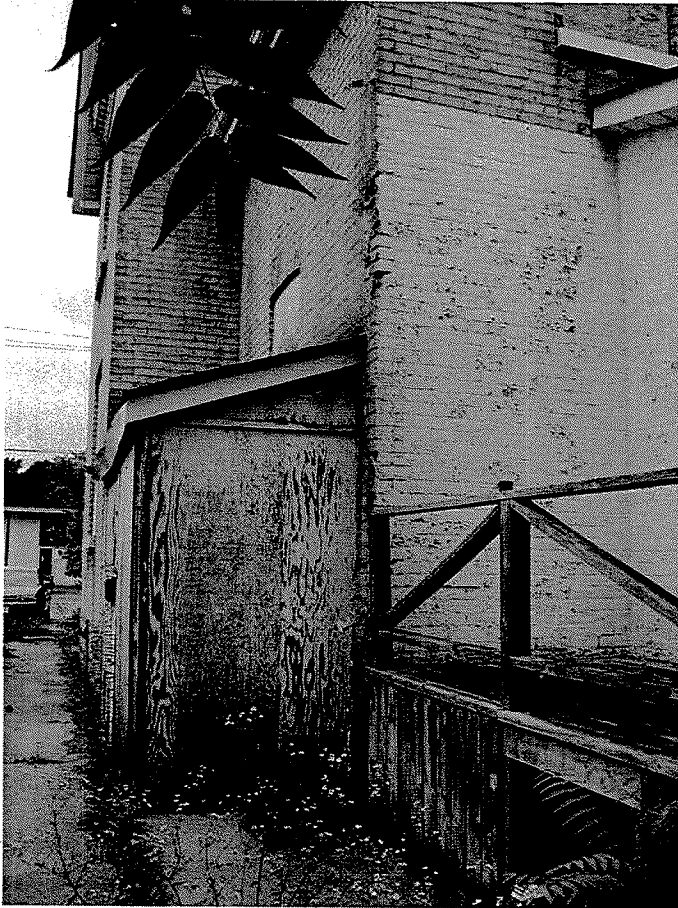
There is access to the basement on the south side of the building via an exterior stair case. This stair case has been covered over with a wood stud and plywood structure. The wood and plywood were only paint finished and the structure is deteriorated and in bad condition. The stair could not be accessed at the time of the review because the door was boarded over. There is also an interior stair which accesses the basement. This stair is accessed only from the entrance on the north side. The north entrance was not accessible from the exterior at the time of the first review but, as noted previously, the wall separating the apartment entrance and the main floor office area has been broken open. This was used during the site review to access the remainder of the building.

Wood enclosure over south stair accessing basement and brick damage.

- Removal or reconstruction of the shed structure over the basement entrance on the south side.
- Review of the boarded up windows, for damage and replacement as required.

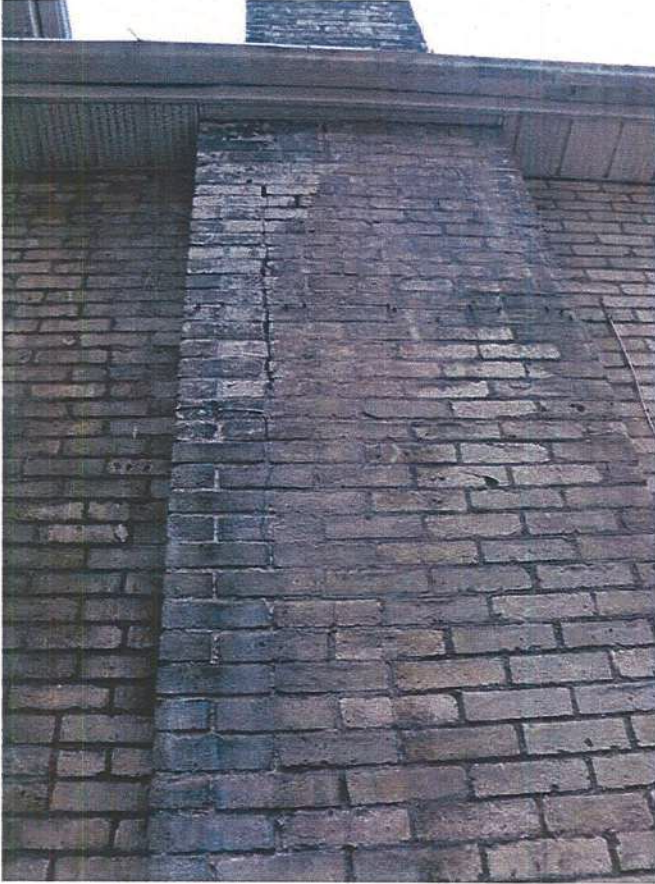
Crack in the brick of the chimney, and deterioration of the mortar joints.

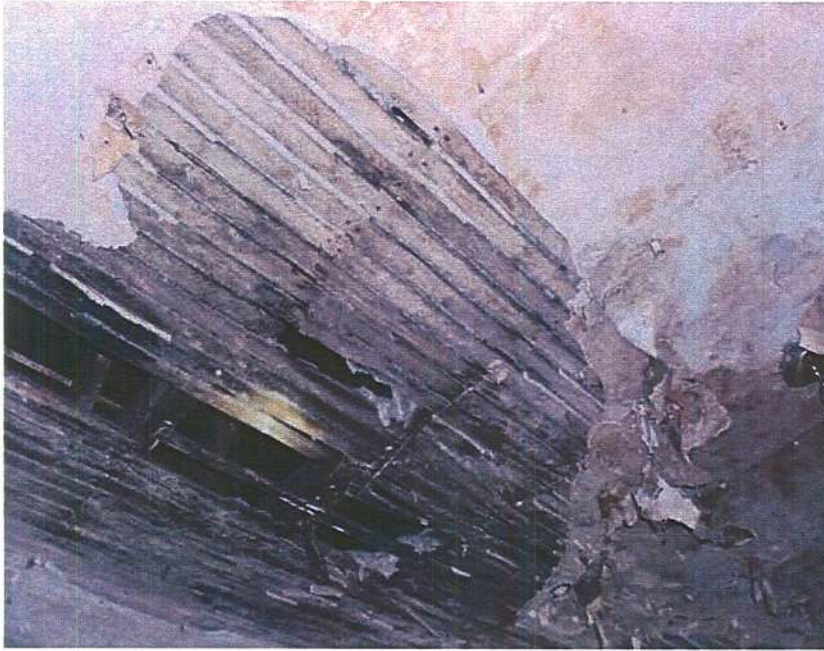
The second floor is accessed from the north side of the building and is separated from the main floor. The space appeared to be an apartment. Here it was found that the ceiling finishes throughout were badly damaged because of water leaking through the roof. It appears that the roof had been leaking for an extended period of time and some of the lath and plaster had fallen in, and some was hanging. There was also a lot of damage to the wall finishes and

Damage to the upper floor ceiling because of water leakage.

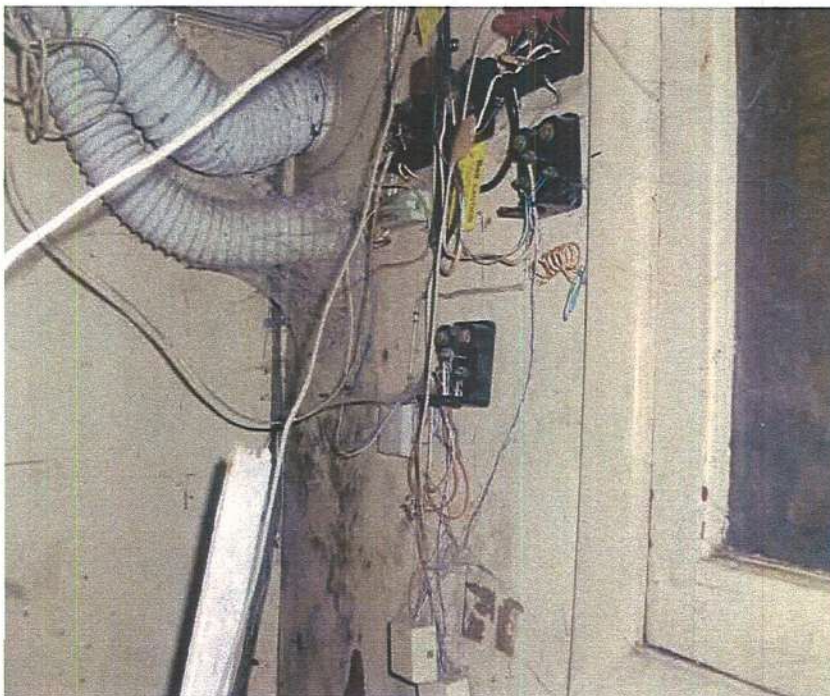
The existing voice/data and cable TV systems for building located at 764 Waterloo St.

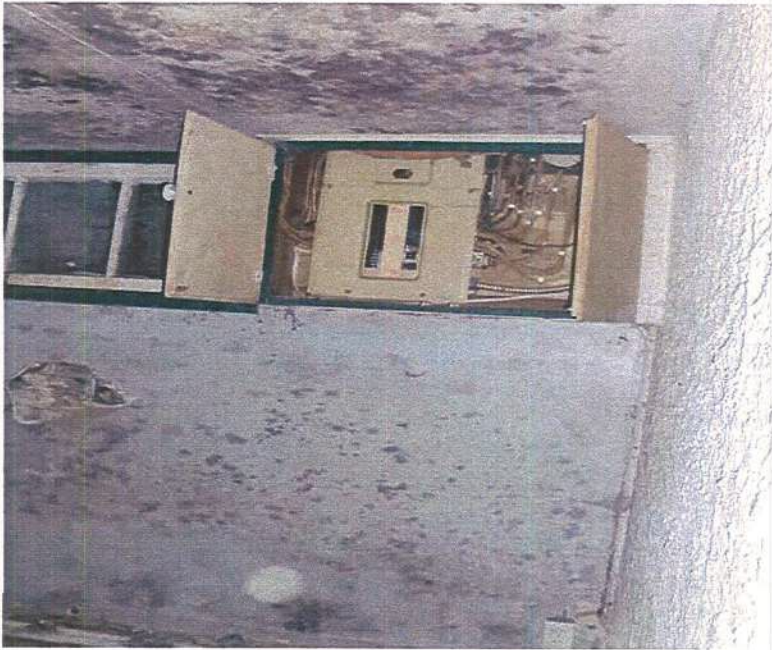
The 100A 120/240V 1Ph distribution panel c/w main breaker is found on the basement. This panel was used to service the whole building.

The mechanical and electrical systems in the building was found to be non-existent or damaged. The existing conditions do not meet the requirements of the current codes. The entire mechanical system needs replacement. Damage to the plumbing will have to be reviewed and the type of piping in the building will also have to be reviewed for lead.

The existing main distribution panel for building located at 764 Waterloo St.

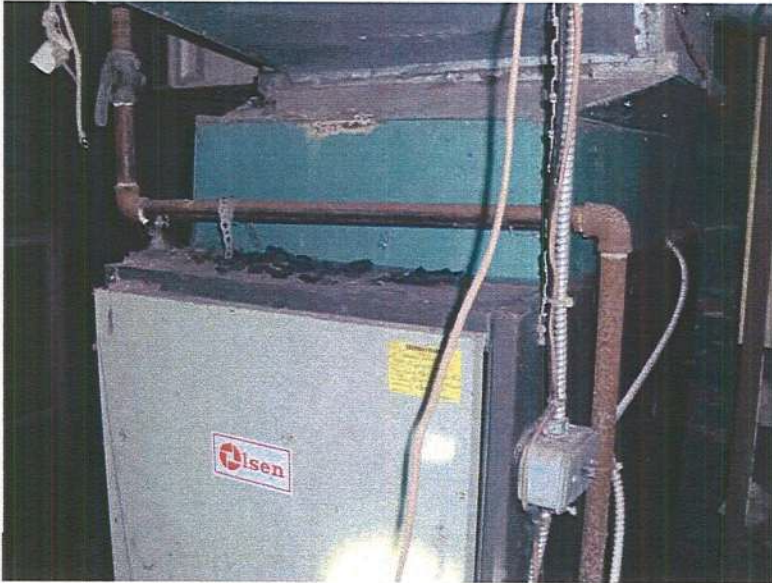
Also, in the basement was found an old gas furnace that was used to service the whole building. Adjacent to the furnace was found an old water heater and the service lines.

The existing gas furnace heater for building located at 764 Waterloo St.

- The floor joists need to be reviewed to repair damage caused by previous renovations and installations.
- A new mechanical system would have to be installed including heating, cooling, ductwork etc. to bring the building up to code. The existing plumbing should be reviewed for lead and where required replaced with proper materials.

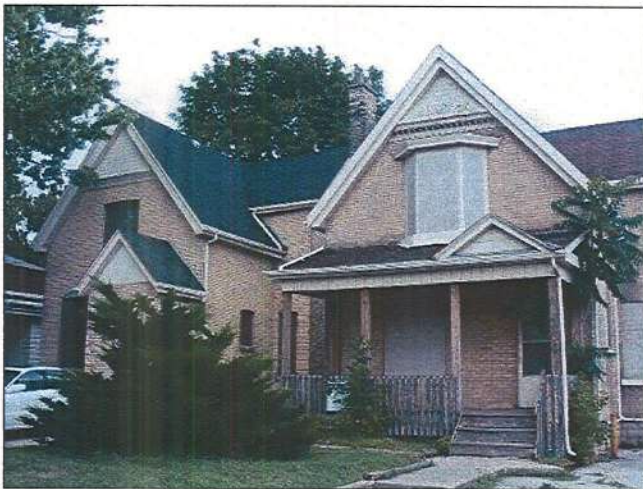
Front with neighboring home (2006)

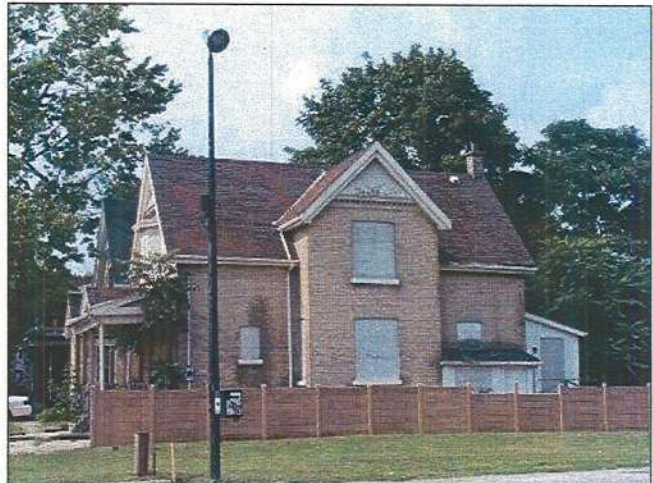
South façade (2006)

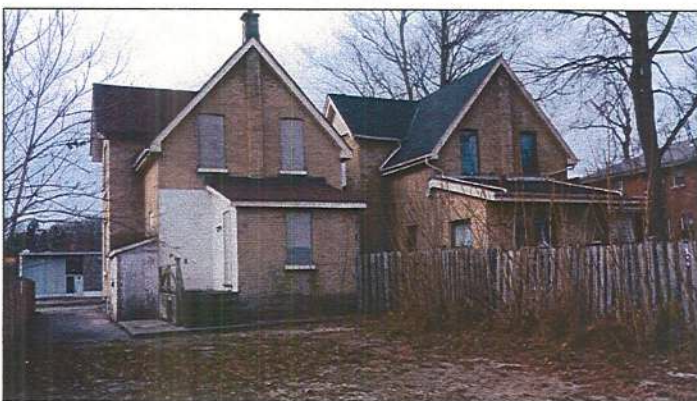
Rear with neighbor (2006)

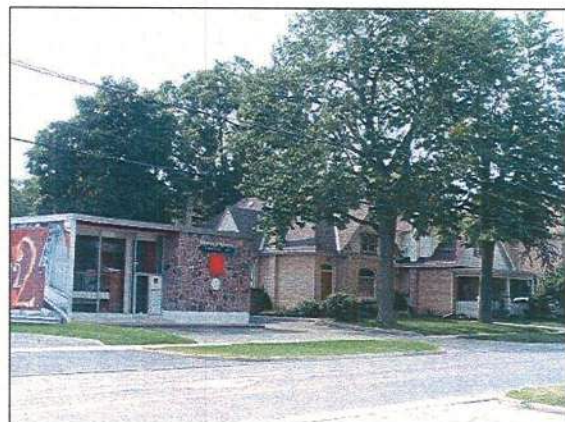
West Streetscape (2006)
