Lambeth Community Health and Wellness

MB McEachren Demolition Analysis Report

May 2016

S3AEC + StudioS3AEC

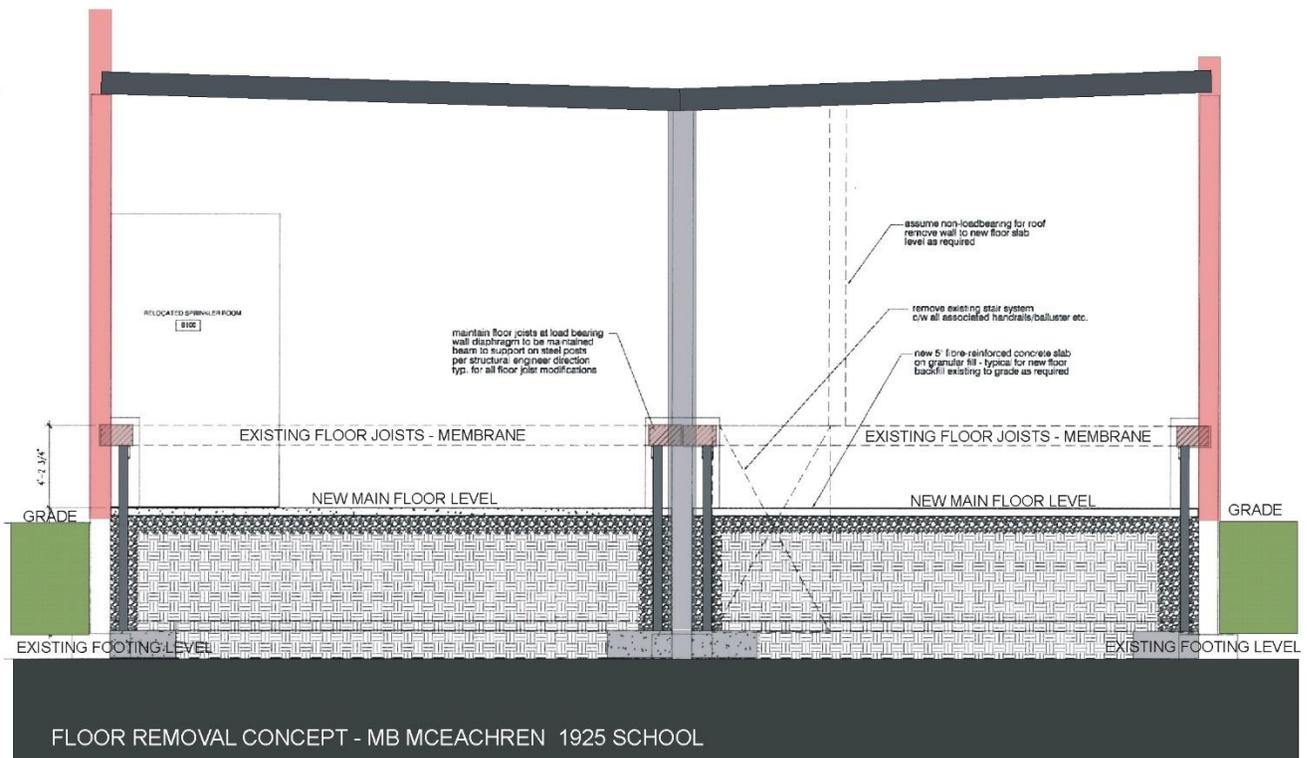
Figure 2.0 Graphic Cross Section of 1925 School

There is significant deterioration primarily to the south and north parapets. The stone copings have failed and over several freeze-thaw cycles, water has penetrated the airspace, frozen and expanded to bow the brick rain screen. The masonry to approximately 3.5 m above grade, on both walls north and south for the entire length, would require a rebuild and tie-back of the masonry to the structure to make them safe and structurally sound. Since the 1925 building is wood framed, further investigation would be required once the exterior materials are removed to determine the extent of structural damage to the exterior skin of the building. We suspect there would be significant damage to the structural integrity of the wall framing due to moisture content, freeze and thaw cycles that over time would cause warping and lead to failure eventually. This is all dependent on the type and quality of sheathing used. Given its age, we can safely assume it is a wood product, and not a fibrous glass product which deflects water.

To ensure the new use of health and wellness services to the Lambeth public meets current and future AODA accessibility standards, one of three approaches must be taken. A ramp system to access the main floor of the 1925 structure, or some form of an elevator system as was contemplated and abandoned in 1997 by the TVDSB. In either scenario, significant alteration will be required to suit the implementation, altering the 1925 building elevations visually from their current form. This ramp system would naturally occur across the front of the 1925 Building facing Colonel Talbot Road. The third, and other solution to prevent major external modification, which we did explore early on in the project contemplation when we investigated the accessibility challenge, is the removal of the floor structure. It is a complicated engineering process due to the floor acting as a membrane to support the main level framing diaphragm and structural support for the roof. The construction procedure, may or may not fail, depending of what is found when the flooring is removed on the main floor. The other engineering challenge will be the entire removal and relocation of the sprinkler system incoming service and distribution hub. Figure 2.0 represents the removal of the floor and replacement of a new fill and concrete slab as floor – relocating the sprinkler distribution to a new location.
