# **Lambeth Community Health and Wellness**

## **MB McEachren Demolition Analysis Report**

May 2016

**S3AEC + StudioS3AEC**

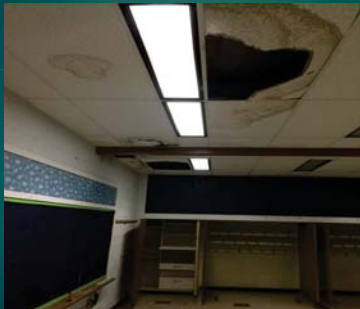
## Mould in Classroom

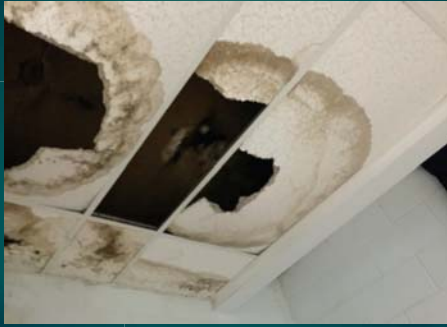
Black Mould

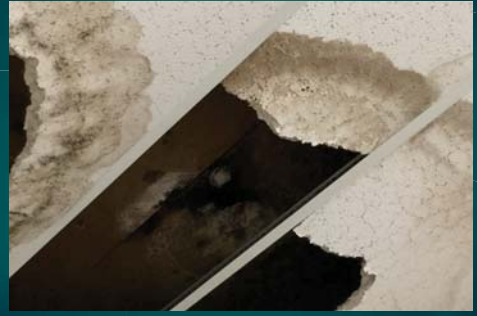
Black Mould

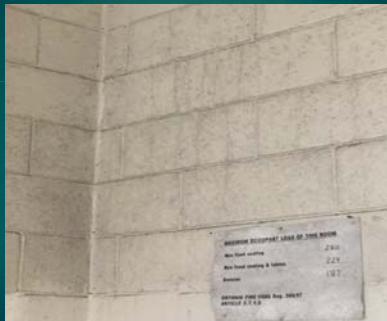
Black Mould in Gymnasium Wall

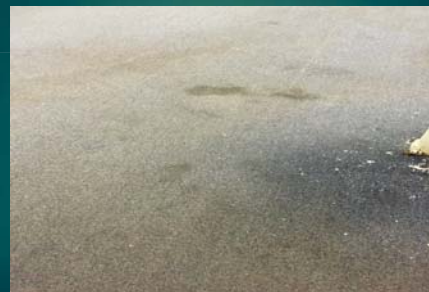
1925 Water Damage Stained Carpet

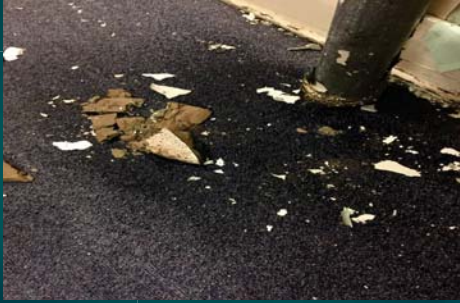
1925 Water Damage and Hidden Mould

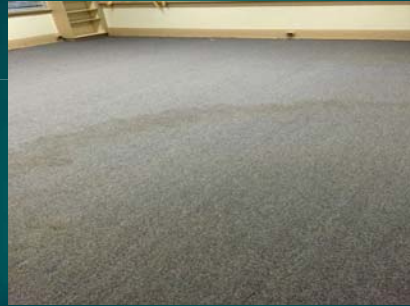
Water Stain – Hidden Mould

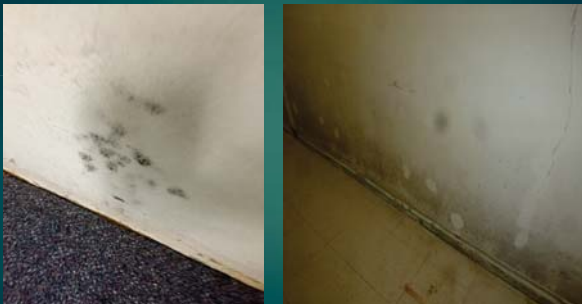
1925 Black Mould on Walls

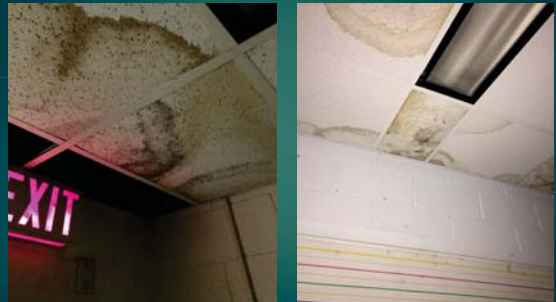
1925 Spread of Black Mould

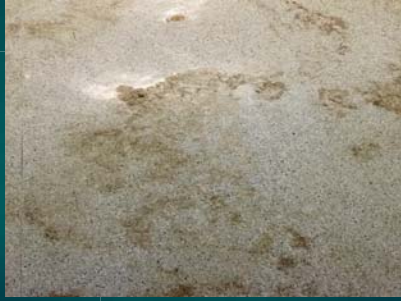
Mould coming through asbestos floor

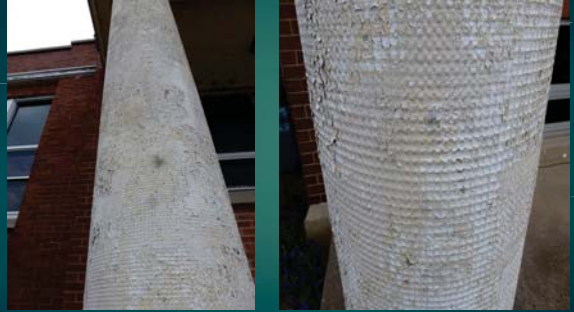
The original 1925 building as mentioned previously, has undergone major modification over the years to accommodate fire protection, removing any remnant of the main entry to the building other than some deteriorating columns and a front miniature porte-cochere, that fails to extend to the parking lot as would be intended by such a structure that does not appear to be a porch, with steps and stairs, or a vehicle drop off point either in its latest iteration. It is difficult to determine if it is actually original. Visible material composition of the canopy and columns are painted plywood and fibreglass wrapped columns. The columns are certainly not original from a 1925 era.

Structural - Front Pillars

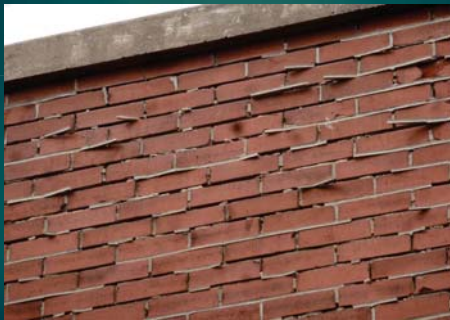
There is significant deterioration primarily to the south and north parapets. The stone copings have failed and over several freeze-thaw cycles, water has penetrated the airspace, frozen and expanded to bow the brick rain screen. The masonry to approximately 3.5 m above grade, on both walls north and south for the entire length, would require a rebuild and tie-back of the masonry to the structure to make them safe and structurally sound. Since the 1925 building is wood framed, further investigation would be required once the exterior materials are removed to determine the extent of structural damage to the exterior skin of the building. We suspect there would be significant damage to the structural integrity of the wall framing due to moisture content, freeze and thaw cycles that over time would cause warping and lead to failure eventually. This is all dependent on the type and quality of sheathing used. Given its age, we can safely assume it is a wood product, and not a fibrous glass product which deflects water.

1925 Structural – Bowing Bricks

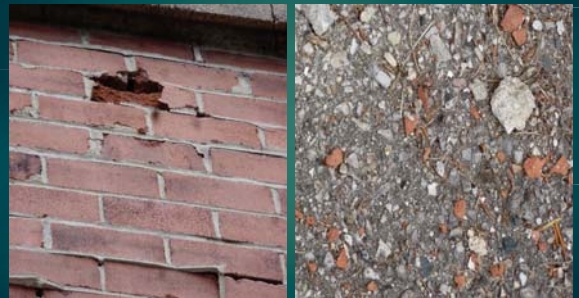
1925 Structural – Exploding Bricks

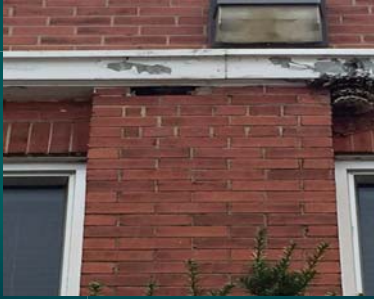
Structural – West Wall blown out  
brick

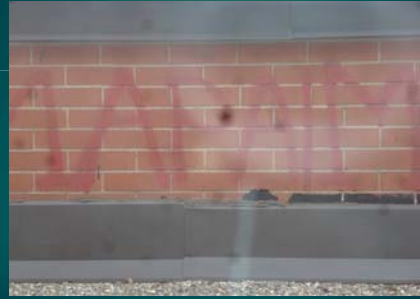
GRAFFITI
