<b>TO:</b>	<b>CHAIR AND MEMBERS LONDON ADVISORY COMMITTEE ON HERITAGE</b>
<b>FROM:</b>	<b>JOHN M. FLEMING MANAGING DIRECTOR, PLANNING AND CITY PLANNER</b>
<b>SUBJECT:</b>	<b>REQUEST FOR DEMOLITION SOUTHSIDE CONSTRUCTION MANAGEMENT LTD. 175/179/181 KING STREET WEDNESDAY, JUNE 8, 2016</b>

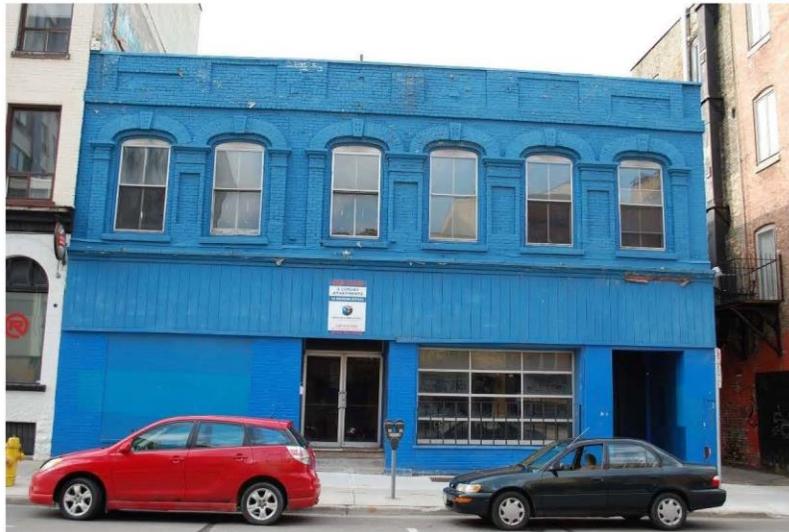
*Photograph 1:* North elevation fronting on King Street.

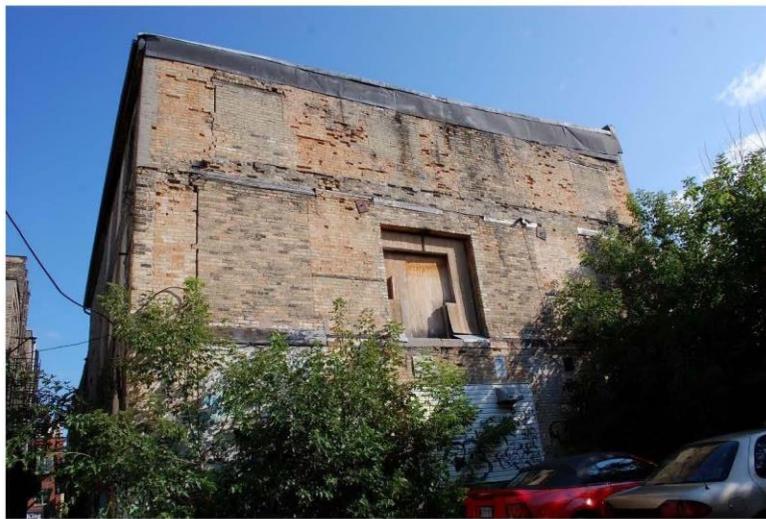
*Photograph 2:* South Elevation; three storeys in height.

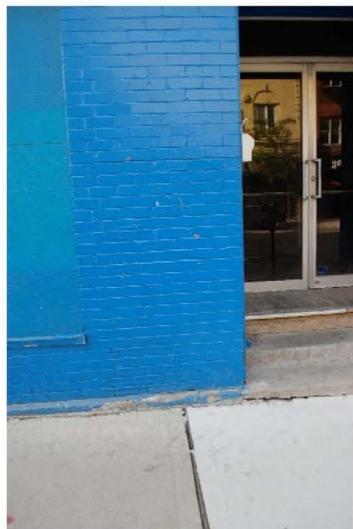
*Photograph 4:* Painted brick on north elevation is in good condition.

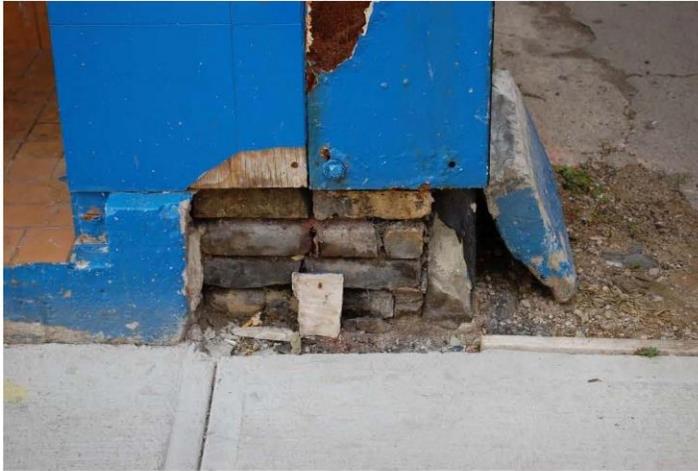
*Photograph 5:* Brick deterioration at the base of pier on the north elevation. Loss of mortar.

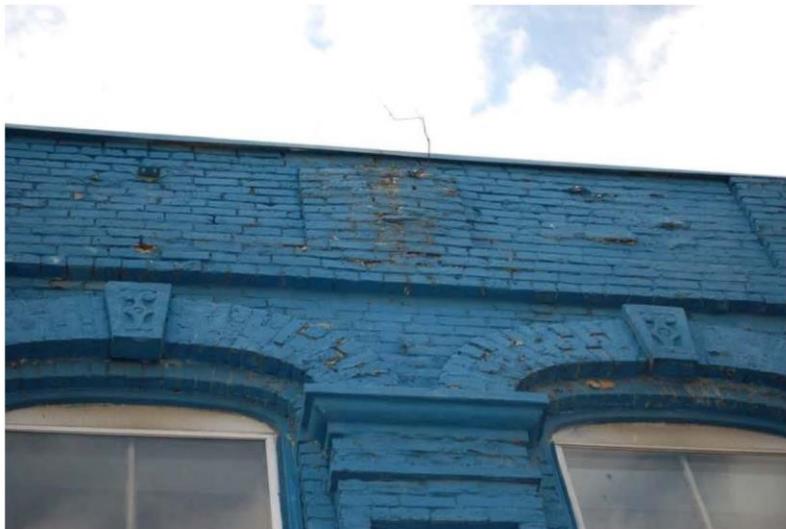
*Photograph 6:* North elevation near the middle of the wall. Outward brick movement and mortar deterioration at the parapet level.

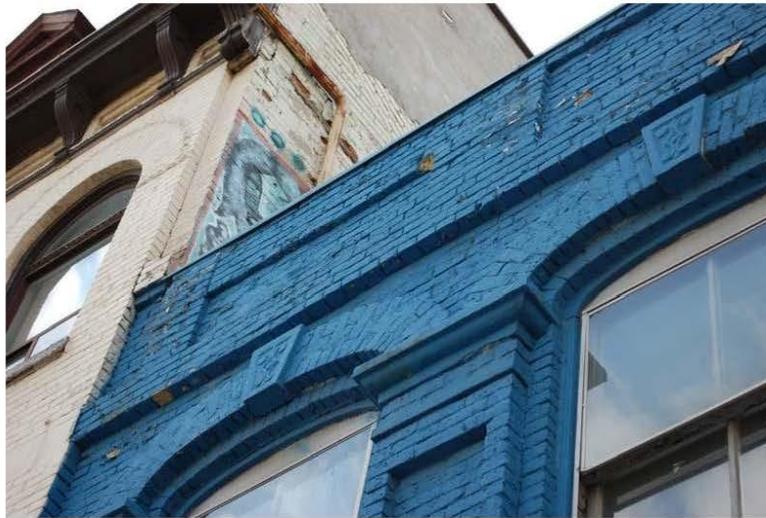
*Photograph 7:* Mortar and brick deterioration at the parapet level.

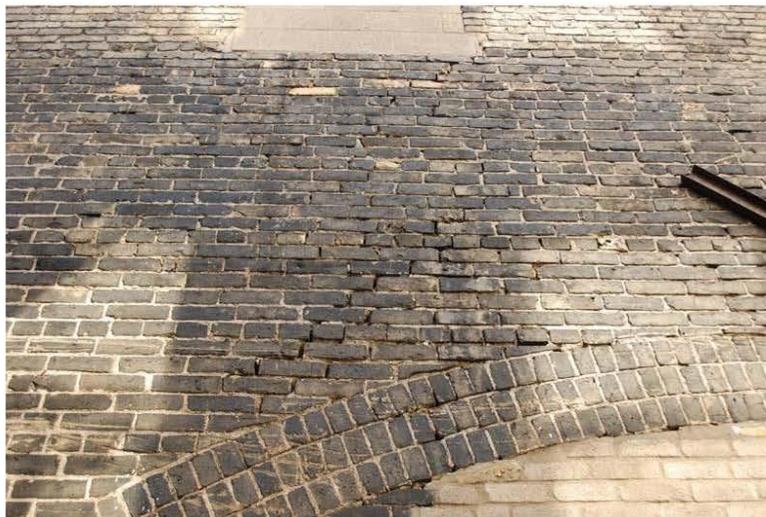
The west elevation was adjacent to an alleyway and was also experiencing mortar joint deterioration and step cracking of the brick masonry (Photograph 8) in more than 15% of the wall area. Severe mortar loss of between 3/4" depth and complete mortar loss was observed in several locations (Photograph 9). The vertical joint between the two-storey and three storey portion of the building was in very poor condition (Photograph 10) with severe mortar loss and loose and missing masonry units. This joint had the most extreme deterioration of the west wall and represented a falling brick hazard. The west parapet was in worse condition than the general wall area, with outward movement in two locations (Photographs 11 & 12). At grade, there were several areas that had total mortar loss and missing bricks (Photographs 13 & 14). Shallow, horizontal grooves and scrapes in the masonry were observed towards the rear of the west alleyway. These were likely due to vehicles scraping against the wall as they moved down the alleyway. In terms of the condition of each section of building, the original (north) portion of the building at the joint between it and the first (middle) addition and the parapet areas were in the worst condition. The first (middle) addition was in fair condition with only a few brick 'popouts' (Photograph 15). Retrofitted plates (Photograph 16) were observed on the exterior of this portion of the addition, which suggest that tying back of the floor system was done at some point to prevent the outward movement of the masonry bearing walls. A distinct masonry joint was observed between the rear (south) and middle additions (Photograph 17). The rear addition (south) was in the worst condition (Photograph 18), with a wide and large diagonal step crack at the base of the wall near the south-west corner of the building, denoting movement of the rear wall. A window at the top storey was broken (Photograph 19), permitting water and snow to enter the building. A hatch in the roof was also observed to be missing (Photograph 20), permitting direct water and snow ingress.

*Photograph 8:* Blocked-in window openings, mortar deterioration and severe cracking in the west elevation.

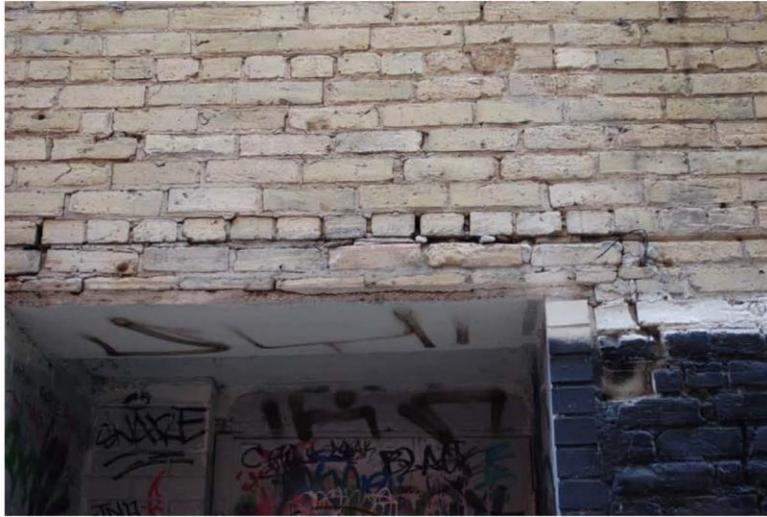
*Photograph 9:* Mortar loss above the doorway lintel on the west elevation.

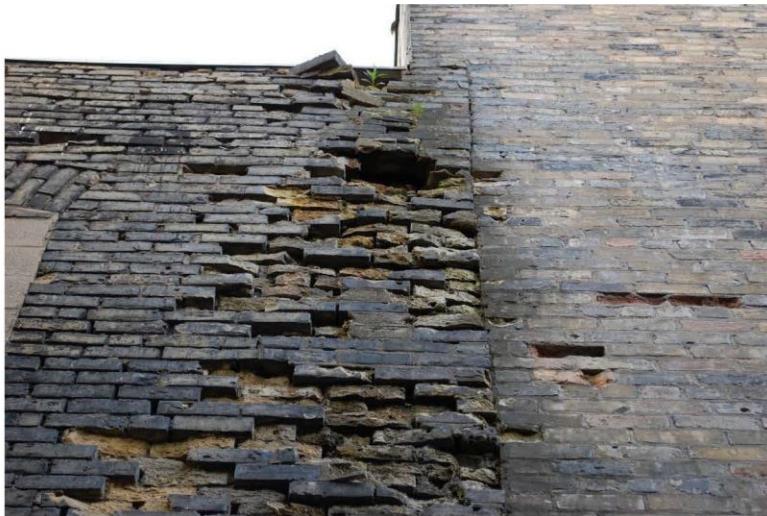
**Photograph 10:** Masonry at the joint between the two and three storey sections was in extremely poor condition. Note the bricks 'ready to fall' near the top of the wall, plus missing and shifting bricks were observed.

- 2) The brick masonry of the west façade requires immediate rehabilitation in the form of selective repointing and masonry unit replacement at the vertical joint between the original building and the first (middle) addition. This location represents an immediate hazard to persons or property in the alleyway immediately west of the building. Repair of the large crack towards the south end of the wall is also an immediate concern as it is likely associated with the deterioration and movement of the south wall. Localized brick rehabilitation at the base of the west wall is also required.

- 4) The loose bricks on the west wall at the joint between the original building and the first (middle) addition should be removed and the wall section restored. This work, although immediately necessary, is a second priority to the work required on the south wall. Access to this area will likely be required via a scissor lift or other elevated platform devices.
- 5) While the elevated platform is on site for the west wall, a closer examination of the north wall should be conducted and selective masonry replacement should be done for all loose masonry units.
- 6) Further investigation of damage to the building interior is recommended.

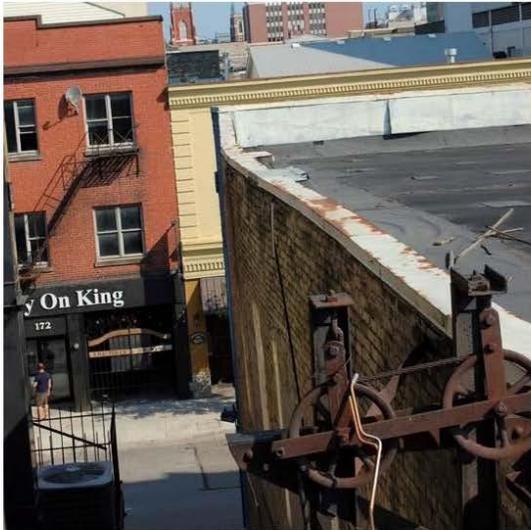
**Photograph 11:** Outward movement of the parapet on the west elevation.

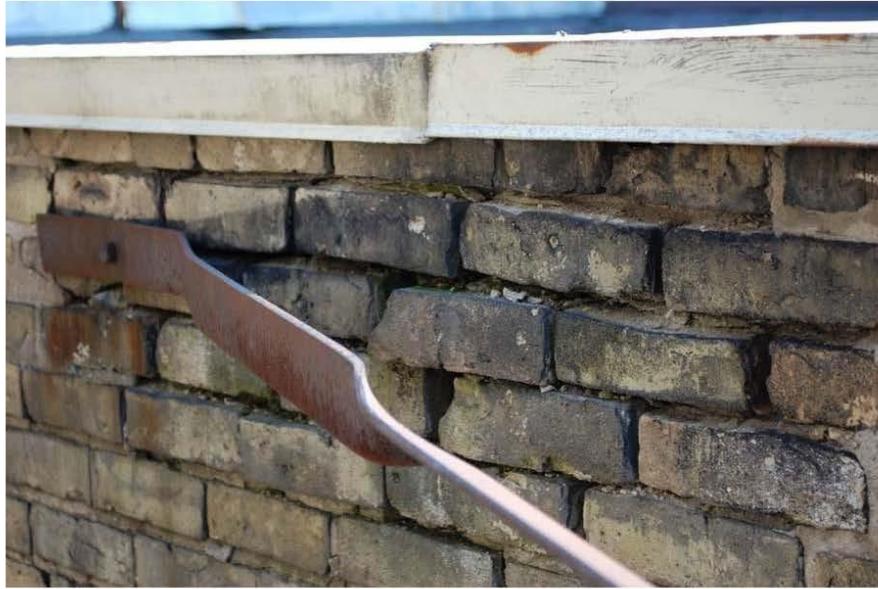
*Photograph 12:* Parapet deterioration at the anchor for the fire escape.

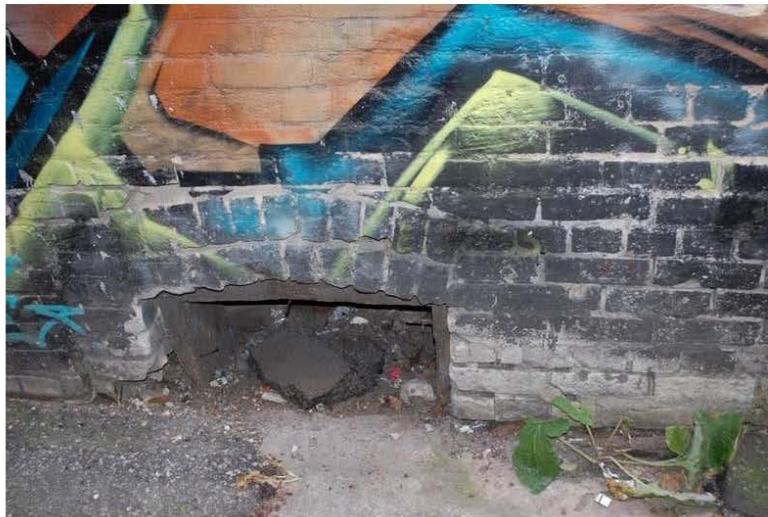
*Photograph 13:* Mortar deterioration and missing brick units at grade.

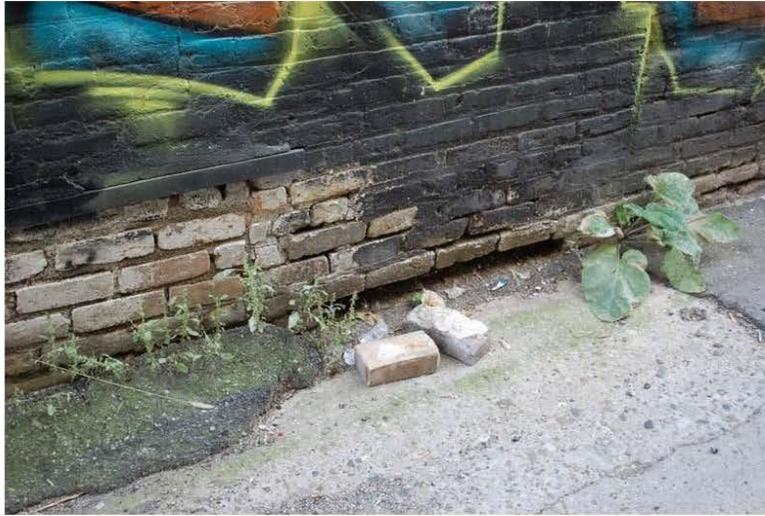
*Photograph 14:* Missing brick units and missing mortar at grade.

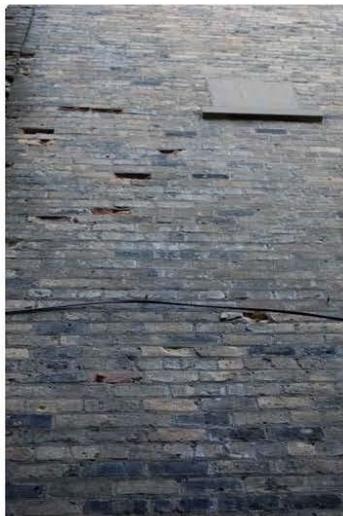
*Photograph 15:* Middle addition with a few brick pop-outs.

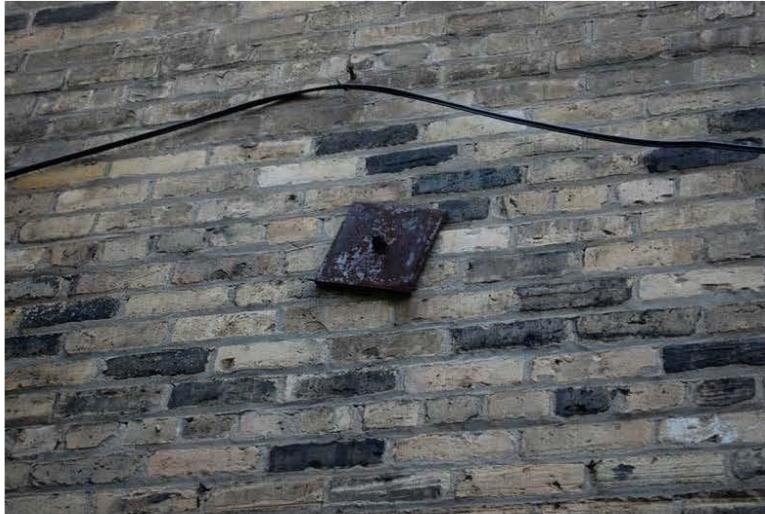
*Photograph 16:* Tie-back plates on the exterior of the middle addition to connect the floor and wall system.

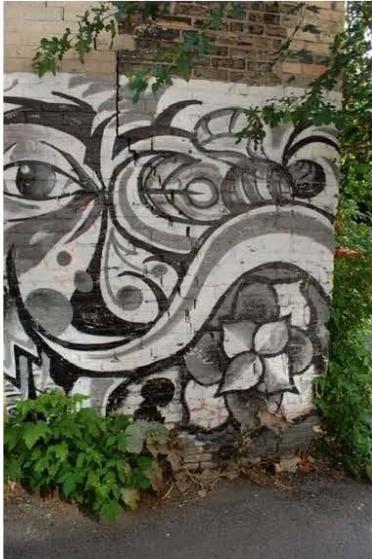
*Photograph 18:* Wide diagonal crack at the base of the west addition.

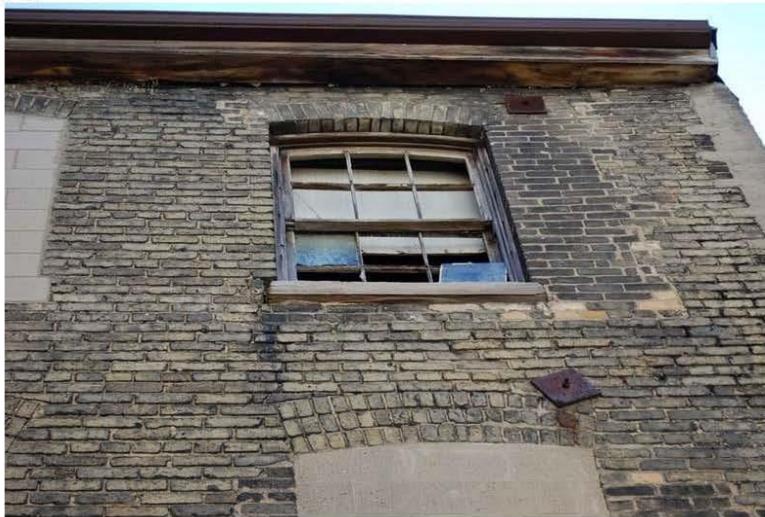
*Photograph 19:* Broken window at the third floor of the south end of the west wall.

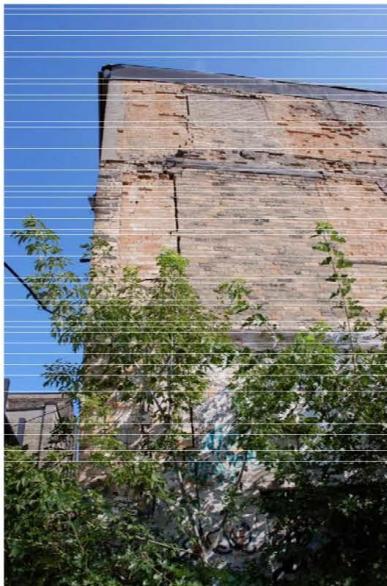
The south wall was in the worst condition of the entire building. A very wide vertical crack, varying from 0.5" to 1.5" in width, extended for almost the full height of the threestorey building at the west end of the south wall (Photograph 21). Almost continuous timber lintels, exposed to the elements were observed on the south wall at the third and second floor levels (Photographs 22, 23 & 24). This caused a discontinuity, or hinge point, in the vertical span of the south masonry wall. A large door opening at the third floor level of the south wall (Photograph 25) was filled in with timber sheathing, however gaps in the materials were present. Given the materials and quality of construction, we expect that this door would permit considerable water ingress. A similar infill was present at the first floor level, however this was done with siding and in a more workmanlike manner. We observed an active parking area immediately adjacent to the south wall.

*Photograph 21:* Movement and wide vertical cracking of the south wall.

- 4) The brick masonry of the south wall is in extremely poor condition and requires immediate repair or shoring. In our opinion, there is potential for the partial collapse of this wall, therefore time is of the essence in addressing this issue.

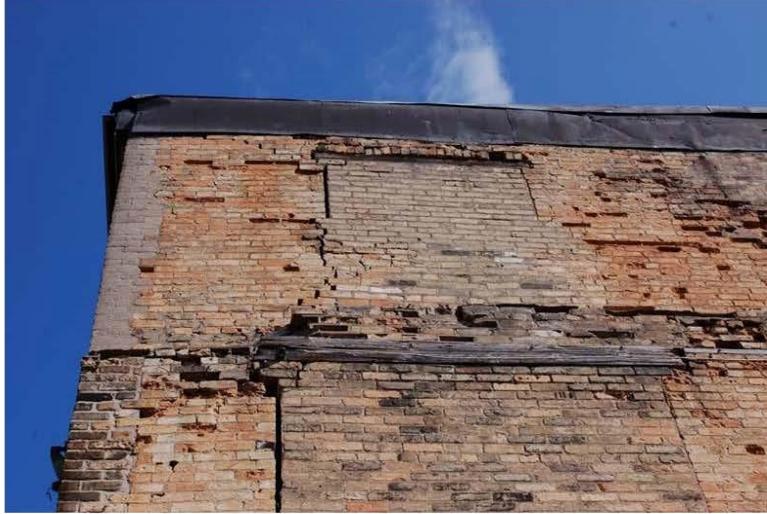
*Photograph 22:* South wall, third floor at the west end.

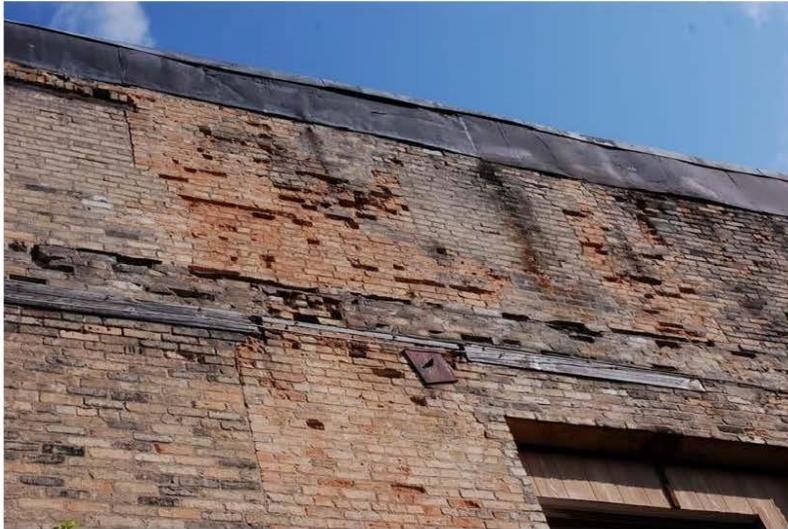
*Photograph 23:* South wall, third floor at the midpoint.

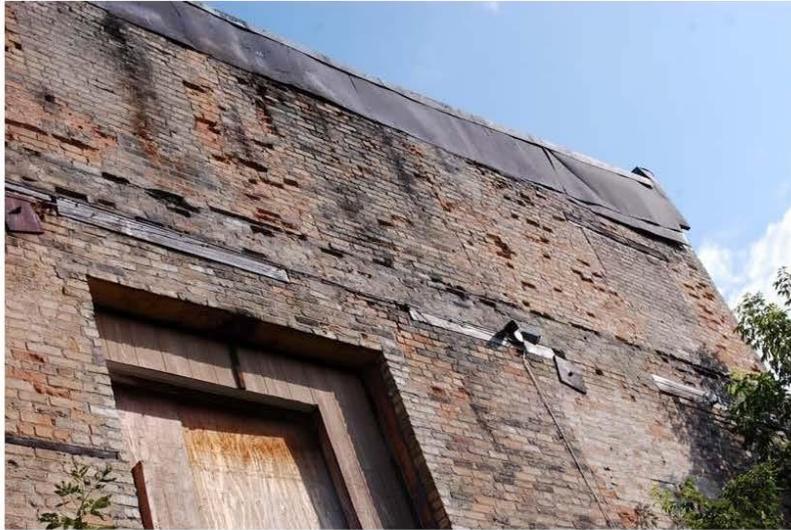
*Photograph 24:* South wall, third floor at the east end.

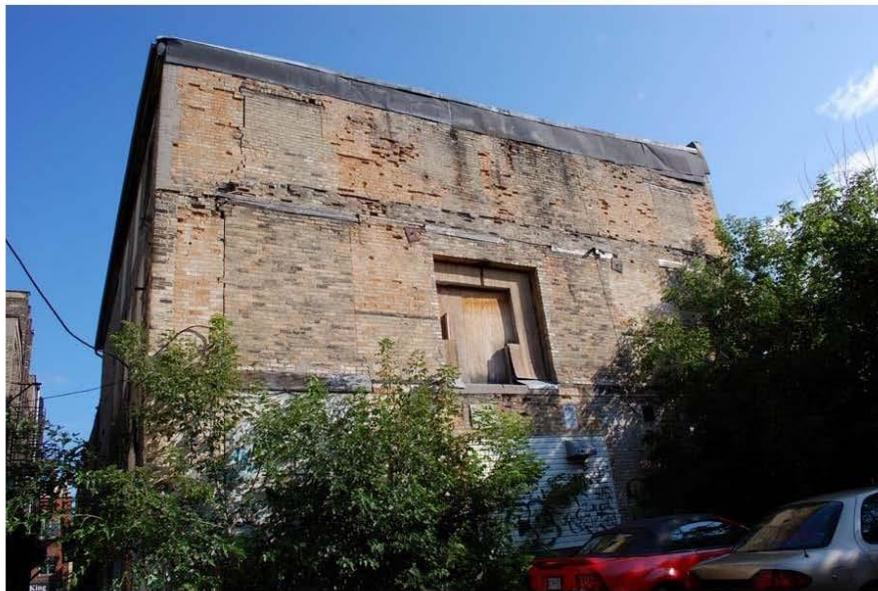
*Photograph 25:* South Elevation.

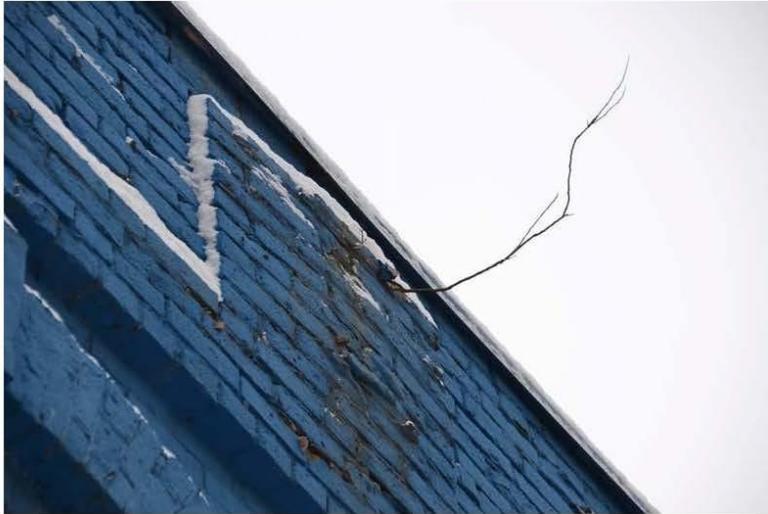
Photo No. 01: Masonry Parapet with Rooted Sapling

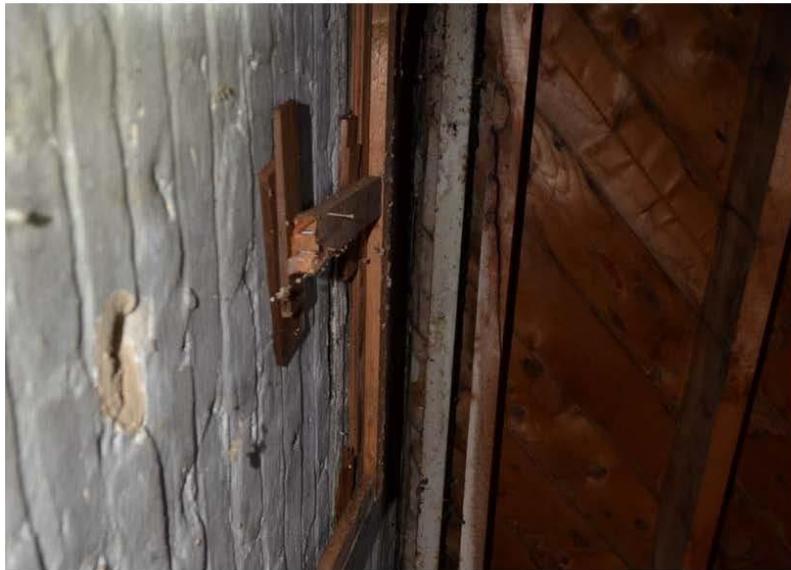
Photo No. 04: Floor Diaphragm Separated from Shear Wall

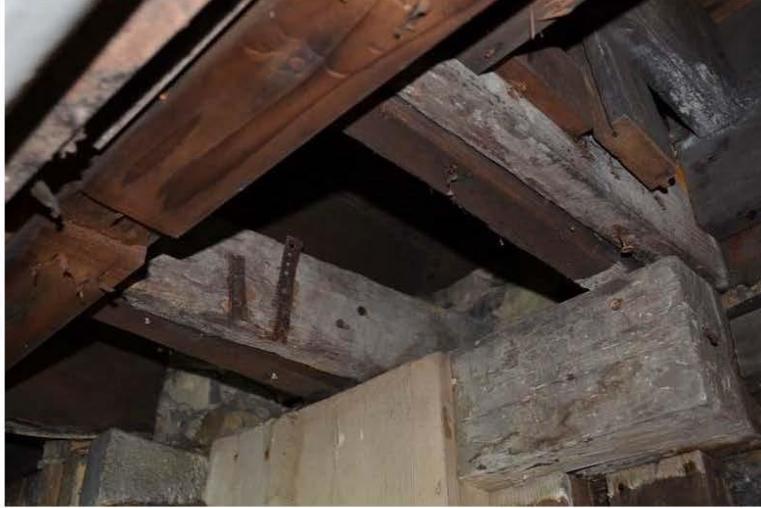
Photo No. 08: Deteriorated Wood Joists

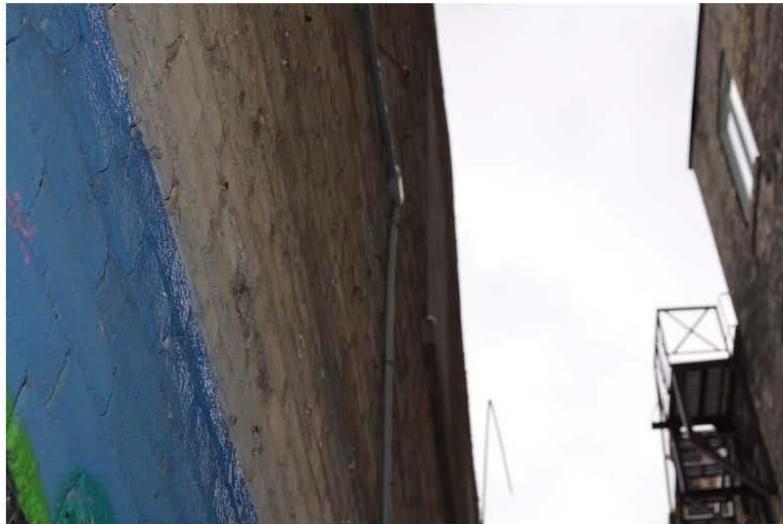
Photo No. 09: Bow out in West Wall

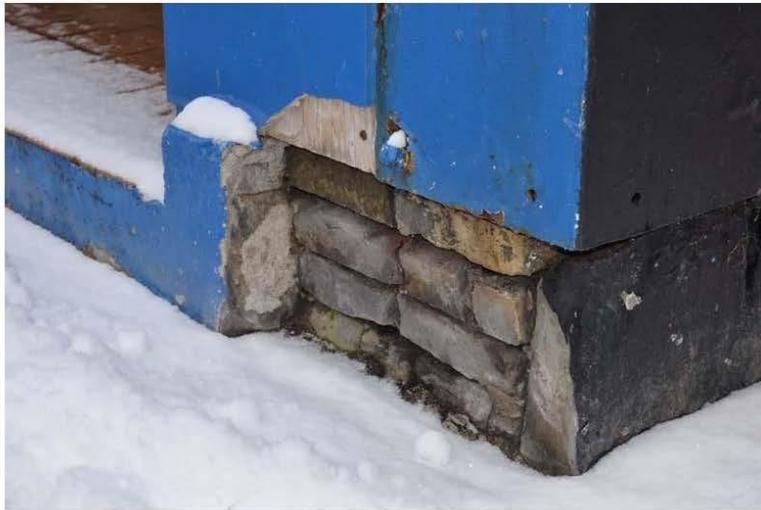
Photo No. 10: Deteriorating Foundation Wall

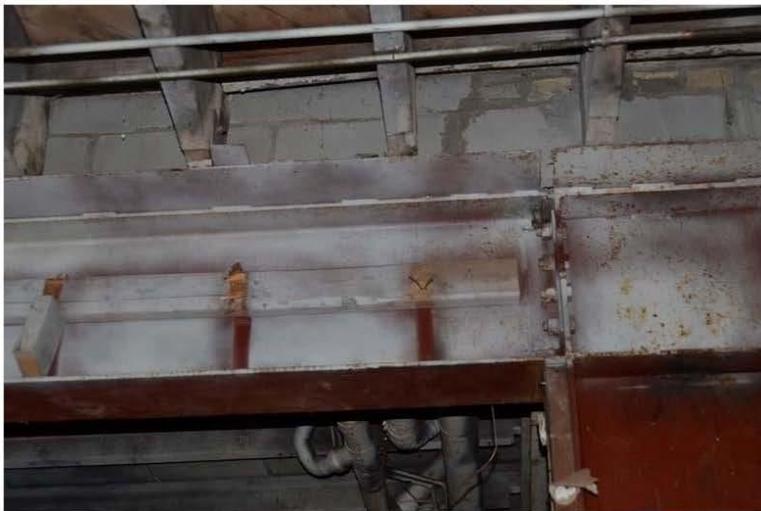
Photo No. 11: Rigid Frame Supporting Masonry Wall

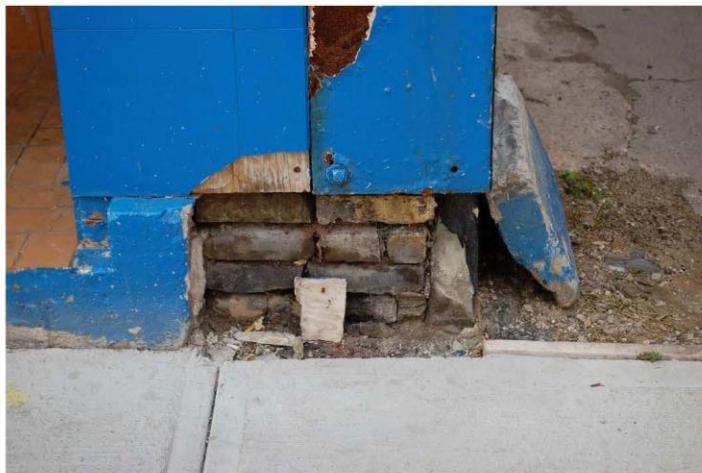
*Photograph 5:* Brick deterioration at the base of pier on the north elevation. Loss of mortar.

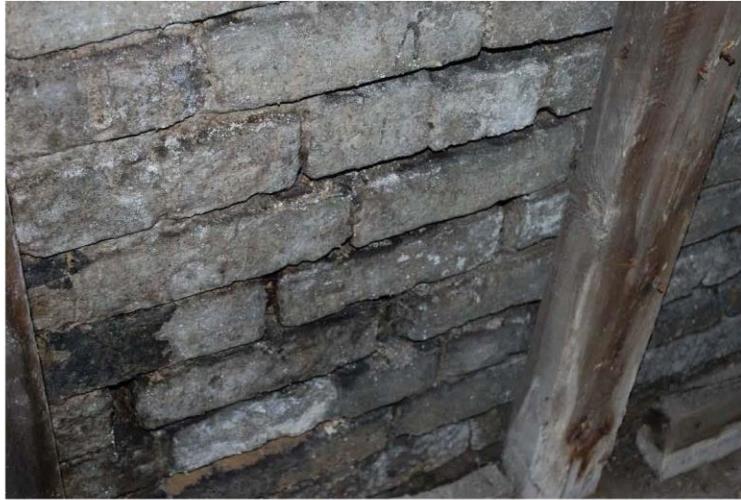
*Photograph 6:* Basement foundation wall with missing mortar. This type of deterioration was observed in all foundation walls in selected areas.

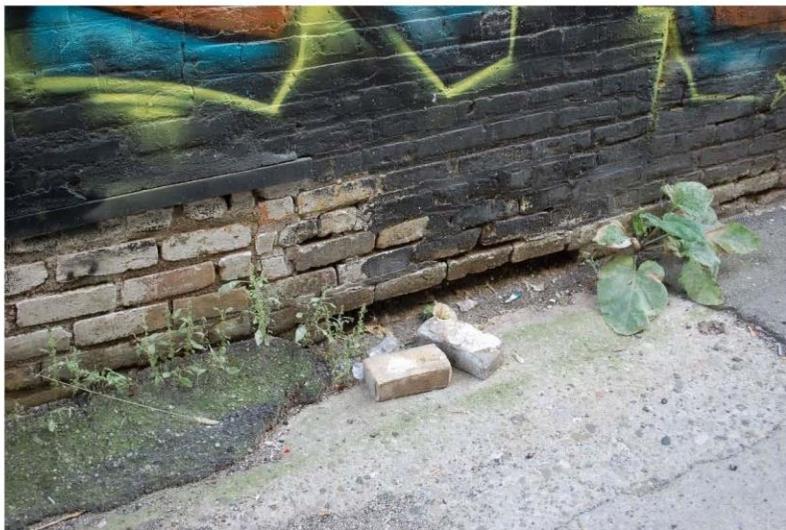
*Photograph 7:* Exterior foundation wall at grade at the west wall. Note the missing mortar and loose bricks.

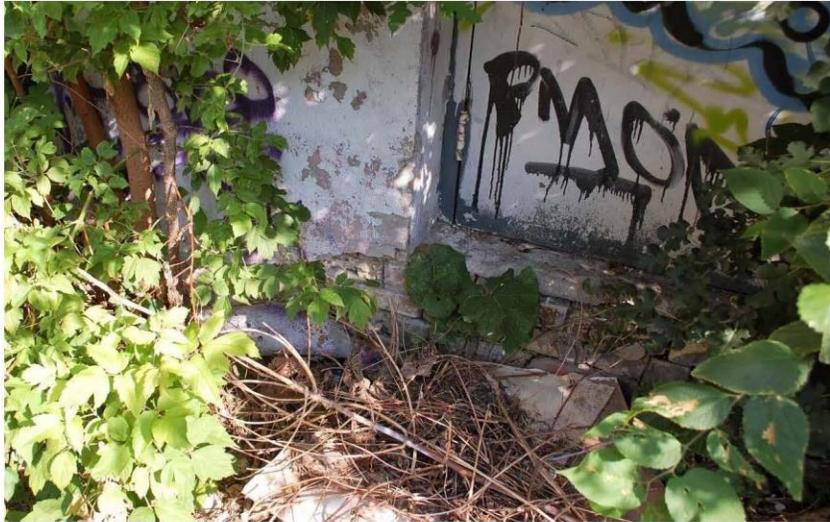
*Photograph 8:* Foundation wall at south elevation. Plant root and water deterioration of the mortar joints and brick units.

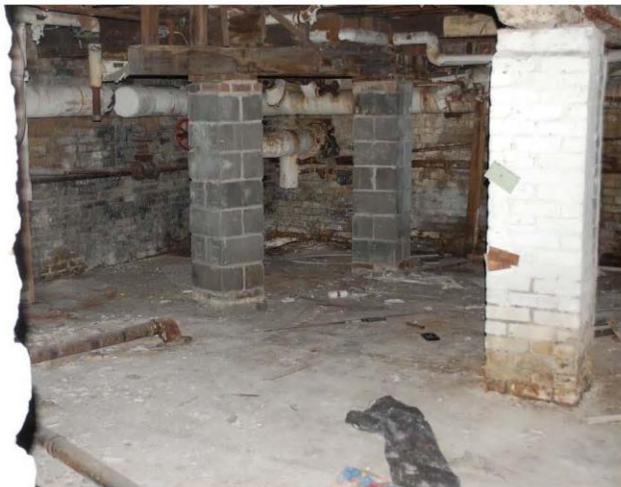
*Photograph 9:* Partial basement with mortar deterioration in exterior walls and masonry piers (both block and brick masonry).

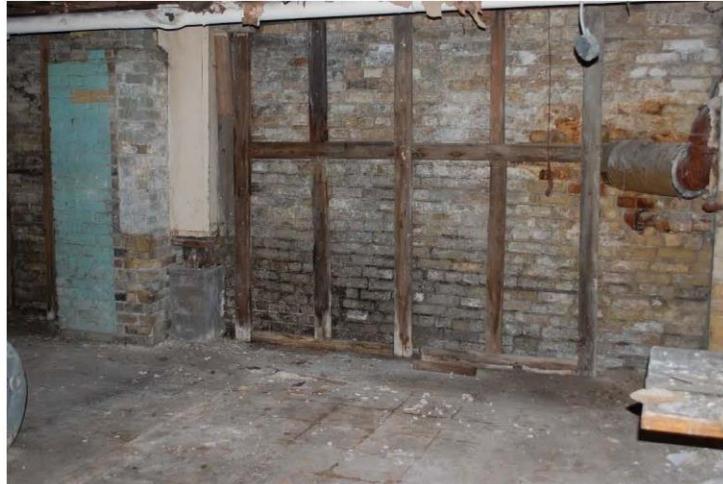
*Photograph 10: Deterioration of the mortar joints in the west basement walls was more pronounced at the base of the wall.*

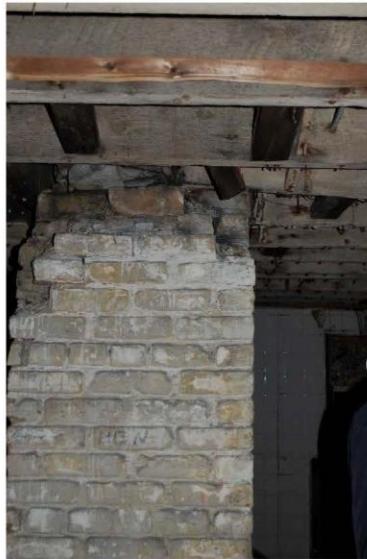
*Photograph 11: Masonry piers with deteriorated mortar at the top of pier.*

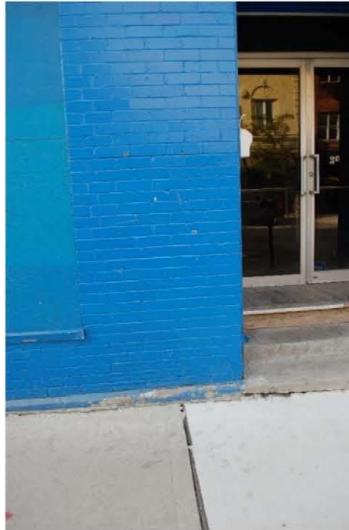
*Photograph 14:* Painted brick piers (not original to the building) on north elevation is in fairly good condition.

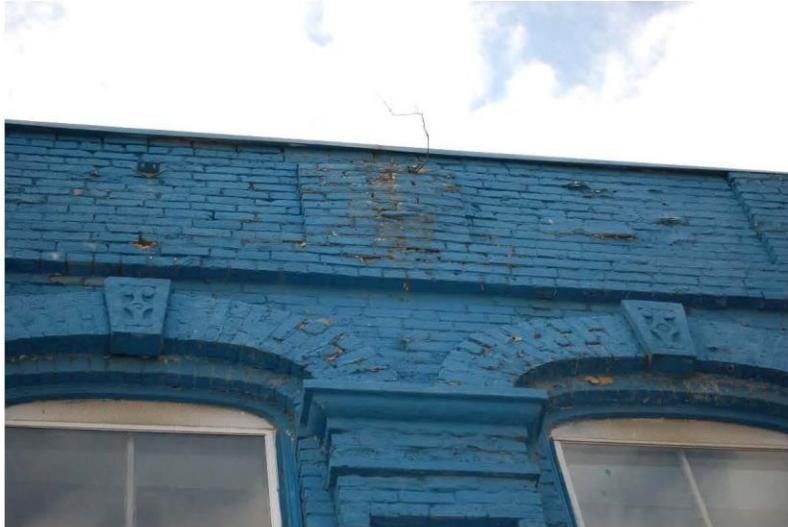
*Photograph 15:* North elevation near the middle of the wall. Outward brick movement and mortar deterioration at the parapet level. 'Tree' growing out of masonry indicating the presence of growing medium and ample water.

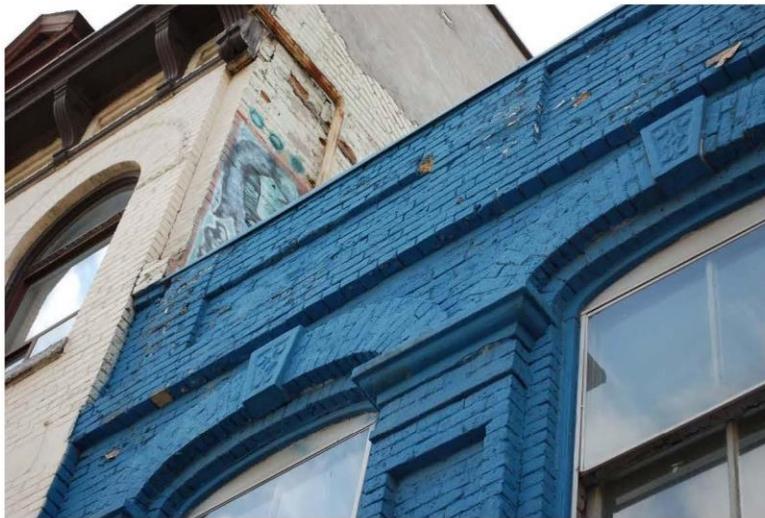
*Photograph 16:* Mortar and brick deterioration at the parapet level.

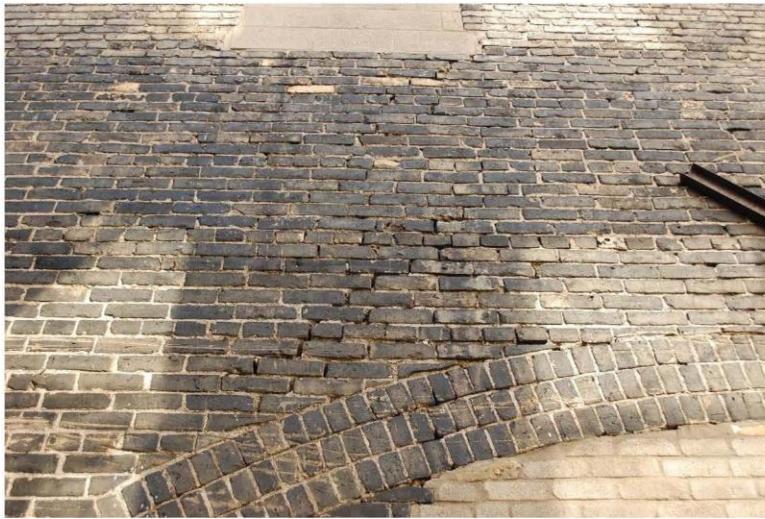
*Photograph 17:* Blocked-in window openings, mortar deterioration and severe cracking in the west elevation.

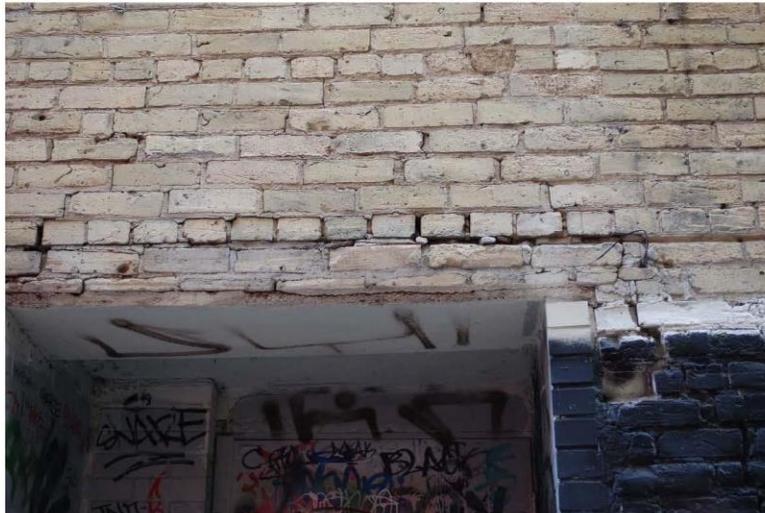
*Photograph 18:* Mortar loss above the doorway lintel on the west elevation.

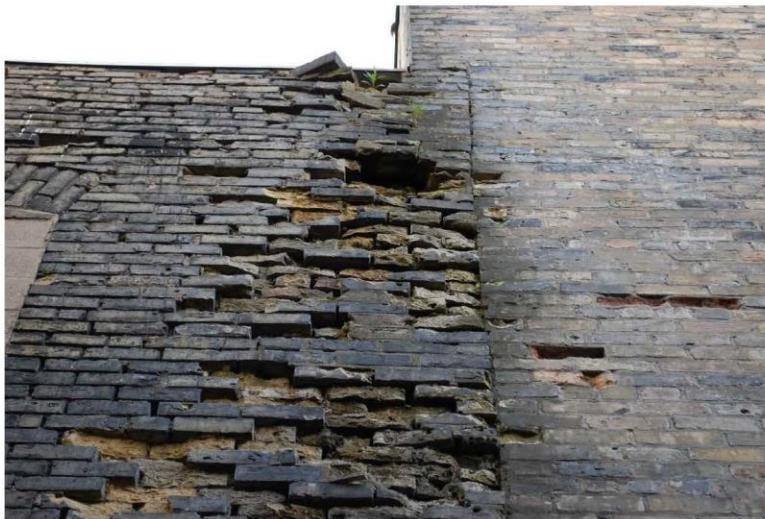
*Photograph 19:* Masonry at the joint between the two and three storey sections was in extremely poor condition. Note the bricks 'ready to fall' near the top of the wall, plus missing and shifting bricks were observed.

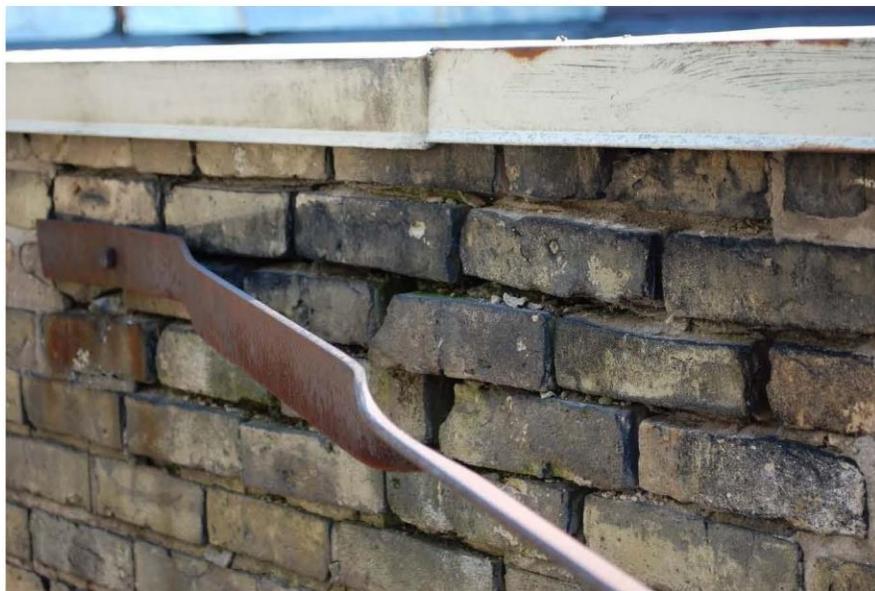
*Photograph 21:* Parapet deterioration at the anchor for the fire escape.

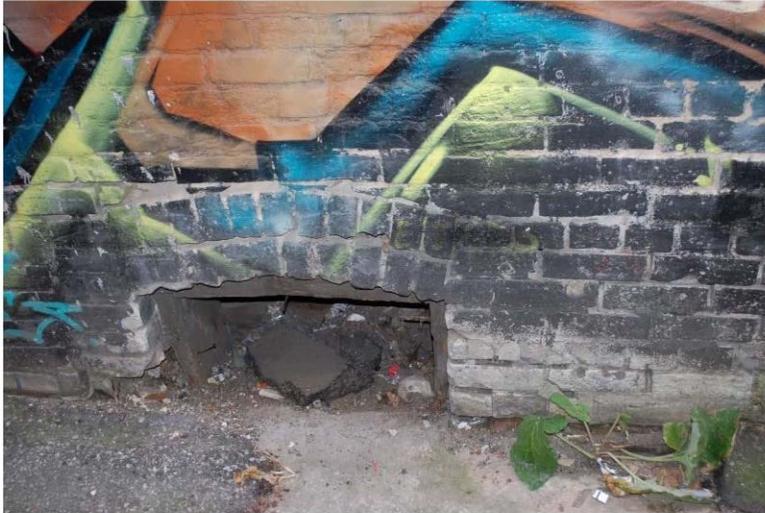
*Photograph 22:* Mortar deterioration and missing brick units at grade.

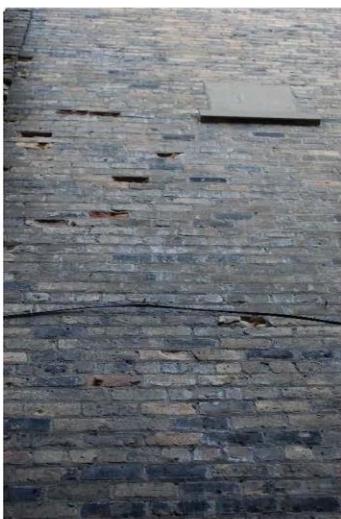
*Photograph 23:* Middle addition with a several brick pop-outs.

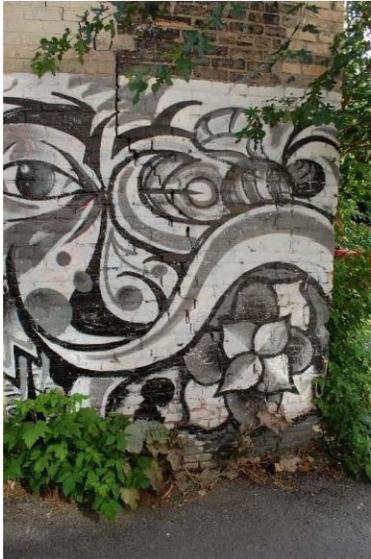
*Photograph 25:* Wide diagonal crack at the base of the west addition.

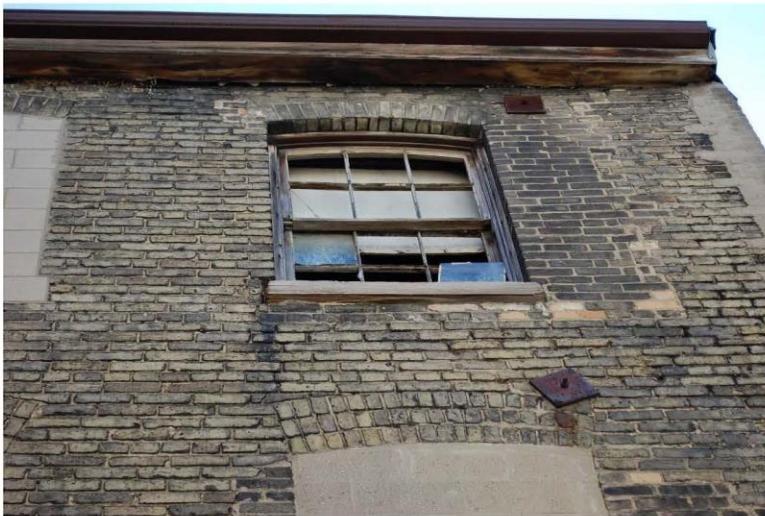
*Photograph 26:* Broken window at the third floor of the south end of the west wall.

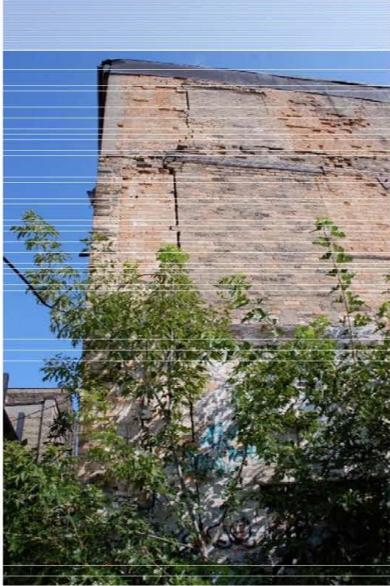
*Photograph 28:* Movement and wide vertical cracking of the south wall.

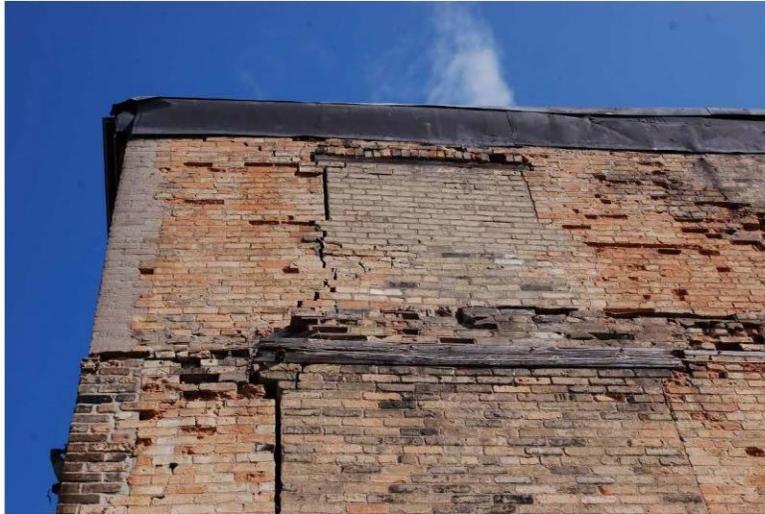
*Photograph 29:* South wall, third floor at the west end.

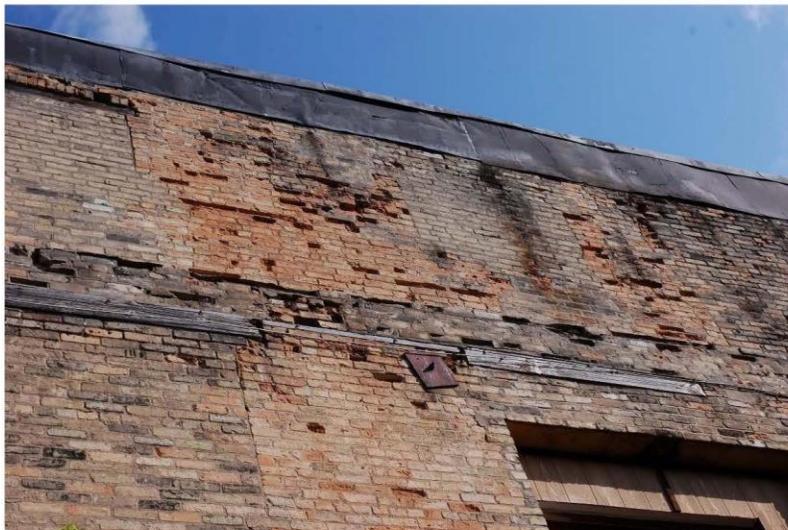
*Photograph 30:* South wall, third floor at the midpoint.

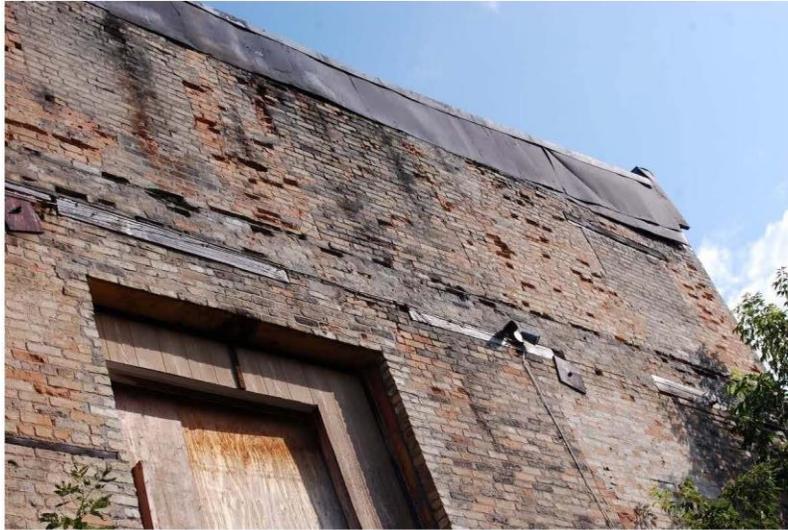
*Photograph 31:* South wall, third floor at the east end.

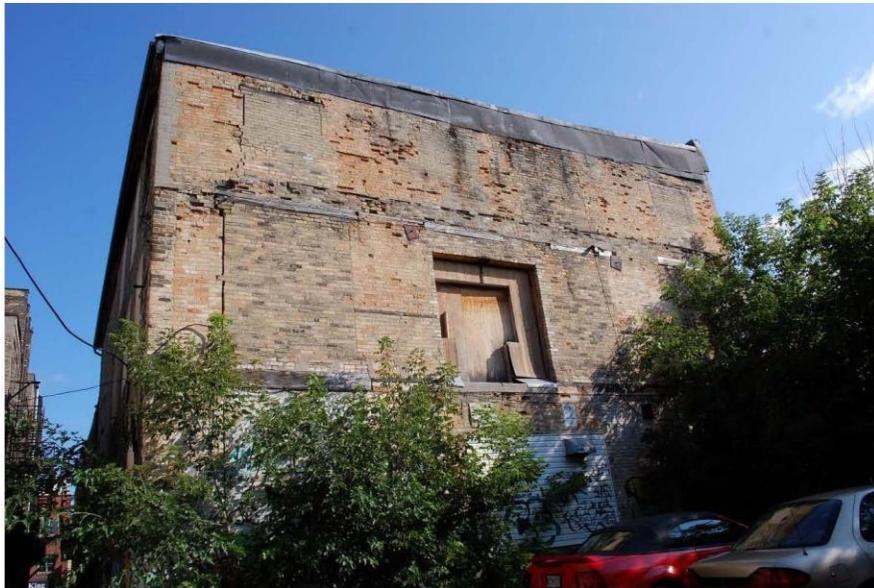
*Photograph 32:* South Elevation.

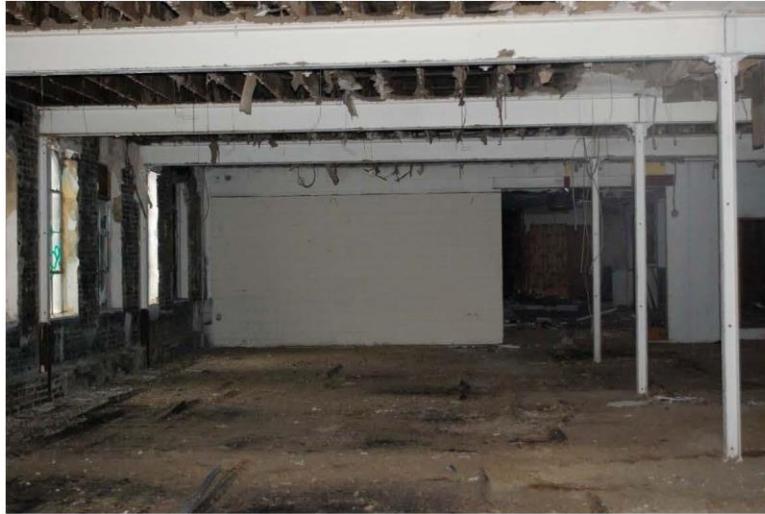
*Photograph 35:* Hollow Concrete block wall at the second floor level.

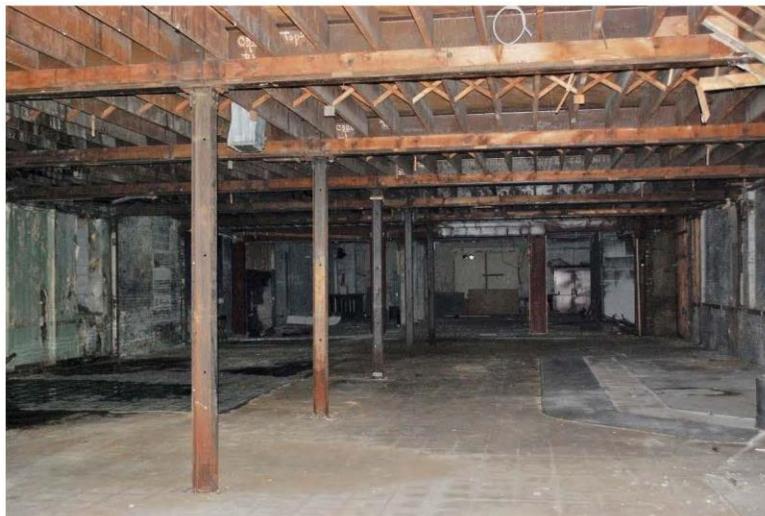
*Photograph 36:* Main floor level- open from front to rear of the building.

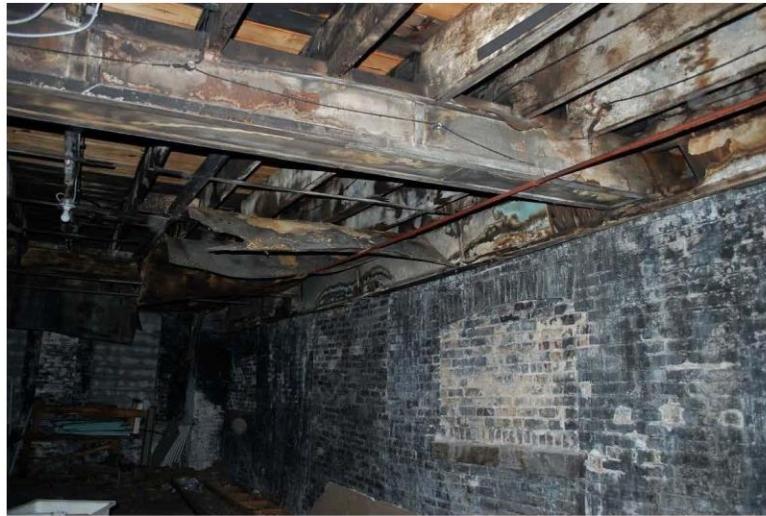
*Photograph 37:* Interior of the South wall below the roof level.

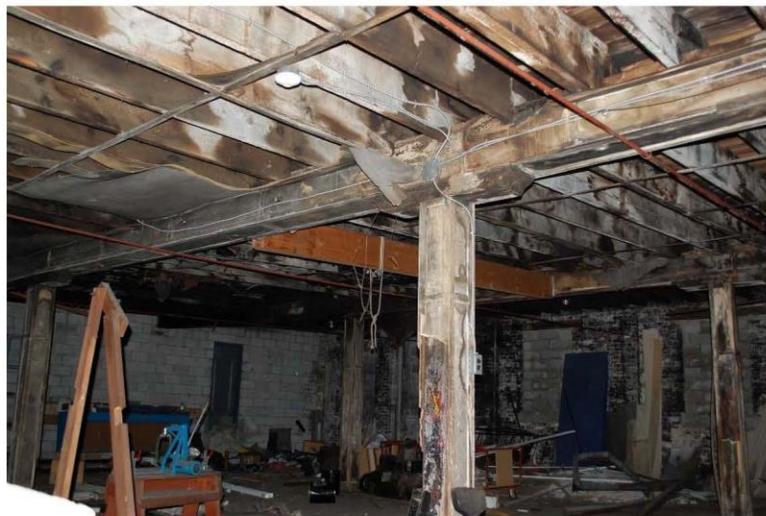
*Photograph 38:* Timber beams and columns at upper roof level, south addition. Note the tie rods.
