<b>TO:</b>	<b>CHAIR AND MEMBERS LONDON ADVISORY COMMITTEE ON HERITAGE</b>
<b>FROM:</b>	<b>JOHN M. FLEMING MANAGING DIRECTOR, PLANNING AND CITY PLANNER</b>
<b>SUBJECT:</b>	<b>REQUEST FOR DEMOLITION SOUTHSIDE CONSTRUCTION MANAGEMENT LTD. 175/179/181 KING STREET WEDNESDAY, JUNE 8, 2016</b>

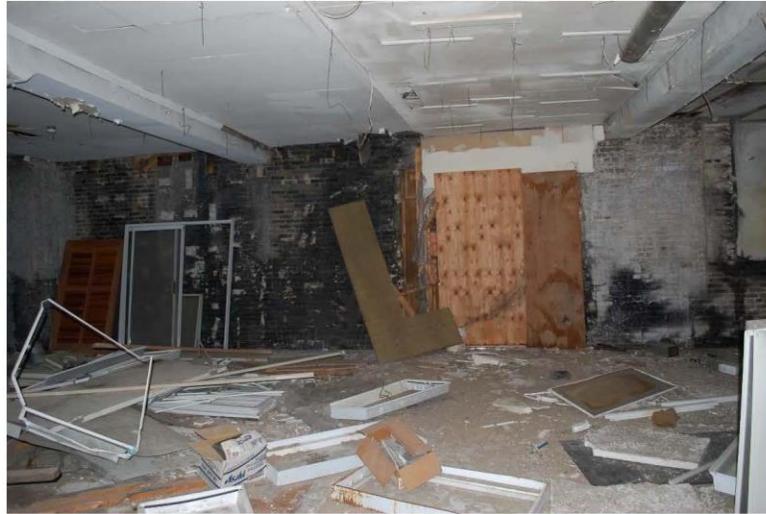
*Photograph 39:* Interior of the south wall at the second floor level. Note the two bulkheads concealing timber beams. Timber joists span in the east-west direction.

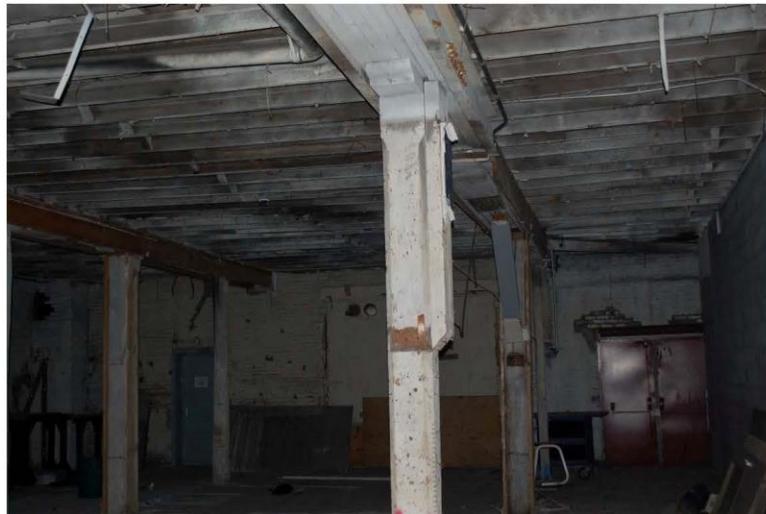
*Photograph 40:* Timber framing of the main floor was similar to that of the roof system.

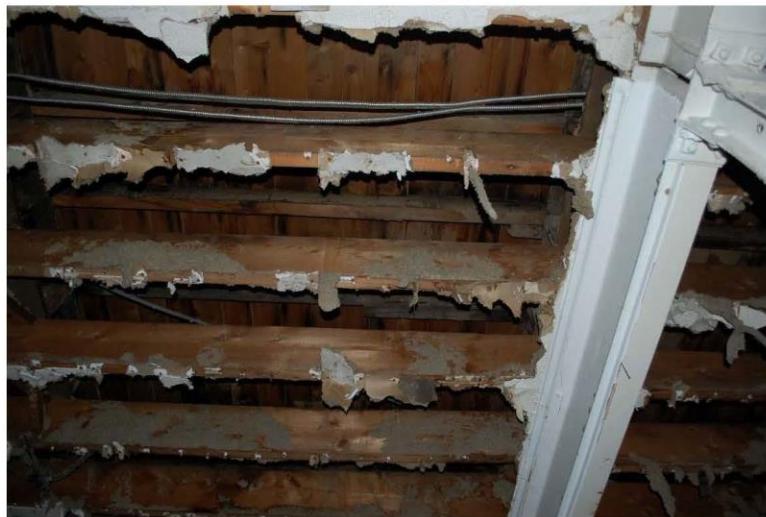
*Photograph 43:* Ceiling and Roof joists spanning between structural steel beams and columns. Joists were parallel to the east and west walls.

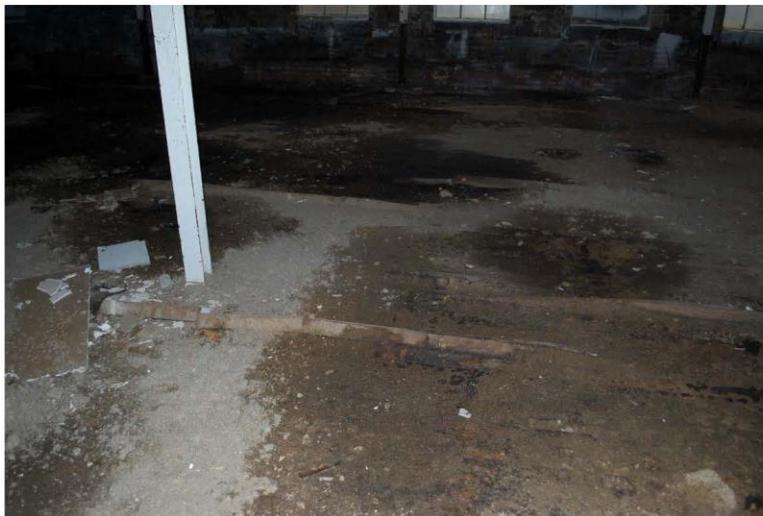
*Photograph 48:* Poor floor sheathing condition with buckling flooring.

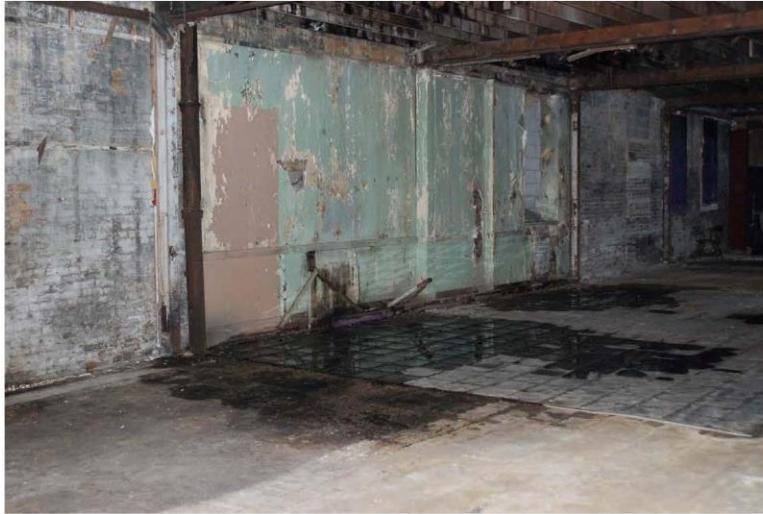
*Photograph 49:* Water staining of second floor joists (and main floor joists) due to roof leaks.

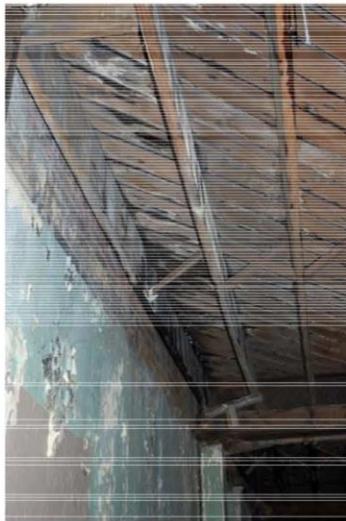
*Photograph 50:* Water staining of second floor joists due to roof leaks.

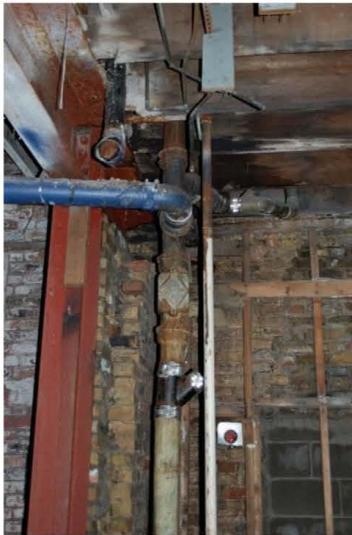
*Photograph 51:* Water staining of roof joists near roof drain stack.

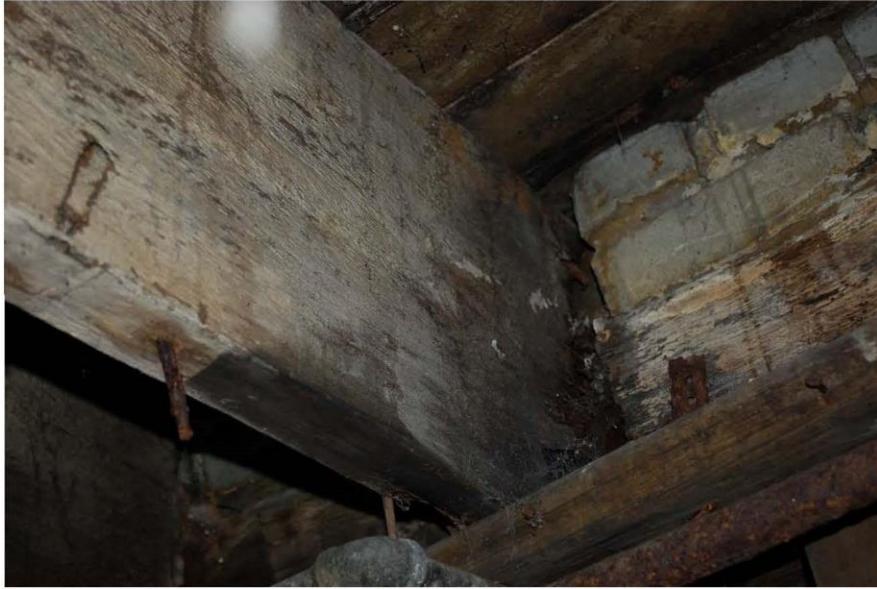
The main floor framing at the exterior foundation walls showed dry rot at the joist bearing pockets (Photograph 52). This condition was typical in the basement area.

*Photograph 52:* Water staining and dry rot in main floor joists at the west wall.
