<b>PREVIOUS REPORTS PERTINENT TO THIS MATTER</b>
--

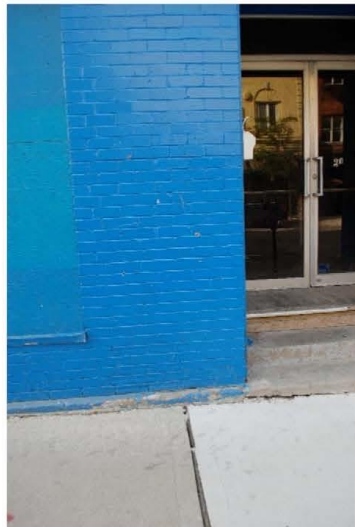
*Photograph 4:* Painted brick on north elevation is in good condition.

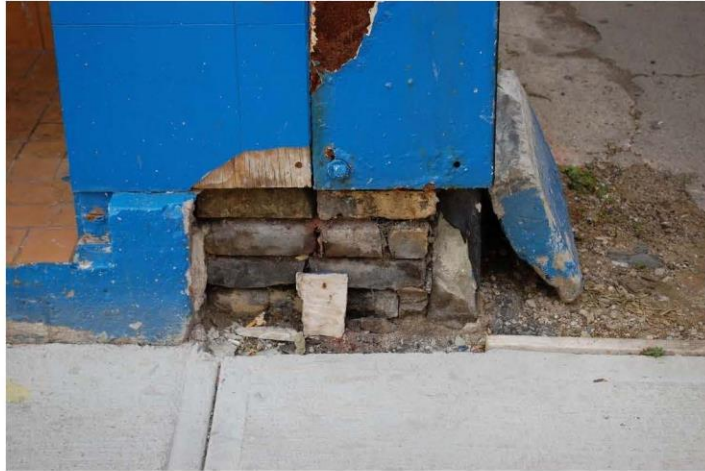
*Photograph 5:* Brick deterioration at the base of pier on the north elevation. Loss of mortar.

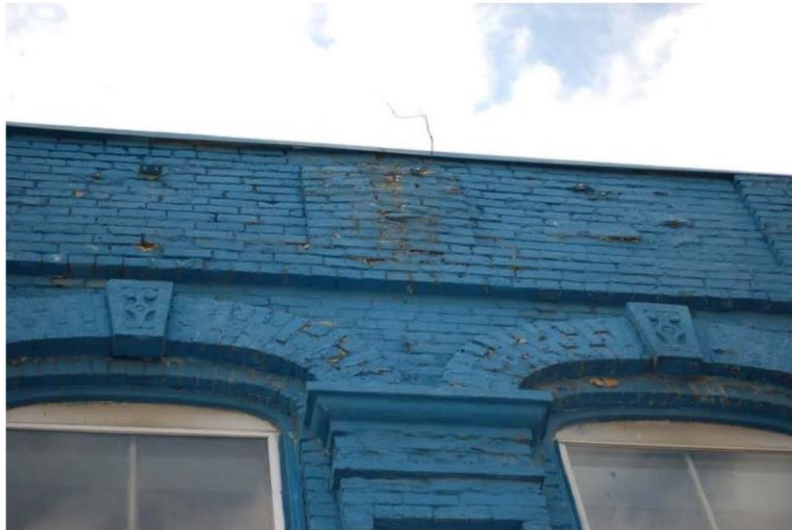
*Photograph 6:* North elevation near the middle of the wall. Outward brick movement and mortar deterioration at the parapet level.

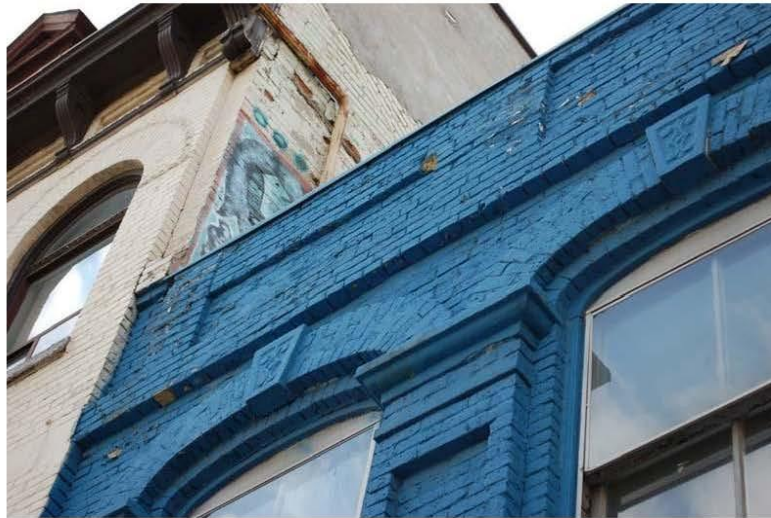
*Photograph 7:* Mortar and brick deterioration at the parapet level.

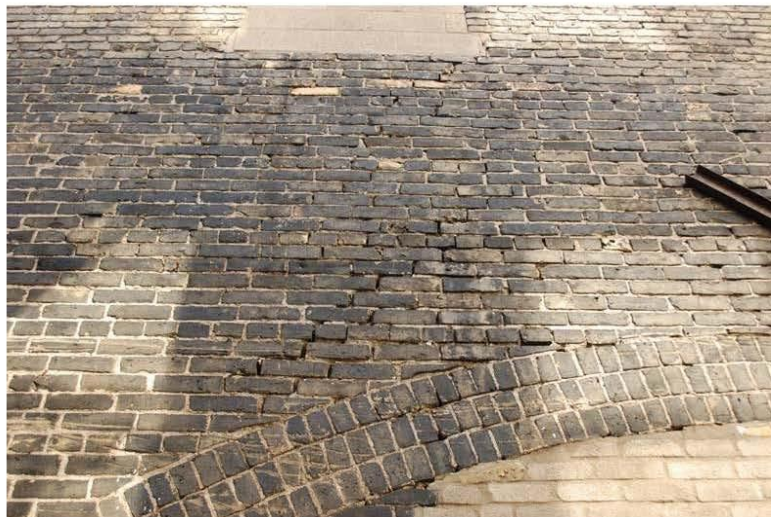
*Photograph 8:* Blocked-in window openings, mortar deterioration and severe cracking in the west elevation.

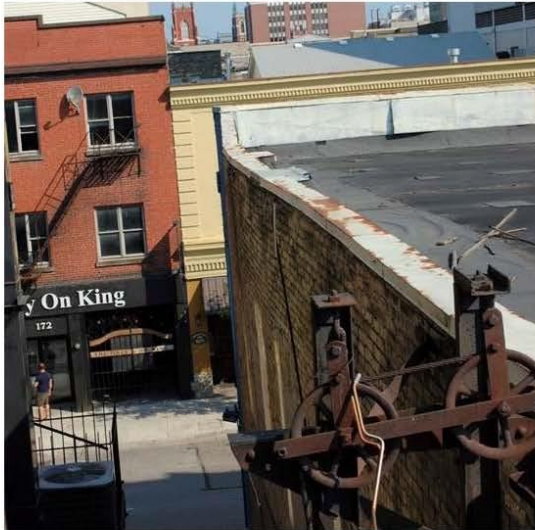
**Photograph 11:** Outward movement of the parapet on the west elevation.

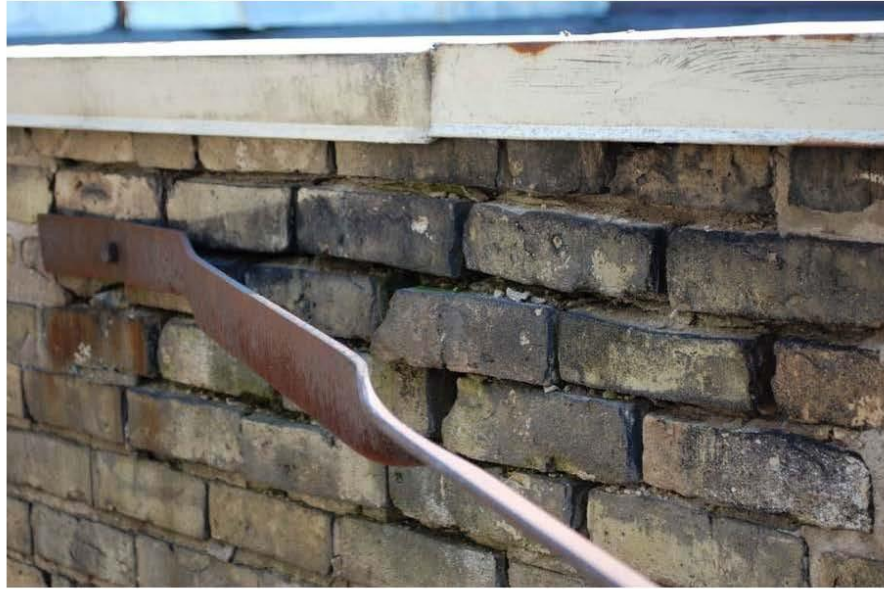
*Photograph 12:* Parapet deterioration at the anchor for the fire escape.

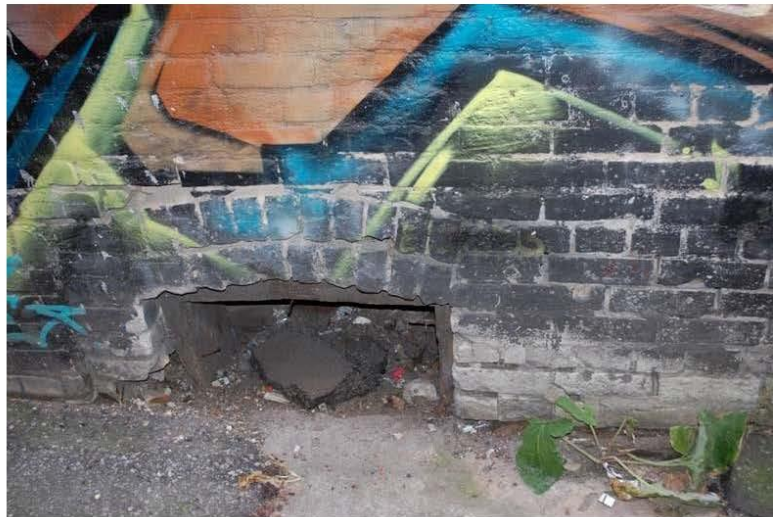
*Photograph 13:* Mortar deterioration and missing brick units at grade.

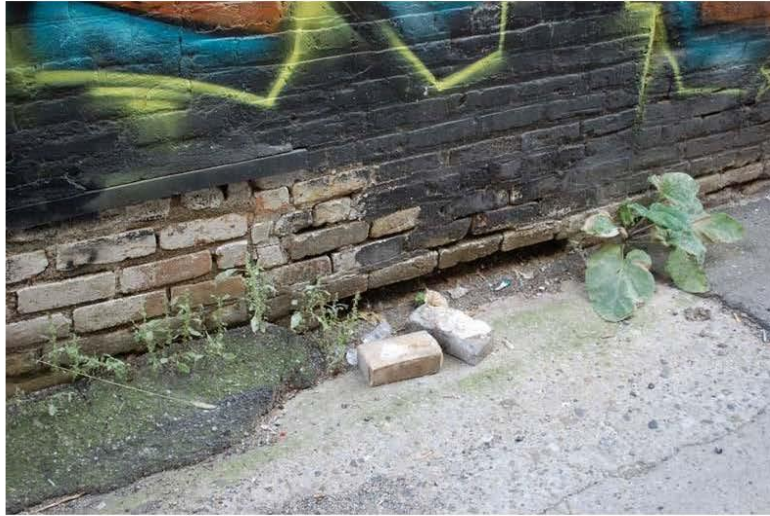
*Photograph 14:* Missing brick units and missing mortar at grade.

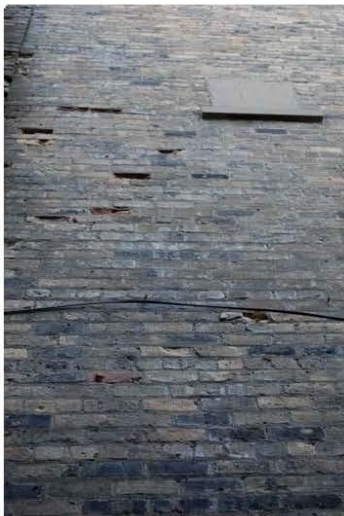
*Photograph 15:* Middle addition with a few brick pop-outs.

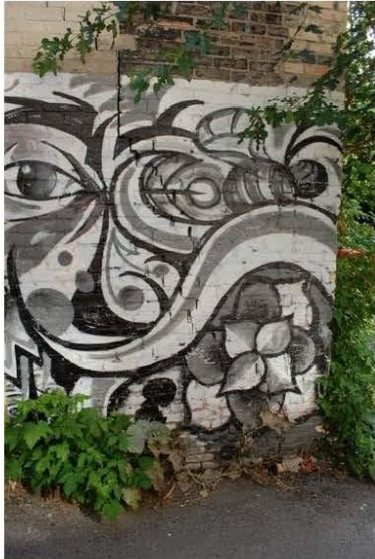
*Photograph 18:* Wide diagonal crack at the base of the west addition.

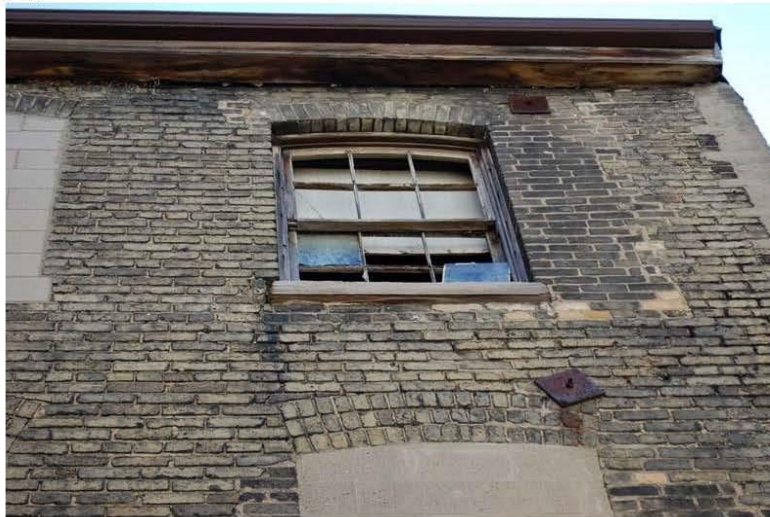
*Photograph 19:* Broken window at the third floor of the south end of the west wall.

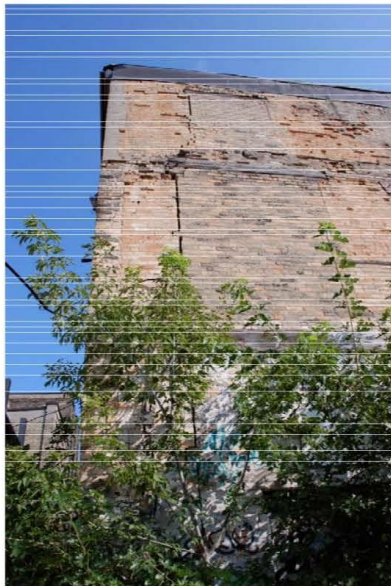
*Photograph 21:* Movement and wide vertical cracking of the south wall.

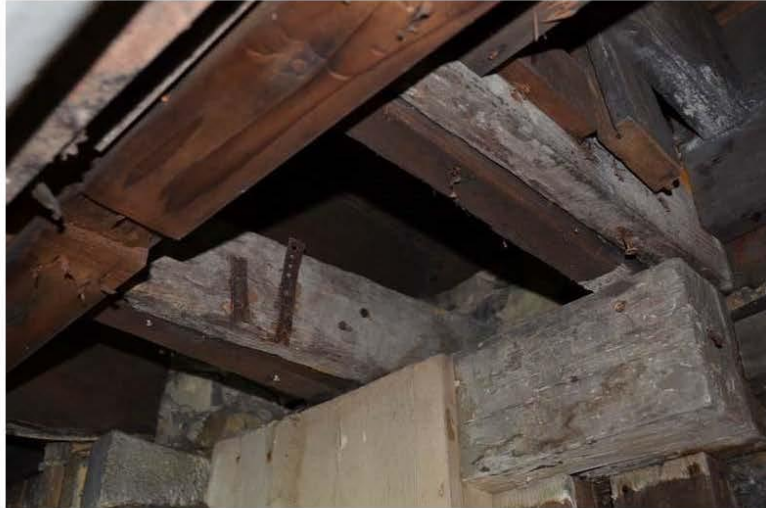
Photo No. 08: Deteriorated Wood Joists

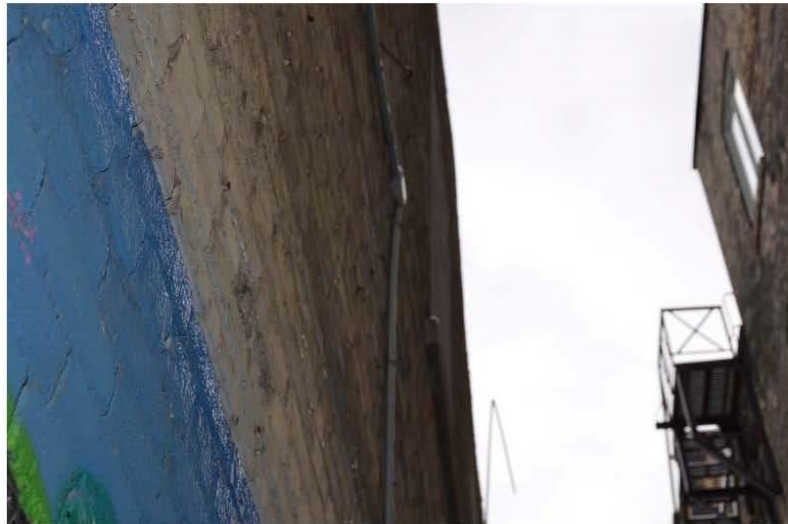
Photo No. 09: Bow out in West Wall

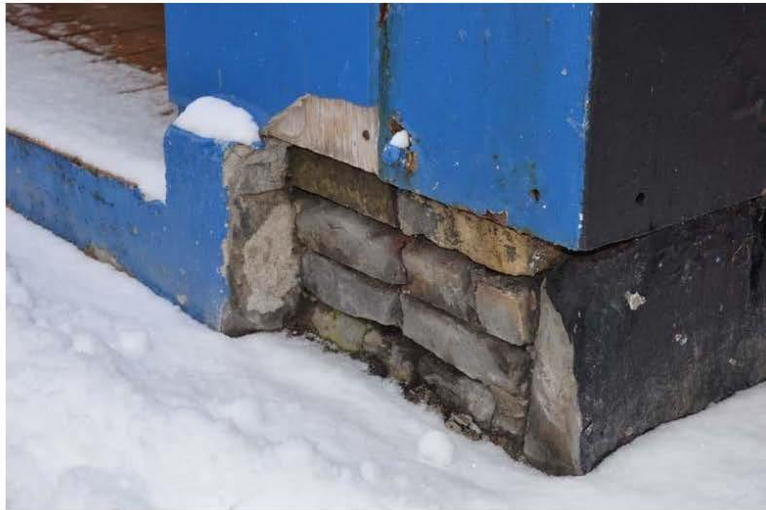
Photo No. 10: Deteriorating Foundation Wall

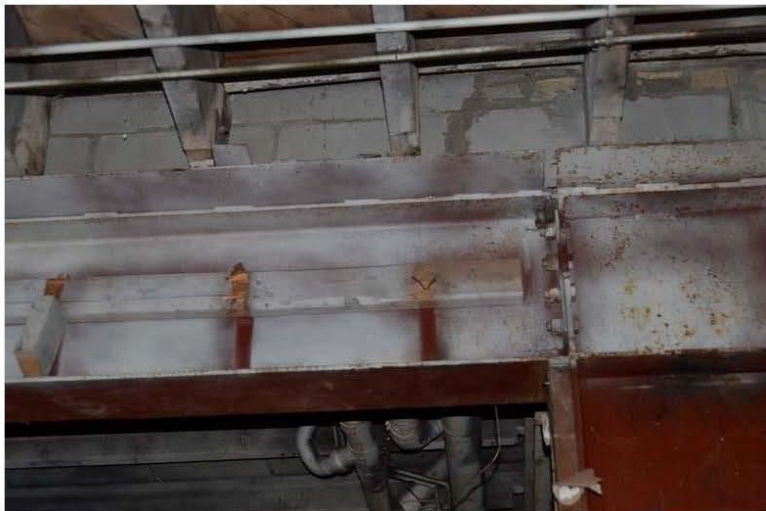
Photo No. 11: Rigid Frame Supporting Masonry Wall

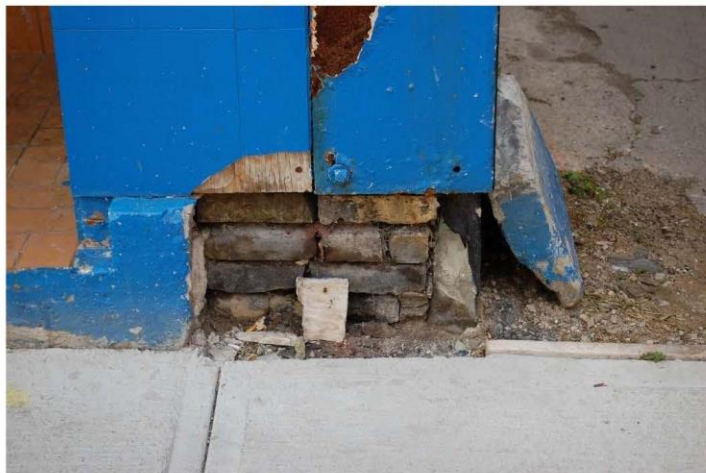
*Photograph 5:* Brick deterioration at the base of pier on the north elevation. Loss of mortar.

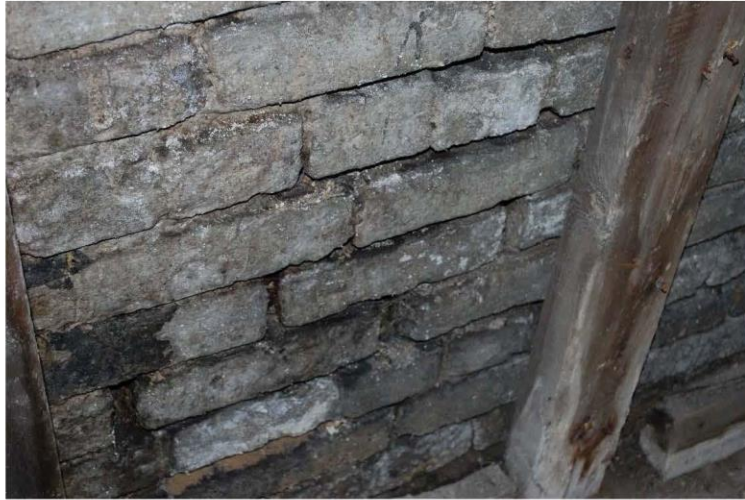
*Photograph 6:* Basement foundation wall with missing mortar. This type of deterioration was observed in all foundation walls in selected areas.

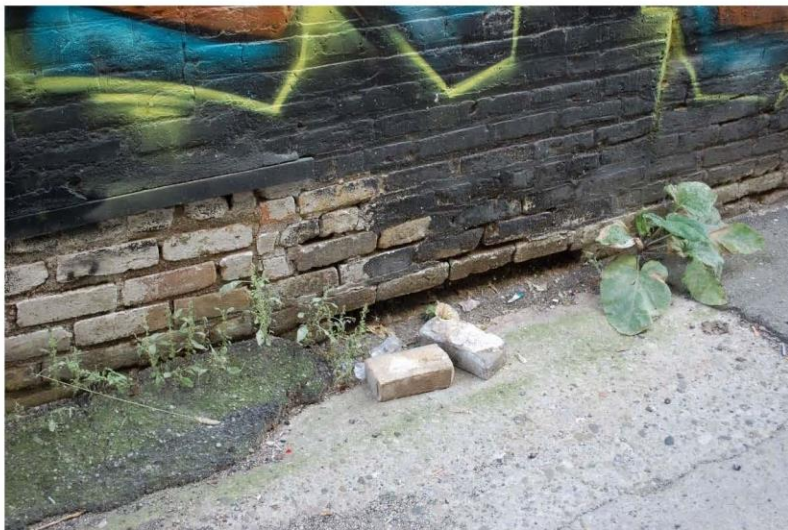
*Photograph 7:* Exterior foundation wall at grade at the west wall. Note the missing mortar and loose bricks.

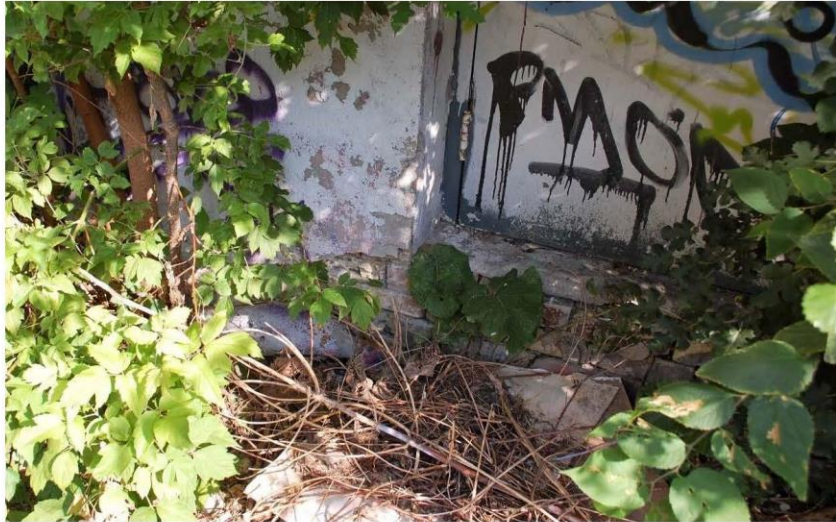
*Photograph 8:* Foundation wall at south elevation. Plant root and water deterioration of the mortar joints and brick units.

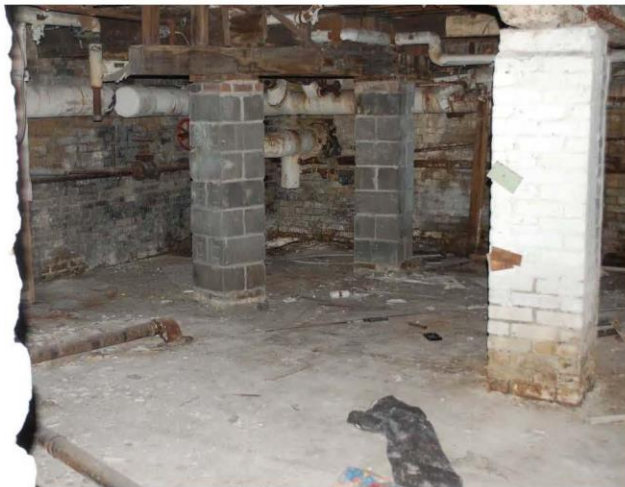
*Photograph 9:* Partial basement with mortar deterioration in exterior walls and masonry piers (both block and brick masonry).

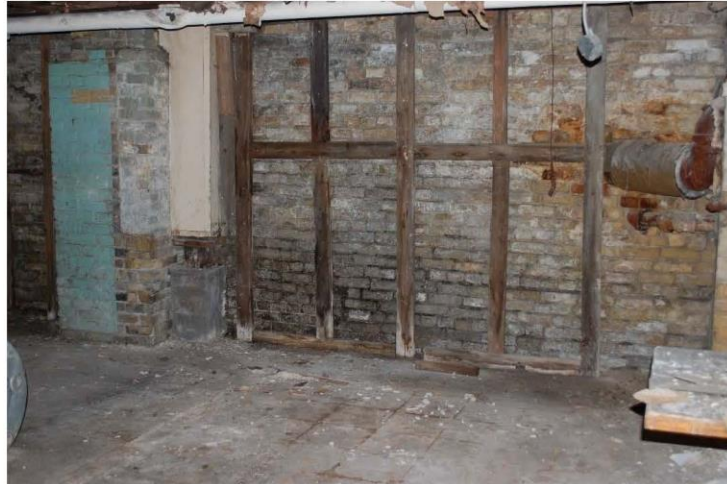
*Photograph 10: Deterioration of the mortar joints in the west basement walls was more pronounced at the base of the wall.*

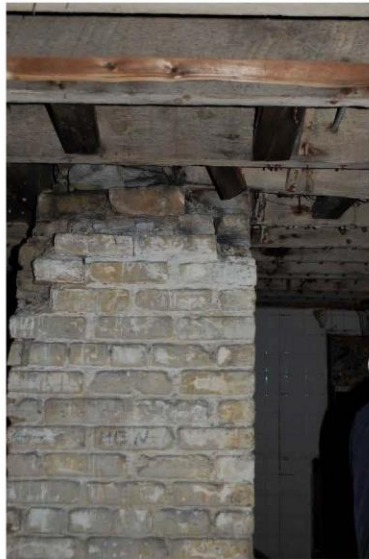
*Photograph 11: Masonry piers with deteriorated mortar at the top of pier.*

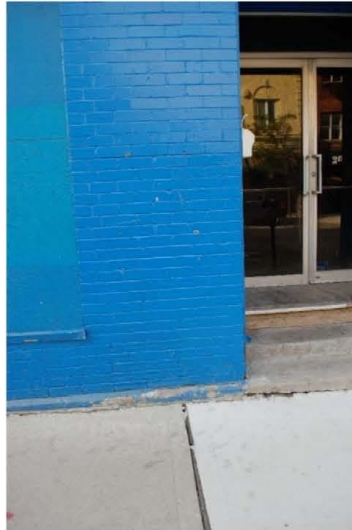
*Photograph 14:* Painted brick piers (not original to the building) on north elevation is in fairly good condition.

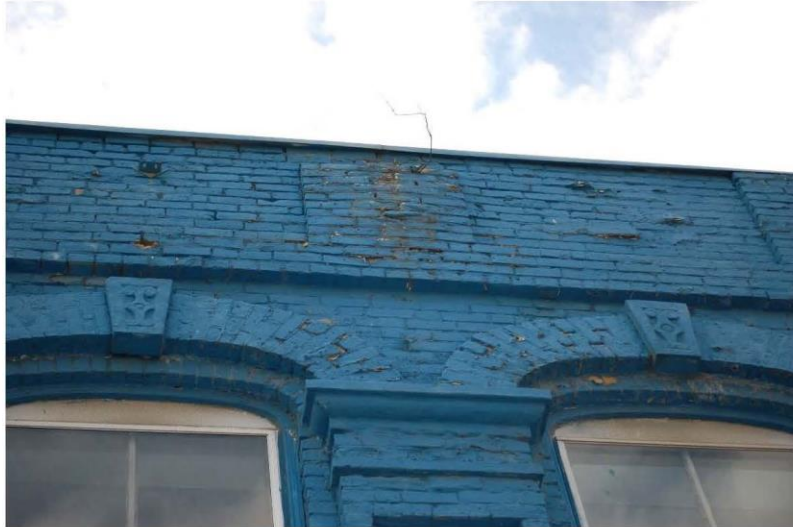
*Photograph 15:* North elevation near the middle of the wall. Outward brick movement and mortar deterioration at the parapet level. 'Tree' growing out of masonry indicating the presence of growing medium and ample water.

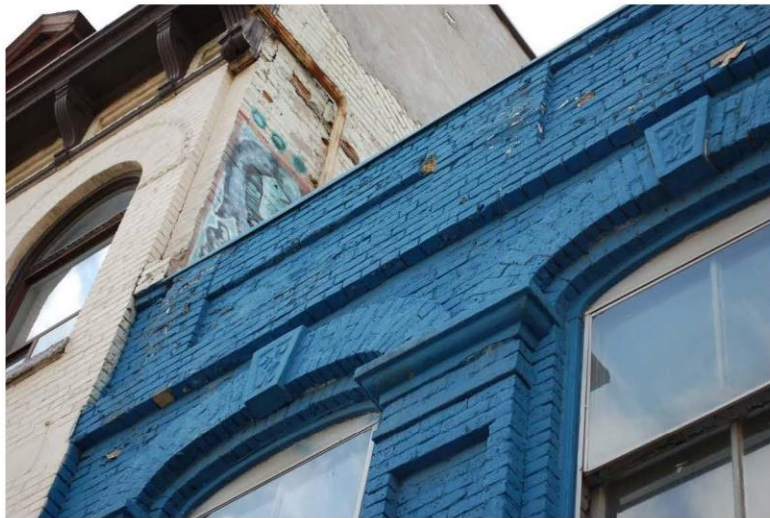
*Photograph 16:* Mortar and brick deterioration at the parapet level.

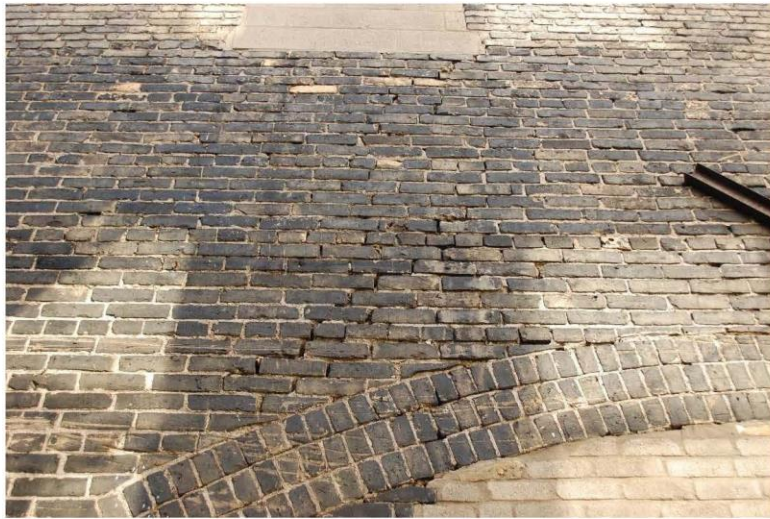
*Photograph 17:* Blocked-in window openings, mortar deterioration and severe cracking in the west elevation.

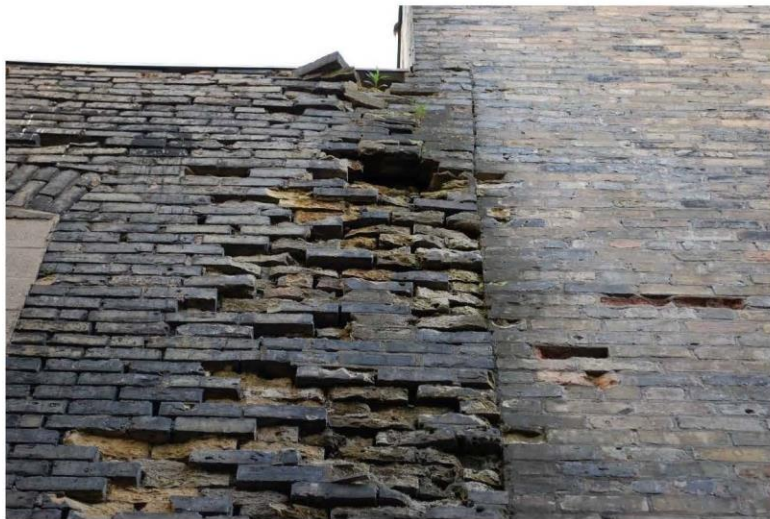
*Photograph 19:* Masonry at the joint between the two and three storey sections was in extremely poor condition. Note the bricks 'ready to fall' near the top of the wall, plus missing and shifting bricks were observed.

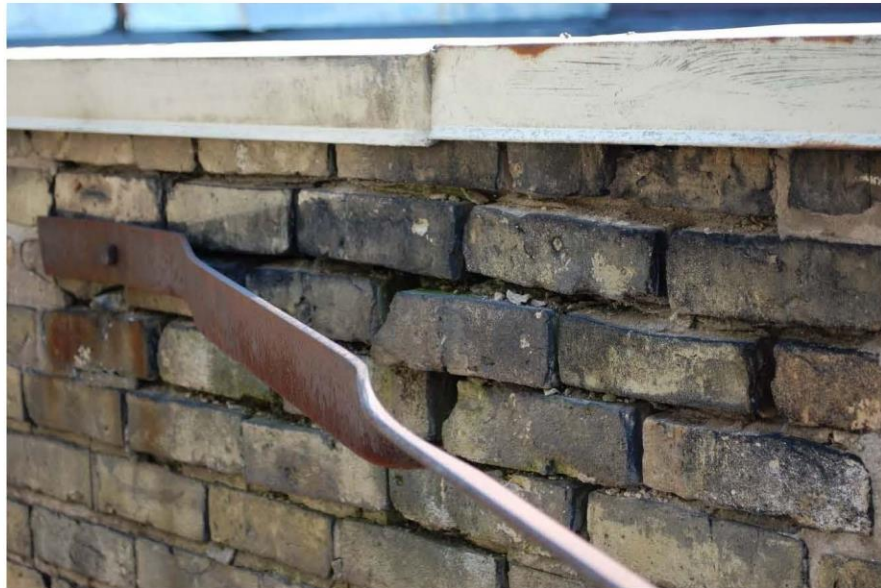
*Photograph 21:* Parapet deterioration at the anchor for the fire escape.

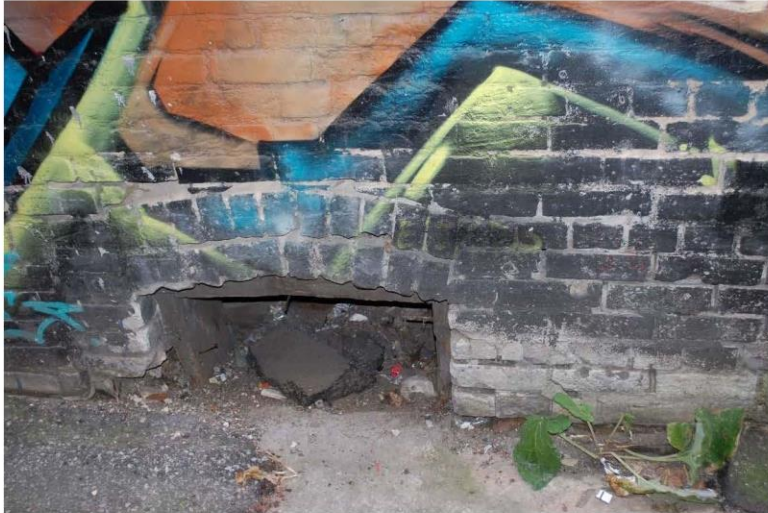
*Photograph 22:* Mortar deterioration and missing brick units at grade.

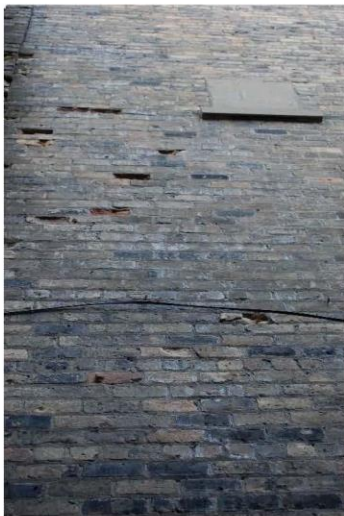
*Photograph 23:* Middle addition with a several brick pop-outs.

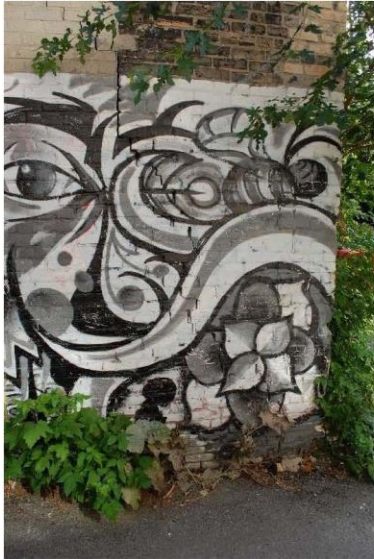
*Photograph 25:* Wide diagonal crack at the base of the west addition.

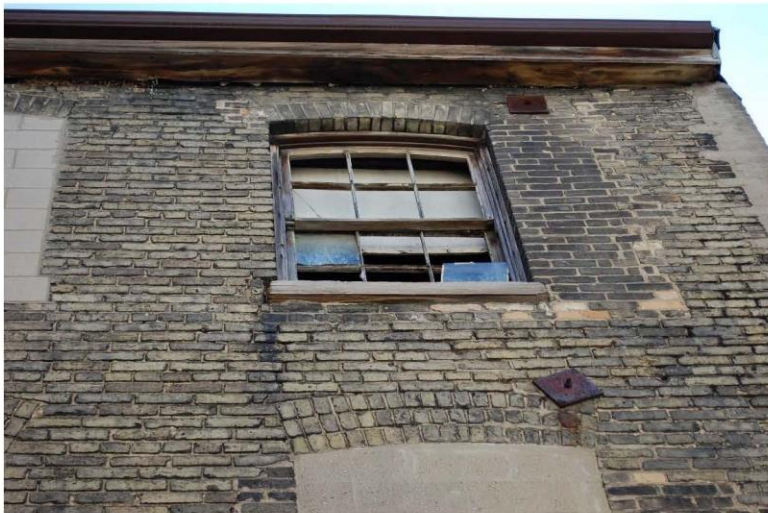
*Photograph 26:* Broken window at the third floor of the south end of the west wall.

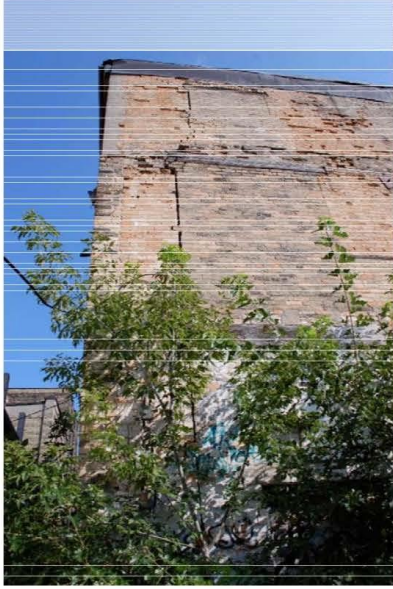
*Photograph 28:* Movement and wide vertical cracking of the south wall.

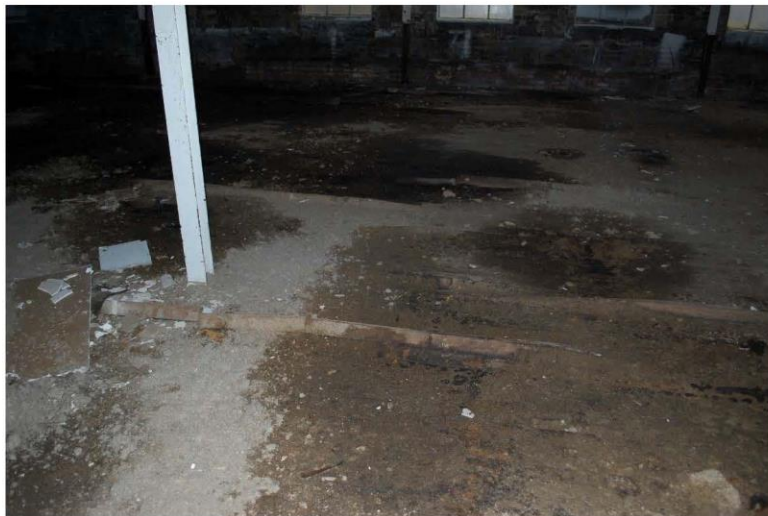
*Photograph 48:* Poor floor sheathing condition with buckling flooring.

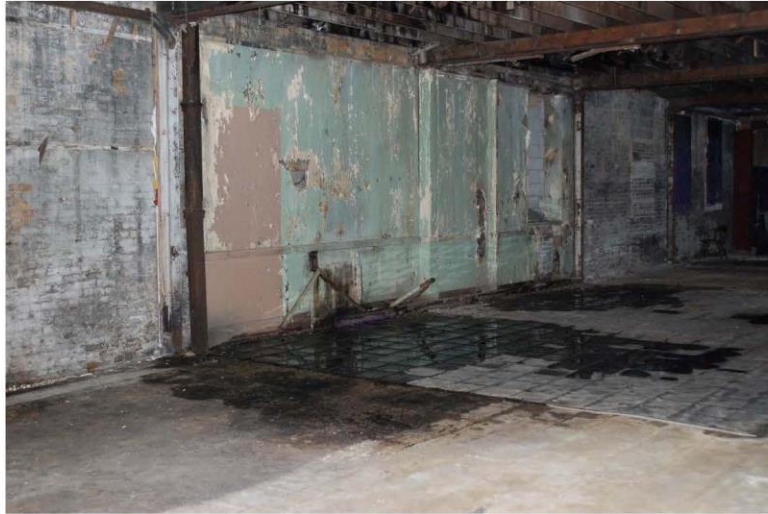
*Photograph 49:* Water staining of second floor joists (and main floor joists) due to roof leaks.

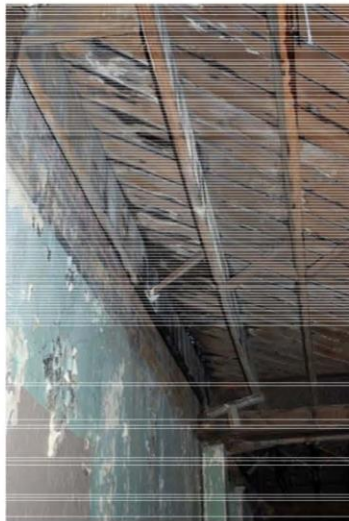
Agenda Item # Page #

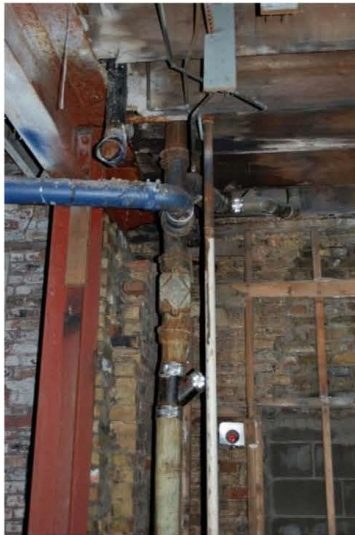
*Photograph 51:* Water staining of roof joists near roof drain stack.

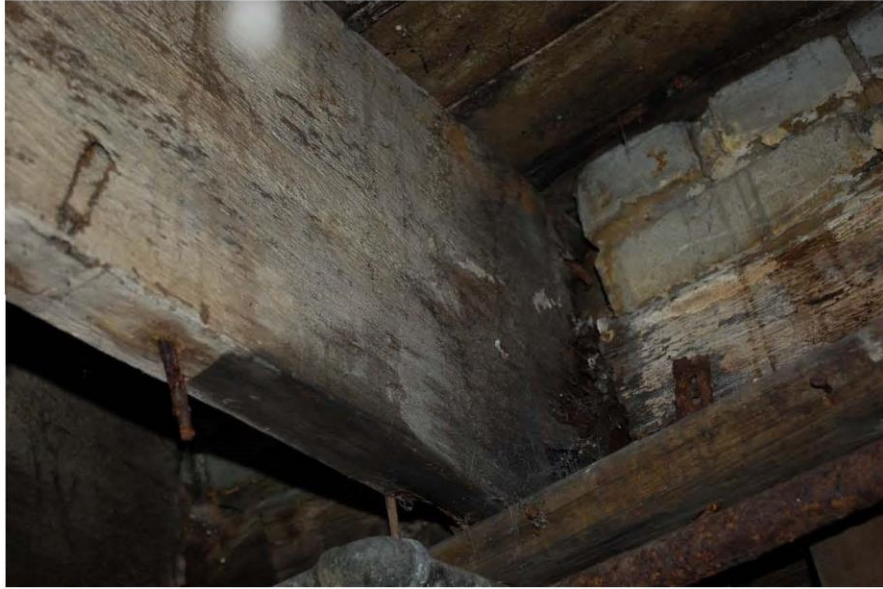
*Photograph 52:* Water staining and dry rot in main floor joists at the west wall.
