CPP Watermain Break

2012 Mt. Carmel, May 23

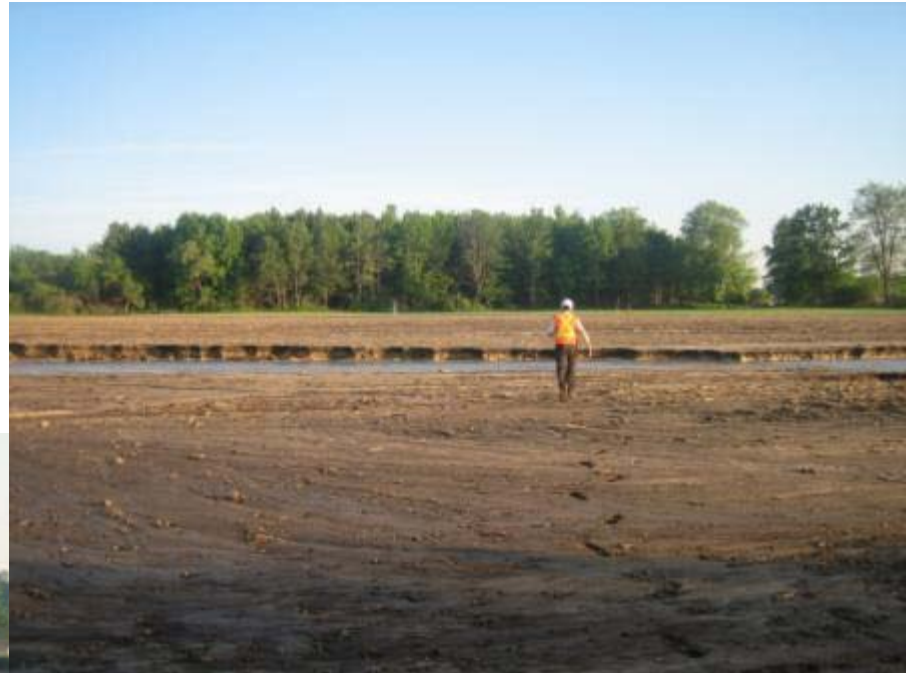
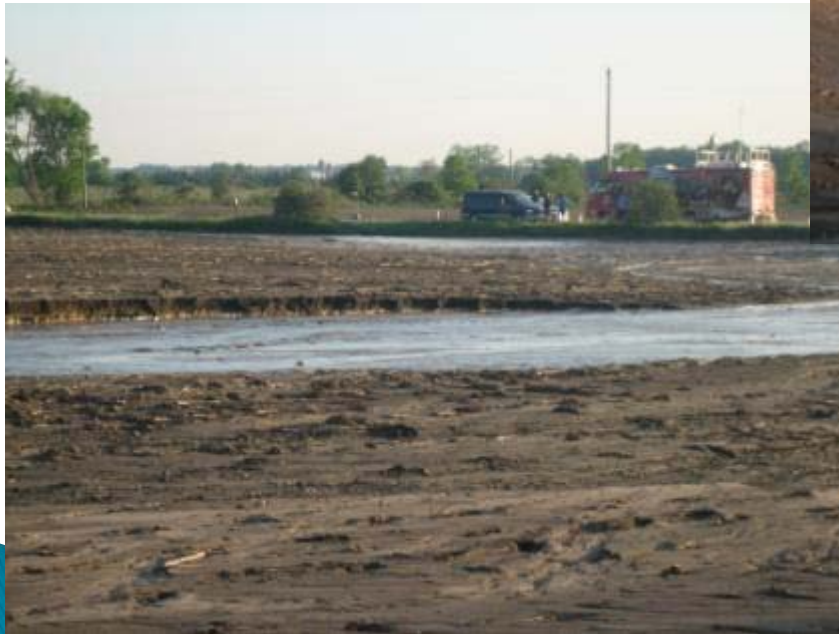
Damage to Field

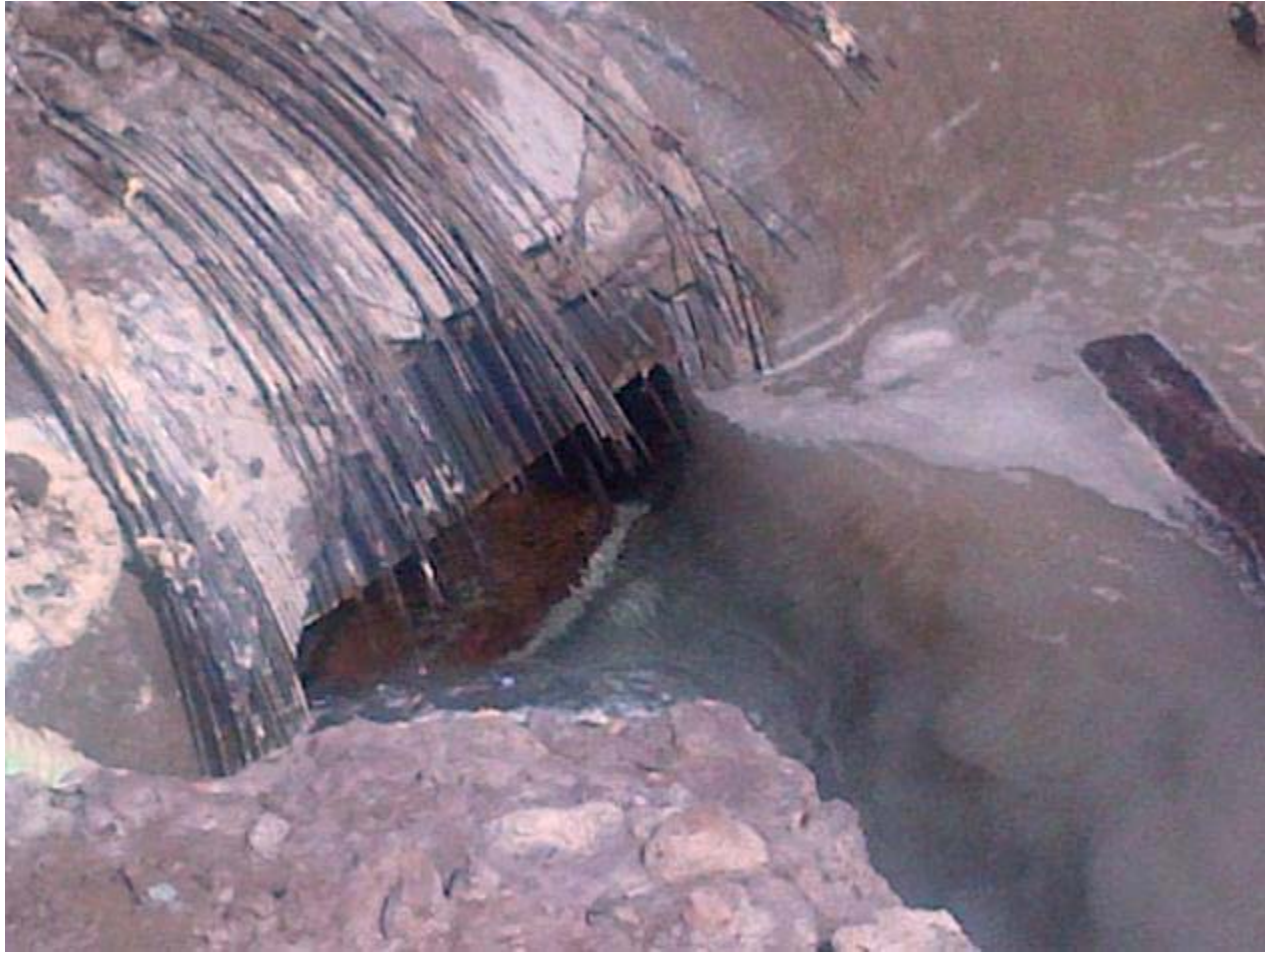
Break uncovered....

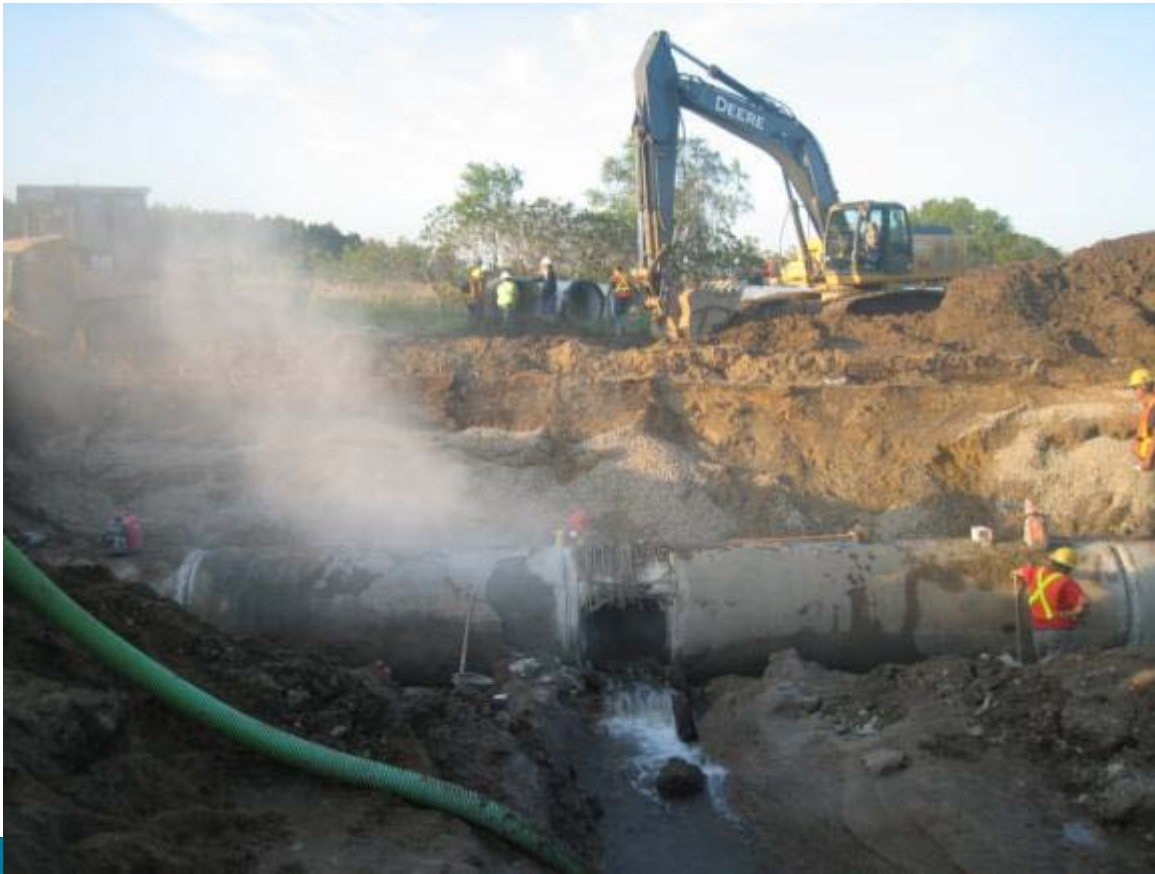
Starting pipe removal- 12hrs after reported break

Spent part of the day shutting down the section, pumping off the field, and building a temporary access road to limit the damage to crops.

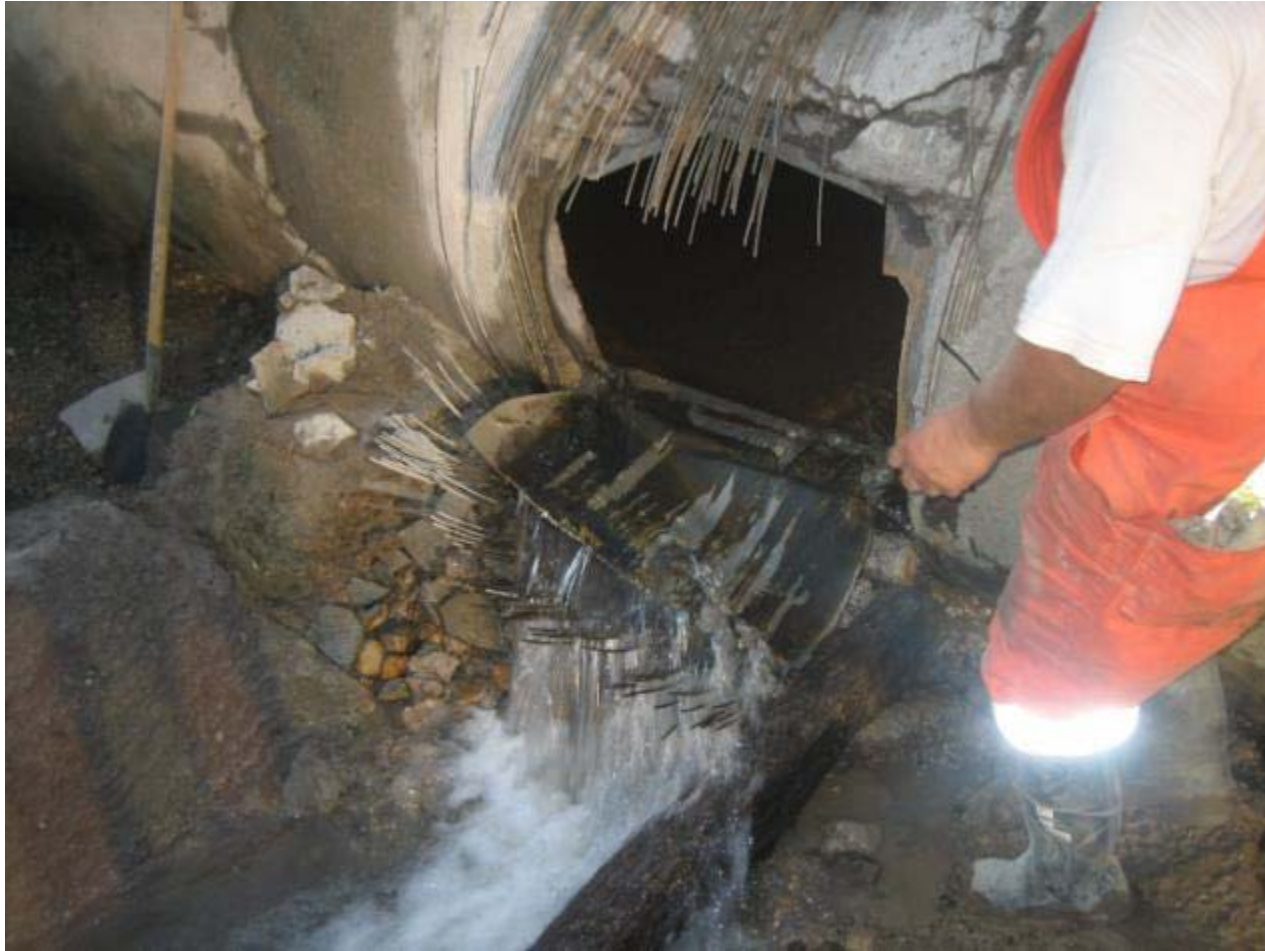
Broken pre-stressed wires and 1200mm diameter watermain

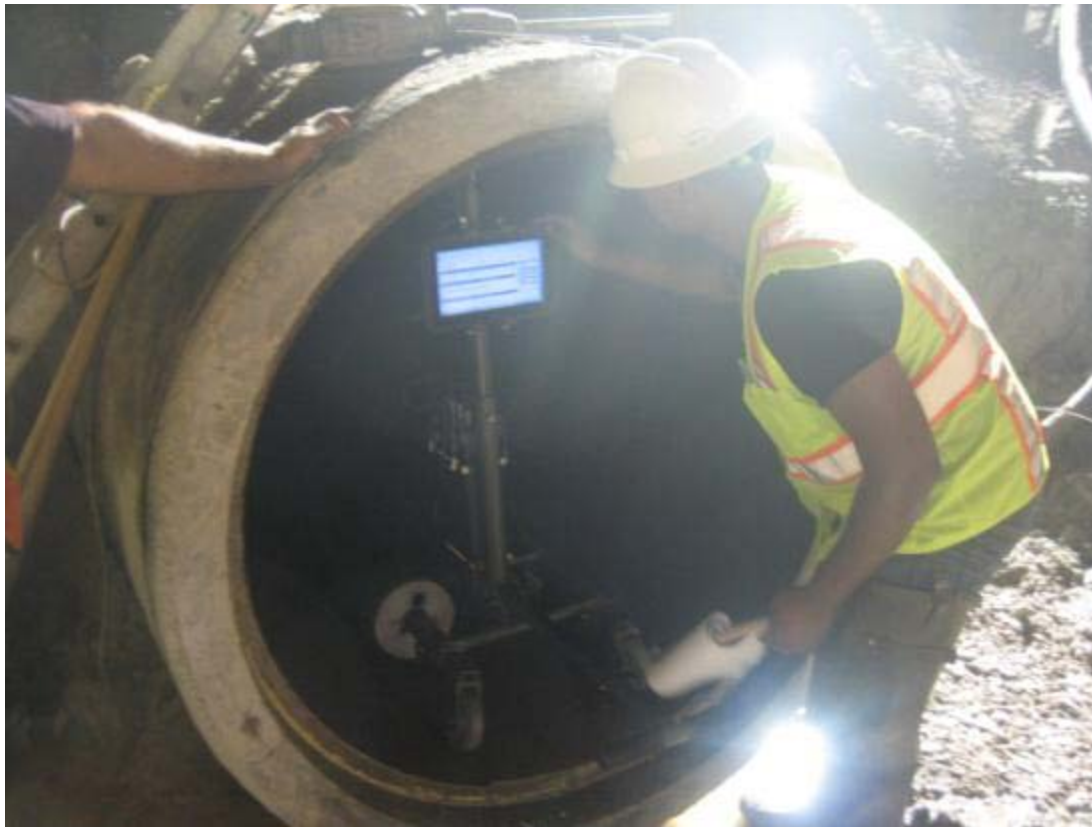
Electromagnetic inspection inside of pipe to ensure no pipes in close proximity of broken section were in distress

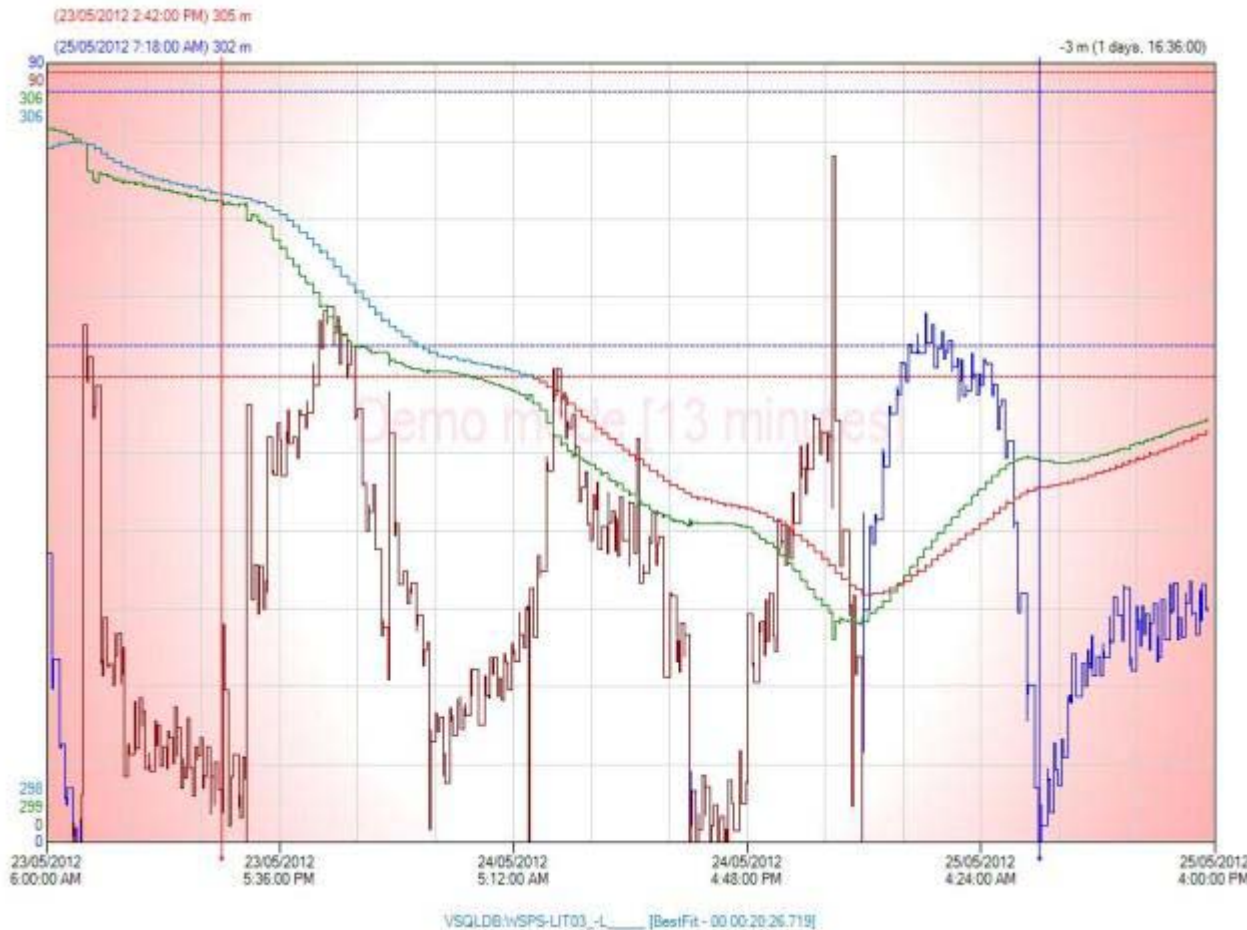
Springbank Reservoir at 4:00pm Friday – SCADA Plot

Blue and red squiggly lines are “in-flow” and “out-flow” respectively. No blue (inflow) from 7:00am Wednesday to 9:00pm Thursday.

Green and blue lines are reservoir levels. Bottom of graph is approx. bottom of reservoir.
