SBM-17-1894 7 September 2017

<u>660 Sunningdale Road East – Structural Inspection of Rear Two Sheds</u> <u>London, Ontario</u>

Pictures of West Shed Showing Levels of Deterioration

Pictures of East Shed Showing Levels of Deterioration

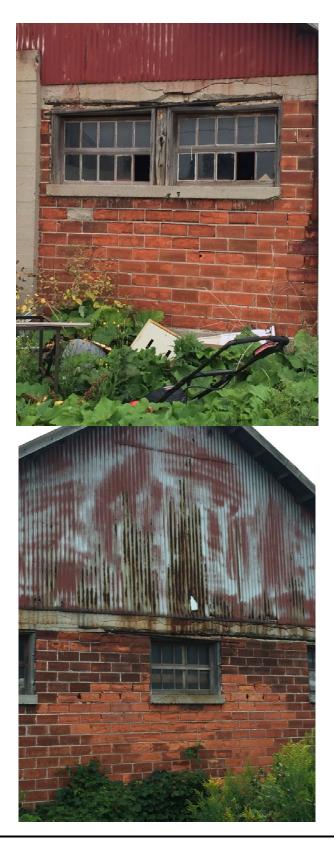
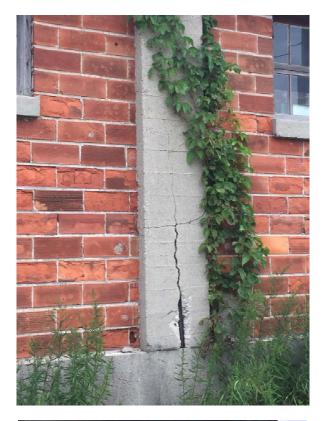
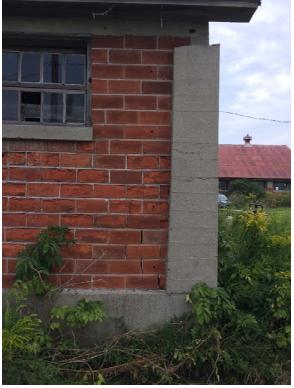
The exterior clay tile walls are in poor condition and have surpassed their lifespan. The concrete beams and concrete columns are also in poor condition and have also surpassed their lifespan. As the walls, beams and columns are an integral part of the overall support of the buildings we feel that the structural integrity and safety has been compromised for both buildings. See pictures below showing damage to each building.

On the basis of the observations outlined above, SBM is of the opinion that the subject buildings are generally in poor condition, and are near or at the end of its usable service life. Due to the age and nature of the construction, as well as the level of deterioration observed, it is our opinion that the cost to reinforce the existing structure, and update it to meet current building and life-safety standards, would far exceed the value of the finished product.

Moving the structure would be unfeasible given its present condition. The existing building materials are in poor structural shape and any re-assembly of the structure would likely require that it be upgraded to current standards and with proper safe building materials.
