Information for LACH Agenda

Submitted by Nancy Tausky

April 3, 2018

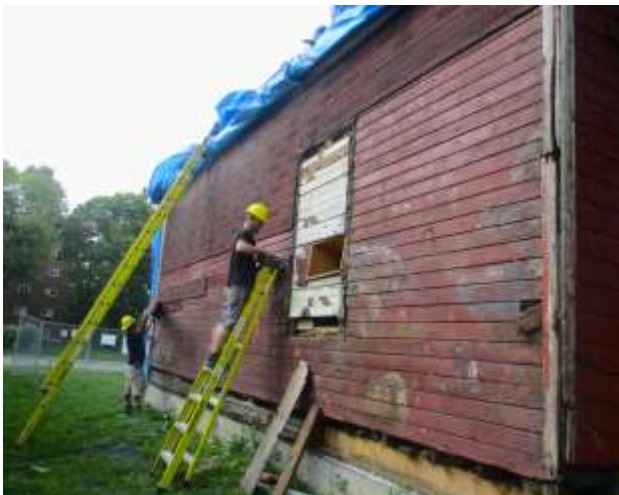
Exposing the original wide tongue-and-groove planks of the east wall

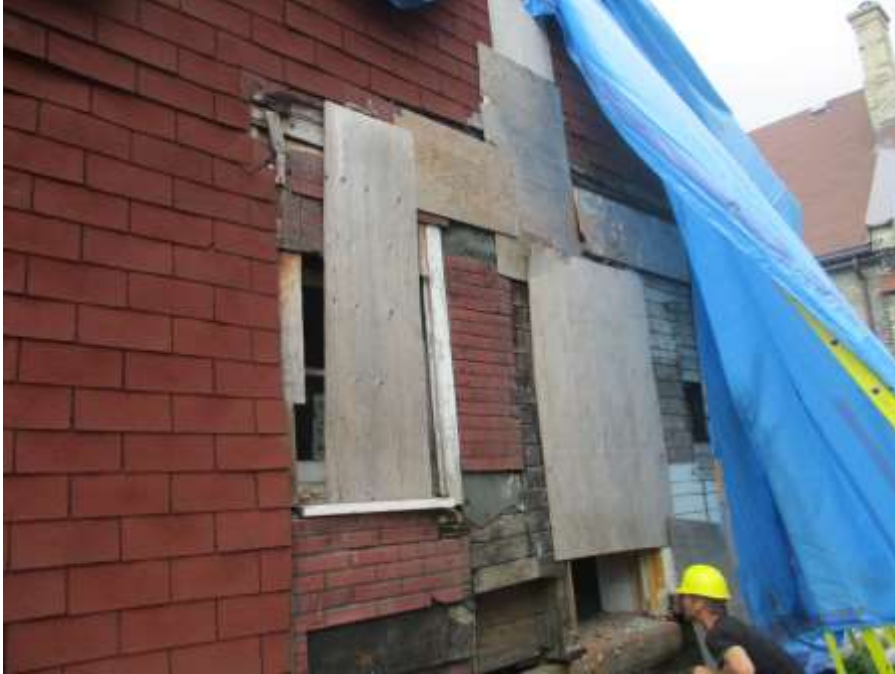
Varieties of materials covering the rear (north) wall

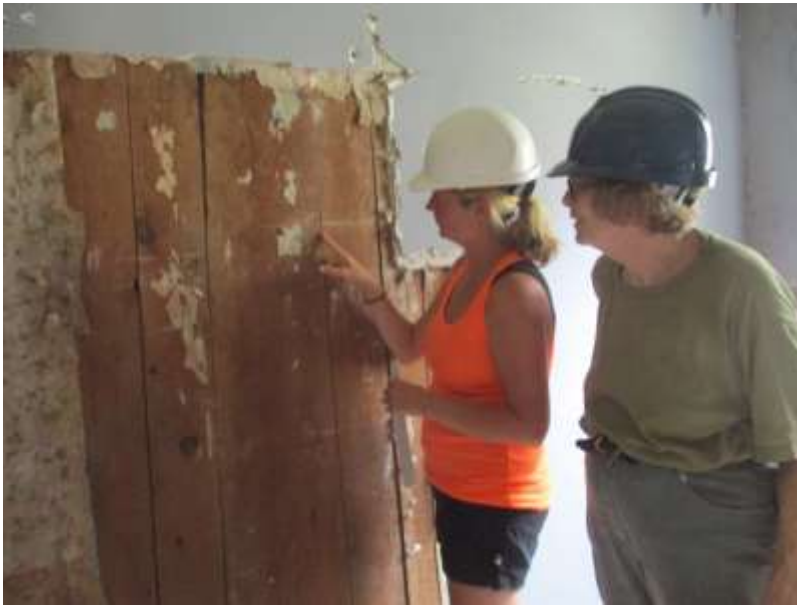
Hilary Neary and Tara Jenkins stripping wallpaper from vertical planks between two rooms in the western portion of the house

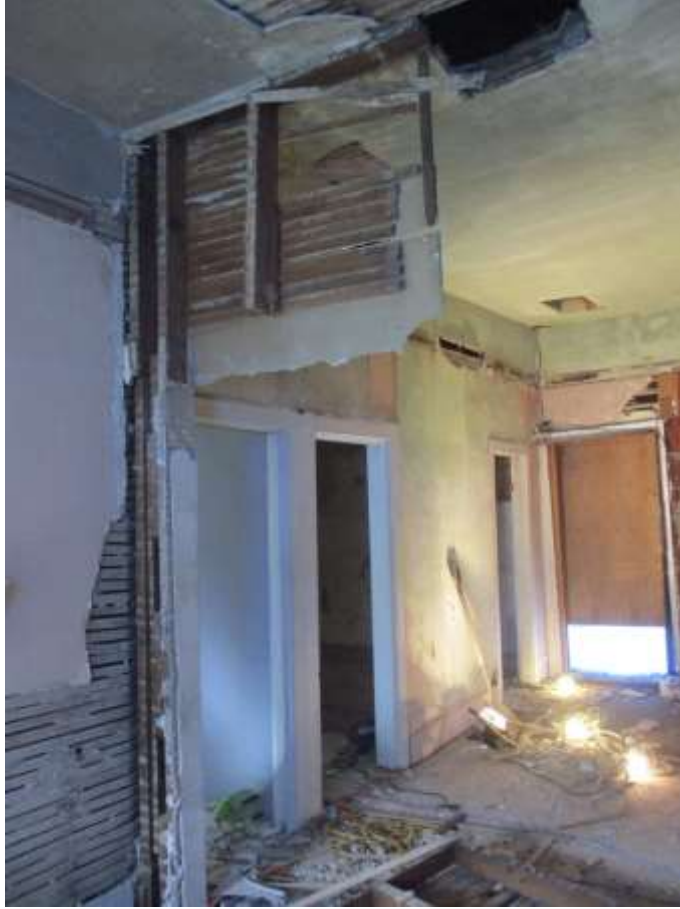
Looking along the north-south wall as it extends towards the rear of the building
