172 Central Ave
Subject Property
Built 1883
“Italianate”
Level 1

Re: Structural Review
Private Residence at 172 Central Avenue
Our file No. 18-15-0142

Unsafe Building – Order to Make Safe

RE: 172 Central Ave Site Inspection

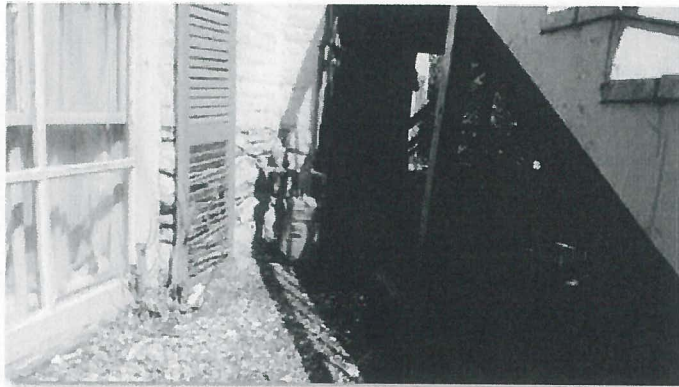
Gas meter; A gas meter is located adjacent to a basement window while also under the front entrance patio. By today's code requirements, this location is unacceptable and the meter is to be relocated.

Front Entrance; The exterior stair and patio accessing the front entrance is constructed from conventional wood framing. Wood posts were placed on grade without proper foundations.

Image 1: West side of exterior wall at main entrance.
(Image shows window at grade; Gas Meter Location, Entrance patio framing.)

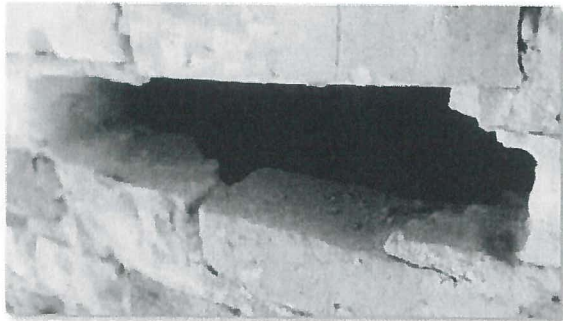
Exterior Brick: The exterior brick Wythe appeared to be non-load bearing. Penetrations in the brick at floor joist locations showed the interior structural framing is supported by the interior Wythe of brick only. The two brick walls were tied together using clay bricks headers. The spacing of the headers was not determined at the time of the review.

Image 3: Penetration in Exterior Brick Wall

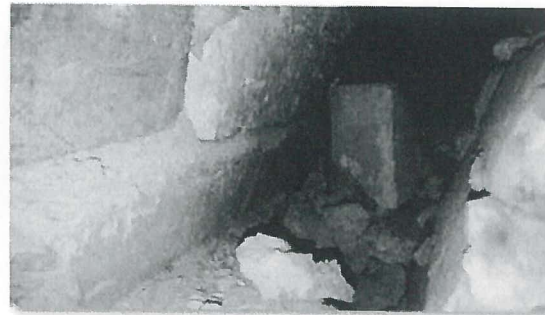
Image 4: Penetration in Exterior Brick Wall at base.

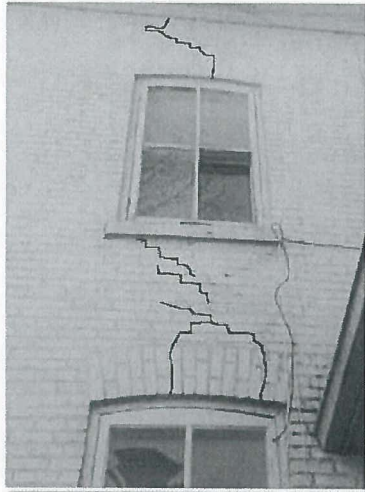
Cracks in the exterior brick were observed at many location including most window and door opening. The cracking was predominantly within the mortar joints however, where windows were stacked between the main floor and second floor, cracks were seen to pass through several bricks. At the rear of the house, cracks in the brick extended from the foundation up to the eave.

A bow in the exterior brick could be seen along the east wall at the second floor elevation. Cracking in the brick has been highlighted in the images below for clarity.

Image 5: Rear Brick Wall

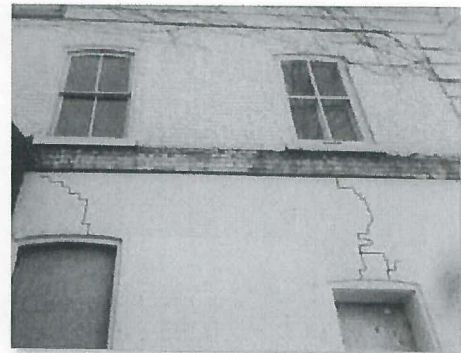
Image 7: Rear Brick wall

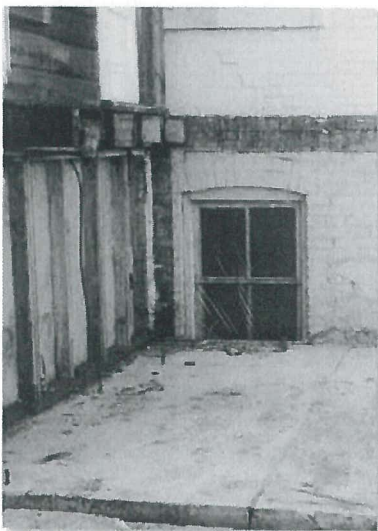
Rear Addition; At the rear of the residence, a small wood framed addition is installed. Portions of a stud wall supporting the addition, with wood floor joists and wood paneling. Along the north end, the wood framing is exposed to the environment. Rotting and damage to the wood structure was observed including warping of the supporting stud wall.

Image 8: Exposed wood framing
And Window at grade. (At Rear)

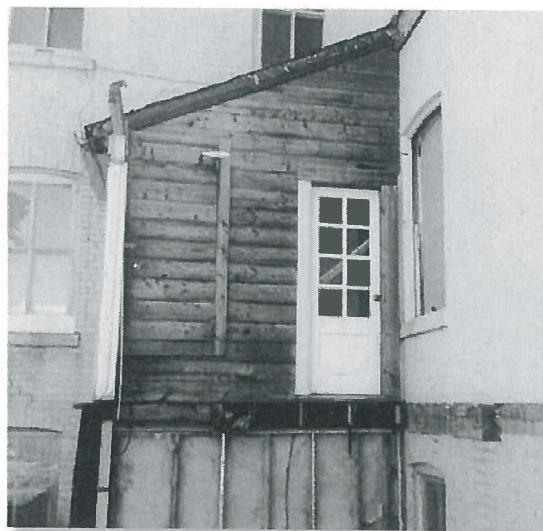
Image 9: Exposed wood framing
(at Rear)

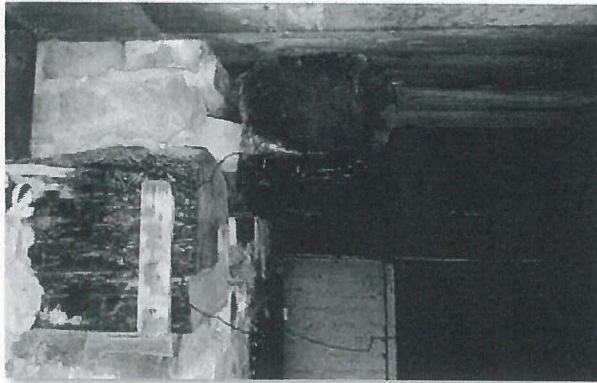
Near the basement stair, another wood beam was cut resulting in an existing joists being unsupported.

Image 10: Basement Beam near stair cut.
Floor joist has no support

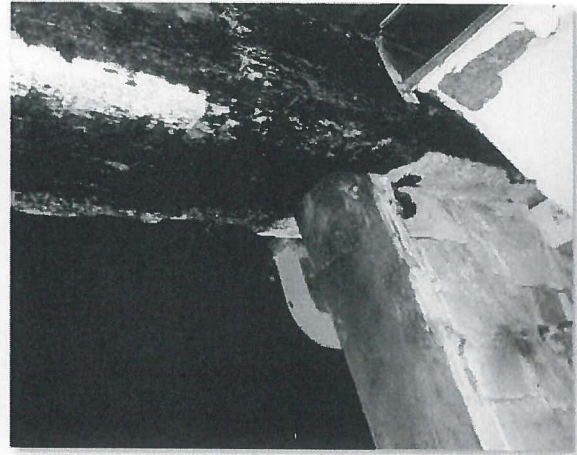
For instance, a beam supporting the floor below the main entrance bears on a single wyse of brick, eccentrically placed. Where this beam spans over an opening in the basement, the beam has been cut short of the bearing point, resulting joists not being supported by the beam, and the beam cantilevering from the single wythe of brick. Load bearing walls supporting the second floor are supported by this beam and wall in the basement.

Image 11: Charred beam eccentrically placed
On single Wythe brick below.

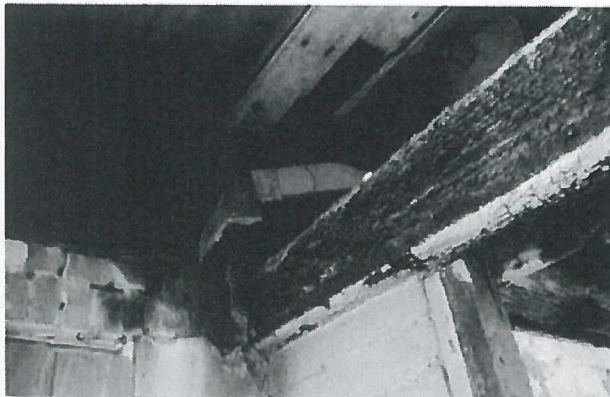
Image 12: Joist near stair cut.
Floor joist has no support

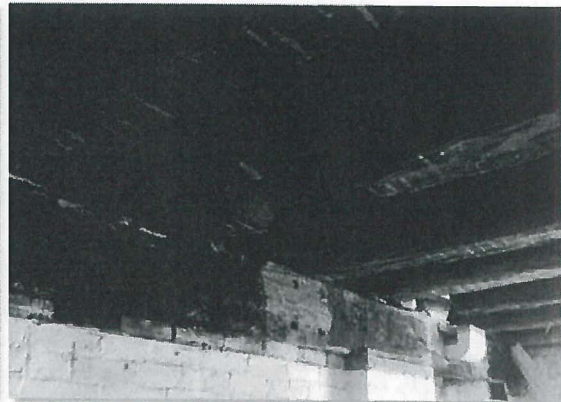
Image 13: Joist below main entrance cut.
Floor joist has no support

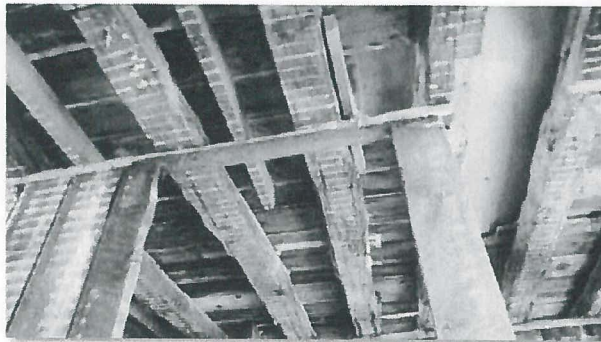
Stud Framing; Stud and headers within interior bearing walls at the front of the house were installed on their flats. At some location, headers and top plate were missing. The stud framing was offset of supporting beams and load bearing wall below. Reworking of the stud framing is required with installation of proper headers to support the floor framing above.

Image 14: Stud and Header framing of load bearing wall
Near main entrance.

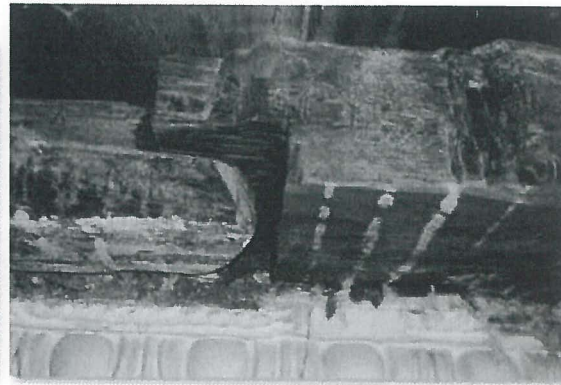
Floor framing; The wood framing supporting the second floor consists of two styles of framing. At the rear of the residence, timber joist spanning between exterior brick walls was used. At the front of the house, a non-conventional double cantilever system was used. The components are friction fit, no wood dowels were observed. The bearing walls on the main floor were offset of the brick walls below.

Image 15: Connection of Double Cantilever Joists
At front of house

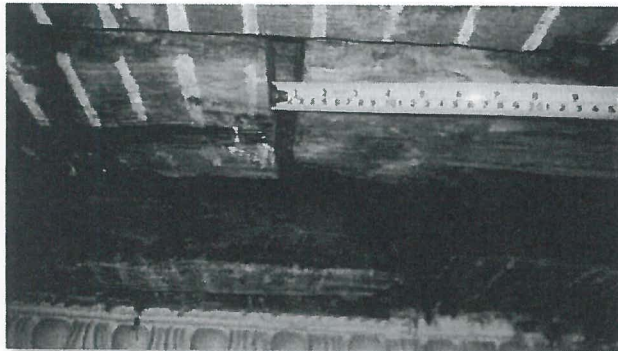
Image 16: Connection of Double Cantilever Joists

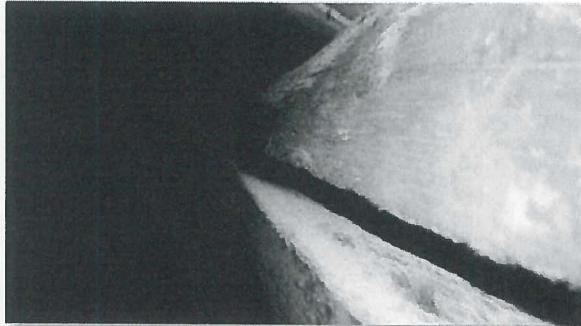
Throughout the second floor framing, several floor joists had longitudinal cracks, in some cases exceeding 1" in width. Joists throughout were seen to be cut, damaged, rotted, charred and in some location with minimal joist depth at bearing points. Spaces between friction joints have developed as the building settles. The current state of the framing requires repair or replacement. Rotting of wood joists were confirmed by drill testing and are not suitable to support the floor loading.

Image 18: Longitudinal Crack in wood joist

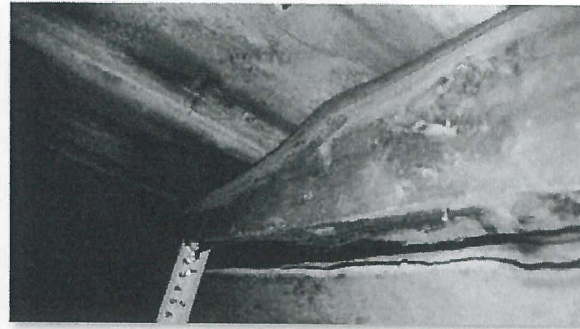
Image 19: Longitudinal Crack in wood joist

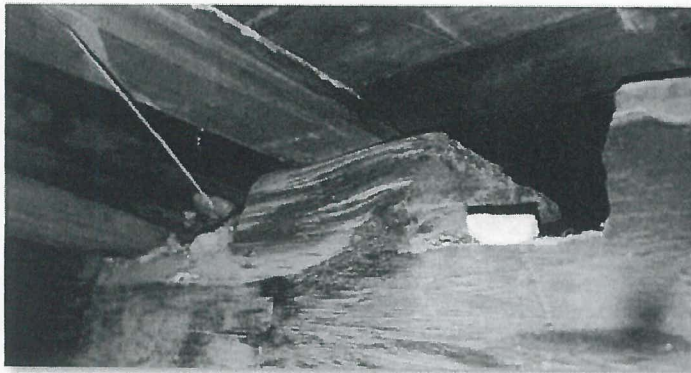
Image 20: Cut joist at rear of house.

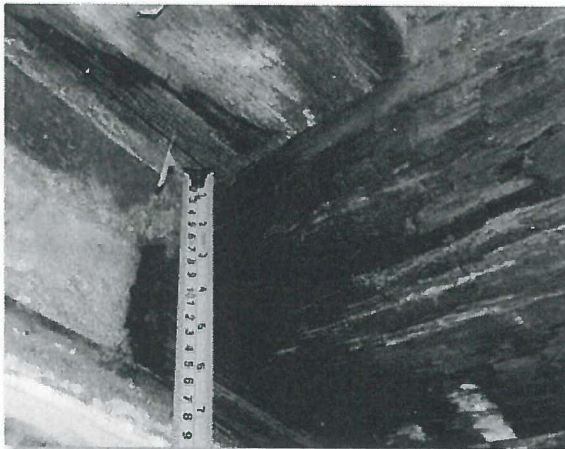
Image 22: Minimal bearing on Brick Wall

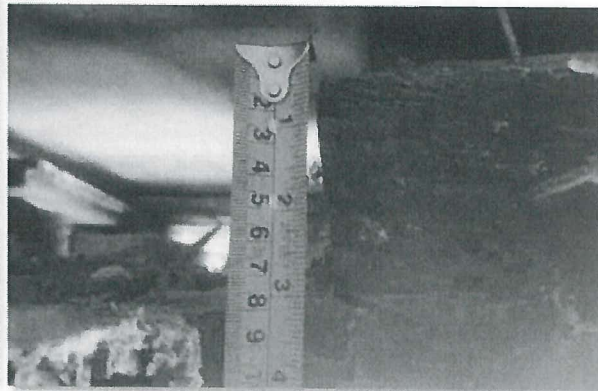
Image 23: Cut beam at rear of house. (Typical of several locations)

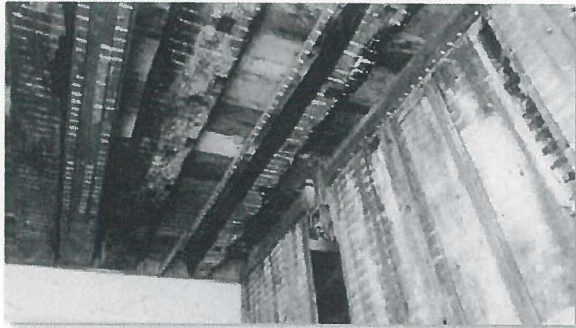
Perimeter Brick Wythe. The existing brick walls consist of two wythe of brick separated and air gap and the floor joist bear solely on the interior wythe. Based on the joist spans and floor loading, the single wythe of brick is overloaded. Cracks and bowing the interior was observed. Additional support of the floor joists is required.

Image 24: Joist framing on brick Wall.
Joist are cut and charred.

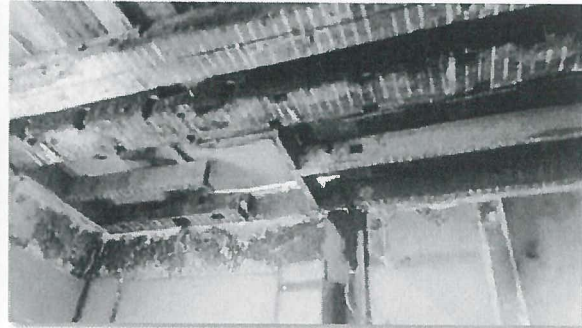
Image 25: Joist framing on brick Wall.
Joist are cut and charred.

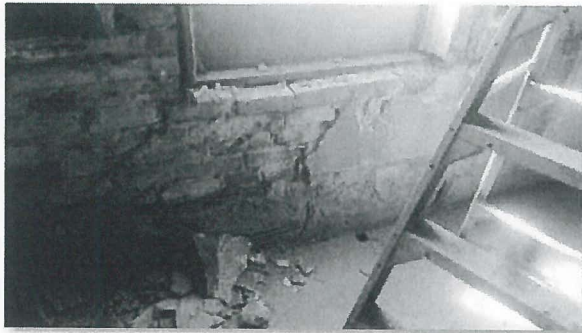
Image 26: Cracked Brick wall at Window

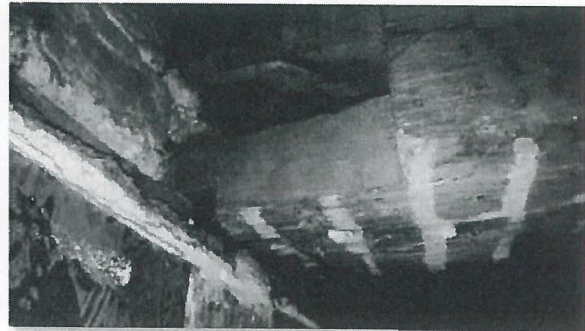
Image 27: Cut floor joists and minimal bearing at brick wall

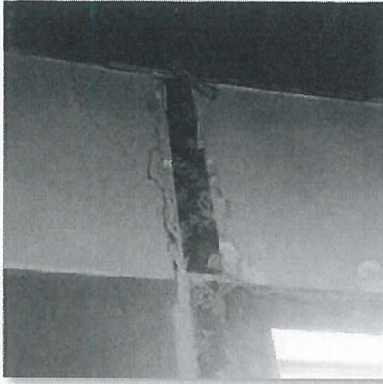
Interior Brick Wythe and Window framing; Brick framing is installed as prescribed previously. Cracking of the plaster and brick wall at the corner of windows was observed. Further investigation determined that wood lintels over windows are damaged due to moisture and a bow in the east brick wall was observed.

Image 28: Cracking at Window

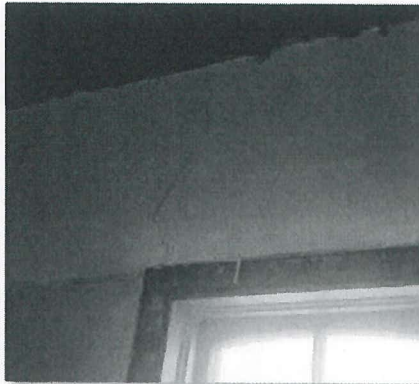
Image 29: Cracking at Window

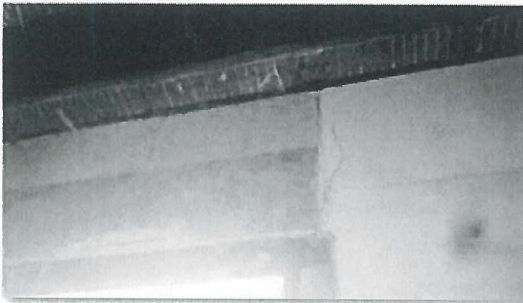
Image 30: Cracking at Window

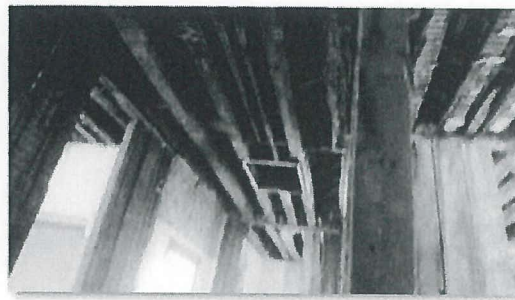
The existing roof; The roof is framed using wood rafters with wood decking. No collar ties were present. Ceiling joists were framed using timber joists. In some areas, ceiling joists could easily be removed.

Image 31: Typical Ceiling Joist Framing.

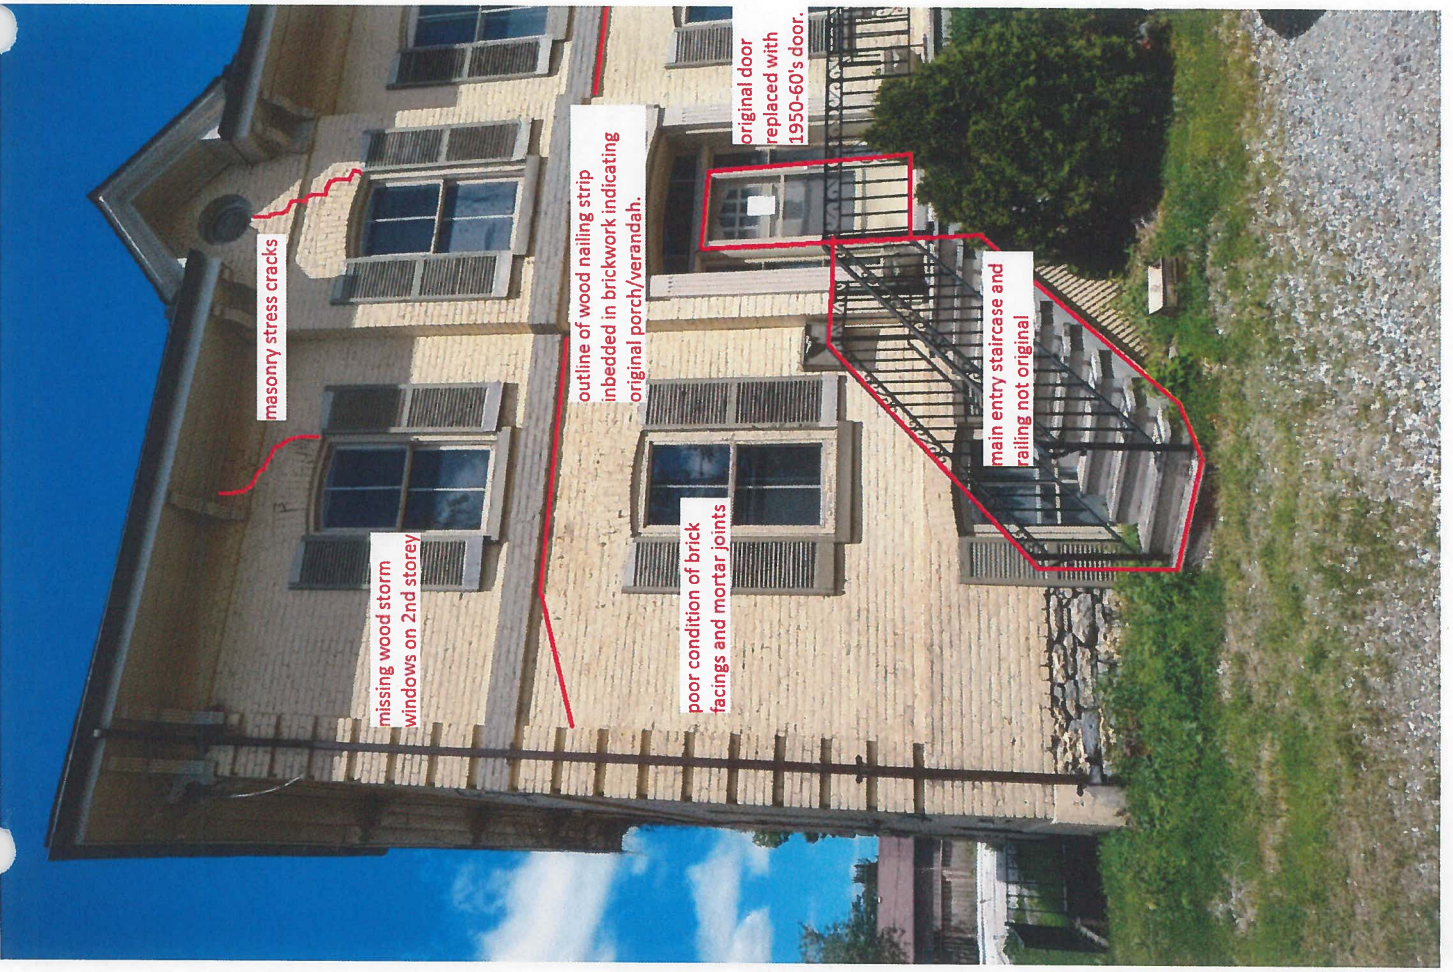
masonry stress cracks

missing wood storm windows on 2nd storey

poor condition of brick facings and mortar joints

outline of wood nailing strip imbedded in brickwork indicating original porch/verandah.

original door replaced with 1950-60's door.

main entry staircase and railing not original

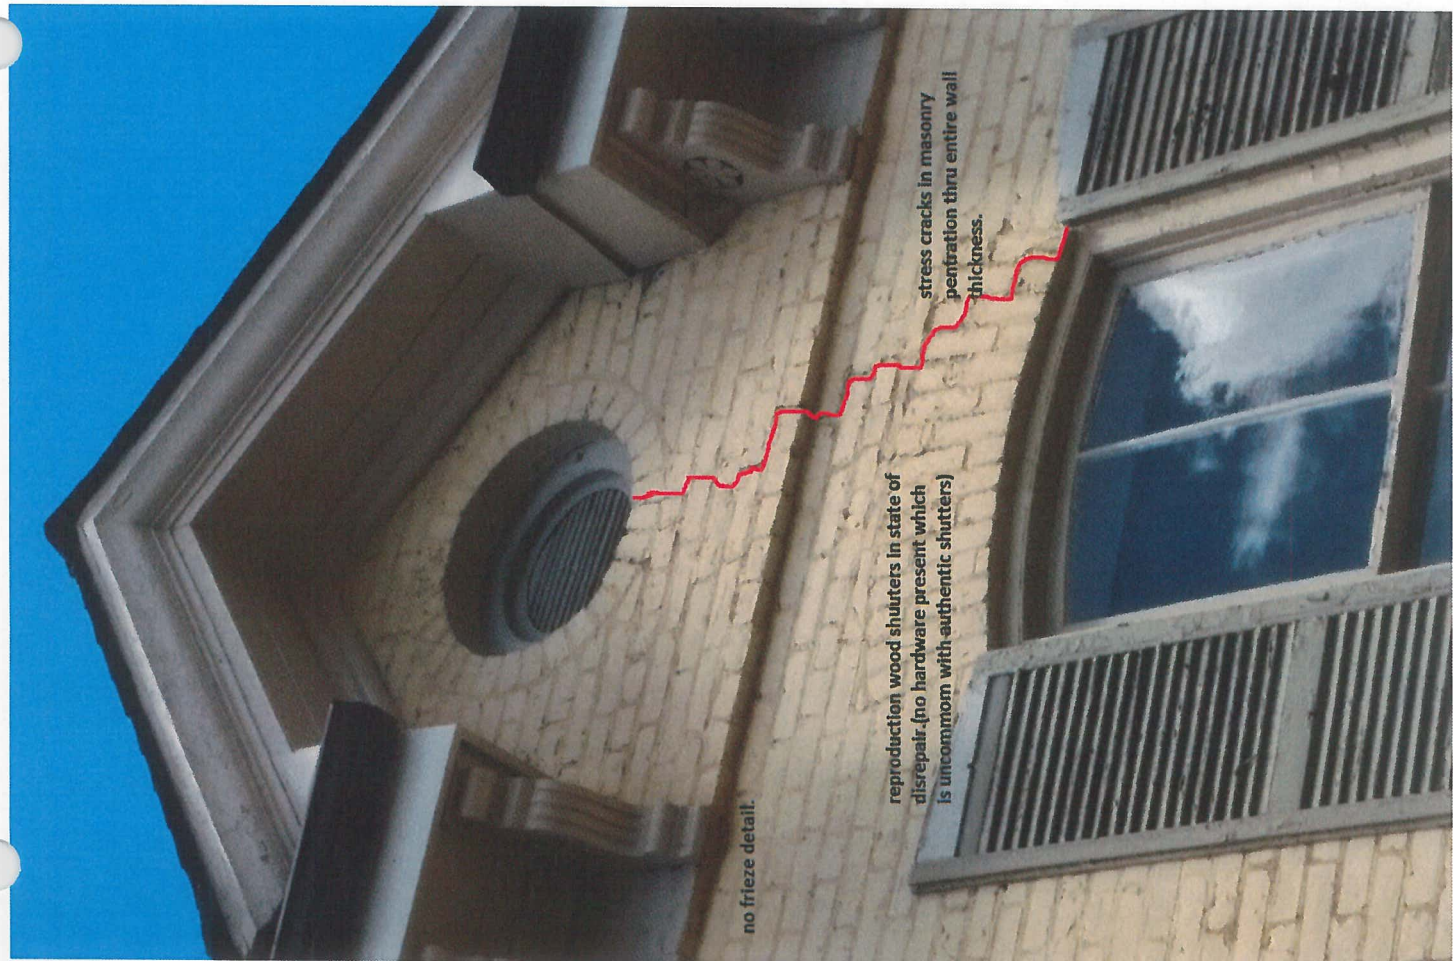
no frieze detail.

reproduction wood shutters in state of
disrepair. (no hardware present which
is uncommon with authentic shutters)

stress cracks in masonry
penetration thru entire wall
thickness.

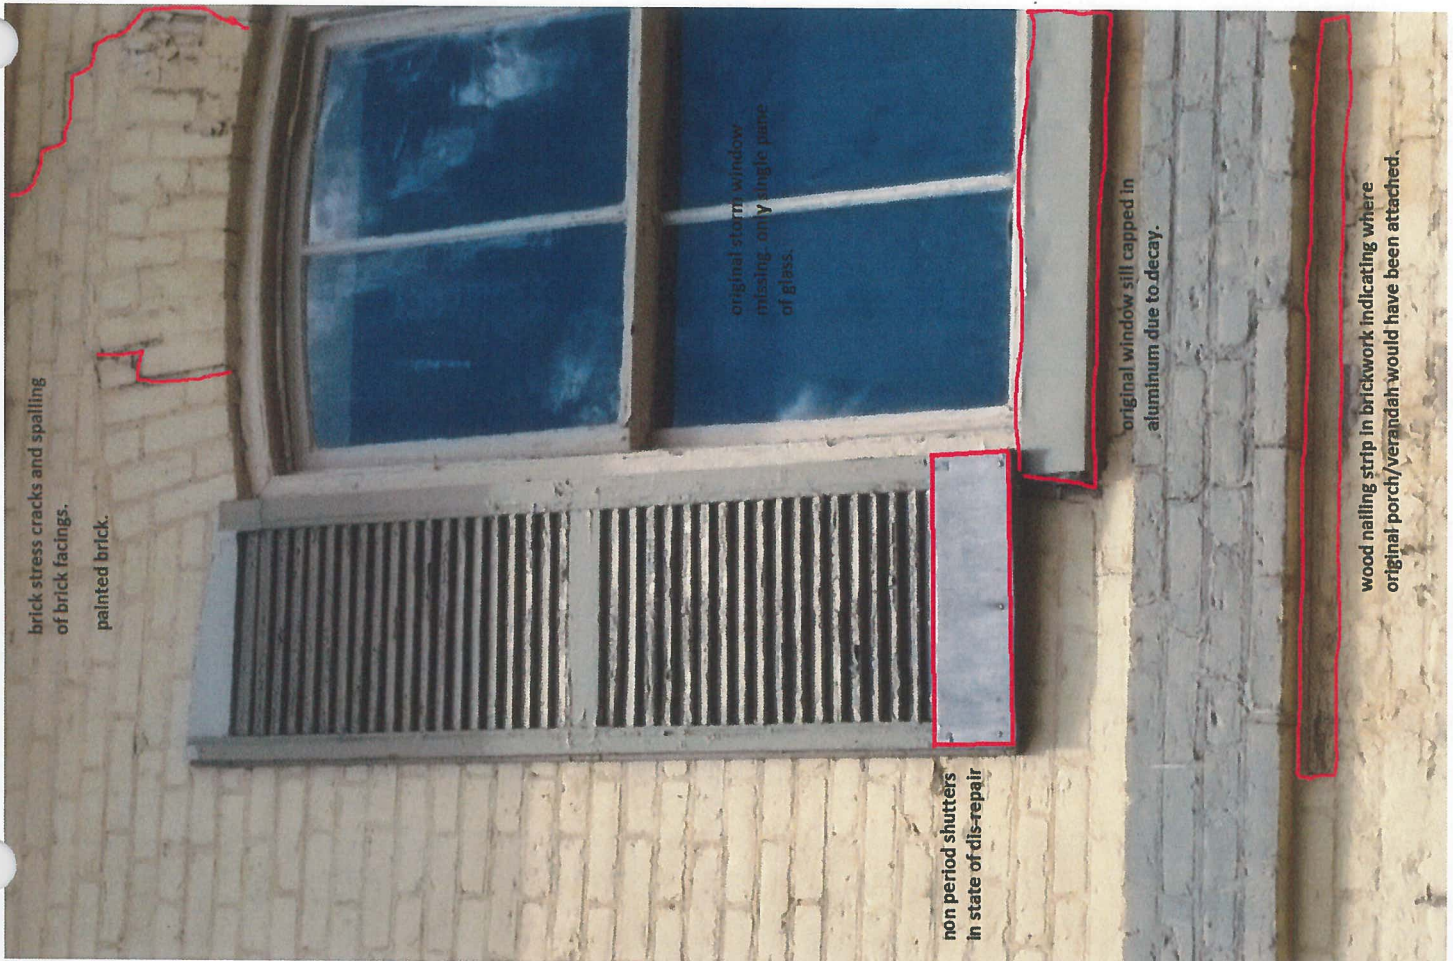
brick stress cracks and spalling
of brick facings.
painted brick.

original storm window
missing only single pane
of glass.

non period shutters
in state of dis-repair

original window sill capped in
aluminum due to decay.

wood nailing strip in brickwork indicating where
original porch/verandah would have been attached.

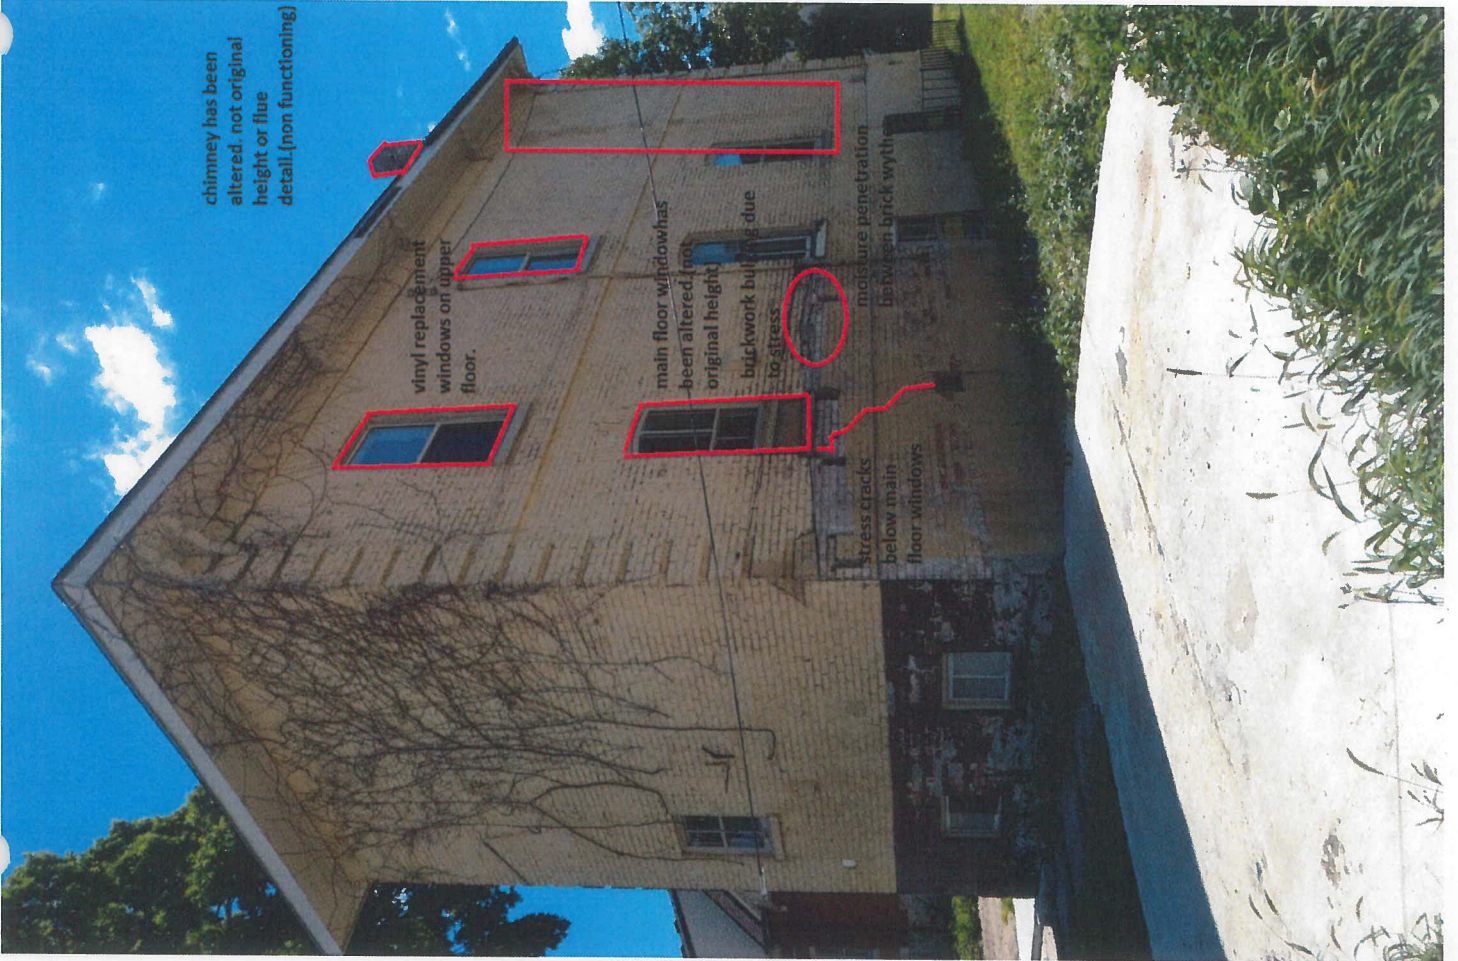
chimney has been altered. not original height or flue detail. (non functioning)

vinyl replacement windows on upper floor.

main floor windows have been altered. (not original height) backwork building due to stress

stress cracks below main floor windows

moisture penetration below brick wythe

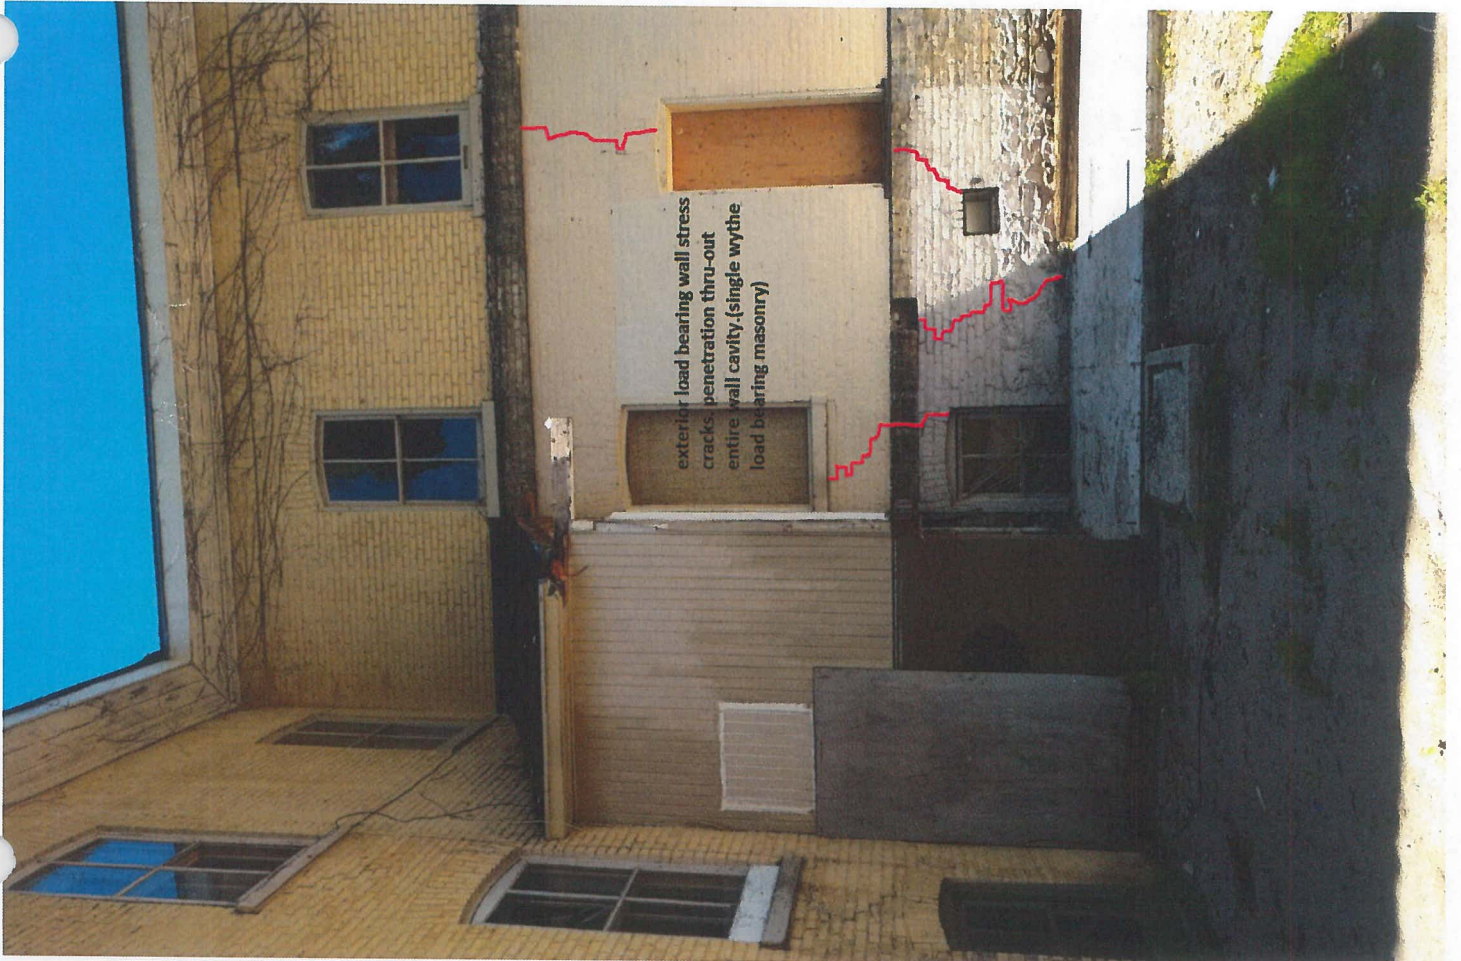
exterior load bearing wall stress
cracks penetration thru-out
entire wall cavity (single wythe
load bearing masonry)

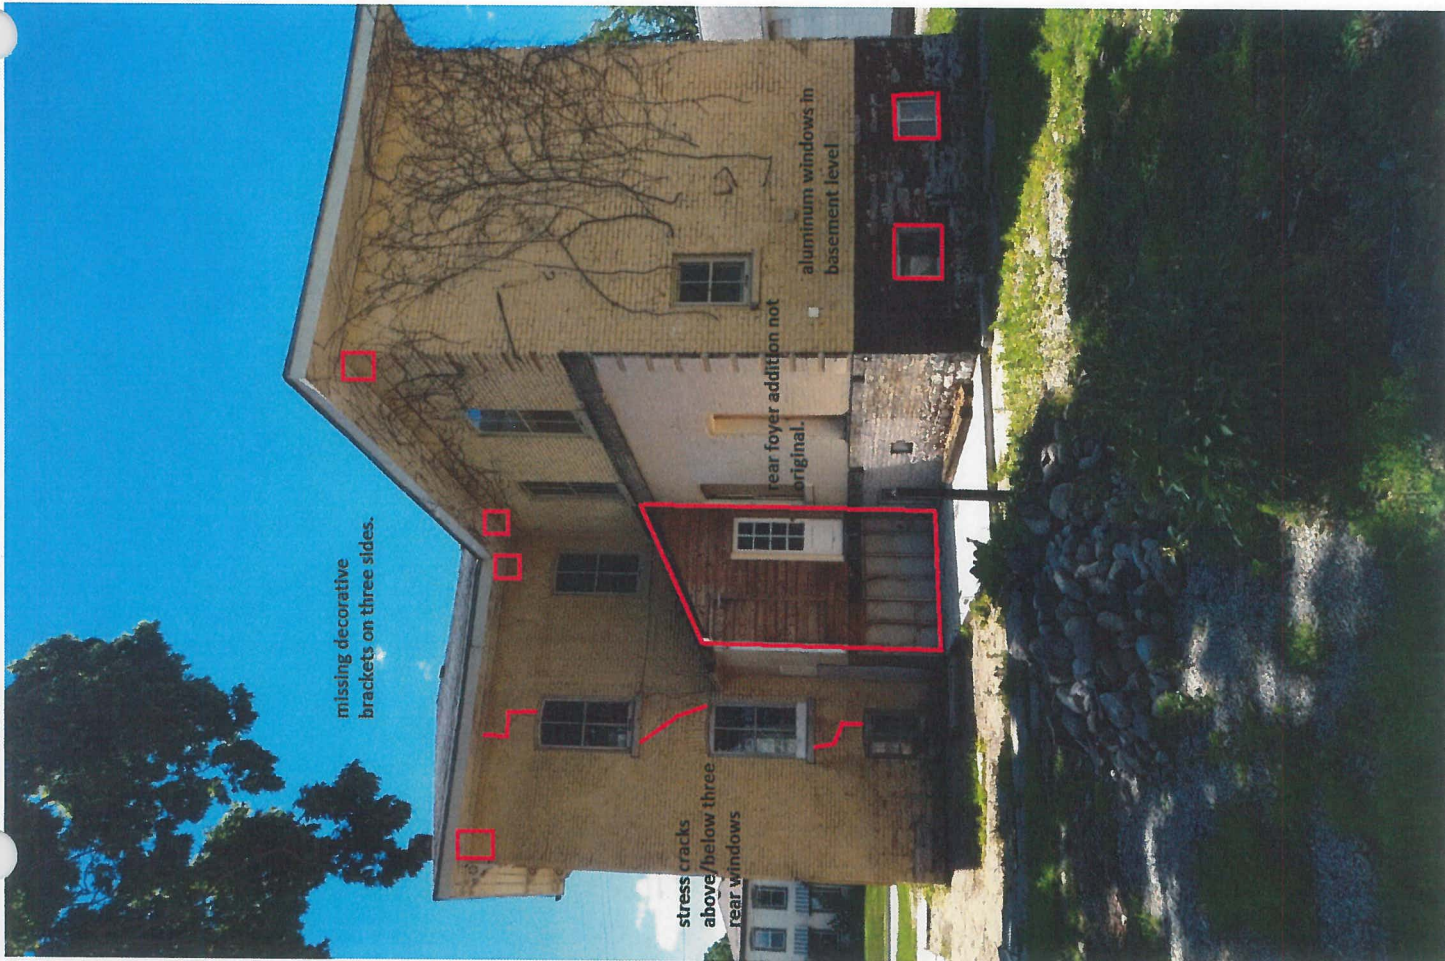
missing decorative brackets on three sides.

stress cracks above/below three rear windows

rear foyer addition not original.

aluminum windows in basement level

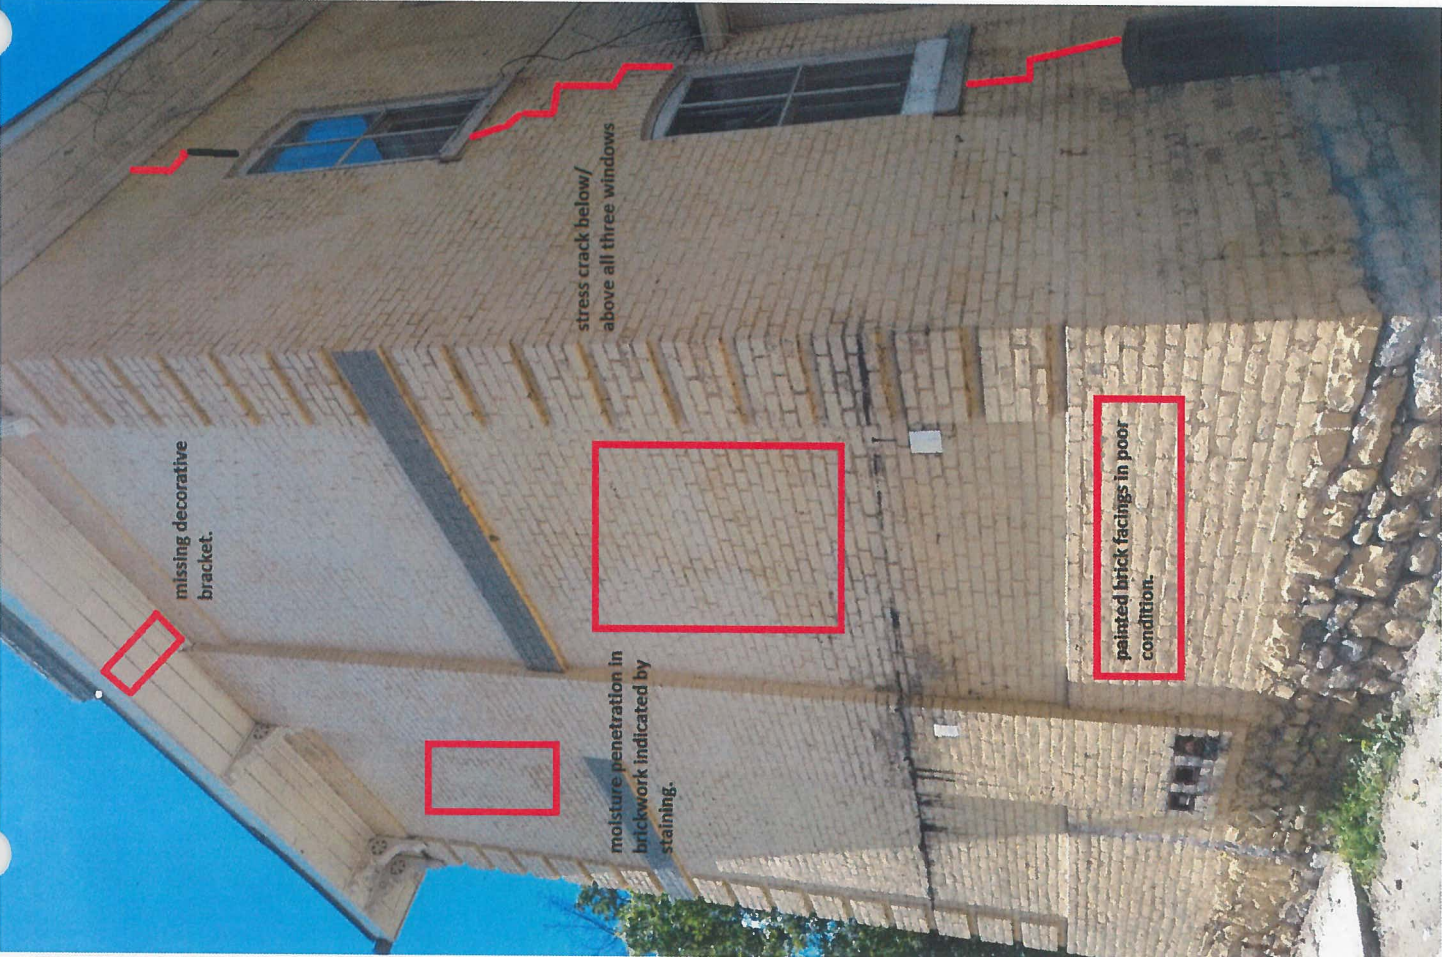
missing decorative bracket.

stress crack below/
above all three windows

moisture penetration in
brickwork indicated by
staining.

painted brick facings in poor
condition.

typical rubble foundation with no footing, not suitable for additional loading.

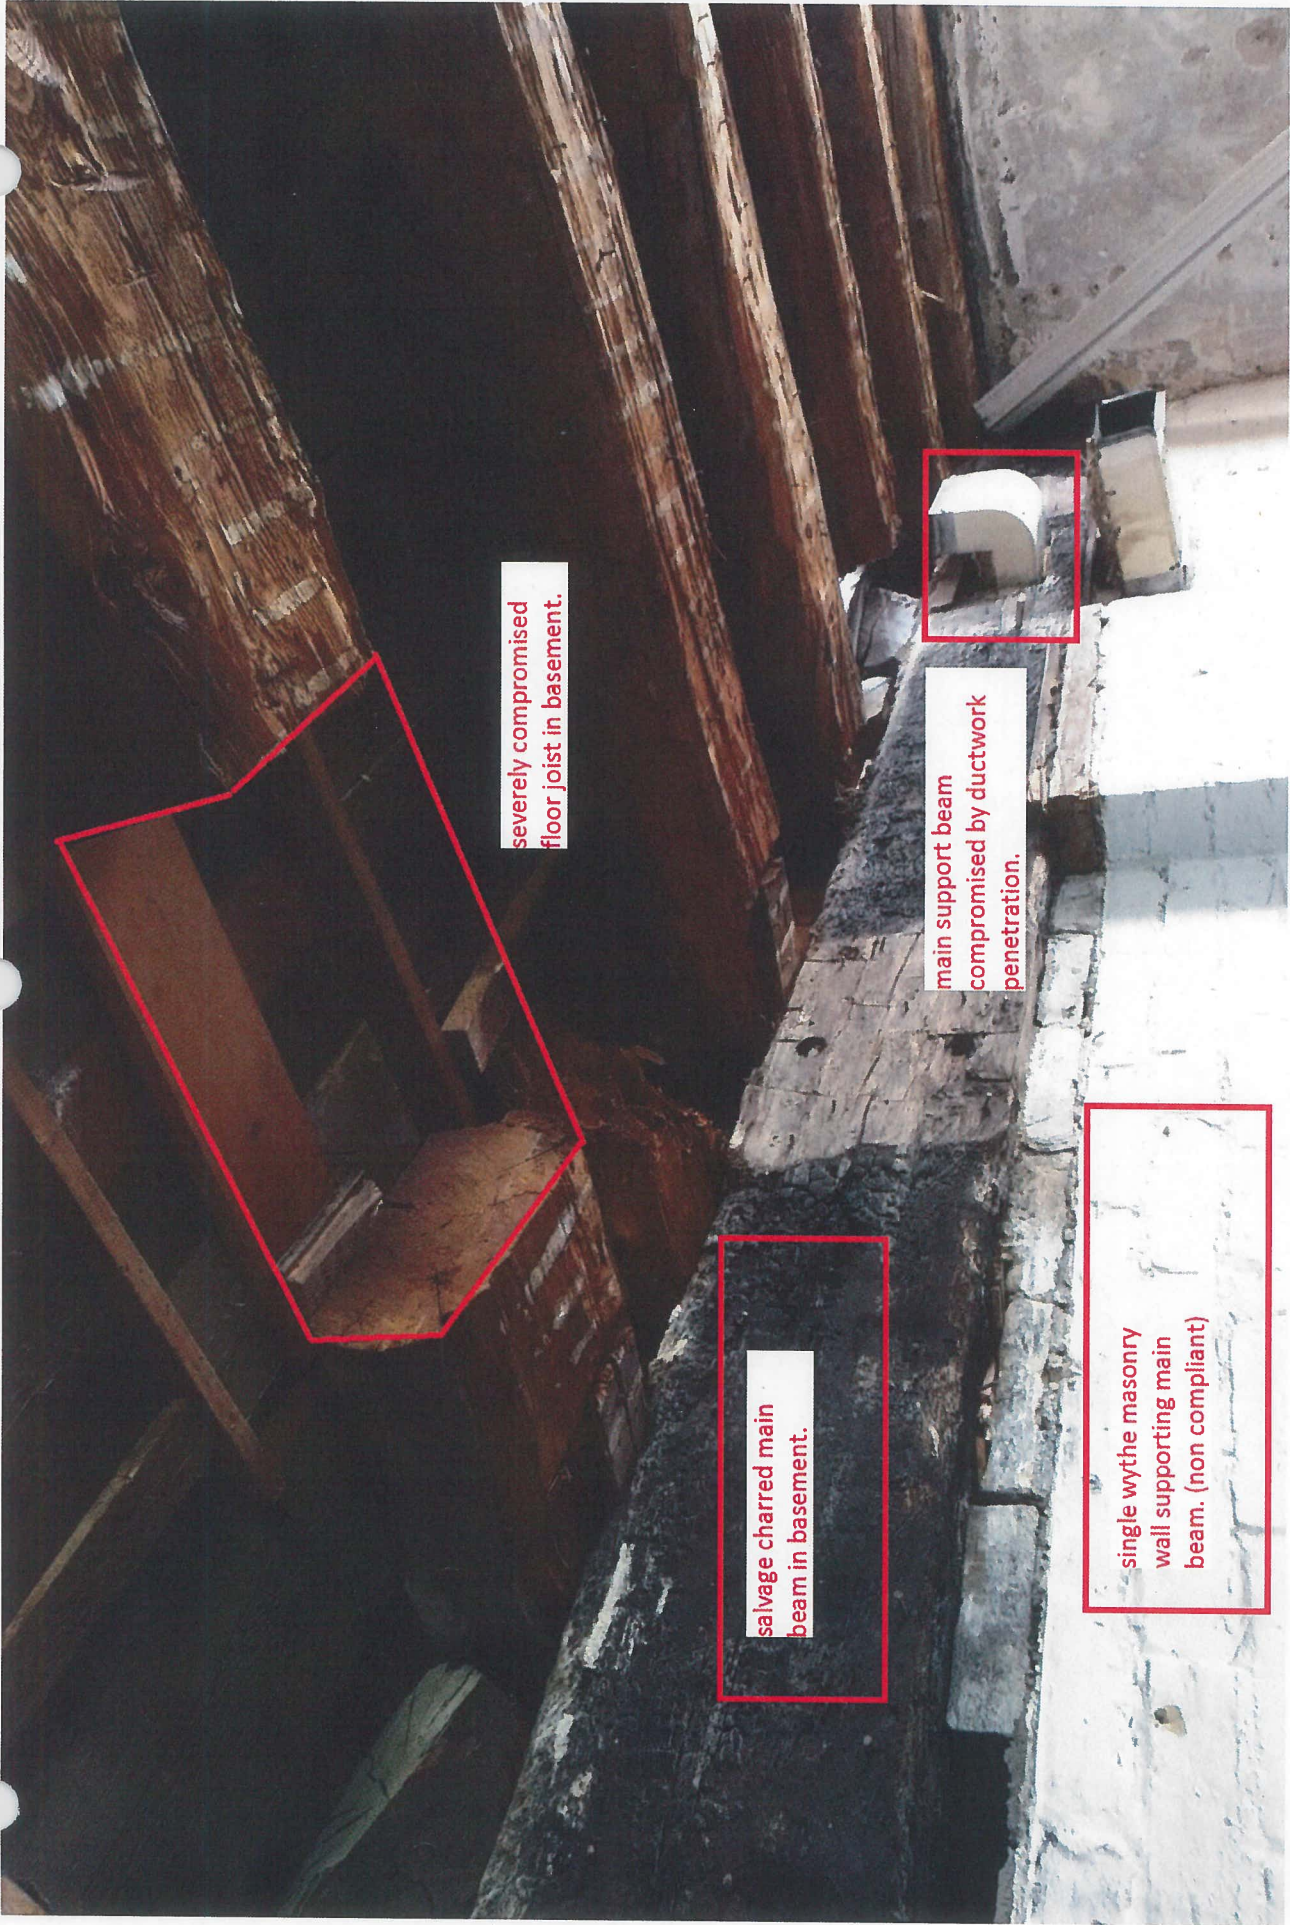
severely compromised floor joist in basement.

main support beam compromised by ductwork penetration.

salvage charred main beam in basement.

single wythe masonry wall supporting main beam. (non compliant)

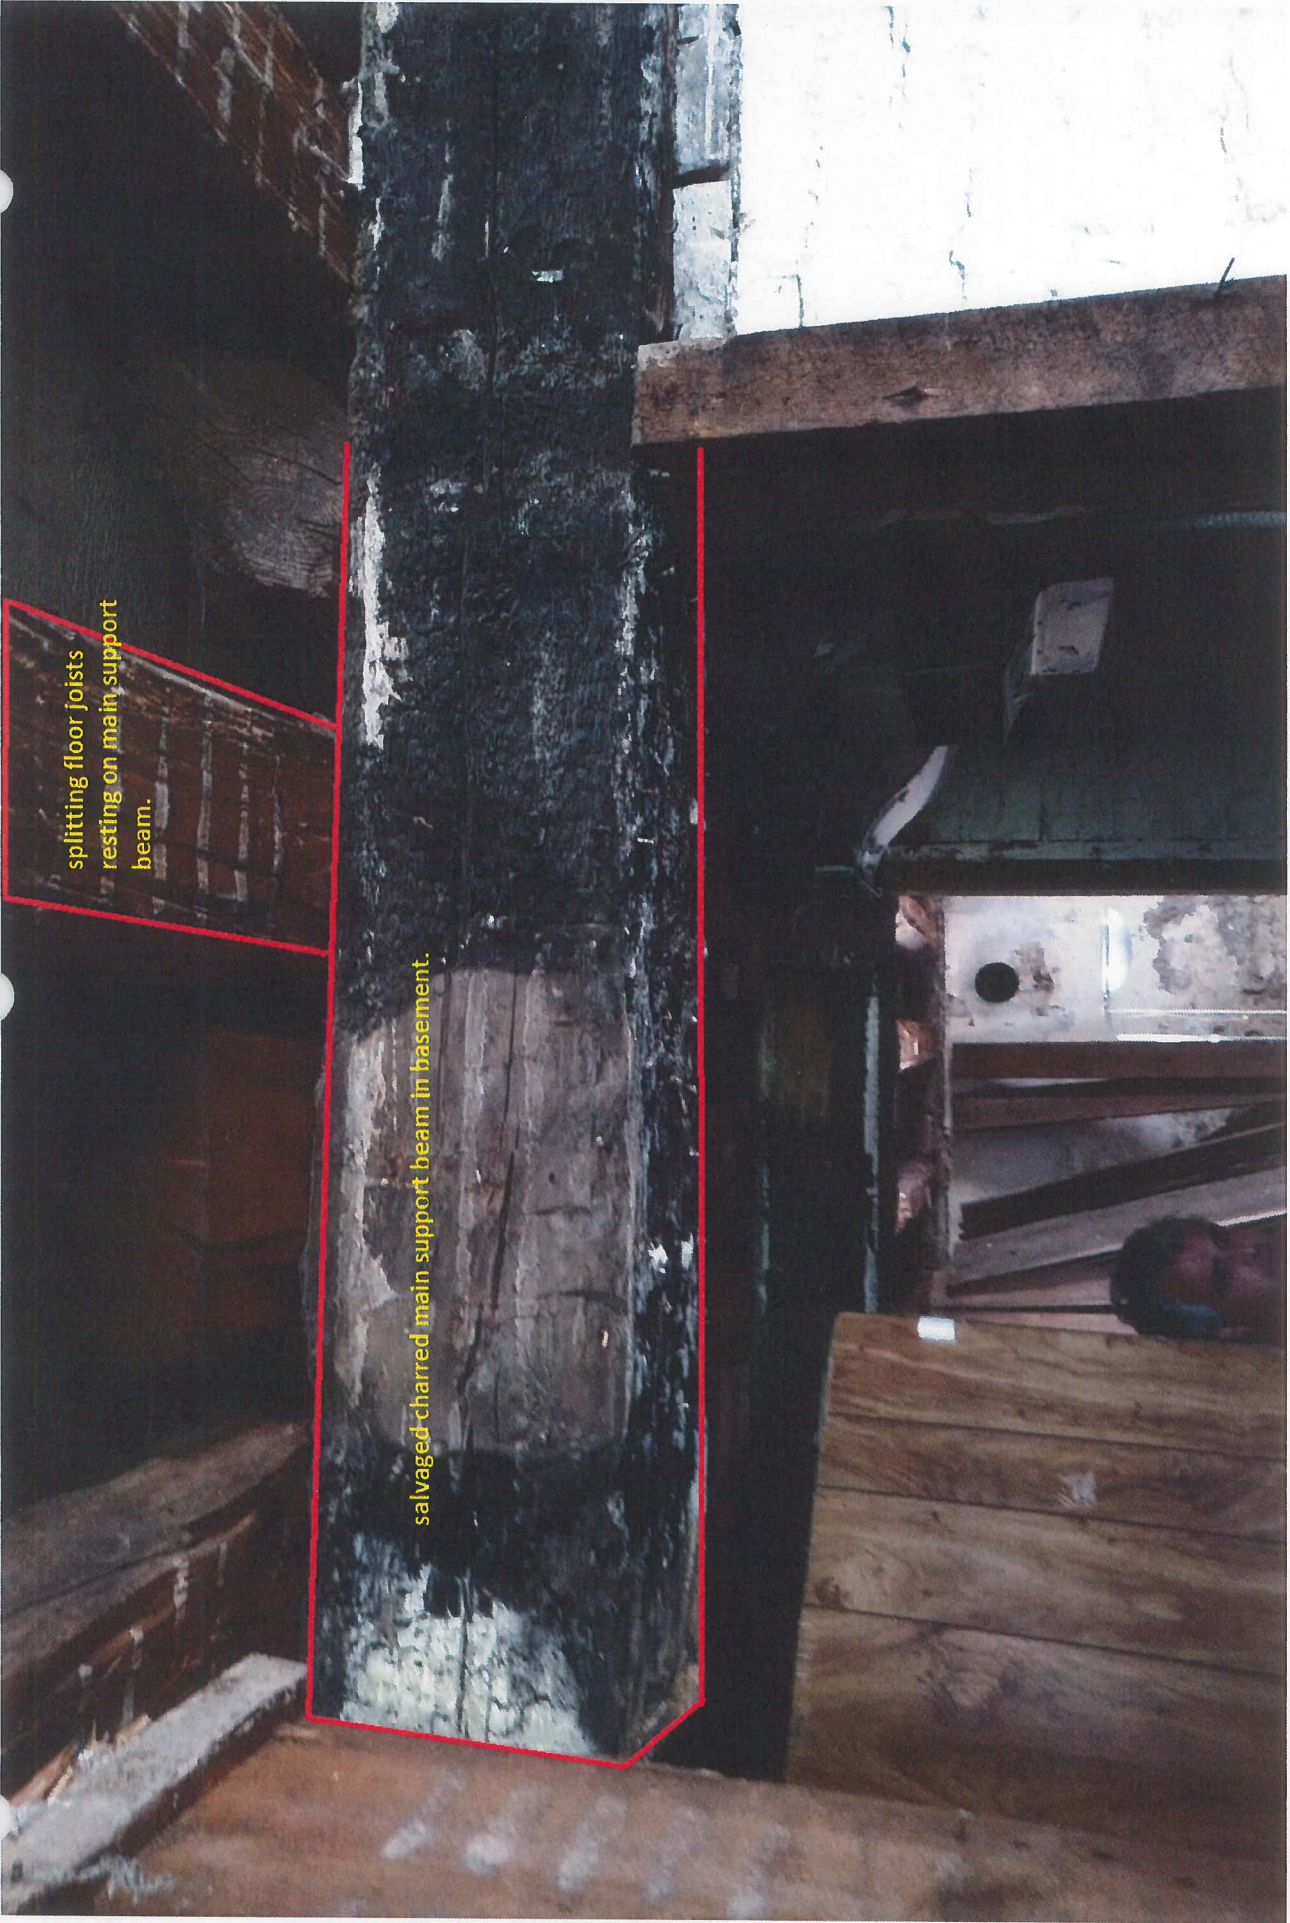
splitting floor joists
resting on main support
beam.

salvaged-charred main support beam in basement.
