172 Central Ave
Subject Property
Built 1883
“Italianate”
Level 1

Re: Structural Review
Private Residence at 172 Central Avenue
Our file No. 18-15-0142

Unsafe Building – Order to Make Safe

RE: 172 Central Ave Site Inspection

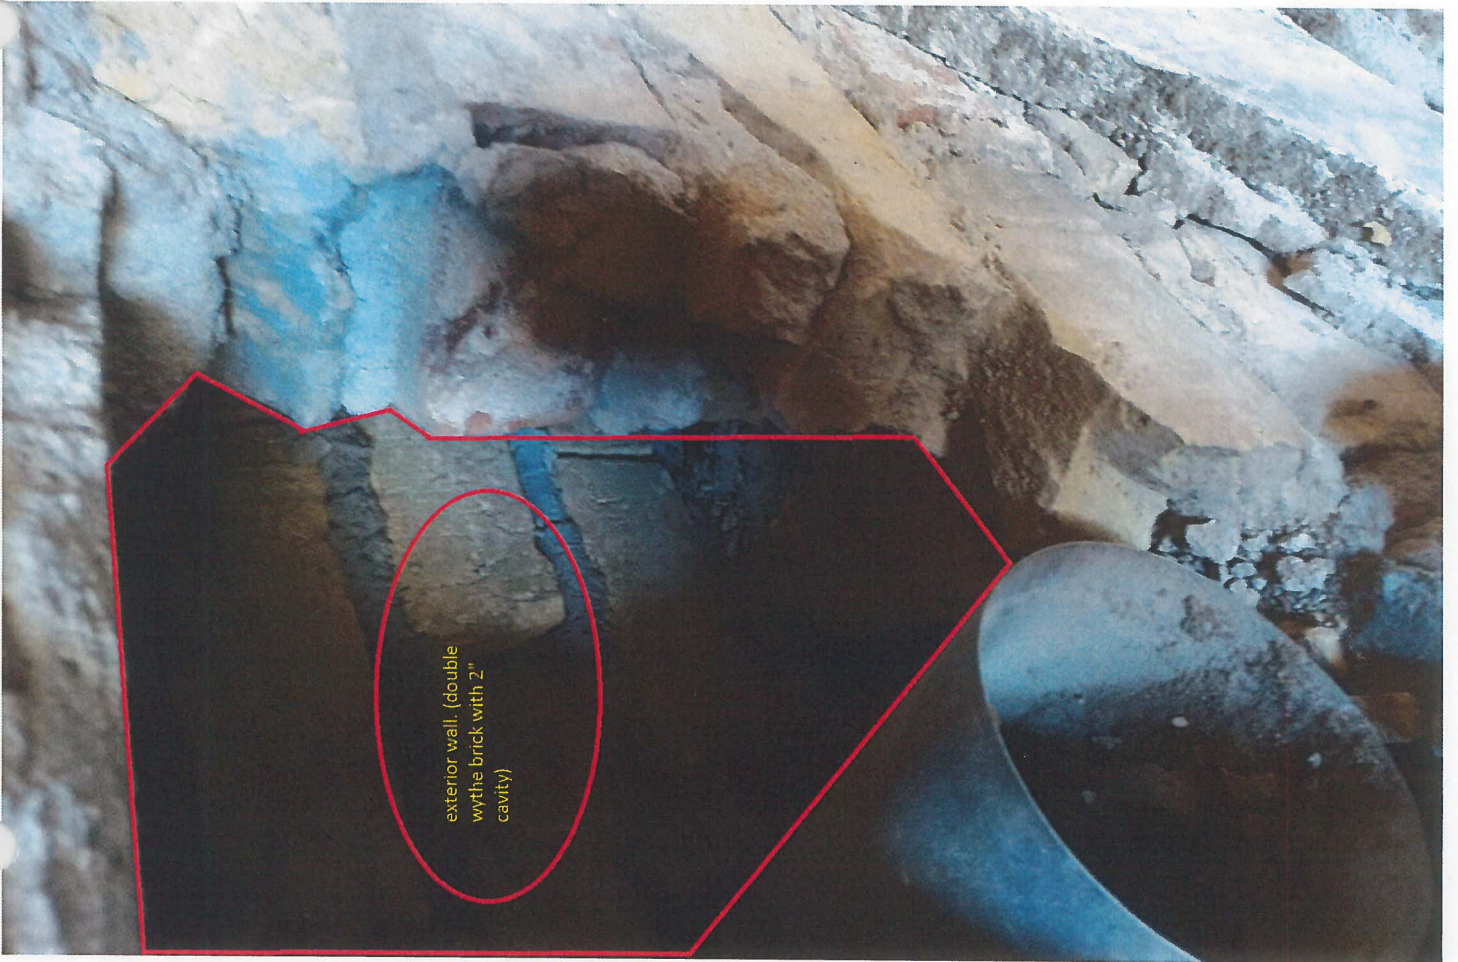
exterior wall. (double
wythe brick with 2"
cavity)

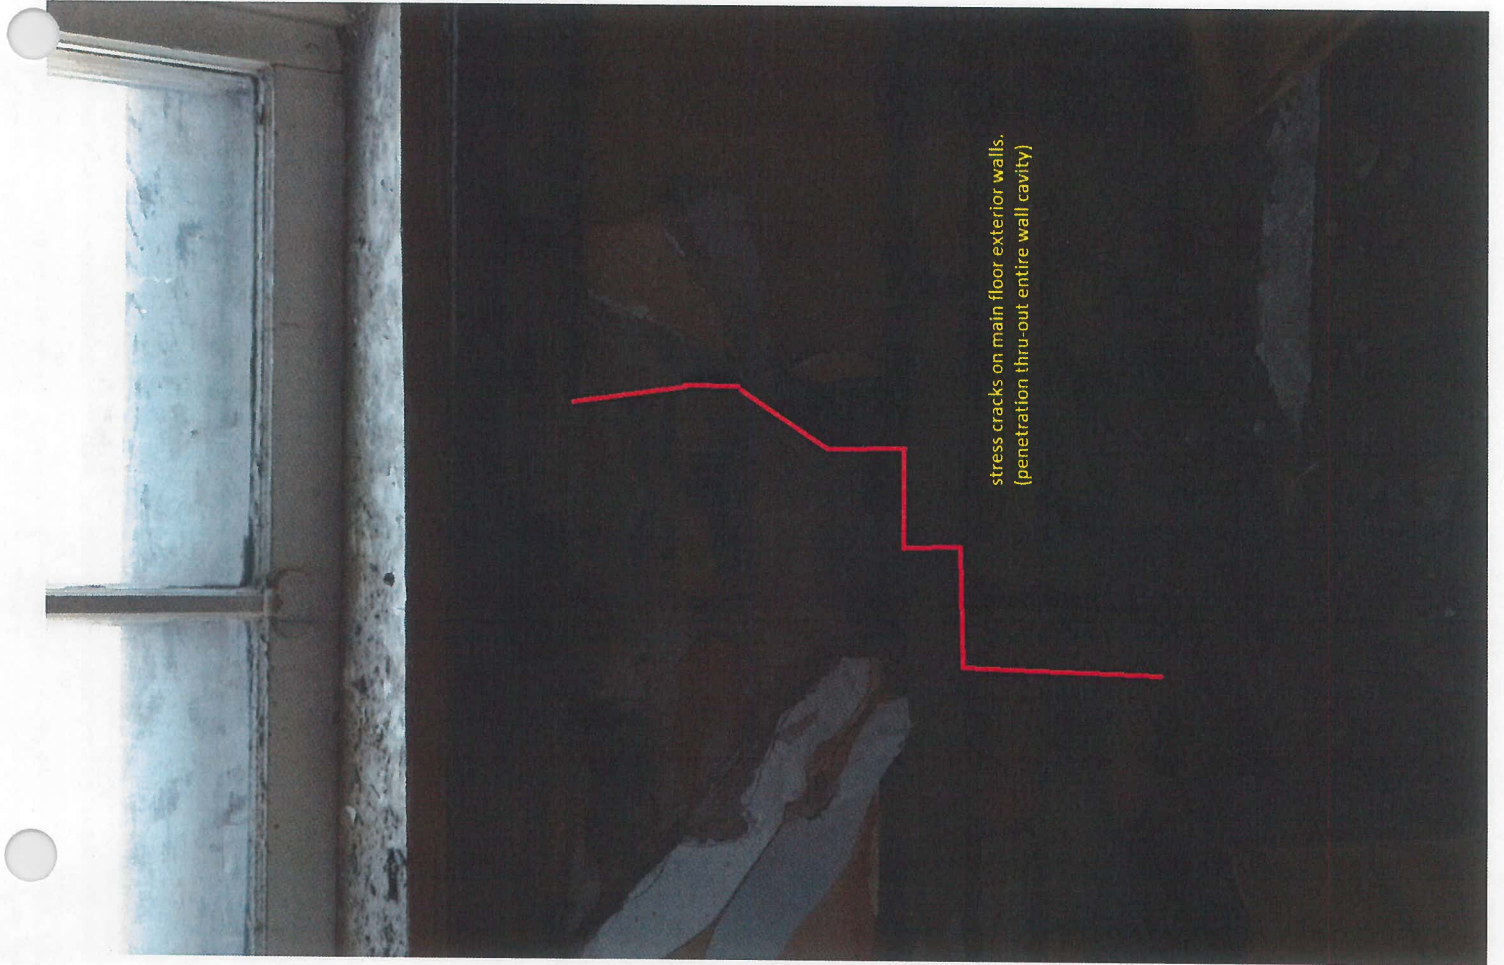
stress cracks on main floor exterior walls.
(penetration thru-out entire wall cavity)

severely split and dry rot floor joists. (throughout many locations of building)

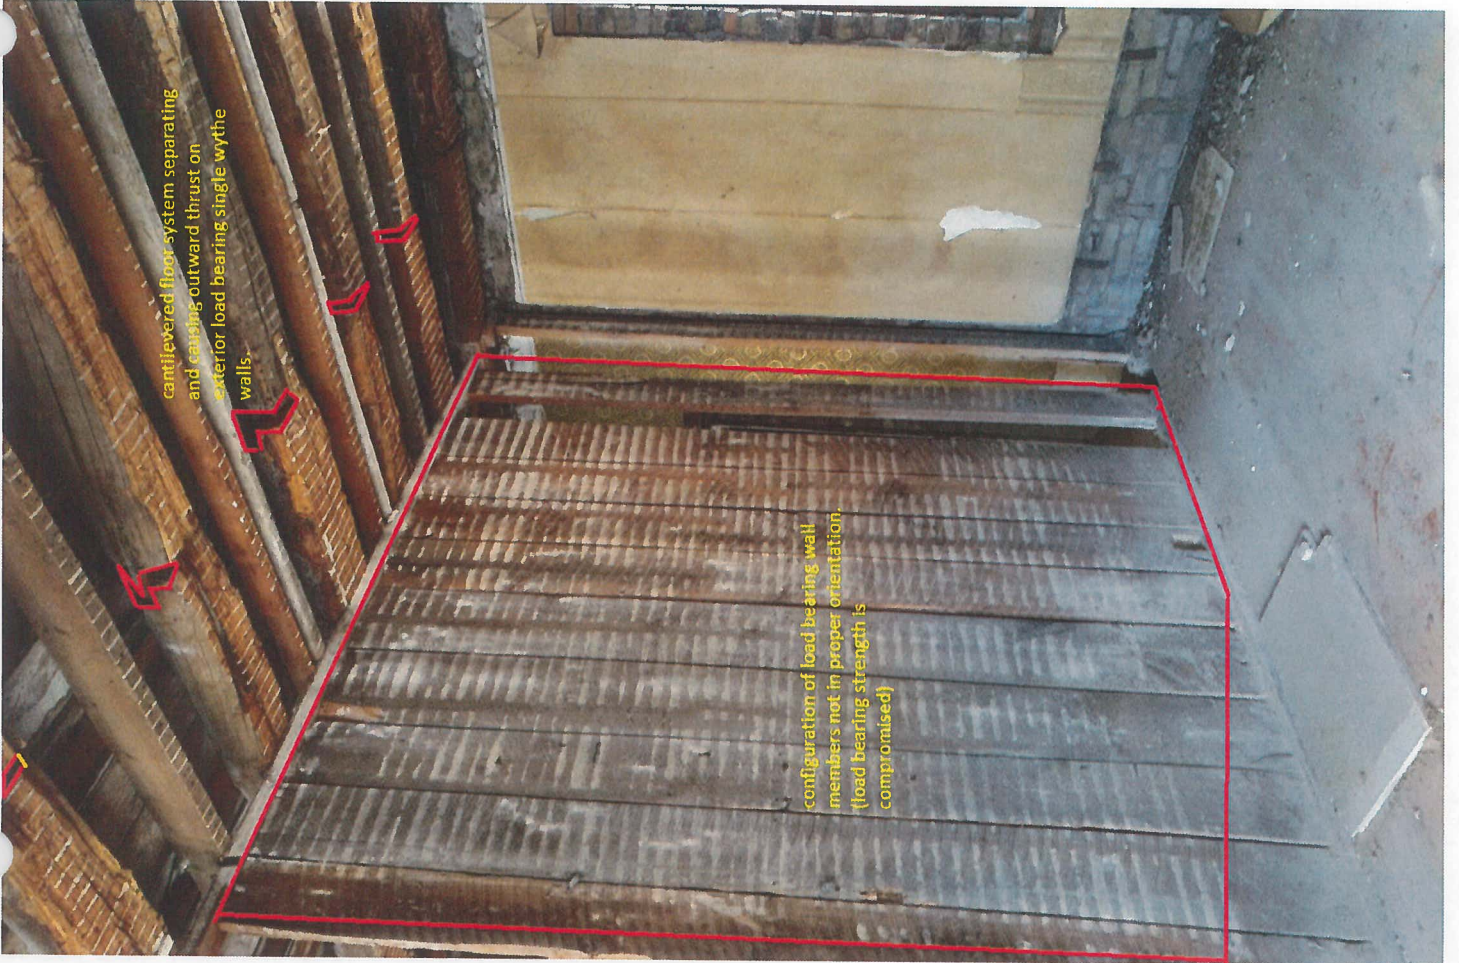
cantilevered floor system separating
and causing outward thrust on
exterior load bearing single wythe
walls.

configuration of load bearing wall
members not in proper orientation.
(load bearing strength is
compromised)

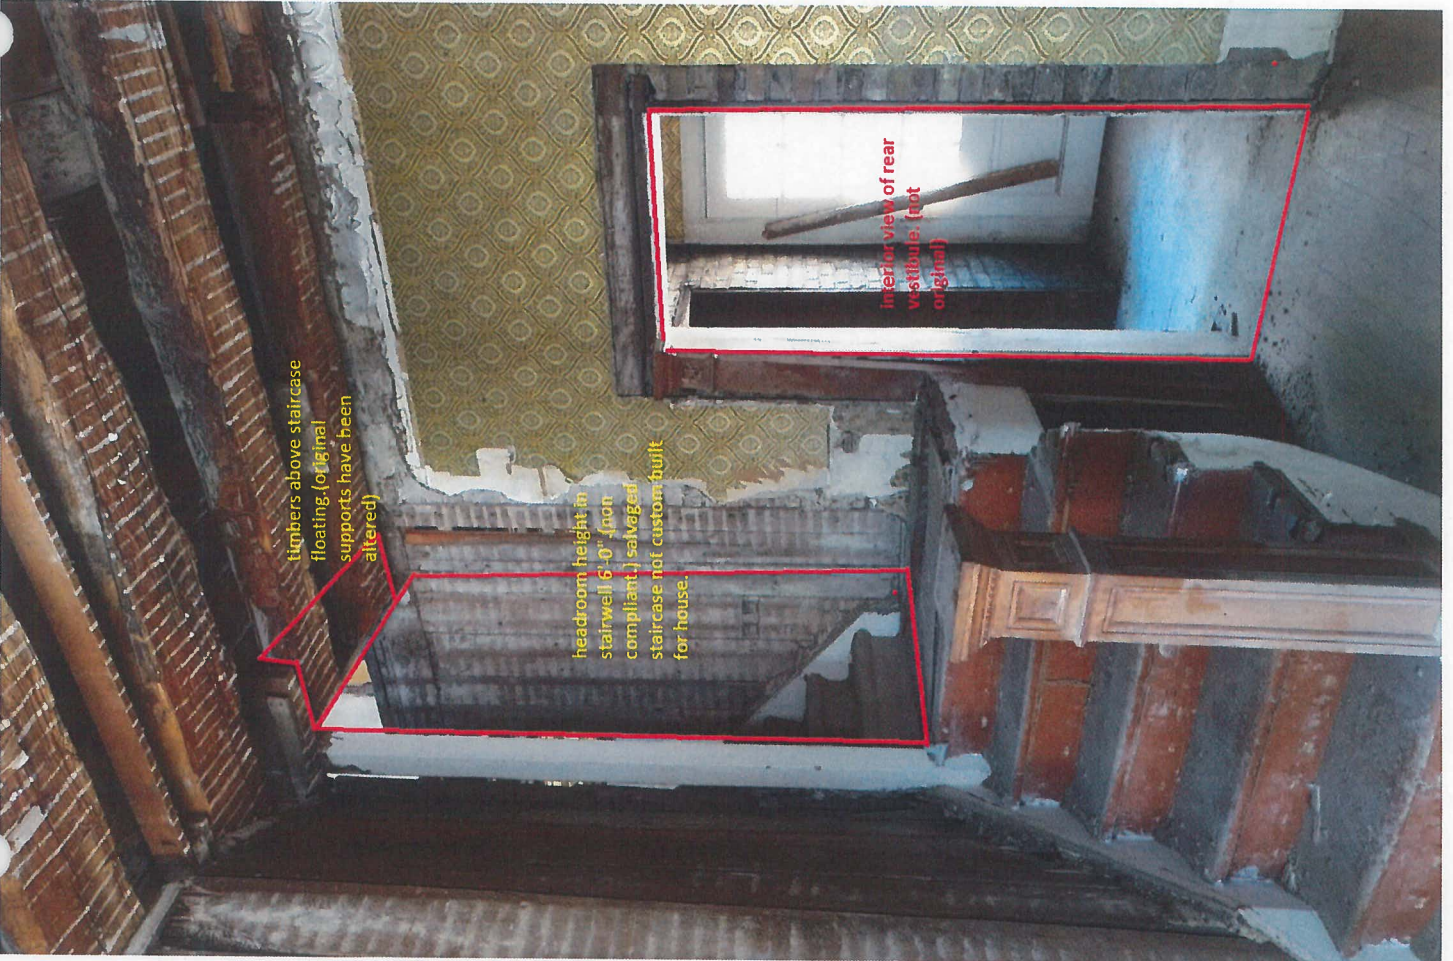
timbers above staircase
floating. (original
supports have been
altered)

headroom height in
stairwell 6'-10" (non-
compliant.) salvaged
staircase not custom built
for house.

interior view of rear
vestibule. (not
original)

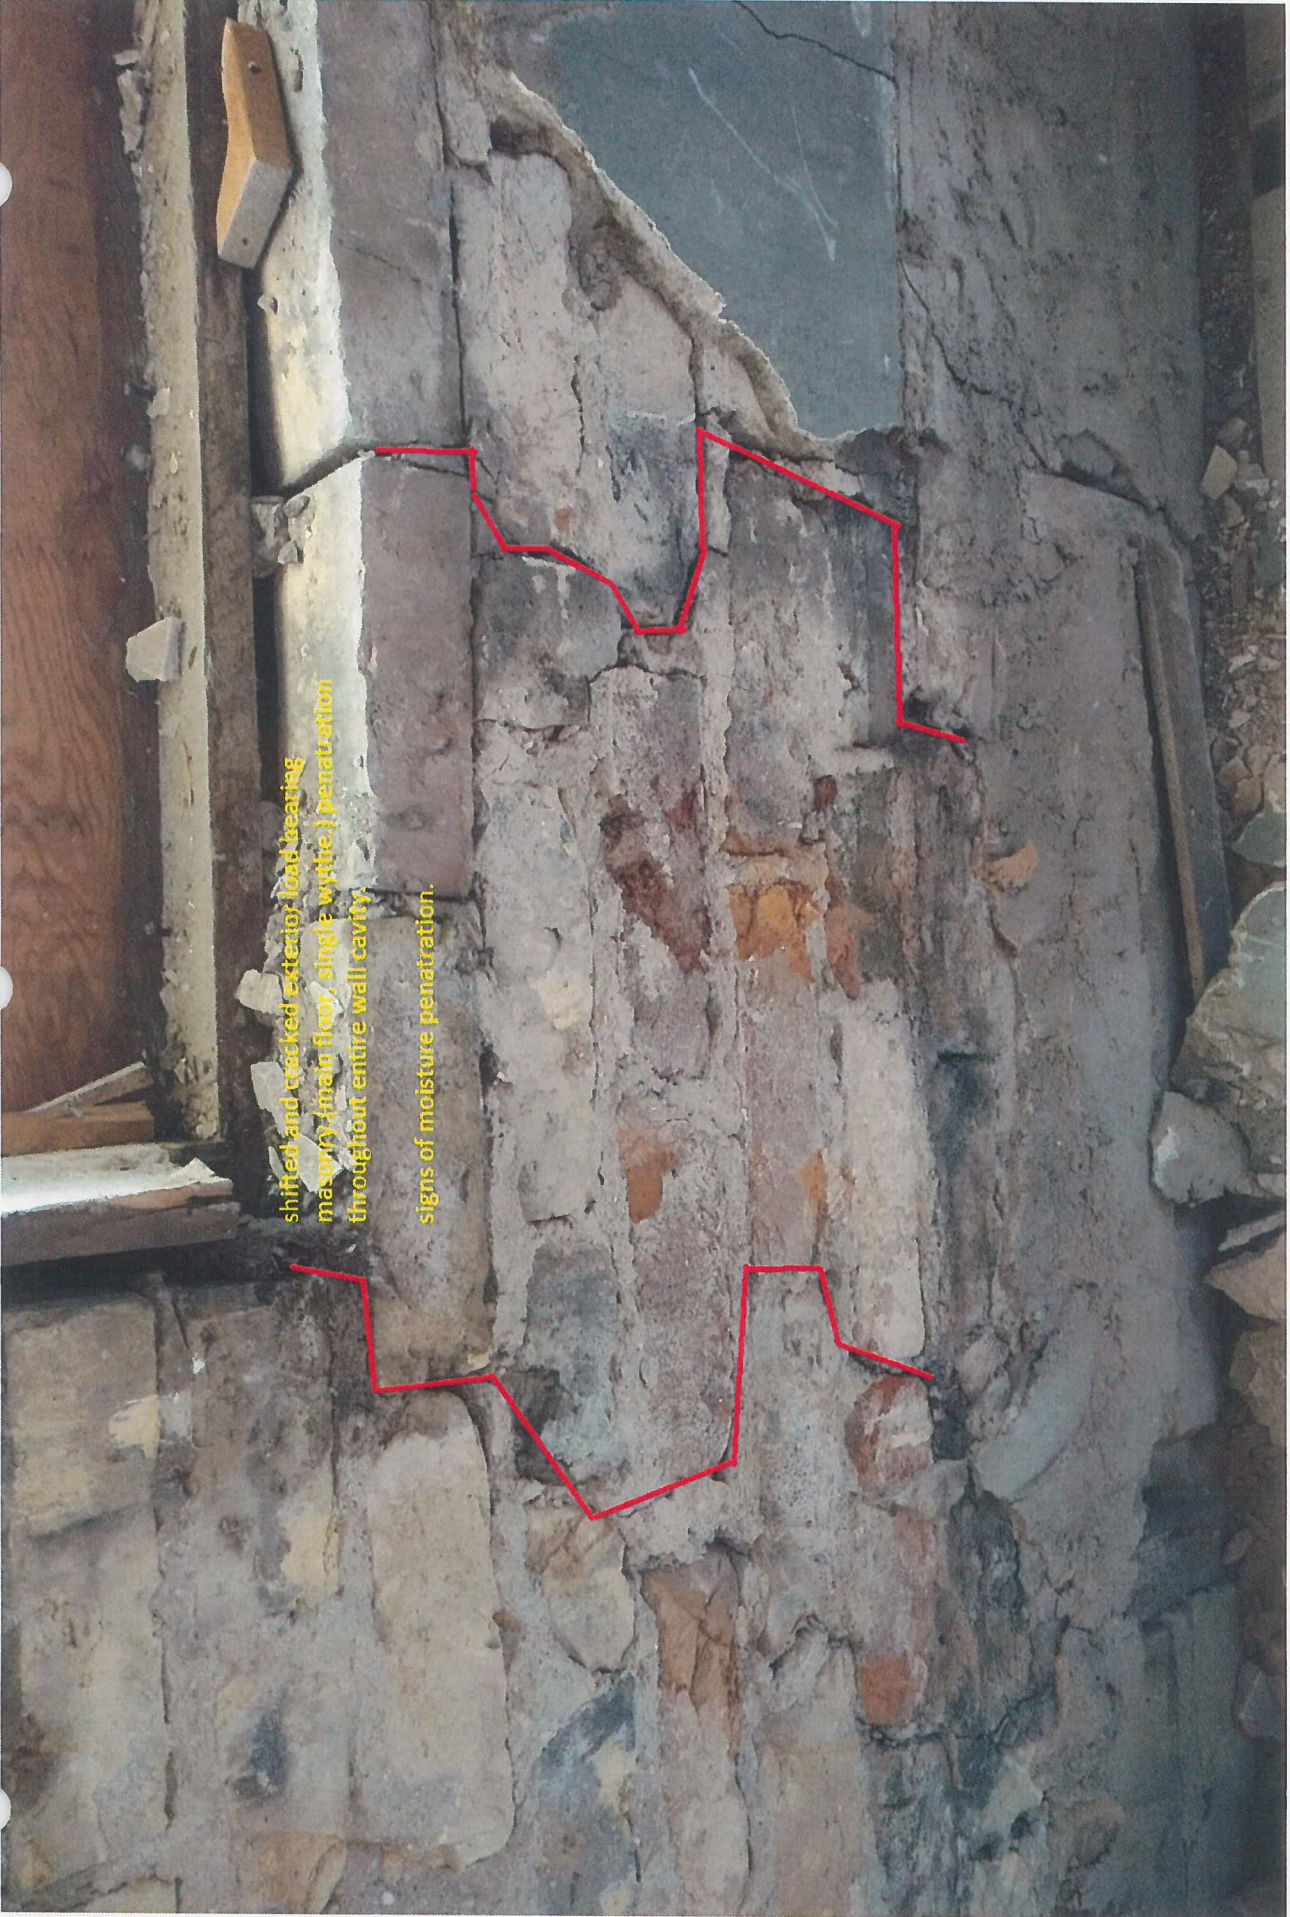
shifted and cracked exterior load bearing masonry (main floor, single wythe.) penetration throughout entire wall cavity.

signs of moisture penetration.

dry rot and decay of floor system. (not certifiable)

salvaged charred timber severely compromised due to notching. (not certifiable)

staining of floor joists indication of decay.

compromised joist due to opening cut in floor.

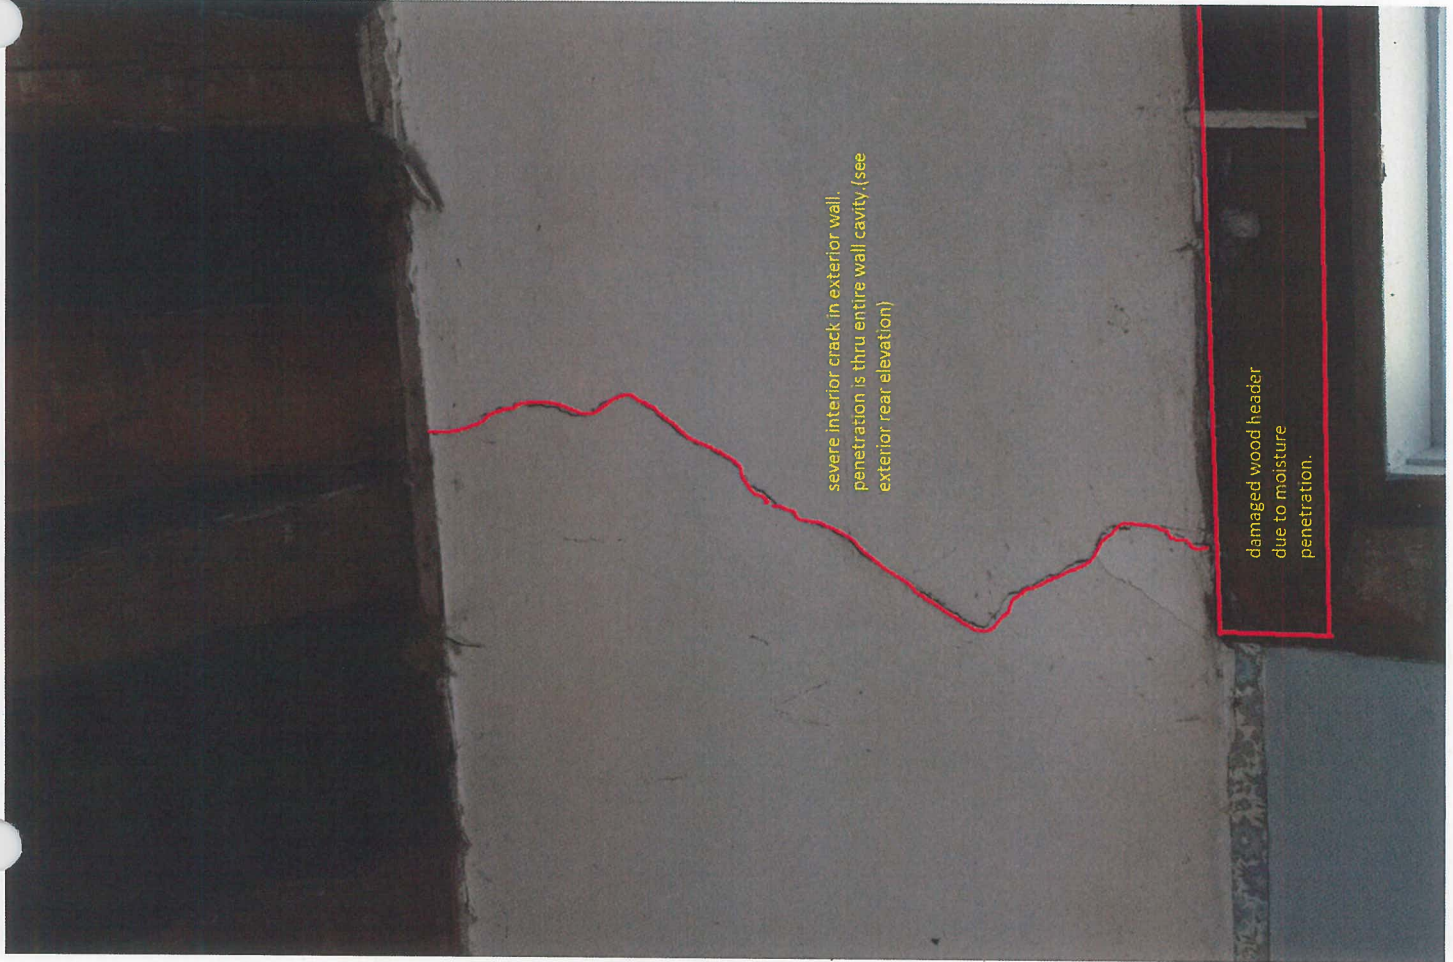
severe interior crack in exterior wall.
penetration is thru entire wall cavity. (see
exterior rear elevation)

damaged wood header
due to moisture
penetration.

main floor severe
masonry stress crack,
penetration thru entire
wall cavity (see rear
elevation)

decay of wood lintel due
to moisture penetration.

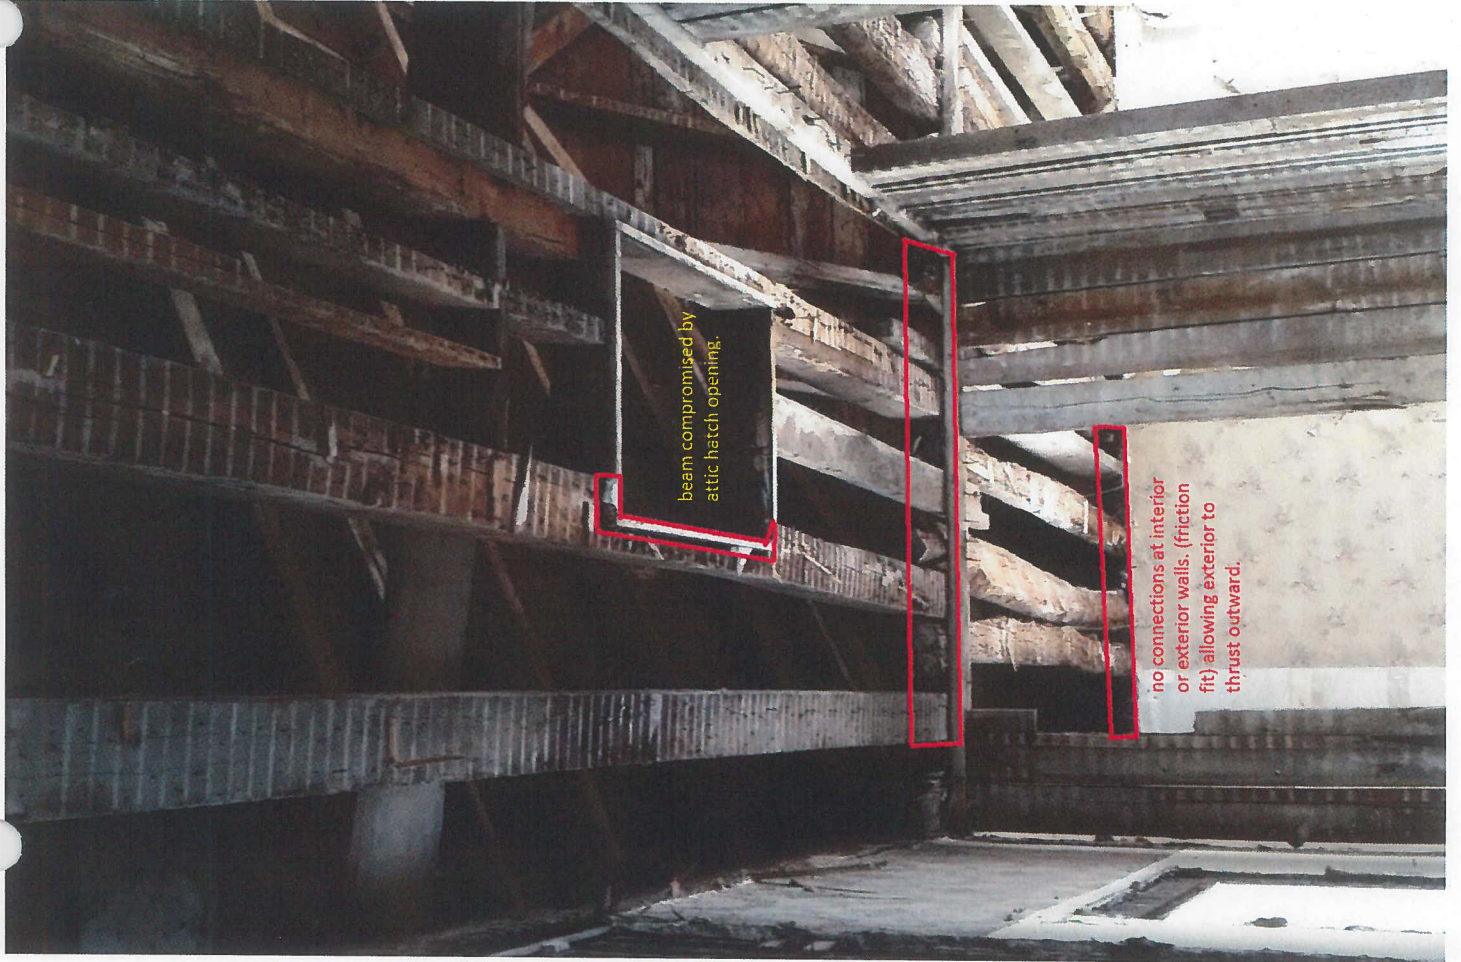
beam compromised by
attic hatch opening.

no connections at interior
or exterior walls. (friction
fit) allowing exterior to
thrust outward.

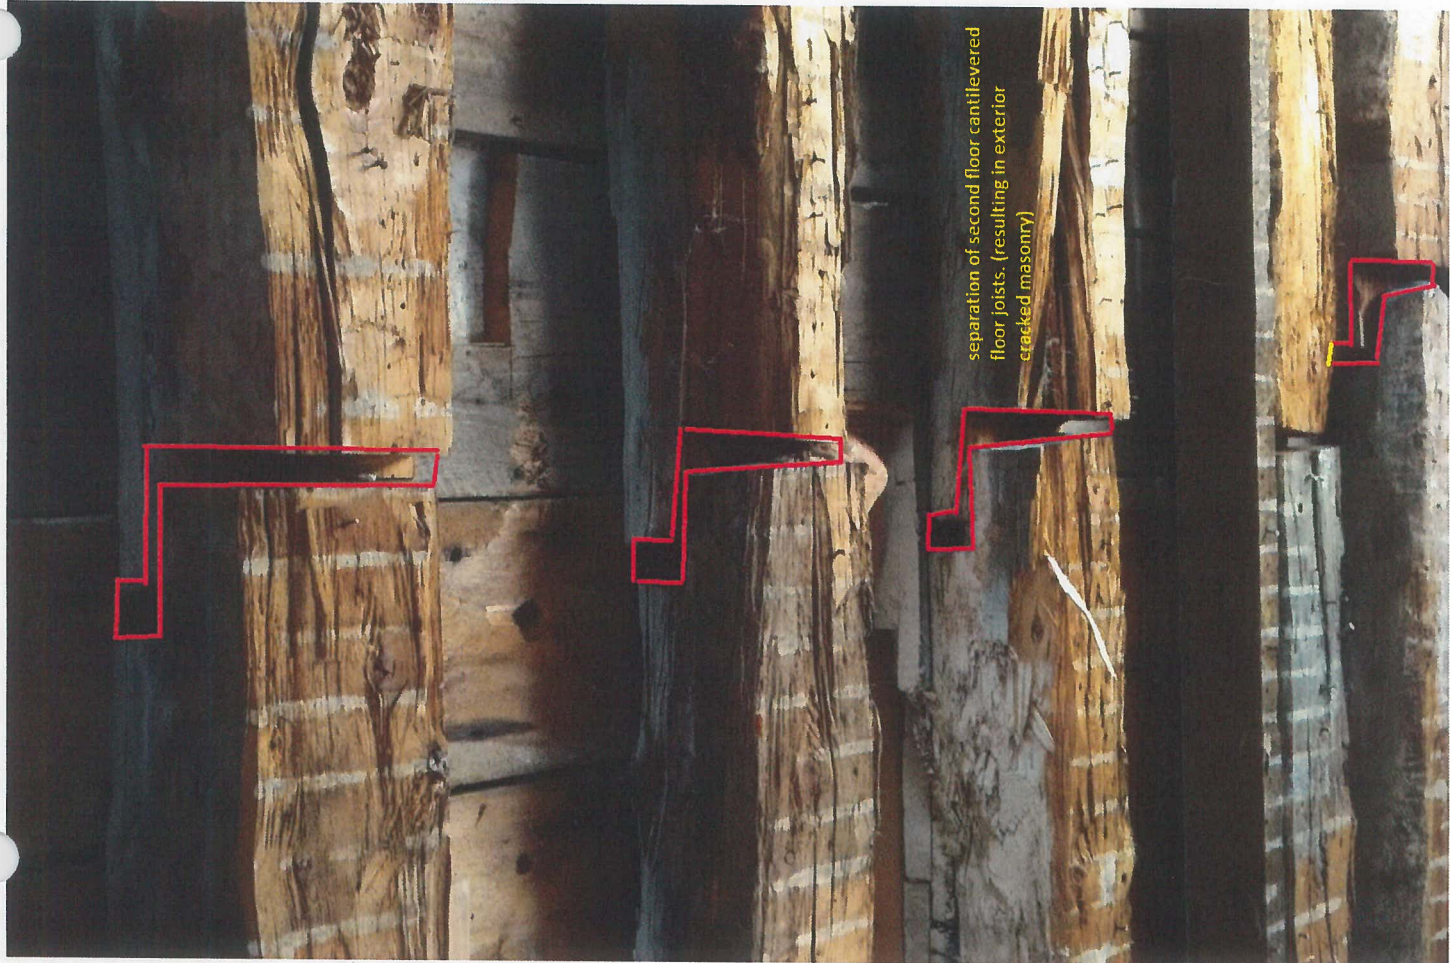
separation of second floor cantilevered floor joists. (resulting in exterior cracked masonry)

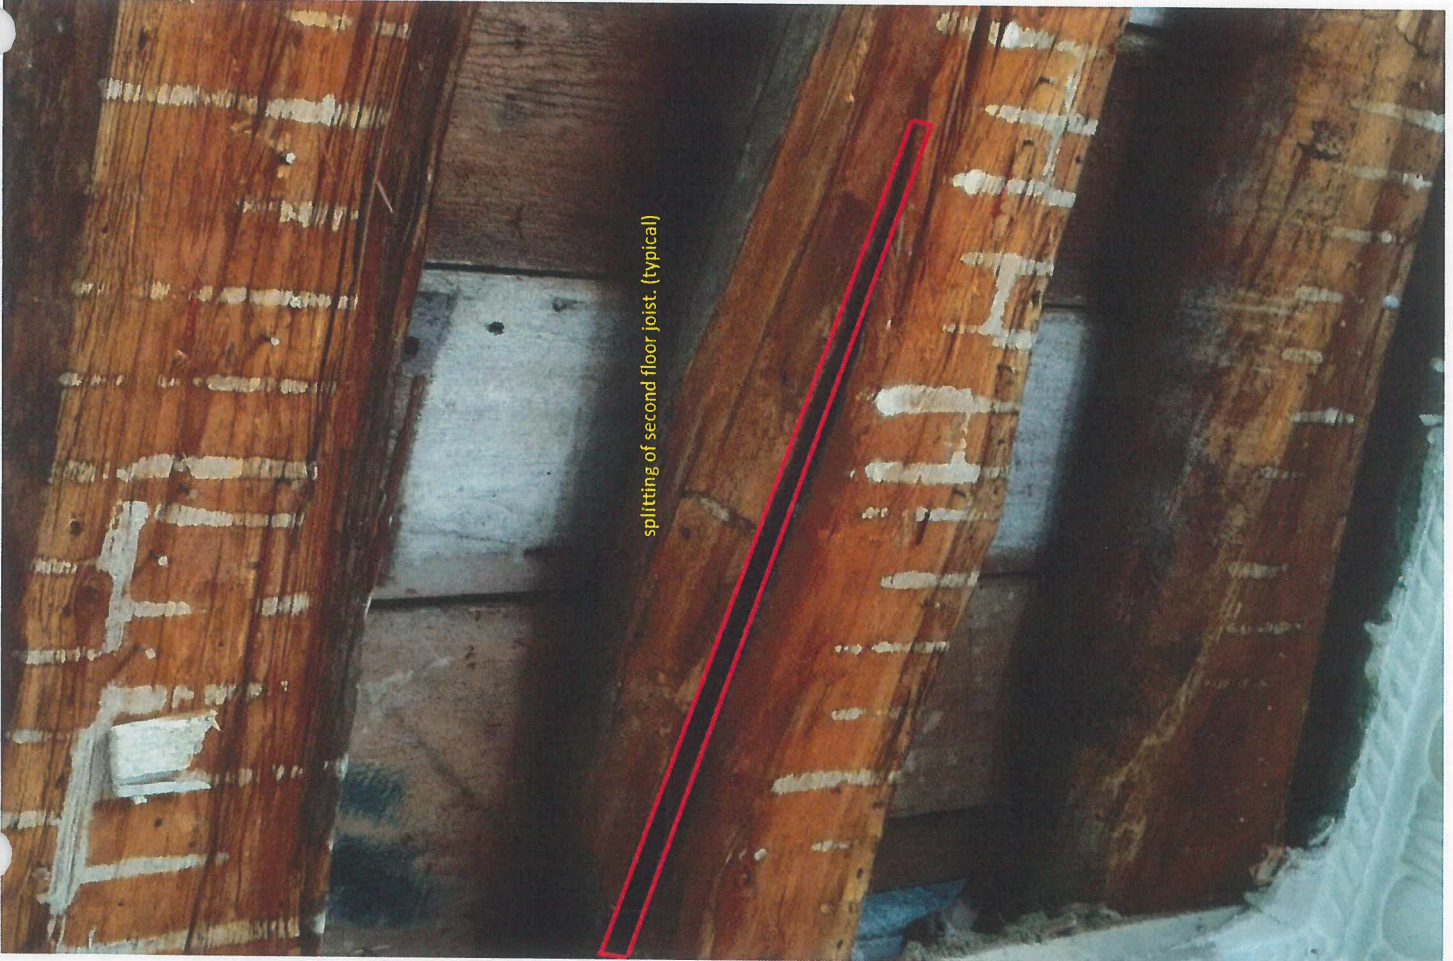
splitting of second floor joist. (typical)

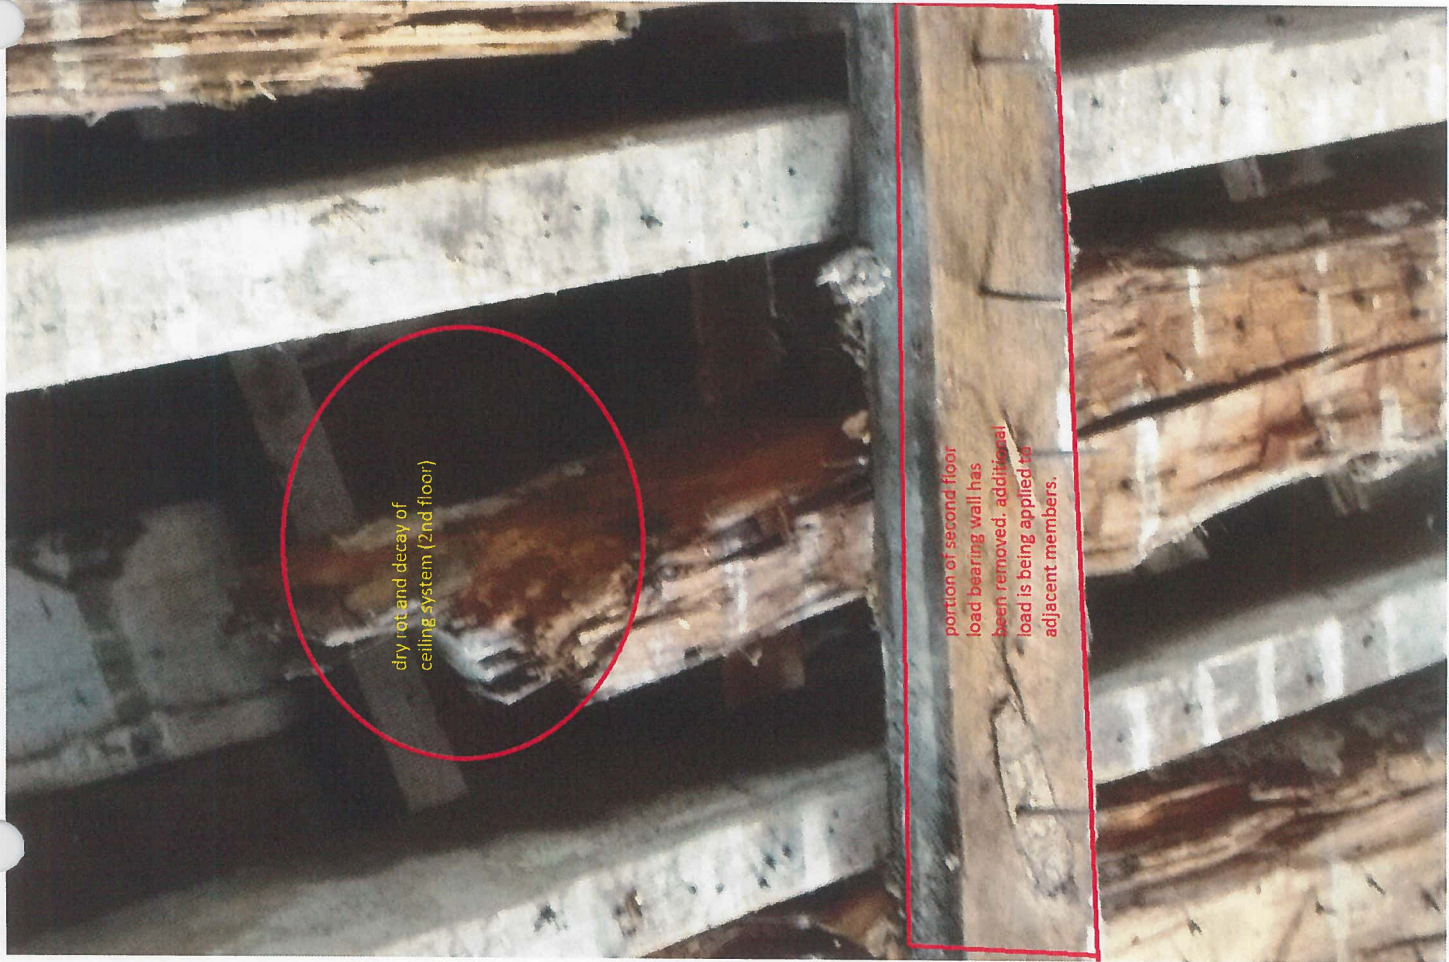
dry rot and decay of ceiling system (2nd floor)

portion of second floor load bearing wall has been removed. additional load is being applied to adjacent members.

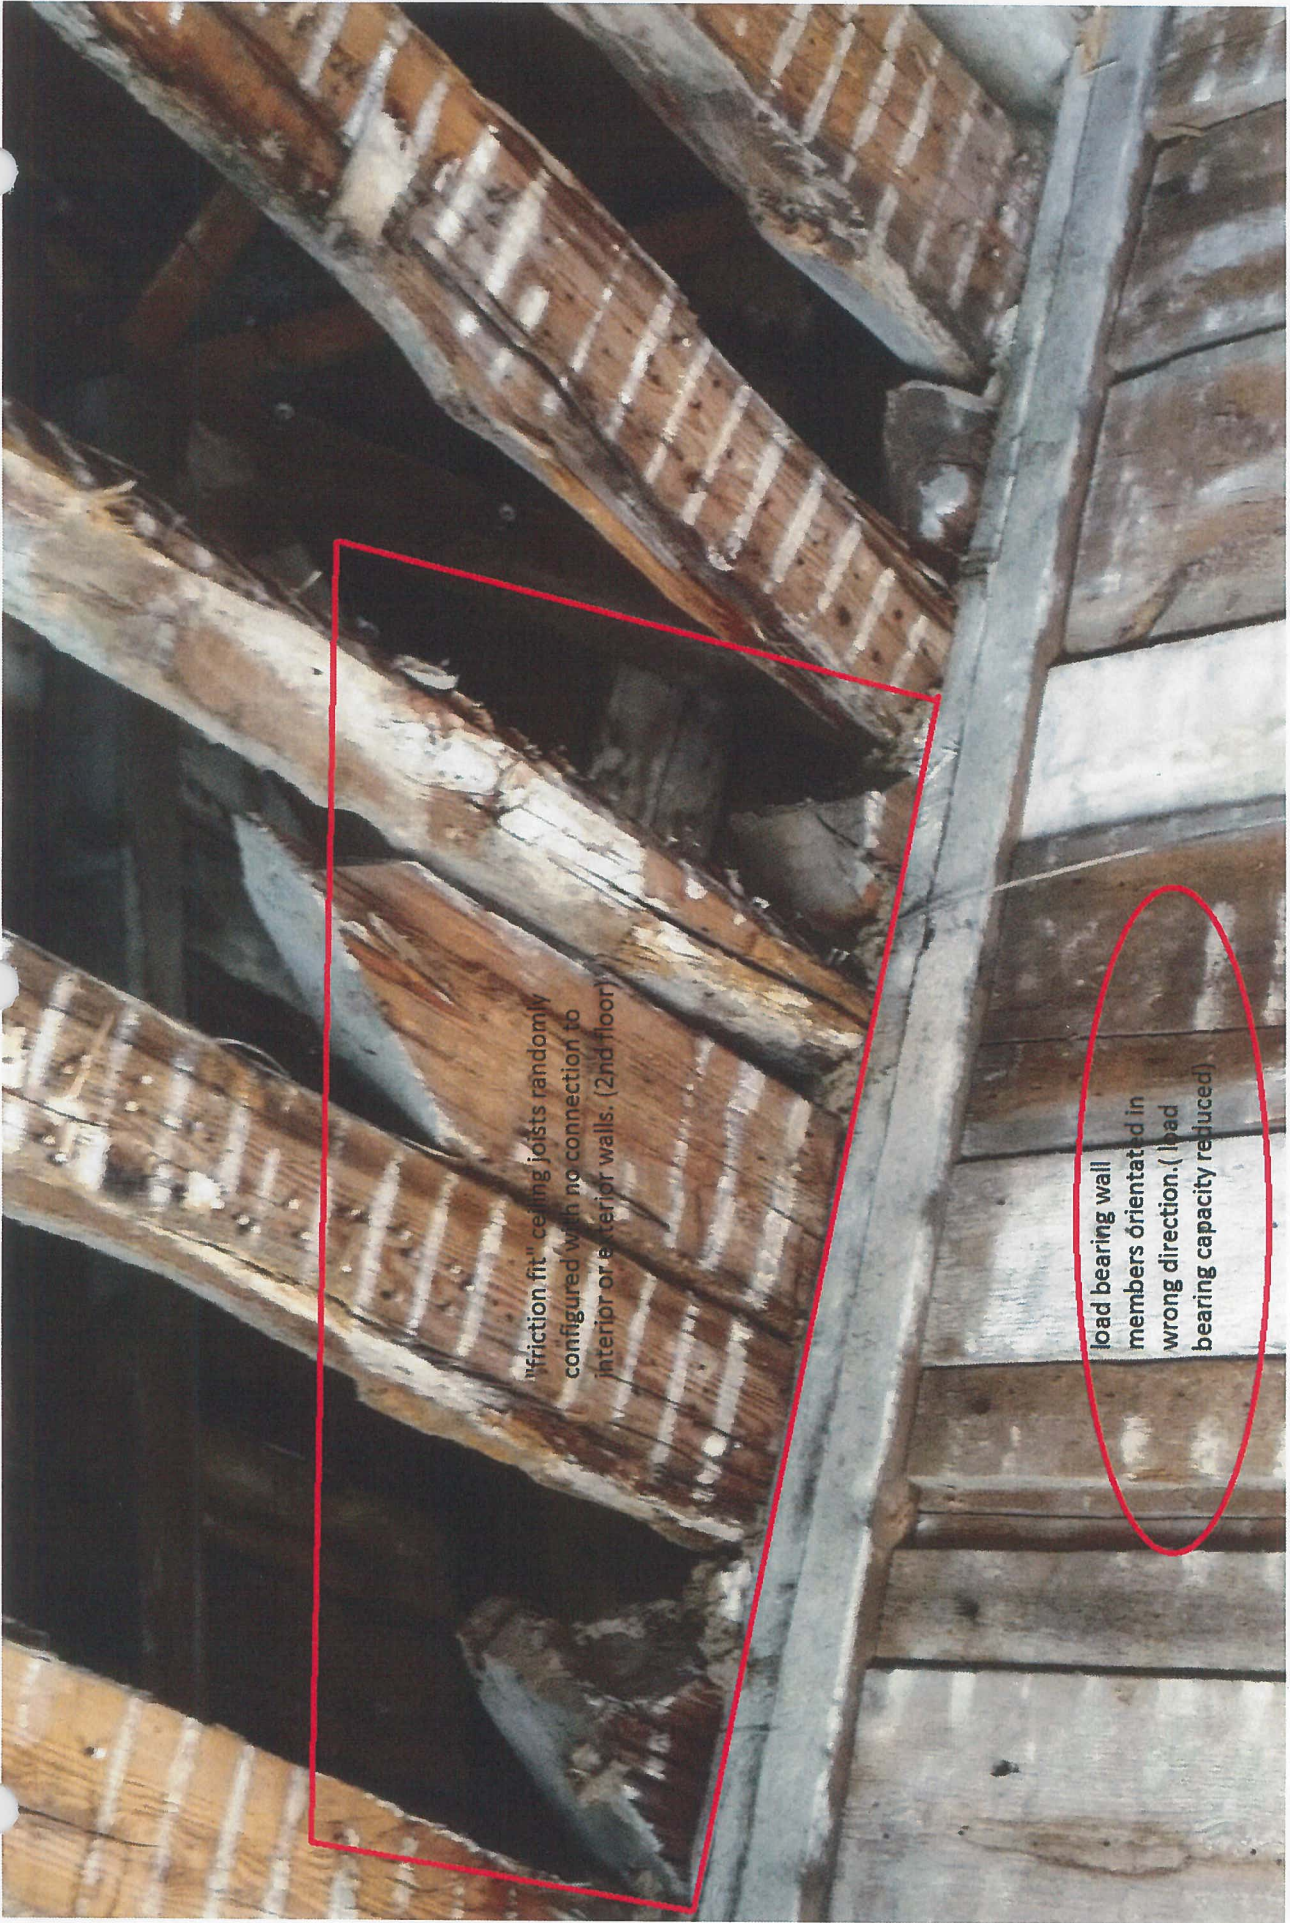
"friction fit" ceiling joists randomly configured with no connection to interior or exterior walls. (2nd floor)

load bearing wall members orientated in wrong direction. (load bearing capacity reduced)
