TREE ASSESSMENT REPORT

348 SUNNINGDALE ROAD, LONDON ONTARIO

DECEMBER 2018

**RON KOUDYS
LANDSCAPE
ARCHITECTS INC**

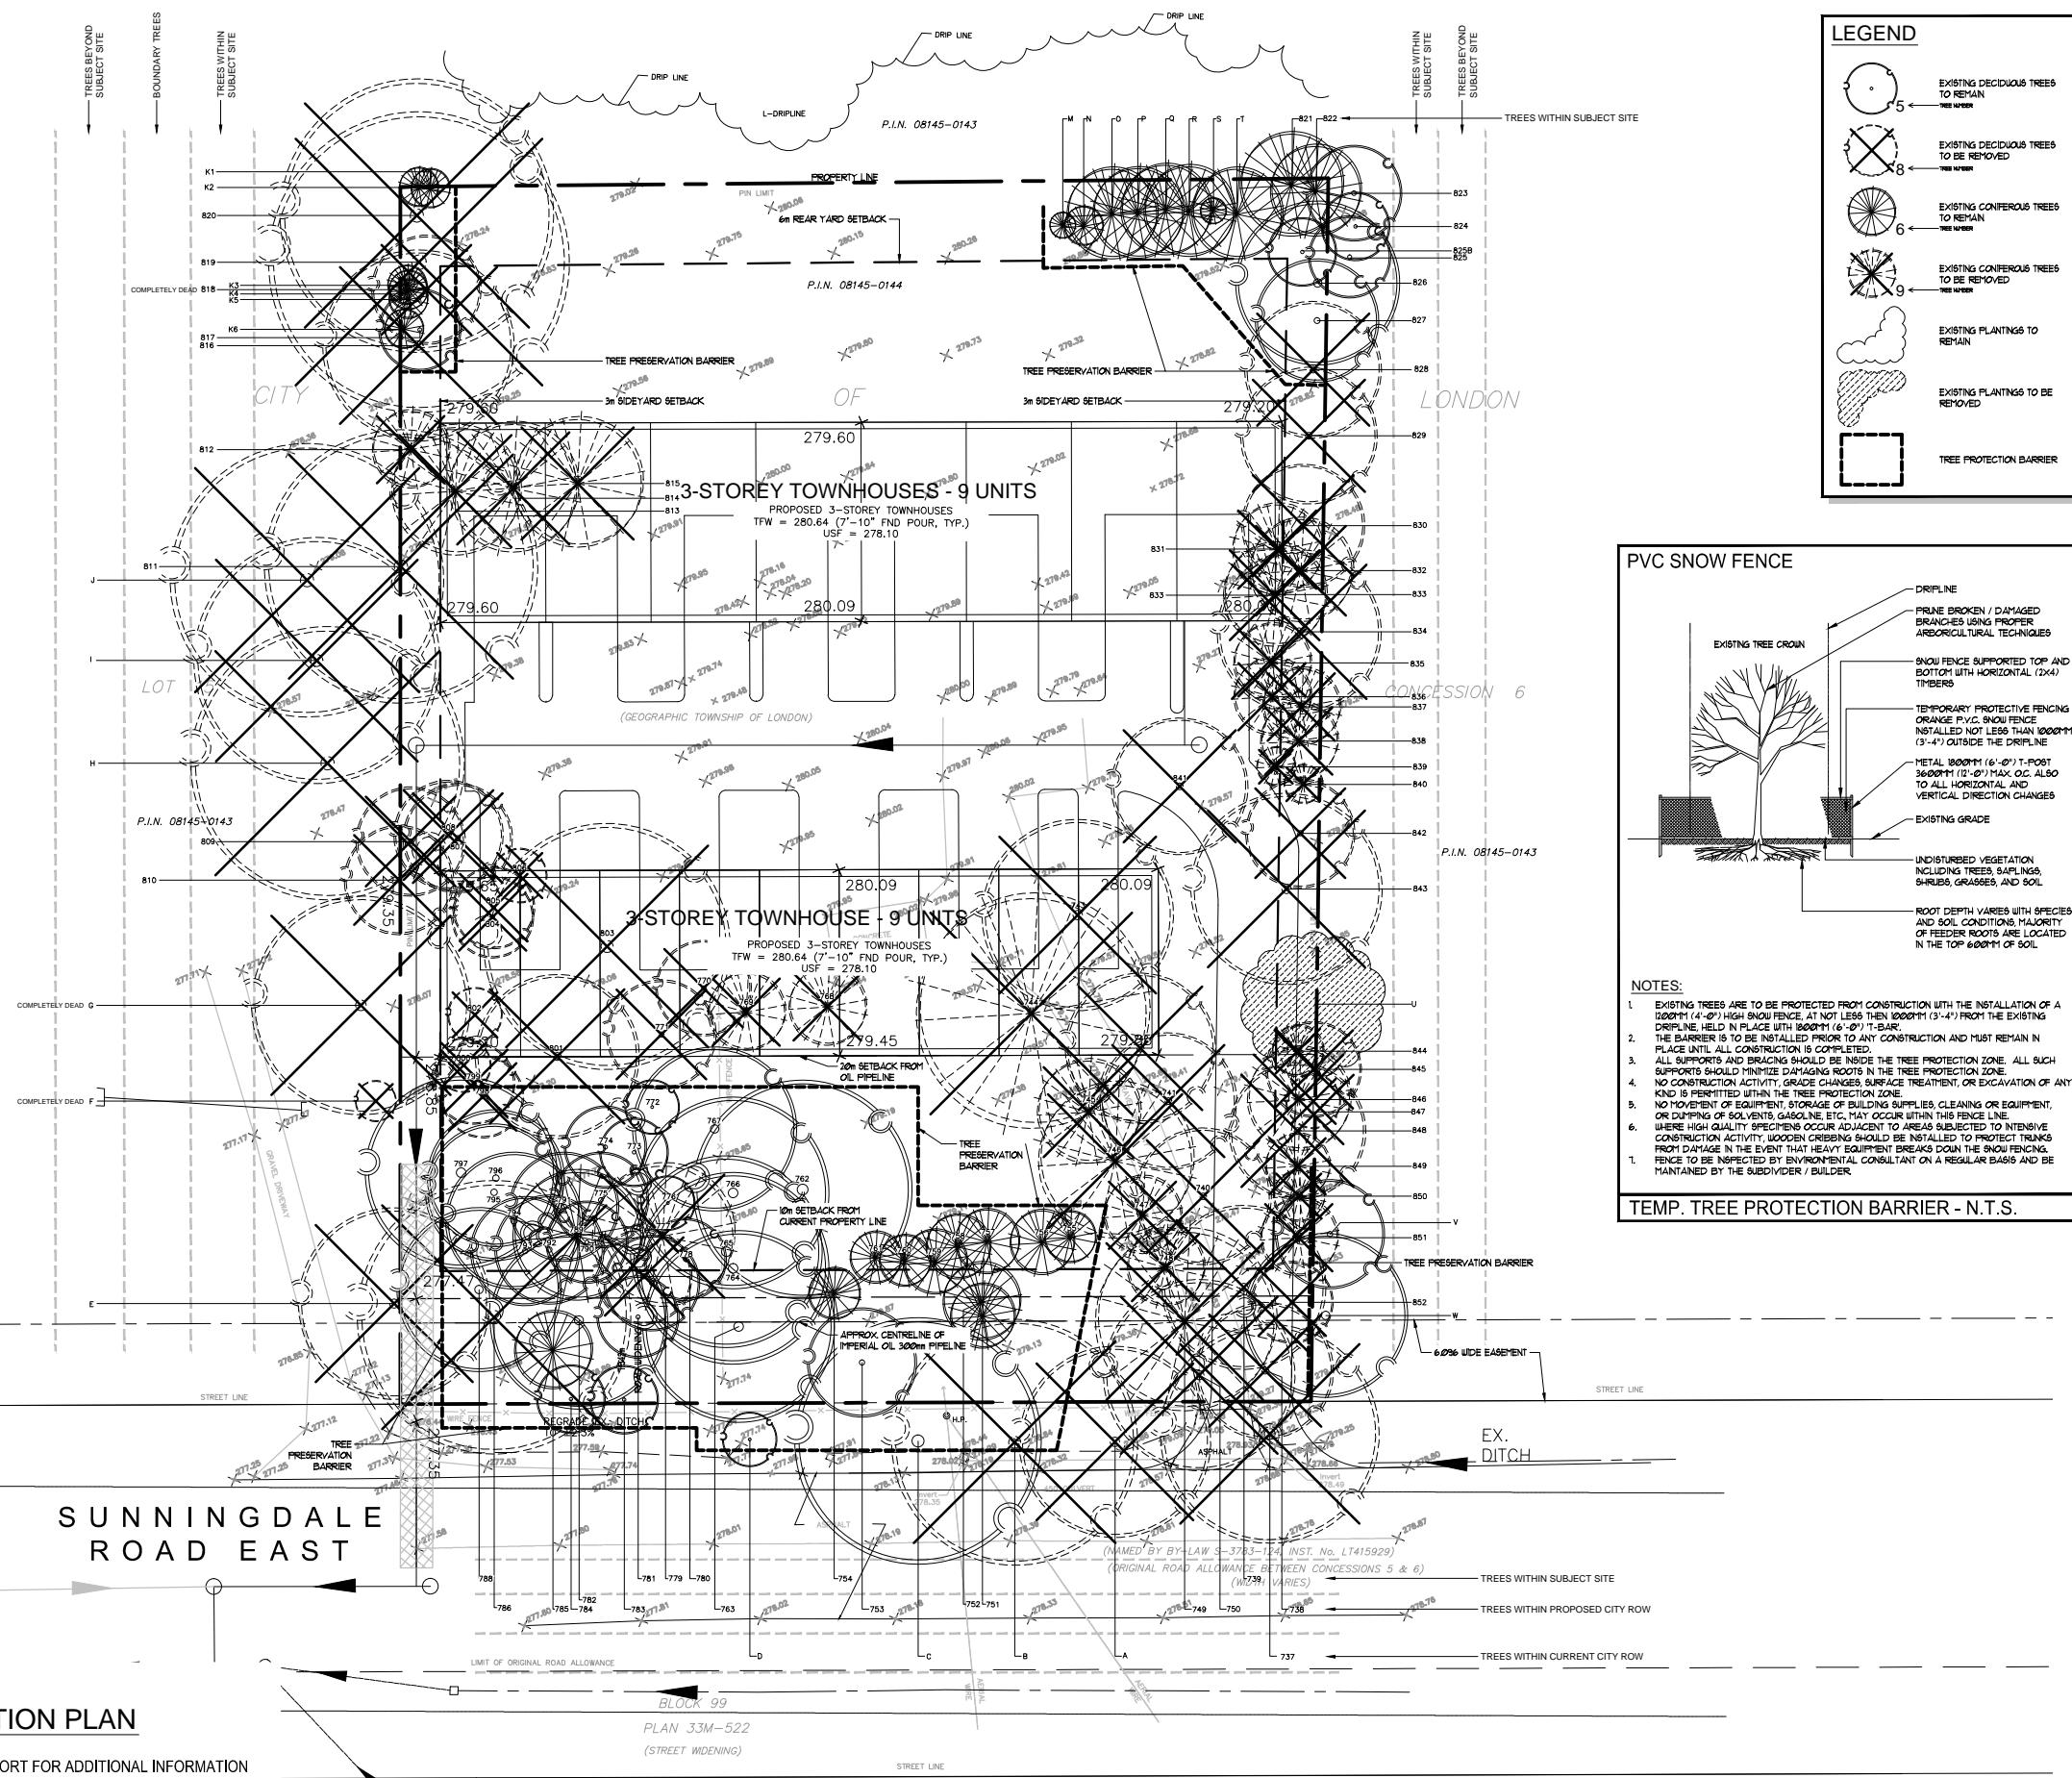
DRAWING TITLE:
 TREE PRESERVATION PLAN

TREE PRESERVATION PLAN
 SCALE = 1:250
 REFER TO TREE ASSESSMENT REPORT FOR ADDITIONAL INFORMATION
