May 07, 2019  
VB&S #: 19158

**JAM Properties**  
**Structural Review and Comments**  
**123 Queens Avenue**  
**London, Ontario**

This letter serves as a summary of our structural review of the building at 123 Queens Avenue. We herewith provide a quick summary of our review of the existing structure.

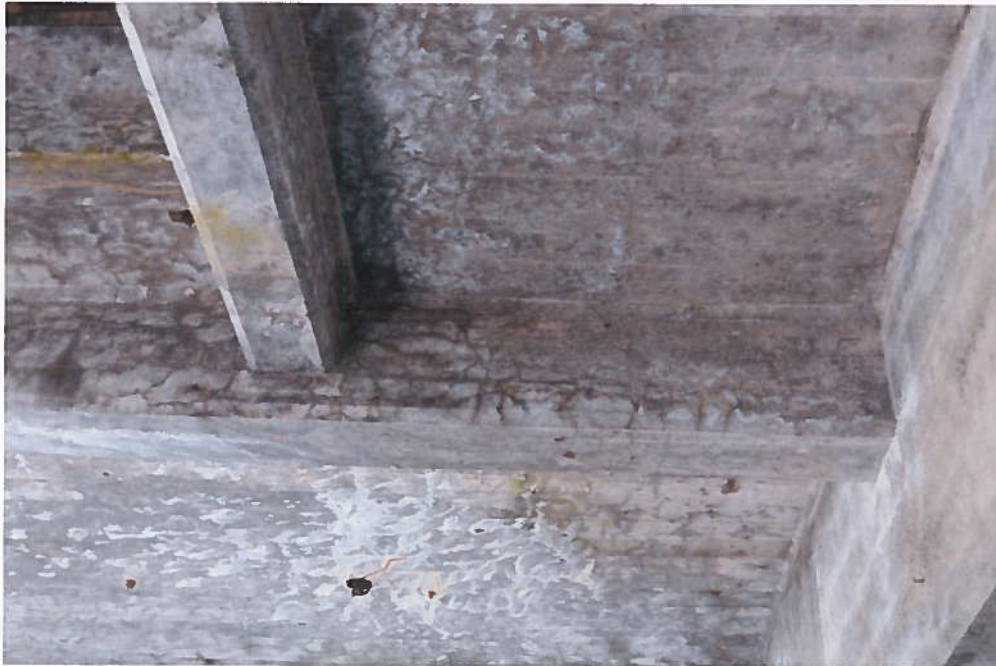
The roof and floor framing is constructed for the most part using cast in place concrete. **See Photo No 01.** There have been subsequent floor additions to the building by adding Hambro Joist and concrete system. **See Photo No 02.** These joists were exposed and not fire rated.

**Photo No 01: Typical Floor Construction**

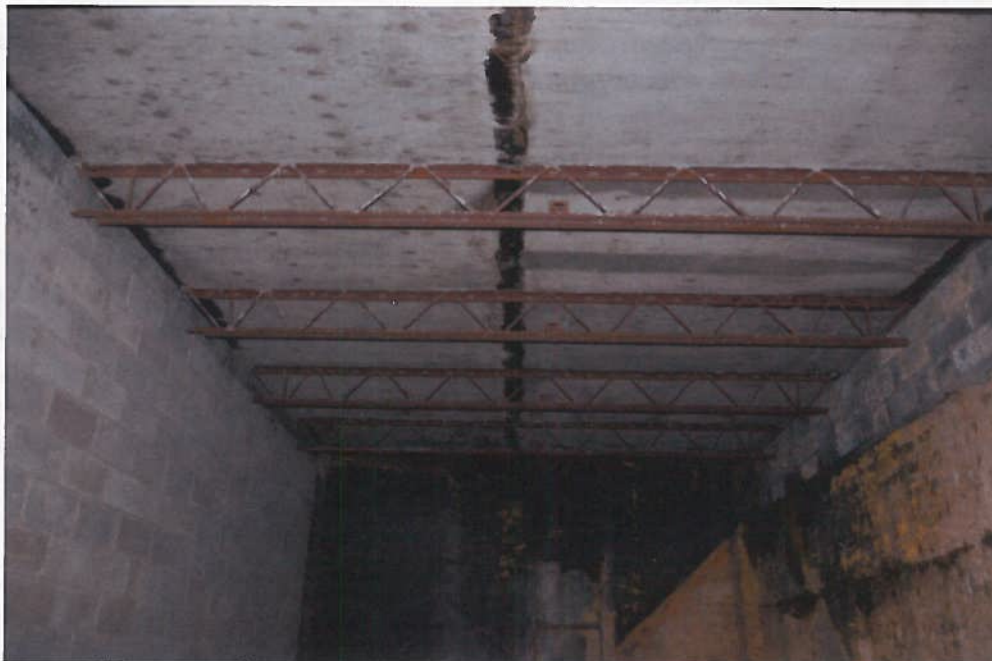
**Photo No 02: Added Hambro Floor System**

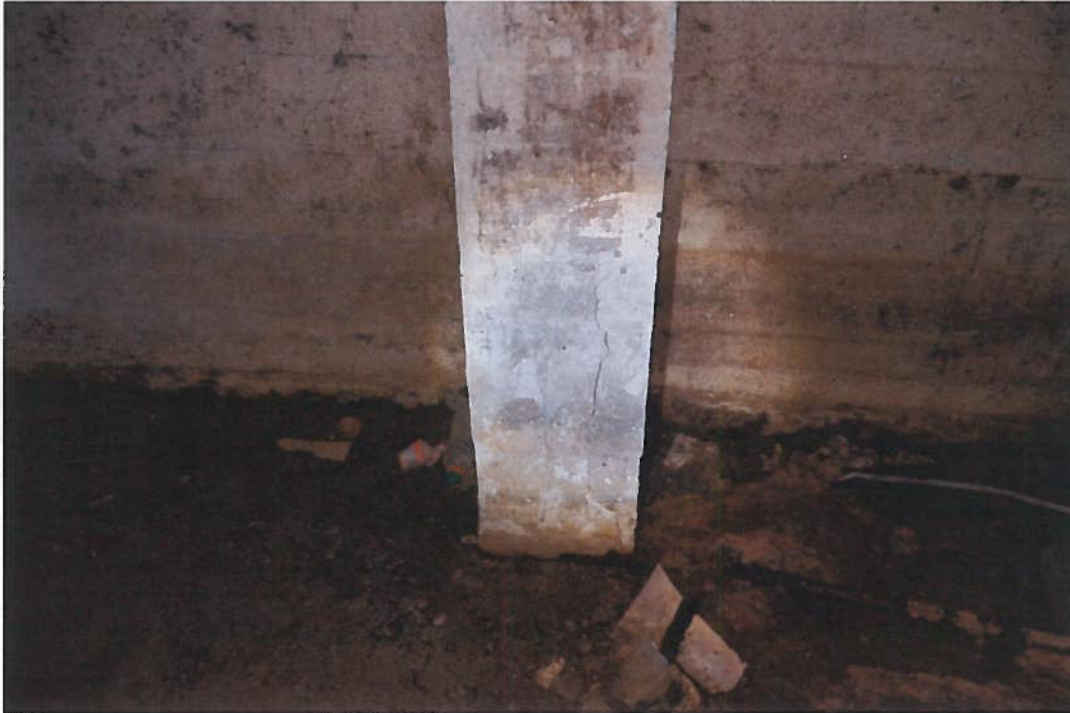
The foundation walls are constructed of cast in place concrete. There many openings in the foundation walls that have been infilled with brick. **See Photo No 03.**

**Photo No 03: Concrete Foundation Walls**

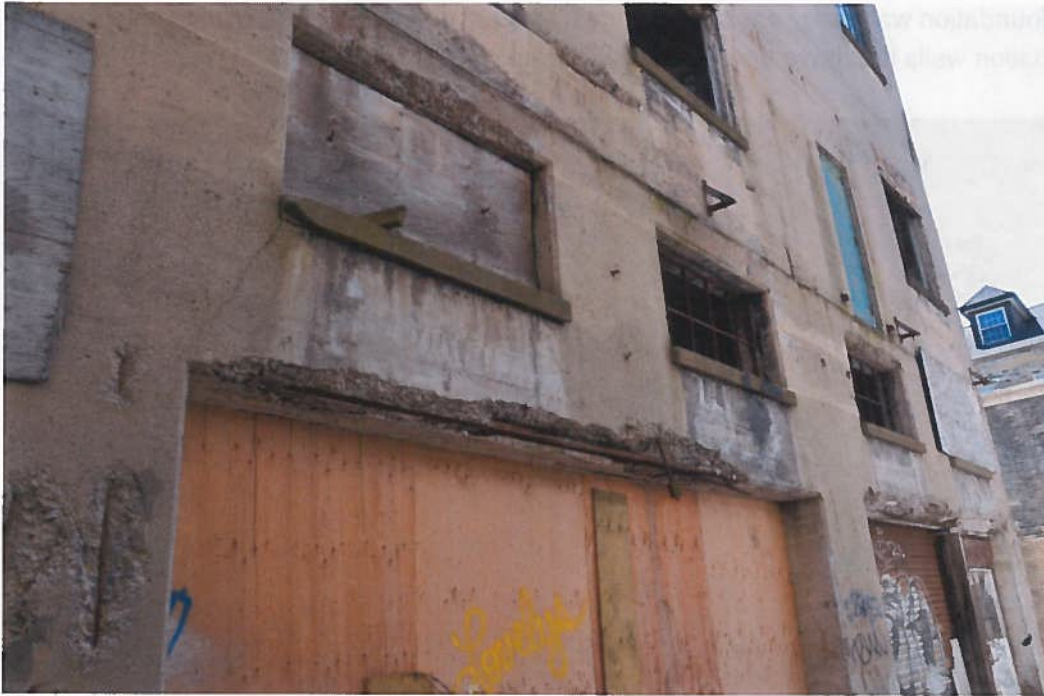
The exterior walls have openings mostly used for windows. However, there are openings at the west side of 123 Queens Avenue facing the lane way that are large framing the opening over the loading doors. **See Photo No 04.** The northmost beam is a transfer beam supporting the bearing wall located between the windows. This beam is carrying a lot of load and it appears to be distressed.

The bottom of the beams are delaminated where the concrete below the main reinforcing steel has broken away from the main body of the beam. The delamination has exposed the reinforcing and the reinforcing is corroding. The delamination of the beams is typical of all large exterior beams along the west face of the building including the beam in the link portion between 450 Talbot and 123 Queens Avenue. **See Photo No 05.**

**Photo No 04: Delaminated Concrete Beams**

The existing reinforcing bars are square non-deformed bars used in construction during that time period. The bars along the bottom of the beams are completely exposed for

approximately 65% of the length of the beam. The reinforcing has lost its bond within the concrete beams and the bars are now ineffective.

Missing in the beams in building of this period, are steel reinforcing stirrups that are a design Code requirement in new concrete beams designed today. We have not completed a design review of the beams however, experience would have us believe that this beam if reviewed would not be adequate to resist the applied loads.

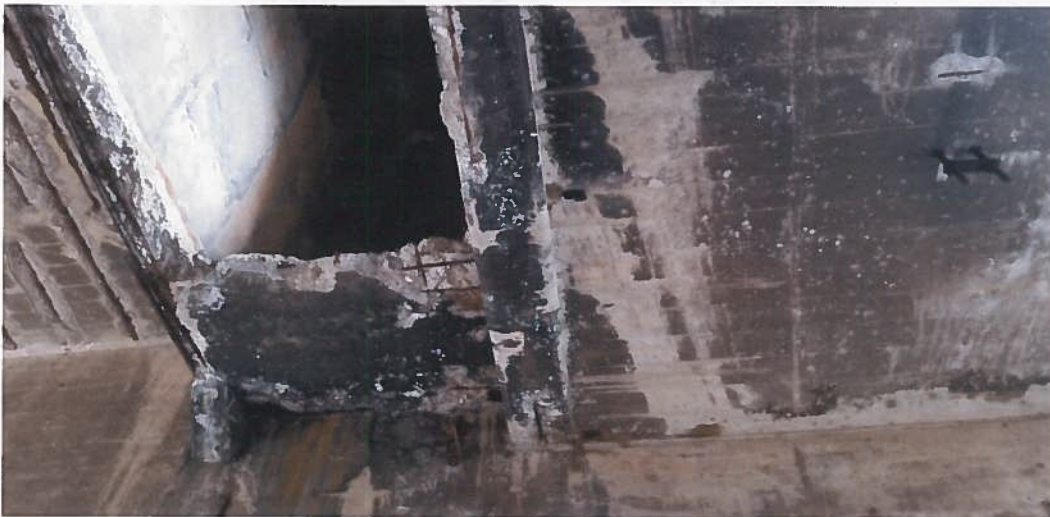
**Photo No 05: Delaminated Concrete Beam at Link**

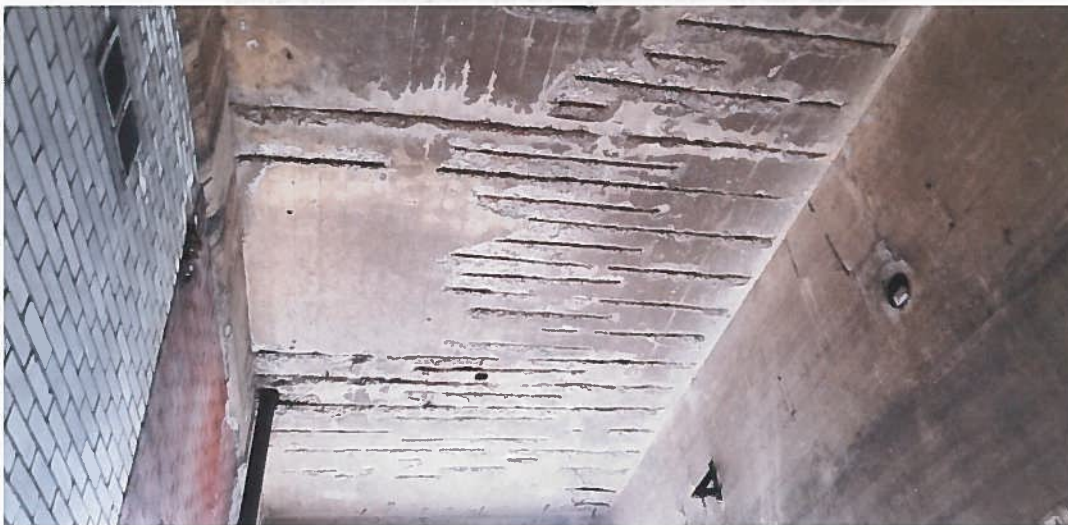
The suspended slab in the link connecting 123 Queens Avenue is exposed to view. See **Photo No 06**. The underside of the concrete slab is severely delaminated exposing the reinforcing bars. Approximately 70% of the reinforcing bar is exposed and corroded. Given the large amount of concrete delamination, bar corrosion and bar exposure, we believe that this slab has lost a majority of original design capacity.

**Photo No 06: Suspended Link Slab (Exterior)**

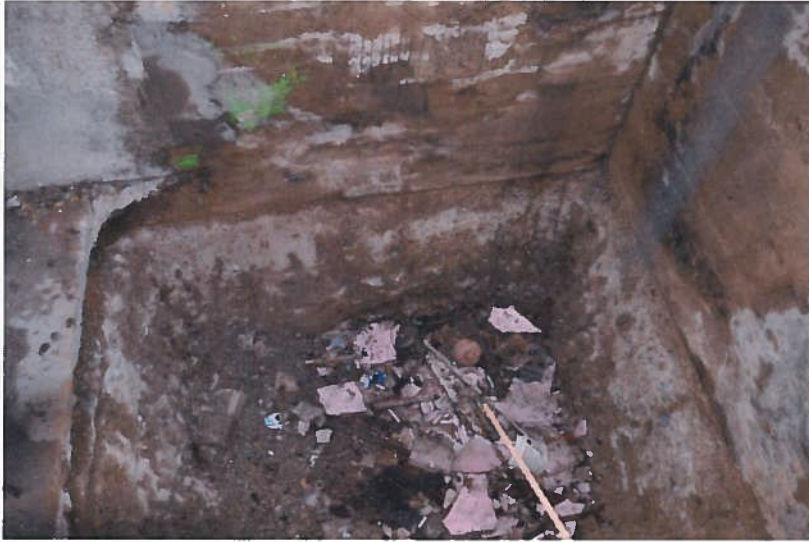
There are signs that during a former renovation, an excavation was completed for what may have been an elevator. We were informed that this excavation could also be the remnants of a demolition of the original smoke stack. See **Photo No 07**. The depth of the excavation extends below the level of the existing footing. This excavation is undermining the footing and should be infilled if the opening is to remain.

**Photo No 07: Excavation of the Interior (east Side)**

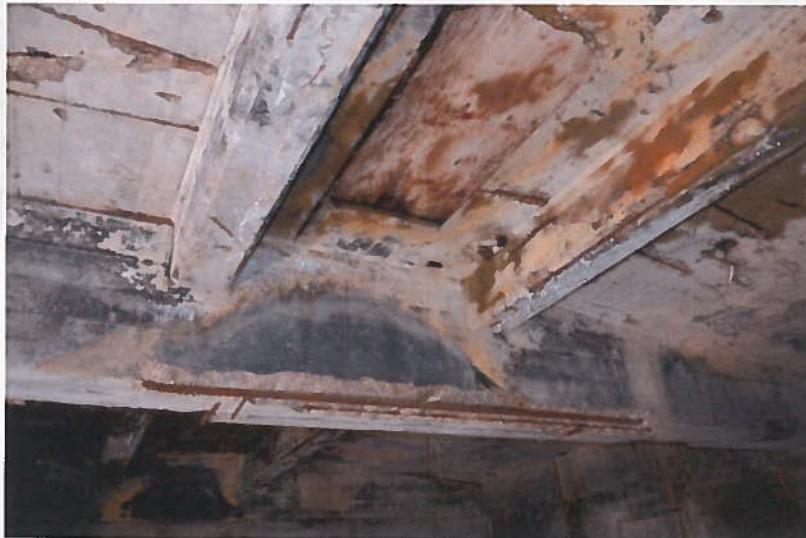
The interior upper beams are all delaminated in varying degrees. Similar to the exterior beam, the concrete at the bottom of the beam has delaminated and has completely spalled and will continue to spall over time. **See Photo No 08.** There are no signs of any stirrups in any of the concrete beams.

**Photo No 08: Typical Interior Upper Beam**

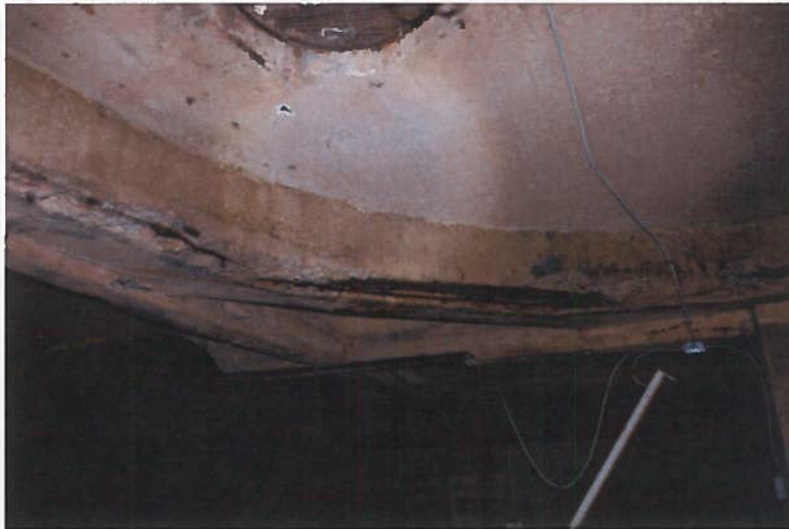
This portion of the floor is constructed of a series of concrete beams and slabs. See **Photo No 09**. It appears that this portion of the floor supported the old boiler. Of all of the beams in the building, it is the beams in this area appear to be the most compromised. The bottom of the beams in the southern half have delaminated and the reinforcing bars being corroded the most. It is presumed that continual humidity and moisture has contributed to the condition of these beams.

**Photo No 09: Interior Basement Beams (south end)**

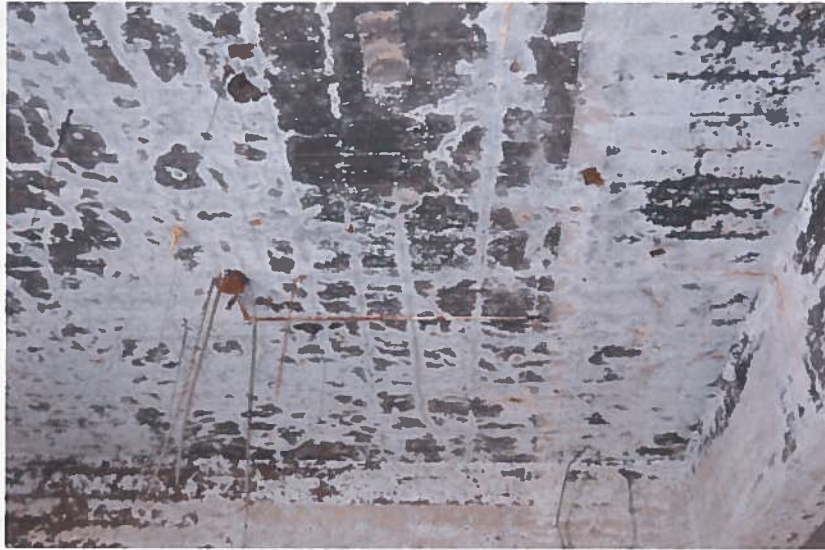
The interior suspended slabs are all showing signs of concrete delamination. While the concrete has not all spalled, there is evidence that the reinforcing has corroded, the steel expanded and a crack has cracked developed along the length of the bar. There are areas similar to the exterior slab on photo No 05 where the concrete is completely spalled exposing the concrete reinforcing. See **Photo No 10 and 11**.

**Photo No 10: Interior Suspended Slab (cracked along rebar)**

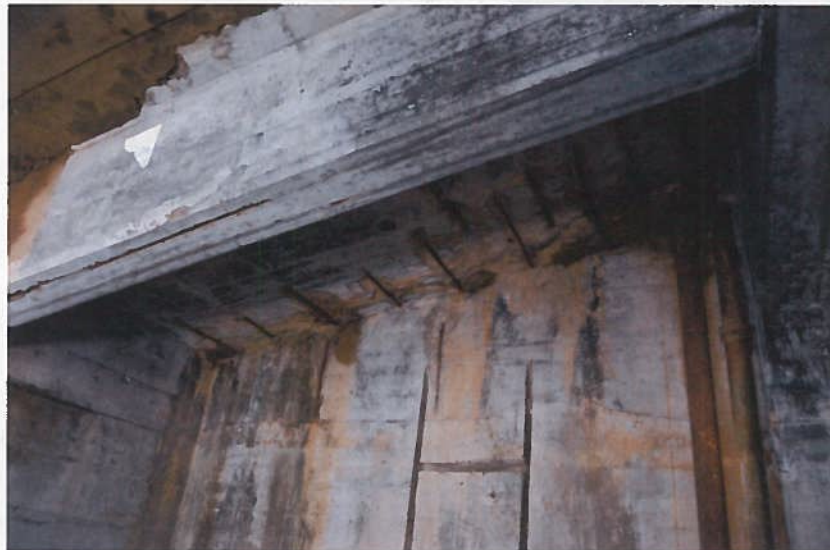
**Photo No 11: Interior Suspended Slab (Delaminated Concrete)**
