Site Review Report

Site Review-01

Client: Carvest Properties Limited	Project ID: CEC-19-0776
Project Address: 3303 Westdel Bourne, London, Ontario	Number of Pages: Nine (9)
Reviewed By: Darryl Twynstra, P. Eng.	Date Issued: 2019/05/07
Regarding: Structural Site Assessment – Existing Barn (Bank Barn) and Ramp/Storage Room Structure

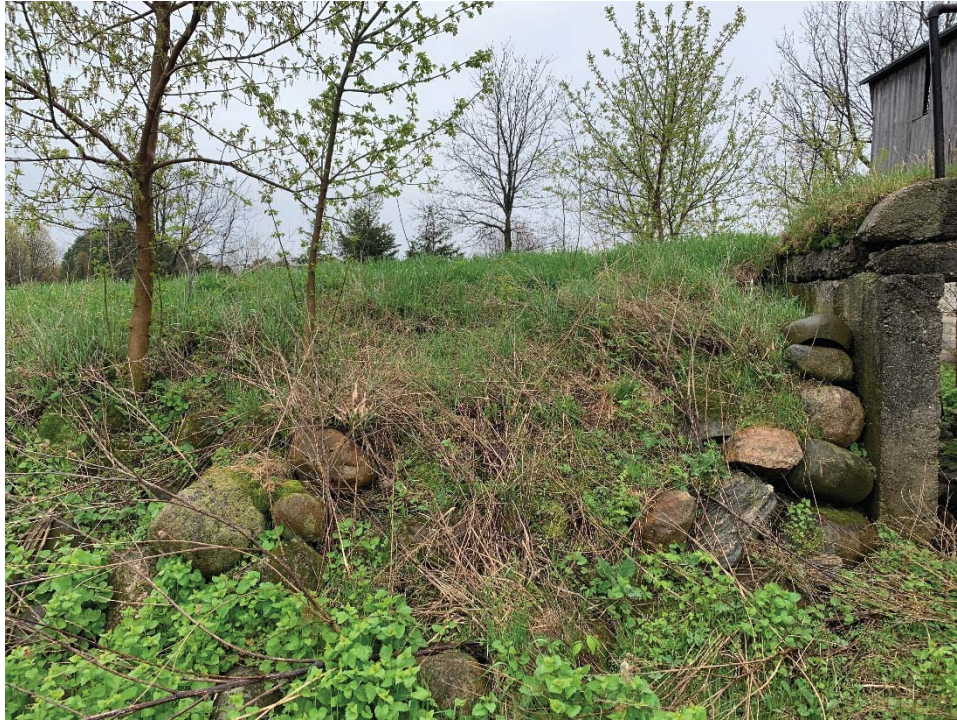
1. During our review it was noted that the existing approach ramp (constructed of soil which is retained by loose laid field stone) is not structurally sound/stable. A considerable amount of soil embedded between the existing field stone had washed away at the location of the ramp buttress wall, see Figure 1.0.

Figure 1.0 – Photo of Existing Approach Ramp to Barn (Bank Barn)

1. Based on our review of the existing ramp structure and cold storage area below the existing ramp structure, we have determined the existing ramp structure to be structurally unsound for use. The degree of deterioration and absence of overall maintenance over its lifespan have rendered it, in our opinion, unusable and unrepairable. As such, access/use of this area of the existing structure should be restricted until such time that it can be safely removed.

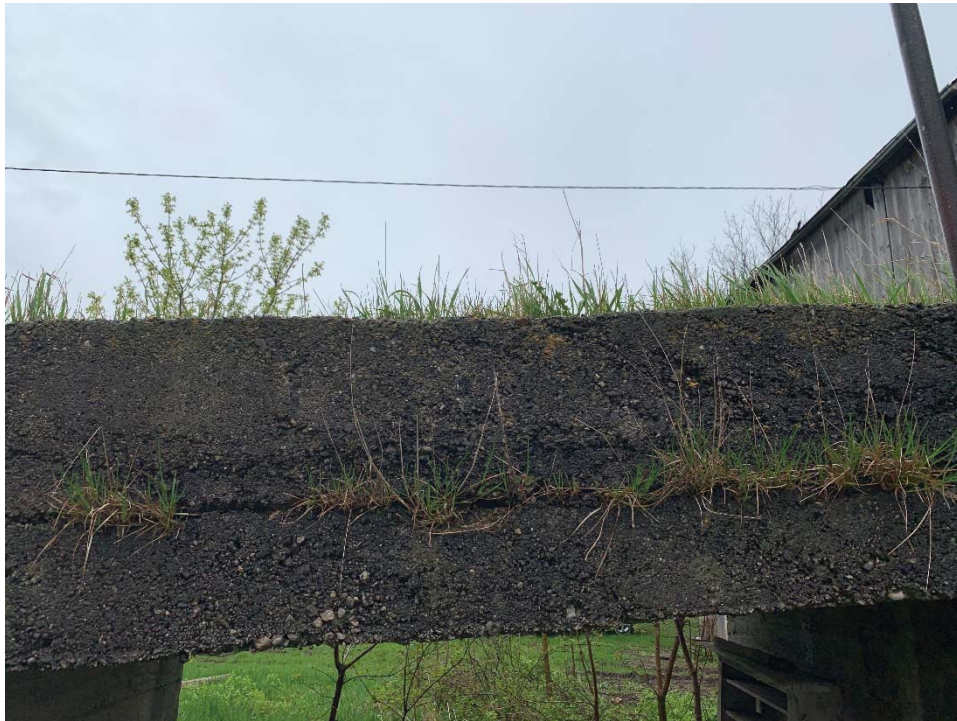
2. It was noted in several locations, that the existing suspended concrete ramp structure, above the passageway and the storage room, has delaminated/deteriorated to a point in which vegetation is able to grow within the structure, see Figures 2.0 and 3.0.

Figure 2.0 – Photo of Existing Ramp Structure with Severe Delamination

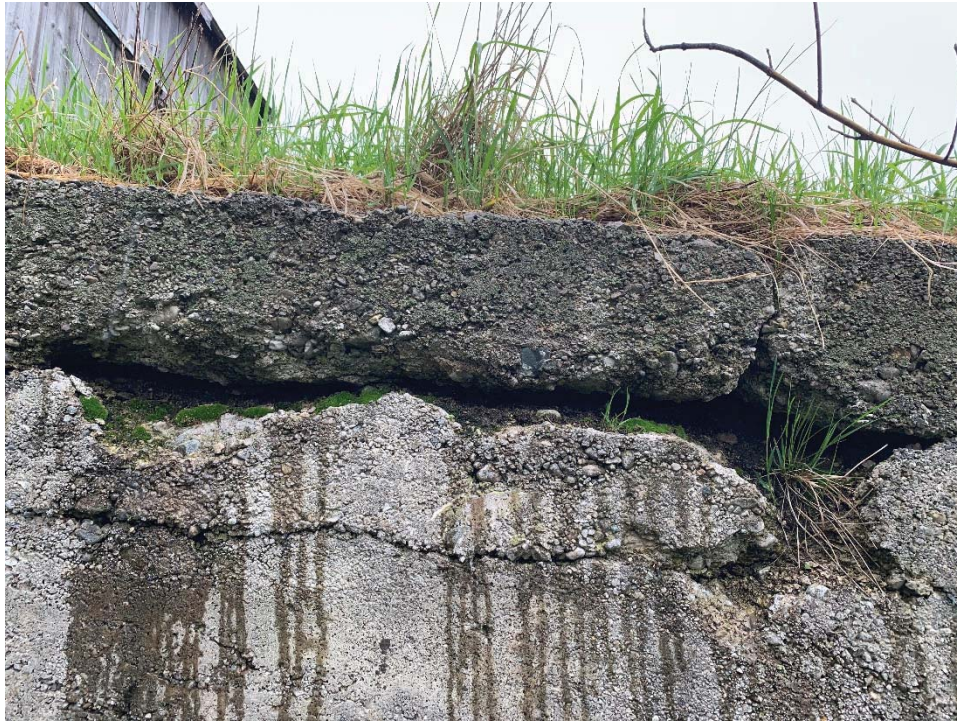
Figure 3.0 - Photo of Existing Ramp Structure with Severe Delamination/Spalling

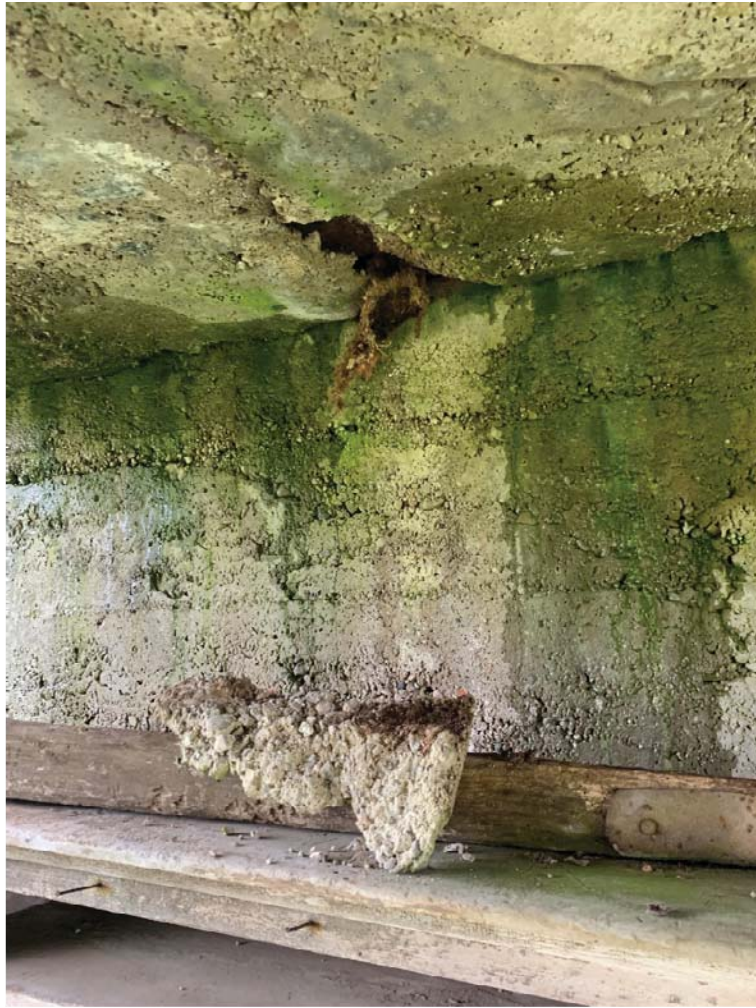
3. Also noted during our site review, was the significant deterioration of the suspended concrete slab overall. The concrete within the slab is severely pitted/spalled/delaminated, see Figure 4.0. The existing embedded reinforcing elements within the concrete slab (structural steel) exhibit signs of severe corrosion as well, see Figure 5.0.

Figure 4.0 - Photo of Existing Ramp Structure with Severe Pitting/Spalling/Delamination

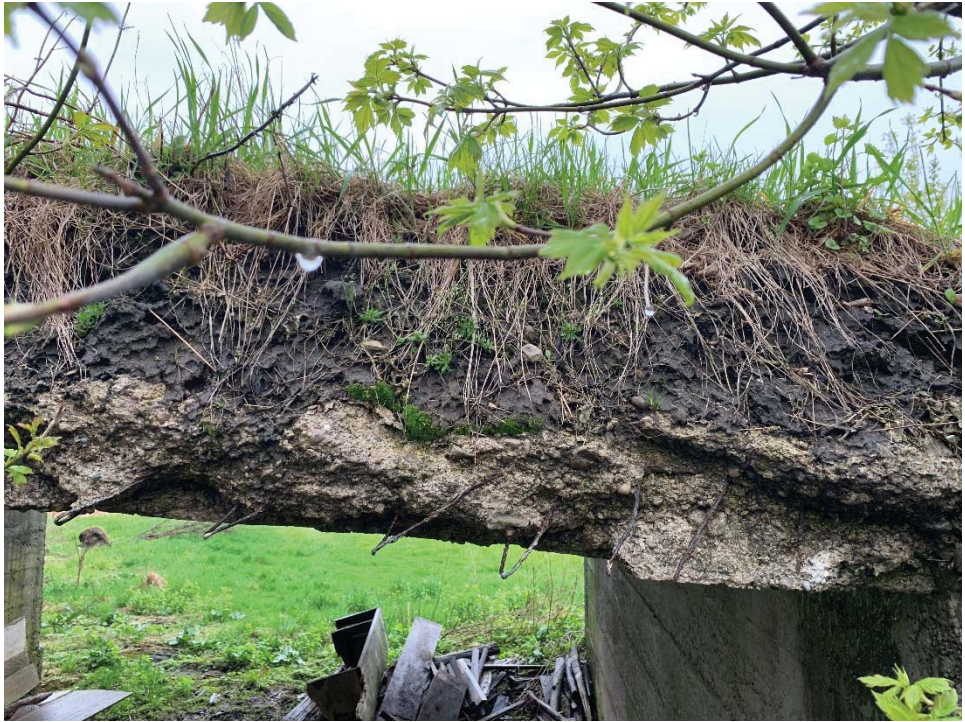
Figure 5.0 - Photo of Existing Ramp Structure with Severe Delamination/Corrosion

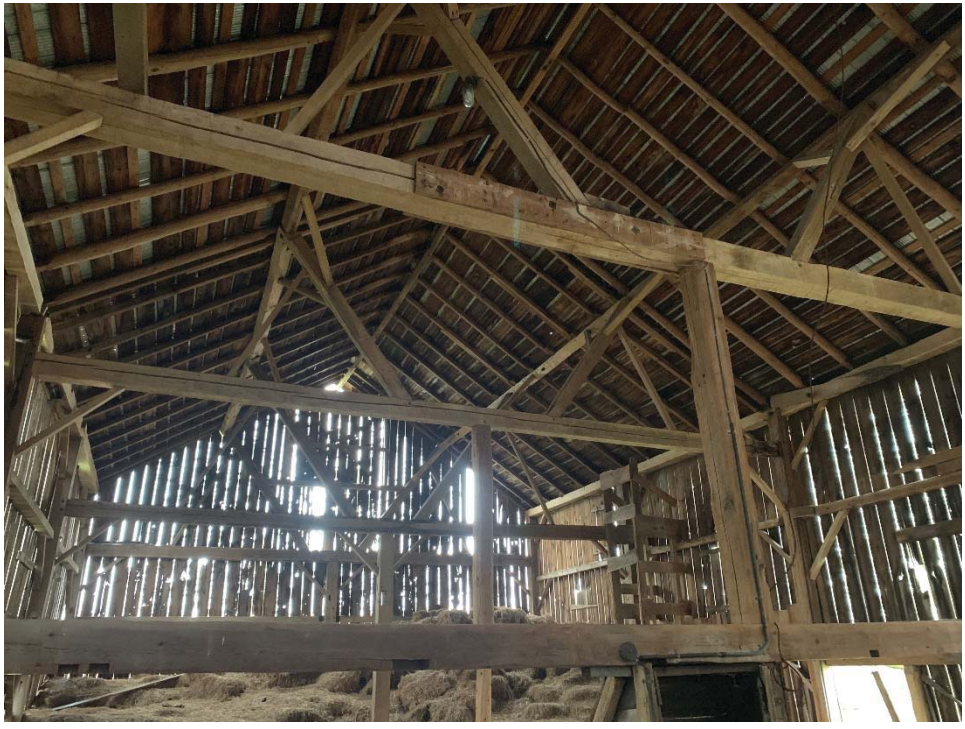
1. During our review it was noted that the existing barn timber structural components are in relatively moderate condition, see Figure 6.0. Some structural members have been compromised due to on site alternations made over time and lack of maintenance, such as the perimeter sill-plate, see Figure 7.0.
2. Localized damage pitting/deterioration and undermining of the existing foundation wall, was also noted on site, see Figure 8.0. Some localized cracking within the existing foundation wall was also noted, see Figure 9.0.

Figure 6.0 - Photo of Existing Barn (Bank Barn) Interior Post and Beam Structure

1. Based on our review of the existing barn (Bank Barn) structure, it appears to be in moderate condition. If it is proposed that the existing structure will remain, a full structural analysis of the existing building should be conducted to ensure it can support the required loading parameters. If the intended use of the structure (i.e. a change of use) is proposed, a significant degree of structural remediation would be necessary to ensure the existing building structure can withstand current building code parameters. It is to be noted that structural analysis of the existing structure would more than likely determine that the existing structure is not capable of supporting the required loading parameters.

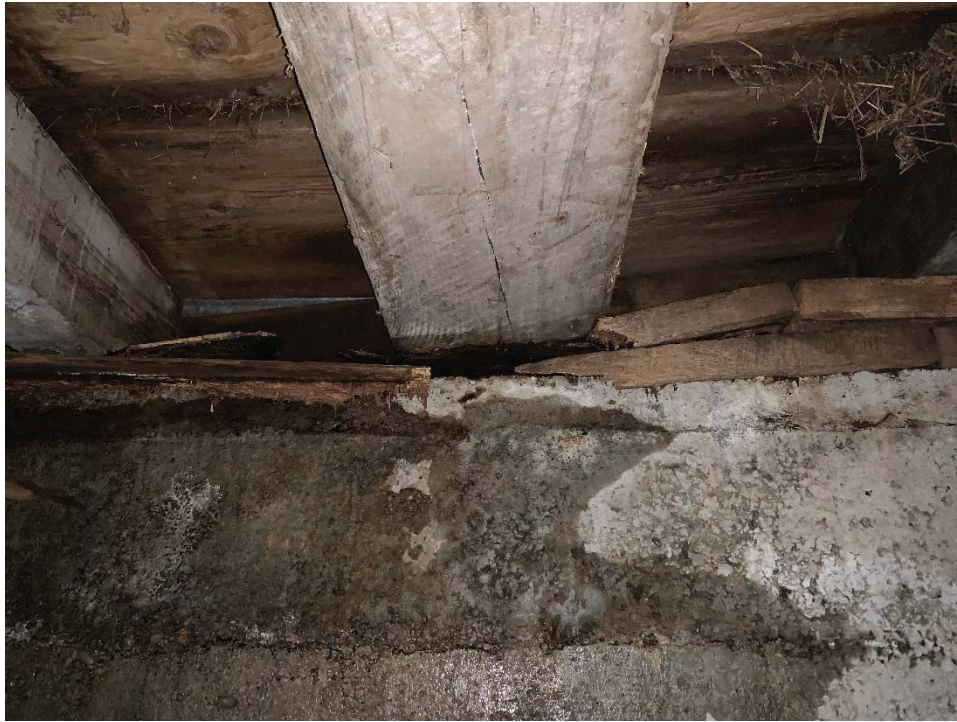
Figure 7.0 - Photo of Damaged Perimeter Sill-plate

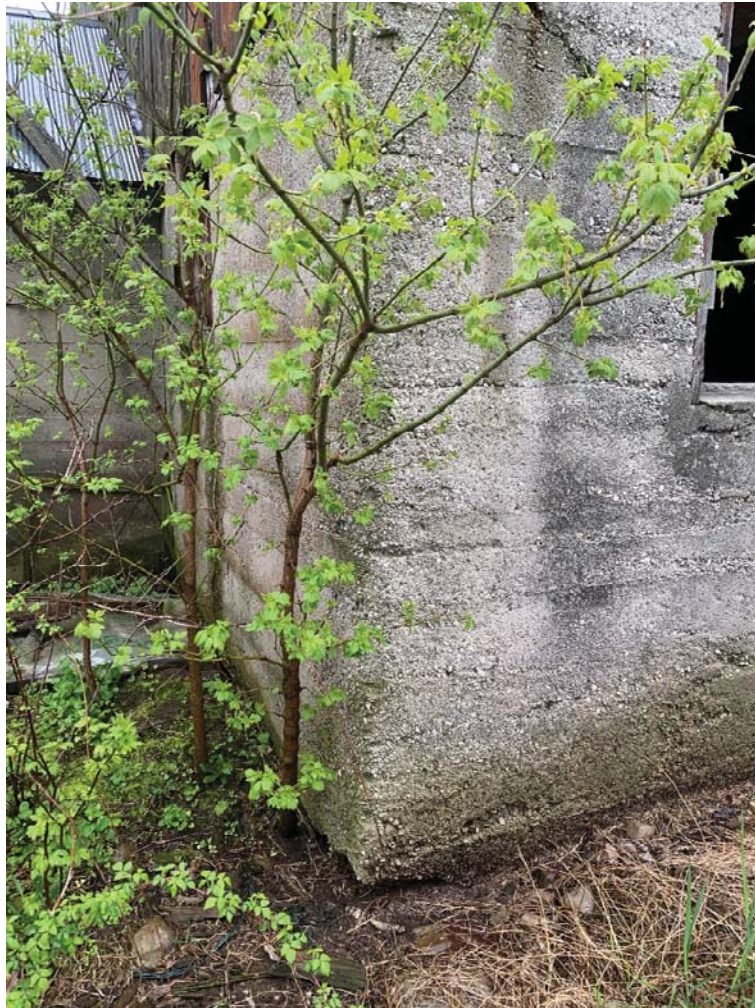
Figure 8.0 - Photo of Pitting/Deterioration and Undermining of Existing Foundation Wall

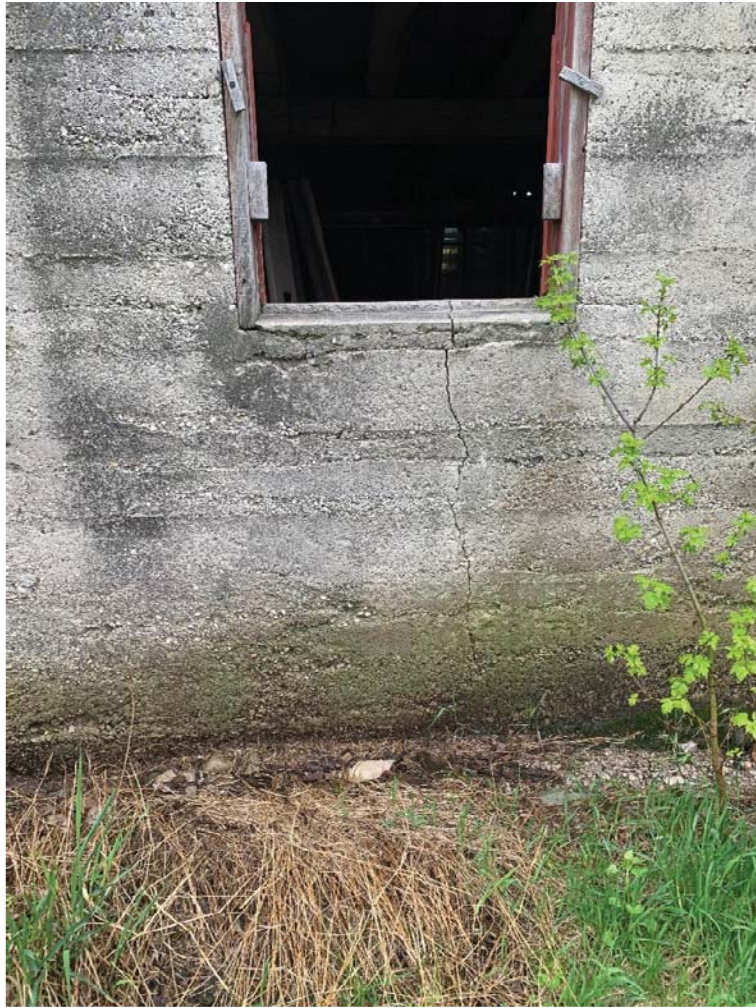
Figure 9.0 - Photo of Cracked Existing Foundation Wall
