# Site Review Report

# Site Review-02

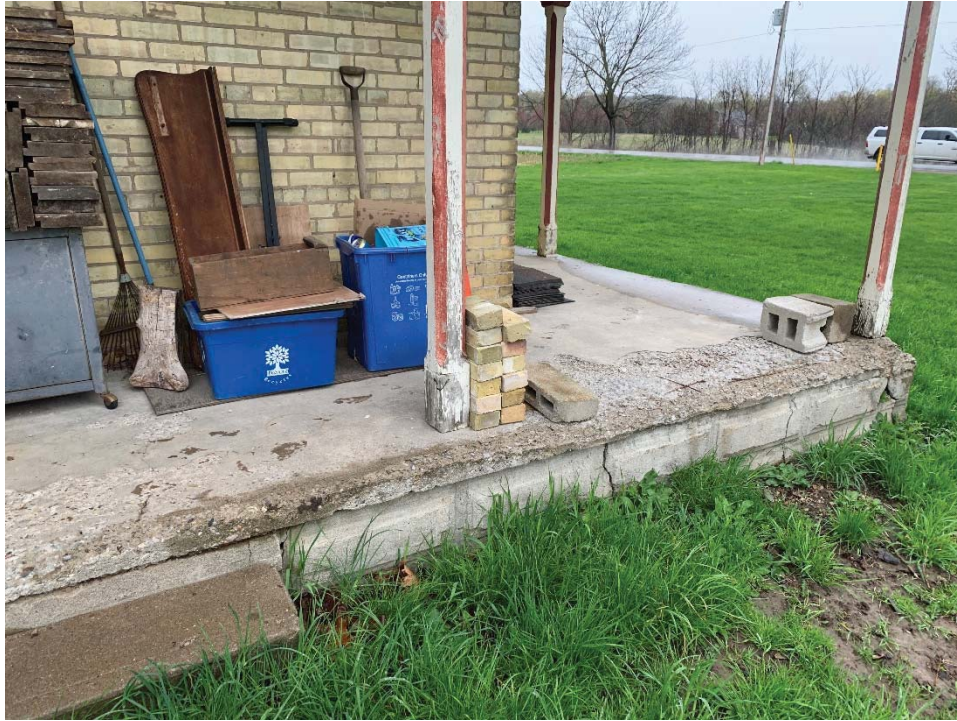
Figure 1.0 – Photo of Existing Porch Slab and Foundation Structure

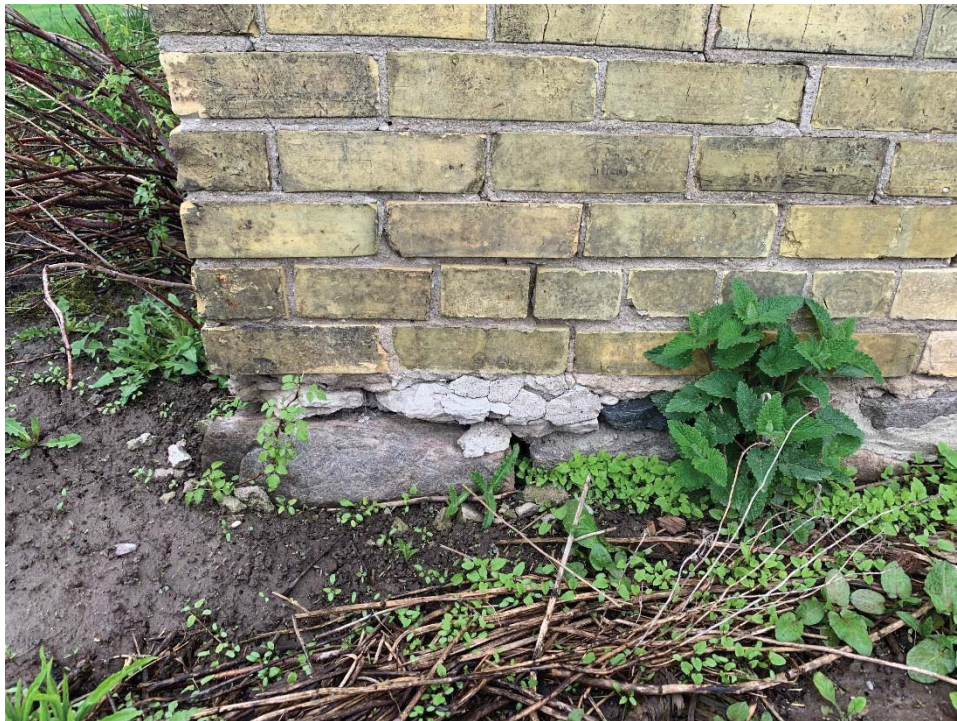
Figure 2.0 – Photo of Existing Foundation Wall Structure with Deteriorated Mortar Joints
