May 07, 2019
VB&S #: 19158

JAM Properties
Structural Review and Comments
123 Queens Avenue
London, Ontario

This letter serves as a summary of our structural review of the building at 123 Queens Avenue. We herewith provide a quick summary of our review of the existing structure.

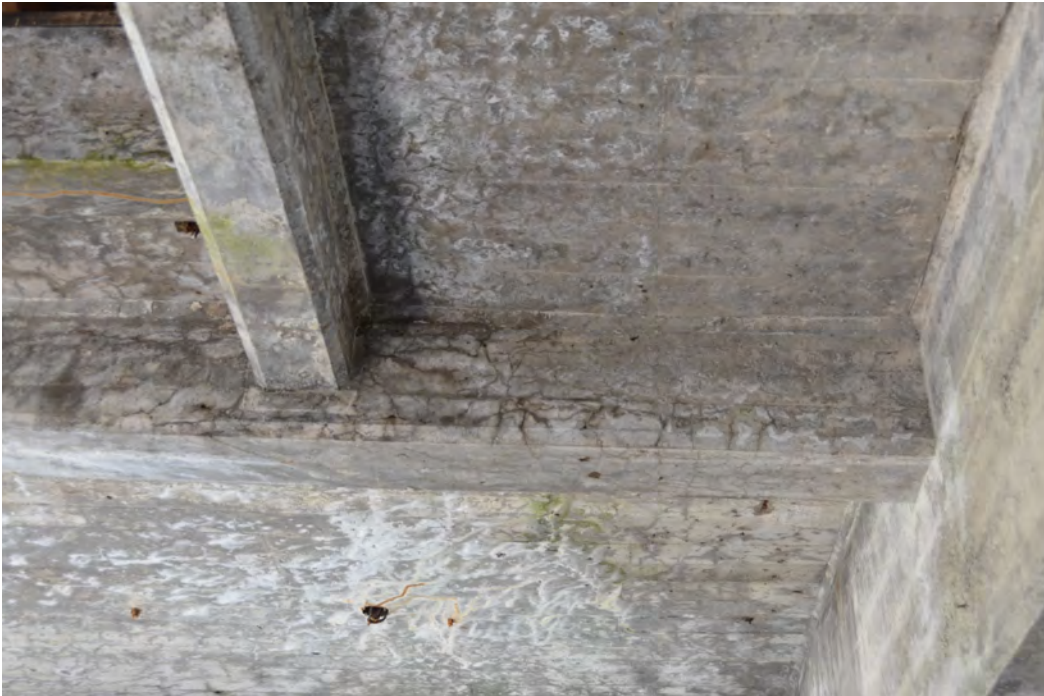
The roof and floor framing is constructed for the most part using cast in place concrete. **See Photo No 01.** There have been subsequent floor additions to the building by adding Hambro Joist and concrete system. **See Photo No 02.** These joists were exposed and not fire rated.

Photo No 01: Typical Floor Construction

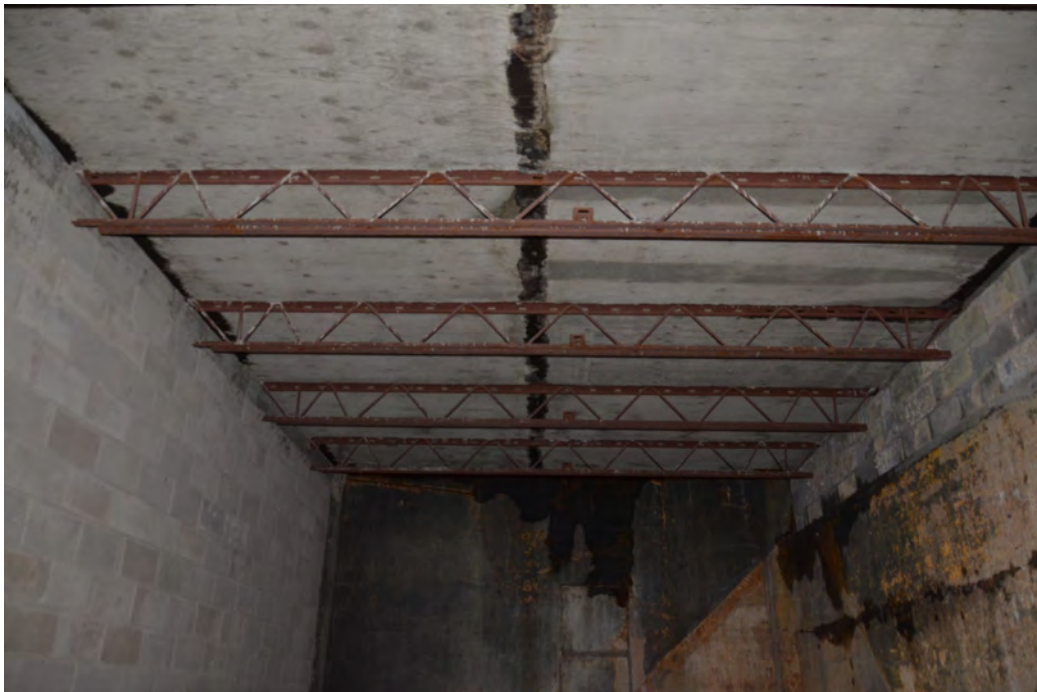
Photo No 02: Added Hambro Floor System

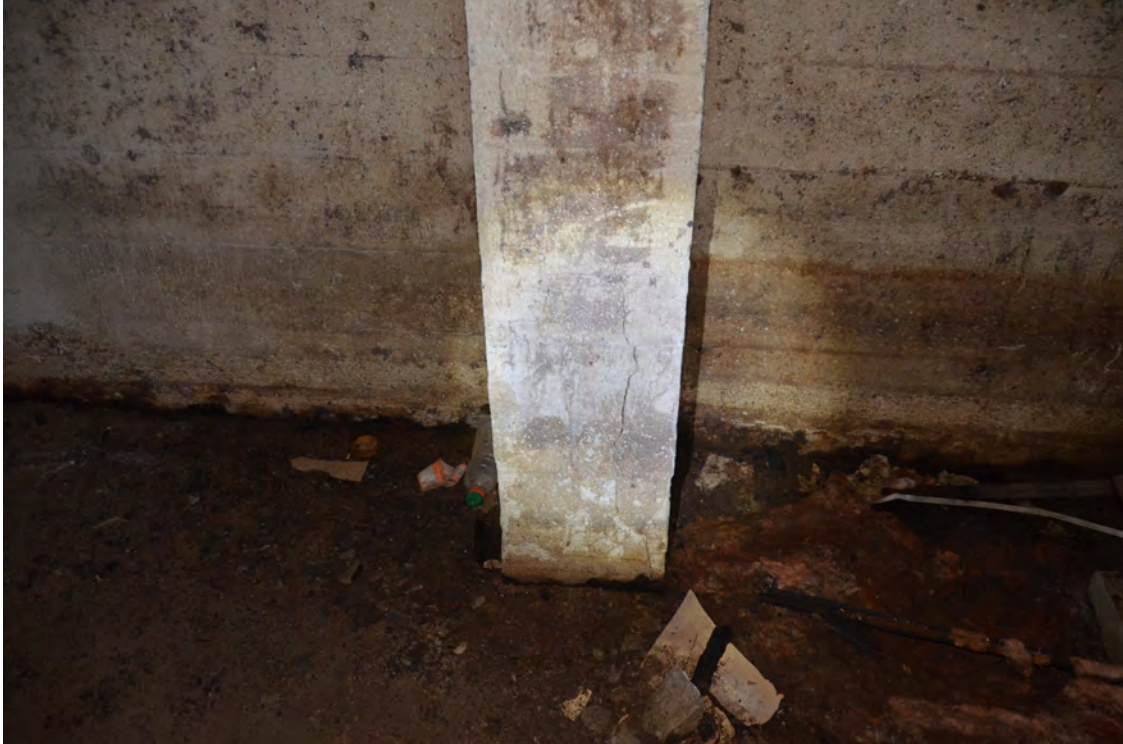
The foundation walls are constructed of cast in place concrete. There many openings in the foundation walls that have been infilled with brick. **See Photo No 03.**

Photo No 03: Concrete Foundation Walls

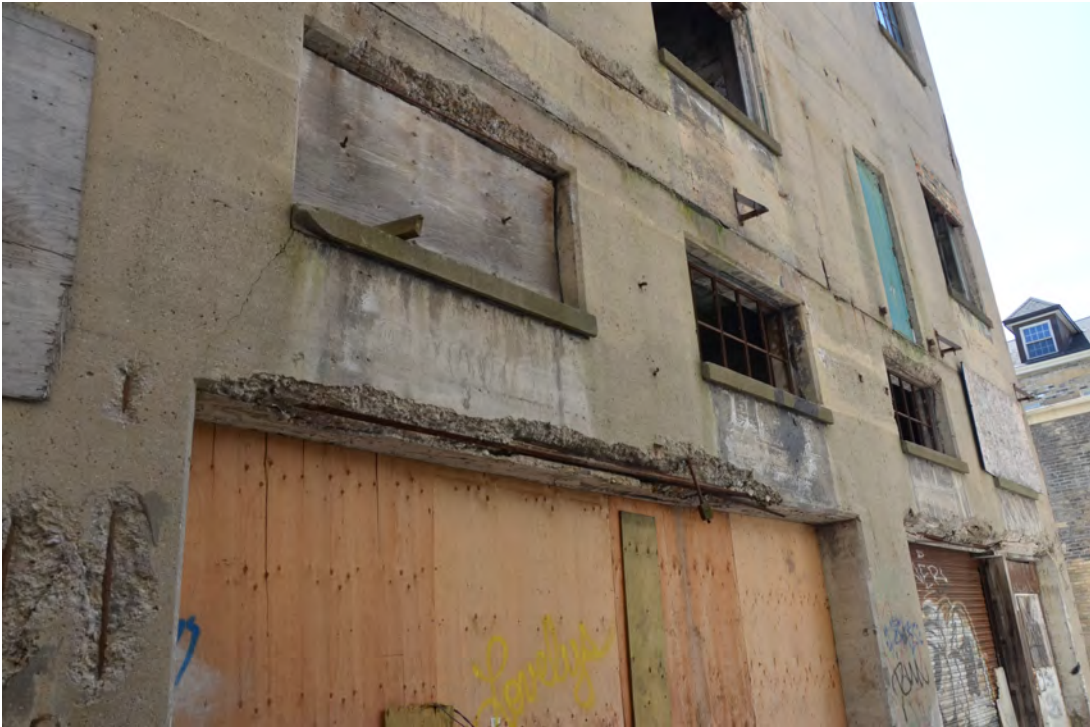
The exterior walls have openings mostly used for windows. However, there are openings at the west side of 123 Queens Avenue facing the lane way that are large framing the opening over the loading doors. **See Photo No 04.** The northmost beam is a transfer beam supporting the bearing wall located between the windows. This beam is carrying a lot of load and it appears to be distressed.

The bottom of the beams are delaminated where the concrete below the main reinforcing steel has broken away from the main body of the beam. The delamination has exposed the reinforcing and the reinforcing is corroding. The delamination of the beams is typical of all large exterior beams along the west face of the building including the beam in the link portion between 450 Talbot and 123 Queens Avenue. **See Photo No 05.**

Photo No 04: Delaminated Concrete Beams

The existing reinforcing bars are square non-deformed bars used in construction during that time period. The bars along the bottom of the beams are completely exposed for

approximately 65% of the length of the beam. The reinforcing has lost its bond within the concrete beams and the bars are now ineffective.

Missing in the beams in building of this period, are steel reinforcing stirrups that are a design Code requirement in new concrete beams designed today. We have not completed a design review of the beams however, experience would have us believe that this beam if reviewed would not be adequate to resist the applied loads.

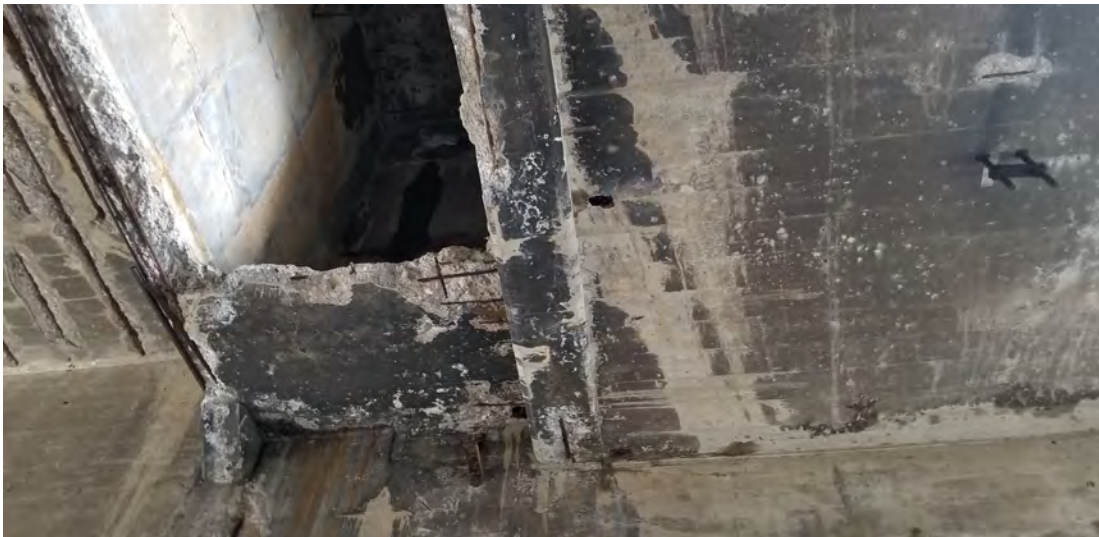
Photo No 05: Delaminated Concrete Beam at Link

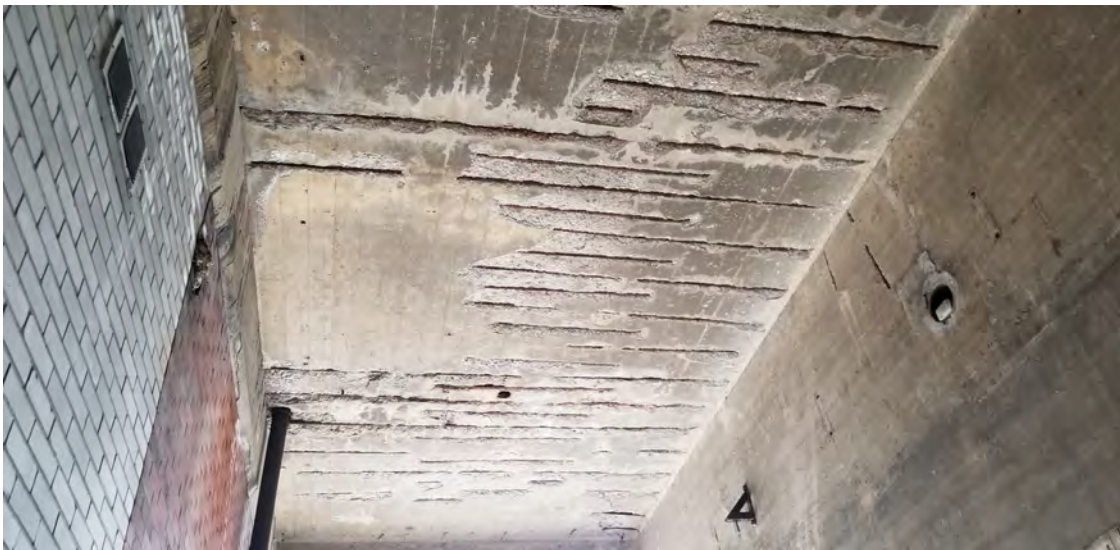
The suspended slab in the link connecting 123 Queens Avenue is exposed to view. **See Photo No 06.** The underside of the concrete slab is severely delaminated exposing the reinforcing bars. Approximately 70% of the reinforcing bar is exposed and corroded. Given the large amount of concrete delamination, bar corrosion and bar exposure, we believe that this slab has lost a majority of original design capacity.

Photo No 06: Suspended Link Slab (Exterior)

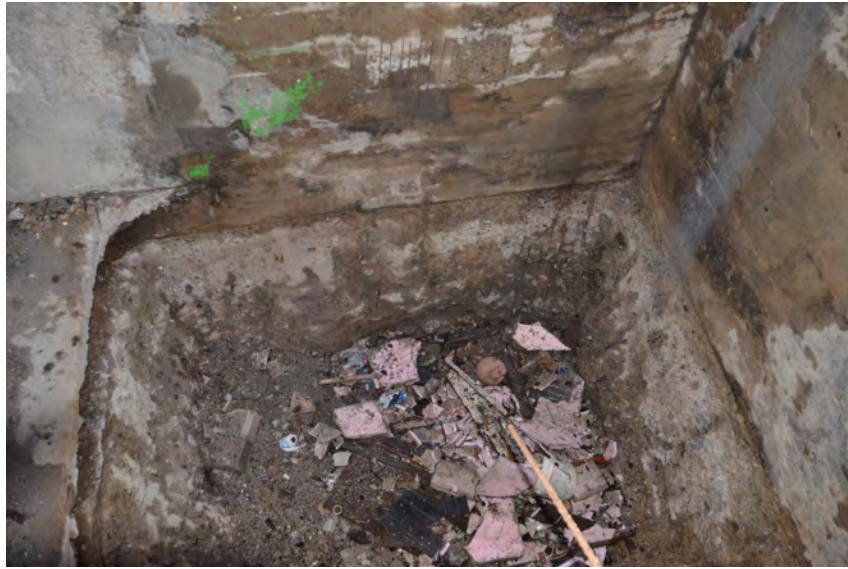
There are signs that during a former renovation, an excavation was completed for what may have been an elevator. We were informed that this excavation could also be the remnants of a demolition of the original smoke stack. **See Photo No 07.** The depth of the excavation extends below the level of the existing footing. This excavation is undermining the footing and should be infilled if the opening is to remain.

Photo No 07: Excavation of the Interior (east Side)

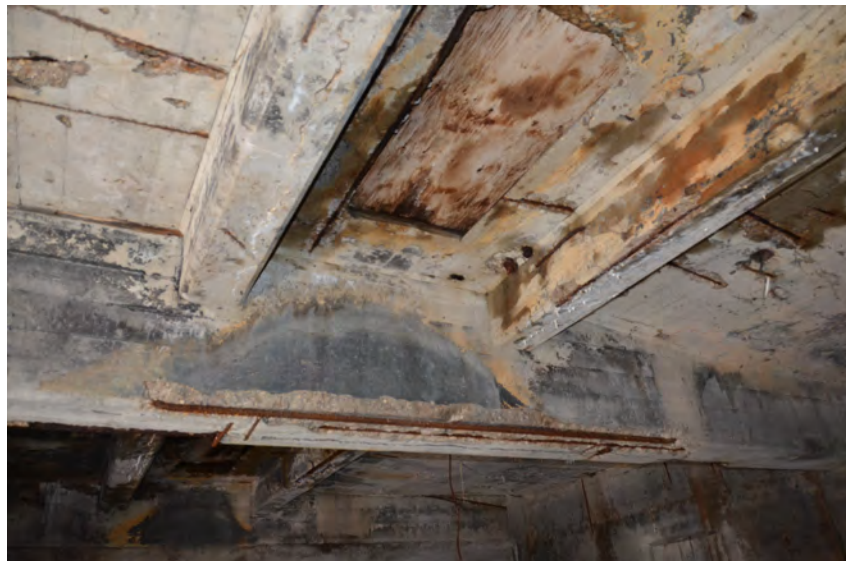
The interior upper beams are all delaminated in varying degrees. Similar to the exterior beam, the concrete at the bottom of the beam has delaminated and has completely spalled and will continue to spall over time. **See Photo No 08.** There are no signs of any stirrups in any of the concrete beams.

Photo No 08: Typical Interior Upper Beam

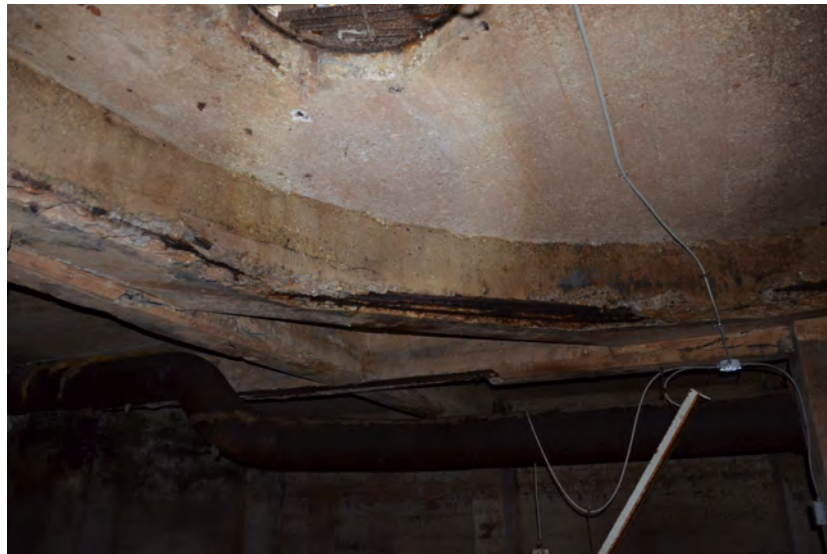
This portion of the floor is constructed of a series of concrete beams and slabs. **See Photo No 09.** It appears that this portion of the floor supported the old boiler. Of all of the beams in the building, it is the beams in this area appear to be the most compromised. The bottom of the beams in the southern half have delaminated and the reinforcing bars being corroded the most. It is presumed that continual humidity and moisture has contributed to the condition of these beams.

Photo No 09: Interior Basement Beams (south end)

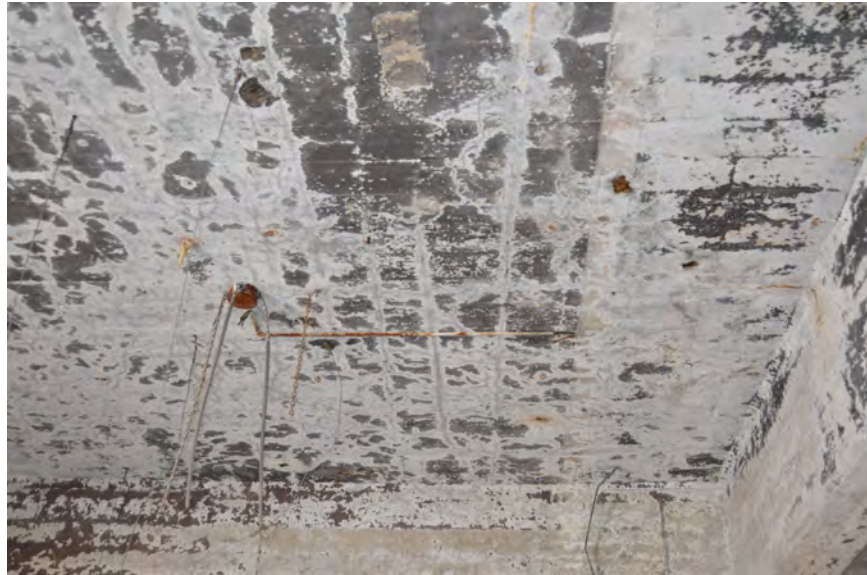
The interior suspended slabs are all showing signs of concrete delamination. While the concrete has not all spalled, there is evidence that the reinforcing has corroded, the steel expanded and a crack has cracked developed along the length of the bar. There are areas similar to the exterior slab on photo No 05 where the concrete is completely spalled exposing the concrete reinforcing. **See Photo No 10 and 11.**

Photo No 10: Interior Suspended Slab (cracked along rebar)

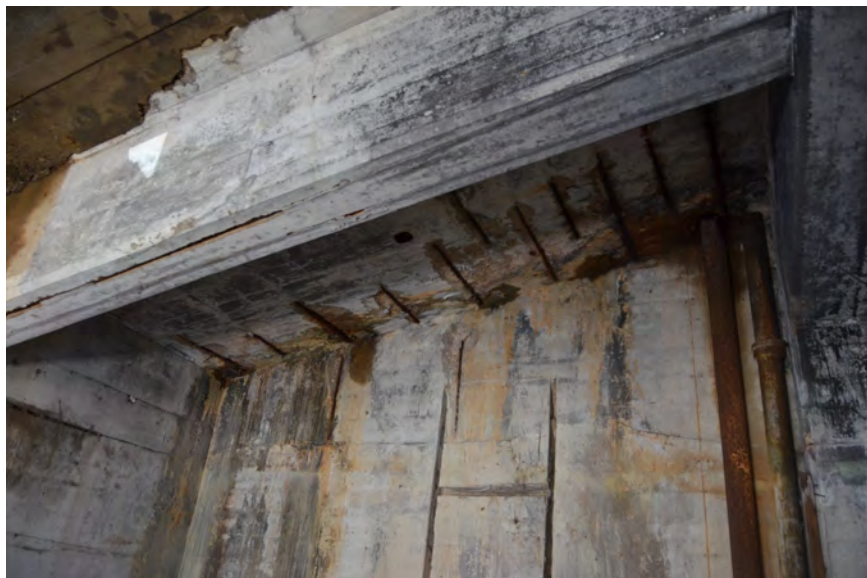
Photo No 11: Interior Suspended Slab (Delaminated Concrete)
