**Old Victoria – Grenier Lands &  
1645 Hamilton Road  
London, Ontario**

**Geotechnical Investigation - Slope Assessment**

Old Victoria – Grenier Lands Slope, London, ON

July 2017  
Reissued March 2019

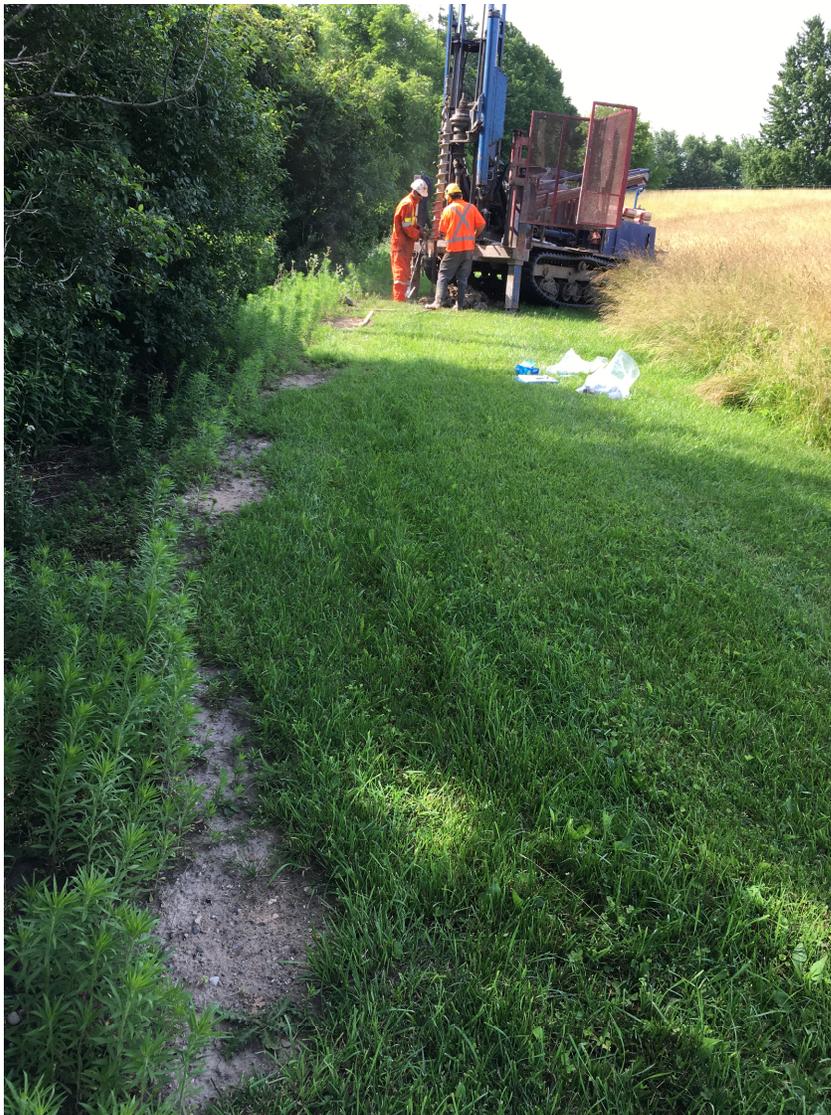
Photo 1 – Tableland and slope crest at Borehole BH1.

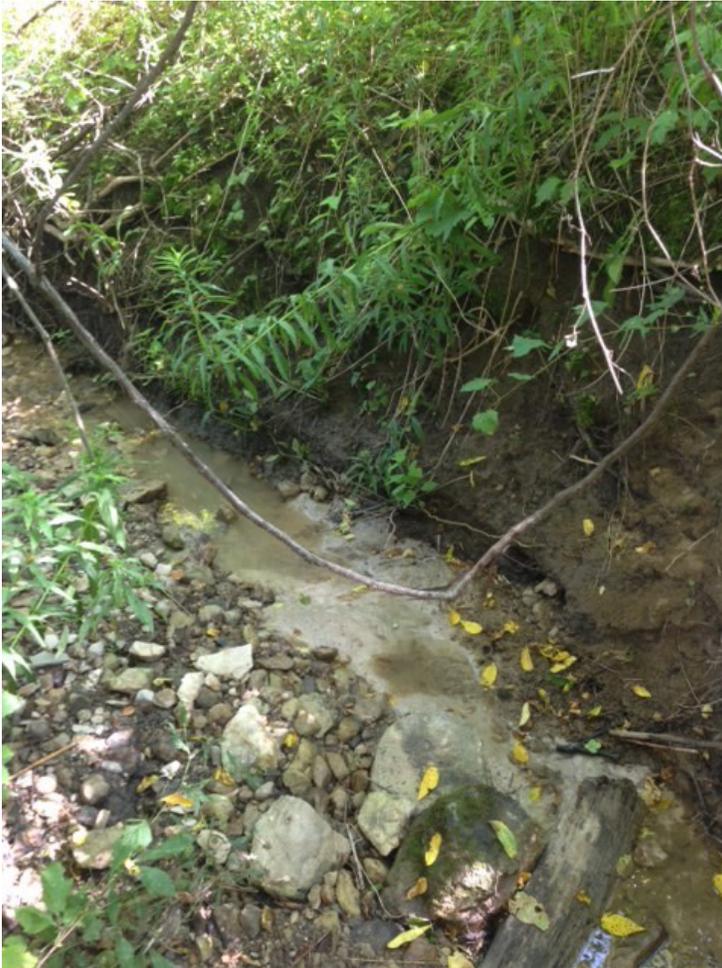
Photo 2 – Drainage Creek Base

The slopes along the watercourse are well vegetated, with a mixture of young and mature trees, and heavy brush. No overturning or bending of the existing trees was observed. This is a sign that significant movement of the soils in the slope has not occurred.

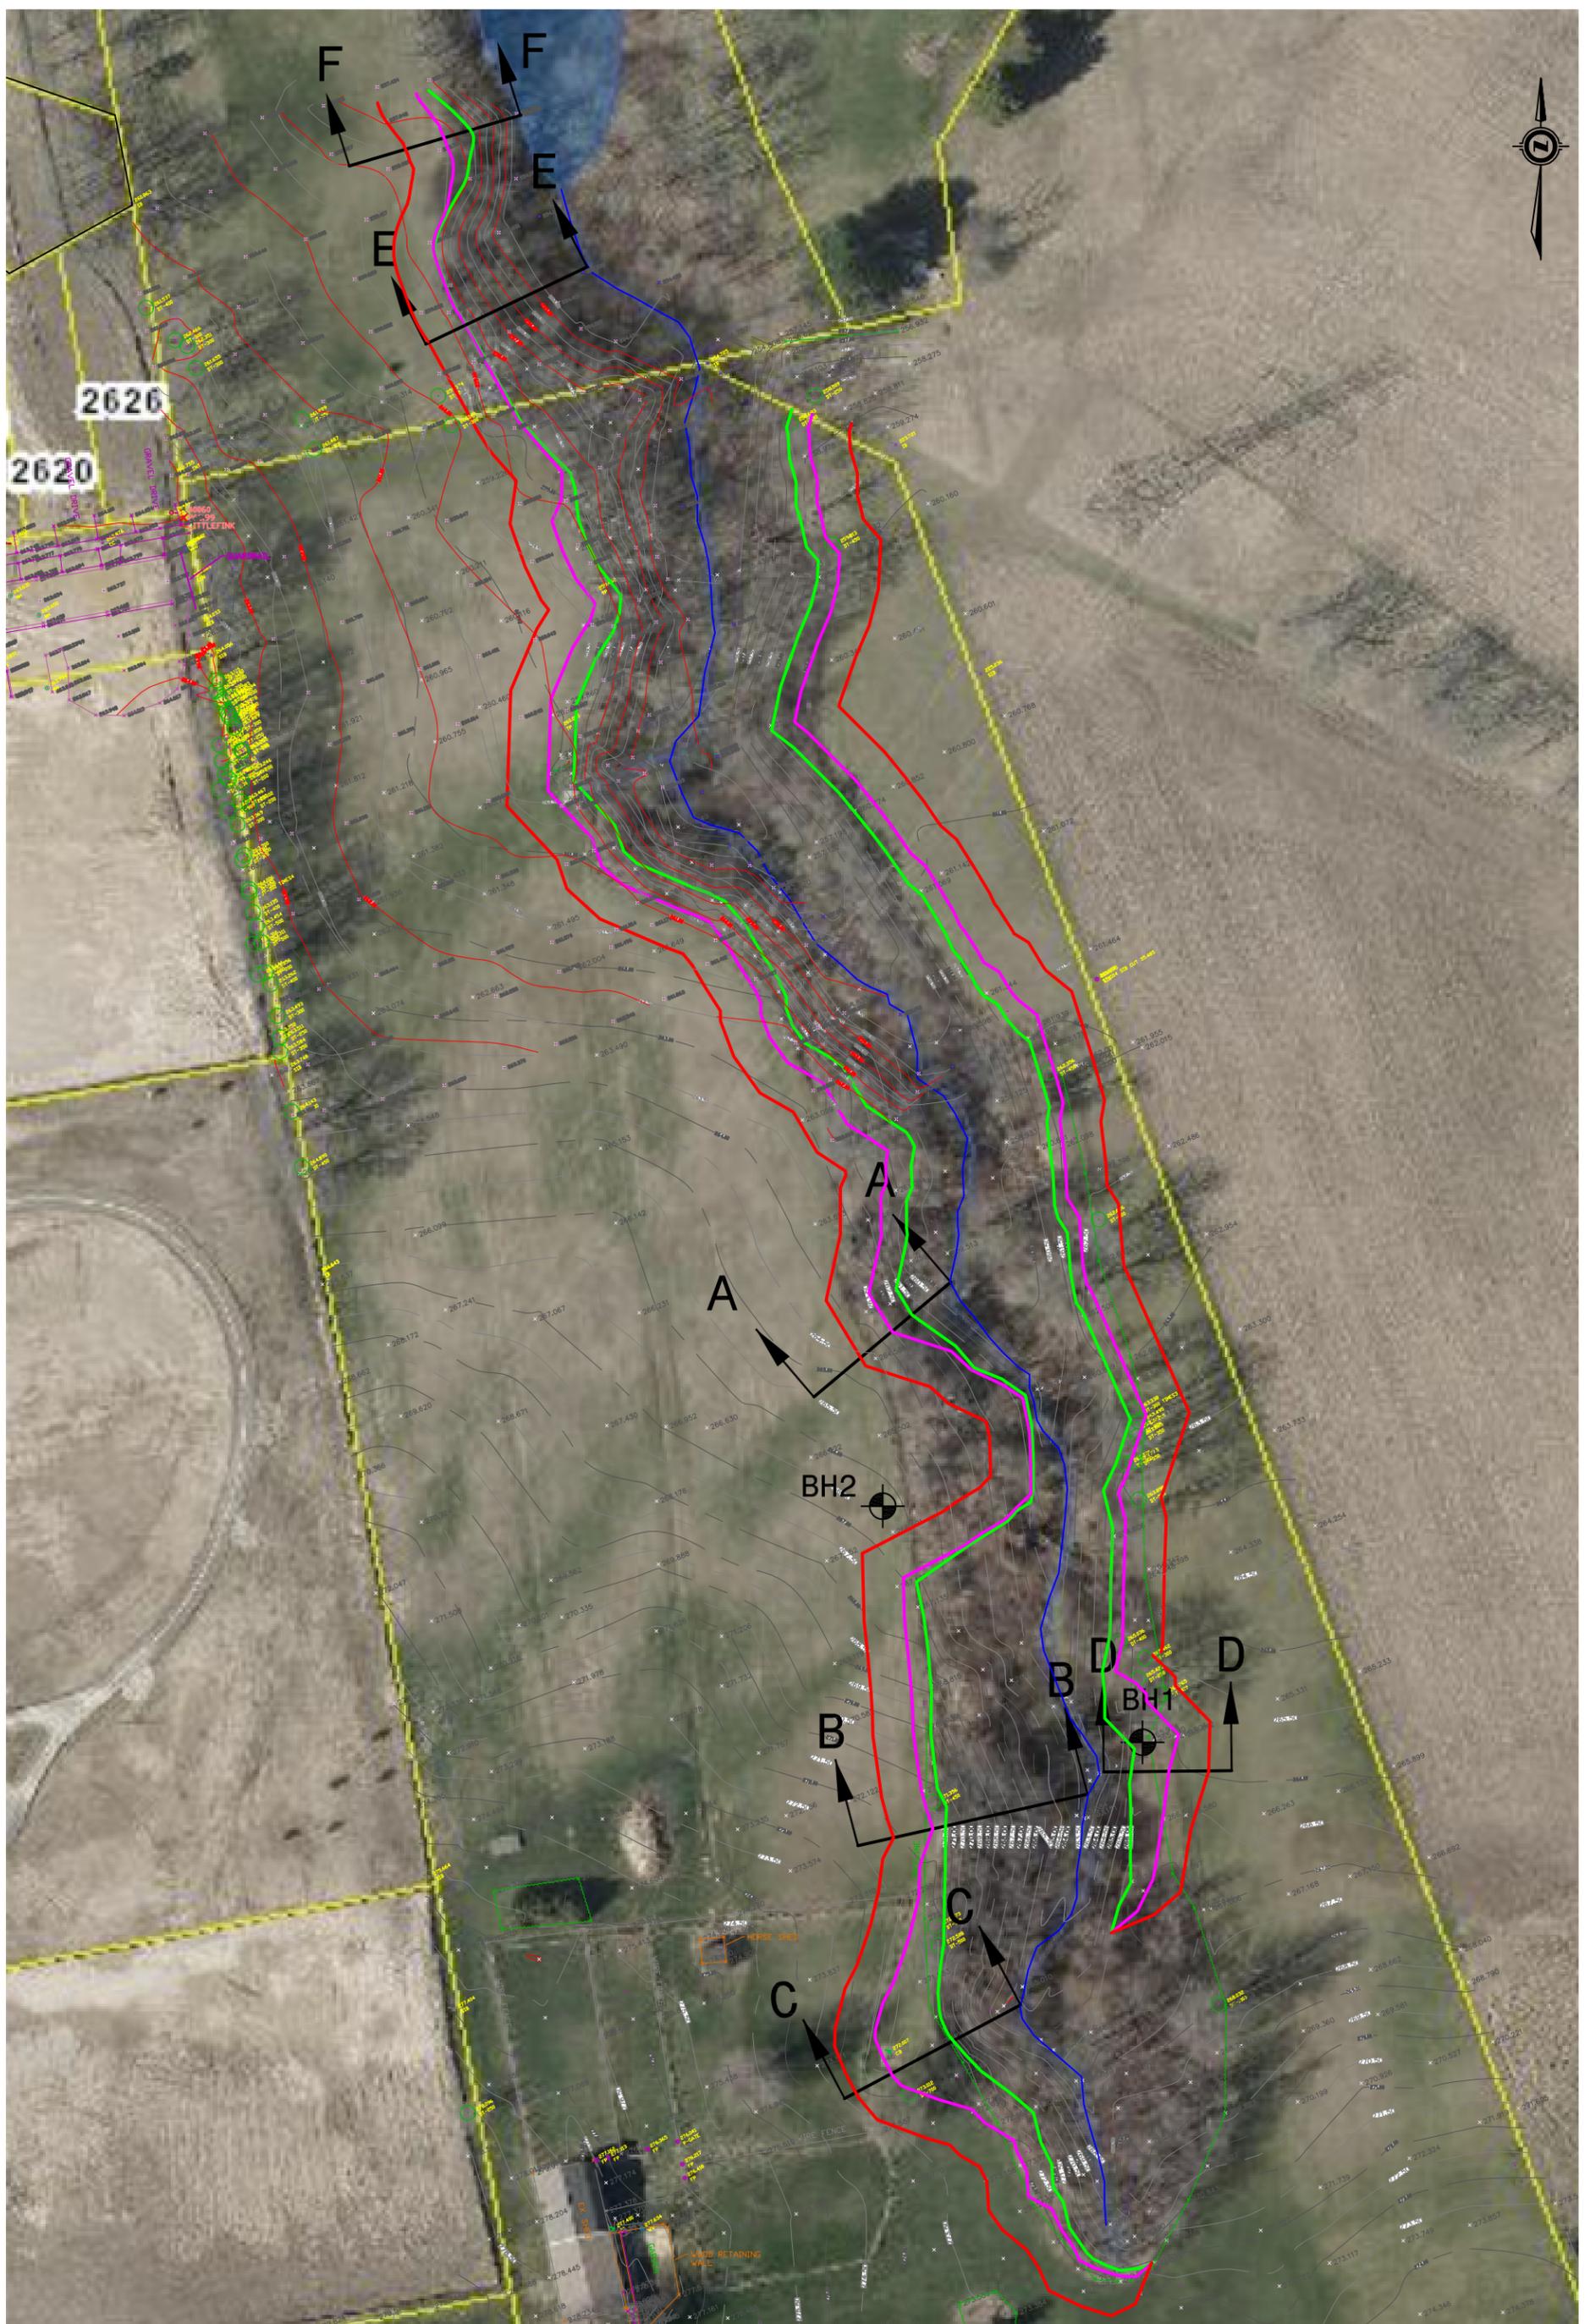
The setback distance from the slope crest varies slightly along the slope, based on the overall slope height and inclination, and the type and amount of toe erosion at the base of the slopes. Further, the inferred location of the Erosion Hazard Limit setback line is provided on Drawing 1 for review and consideration.

3. Any buildings and permanent structures associated with the proposed site development must be located outside of the Erosion Hazard Limit, which is identified on the Site Plan. The Cross Section drawings helps identify the location of this line.

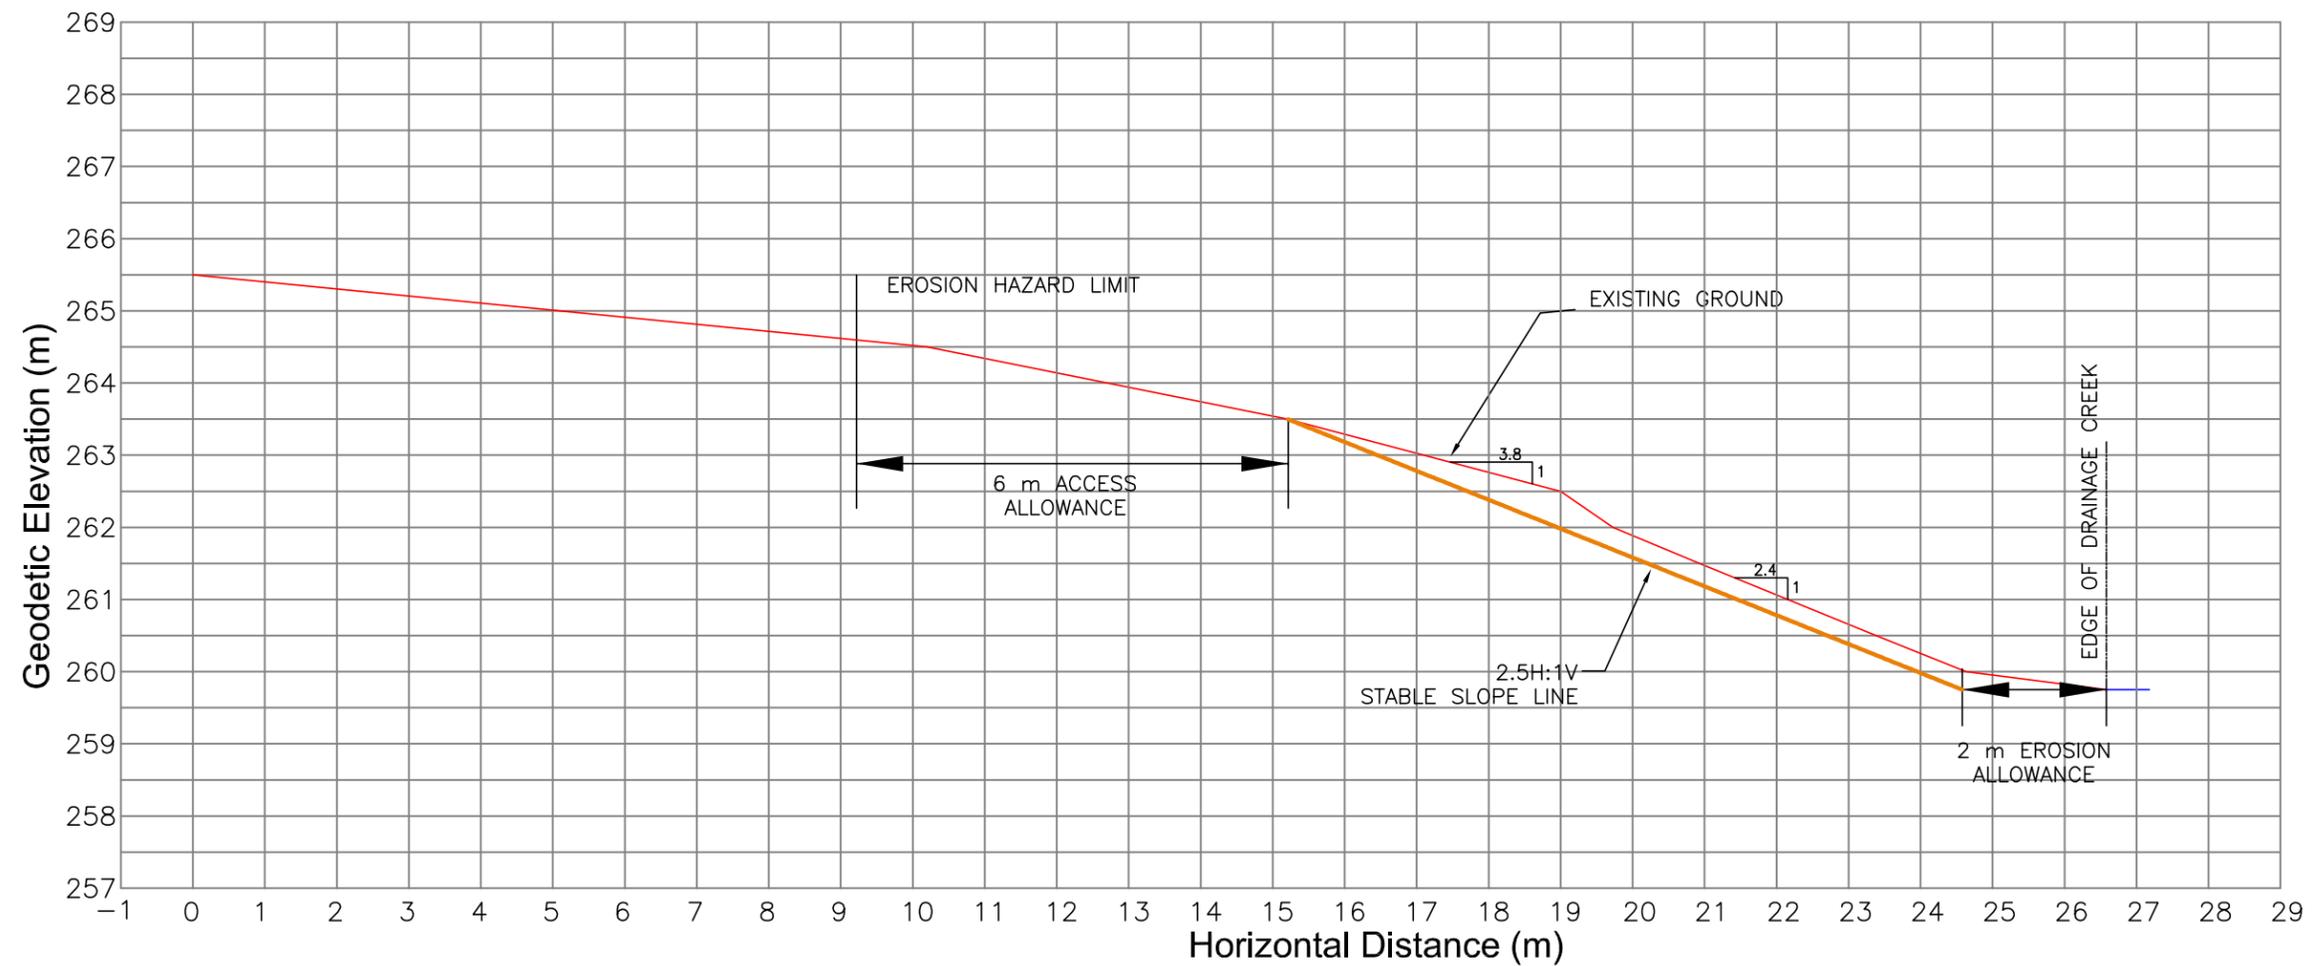
<b>Cross-Section Condition</b>	<b>Computed Factor of Safety</b>
Slope Section, A-A:	1.70
Slope Section, B-B:	1.52
Slope Section, C-C:	1.52
Slope Section, D-D:	1.97
Slope Section, E-E:	1.90
Slope Section, F-F:	1.57
