VanBoxmeer & Stranges Ltd.

July 5, 2019
VB&S #: 19158

JAM Properties
Structural Review and Comments
123 Queens Avenue
London, Ontario
SUPPLEMENTAL REPORT #1

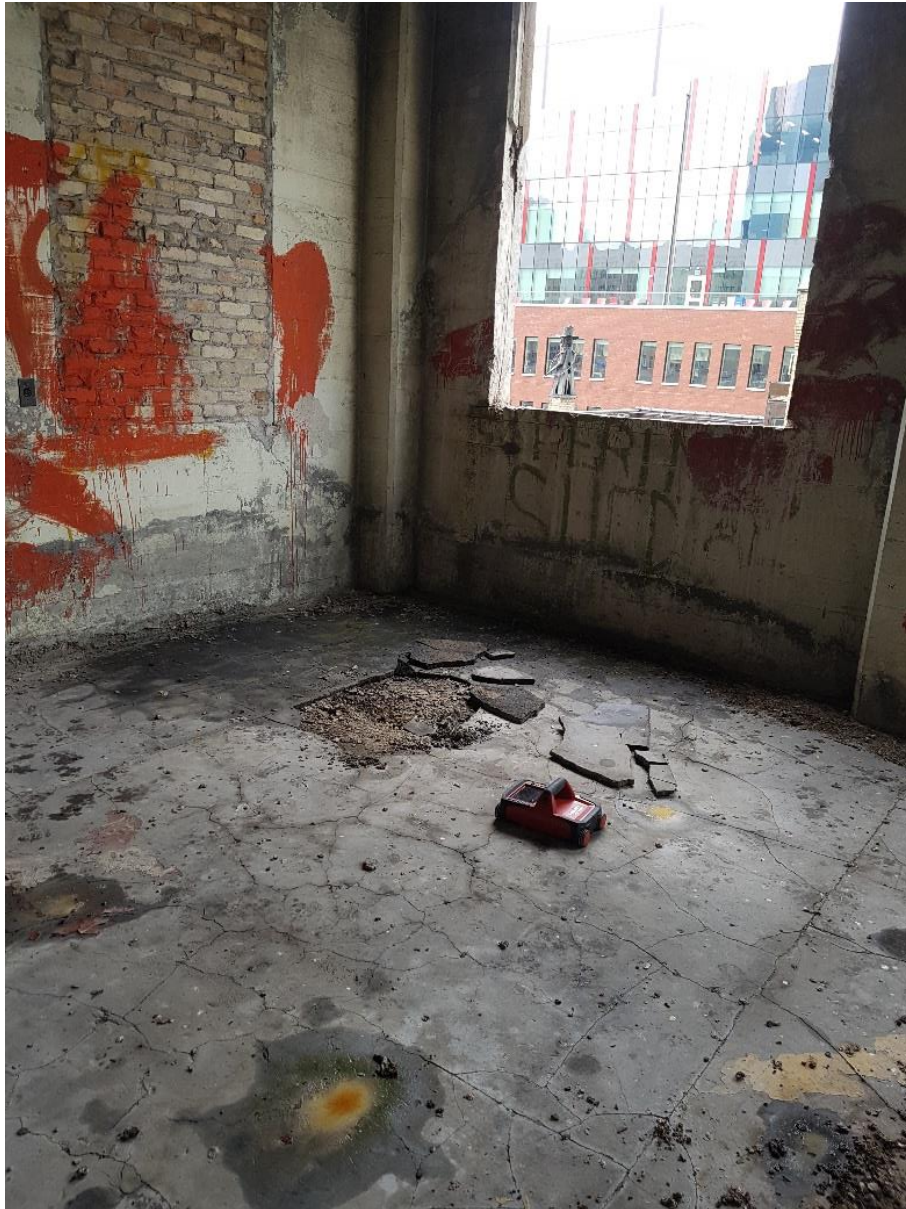
Upon arrival at the site, located at 123 Queens Ave, London, Ontario, it was observed that the building is an old concrete building with obvious signs of severe cracking in the walls and the suspended floor slab area. Inspection of the suspended floor slab, at some areas, indicated that a thin layer of asphalt with approximate thickness of 25 mm was overlying the concrete floor slab where rebar was observed at approximately 150 mm from top of the slab. Upon trying to core-drill, the concrete crumble and broke into pieces.

Photograph No. 1 – Severe Concrete Floor and Wall Cracks

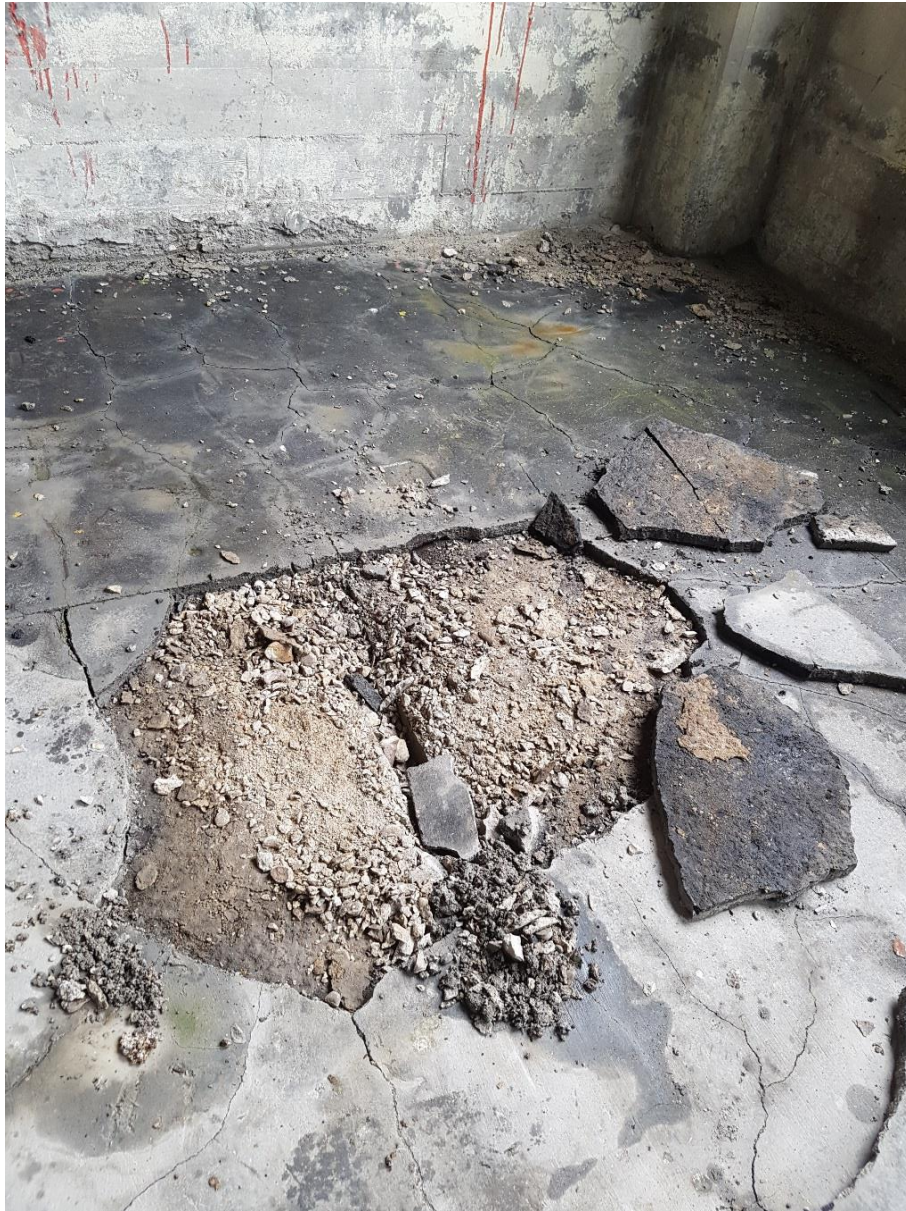
Photograph No. 2 – Asphalt Layer Overlying the Poor Concrete Floor Slab

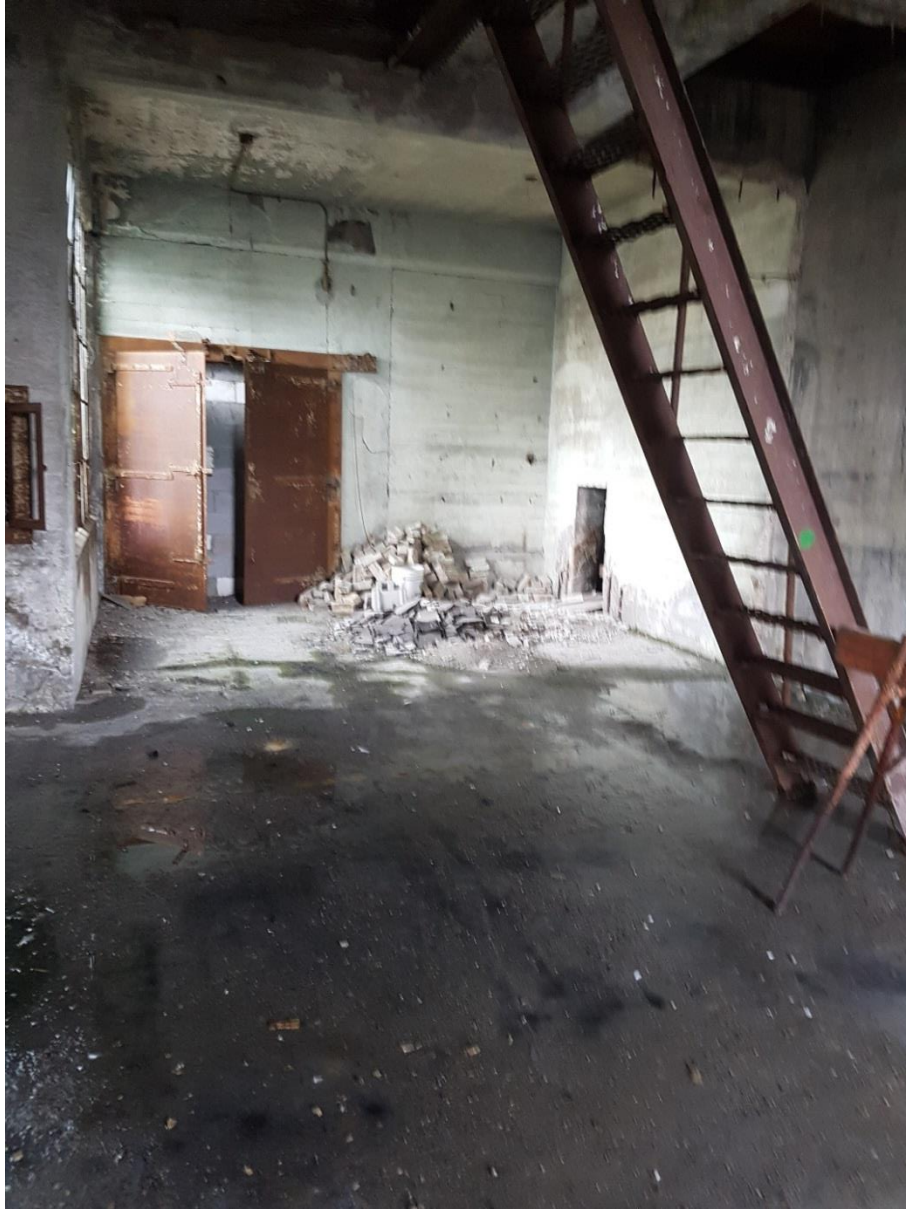
Photograph No. 3 – Overall Picture Showing Poor Concrete Floor and Wall Conditions

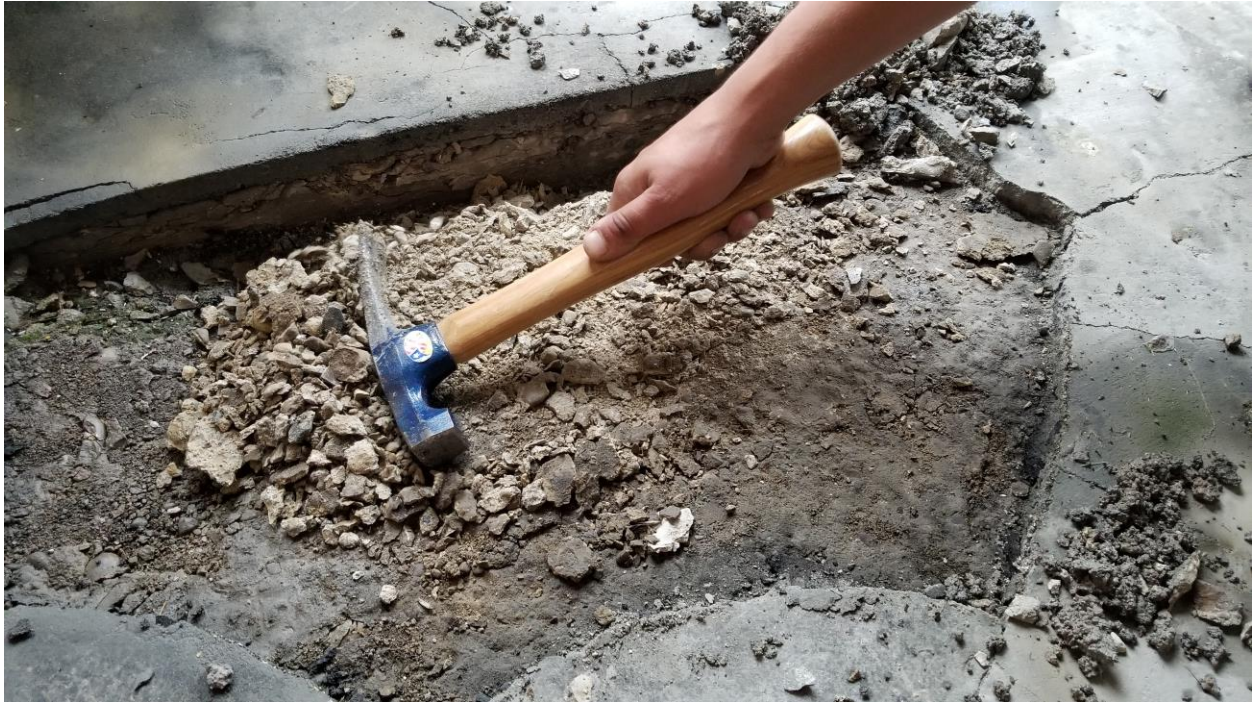
Based on our observations during the attempt to extract core samples for testing, the slab concrete has deteriorated to the extent that sound (or intact) concrete core samples could not be extracted. The fact that the concrete easily crumbled into pieces upon core-drilling is indicative of deteriorated concrete with extremely low compressive strength. From a concrete material view point, the concrete slab is not suitable for the purpose for which the structure was designed. A structural analysis/evaluation should be carried out to assess the remaining service life, if any.

Photograph No. 4 – Broken Pieces/Crumble of Concrete Floor Showing Unsuitable Coring Conditions

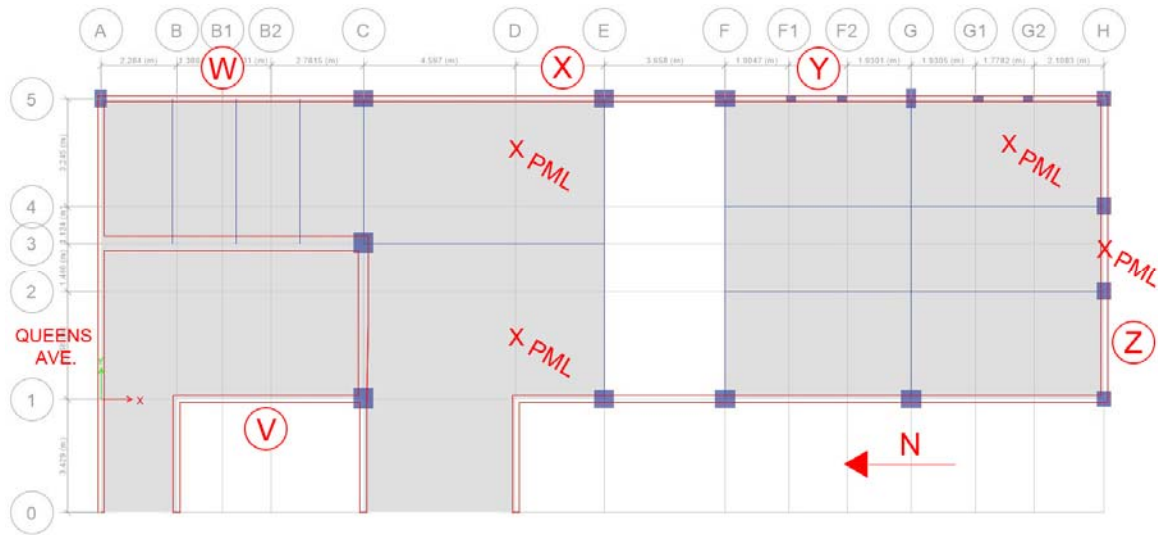
Figure 3 - 3rd Floor Framing Plan

Peto MacCallum Ltd. (PML) was requested by VB&S to obtain samples of the concrete structure and report on the integrity of the concrete. On June 13, 2019, two PML technicians met with Michael Hatt on site. PML attempted to take concrete samples at three slab locations and one wall location on the third floor of the building. See Appendix ‘B’ Figure 3.

PML reported that the concrete was in such poor condition that proper samples could not be cored and sent to the lab for analysis. Due to the severe deterioration and delamination of the concrete, PML abandoned taking additional samples from the remaining floors. It was reported that attempting to obtain additional samples would be useless as the crumbled and broken concrete could not be tested. Photographs #2 and #4 of the PML report show the condition of the delaminated concrete, where asphalt topping was removed. It was verified by both VB&S and PML that the concrete was severely deteriorated and spalled.

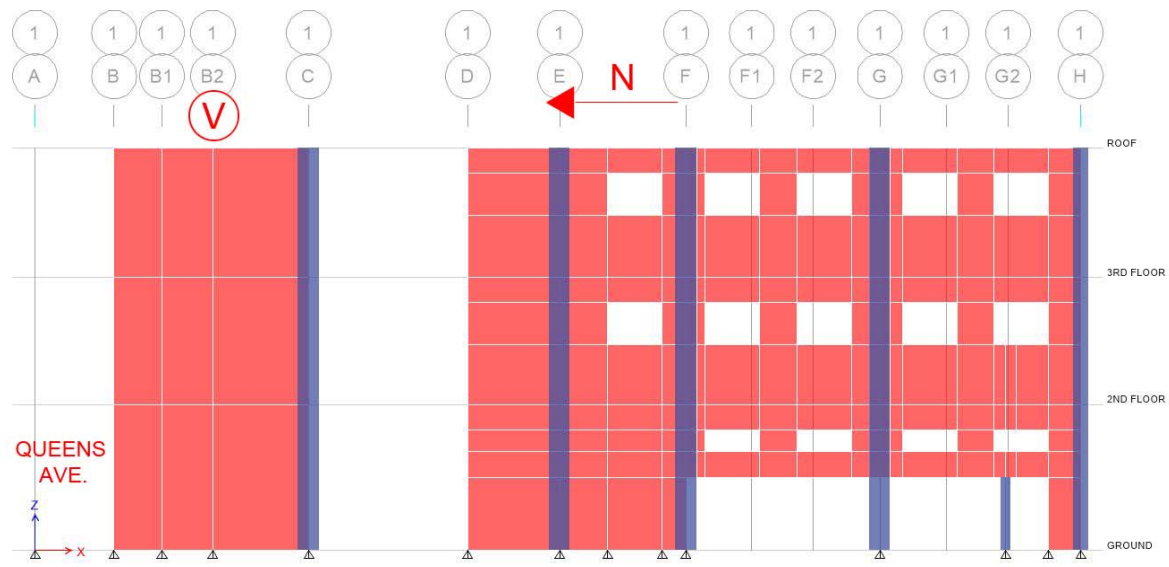
Figure 4 - Gridline 1 Elevation

Design Inadequacy Message: Pier fails in flexure or P-M-M interaction !!

LOCATION V: ETABS Results for Wall on Gridline 1 From B to C

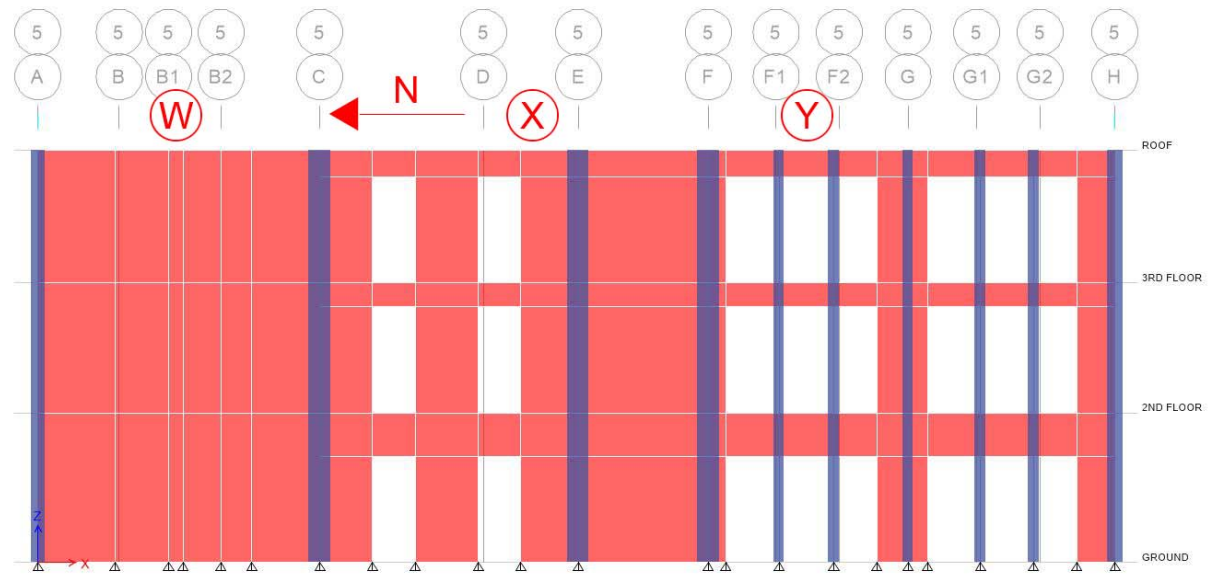
Figure 5 - Gridline 5 Elevation

Design Inadequacy Message: Pier fails in flexure or P-M-M interaction !!

LOCATION W: ETABS Results for Wall on Gridline 5 From A to C

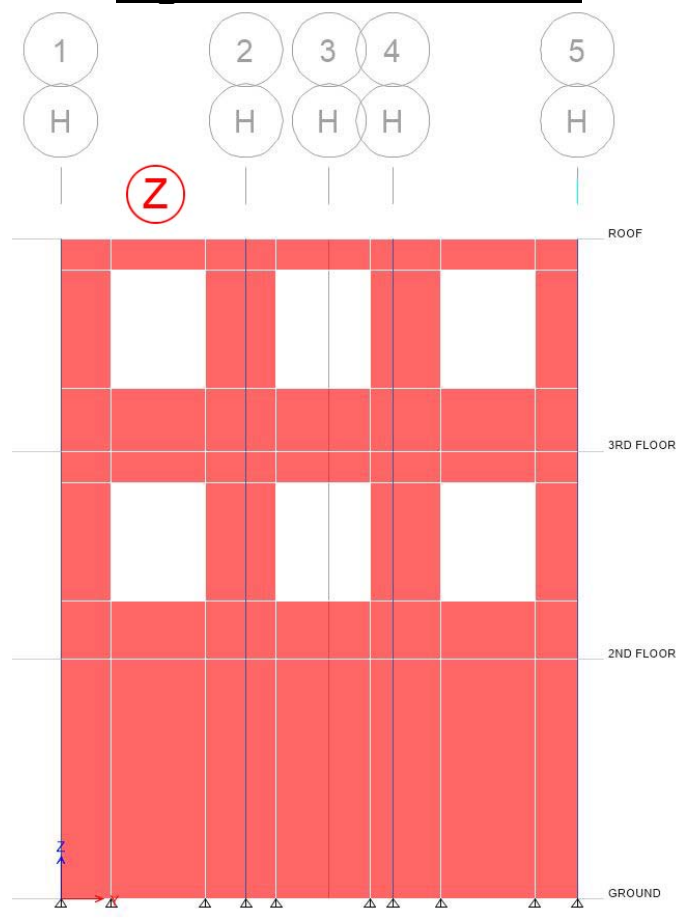
Figure 6 - Gridline H Elevation

LOCATION Z: S-Concrete Results for Wall on Gridline H From 1 to 2 – Page 1
