Subject Lands Status Report – Springbank Drive

dated March 21, 2013

Reviewers: F. Cirino, B. Maddeford, G. Sass, N. St. Amour
January 14, 2014

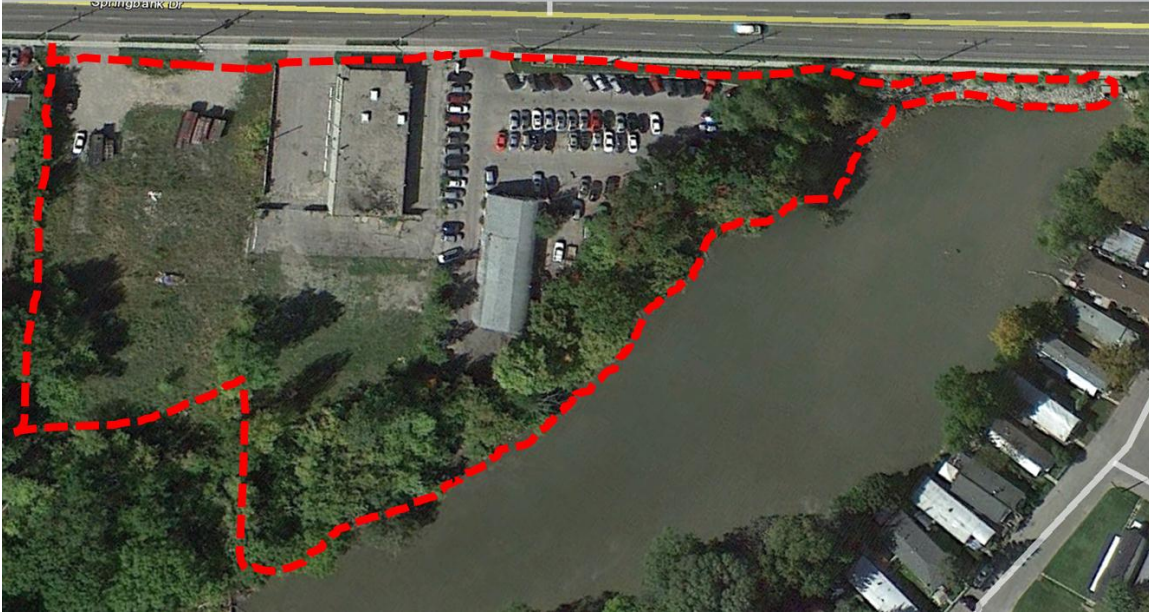
Recommendation 3: The ESA boundary must be identified within the context of this SLSR. Just based on a simple desk-top analysis the drip-line of trees certainly extends beyond the ESA boundary shown in the SLSR (which was taken from another study)(Figure 1).

Figure 1: Subject lands viewed from above during the summer (Source Google).

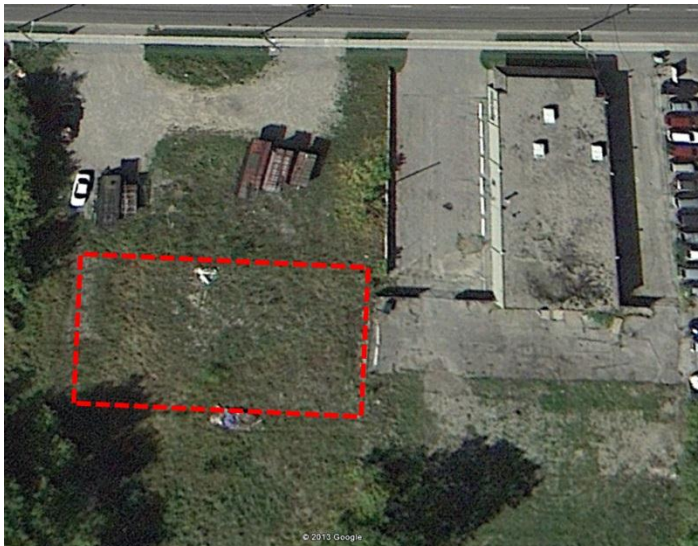
Given its former use as an auto-dealership and auto/bus service site, there is ample concern to carry out soil testing for contaminants. A brownfield assessment is necessary which may also determine if brownfield pollution is affecting the ESA currently. (The SLSR calls for soils testing during the EIS, however, it should be the job of this SLSR to undertake that study.)

Figure 3: Footprint of former bus repair building (Source Google).

Recommendation 4: Appropriate soil testing is necessary to determine the level of soil contamination. Soils may be compacted now, but during excavation contaminants may be disturbed and may be washed into the West Pond of the Coves.
