TO:	CHAIR AND MEMBERS LONDON ADVISORY COMMITTEE ON HERITAGE MEETING ON WEDNESDAY, SEPTEMBER 10, 2014
FROM:	JOHN M. FLEMING MANAGING DIRECTOR, LAND USE PLANNING AND CITY PLANNER
SUBJECT:	APPLICATION BY: B. JEFFERY 317 HYMAN STREET

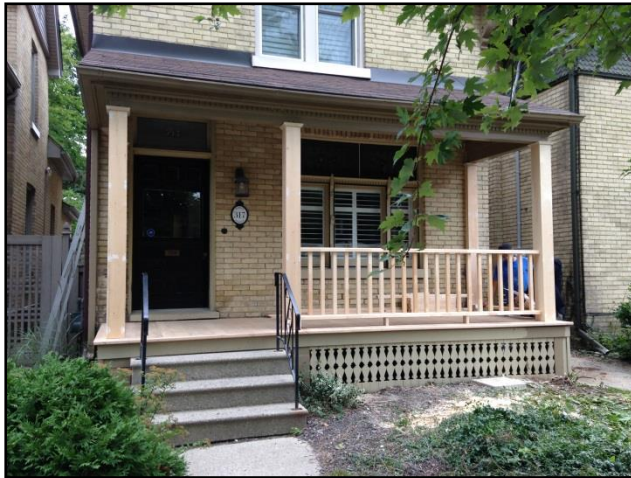
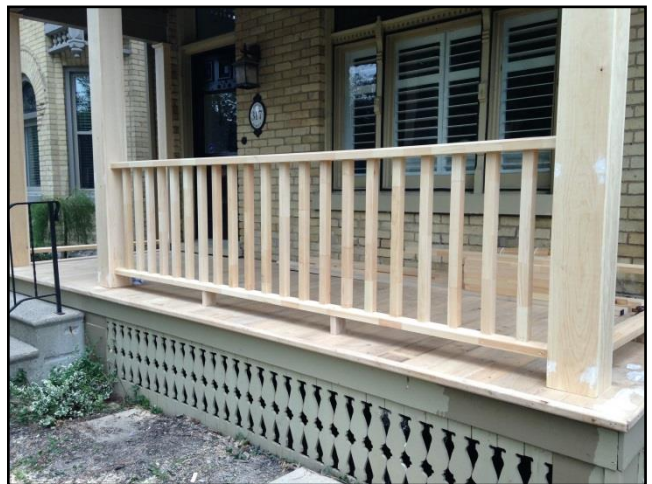
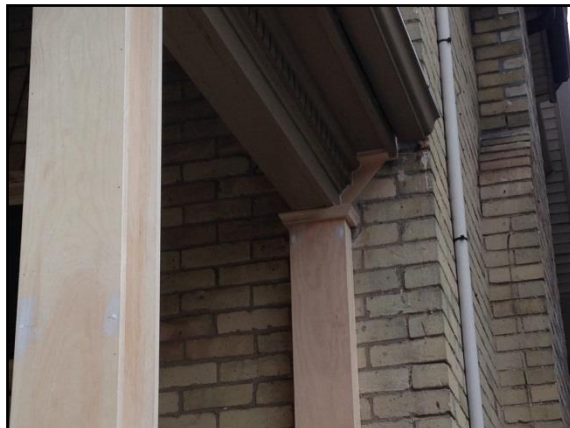
Appendix 2- Photos- 317 Hyman Street
(Showing recent changes)

Unauthorized alterations to the front porch were noted and are shown in the pictures. (Appendix 2) The owner and contractor indicated that they were unaware of the need for alteration approval and had initiated the changes in response to elements which had deteriorated. Specifically, they indicated that the plywood porch decking required replacement and that rails had been constructed preventing the drainage of water from the deck leading to damage to the wood on the deck and in the rails and lower ends of turned spindles. Further, it was indicated that some deterioration was apparent in the turned columns. Rails, spindles and columns were removed prior to any consultation

Alterations have been made with the removal of the previously existing rails, spindles and columns. Some visual information suggests that there have been some changes to the porch in the past. The removed columns may have been placed over later posts and the boxed base element may have been designed to cover deteriorated column bases.

The replacement spindles and columns represent the most significant change to the porch. Whether those removed were original or not, they were present at the time of the creation of the

District. Notwithstanding this, the style of the replacement spindles is not uncommon on the streetscape. Squared wood- faced columns can be found elsewhere also. Both will be painted.

It is recommended that this application be approved with respect to the alterations already made but that the request for shutters not be approved unless it can be demonstrated that such shutters were original to the house.
