то:	CHAIR AND MEMBERS PLANNING & ENVIRONMENT COMMITTEE
FROM:	JOHN M. FLEMING MANAGING DIRECTOR, PLANNING AND CITY PLANNER
SUBJECT:	REQUEST FOR DEMOLITION BY D. CHARABIN HOLDINGS 471 - 473 ELIZABETH STREET PUBLIC PARTICIPATION MEETING ON TUESDAY, SEPTEMBER 23, 2014: NOT BEFORE 5:00 P.M.

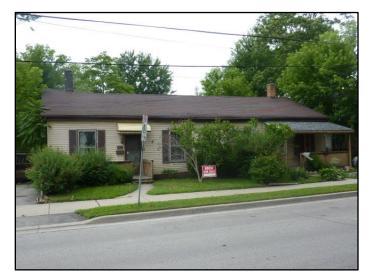
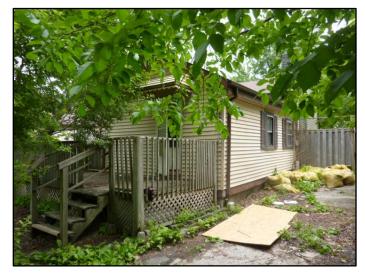
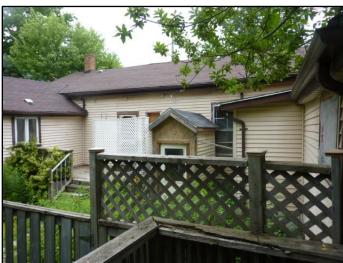
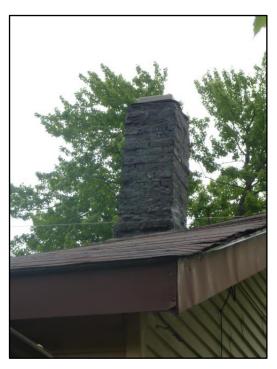
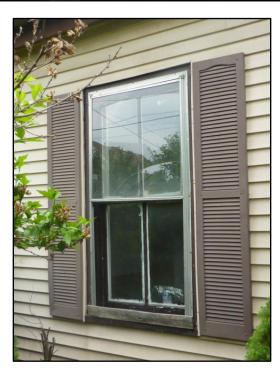
Appendix 2: Photos - 471-473 Elizabeth Street

Information provided by the owners included photographs and a summary of a home inspection report completed in May 2014. (No engineer's report has been provided.) The home inspector inspected the plumbing system, the electrical system, heating and air conditioning systems, roof cover and other elements and reported in each instance that repairs or replacement were needed. Specific defects noted: standing water in the basement resulting from burst frozen supply pipes; an electrical system in need of major repair; potential fire hazard in the heating system which were beyond their life expectancy; a foundation with "serious defects"; doors, windows and ceilings falling or collapsing; and defective roof coverings requiring replacement.(Appendix 2 Photos)

An exterior visual inspection by staff in July of 2014 confirmed the information related to roofing issues and suggested also that the building had been vacant for some time. Doors and windows were boarded up preventing interior access on that visit. Subsequently, the owners provided some interior photos. (Appendix 2)

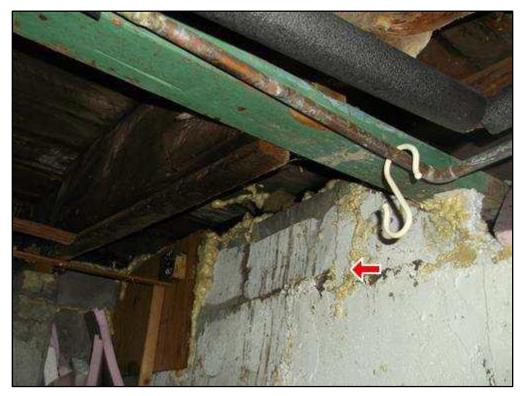
(basement foundation wall issue)

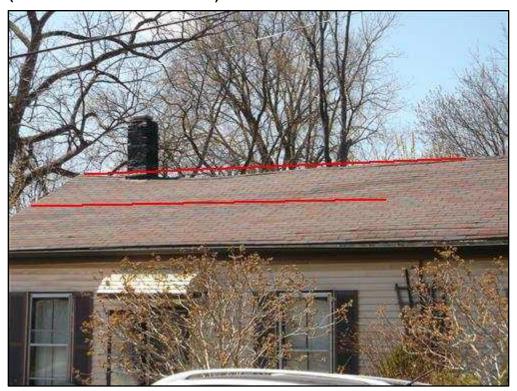
(roofline issues)
