TO:	CHAIR AND MEMBERS PLANNING & ENVIRONMENT COMMITTEE
FROM:	JOHN M. FLEMING MANAGING DIRECTOR, PLANNING AND CITY PLANNER
SUBJECT:	DEMOLITION REQUEST 445-447-449 DUNDAS STREET D. SHINKELSHOEK PUBLIC PARTICIPATION MEETING TUESDAY NOVEMBER 18, 2014

**Re: Structural Condition Survey
 447 Dundas Street, London, Ontario**

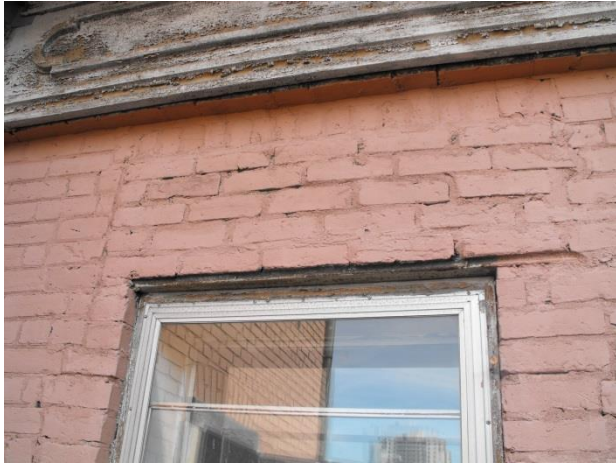
The Structural Condition Survey submitted by the applicant highlighted several concerns regarding the condition of the building located at 445-447-449 Dundas Street (see Appendix 3). It notes movement, particularly at the northwest corner of the building. This movement may be attributed to failure in the soil bearing and/or insufficient frost protection causing frost heave. Evidence of this is seen in the interior and exterior of the building, particularly in the northwest corner of the façade (see Appendix 2, Images 8-11).

Image 8: Evidence of former repair and structural settling in brickwork (October 24, 2014)

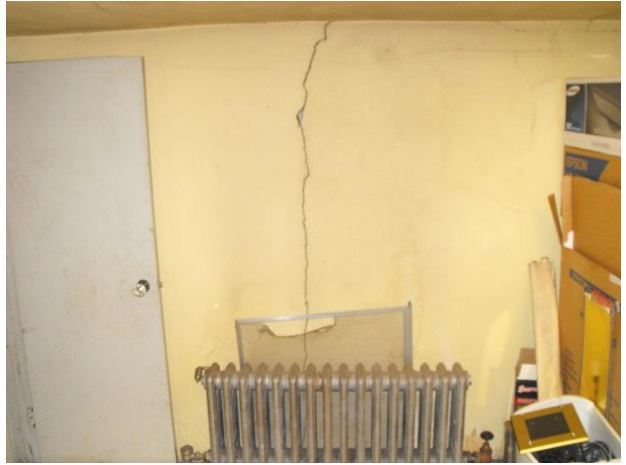
Image 9: Evidence of settling is visible on the interior of the building (October 24, 2014)

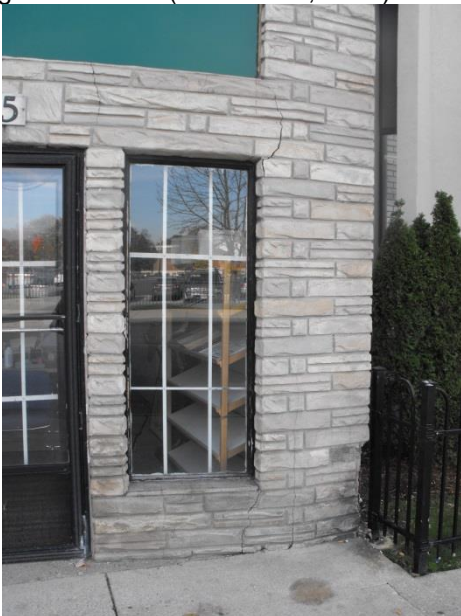
Image 10: Vertical stress is particularly evident at the northwest corner of the building (October 24, 2014)

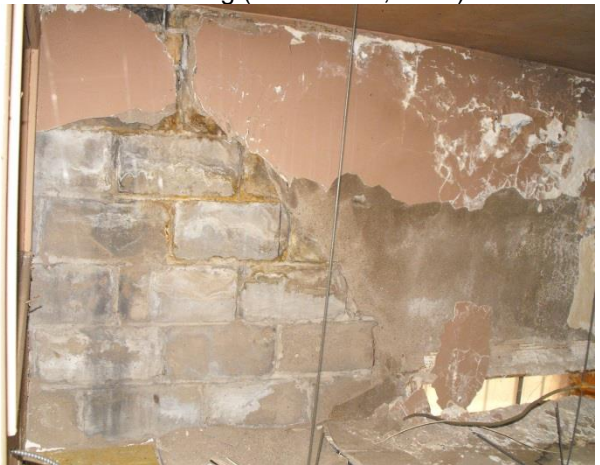
Image 11: Evidence of moisture penetration and settling on the interior (above drop ceiling) (October 24, 2014).

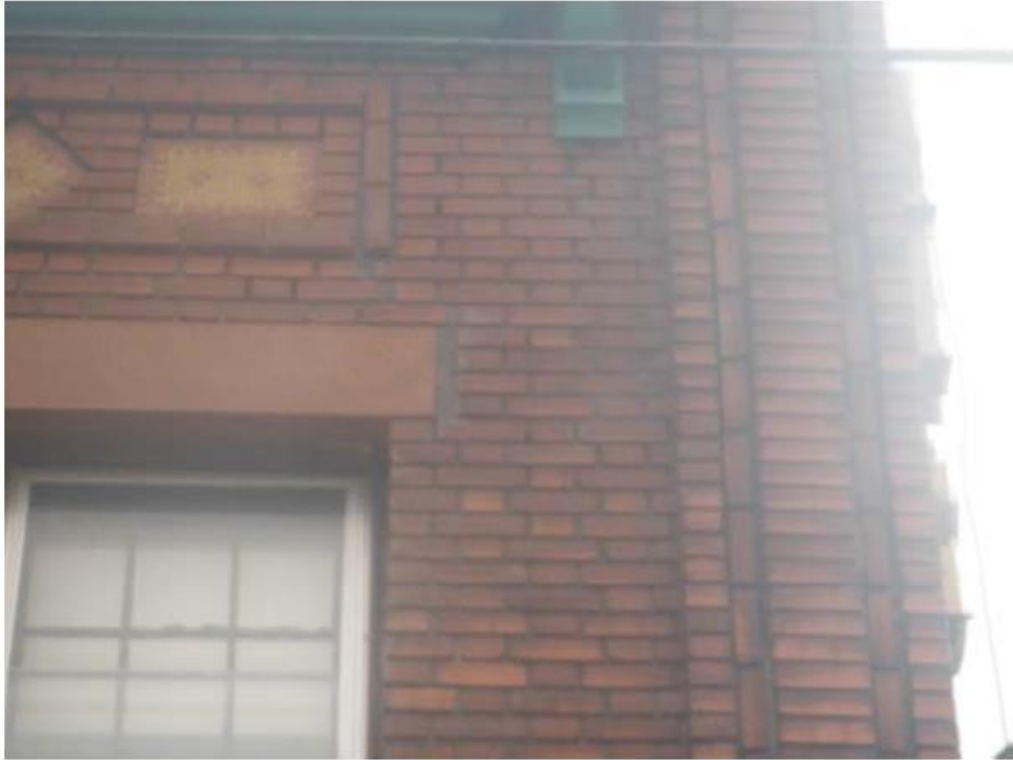
FIGURE 3

The building appears to have undergone movement in the north-west corner, see Figure 3, 4, 5. Work has been completed to accommodate the brick movement with partial re-parging of the front fascade. Reasons for the movement may be attributed to, failure in the soil bearing and/or insufficient frost protection causing frost heave.

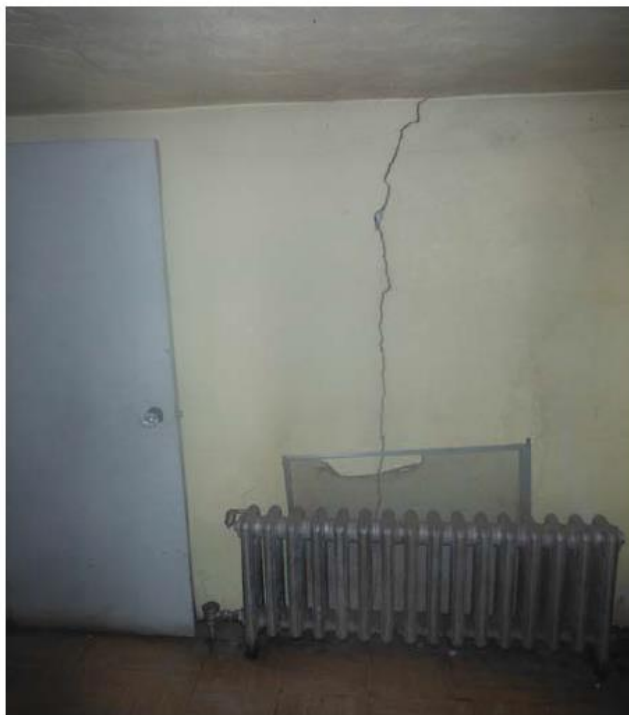
FIGURE 6

Several cracks are located in the load bearing walls, as seen in Figure 6, 7, 8 are most likely to due to building movement over the past 80+ years.

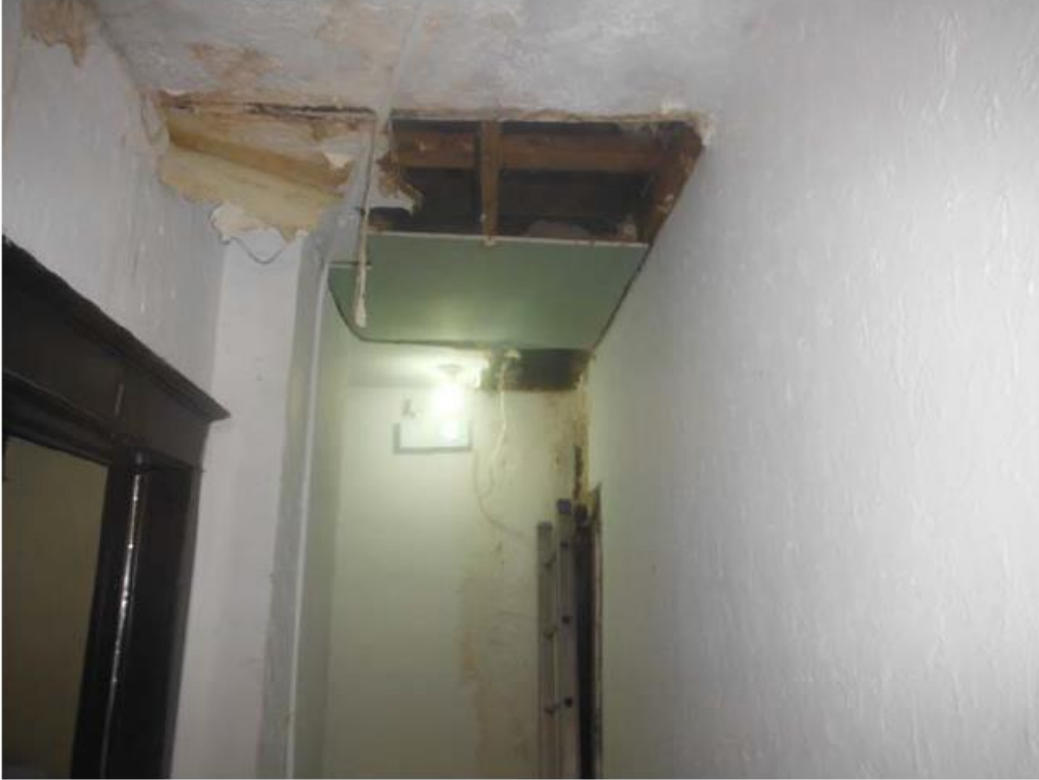
FIGURE 9

At the time of our inspection, water was infiltrating the building causing water damage to the wood framed structure (wood floor/roof) as noted in Figure 9, comprising the structural integrity of the wood framing and load bearing floor joists.

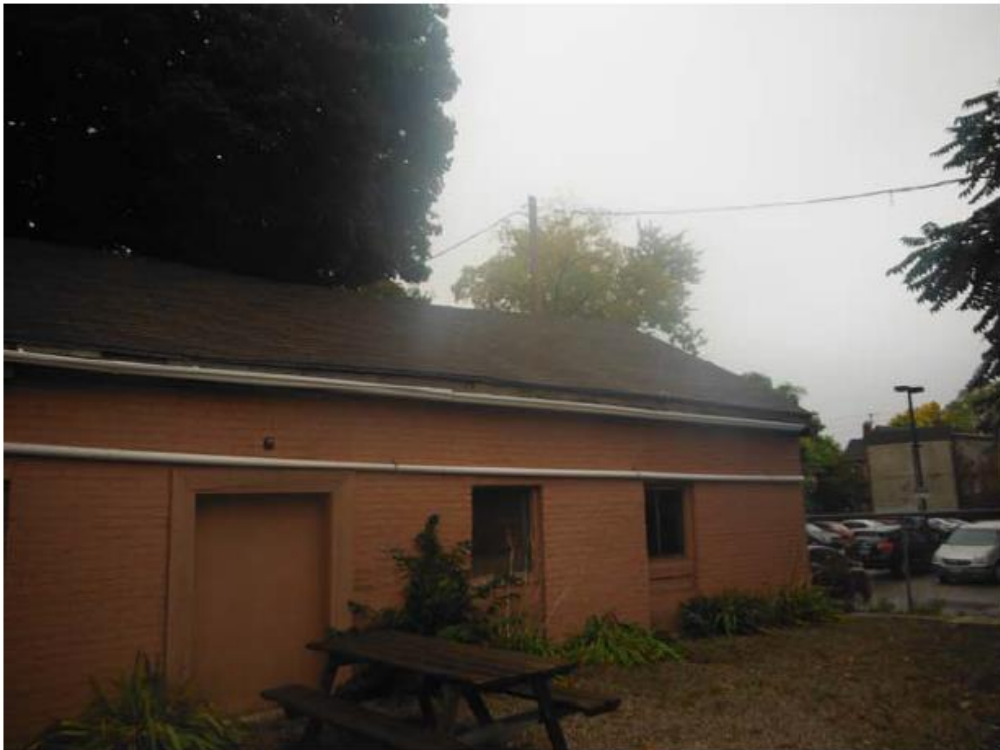
FIGURE 10

The rear roof, seen in Figure 10 appears to have deflected substantially with failure imminent under a heavy wind event or snow fall. This area should be temporarily shored until it can be properly reinforced.
