EEPAC COMMENTS

Southdale Road West Class

Environmental Assessment

Subject Lands Status Report and Environmental Impact study

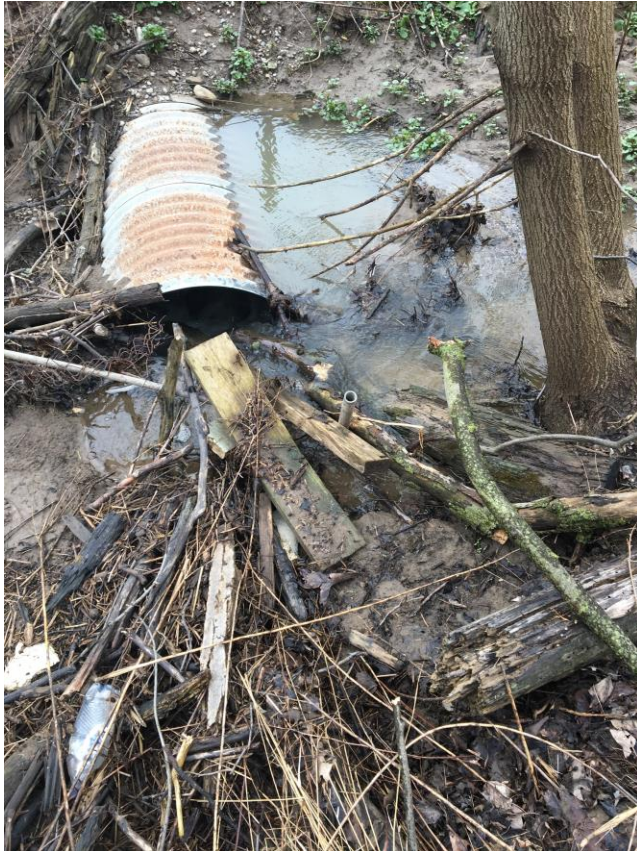
2. The Western Tributary is conveyed beneath Southdale Road West through a Corrugated Steel Pipe (CSP) culvert approximately 650 mm in diameter. After field visits, it was determined that it had become buried and serves as a dispersal barrier for fishes. Based on this, it can be concluded that keeping a culvert of the same size will “limit or diminish the ability of fish to use such habitats as spawning grounds and as a migration corridor” which is a direct violation of the Fisheries act section 4.

Provincial policy statement: Policy 2.1 and 2.2 states alteration of fish habitat is prohibited unless it can be demonstrated that no negative impacts will occur (2.1.5). The current Southdale culvert size is too small and cannot handle flows. Current condition of the culvert is buried as a result of a build up of sediment and detritus around its northern opening (Fig. 1). This build up of debris has cut off much of the opening and future flooding events could result in the complete blockage of the culvert and cause flooding in the surrounding area. As such, keeping it in its current condition will result in negative impacts to fish habitat and culvert size must be address during the design phase.

In the report it is mentioned that there is moderate bank erosion downstream of the CSP and transitions to a poorly defined channel. Much of this erosion and channelization is most likely due to the stream passing through a CSP of 650mm in width. Several studies have shown that too small a culvert actually increase downstream erosion and the major cause of this erosion is most likely the result of this undersized culvert (Booth and Henshaw 2013).

Figure 1. Image of the partially buried culvert on the north side of Southdale Road. The image shows a large build-up of detritus causing the burying of the opening and restricting fish passage.

Recommendation #3: There is an opportunity to enhance (a net gain) the fish habitat upstream and downstream of the Southdale crossing by installing a large box culvert where the Western Tributary goes under the road.
