Report to London Advisory Committee on Heritage

Subject: Heritage Alteration Permit Application by Josef Dolezel
508 Waterloo Street
West Woodfield Heritage Conservation District

Meeting on: Wednesday November 14, 2018

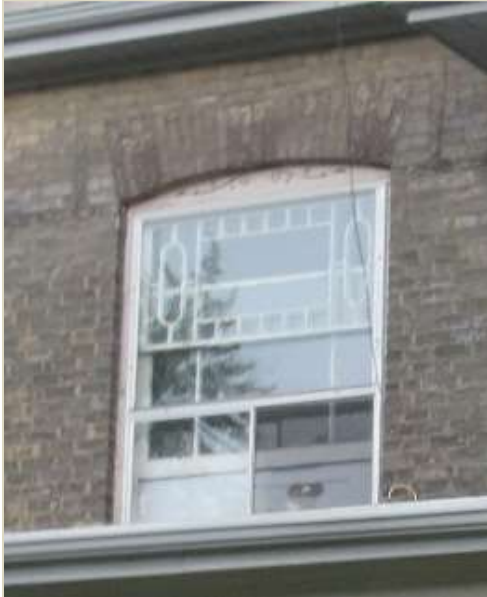
Image 6: 2nd floor, main window c.2016

The second floor main window was an original single hung sash wood window with unique decorative detail. While the original wood framing was retained, the replacement aluminum window has two awning windows with faux muntins. It is clear that the property owner has attempted to replicate the styling of the solarium windows throughout the other replacement windows, but this styling is not similar to the original window. Also, the two new awning windows change the proportions and how the window operates, which does not comply with the conservation guidelines.

- a) The second floor main window replacement should mimic the same style, size and proportions as the original window
- b) The first floor main window should be preserved
- c) The Heritage Alteration Permit be displayed in a location visible from the street until the work is completed.

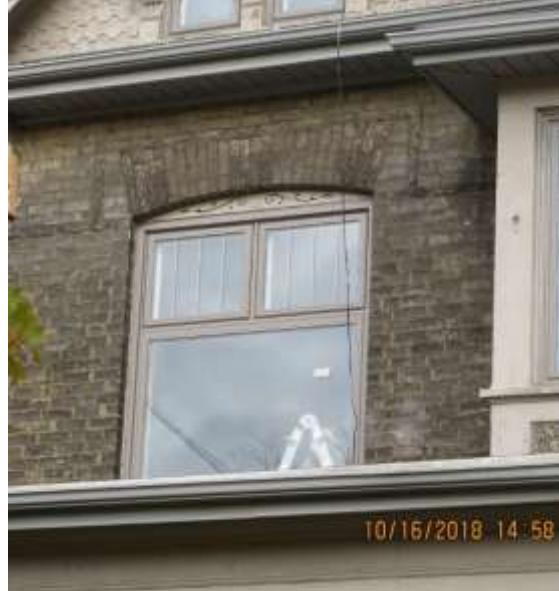
Image 7: 2nd floor, main window – after alteration

The alteration to the second floor main window does not comply with the guidelines as the original window was not preserved and the replacement does not mimic the style and proportions of the original window as directed by the guidelines. The proposed replacement of the first floor main wood window also does not comply with the guidelines as documentation supporting the removal of the window was not provided, therefore the current window can be restored and should be preserved.

To ensure there are no adverse impacts to the heritage character of the West Woodfield Heritage Conservation District, the second floor main window replacement should mimic the same style, size and proportions as the original window and the first floor main window should be preserved.

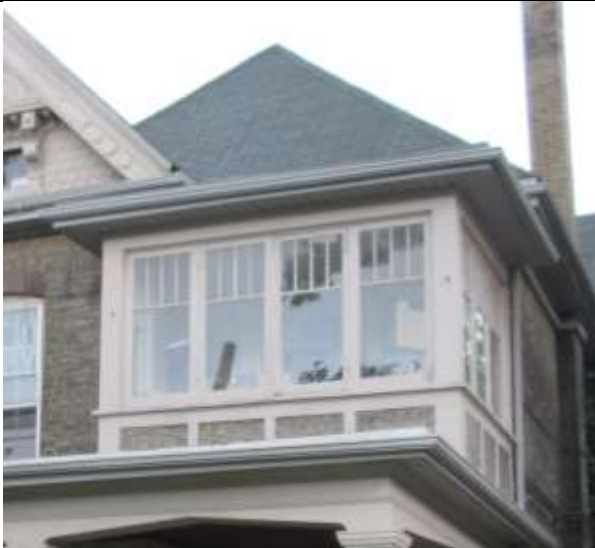
Image 8: Solarium Windows c.2016

Based on the review of guidelines pertinent to this heritage alteration permit application, the attic and solarium replacement windows are in accordance with the guidelines as the windows are similar in style, size and proportions. However, the alterations to the second floor main windows and proposed alterations for the first floor main window do not comply to the guidelines.

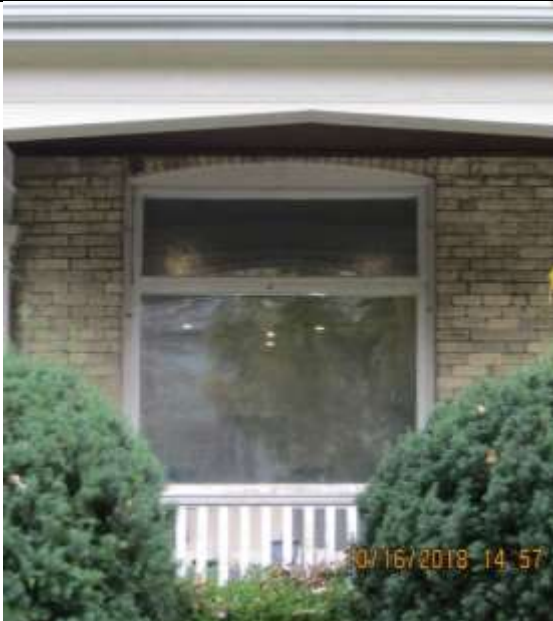
Image 10: 1st floor, main window- present

The first floor main window, which has not yet been replaced, is a single hung sash wood window. The proposed replacement for the first floor wood window is similar to the

window currently on the second floor (an aluminum window that has two awing windows with faux muntins). Documentation supporting the removal of the window was not provided, therefore the current wood window can be restored and should be preserved. The West Woodfield Heritage Conservation District Plan provides the direction to “restore wherever possible rather than replace” and strongly encourages the preservation of wood windows.
