## WESTERLY INTERIOR SIDE YARD SETBACK

# TREE PROTECTION ZONE

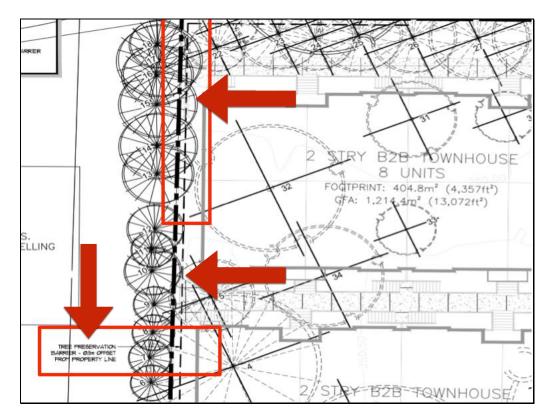
- when side yard setbacks were 1.7m, the original tree plan set the tree protection zone indicated by the dashed line, at 0.5m from the west property line.
- The tree protection zone is supposed to establish the necessary distance required to protect the trees
- Notice how the canopy for the larger trees extend beyond this zone.
- these trees are on the neighbouring property and are not supposed to be impacted by this development.

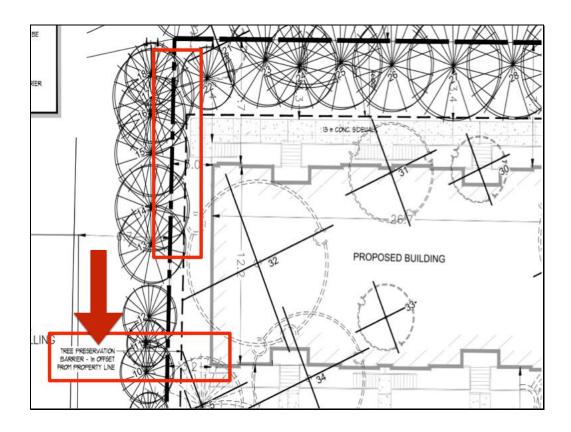
- With side yard setbacks now at 3m, the latest tree plan sets the tree protection zone at 1m
- Which is correct and why is it changing?

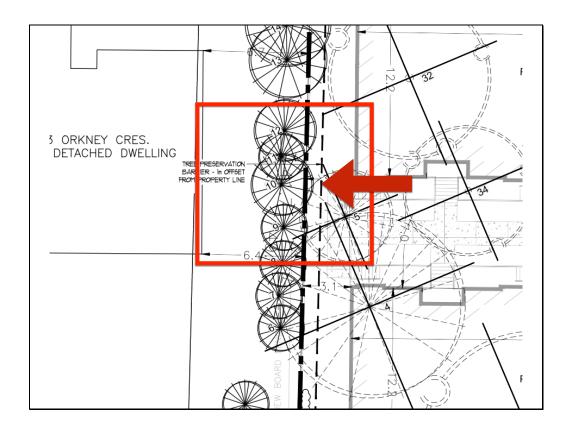
- Focusing on tree #10 located on the 123 Orkney Cres property but close to the shared property line

- The drip line for tree #10 is shown as 2m, which is smaller than several other trees, even though the diameter is the largest in this section at 30cm.

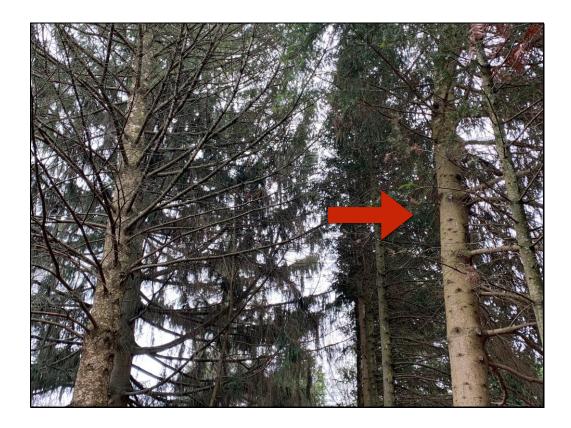
- It appears the drip line measurement for tree #10 was taken based on the canopy on the east side of the tree, which is sparse

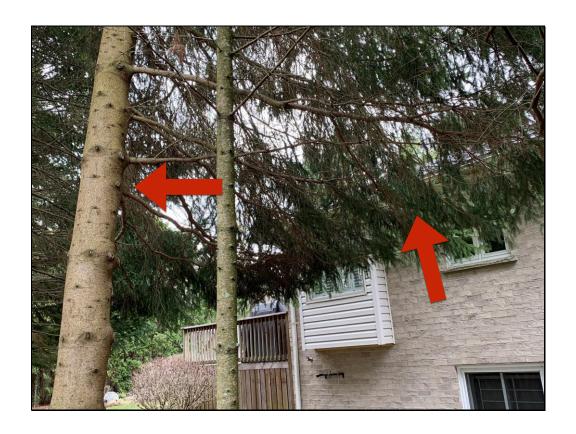
- rather than the west side which is much larger, measuring 3.3m even AFTER PRUNING BY THE OWNER

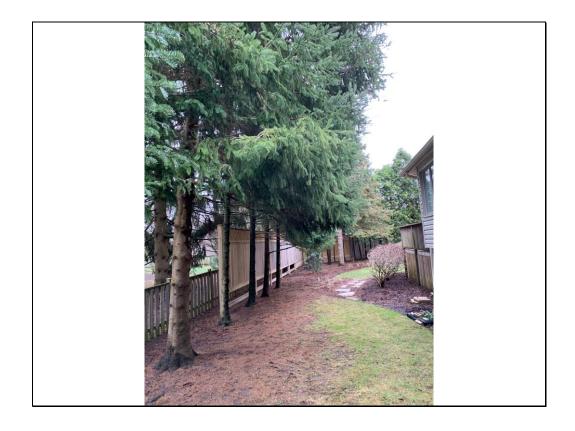
- meaning that the west side canopy should have been considered to establish the drip line of this tree

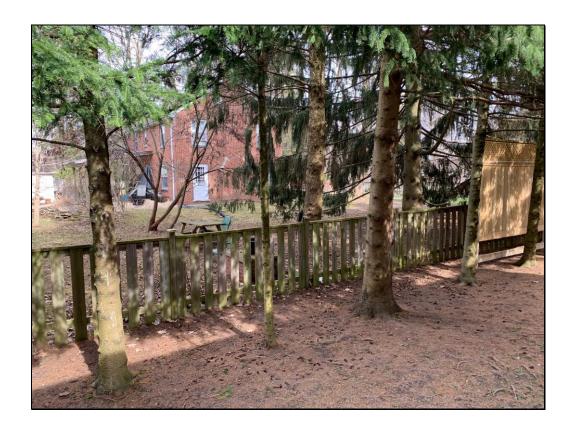
- the majority of the trees on the property of 123 Orkney have been pruned with lower branches/boughs removed

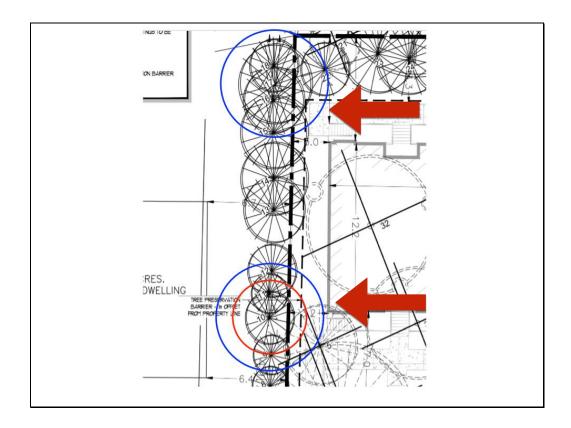
- For tree #10, with a diameter of 34cm, based on up to date measurements, the critical root zone shall be 4.8m

- red circle represents the more recent measurement of tree #10's canopy.
- blue circle represents the DBH method which is recommended in this case
- notice the proximity of the critical root zone to the proposed building at a 3m setback
- notice also the critical root zone for tree #17 near the top and how it extends well past the tree protection zone

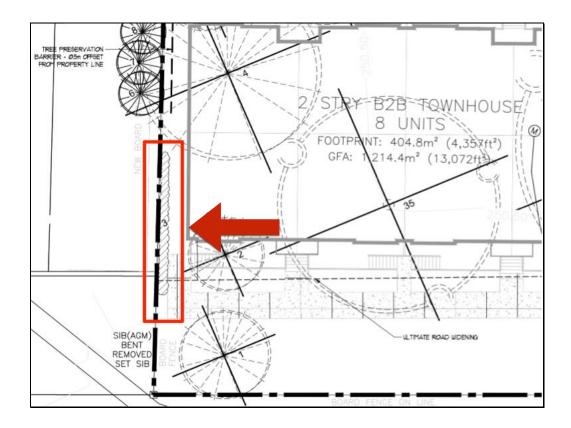
An additional example of the tree report and plan not accurately representing the trees on this site

- this is highlighting cedar hedge #3 from the tree plan.

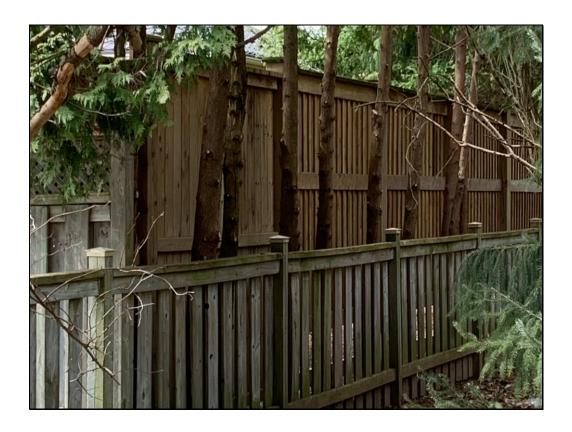
- which is in fact a row of trees

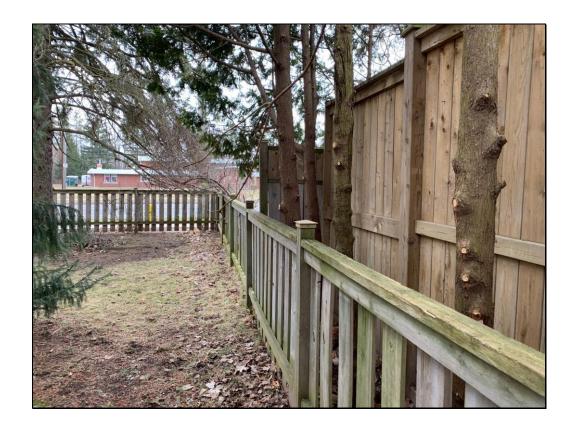
- these trees are located on 123 Orkney Cres property, NOT 536 Windermere as shown on the tree plan

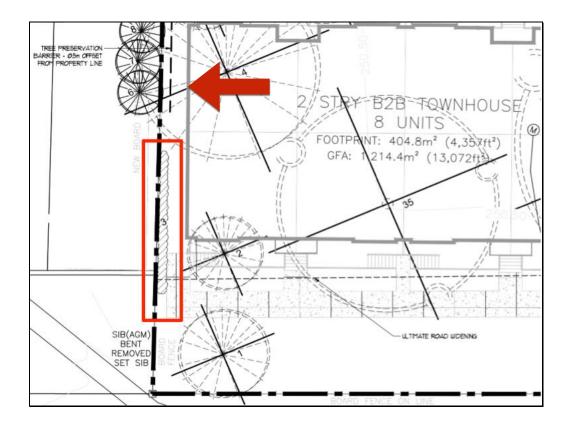
- these trees do not appear to be considered when establishing the tree protection zone, as you can see from where the dashed line ends.

- One of these trees has a diameter of 14cm, and a critical root zone of 3.6m.
- which extends beyond the 3m side yard setback recommended.

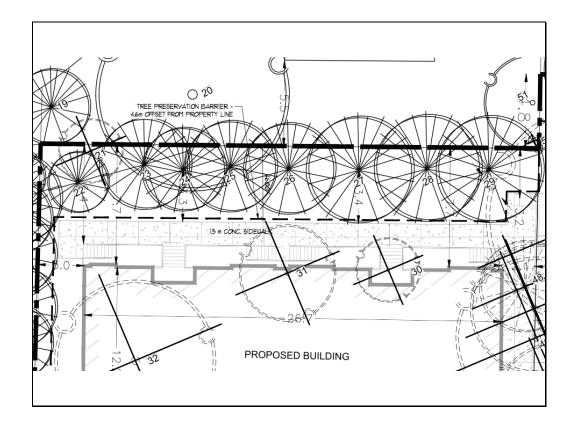
- A similar situation regarding inaccurate canopy measurements also occurs with regards to the trees along the northern property line
- some measures are off by more than 1m
- calling in to question the tree protection zone on this side as well.
- If we don't get this right, these trees, and the screening they provide may be lost

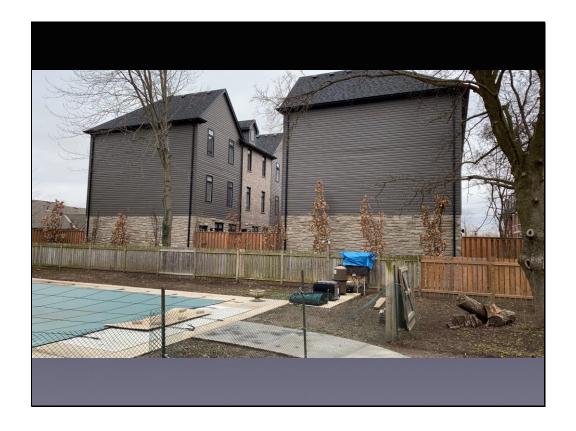
This is the back yard of 1 Medway Cres, behind another recent townhouse development at 1576 Richmond St.

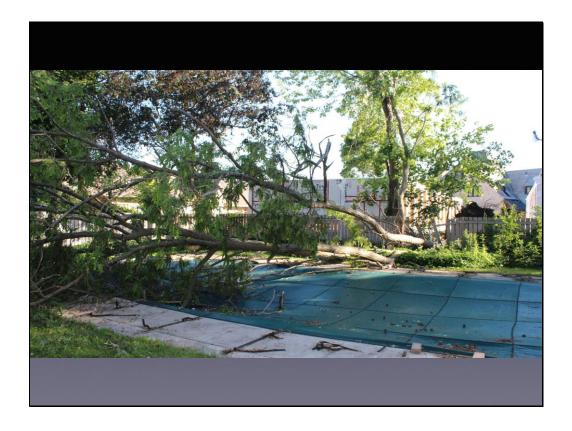
This is the tree that came down during the construction of these townhouses

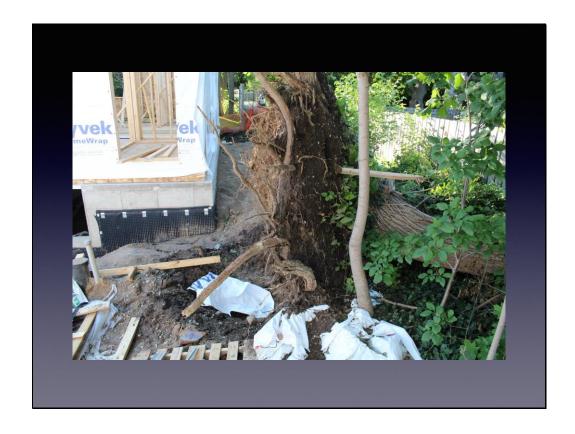
- here is the cause. The foundation was established too close to the tree and significantly compromised the critical root zone.
