Report to London Advisory Committee on Heritage

To: Chair and Members
London Advisory Committee on Heritage
From: Gregg Barrett, Director, City Planning and City Planner
Subject: Heritage Alteration Permit application by P. Scott at 40 & 42 Askin Street, By-law No. L.S.P.-2740-36 and Wortley Village-Old South Heritage Conservation District
Date: Wednesday May 12, 2021

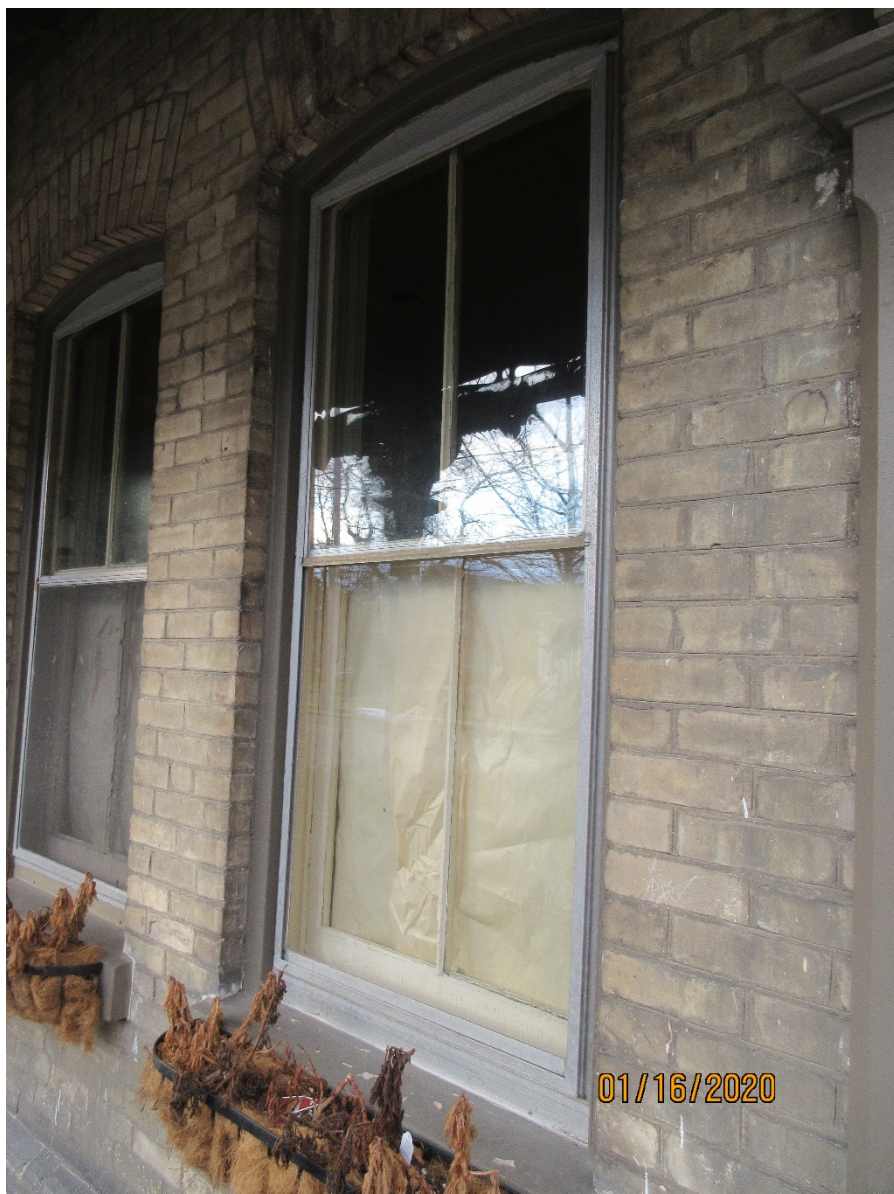
Image 4: Detail photograph of the windows under the porch on the property at 42 Askin Street. Note that the window openings are topped by a segmented arch brick voussoir; the wood windows feature a segmented arch top sash which is obscured by the rectangular aluminum storm window applied over top.

Staff encouraged the removal of the aluminum storm windows and their replacement with wood storm windows, suggesting an application to the London Endowment for Heritage Fund to support a heritage conservation project.

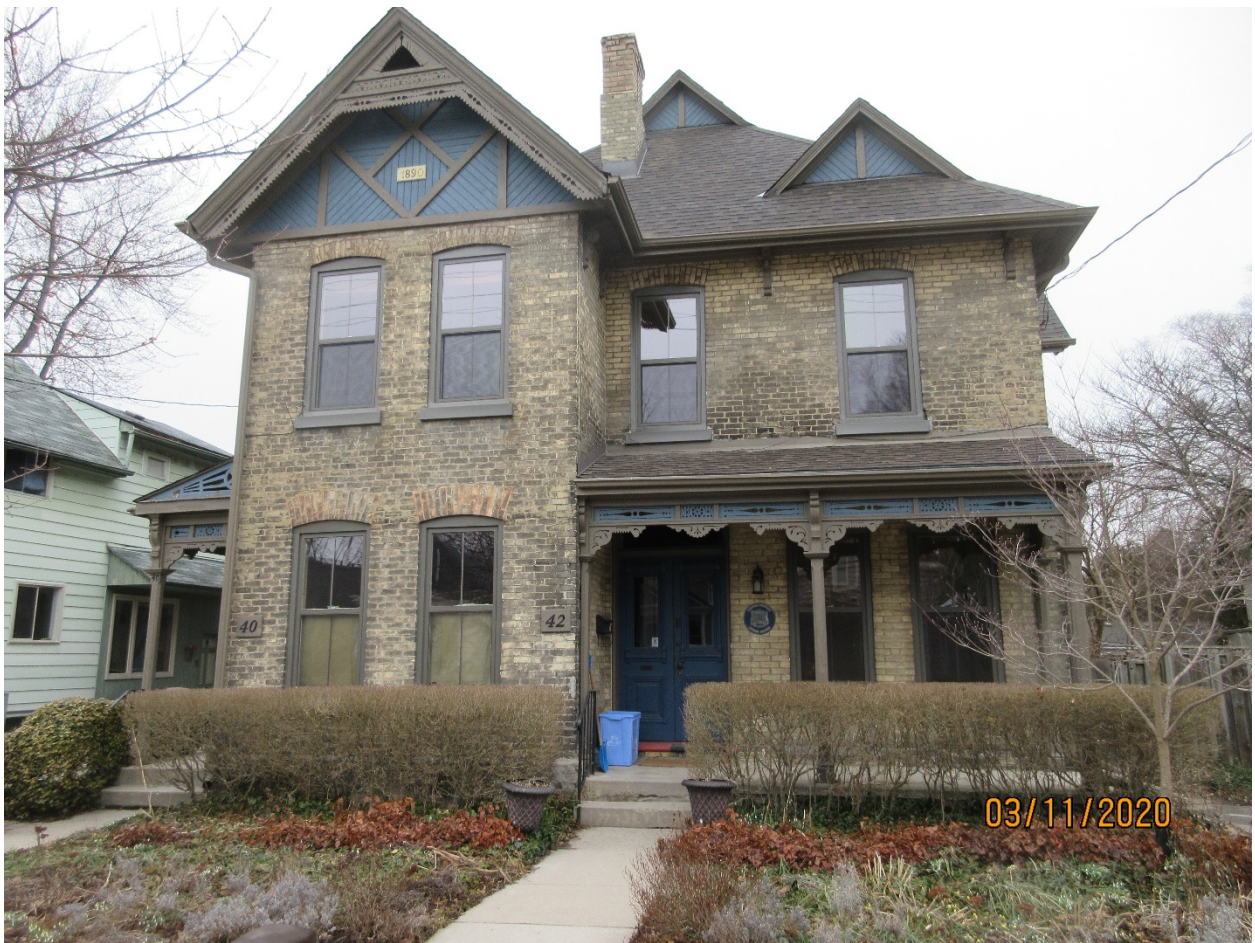
Image 7: Photograph of the properties at 40 & 42 Askin Street on March 11, 2020, showing the replacement windows installed.

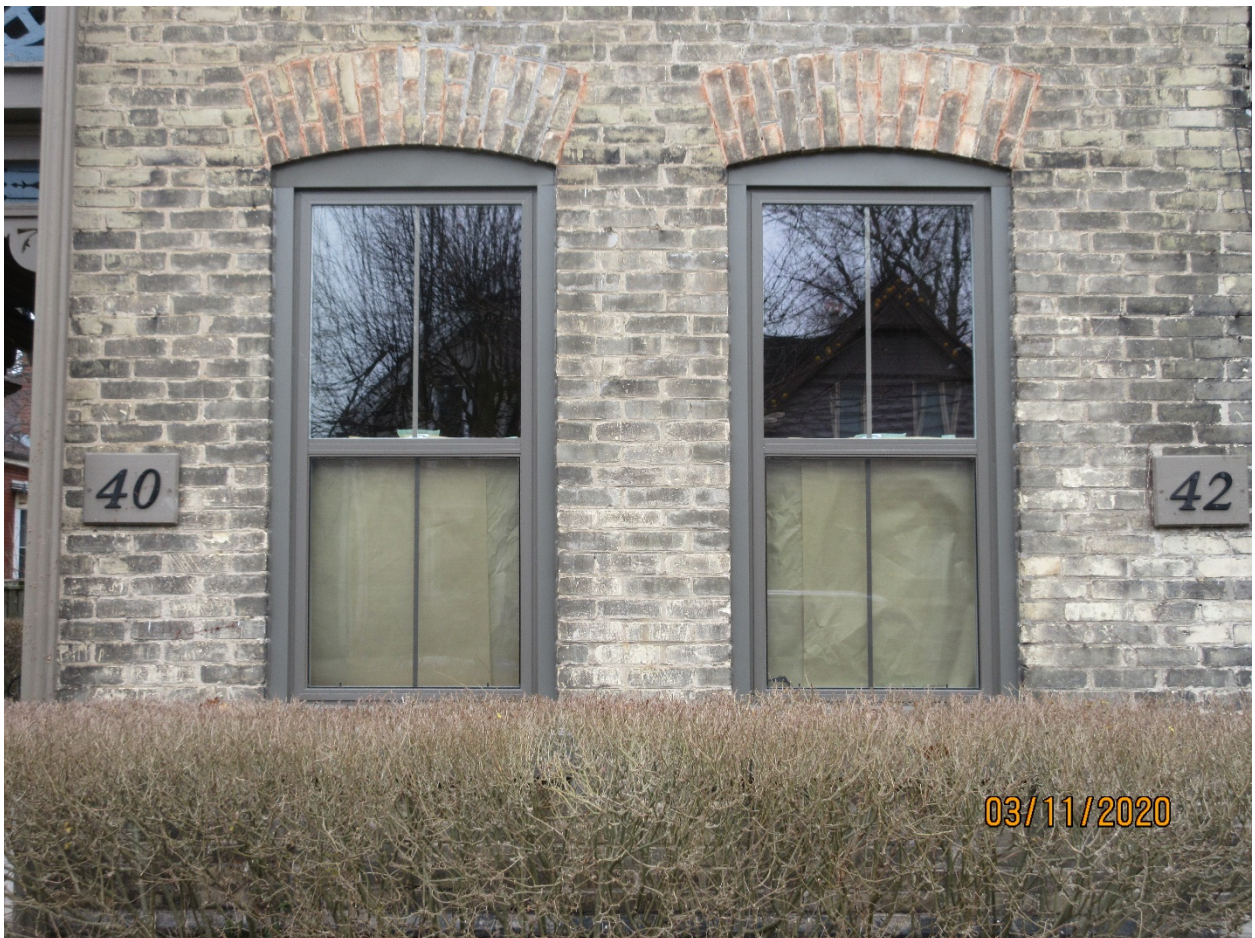
Image 8: Detail photograph of the replacement windows on the property at 40 Askin Street. Note that the insert windows do not fill the window opening and require capping, particularly as the replacement windows do not maintain the segmented arch shape of the window opening. The faux grille (muntin) lacks the authenticity of the former true divided light windows.

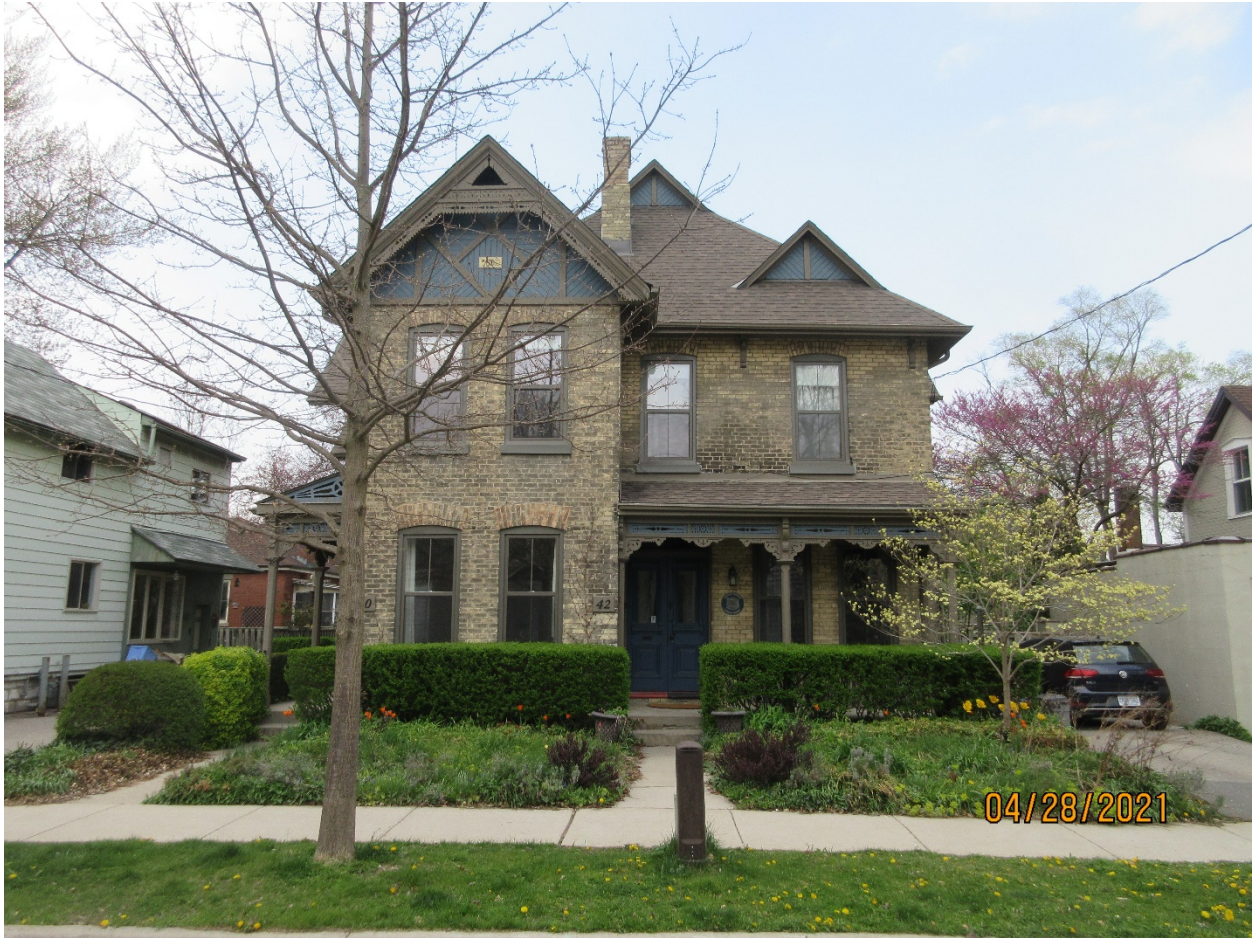
Image 9: Photograph of the subject property on April 28, 2021.

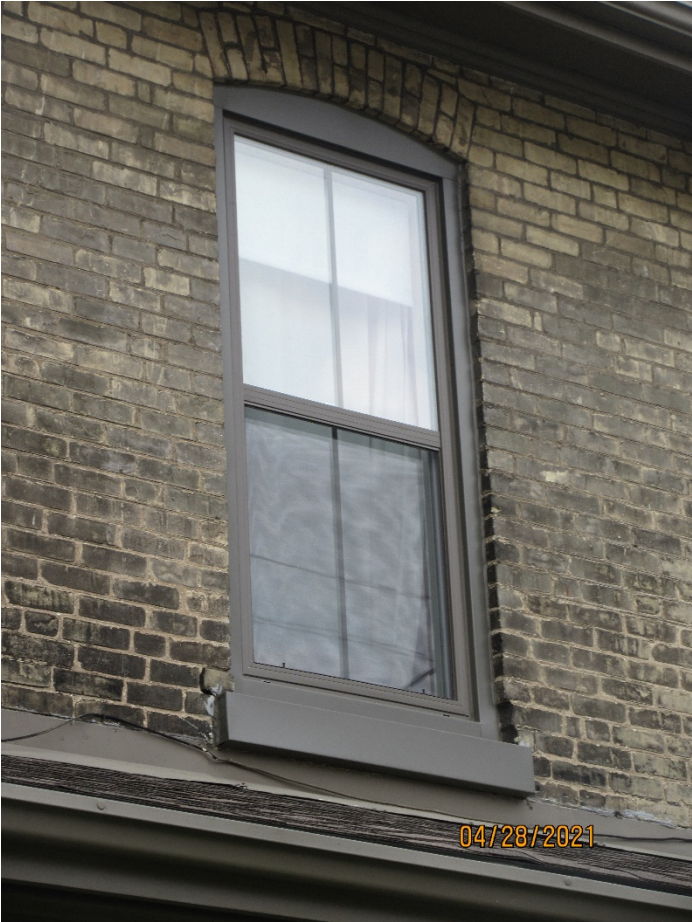
Image 10: Detail photograph of the replacement windows, showing the faux grille (muntin) of the replacement window. The faux grille is only between the glass panes and fails to accurately replicate any historic details.

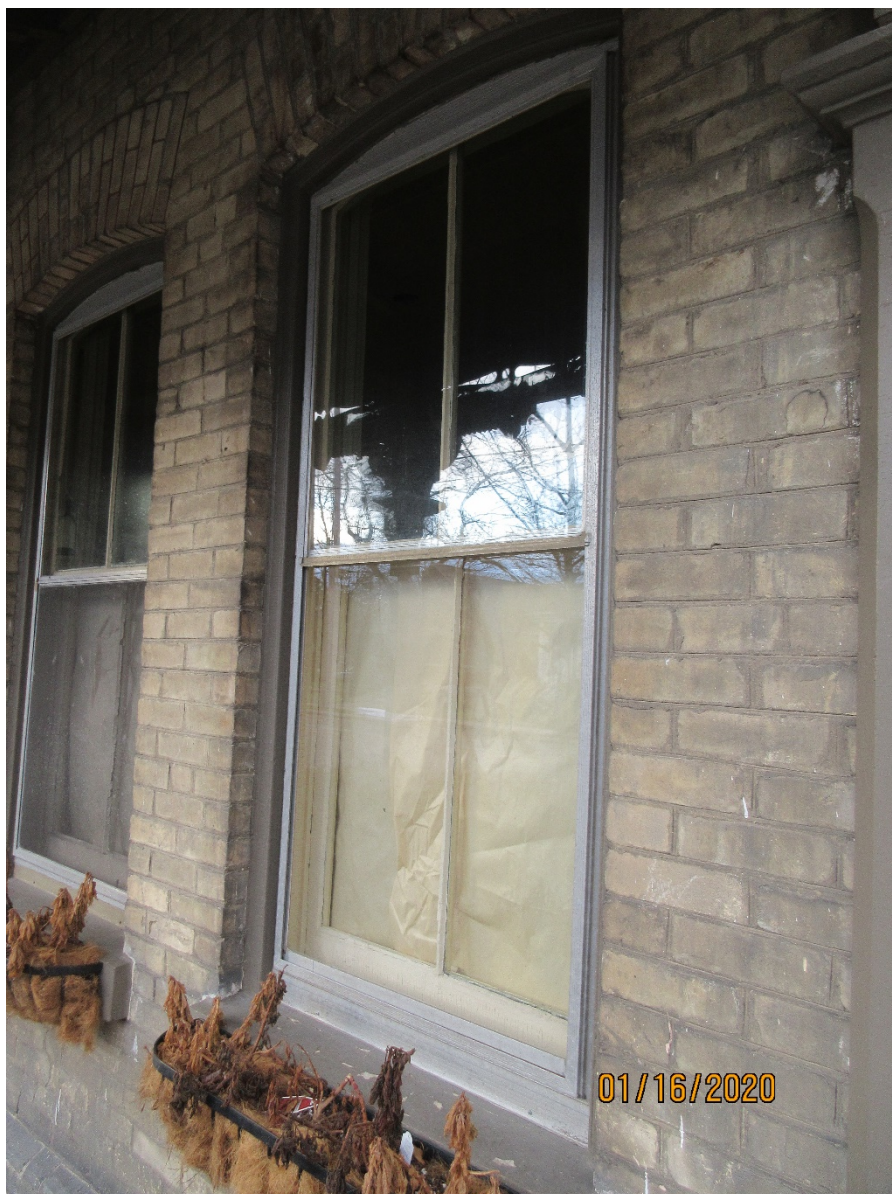
Image 4: Detail photograph of the windows under the porch on the property at 42 Askin Street. Note that the window openings are topped by a segmented arch brick voussoir; the wood windows feature a segmented arch top sash which is obscured by the rectangular aluminum storm window applied over top.
