TO:	CHAIR AND MEMBERS BUILT AND NATURAL ENVIRONMENT COMMITTEE PUBLIC PARTICIPATION MEETING ON MONDAY, NOVEMBER 28, 2011; 5:30 P.M.
FROM:	J. M. FLEMING DIRECTOR, LAND USE PLANNING AND CITY PLANNER
SUBJECT:	DEMOLITION APPLICATION MEDD-CO HOLDINGS CORP. 91 SOUTHDALE ROAD EAST

Appendix 3: Condition Report

St Elias Church
 91 Southdale Rd E
 London, On

RE: CONDITION REPORT

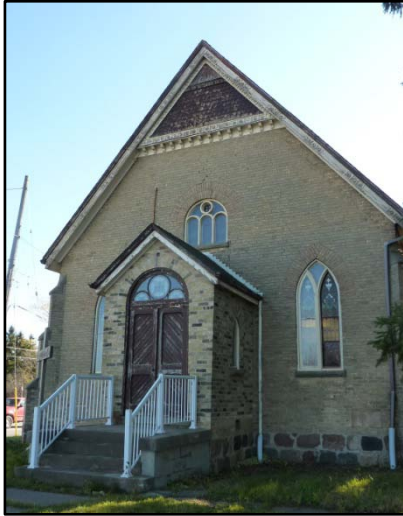
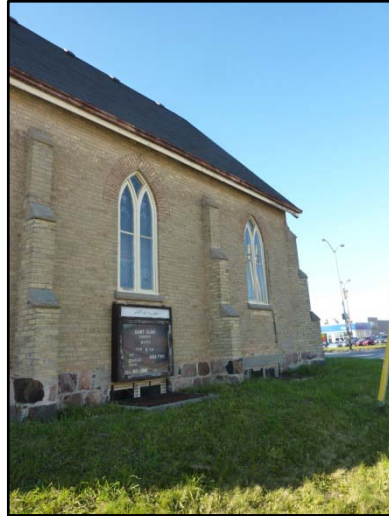
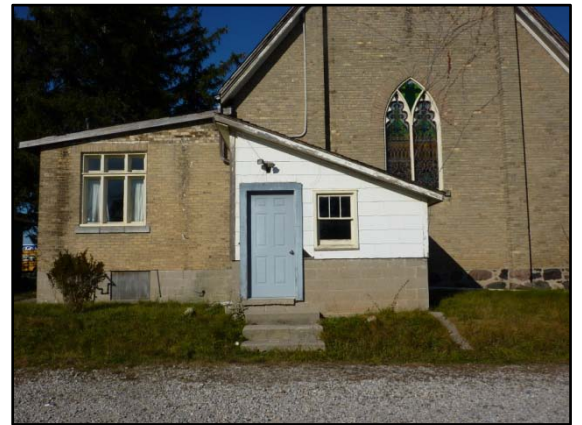
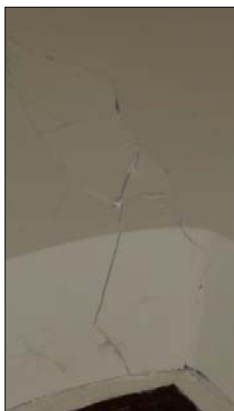
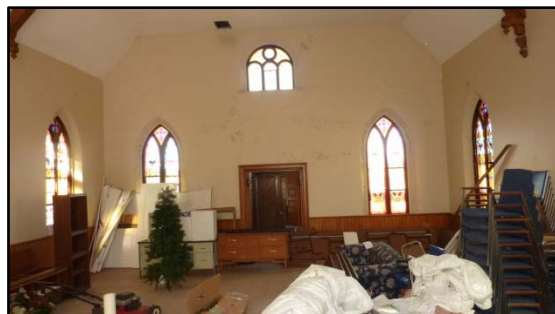
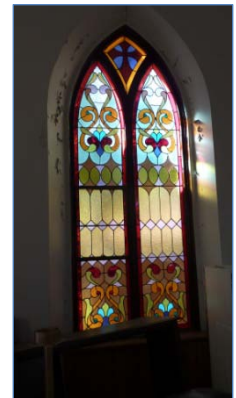
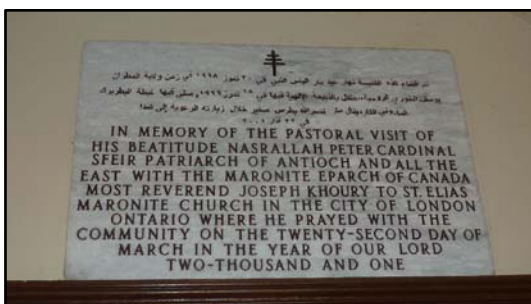
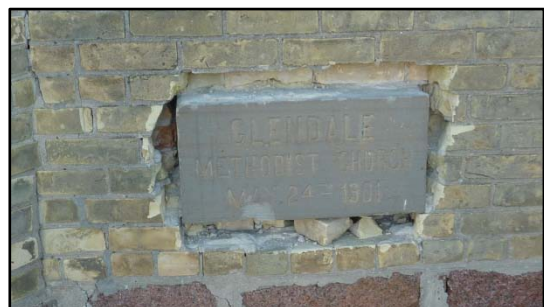
Appendix 2- Photos -

In subsequent years, members of the Maronite congregation considered repairs but, given their need for larger accommodation, and the costs for rehabilitation, relocated the church and placed the property on the market. The building has been empty for a number of years and conditions inside have worsened, most recently with serious flooding in the basement.

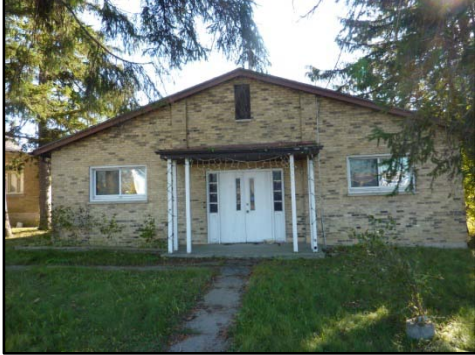
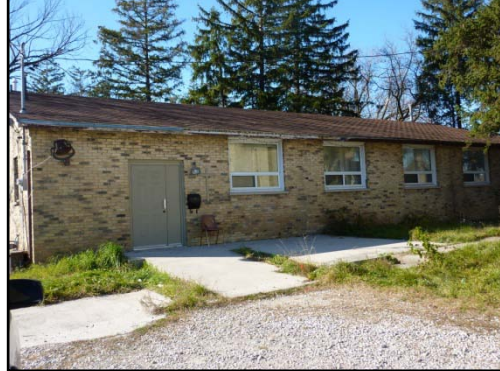
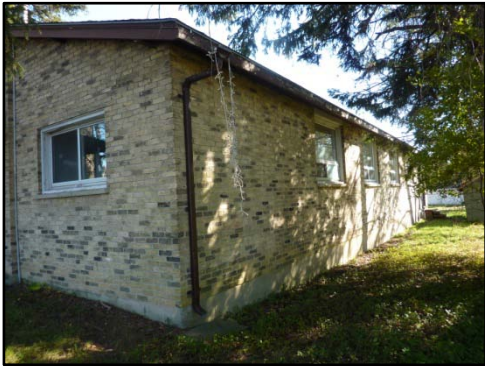
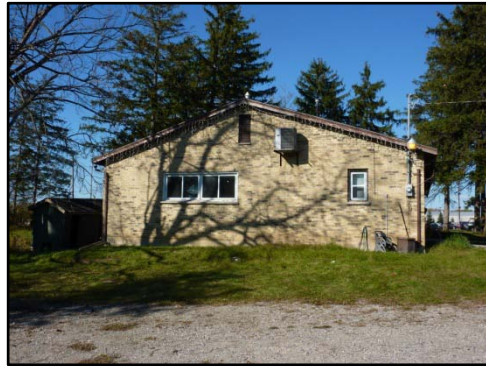
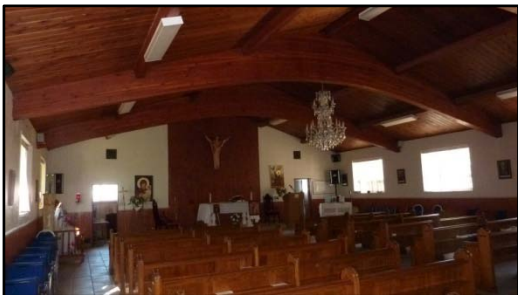
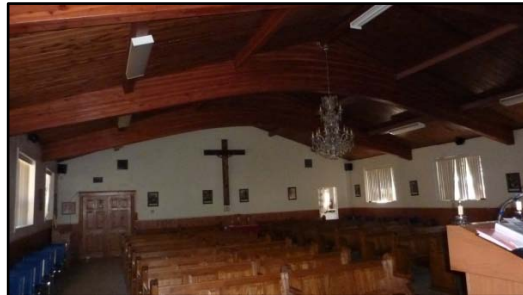
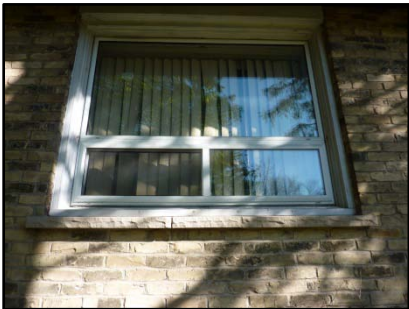
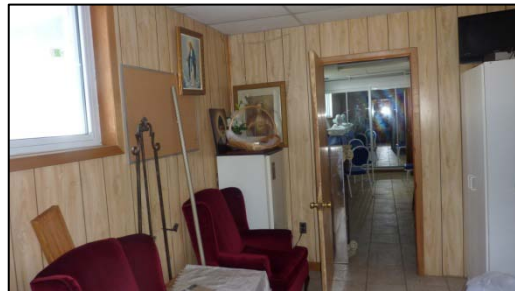
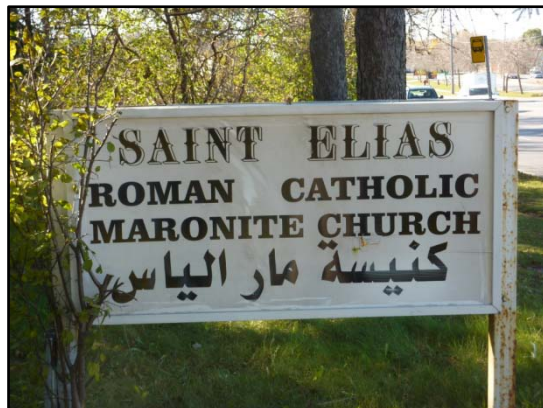
Appendix 2 –Photos – 91 Southdale Road –Church Hall

- 10 While our assignment did not include review of the adjacent community hall facility, we would indicate that there are significant life safety issues in this facility, which require further discussion and review.
