Agenda Including Addeds

London Advisory Committee on Heritage

4th Meeting of the London Advisory Committee on Heritage

April 14, 2021, 5:30 PM

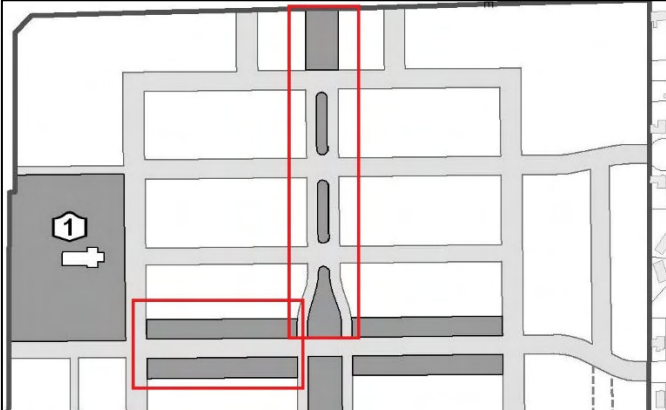
Secondary Plan Policy Section 20.4.3.6 Heritage Area Designation	Assessment
<p>Schedule 7 - the boundaries of the Heritage Sub Area Designation. Mainly the area shown in red.</p>

<p>The area within the Heritage Sub Area Designation is referred to as the area of significant cultural heritage landscape to be conserved. What was prepared to support this, most notably the areas north of the Infirmary building. This is not consistent with the boundaries of the Heritage Conservation Easement, nor is identified in designating By - law L.S.P.-3321-208.</p> <p>Page 9, Section 20.4.2.2, within the Secondary Plan states “Based on the conservation plan prepared for this Secondary Plan...”</p> <p>Is the assessment for the Heritage Sub Area Designation found in the conservation plan prepared for the Secondary Plan?</p>
<p>I. Function and Purpose</p> <p>The Heritage Area designation includes the cultural heritage landscapes as well as the individual heritage buildings and their landscape setting that exist on the LPH lands. These buildings, and the heritage landscape, will be conserved. Conservation allows for alterations to a property and buildings, if it can be demonstrated that the significant heritage attributes of the heritage resources are not negatively impacted by the change. The conservation and re-use of the potting shed, vegetable shorting shed and central heating plant is encouraged but not required.</p> <p>The following policies apply to areas identified on Schedule 7 – Cultural Heritage Framework of</p>	<p>The heritage attributes of the buildings and features to be conserved are not consistently defined.</p> <p>Please see the following charts that outline the lack of consistency for each of the buildings and features to be conserved.</p>

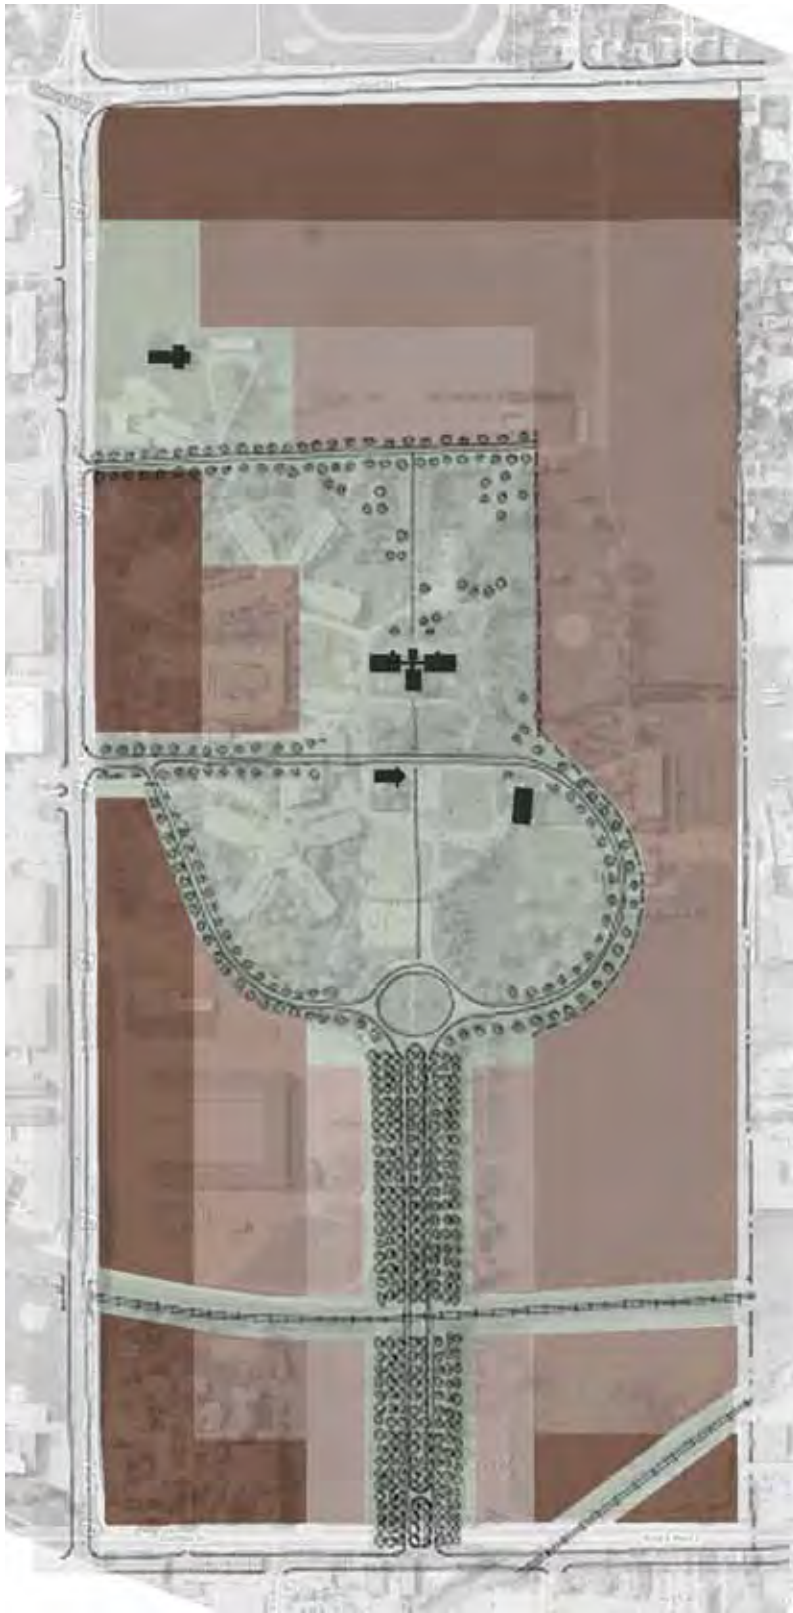
Proposed redevelopment of London site, including preservation of existing heritage resources. Shading is used to indicate progressively higher height limits.

The attached plan shows the recommendations for the site overlaid on the existing site conditions. The shading indicates the proposed gradation in recommended building heights. The development areas are designed not only to protect the existing buildings, but also their landscape settings and the visual connections between them.

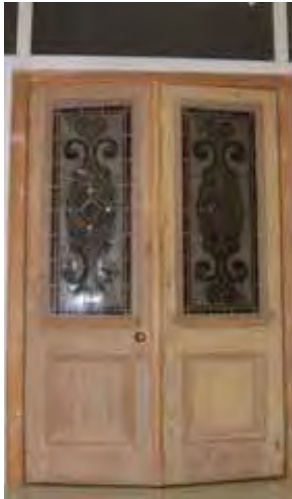
Entrance doors

entrance hall with a soaring transom window and sidelights, this section was built to impress. The original set of double entrance doors with brilliant stained glass lights and an etched glass transom are now installed in the London Asylum Archives.

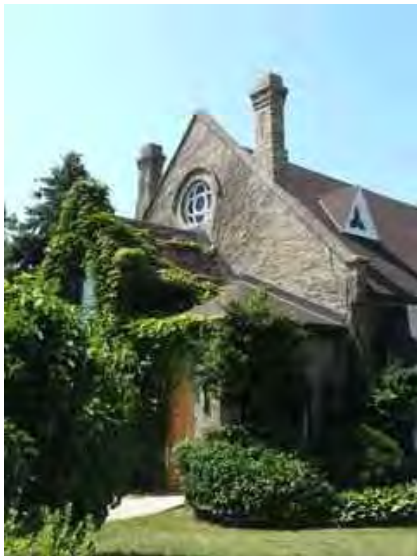
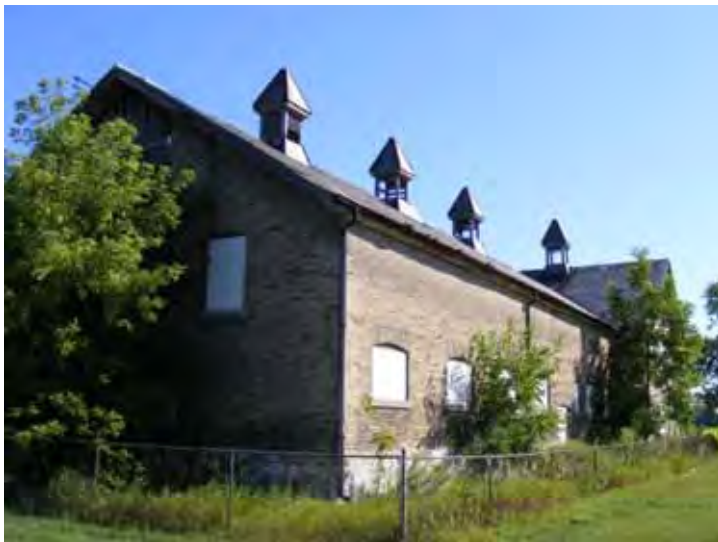
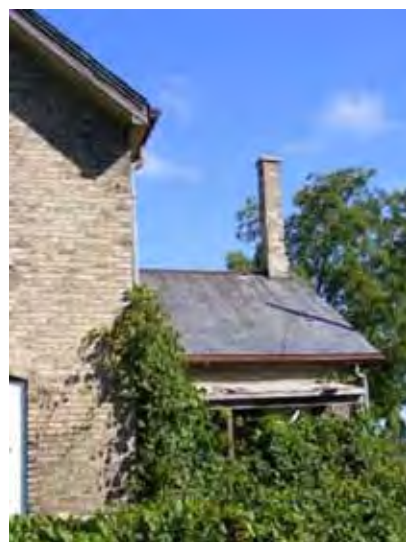
The Chapel of Hope:

The exterior of this building should be restored, but the interior should be rehabilitated as an adaptive reuse project. Only minor additions, if any, should be added to the exterior so as not to unbalance the current form and silhouette. The brick requires localized repair and complete repointing. The slate roof needs extensive repair, as do the wood venting cupolas. As with the Infirmary Building, paint analysis should be used to determine the original colour of wood elements, including cornices, gables, doors and windows, and this should guide the restoration process.

Inside, the building can be adapted for almost any viable use. The particular cross section with its limited second floor height suggests either removing the second floor, already in bad condition in areas of water infiltration, or developing residential uses where each bay is a separate vertical two-storey space. The heavy timber beams define the logical bay sizes. Because of the unusual truss design, a single open space would provide a dramatic setting for certain commercial or community uses. The trusses appear to be structurally sound, but at risk because of ongoing water problems.

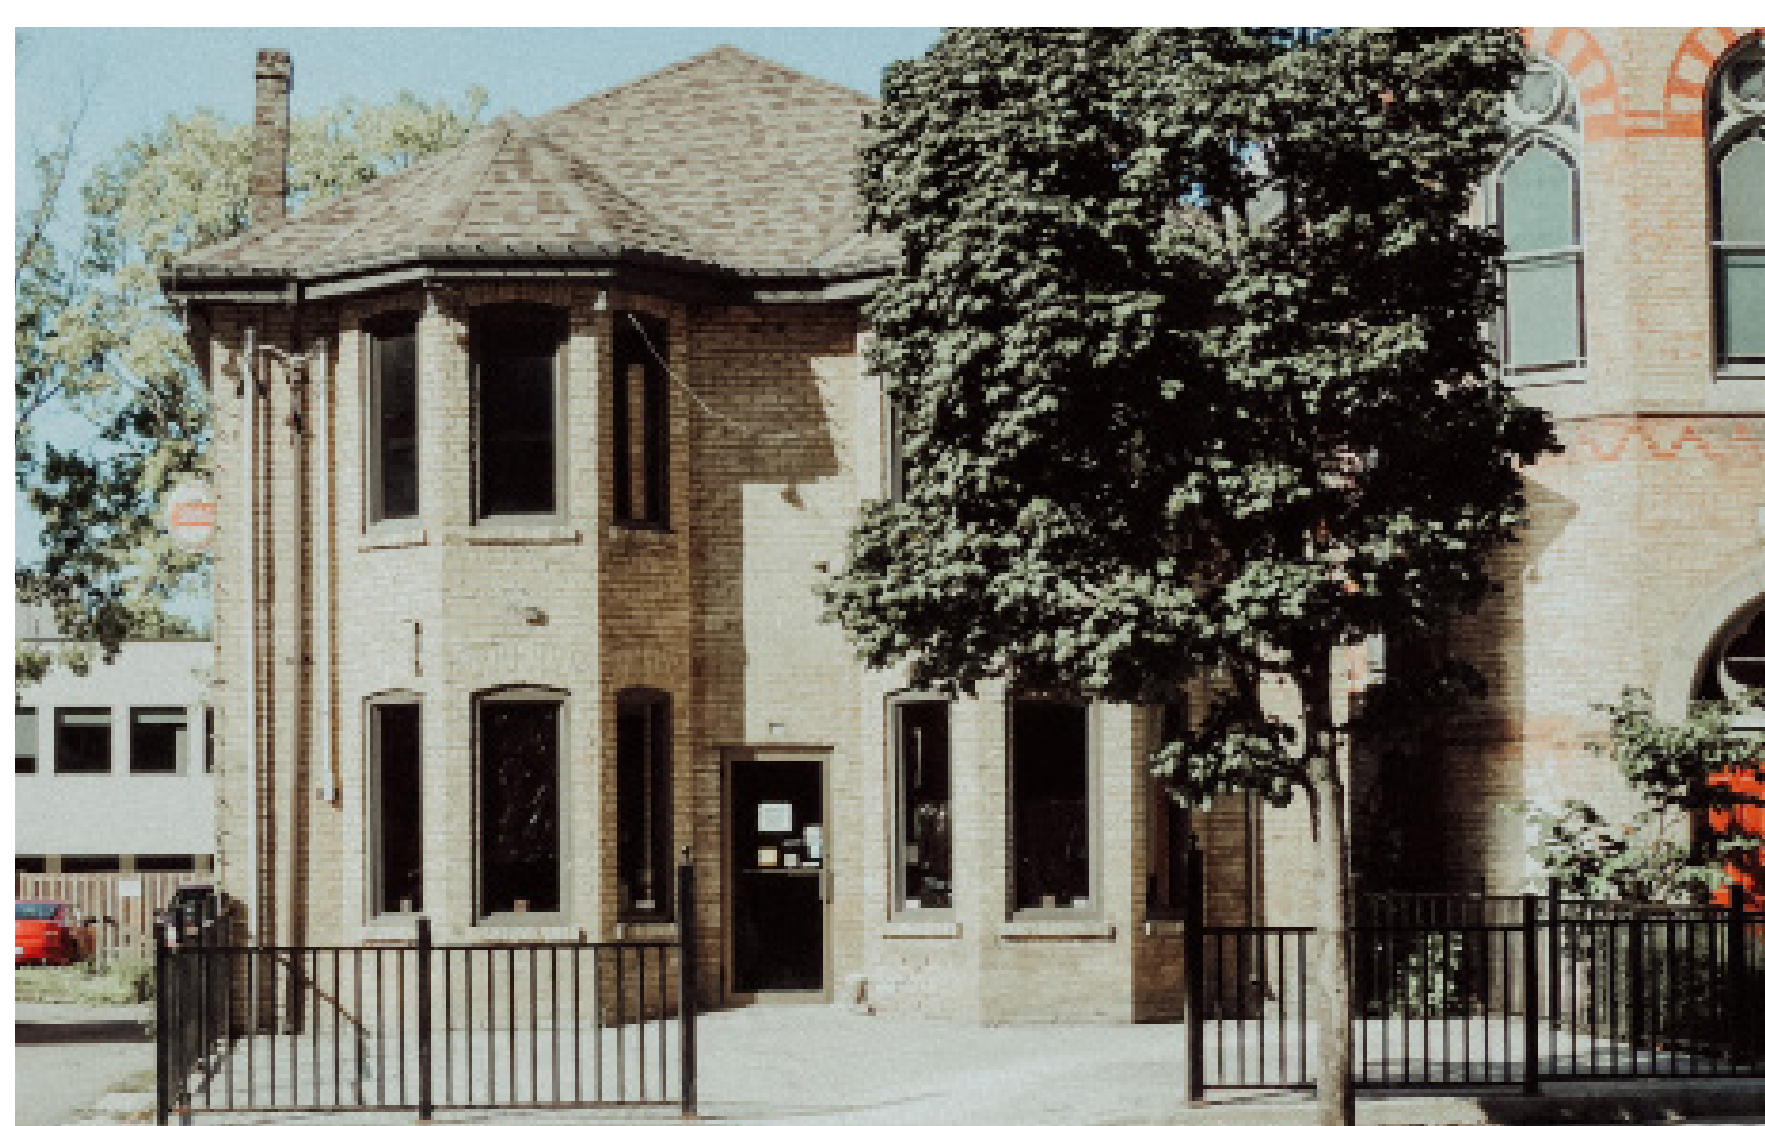
511 Talbot Street

Originally this residence was a duplex and can be seen in fire insurance plans as having the address 509 and 511 Talbot street. This was later changed to just 511 Talbot street when the duplex was converted into a single residence. This late Italianate house, which replaced an earlier single-storey frame house, featured two front bay windows and octagonal hipped rooflines that are highly individual.

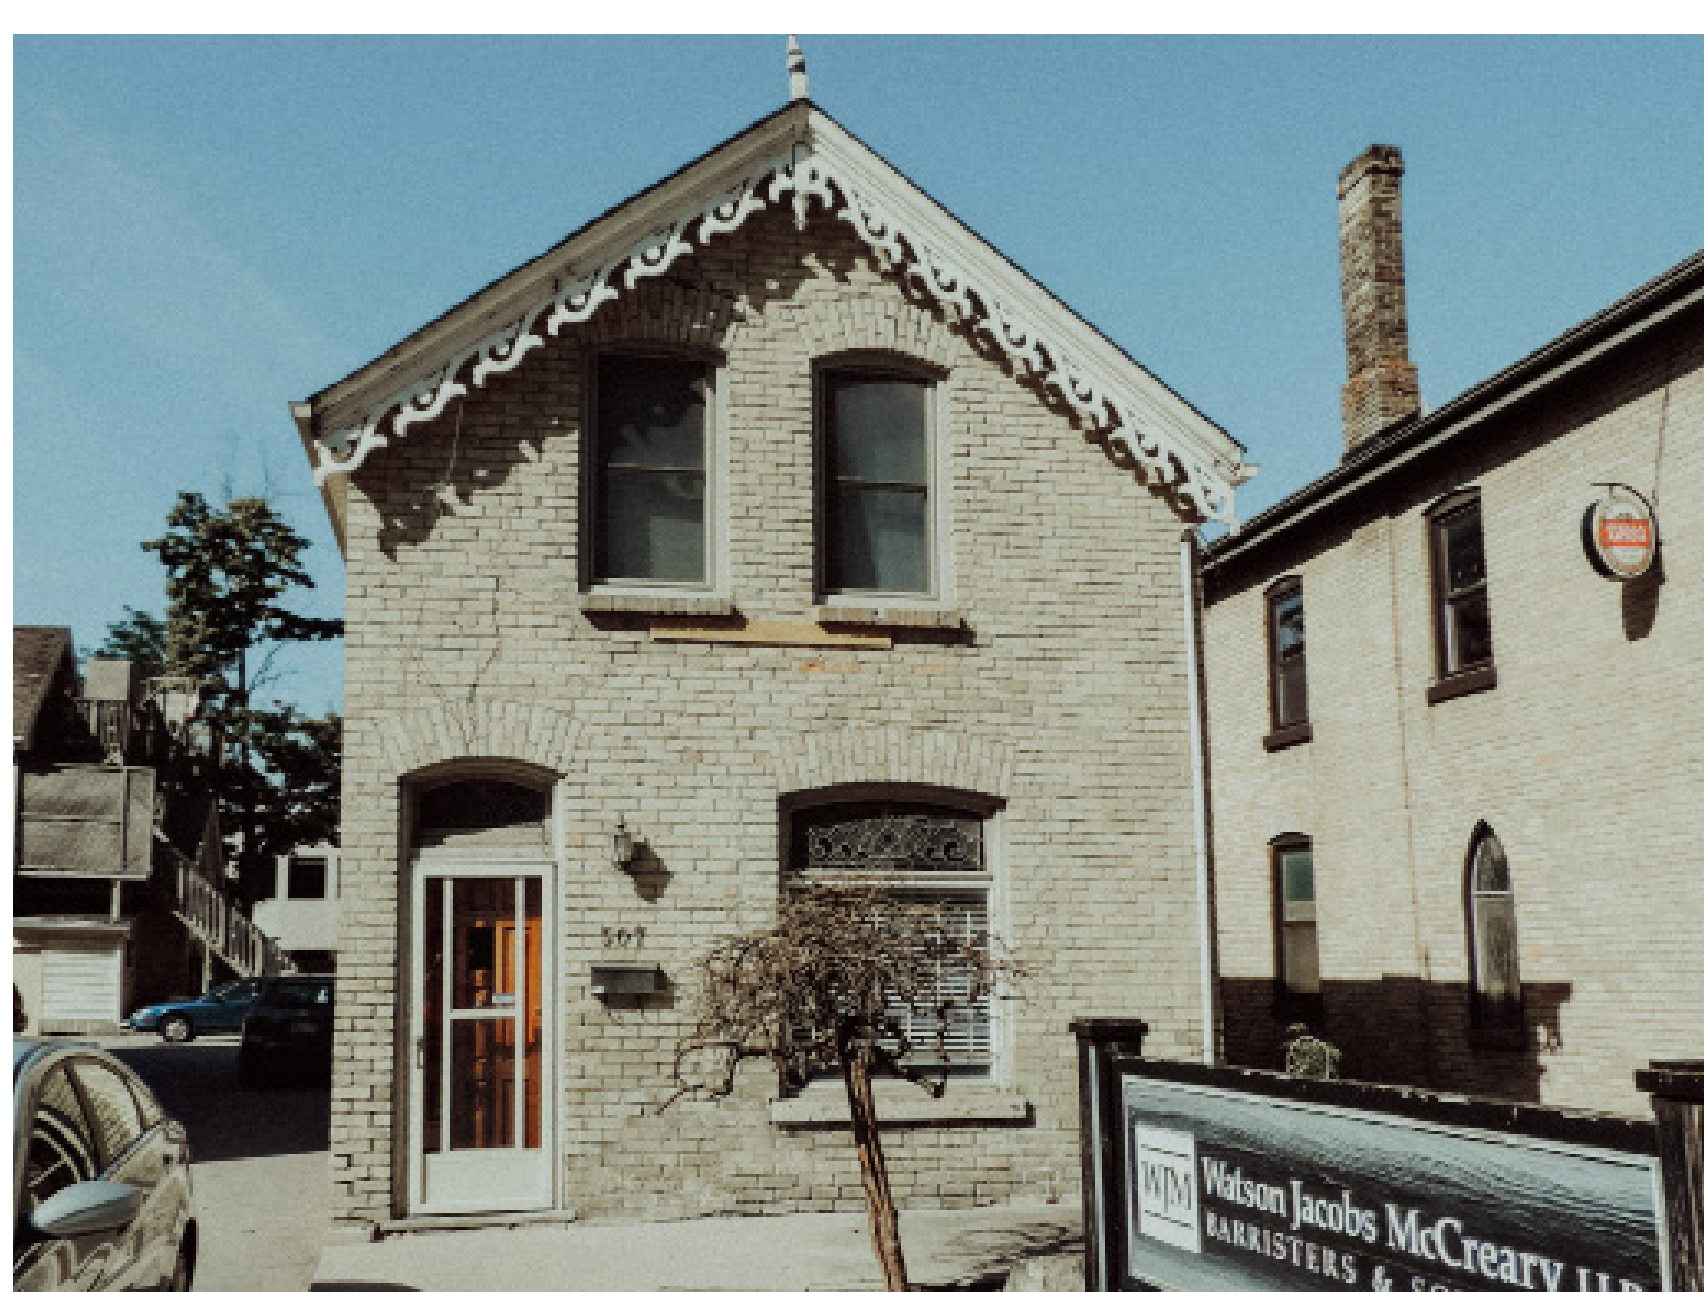
The most modest of the three buildings was 507 Talbot street. Built in 1886, this smaller buff brick residence was first occupied by William Brown, a carriage-maker, and later by John Farrell (a barber) and David Harris (a real estate agent).

This building had vernacular structure with Italianate and Gothic Revival elements, which were two popular mid to late 19th century architectural styles. 507 Talbot Street had characteristic segmental arches above the windows and door (indicating Italianate influence), fretwork bargeboard (Gothic Revival style) as well as stained glass designs that seem to be later 20th century additions.

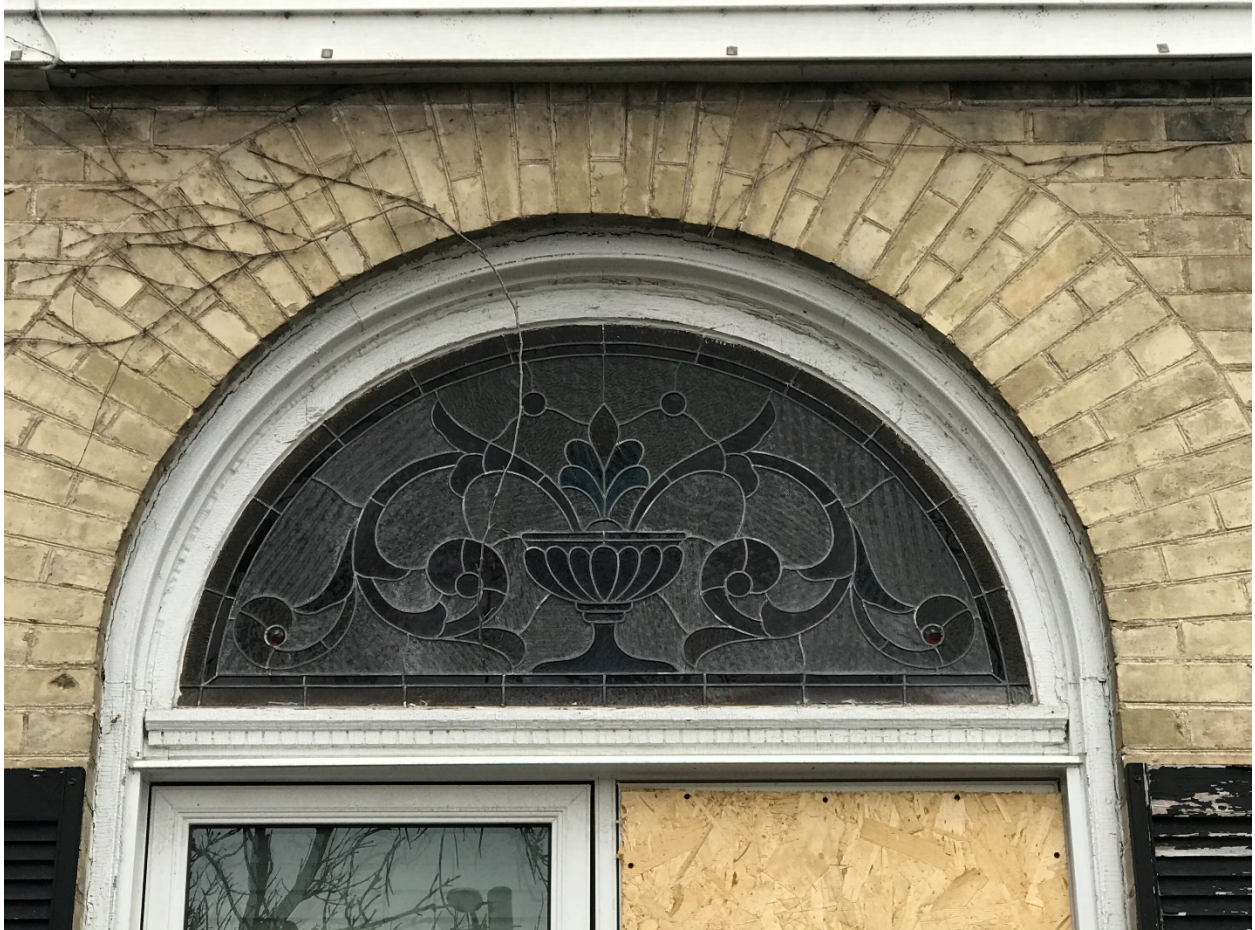
Image 3: Detail photograph of the arched transom over the front window with stained glass (April 5, 2021). The stained glass has an urn and floral motif, typical of the period of construction for the subject property. Salvage of this window in advance of demolish is strongly encouraged.

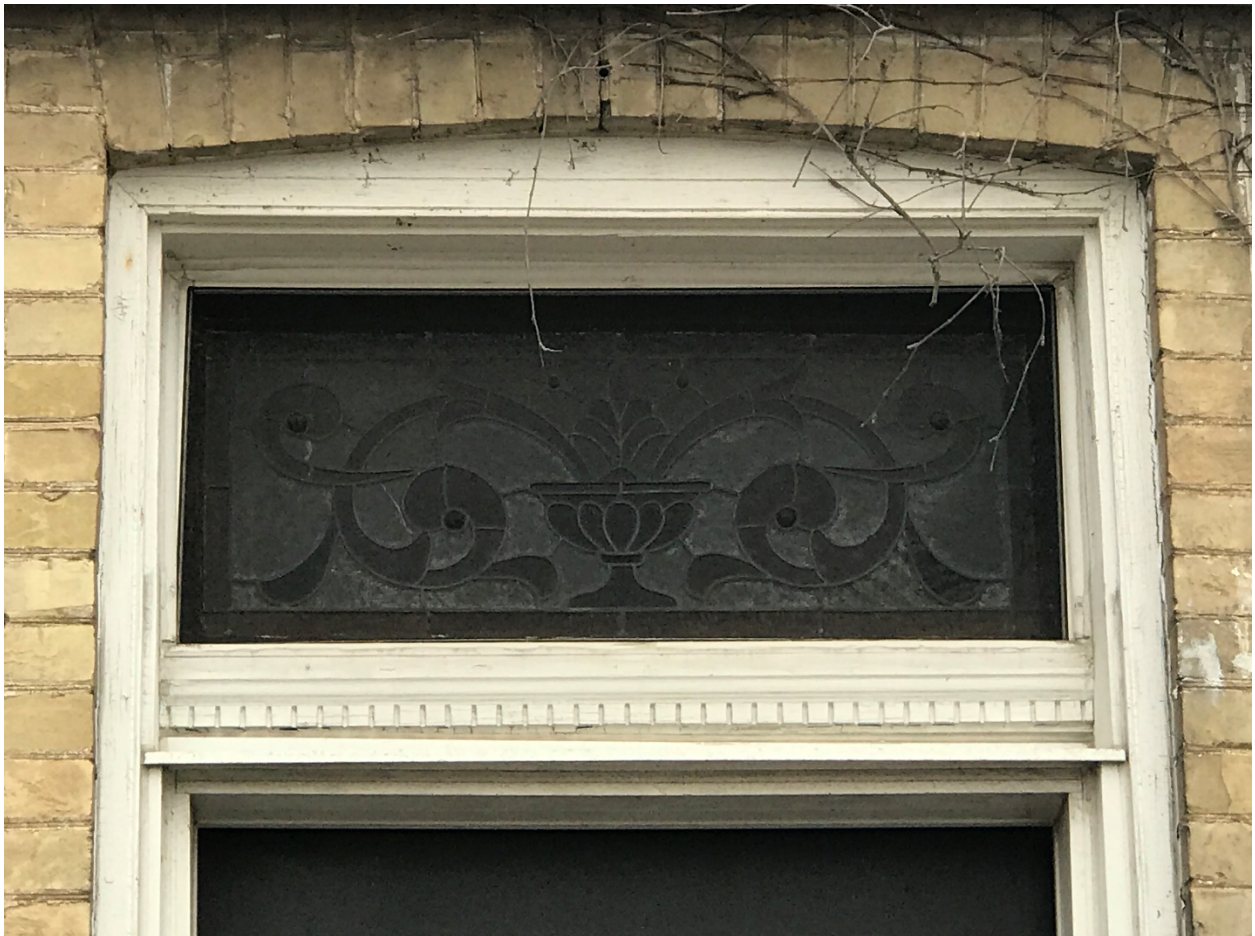
Image 4: Detail photograph of the rectangular transom over the front doorway with stained glass (April 5, 2021). The stained glass has an urn and floral motif, typical of the period of construction for the subject property. Salvage of this window in advance of demolish is strongly encouraged.

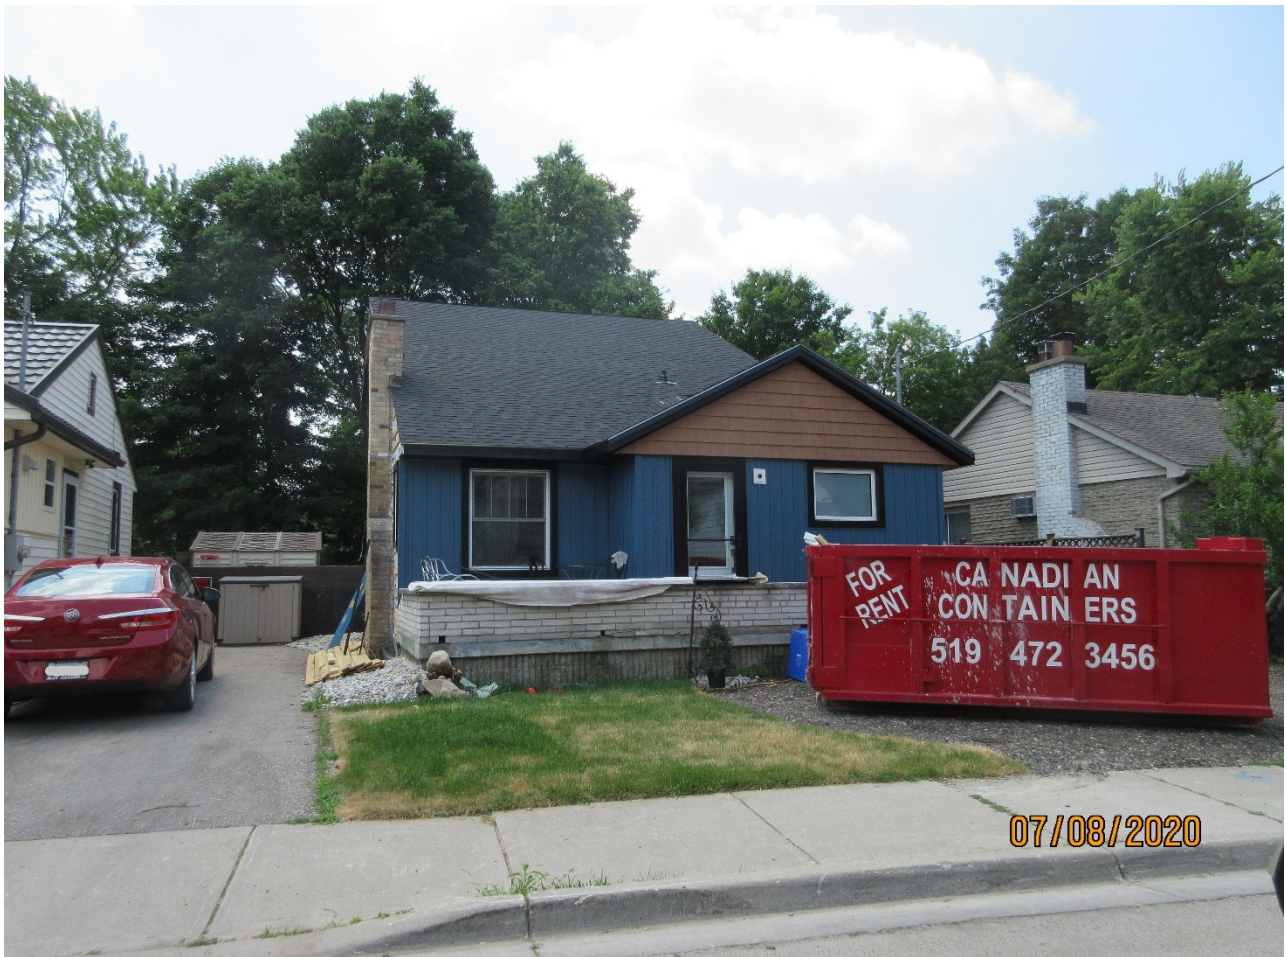
Image 4: Photograph of the subject property, on July 8, 2020, when non-compliance with the Heritage Alteration Permit was identified. Note the change in the exterior cladding, including gable, and the front door replacement. The shutters were also removed.
