# Agenda Including Addeds

5th Meeting of the Community Advisory Committee on Planning

# Heritage Impact Assessment: 150 Philip Aziz Avenue

Western Road and Sarnia Road/Philip Aziz Avenue Improvements

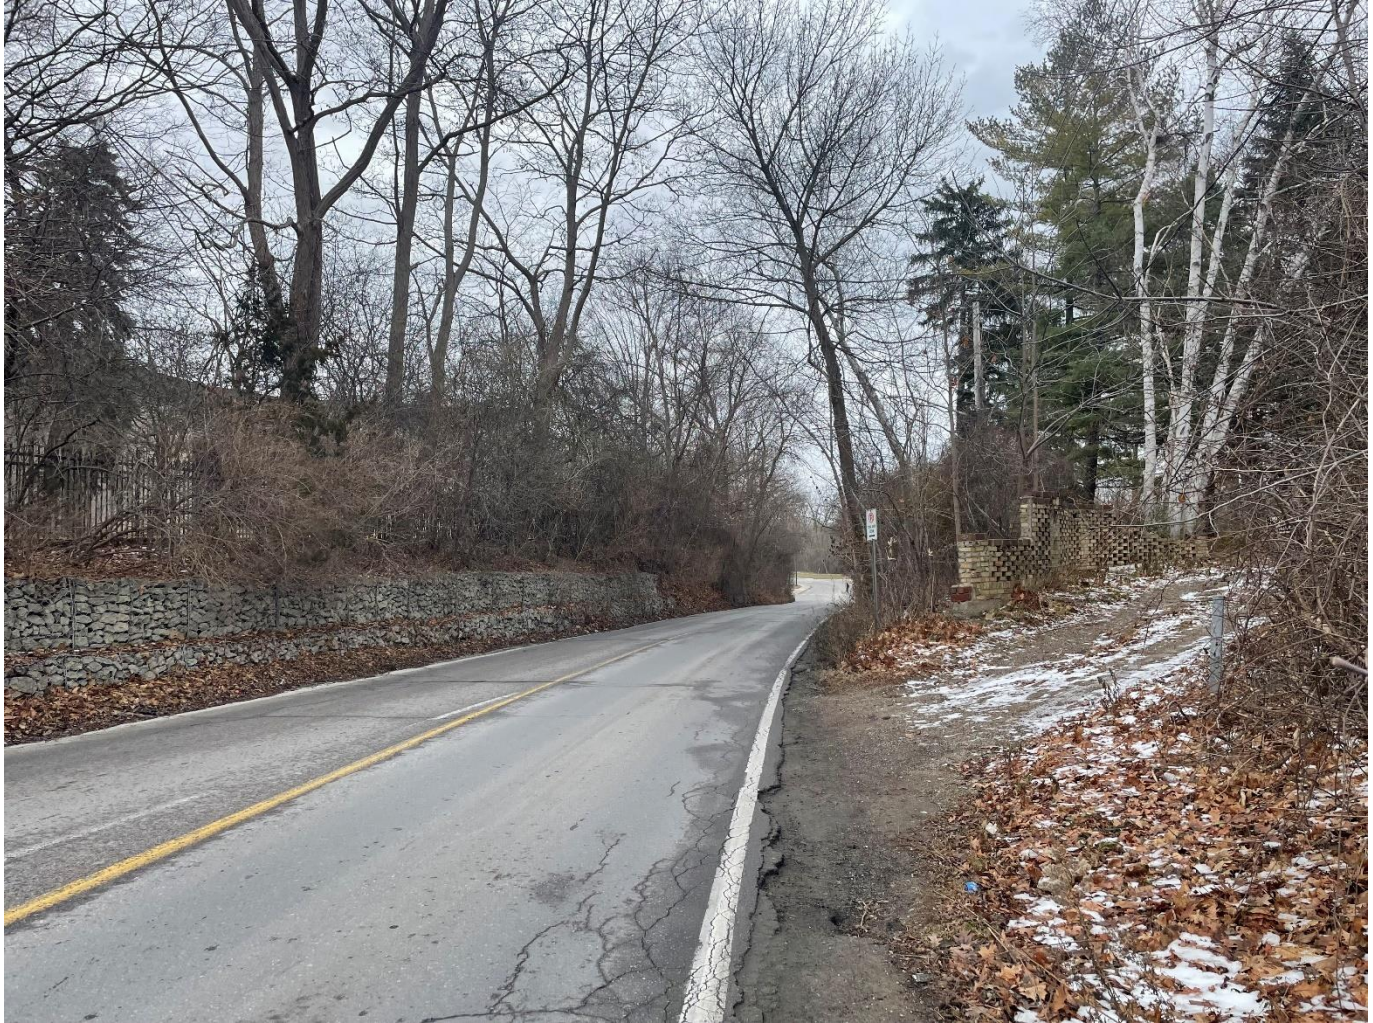
**Photograph 1:**  
A view of Philip Aziz Avenue, looking east

The Subject Property is an irregularly shaped lot, approximately 0.13 hectares in size, and is located on high ground that generally slopes towards Philip Aziz Avenue (**Photograph 1**). The property is comprised of a circa 1875 one-and-a-half storey house, an art studio and gallery that was constructed in 1957, a large courtyard, a gravel driveway, a number of brick landscape features and mature trees and dense brush that screen the property from the surrounding urban landscape. The mature trees and dense brush largely surround the art studio and gallery and other landscape features located within the Subject Property. The landscape of the property in December 2022 can be interpreted as a rural “bucolic” property, despite the property being surrounded by intuitional buildings associated with Western University.

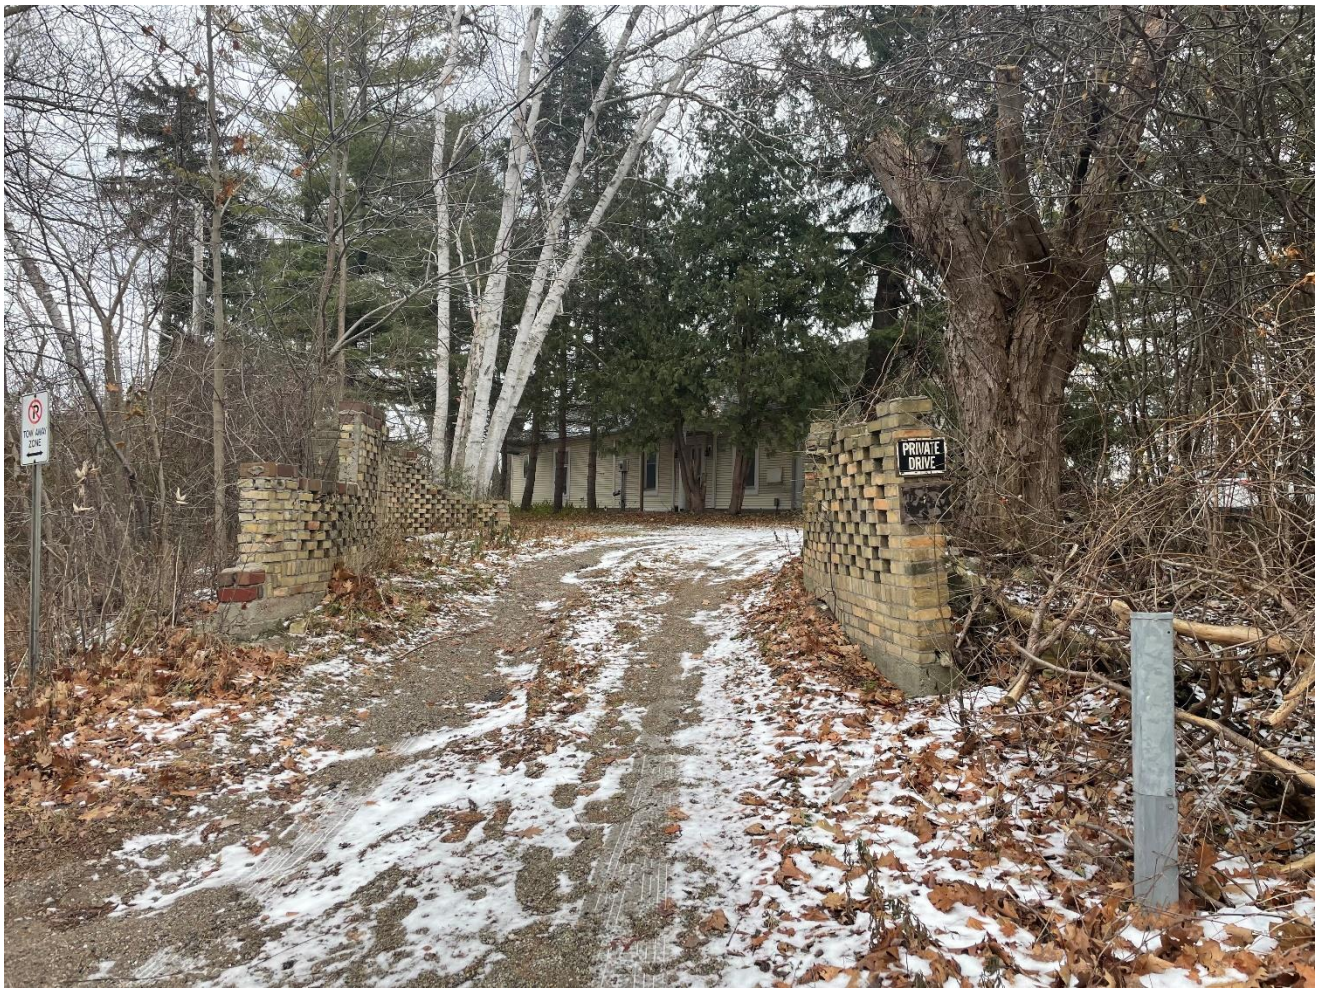
**Photograph 2:**

A short curved gravel driveway leads from Philip Aziz Avenue into the Subject Property. Flanking on both sides of the gravel driveway is a decaying pierced brick entrance feature (**Photograph 2** and **Photograph 3**). The pierced brick entrance feature is partially located within the boundary of the Subject Property, but it is directly associated with the cultural heritage value or interest (CHVI) of the Subject Property. The pierced brick entrance feature acts as a wall. The wall consists of several different base heights that are dependent on the elevation of the land.

A view of the pierced brick entrance feature that flanks the gravel driveway, looking south (AECOM 2022)

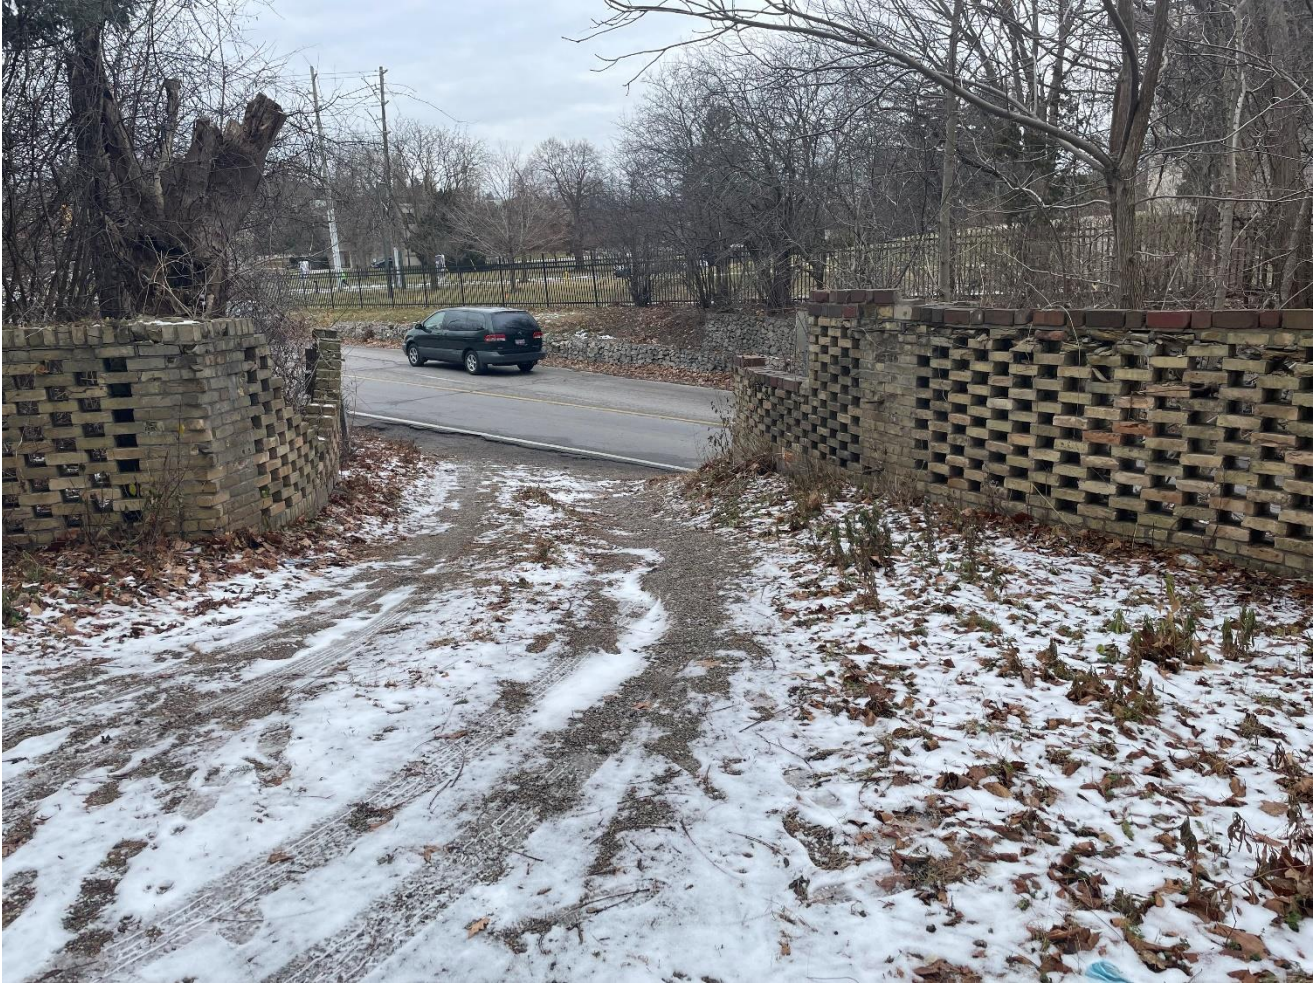
**Photograph 3:**

A view of the pierced brick entrance feature that flanks the gravel driveway, looking north (AECOM 2022)

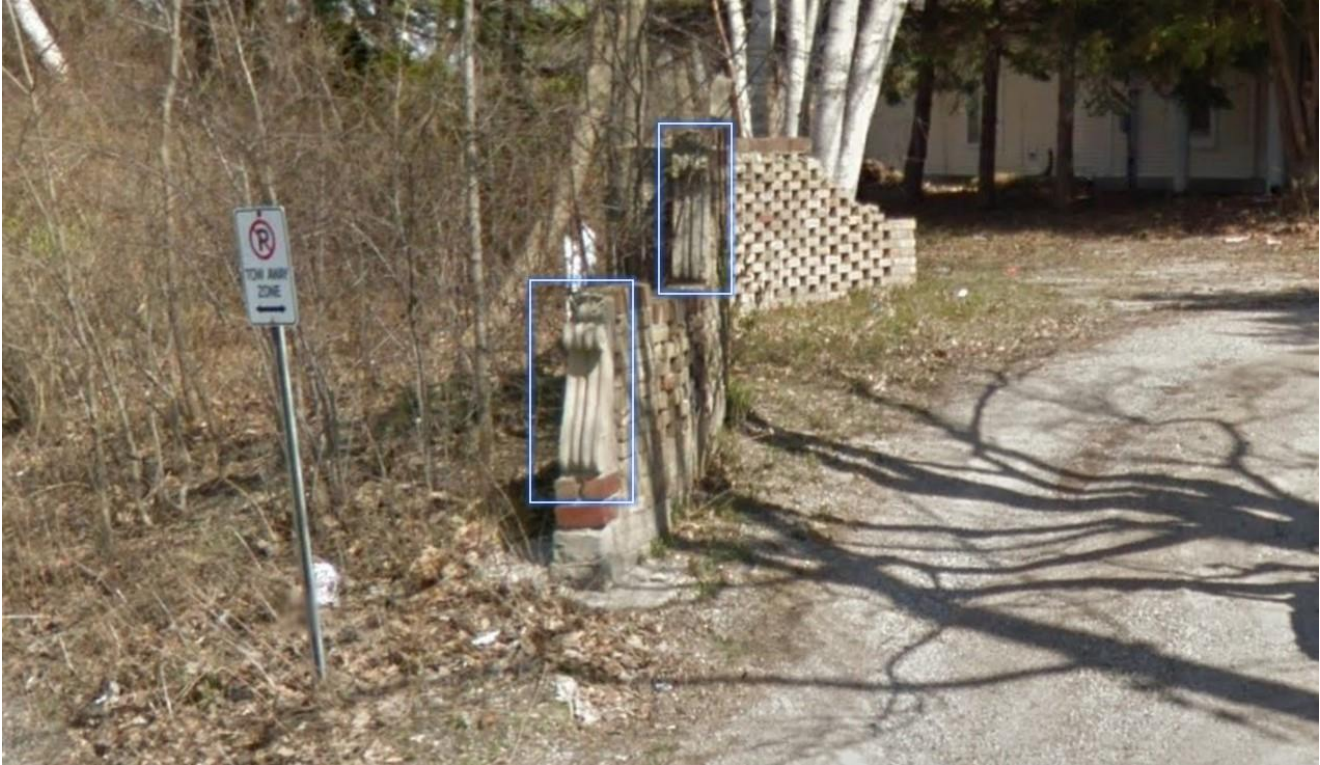
**Photograph 4:**

Historical images found on Google Street View illustrate that the pierced brick entrance feature was adorned with stone brackets that may have been salvaged from the former Bank of Montreal building (**Photograph 4**). The stone brackets are no longer adorned on the pierced brick entrance feature (**Photograph 5**) and their locations are unknown.

A 2015 image of the pierced brick entrance feature, illustrating the two stone brackets (Google Maps, 2015)

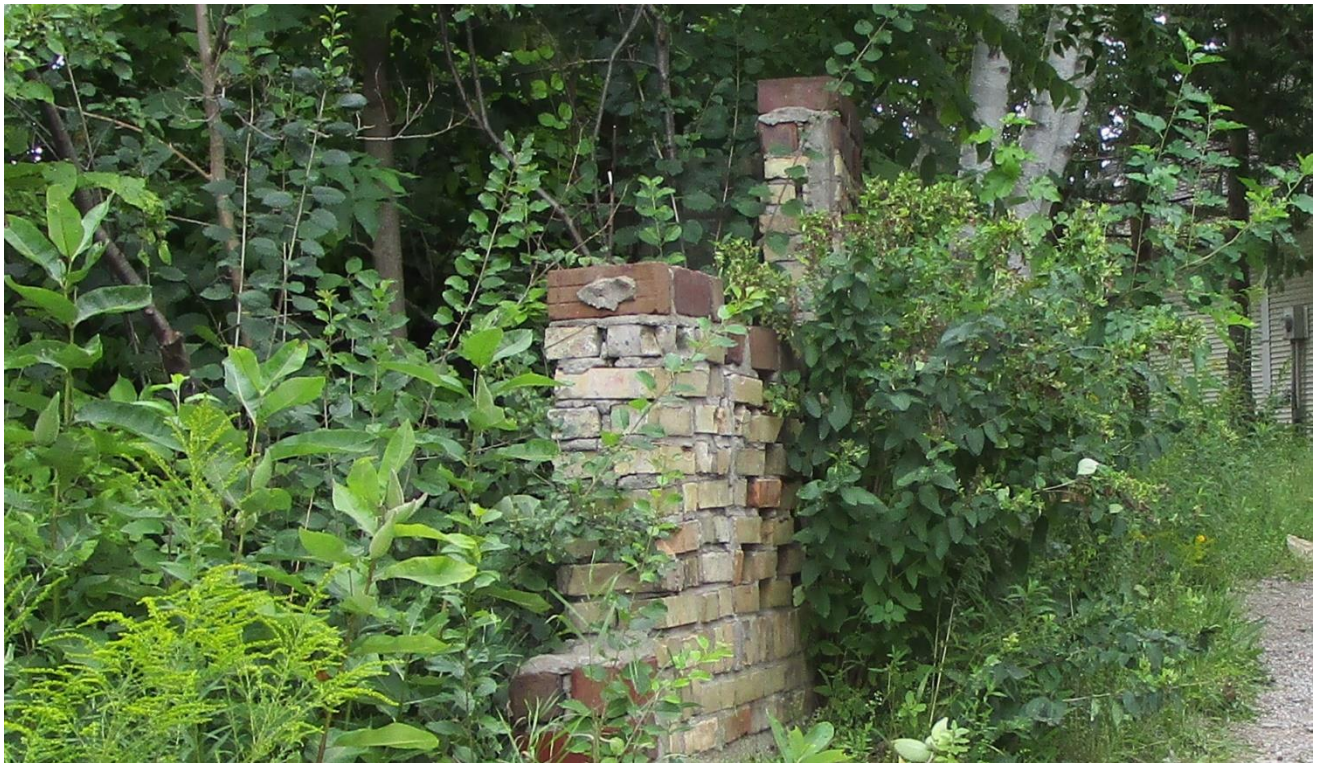
**Photograph 5:**

A view of the pierced brick entrance feature, illustrating the missing stone brackets, looking south (AECOM 2021)

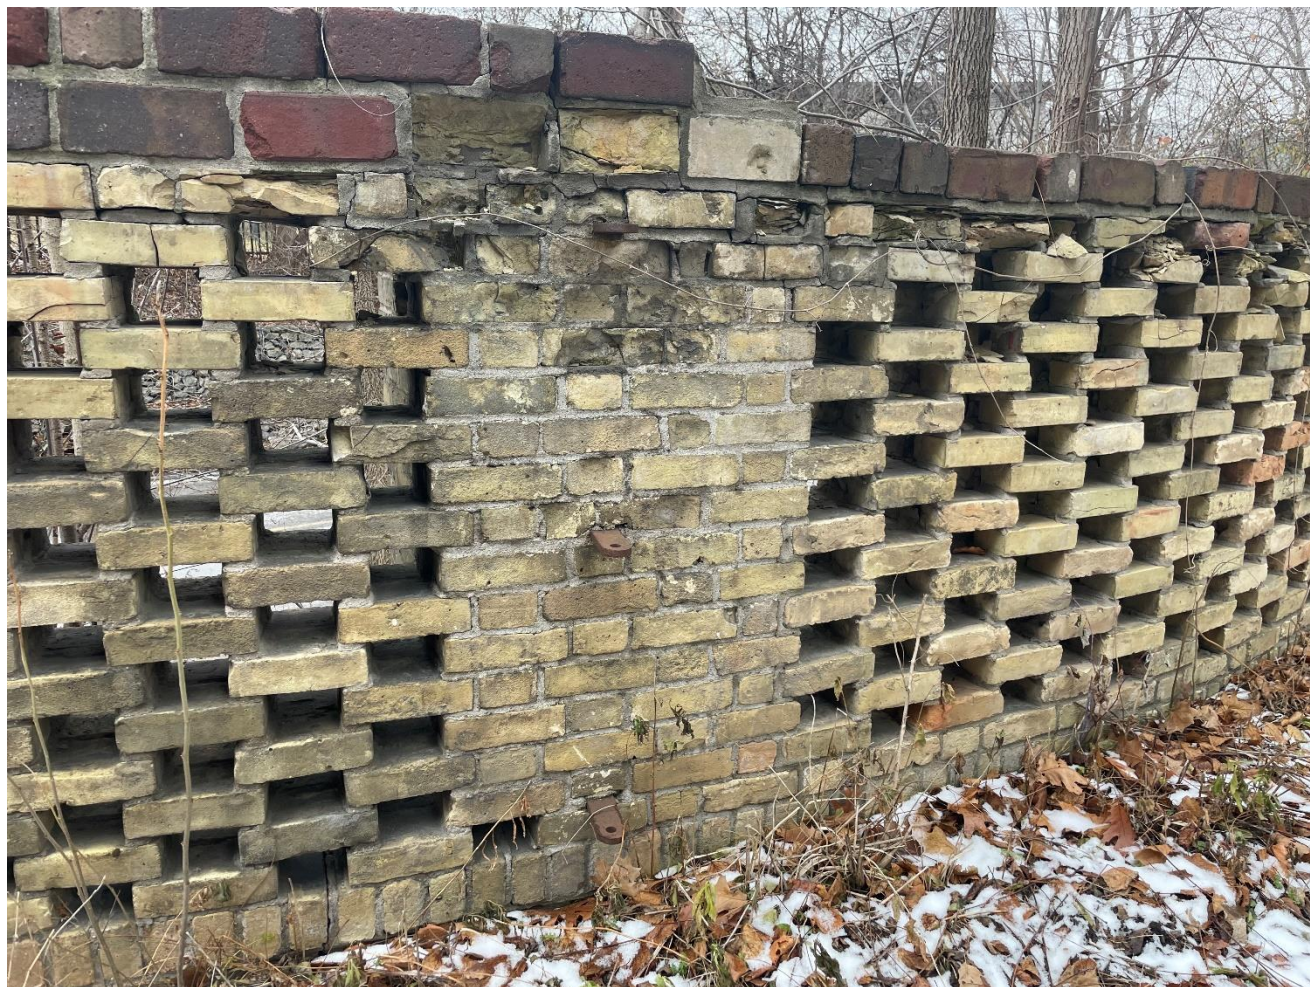
**Photograph 6:**

The pierced brick entrance feature's current condition is illustrated by crumbling, spalling, and cracked bricks, deteriorating mortar joints, missing embellishments (i.e., spolia), and an overgrowth of foliage that weaves through the cracks of the feature (**Photograph 6** and **Photograph 7**).

A view of the pierced brick entrance feature, illustrating crumbling, spalling, and cracked bricks, deteriorating mortar joints, and an overgrowth of foliage, looking north at the pierced brick entrance feature east of the driveway (AECOM, 2022)

The current brick of the pierced brick entrance feature is in poor condition and the original design has been compromised. The brick is not suitable for reuse in the new structural high pierced brick wall. Furthermore, the arrangement of existing pierced brick entrance feature is not suitable by current structural perspectives. Since direct relocation and reconstruction with replication is not possible, a new high pierced brick wall has been proposed with the original design sympathetically modified to incorporate the essential characteristics into the design. The proposed concept is shown in **Figure 5** below.

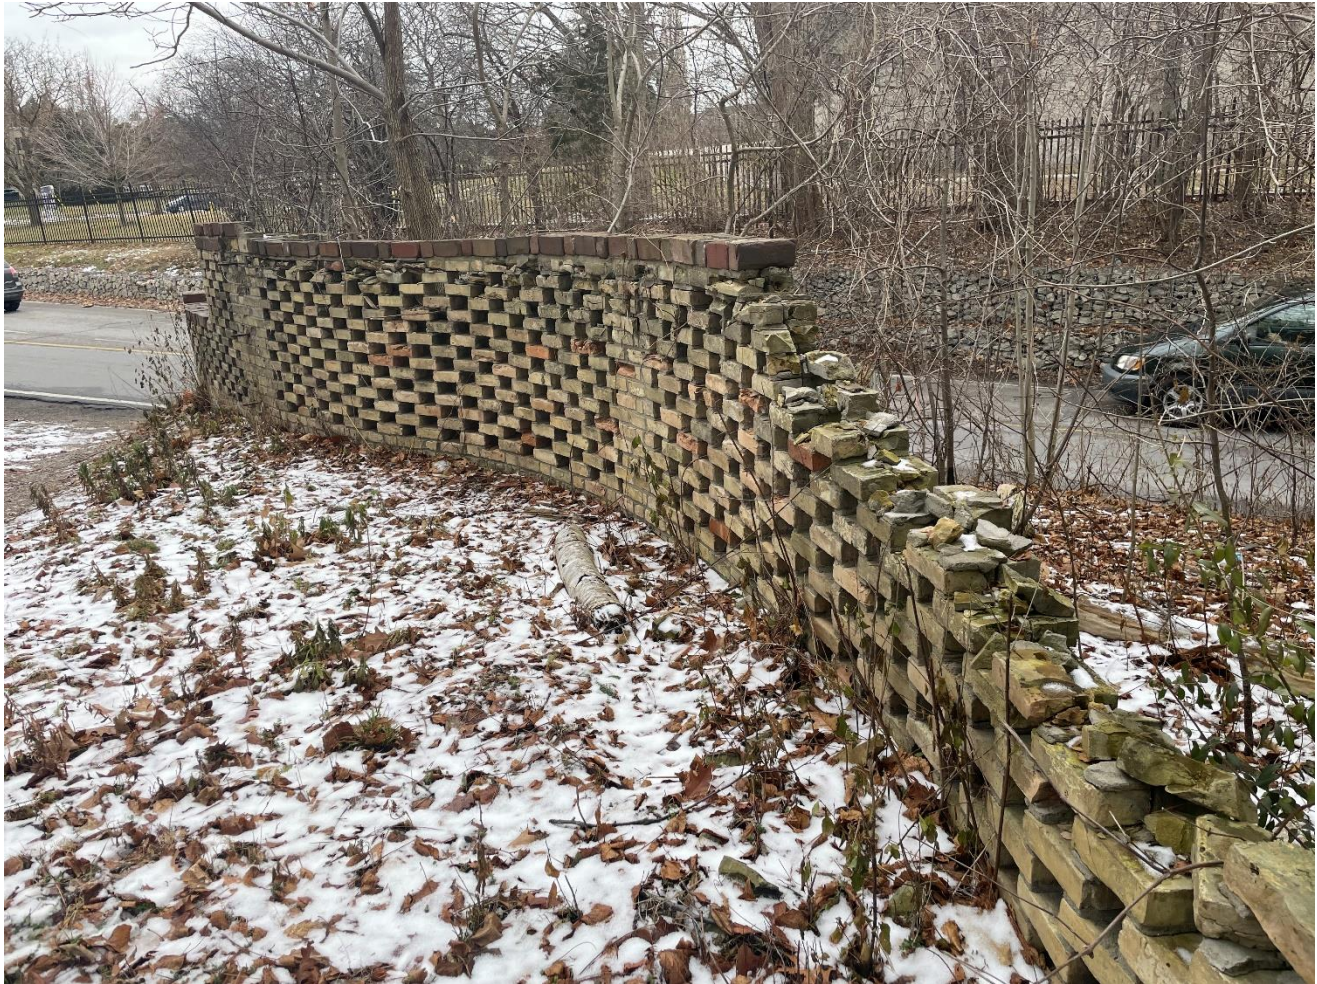
**Photograph 7:**

A view of the pierced brick entrance feature on the east side of the driveway, illustrating its decaying condition, looking north (AECOM, 2022)

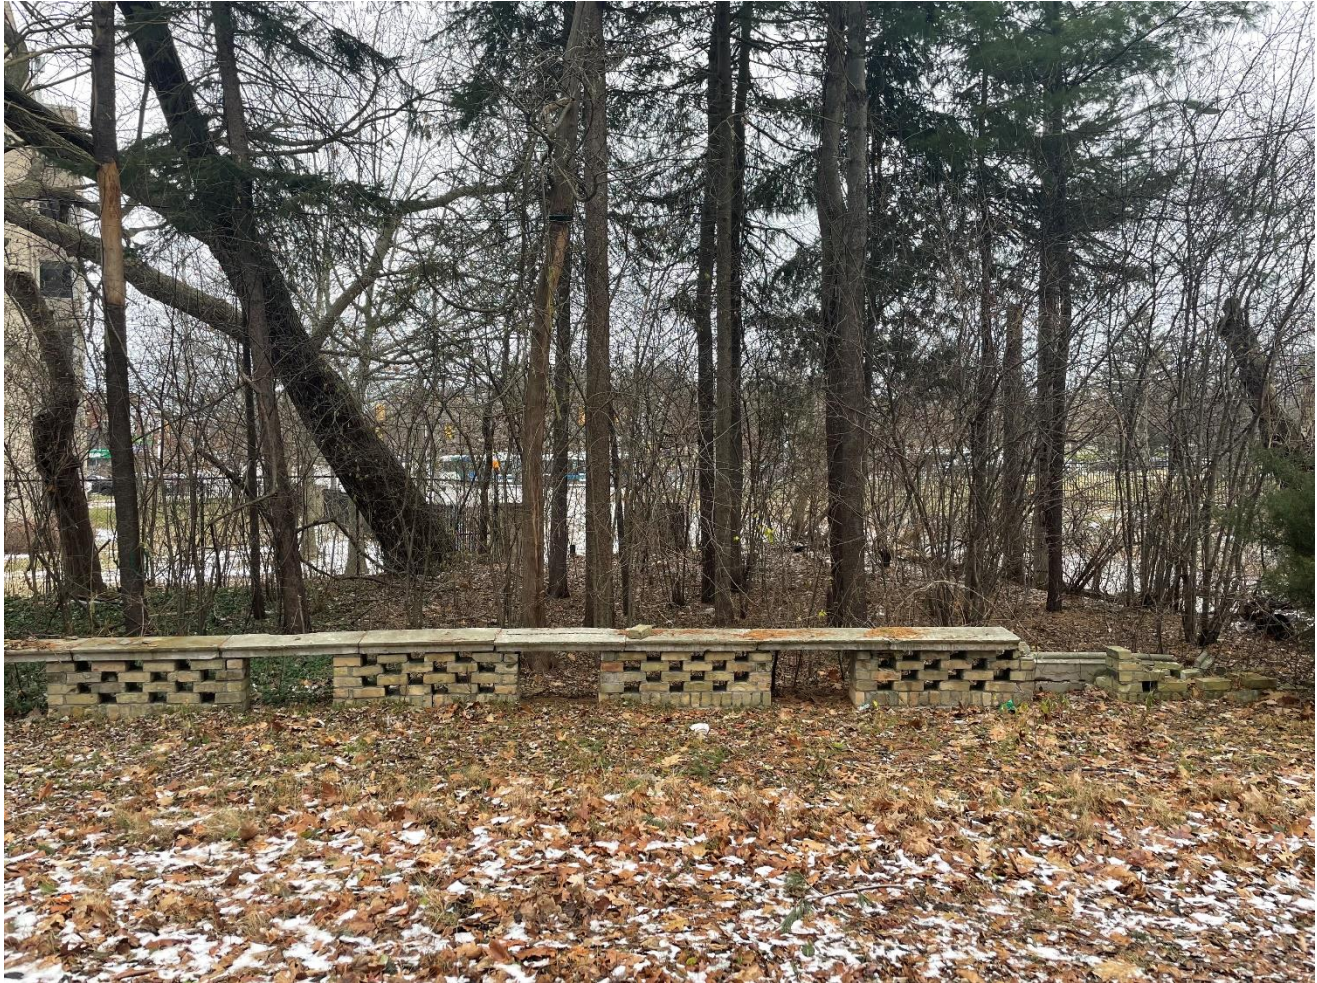
**Photograph 8:**

The pierced brick low seat wall consists of an alternating pattern of a double width of buff brick stretchers laid in a pierced brick pattern, with grey mortar (**Photograph 8** and **Photograph 9**). In general, the seat wall is capped with stone slabs which provides the surface area for seating. Different from the pierced brick entrance feature, there is a space between the brickwork and the brickwork essentially forms piers to the capstone. The foundation of the pierced brick low seat wall is constructed on a course of headers. The pierced brick low seat wall is in poor condition with crumbling, cracked and spalled bricks, cracked stone slabs, deteriorating mortar joints and sections of the wall that have collapsed (**Photograph 10** and **Photograph 11**).

A view of the piered brick low seat wall, looking west (AECOM, 2022)

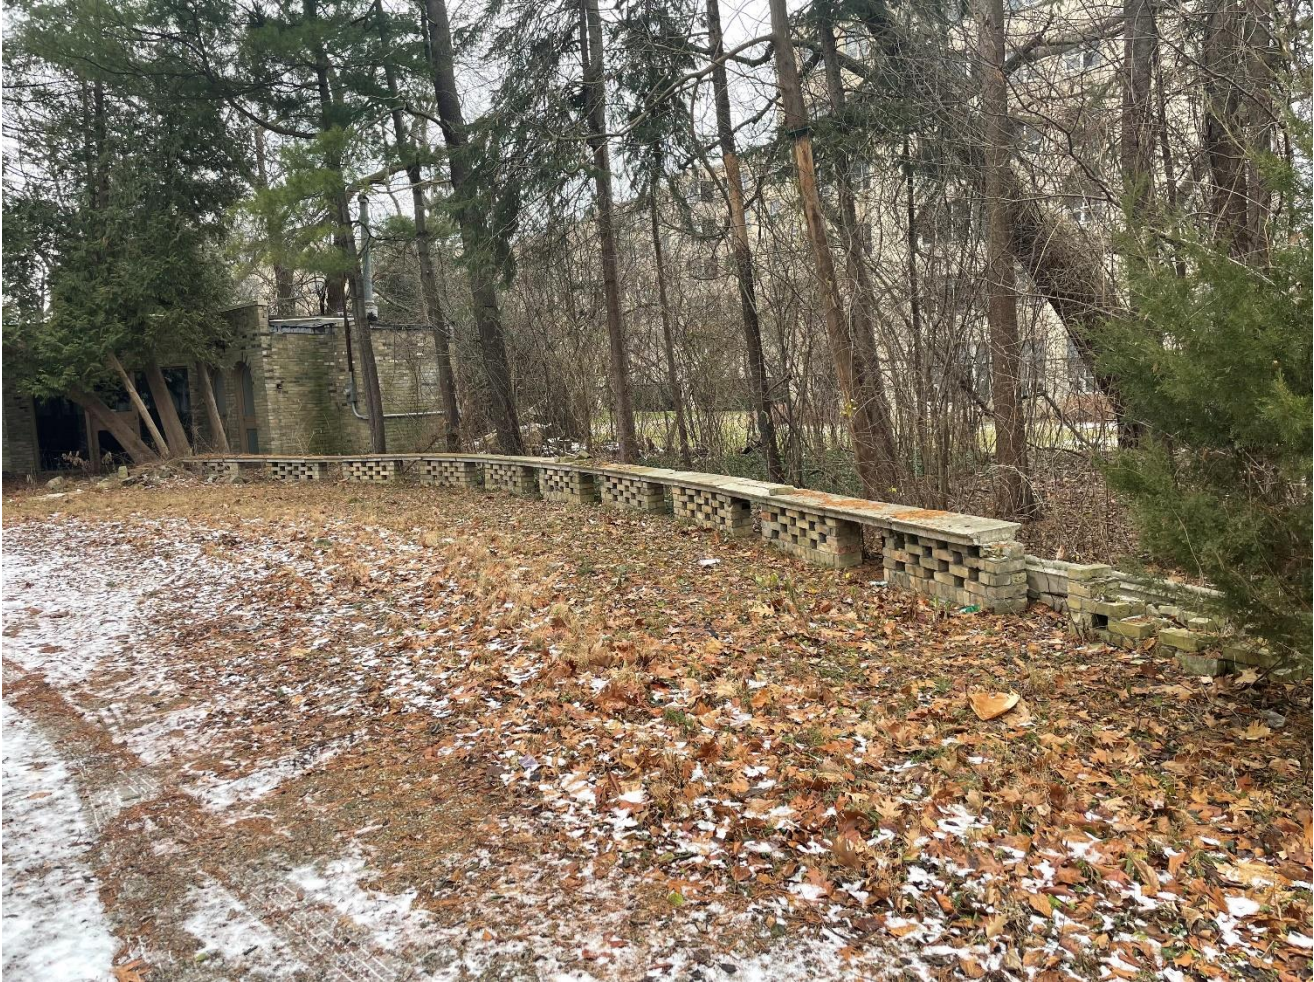
**Photograph 9:**

A view of the pierced brick low seat wall, looking southwest marking the west boundary of the courtyard area (AECOM, 2022)

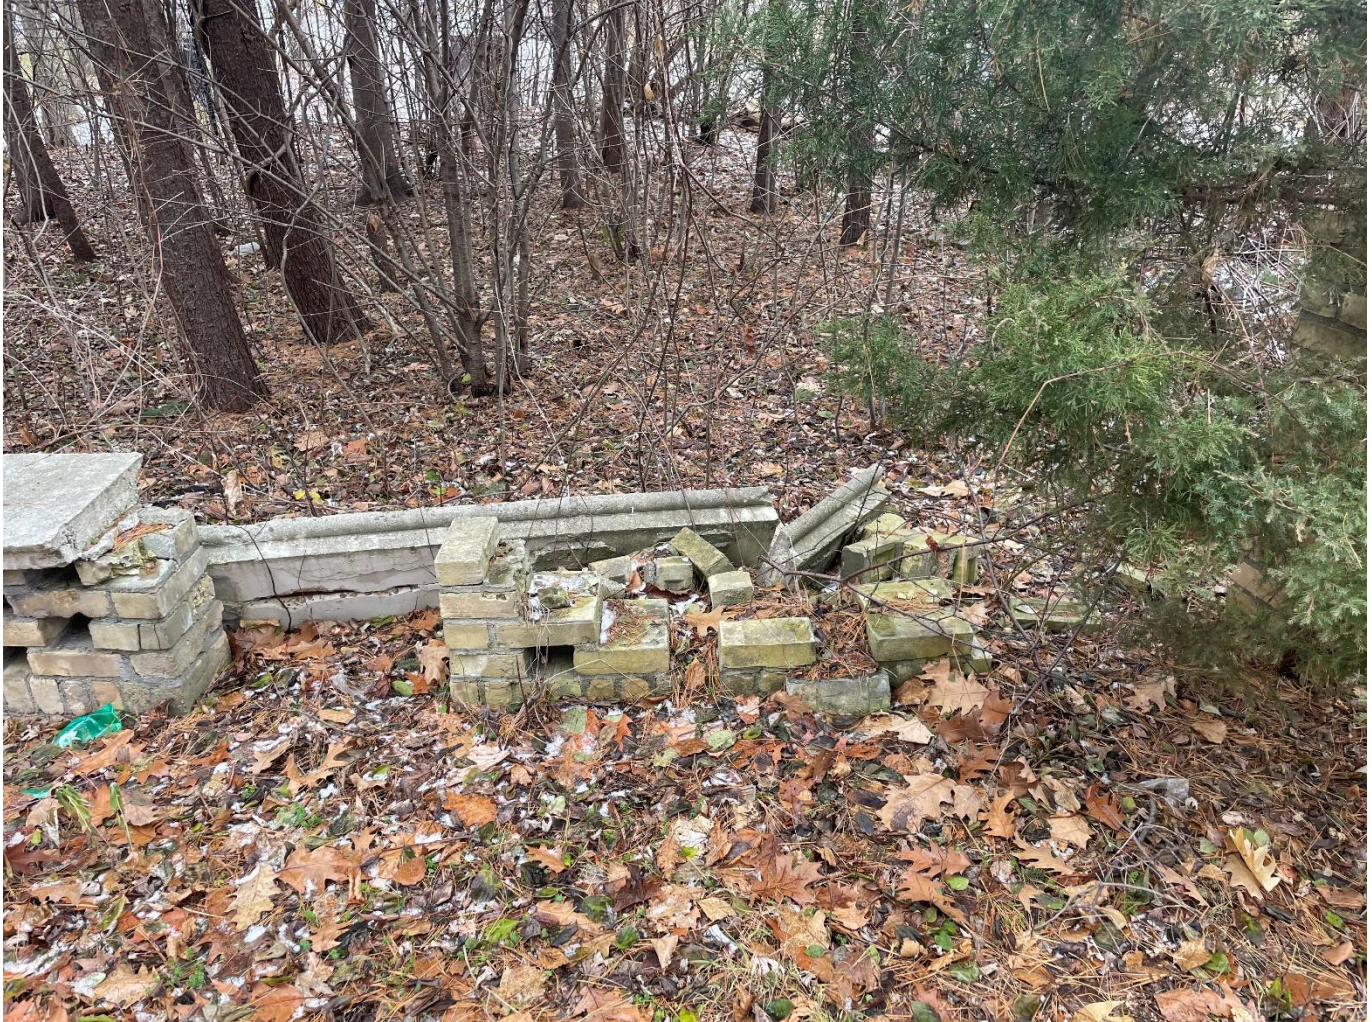
**Photograph 10:**

The northern portion of the pierced brick low seat wall is not believed to have been connected to the pierced brick entrance feature that flanks the gravel driveway (**Photograph 10**).

A view of the pierced brick low seat wall, illustrating a collapsed portion of the seat, looking west along the west boundary of the courtyard area (AECOM, 2022)

**Figure 5** shows that the removed section of the 11.1 m of the pierced brick low seat wall will be relocated to each side of the new high pierced brick wall (5.5 m on each side). The existing pierced brick low seat wall will be removed and reconstructed as close as possible to the current configuration of the seat wall. The relocation and reconstruction will use salvaged brick from the relocated seat wall and from the brick salvaged from the pierced brick entrance feature. The stone caps/seats will also be salvaged and reinstated. It is understood the replication will include the pierced brick pattern which follows the alternating pattern of a double width of buff brick stretchers laid in a pierced brick pattern. The foundation will also be sympathetic to the existing pierced brick walls with a row of headers along the bottom of the low seat wall. The following mitigation measures should be considered in the reconstruction of the pierced brick low seat wall:

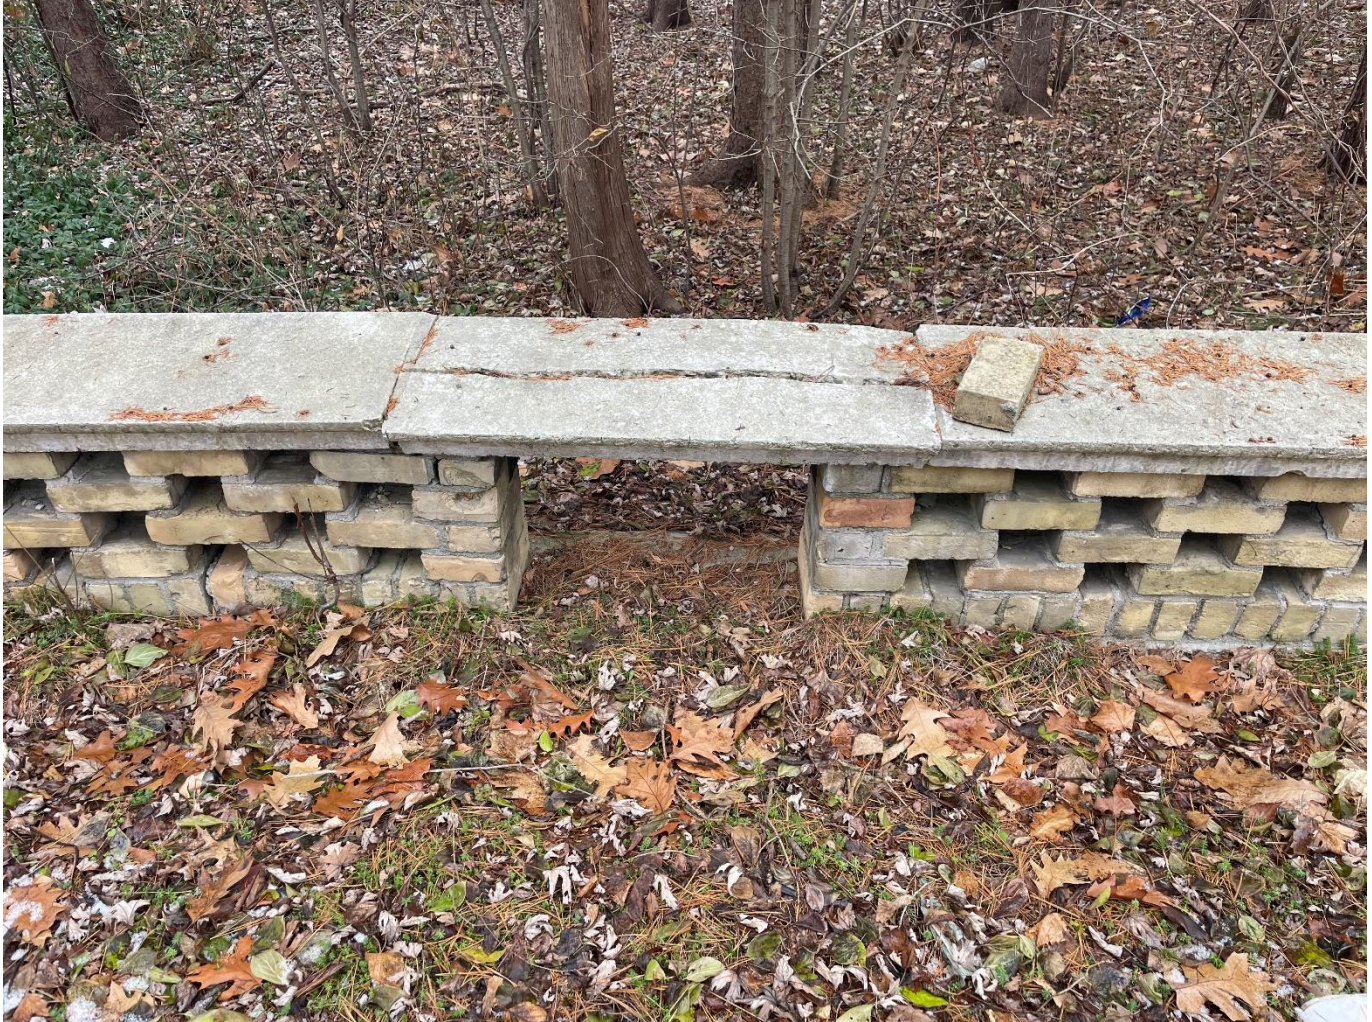
**Photograph 11:**

A view of the low pierced brick seat wall, illustrating a large crack located on a stone slab (AECOM, 2022)

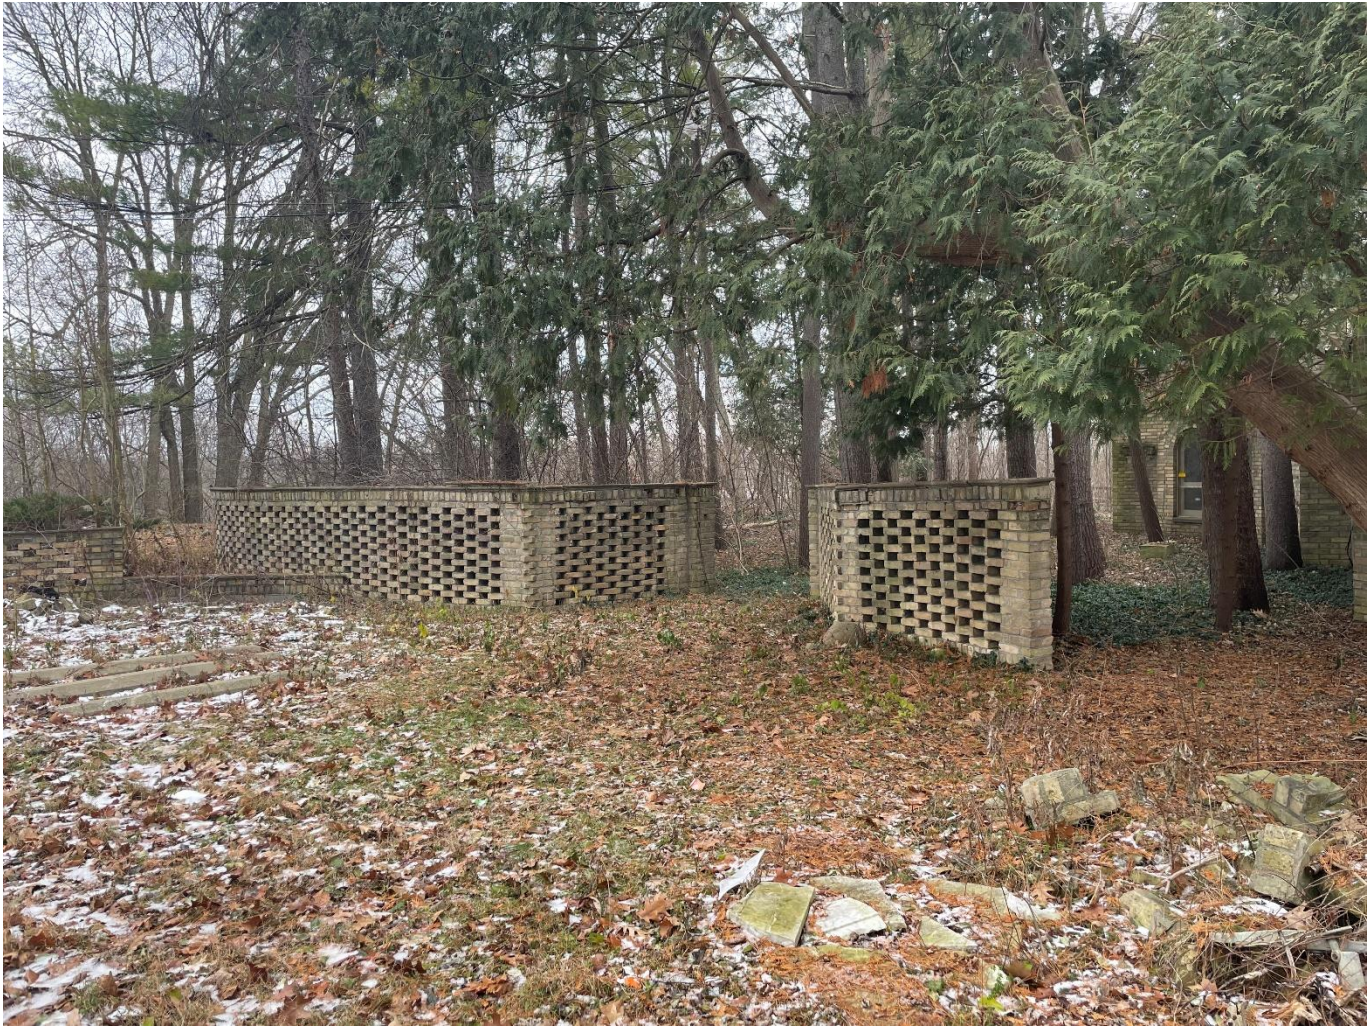
**Photograph 12:**

Defining the south end of the courtyard is another pierced brick entrance feature to the art studio and gallery. This brick feature is in fair condition. The walls have experienced little deterioration and are largely intact. Similar, to the other walls on the property these walls consist of an alternating pattern of a double width of buff brick stretchers laid in a pierced brick pattern with grey mortar. The pierced brickwork is integrated with columns. Similar to the driveway pierced brick entrance feature, the columns add strength to the pierced brick high wall and are constructed of buff brick that are laid with a pattern of stretchers and headers. The foundation of the pierced brick entrance features consists of a course of headers. Different from the driveway pierced brick entrance features, the south end brick feature is capped with a row of headers and a flat concrete cap (**Photograph 12** and **Photograph 13**).

A view of the pierced brick high wall and art studio and gallery pierced brick entrance feature, looking south (AECOM, 2022)

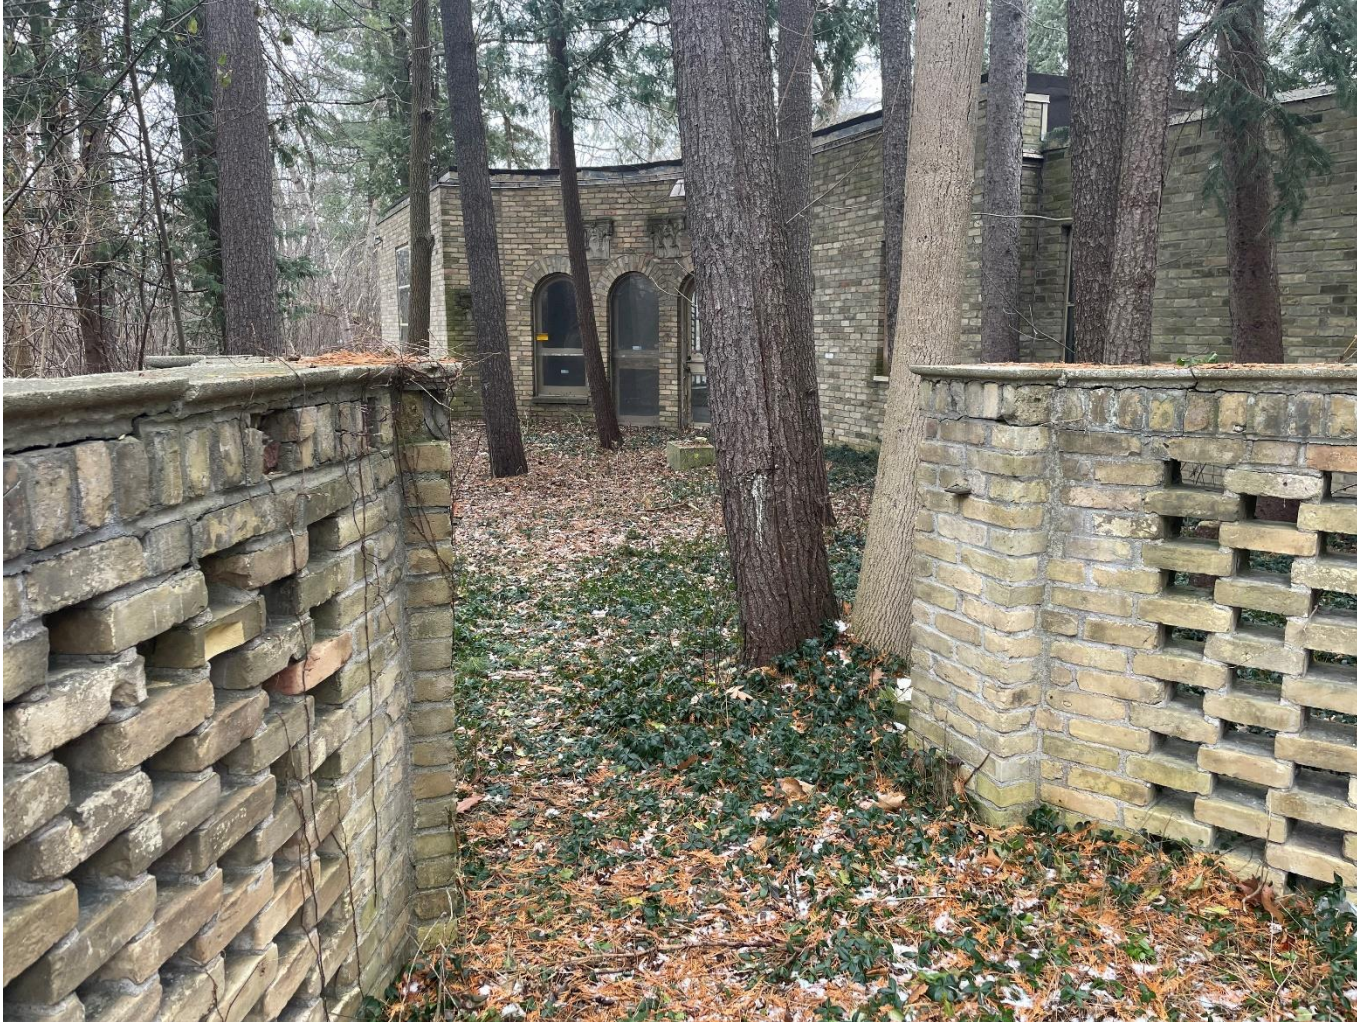
**Photograph 13:**  
A view of the art studio and gallery through the entrance of the pierced brick entrance feature, looking south (AECOM, 2022)

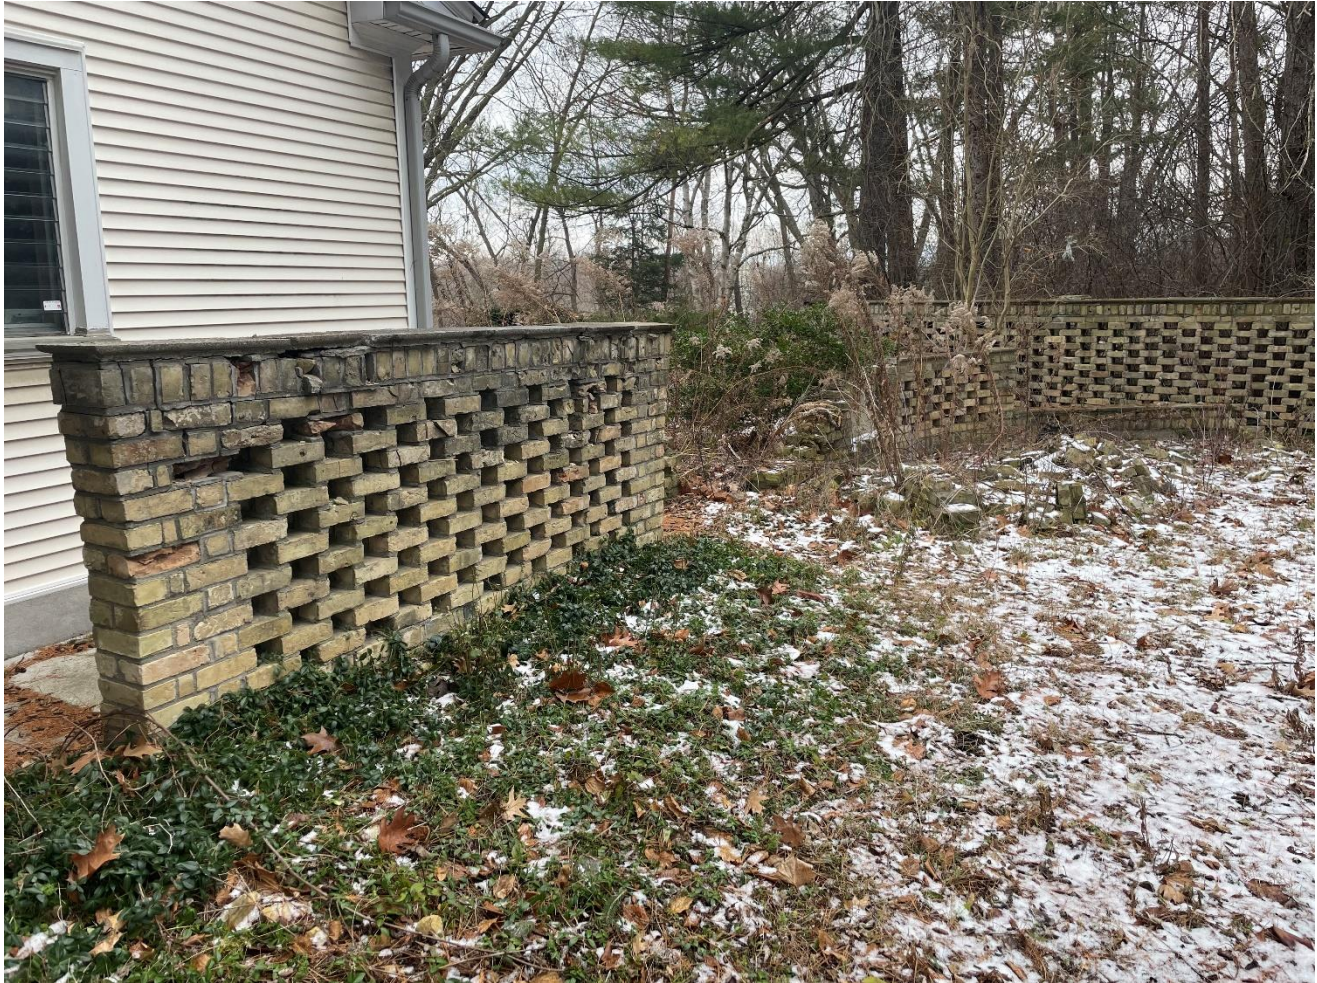
**Photograph 14:**

Located within the vicinity of the circa 1875 one-and-a-half storey house and defining the southeastern boundary of the courtyard, is another section of a pierced brick wall. Unlike the pierced brick high wall found surrounding and protecting the art studio and gallery, this section of the pierced brick high wall is in poor condition. The wall consists of crumbling brick, deteriorating mortar joints and sections of the wall that are no longer extant (**Photograph 14** and **Photograph 15**). The construction of this section is consistent with the brickwork in the south end pierced brick entrance features. The foundation of this section is obscured by foliage however, it is assumed that they are constructed on a course of buff brick headers.

A view of the pierced brick high wall located within the vicinity of the circa 1875 one-and-a-half storey house, looking east (AECOM, 2022)

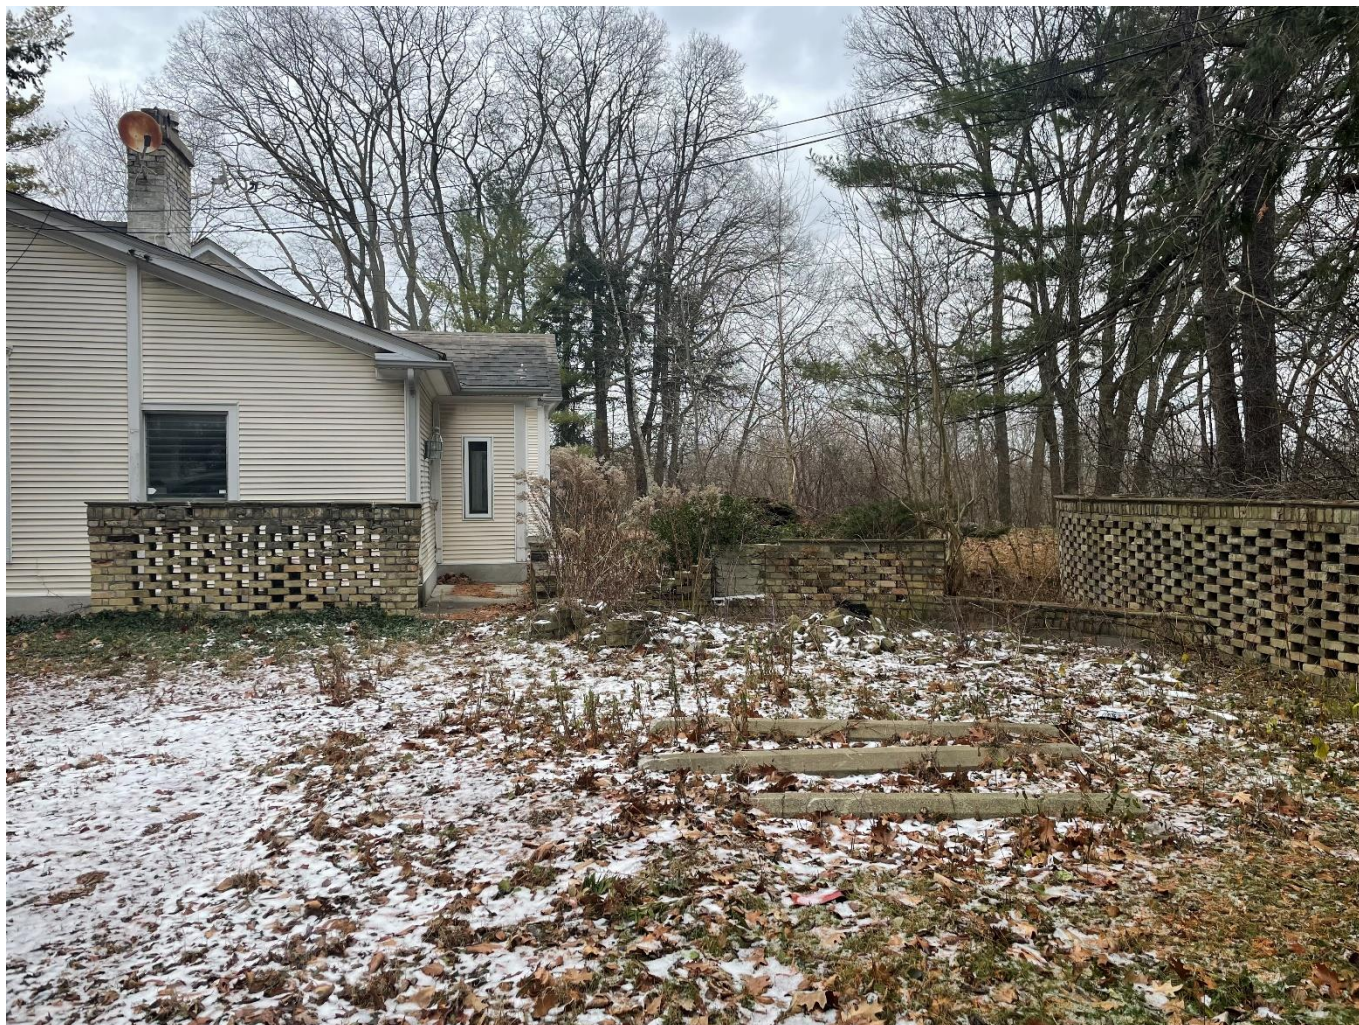
**Photograph 15:**

A view of the pierced brick high wall located within the vicinity of the circa 1875 one-and-a-half storey house, looking east (AECOM, 2022)
