# Agenda Including Addeds

5th Meeting of the Community Advisory Committee on Planning

# Heritage Impact Assessment: 150 Philip Aziz Avenue

Western Road and Sarnia Road/Philip Aziz Avenue Improvements

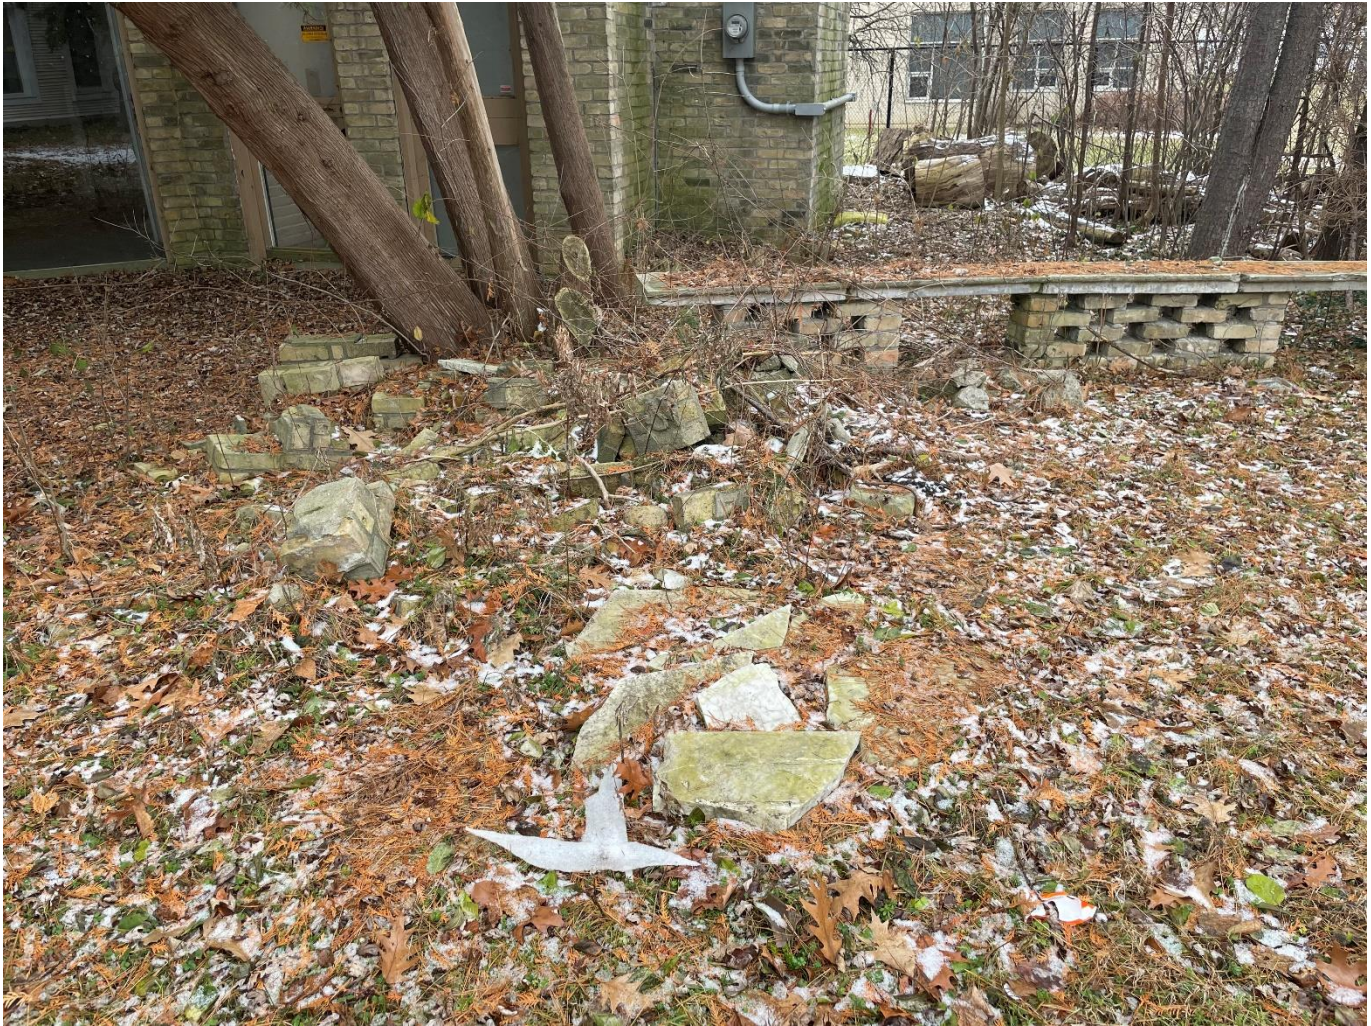
**Photograph 16:**

Located in the vicinity of the courtyard are a number of piles of rubble that consist of bricks of various tones, mortar, and stone (**Photograph 16**). It is believed that these piles of rubble would have at one point in time been a section of one of the missing pierced brick walls.

A view of one of the rubble piles found throughout the Subject Property, looking south (AECOM, 2022)

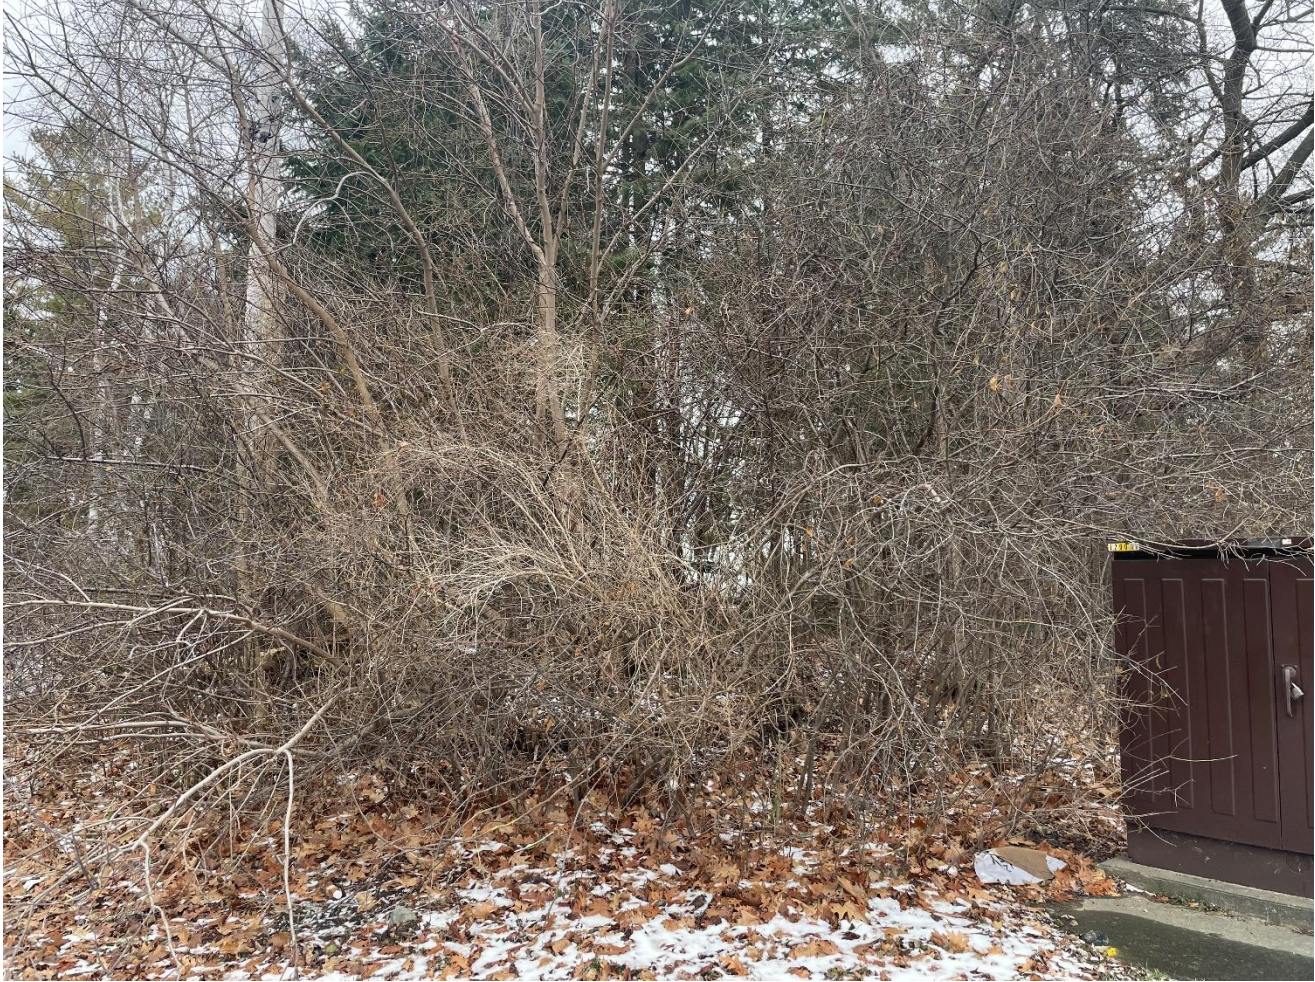
**Photograph 17:**

A number of mature trees and dense brush are located along Philip Aziz Avenue and along the northern, eastern, southern, and western boundaries of the Subject Property. The mature trees and dense brush that surround the property screen the interior of the property from the surrounding urban landscape (**Photograph 9** and **Photograph 17**).

A view of the mature trees and dense brush that are located along the northern and western boundary of the Subject Property (AECOM, 2022)

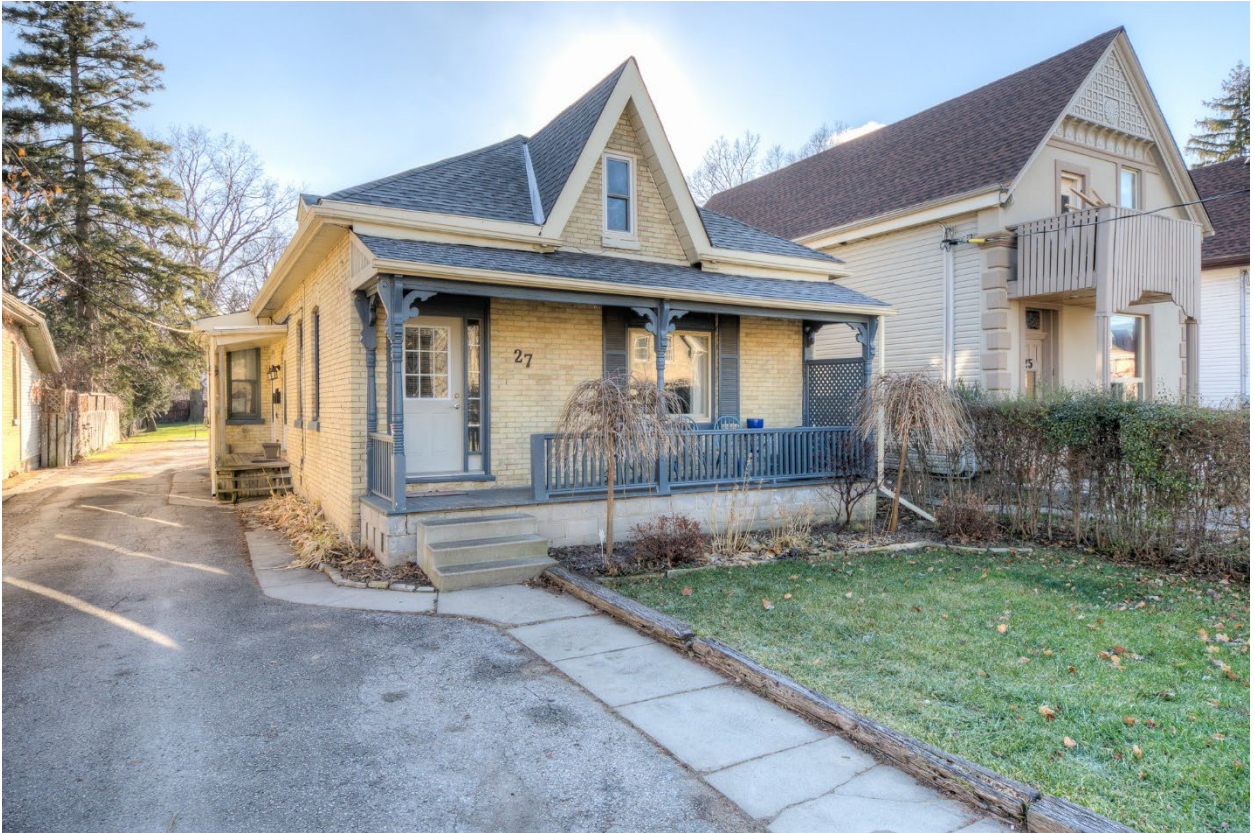
*Image 1: Photograph submitted with the Heritage Alteration Permit application showing the previous porch prior removal without Heritage Alteration Permit or Building Permit approval. The porch posts and railings consisted of wood materials. The decorative brackets have also been removed.*

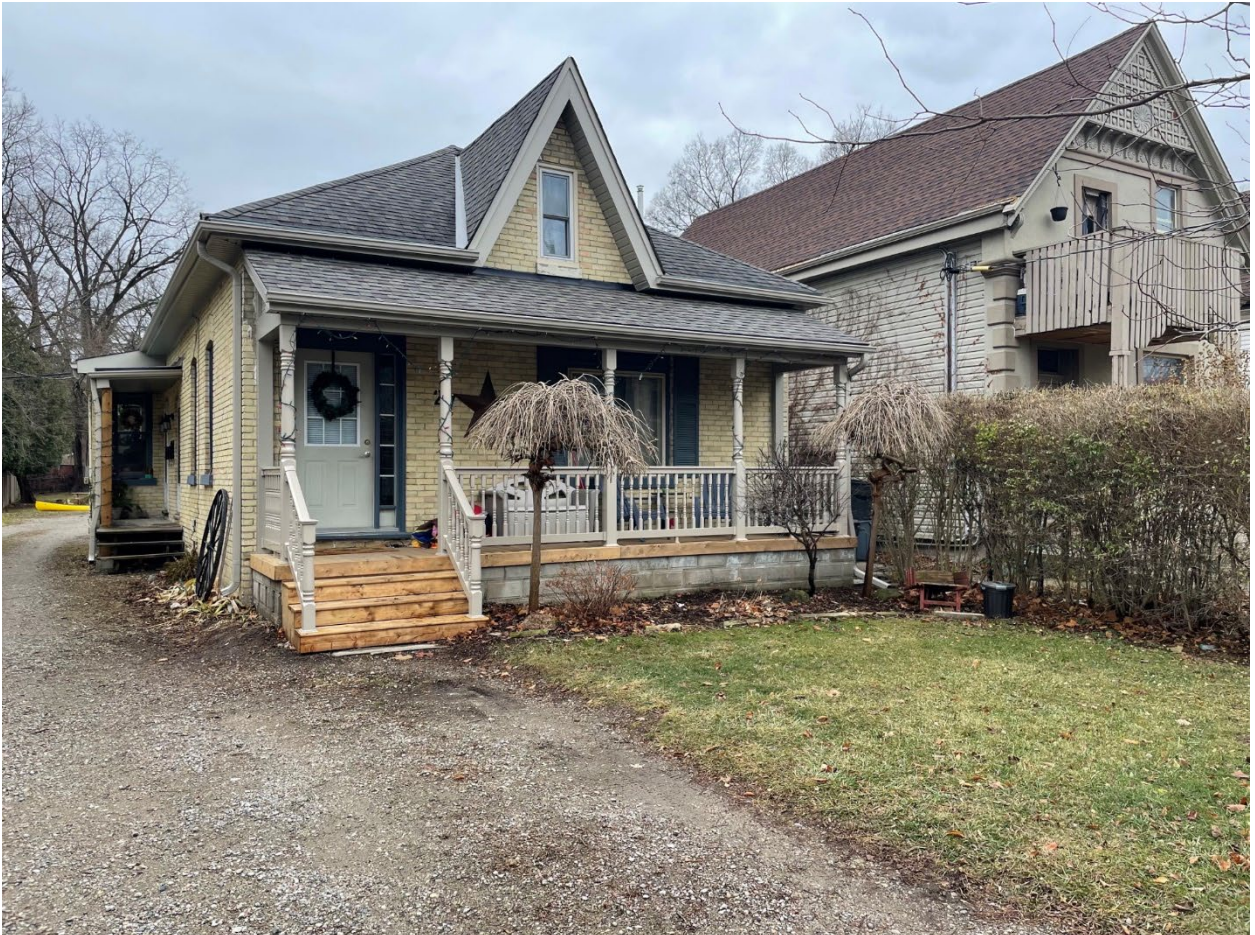
*Image 2: Photograph submitted with the Heritage Alteration Permit application showing the porch with vinyl-clad (plastic) posts and vinyl railings, with pressure-treated decking.*

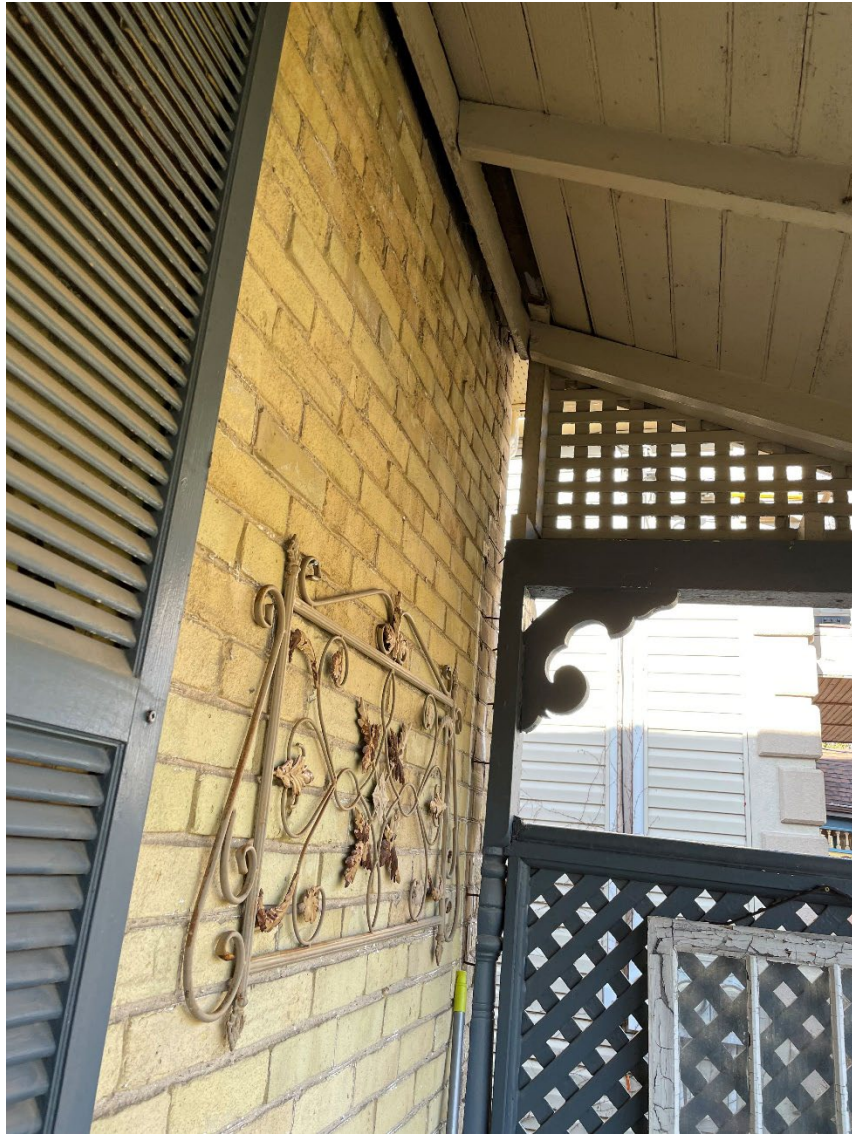
*Image 3: Photograph submitted with the Heritage Alteration Permit application demonstrating the need for repairs to the porch at 27 Bruce Street. This photograph also documents the turned posts and bracket detail of the former porch.*

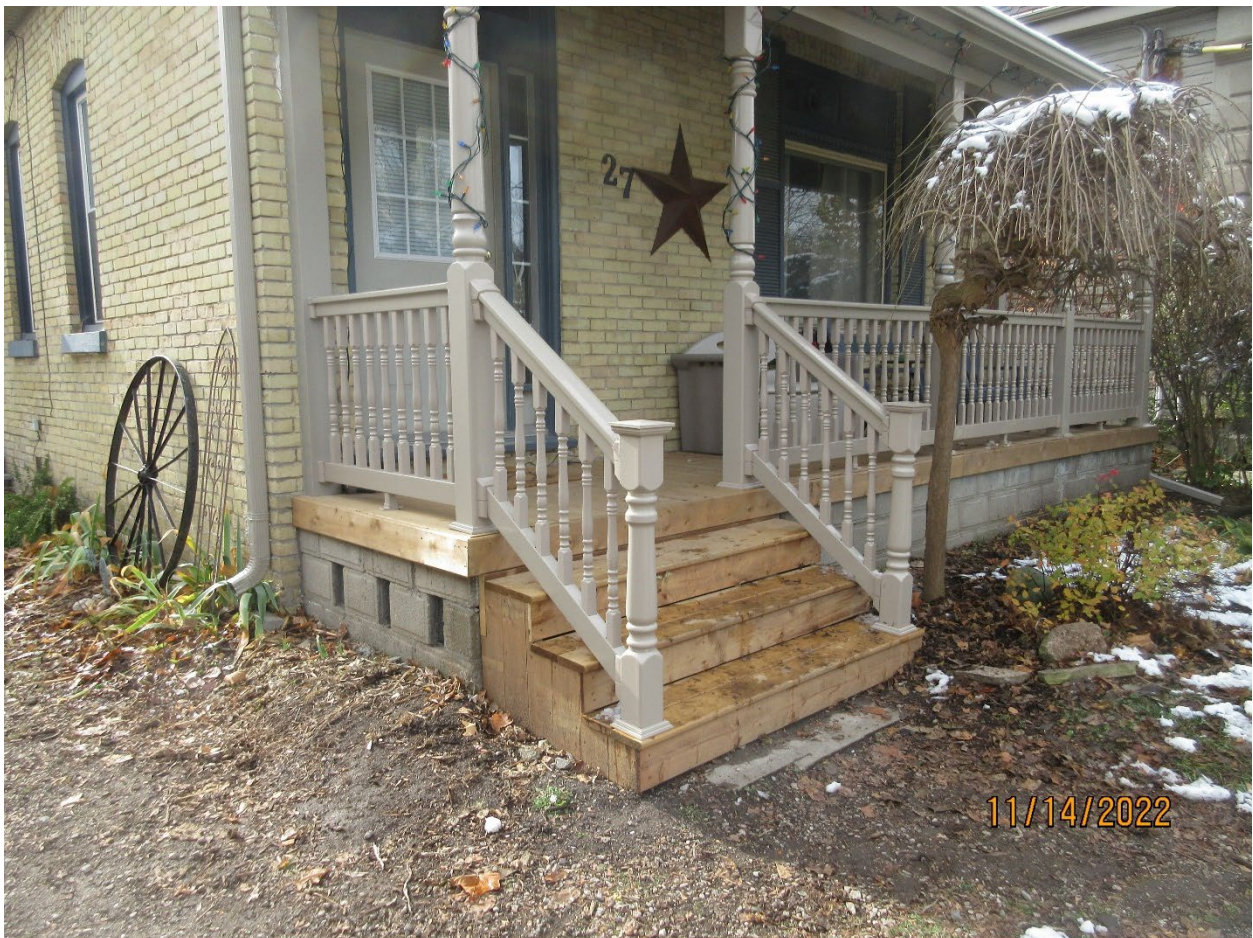
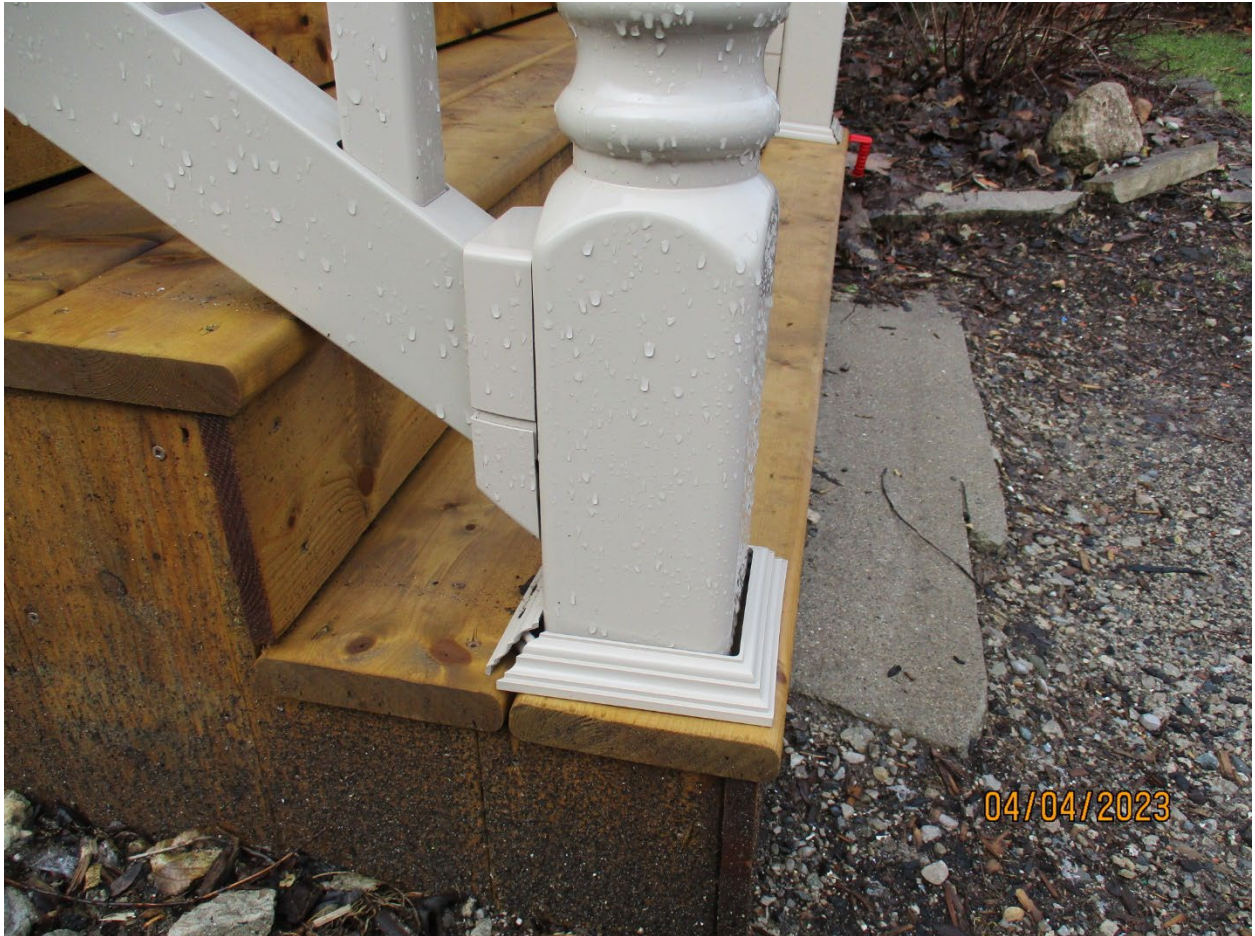
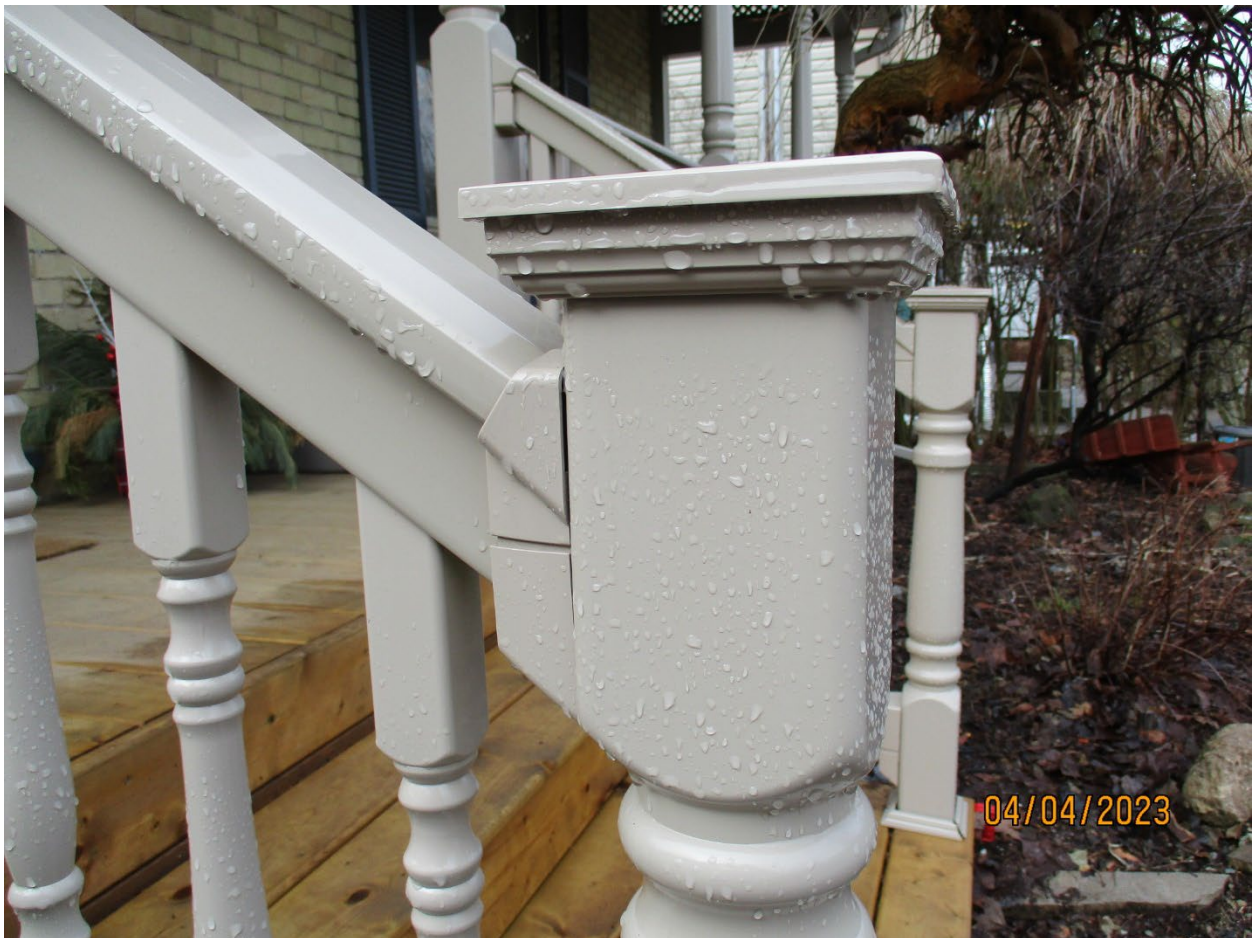
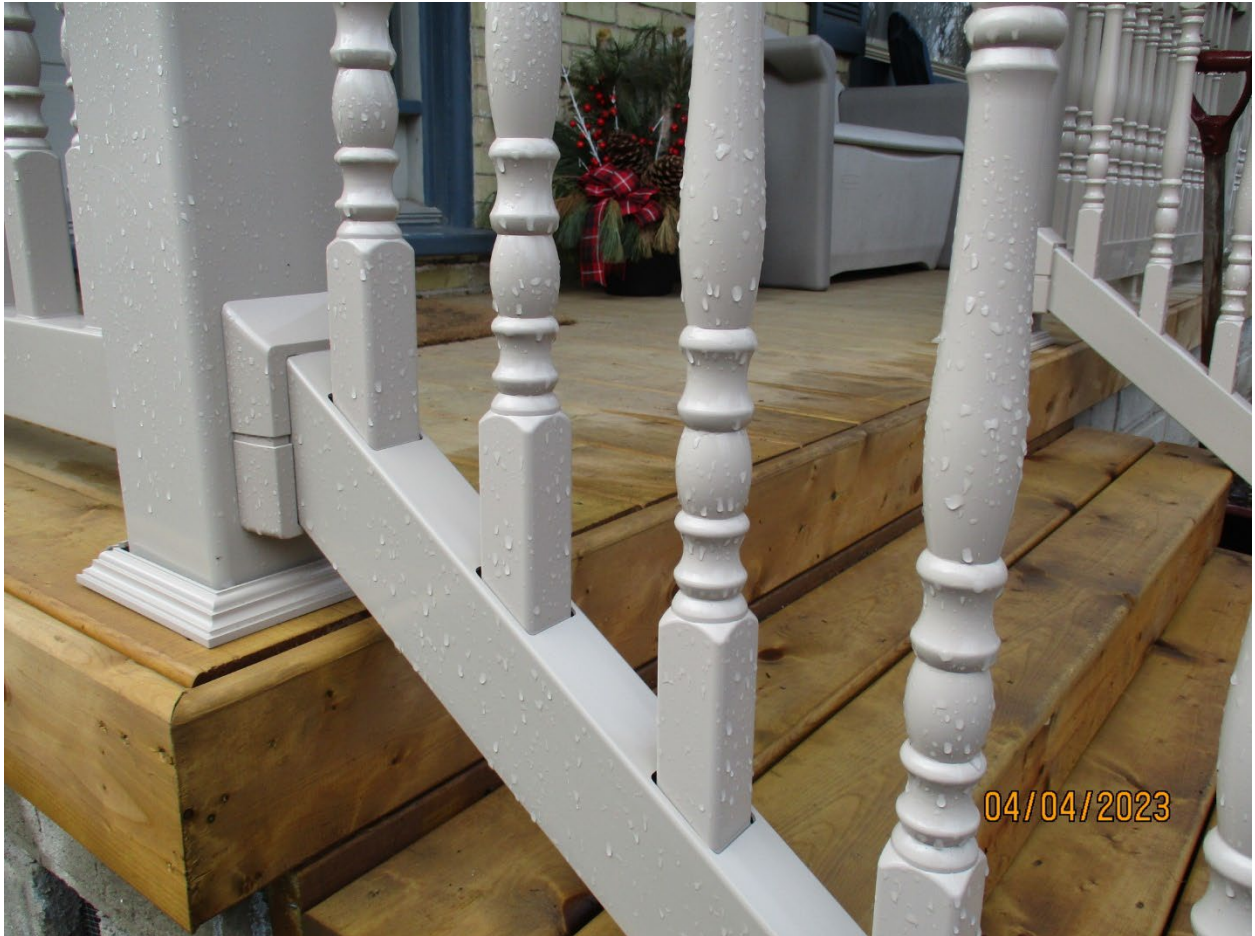
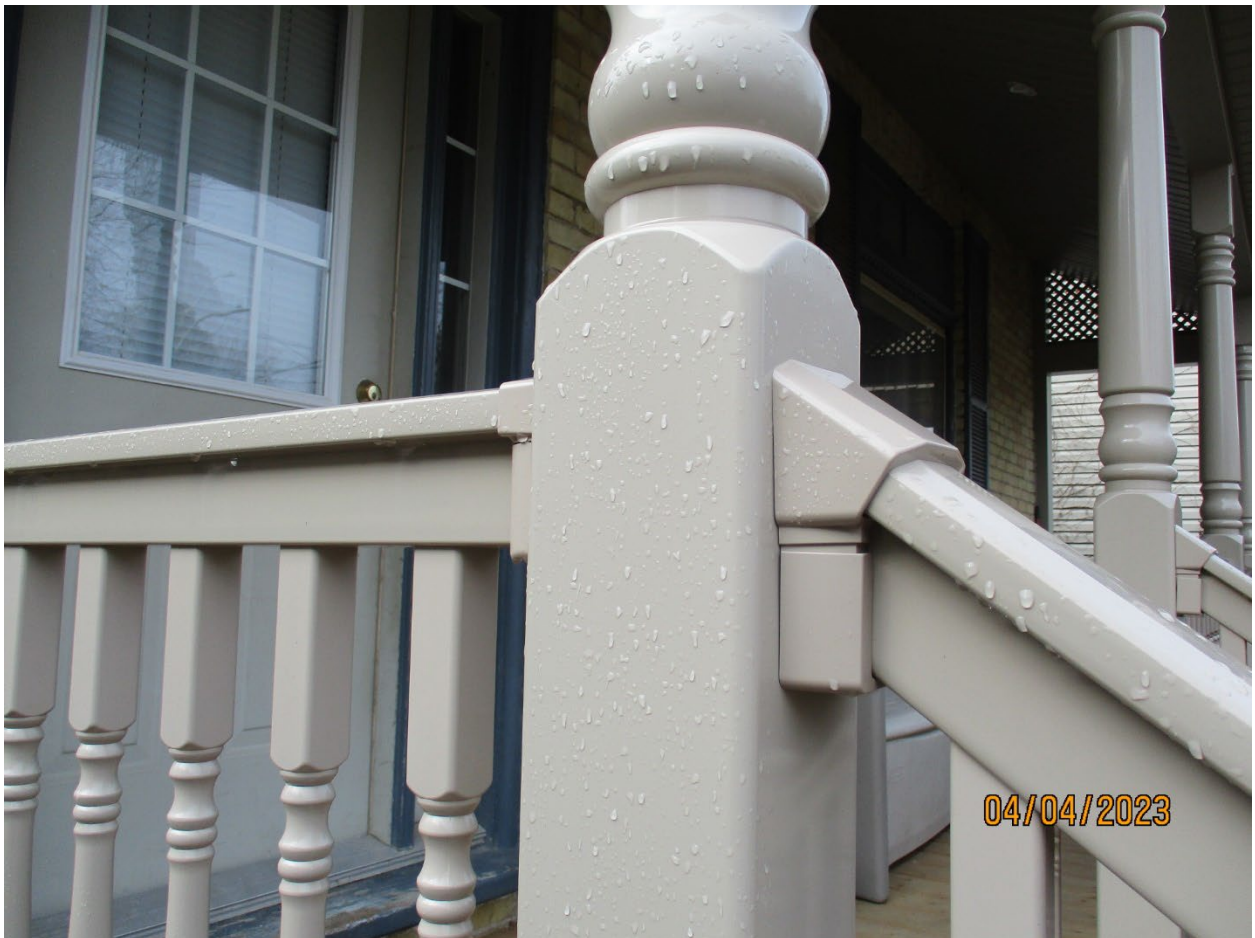
*Image 4: Photograph showing detail of the vinyl (plastic) porch materials used for the replacement of the porch at 27 Bruce Street within the Wortley Village-Old South Heritage Conservation District.*
