Agenda Including Addeds

Ecological Community Advisory Committee

7th Meeting of the Ecological Community Advisory Committee

June 15, 2023, 4:30 PM

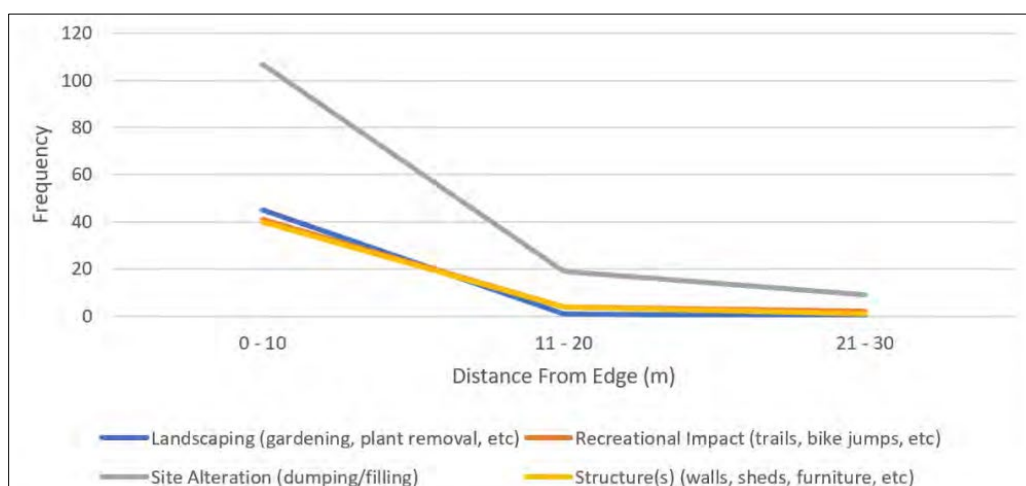
FIGURE 1 - FREQUENCY OF DISTURBANCE AT A DISTANCE FROM THE EDGE OF FEATURE¹

Most disturbances were detected within the natural feature; however, for many of the sites, disturbances were found to be occurring within a buffer area (where one was provided), suggesting that buffers are effective as a mitigation measure. When looking at the distribution of disturbances in Figure 1 below, the majority of encroachments were found to occur within 0-10 m of the edge of the natural feature; this would further suggest that buffers should be a minimum of 10 metres wide.

Furthermore, when upon comparing the average number of disturbances per metre of transect surveyed, it was found that disturbances occurred most frequently on sites with just fencing (with or without gates) implemented as a mitigation measure. Sites with a combination of buffers and fencing (with or without gates) had less disturbances than just fencing but, experienced more disturbances than sites with just buffers (which was likely due to dense vegetation in the natural area making the feature difficult to access).

Based on the findings of the 2021 post-development monitoring fieldworks it was found that most encroachments occur within 10 metres of the edge of the natural feature, which could be within a 10 metre wide buffer (if one was present). Staff should undertake a review of buffer requirements and their recommended minimum widths and adjust Table 5-2 of the City's Environmental Management Guidelines (2021) where buffers less than 10 metres are proposed.

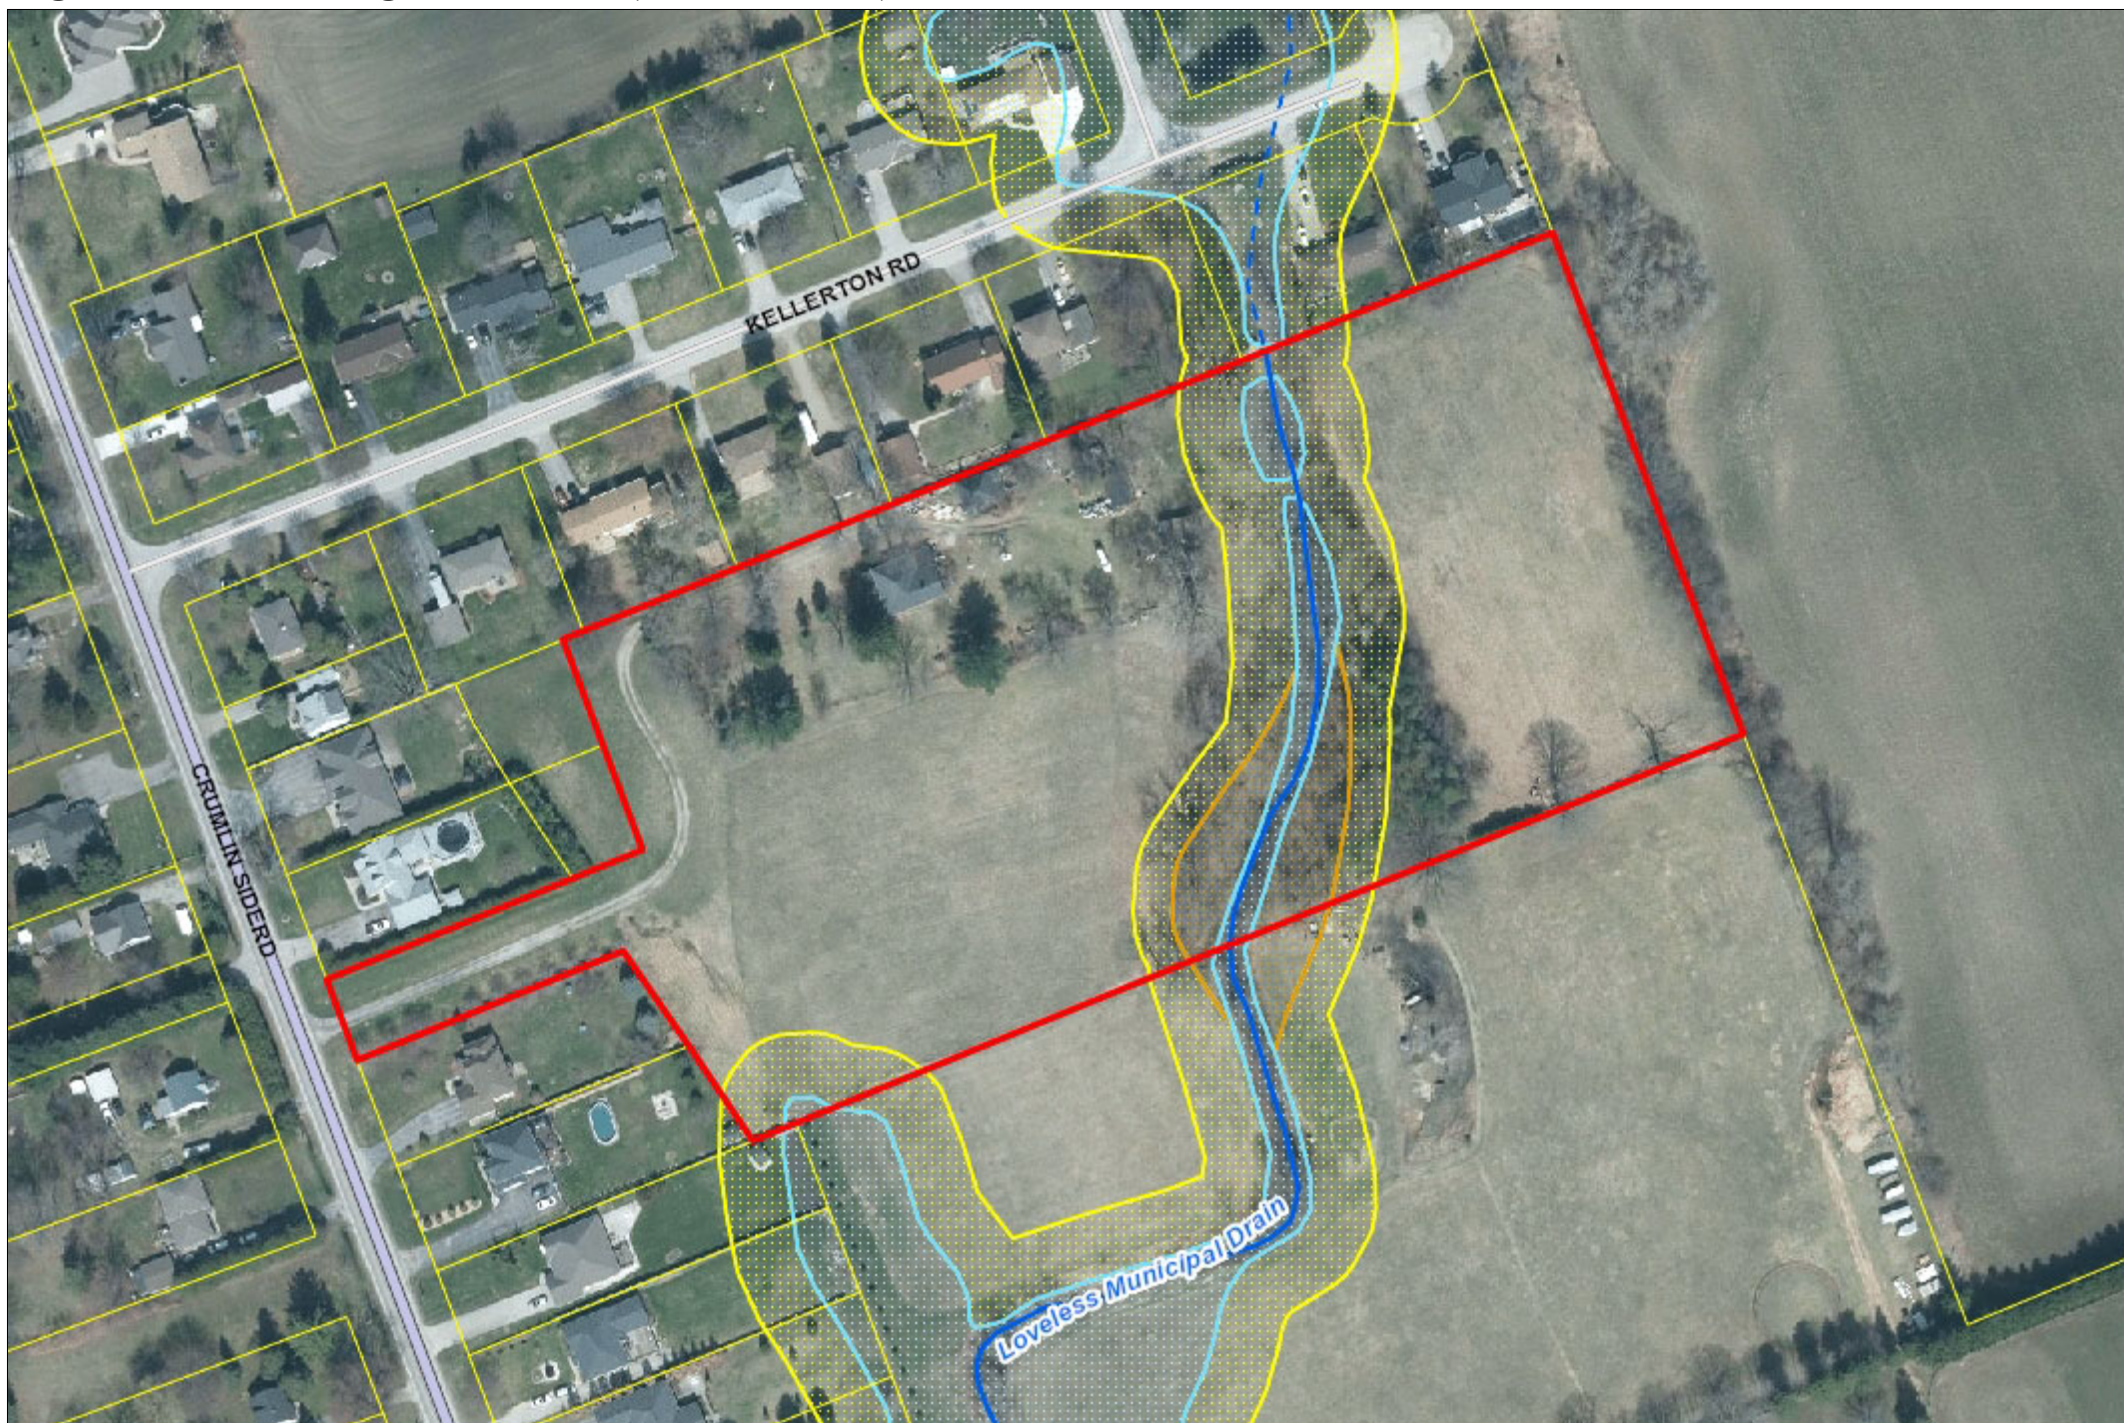
Figure 5: UTRCA Regulated Areas (UTRCA, 2022)

The Upper Thames River Conservation Authority (UTRCA) regulations within the Subject Lands are primarily associated with the flood and erosion hazard of the drain flowing through the property [Figure 5]. An area in the southwest is also regulated due to a flood hazard. These regulation areas will be discussed further in this EIS.

A drain flows approximately north to south through the Subject Lands. This drain is identified as “Loveless Drainage Works -1998” on the Ministry of Agriculture, Food and Rural Affairs mapping (OMAFRA, 2022) and “Loveless Municipal Drain” on UTRCA mapping (2022) [Figure 5]. The drain flows south to Waubuno Creek approximately 2.9 km downstream. The drain is classified as a Class F drain by DFO (AgMaps, 2022), indicating it is an intermittent drain that is dry for at least three months of the year (Kavanagh, Wren, & Hoggarth, 2017). Field observations of the Loveless Municipal Drain were limited, but the drain was observed to be clearly channelized on August 31, 2022. This drain is piped north of the Subject Lands.

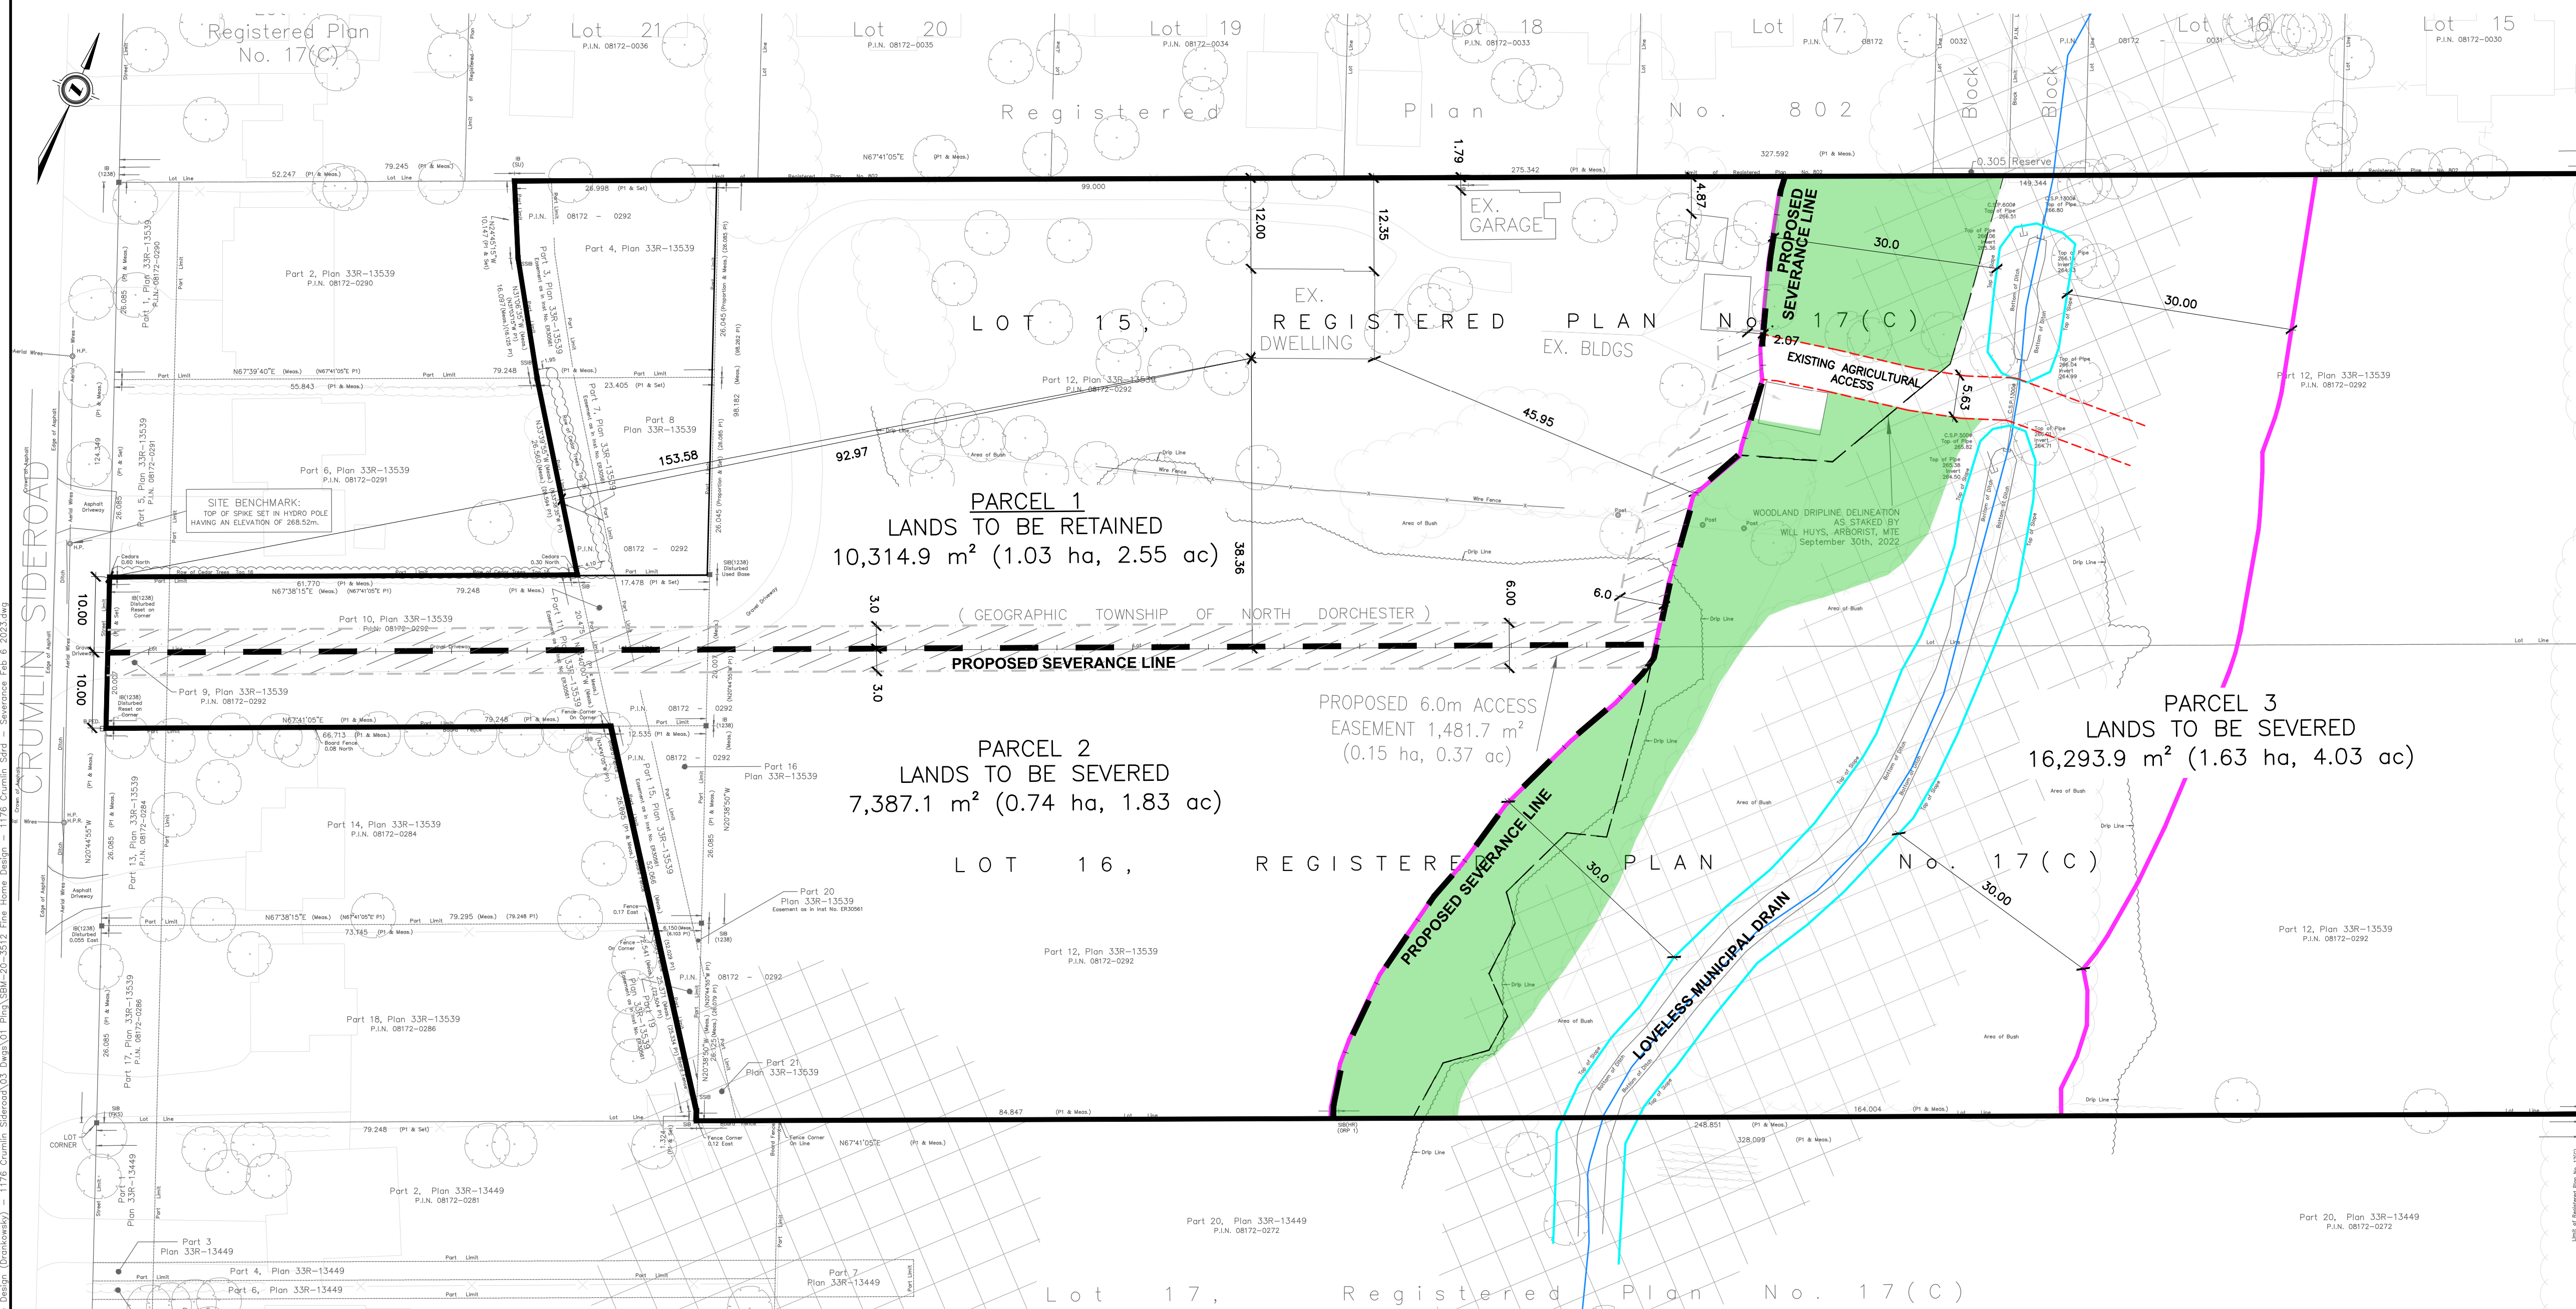
FIGURE 8

The existing agricultural access pathway (maintained grass path several metres wide) provides access over a culvert for farm equipment travelling to the east (Parcel 3). This pathway is shown on Figure 8 and is proposed to be retained for agricultural vehicle access from Parcel 1 to the east field (Parcel 3). Agricultural use of the east property will continue and will not be impacted by the OS4 zoning.

are anticipated because the OS4 buffer, as discussed in Section 6.1, will protect all significant natural heritage features present. This OS4 zone is shown on Figure 8 and is defined by a 30 m buffer from the high-water mark of the Loveless Municipal Drain and including the staked woodland dripline. The buffer is proposed to be vegetated with native species on the west side of the drain and is discussed further in Section 7.1.

No mowing or encroachment should occur within the Naturalization Area. Small concrete monuments engraved with "OS4 Zone" should be installed along the west boundary of the Naturalization Area to clearly mark the permissible limits of mowing and maintenance. An example of City-designed monuments is provided in Appendix G of this EIS. The conceptual location of the monuments is shown on Figure 8.

The Proponent (Peter Drankowsky) is proposing the severance of the Legal Parcel located at 1176 Crumlin Sideroad, London, ON into three Parcels [Figure 8]. The existing home will remain, and one new single-family home will be constructed on Parcel 2. Parcel 3 will continue to be actively farmed.

The proposed Severance Plan will provide an OS4 zone that builds upon the existing Open Space area to incorporate buffers to the natural heritage features surrounding the Loveless Municipal Drain within the Subject Lands [Figure 8; MTE, 2022] in accordance with the London Environmental Management Guidelines (2021). This OS4 zone, as agreed upon with the City of London, is defined as 30 m from the high-water mark of the drain plus contiguous woodland vegetation. This buffer is shown on Figure 8 of the EIS and protects the Significant Woodland, Candidate SWH for bat roosting and Eastern Wood-pewee, possible fish habitat, and potential habitat for endangered bat species inside the OS4 zone. The west side of the buffer will be naturalized where woodland vegetation does not already exist, and the east side will continue to be used for agricultural activities. Naturalization activities are described in more detail in the Focused EIS and under Section 3.0 Post-Construction of this EMP.

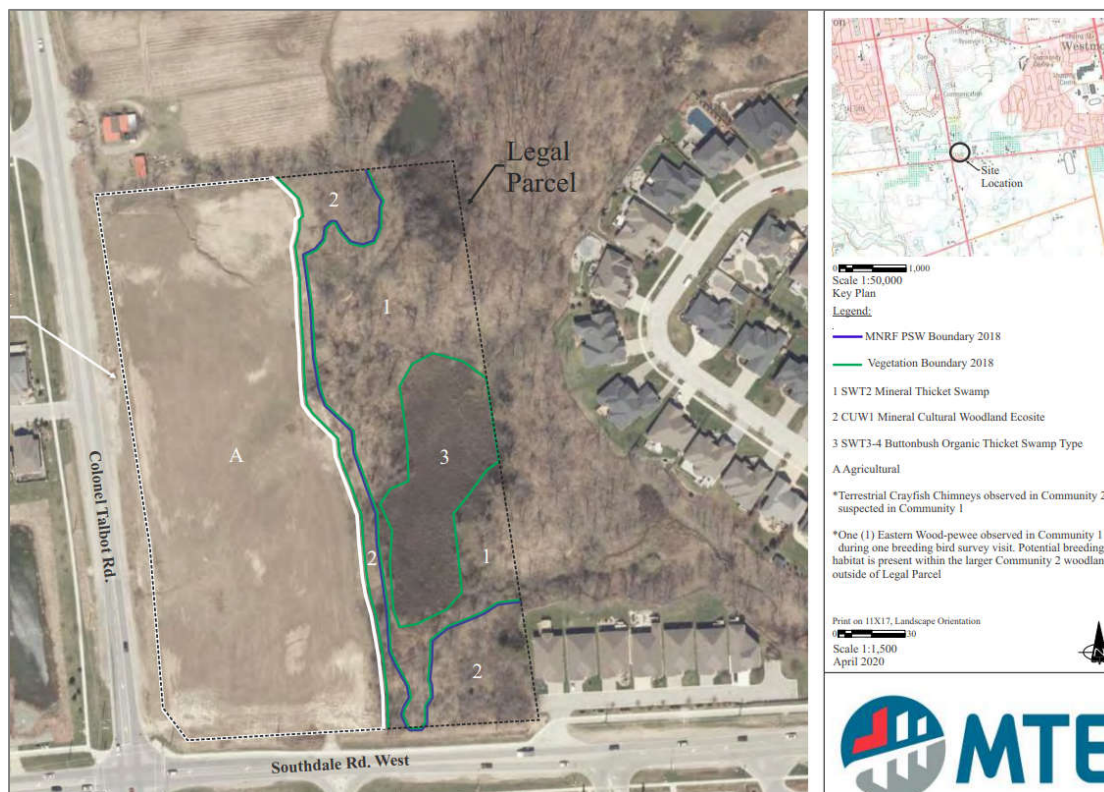
Figure 3: Vegetation Communities Mapping (Excerpt)

The head of the wetland feature is immediately downstream of two stormwater management ponds, accessed from Longworth Road and Gabor Street. The Buttonbush Wetland falls within the Upper Thames River Conservation Authority (UTRCA) Regulated Lands. The UTRCA has Regulated Lands along the eastern boundary and to the north-east of the site. The requirements for development within UTRCA Regulated Lands are discussed further in Section 2.3

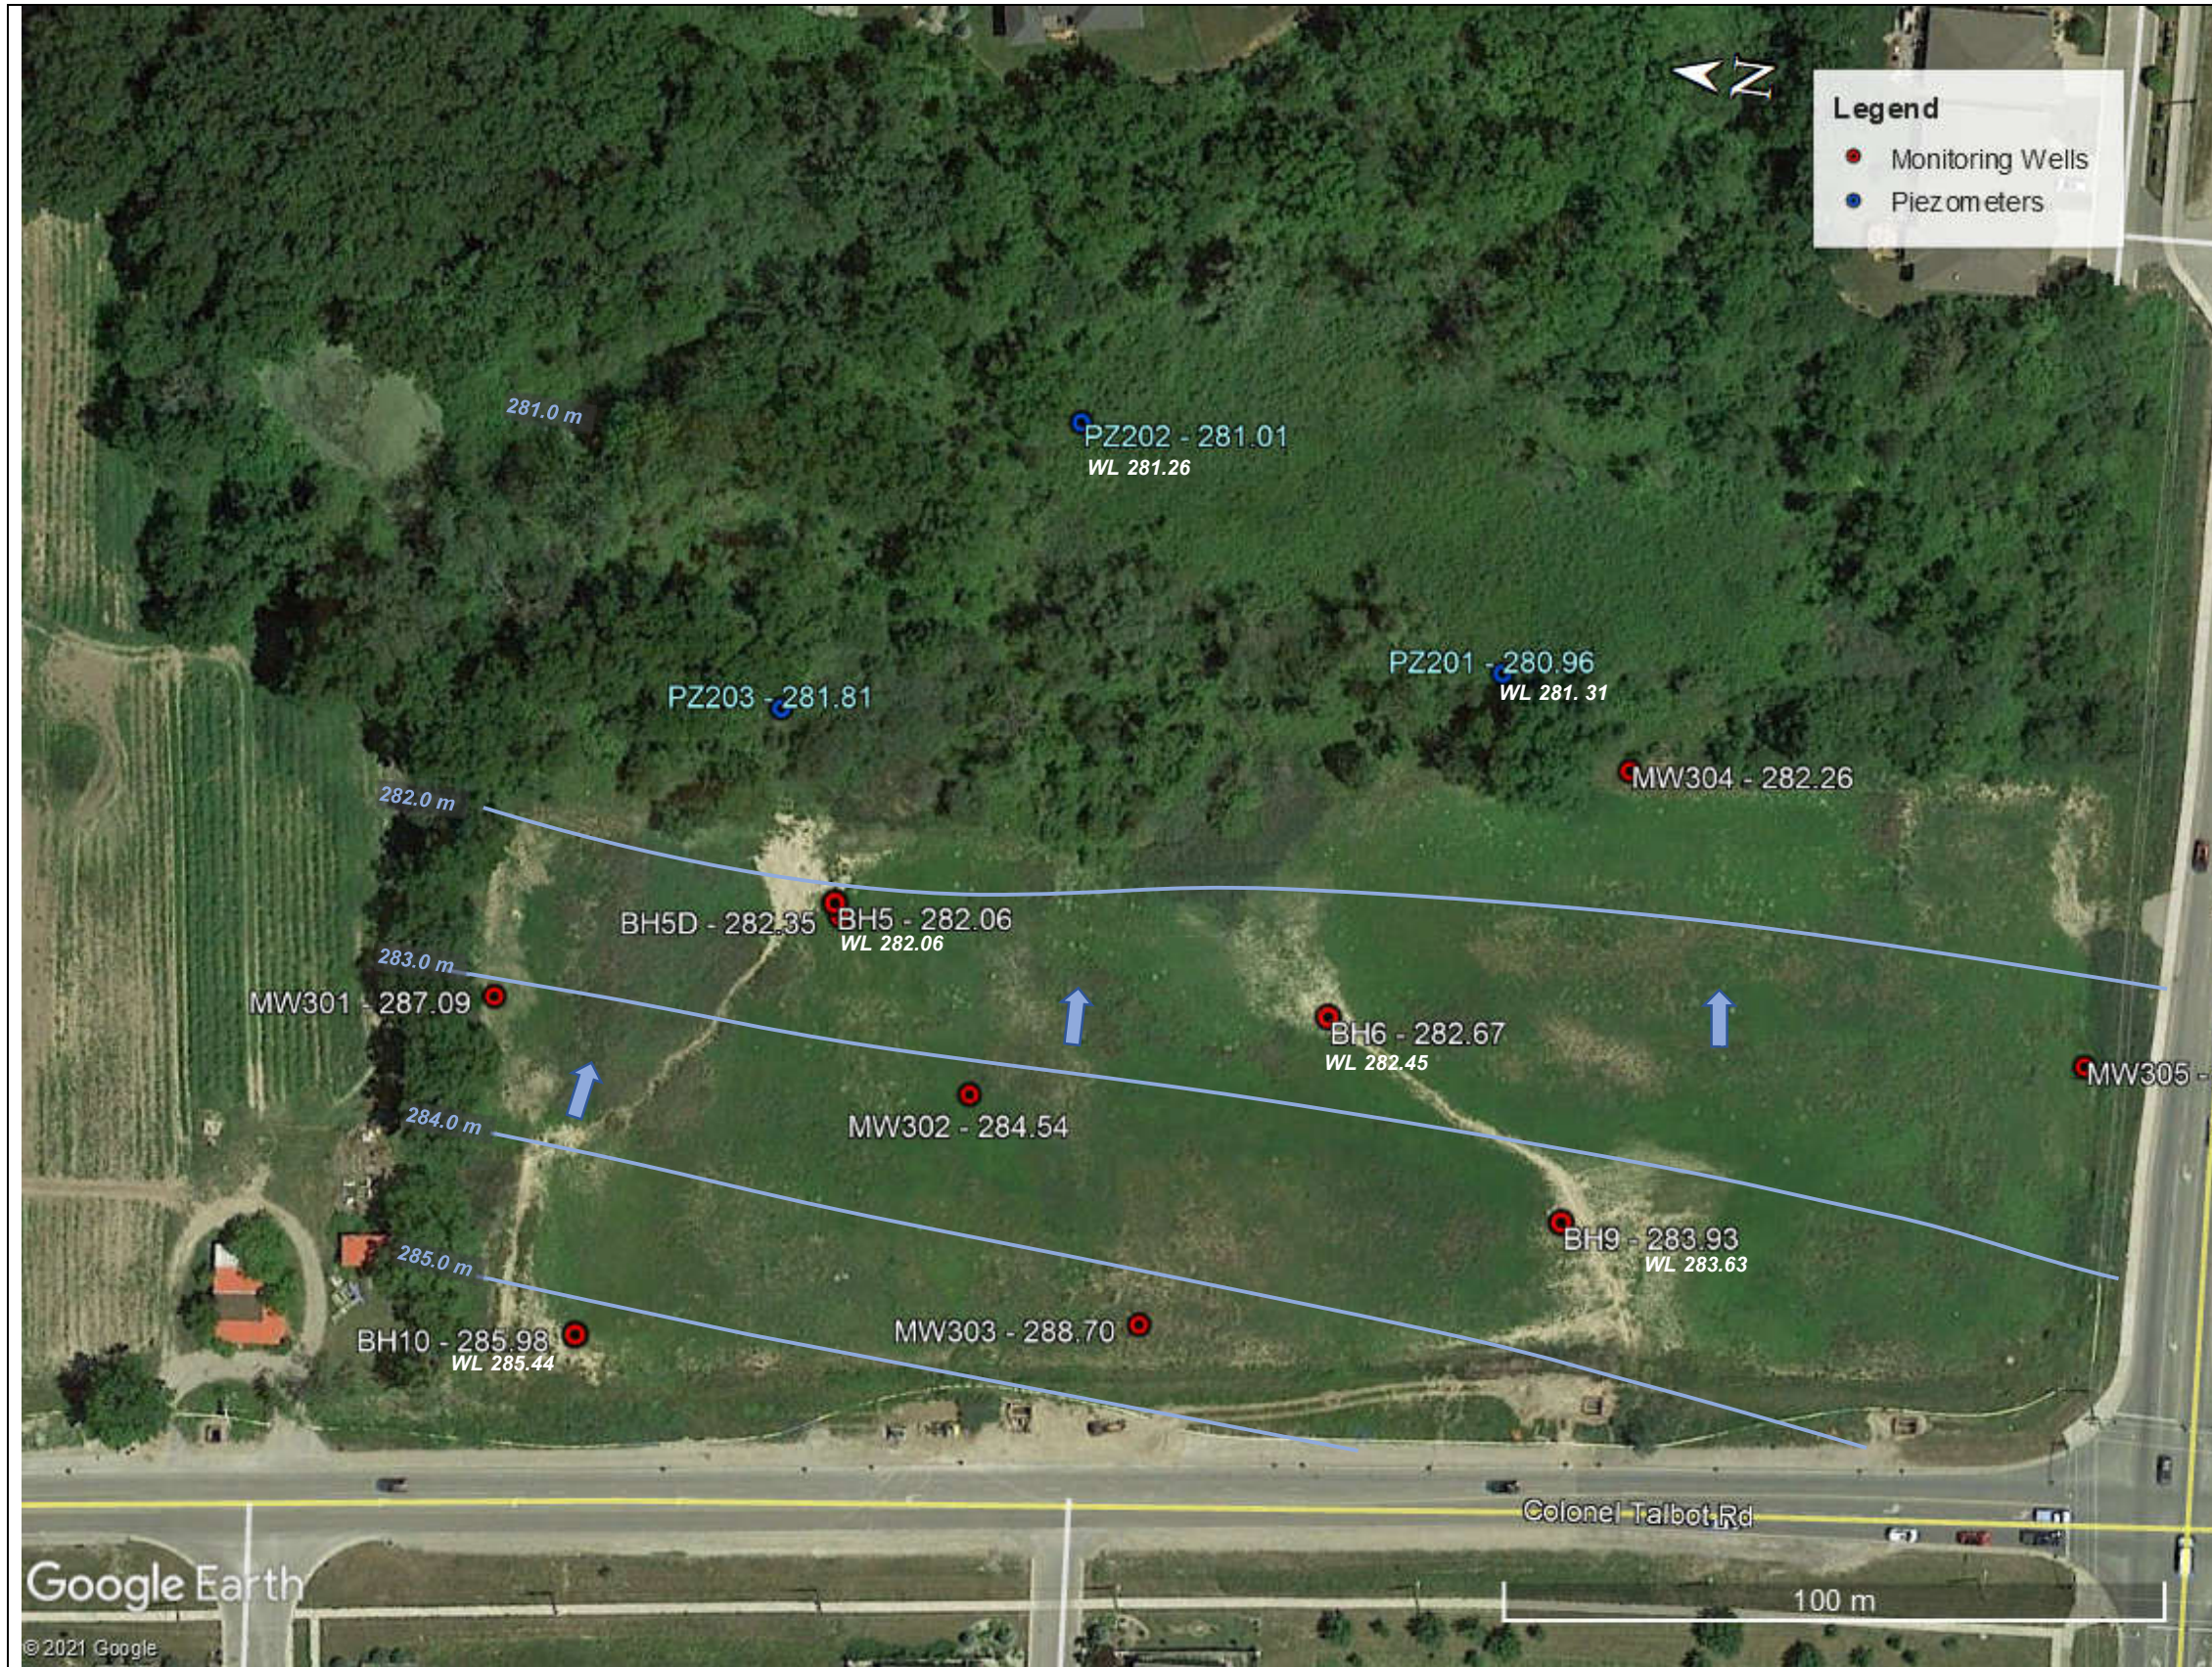
SCALE As Shown	PROJECT NO. GE-00085
DATE August 2021	DRAWING NO. 7

Groundwater Contour Plan
Spring 2018

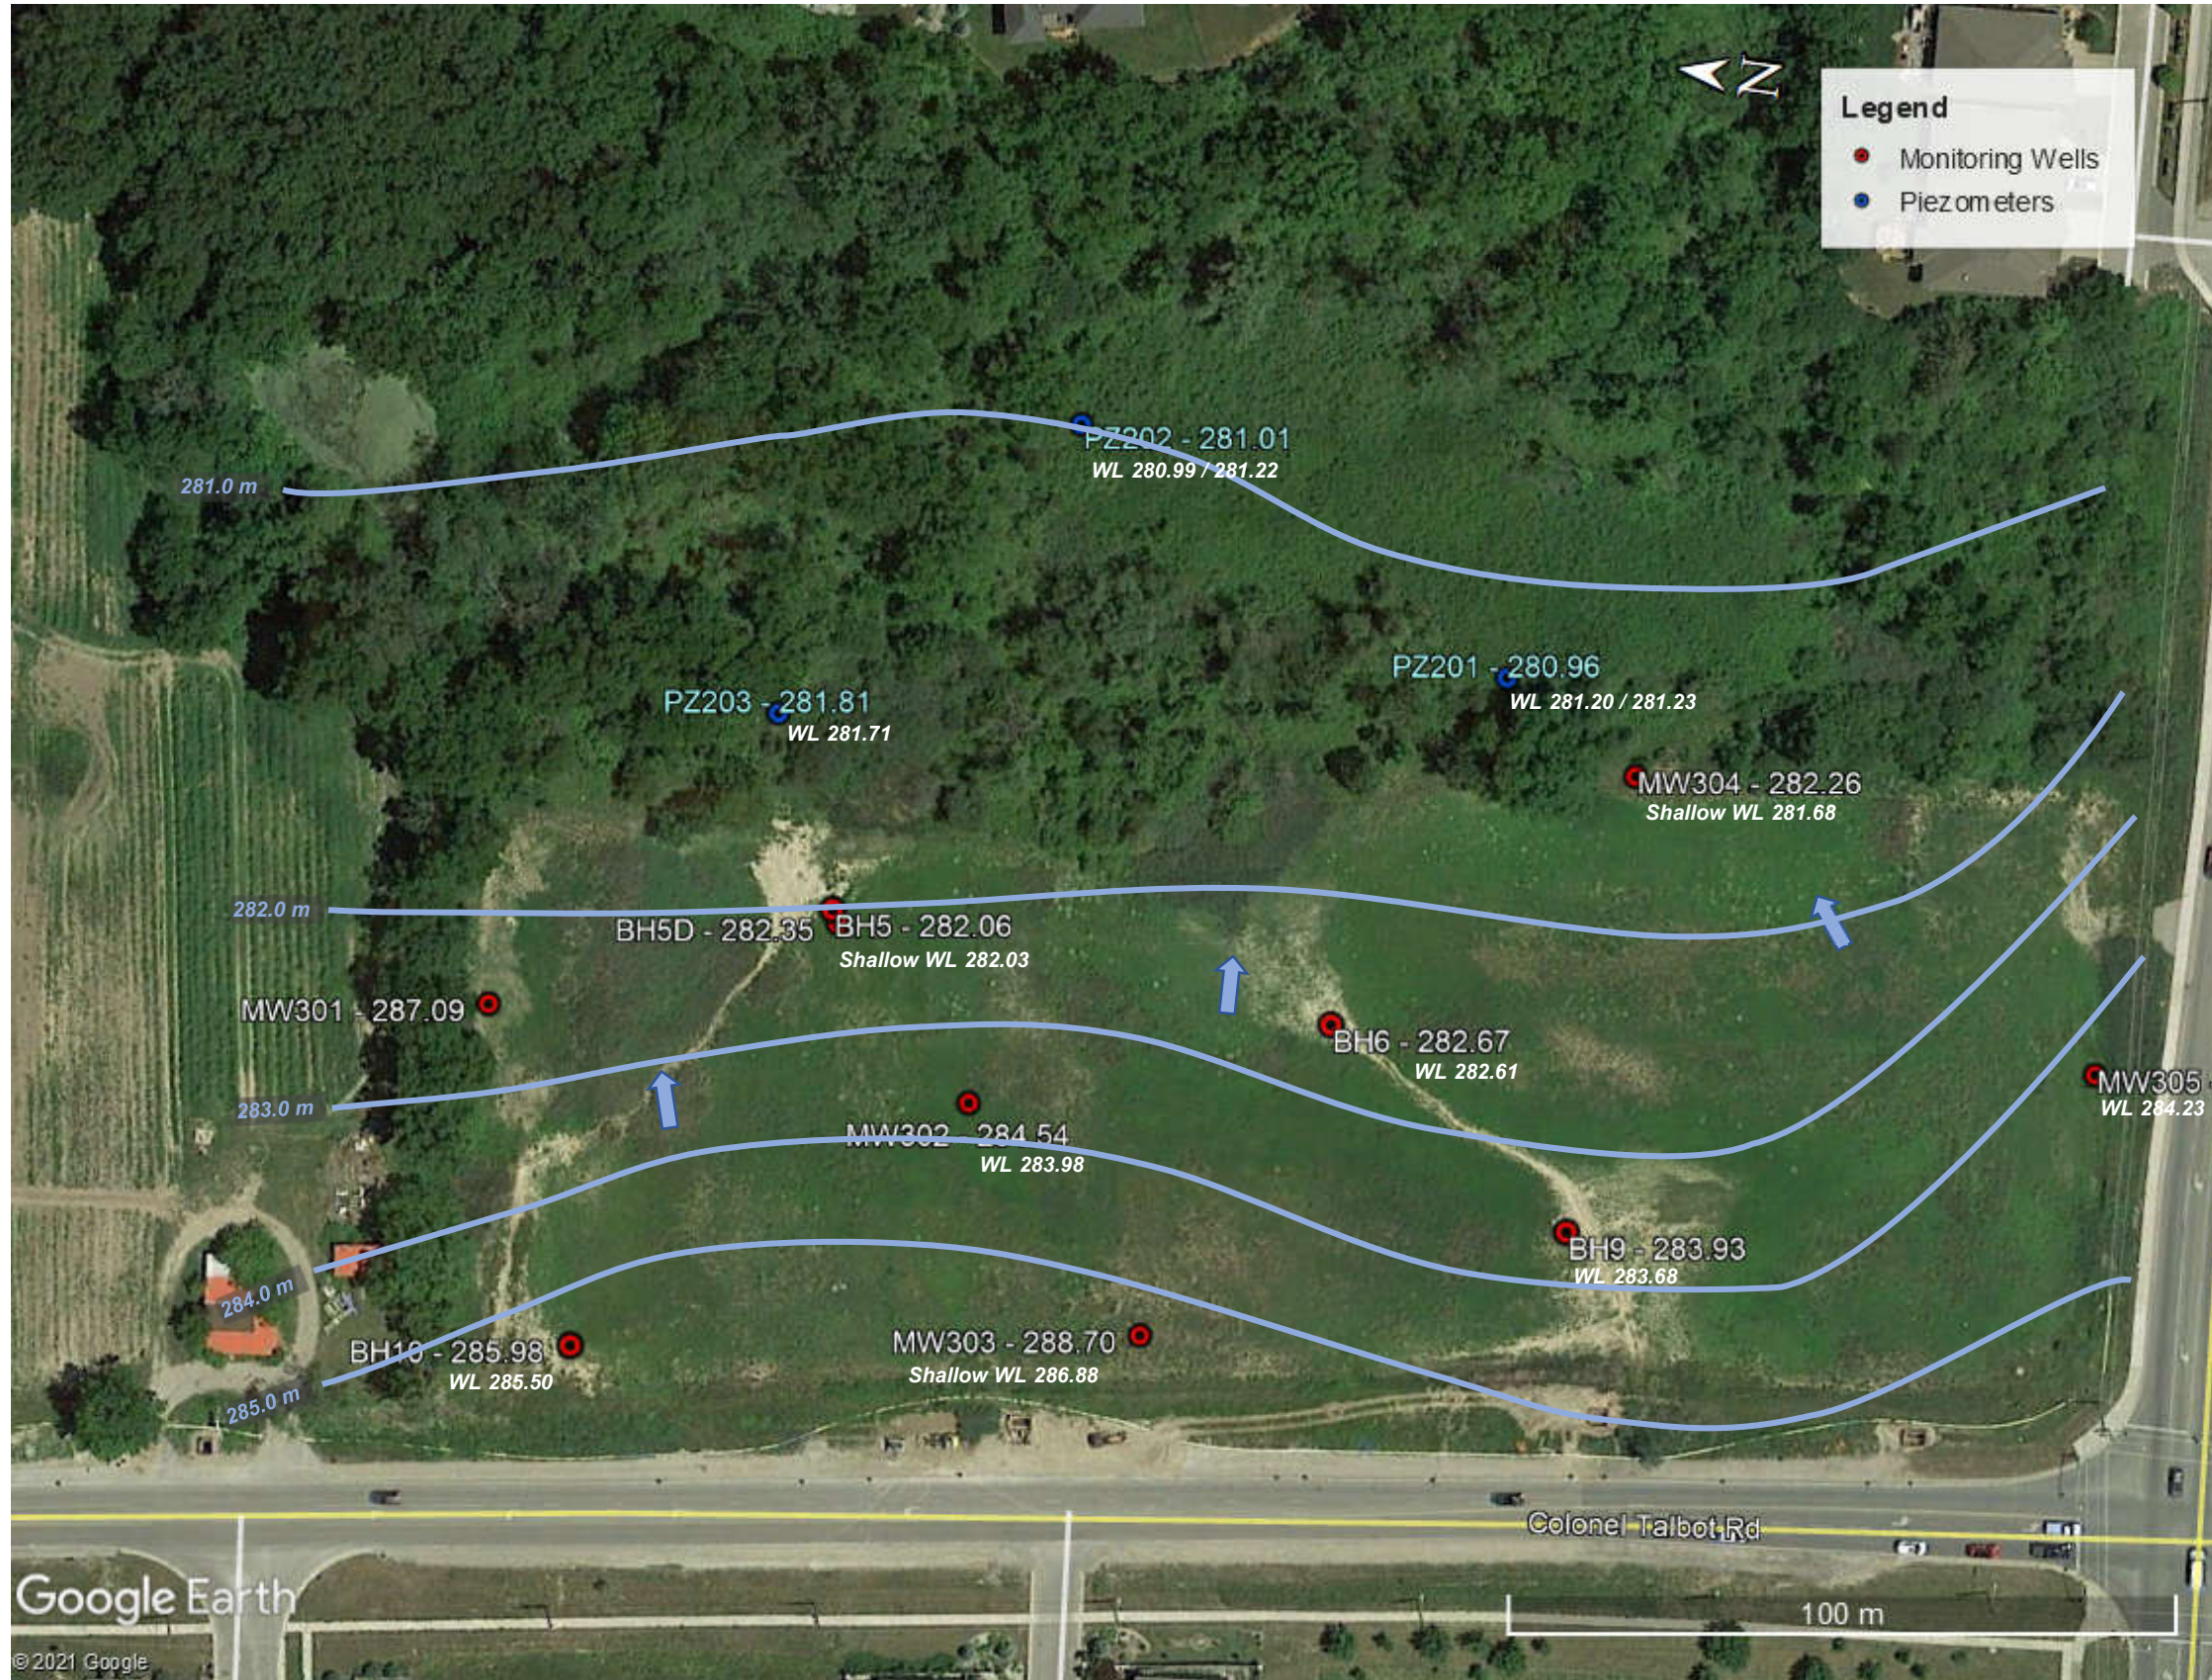
SCALE As Shown	PROJECT NO. GE-00085
DATE August 2021	DRAWING NO. 8

DRAWING NAME
 Groundwater Contour Plan
 Spring 2019

- Groundwater Piezometric Contour, m
- Inferred Groundwater Flow Direction

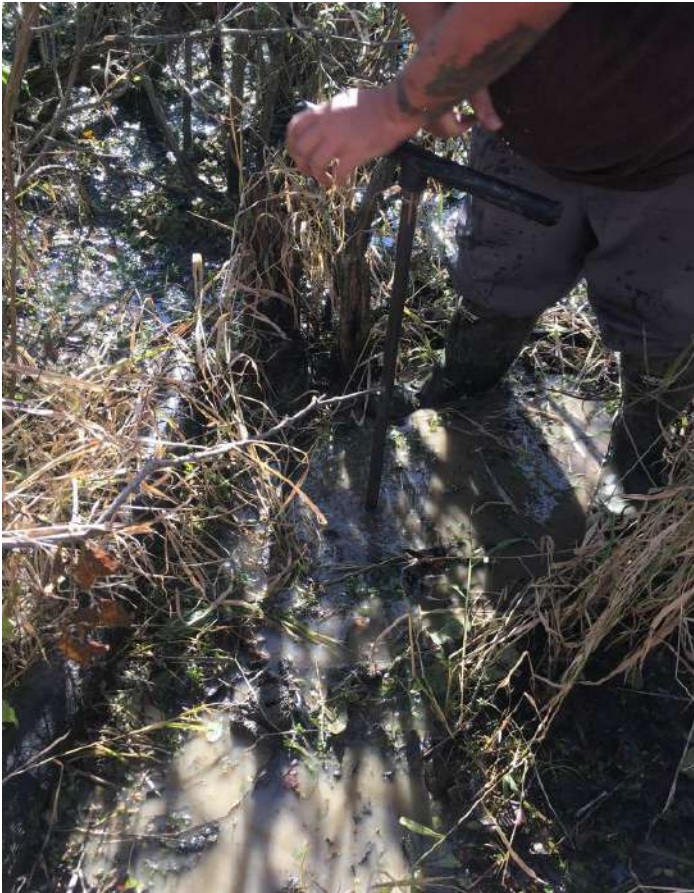
Installation of PZ201

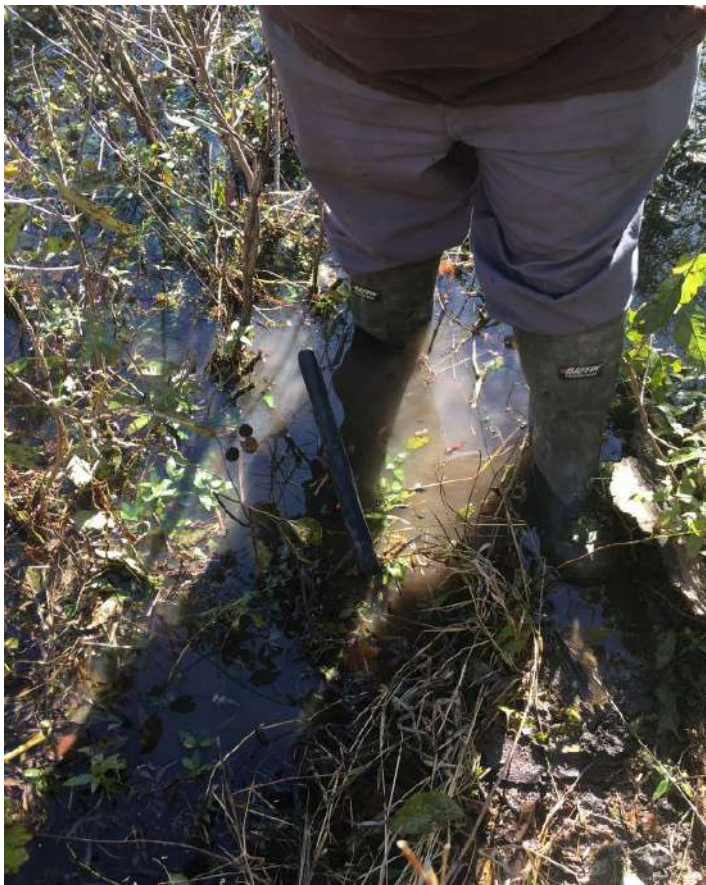
Installation of
PZ202

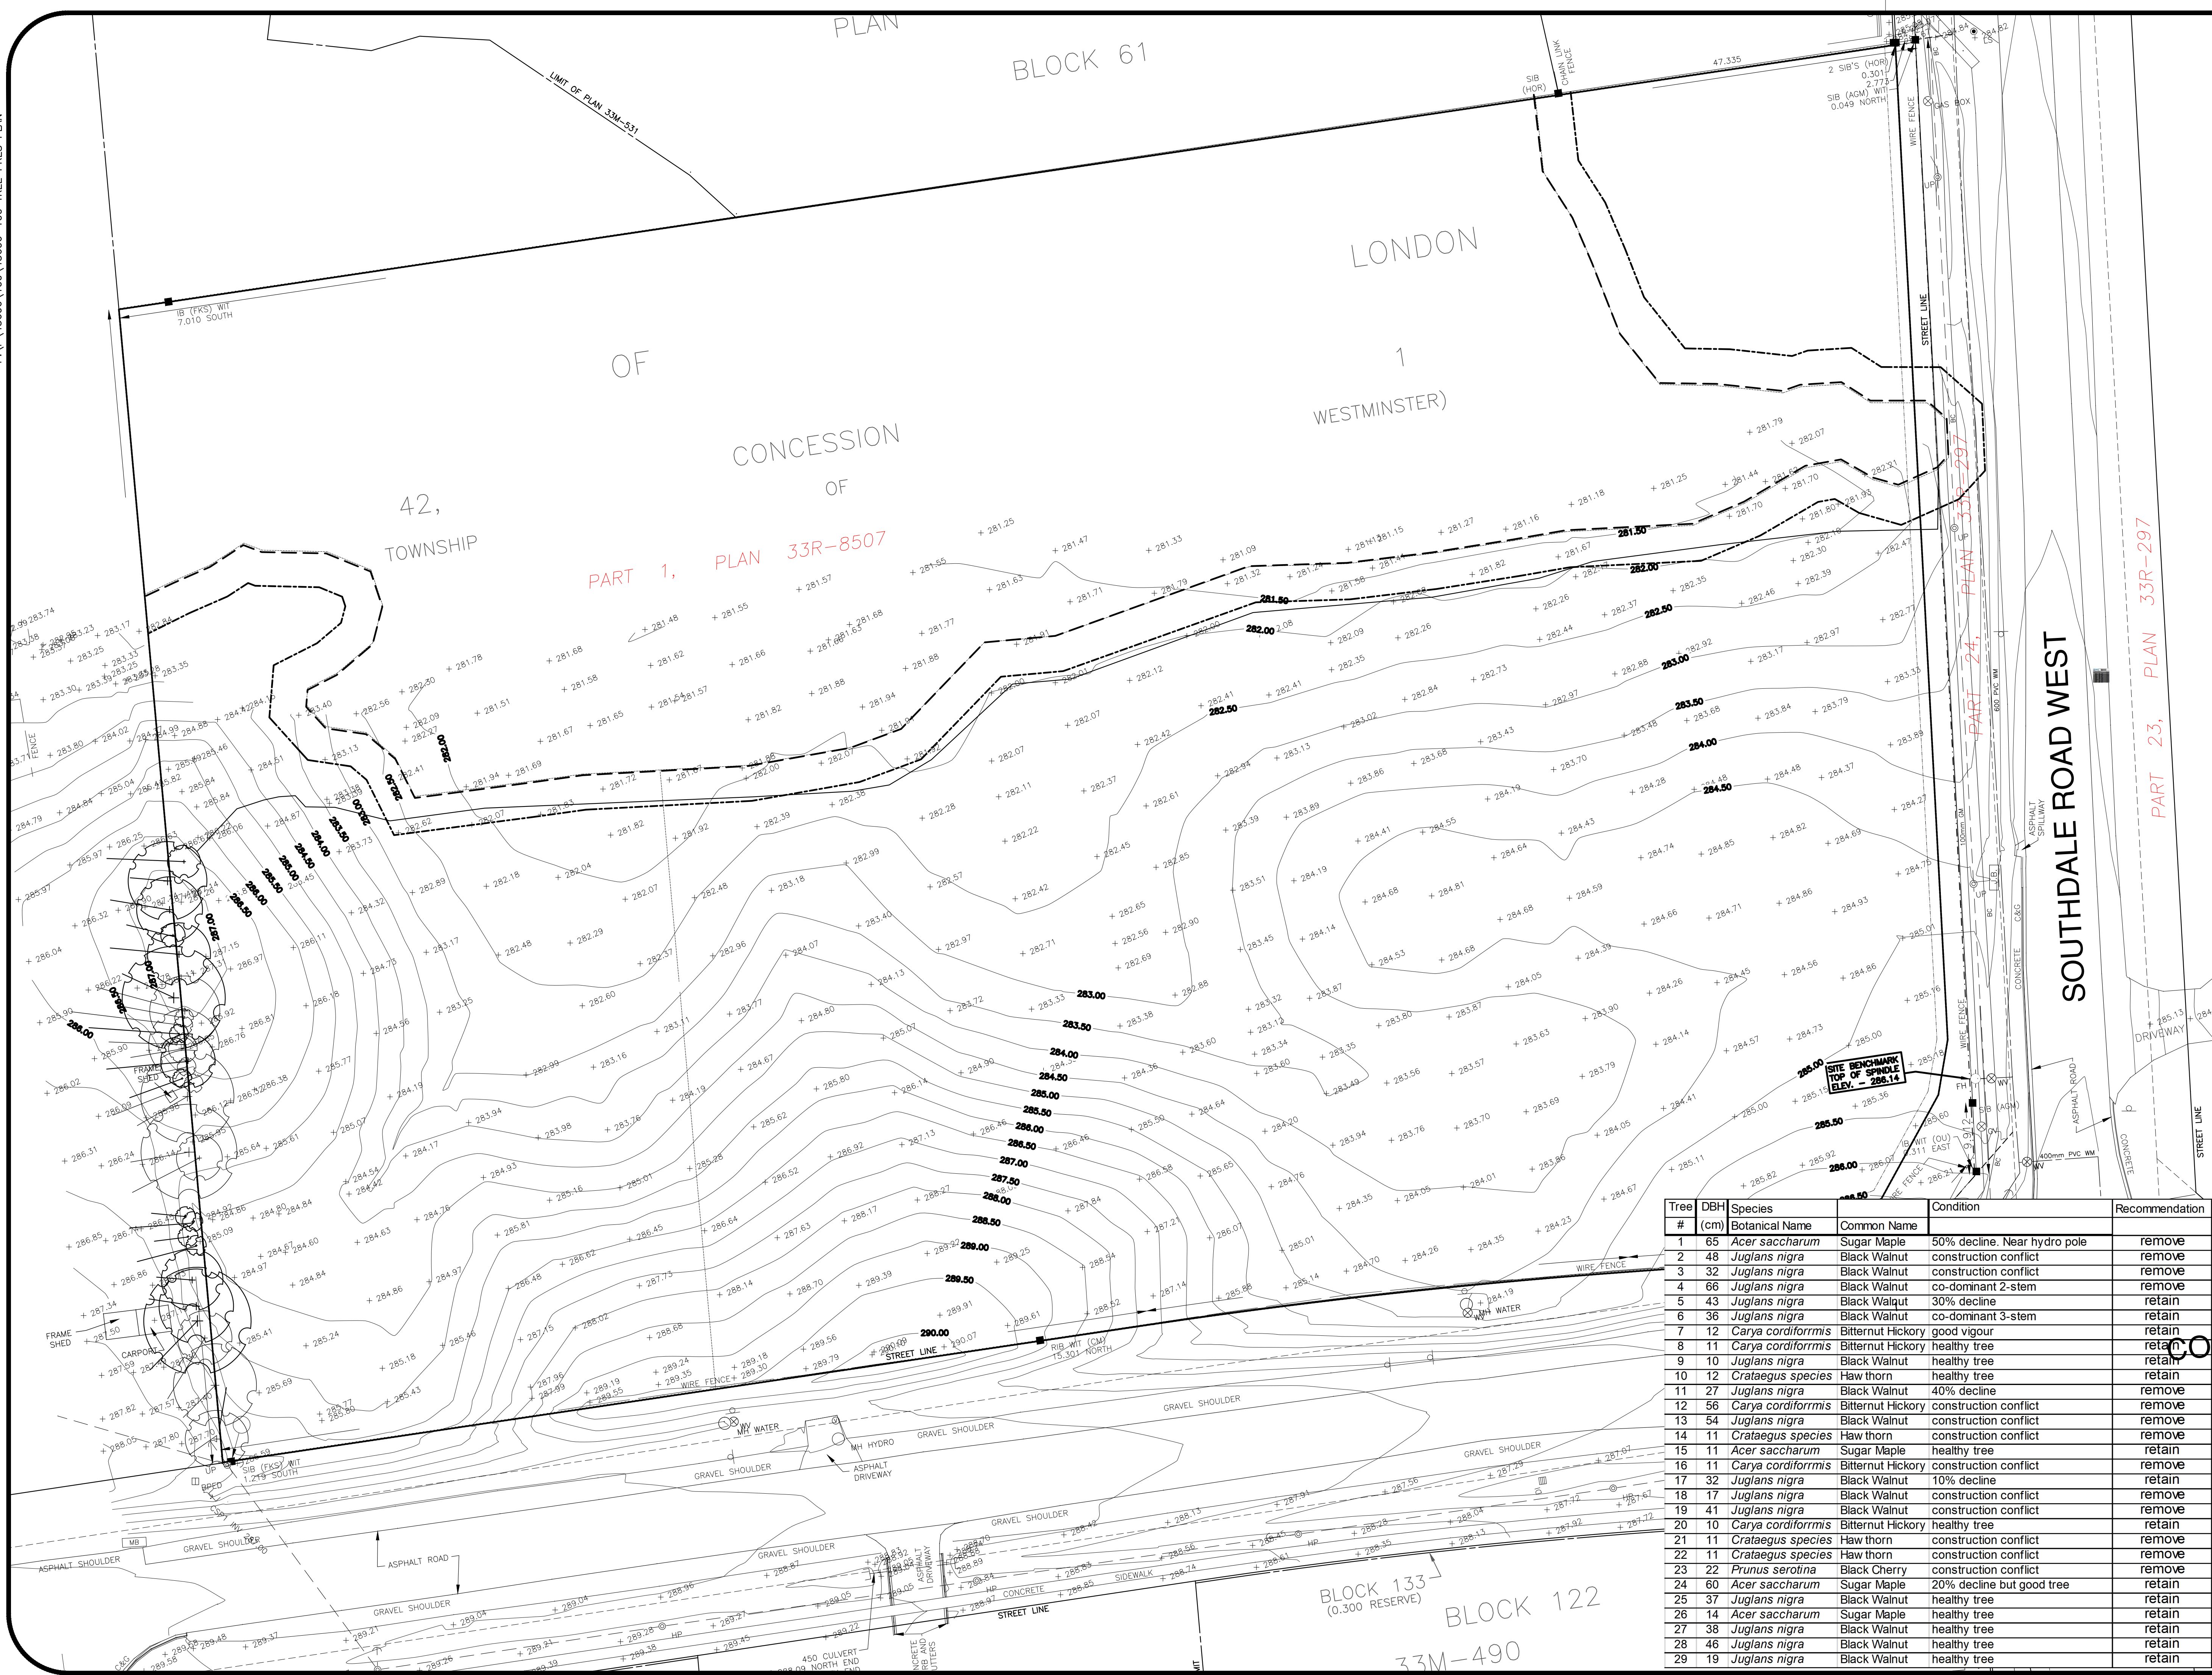
DATE: JANUARY 2023	SCALE: AS NOTED	DRAWING No.:
DRAWN: RKL/A Inc.	CHECKED BY: B.R.M.	T-1
PROJECT No.:	22-304FL SPA

DRAWING TITLE:
TREE PRESERVATION PLAN

The existing conditions and tree preservation details for the site are illustrated on the enclosed MTE drawings: TP1 and TP2.

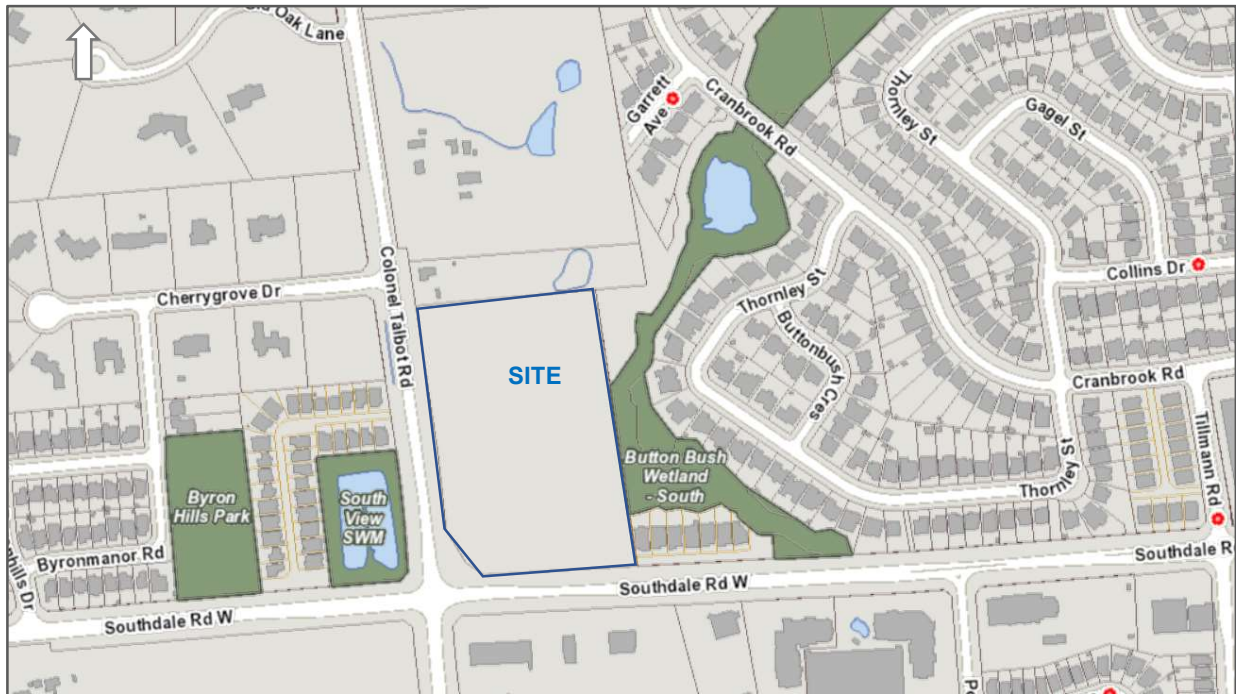
Figure 1: Key Plan

The subject lands are located at the north-east junction of Colonel Talbot Road and Southdale Road in West London, Municipal Number (MN 952) Southdale Road East. The Button Bush wetland feature which is located on the east side of the site has been identified as a Provincially Significant Wetland. A key plan showing the site location is provided below as Figure 1, for reference.
