Agenda Including Addeds

Ecological Community Advisory Committee

7th Meeting of the Ecological Community Advisory Committee

June 15, 2023, 4:30 PM

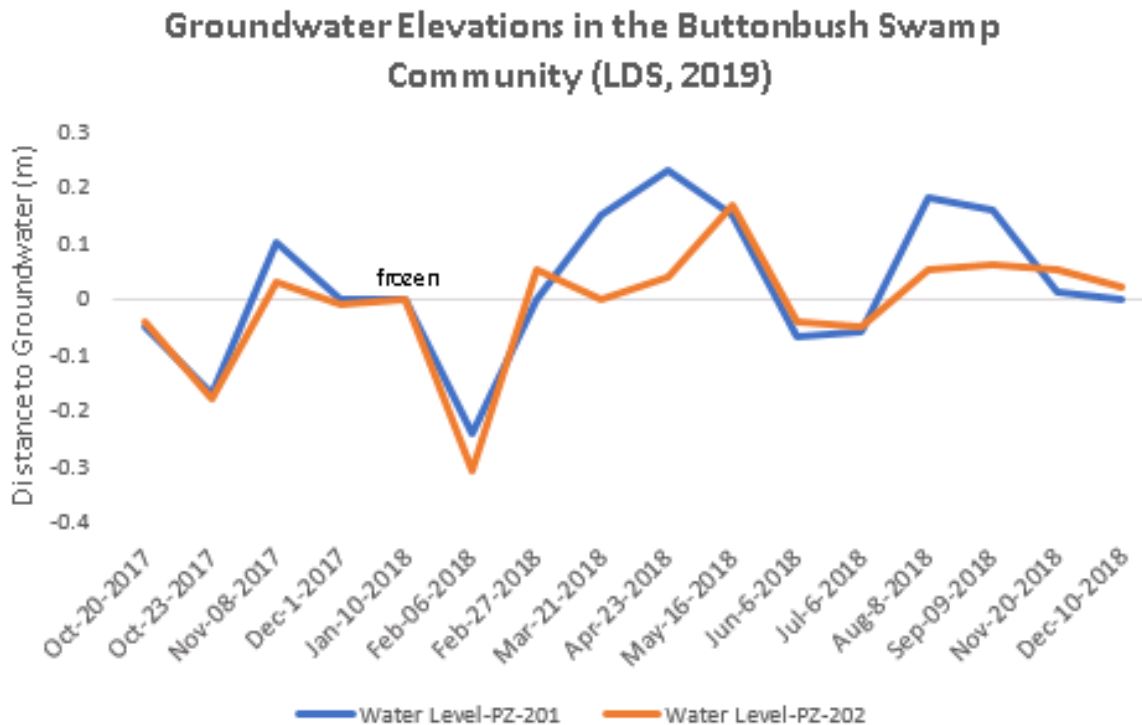
Graph 1: Piezometer measurements of shallow groundwater elevations within the Buttonbush Swamp community. A positive value indicates water observed above or at the surface and negative values are groundwater.

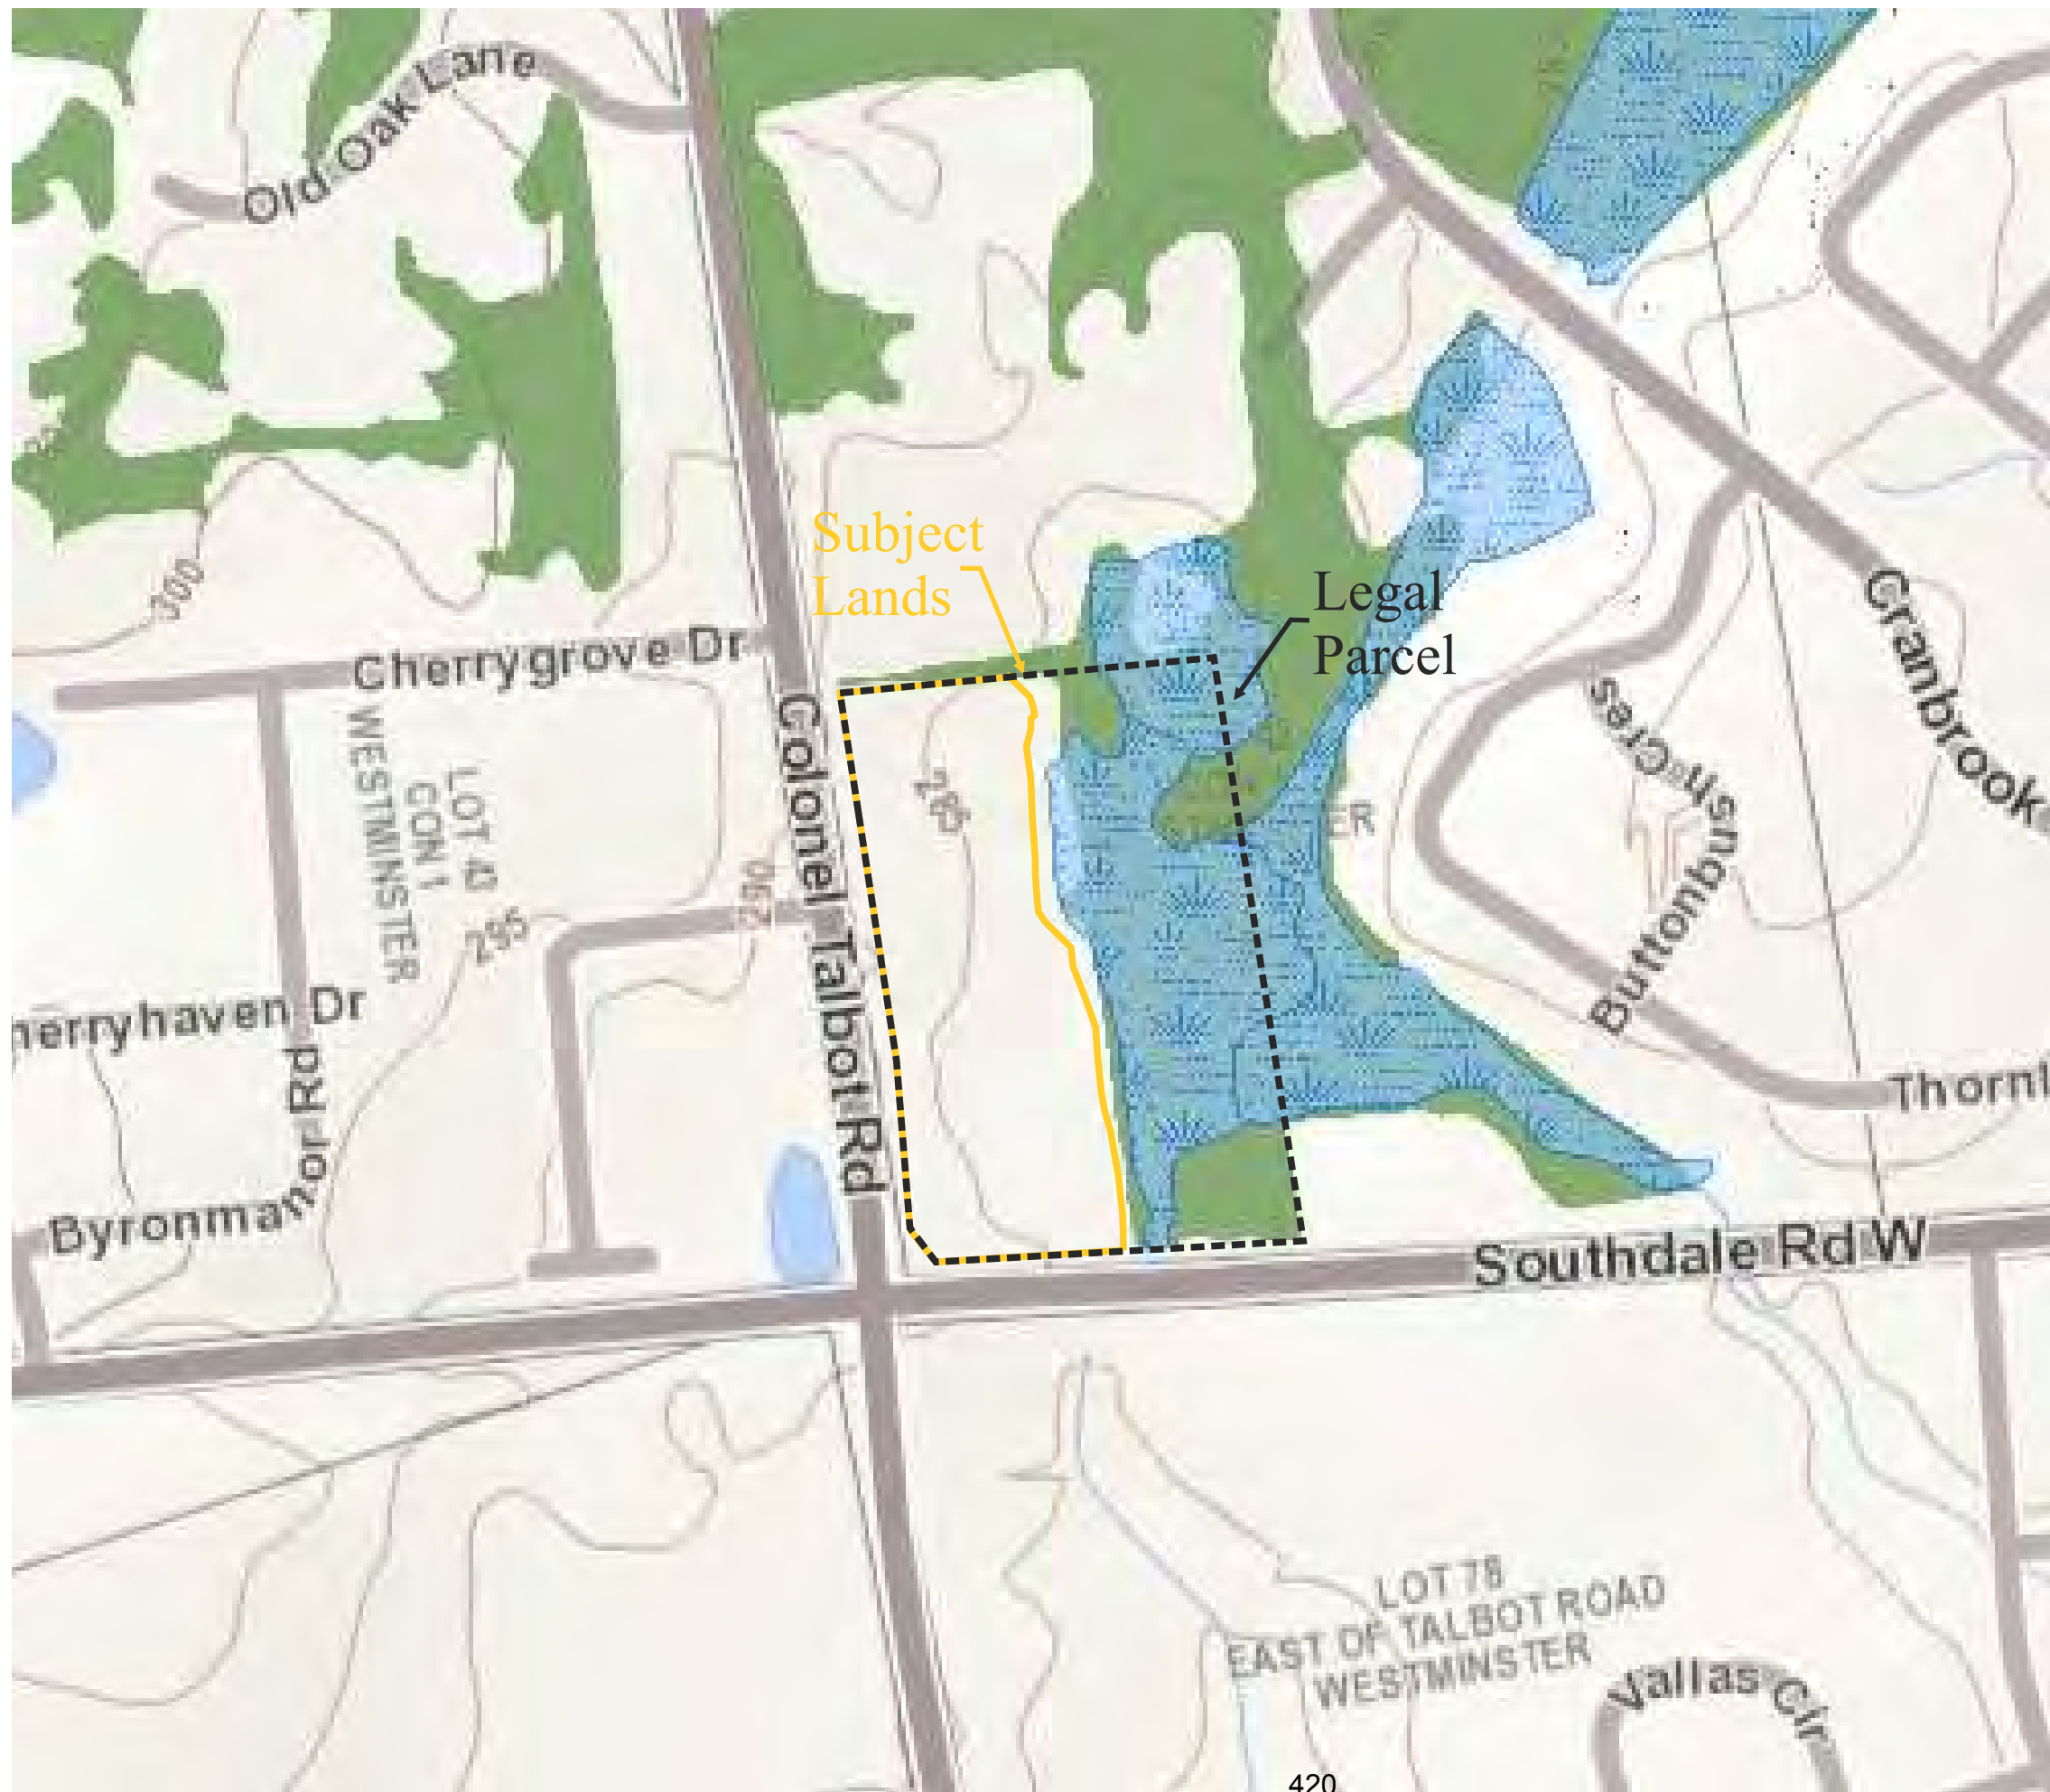
Figure 5: NHIC
(2020 NHIC Make a Map)

A review of the Natural Heritage Information Centre (NHIC) database identifies the North Talbot Wetlands [Provincially Significant Wetland (PSW)] on and within 1km of the Subject Lands [Figure 5a]. The wetland boundary is current as of the time of this reports writing.
