Report to Planning and Environment Committee

To: Chair and Members
Planning and Environment Committee
From: Scott Mathers, MPA, P.Eng.
Deputy City Manager, Planning and Economic Development
Subject: Post-Development Environmental Impact Study Monitoring Update
Date: May 23, 2023

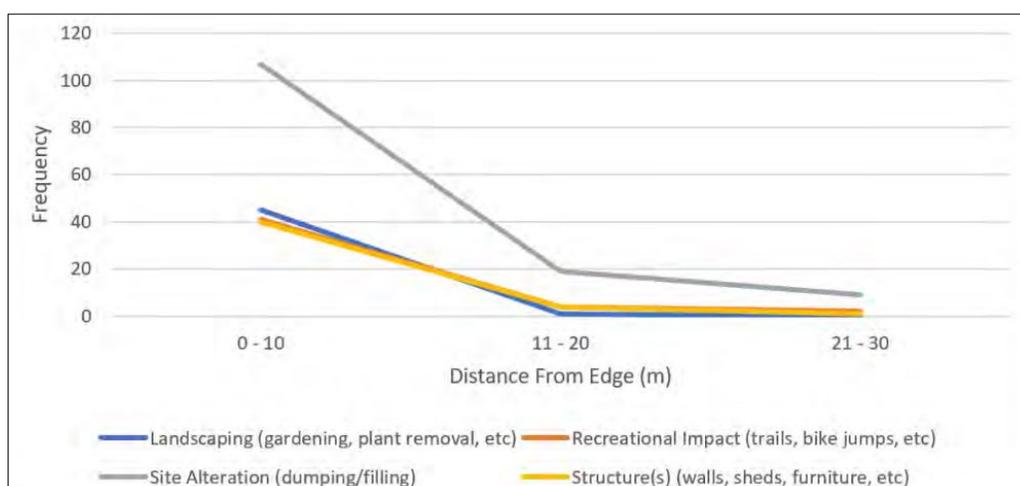
FIGURE 1 - FREQUENCY OF DISTURBANCE AT A DISTANCE FROM THE EDGE OF FEATURE¹

Most disturbances were detected within the natural feature; however, for many of the sites, disturbances were found to be occurring within a buffer area (where one was provided), suggesting that buffers are effective as a mitigation measure. When looking at the distribution of disturbances in Figure 1 below, the majority of encroachments were found to occur within 0-10 m of the edge of the natural feature; this would further suggest that buffers should be a minimum of 10 metres wide.

Furthermore, when upon comparing the average number of disturbances per metre of transect surveyed, it was found that disturbances occurred most frequently on sites with just fencing (with or without gates) implemented as a mitigation measure. Sites with a combination of buffers and fencing (with or without gates) had less disturbances than just fencing but, experienced more disturbances than sites with just buffers (which was likely due to dense vegetation in the natural area making the feature difficult to access).

Based on the findings of the 2021 post-development monitoring fieldworks it was found that most encroachments occur within 10 metres of the edge of the natural feature, which could be within a 10 metre wide buffer (if one was present). Staff should undertake a review of buffer requirements and their recommended minimum widths and adjust Table 5-2 of the City's Environmental Management Guidelines (2021) where buffers less than 10 metres are proposed.
