## Report to Planning and Environment Committee

**To:** Chair and Members  
 Planning and Environment Committee  
**From:** Scott Mathers, MPA, P.Eng.  
 Deputy City Manager, Planning and Economic Development  
**Subject:** Demolition Request and Heritage Alteration Permit  
 Application at 187 Wharncliffe Road North,  
 Blackfriars/Petersville Heritage Conservation District, Ward 13  
 Public Participation Meeting  
**Date:** November 13, 2023

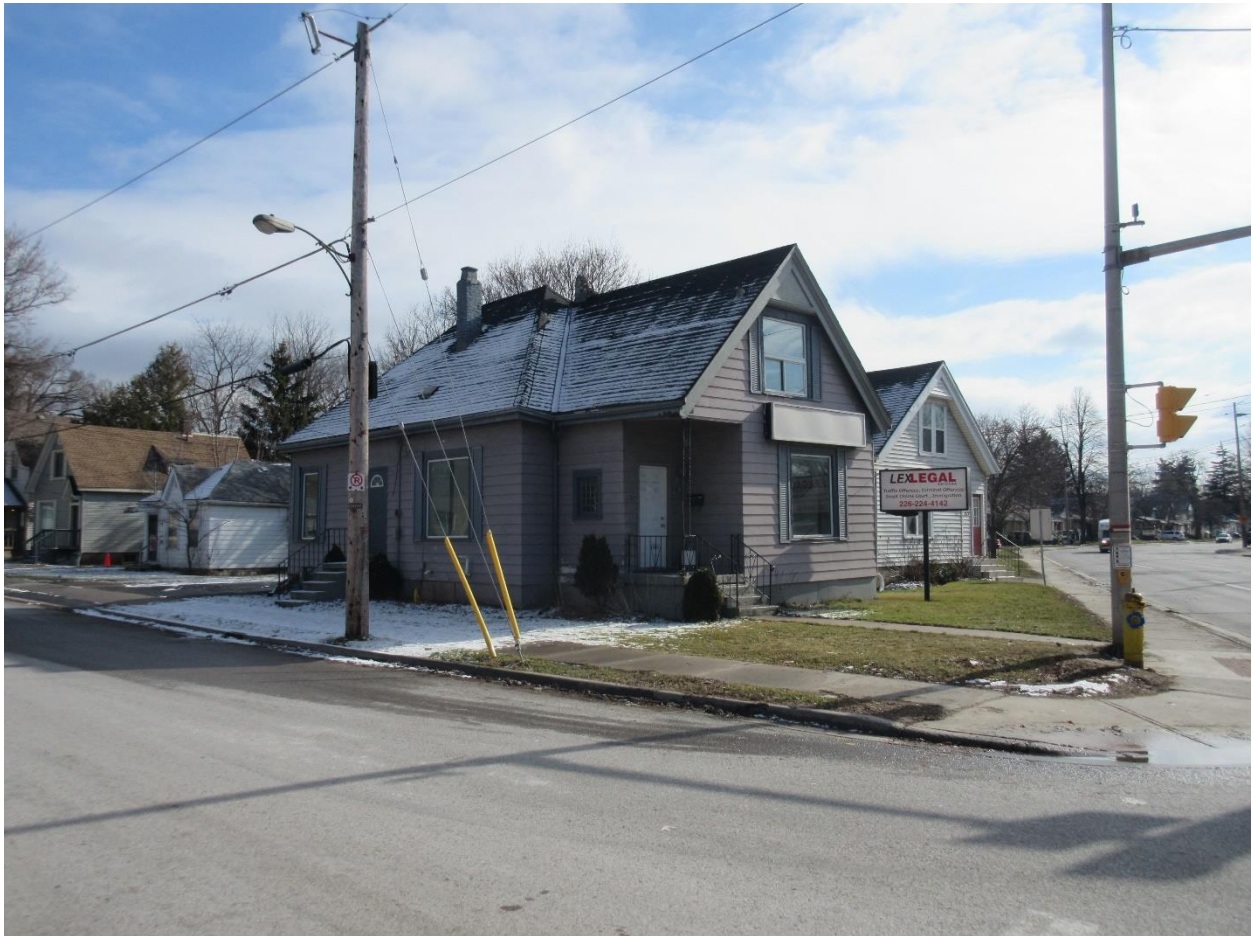
Image 1: Northwest corner of the Contributing Resource at 187 Wharncliffe Road North (taken February 5, 2016).

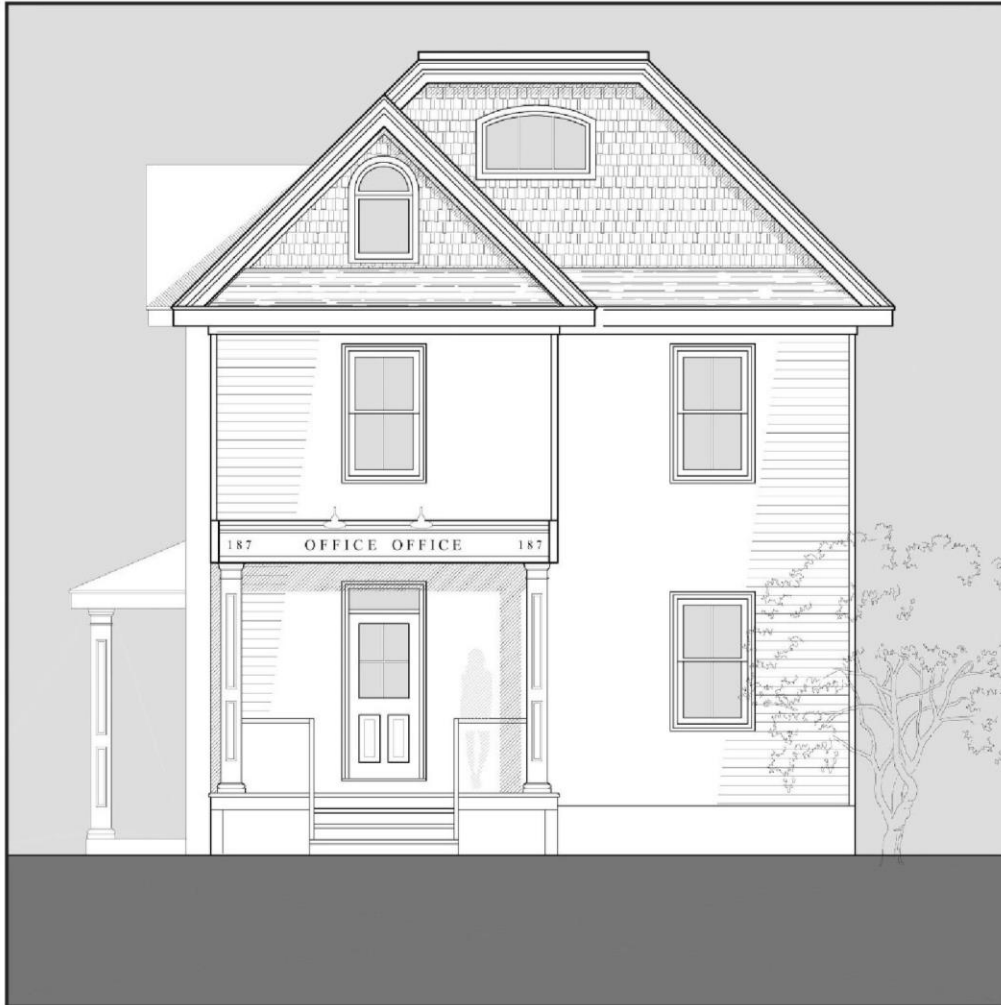
57. West elevation of the proposed building with indirectly illuminated sign board. The cornice sign board area is approximately 5% of the wall area and conforms to the City of London sign by-law.

Figure 5: West elevation of the proposed building with indirectly illuminated sign board for the proposed office use on the main floor (TD-BAS Inc., dated August 31, 2023).

- d) Side (north) porch to feature panelled columns with cap and base details, primed and painted;
- e) Front yard parking is prohibited;
- f) Any signage for the proposed office use be limited to the small band above the west entrance and be indirectly illuminated by hanging light fixtures, as indicated on plans submitted;

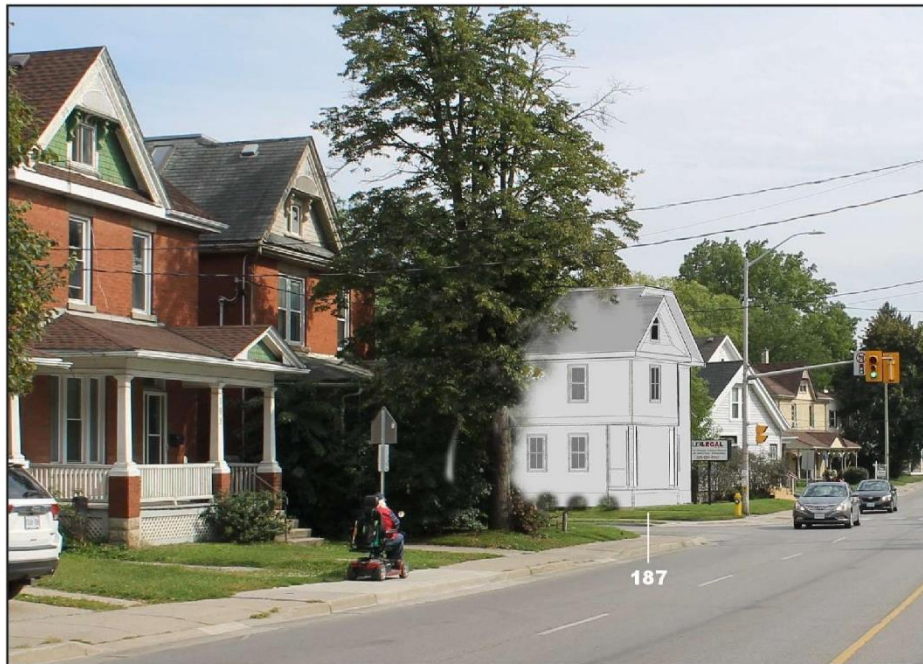
54. Above: Photomontage streetscape study montage with a rendering of the proposed building at 187 Wharncliffe Road South. The view is looking southward along Wharncliffe Road North.

Figure 6: Rendering showing the proposed building at 187 Wharncliffe Road North in its context on the east side of Wharncliffe Road North (TD-BAS Inc., dated August 31, 2023).

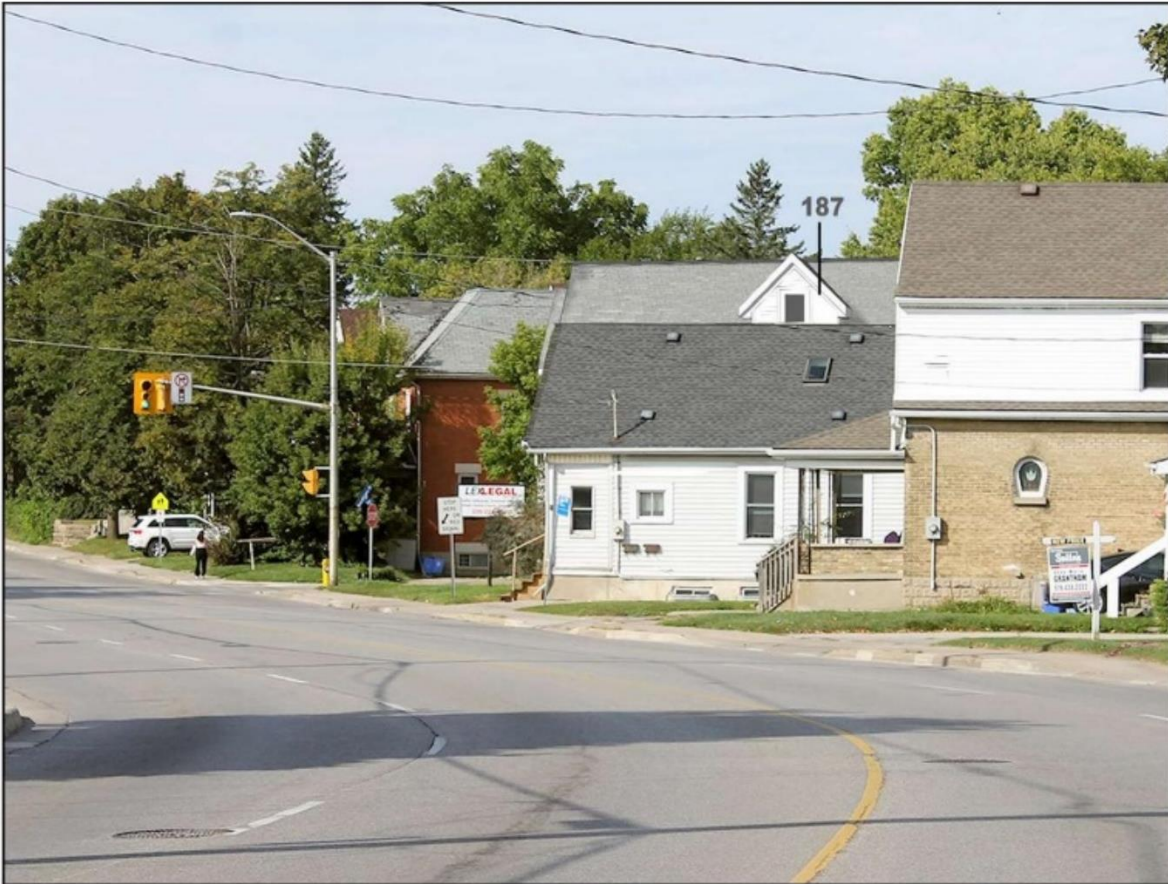
55. Above: Photomontage streetscape study of the proposed building at 187 Wharnclyffe Road North. The view is looking northward along Wharnclyffe Road North.

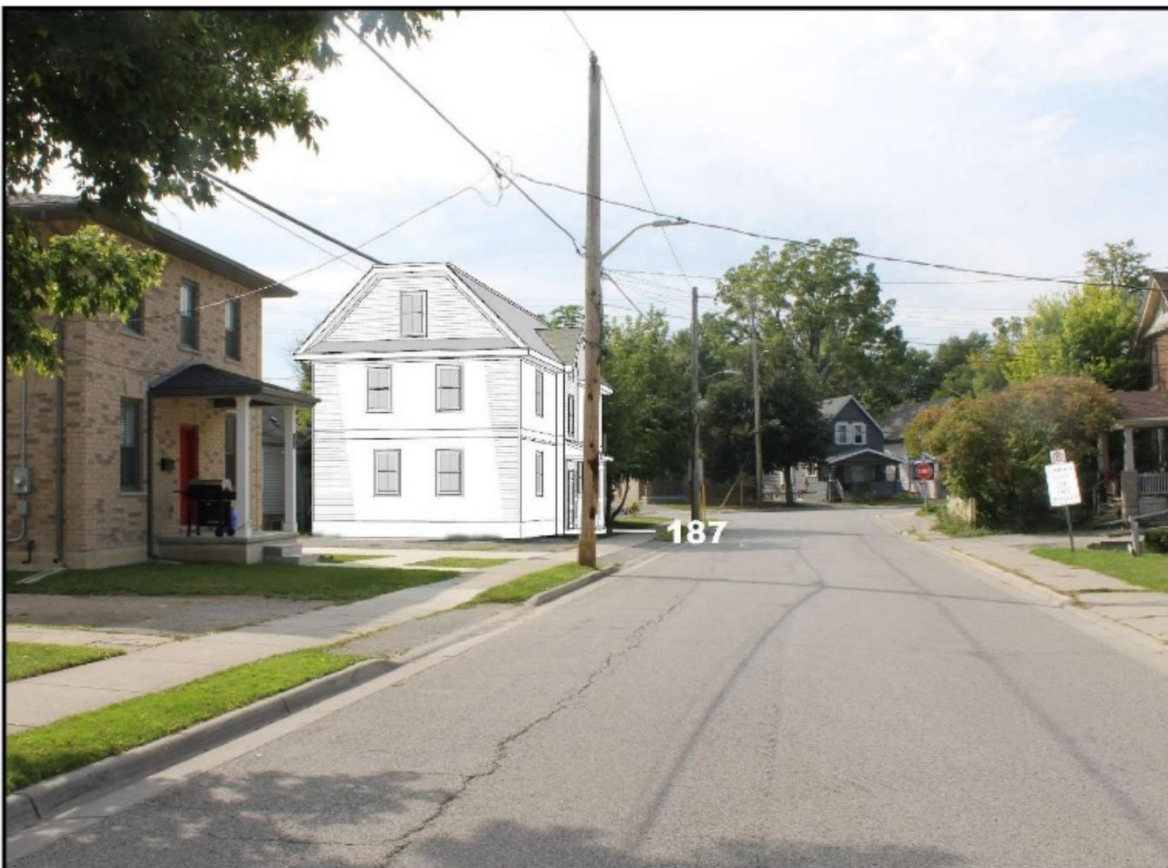
56. Above: Photomontage streetscape study of the proposed building at 187 Wharnclyffe Road North. The view is looking westward along Blackfriars Street.

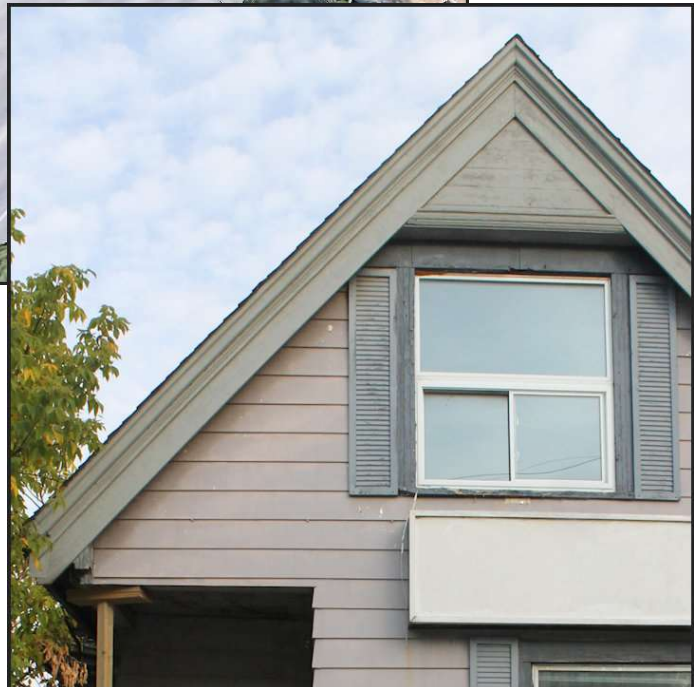
39. (right) The west gable of the existing house retains the original deep barge board with decorative moulding and triangular fronton above the central window.

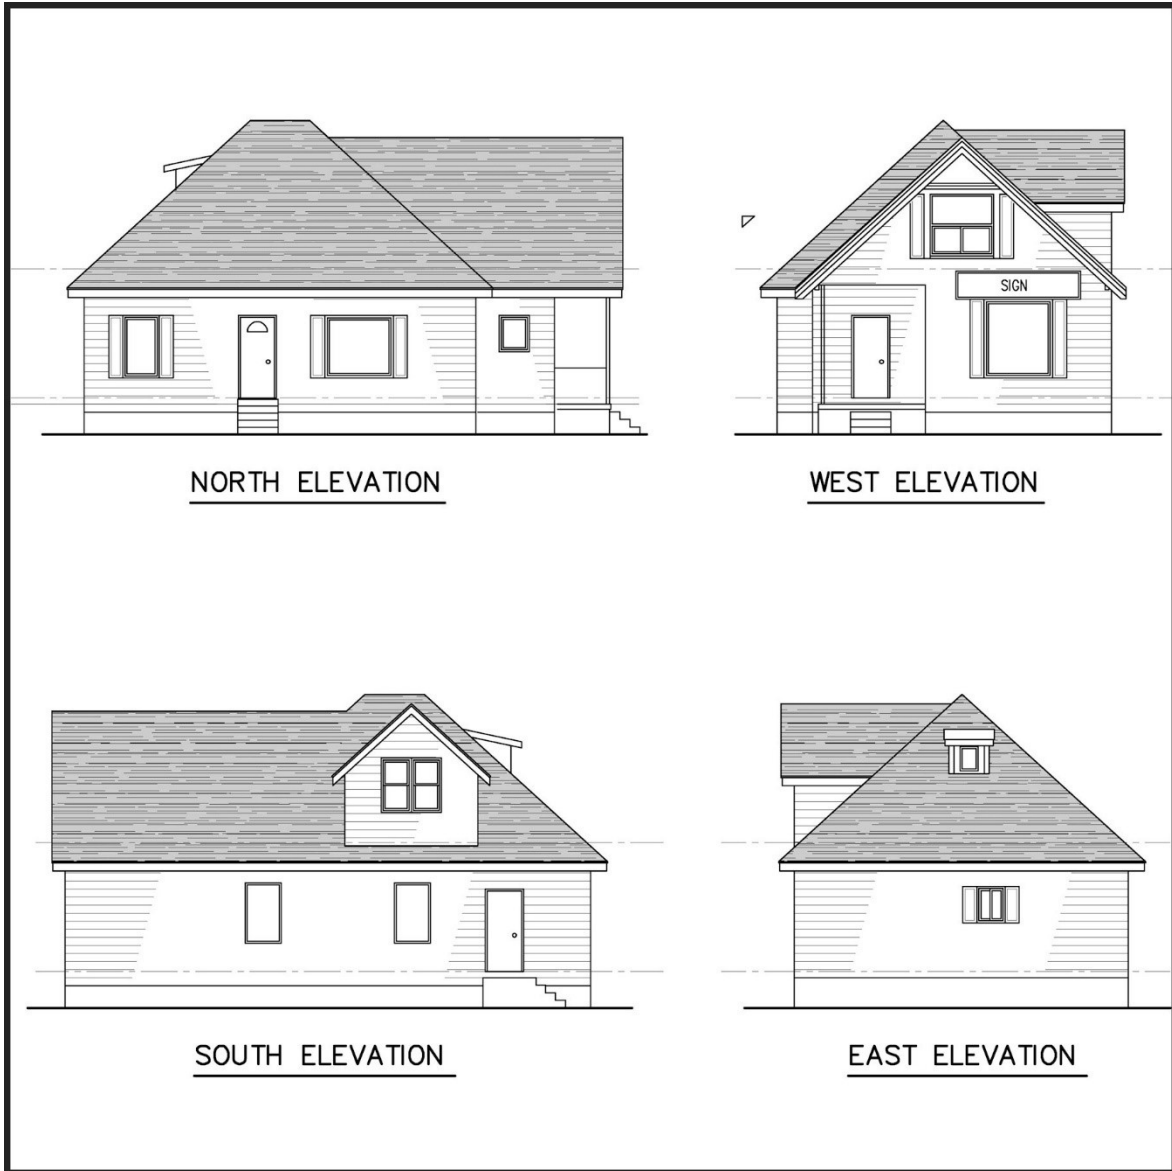
41. (left) Measured elevations of the existing building at 187 Wharncliffe Road North.

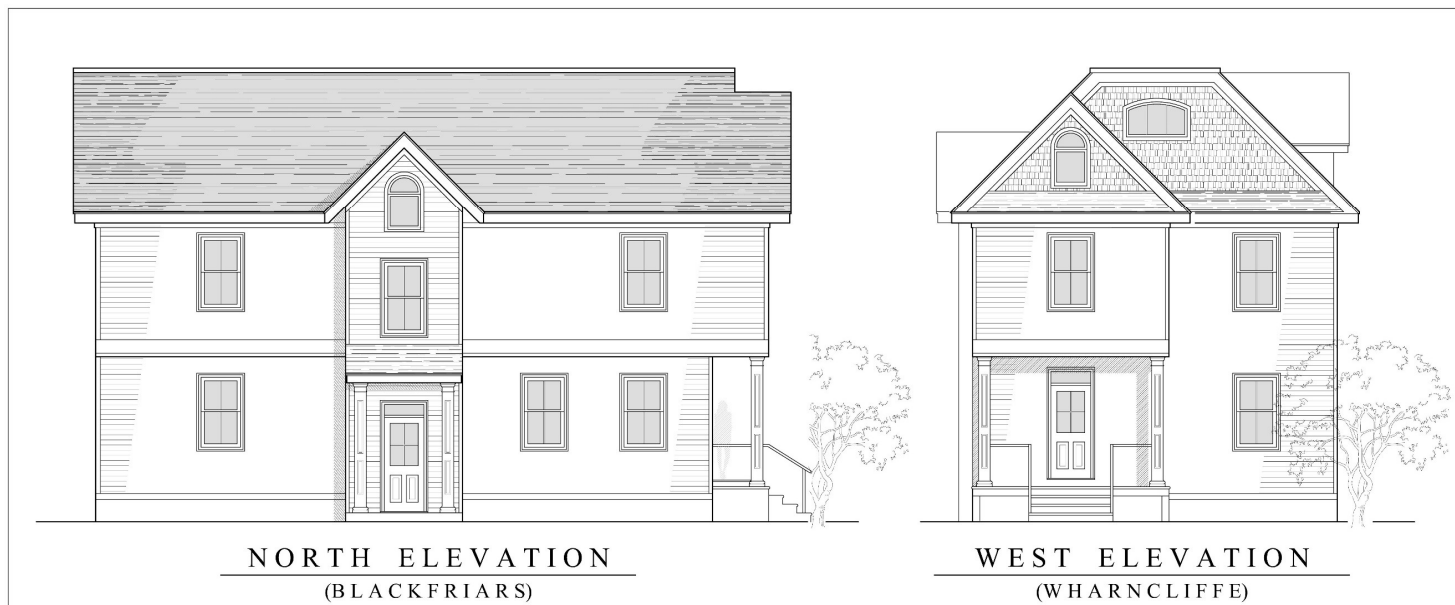
53. Above: Architectural design elevations for the proposed reconstructed house at 187 Wharncliffe Road North.

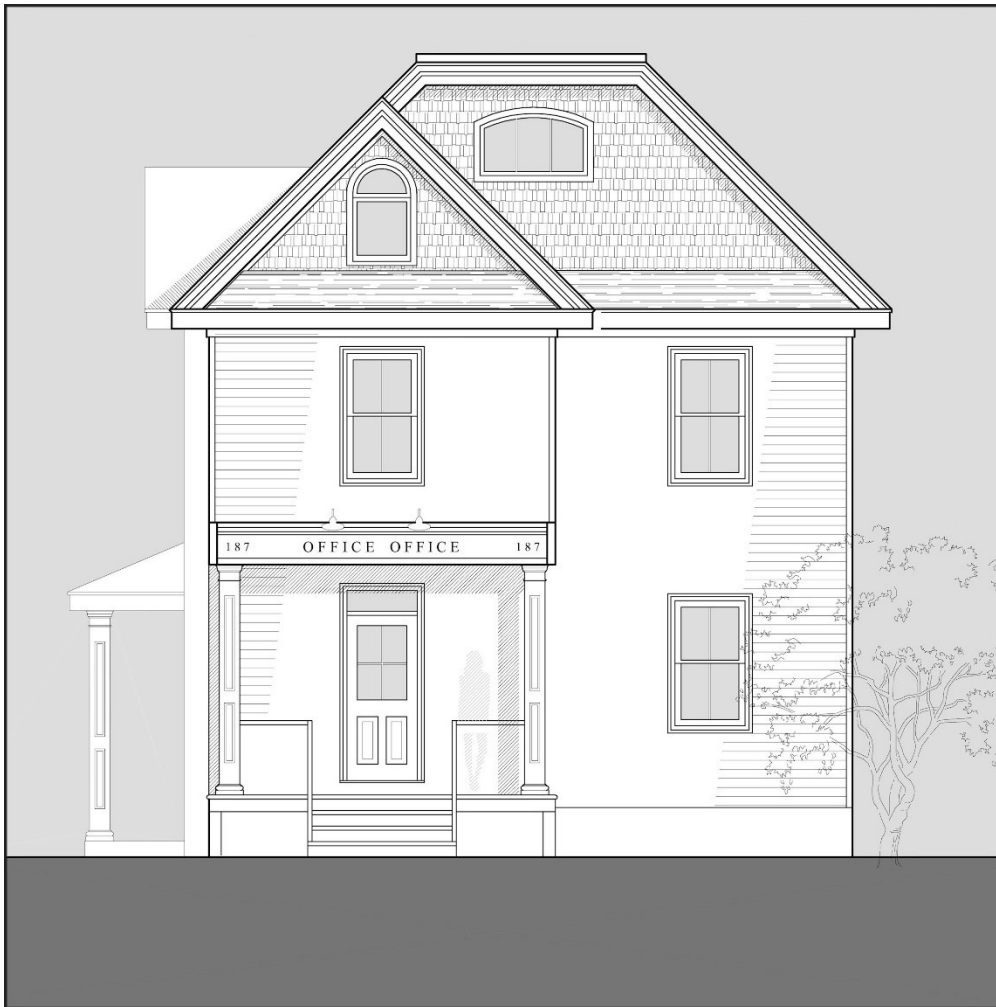
57. West elevation of the proposed building with indirectly illuminated sign board. The cornice sign board area is approximately 5% of the wall area and conforms to the City of London sign by-law.

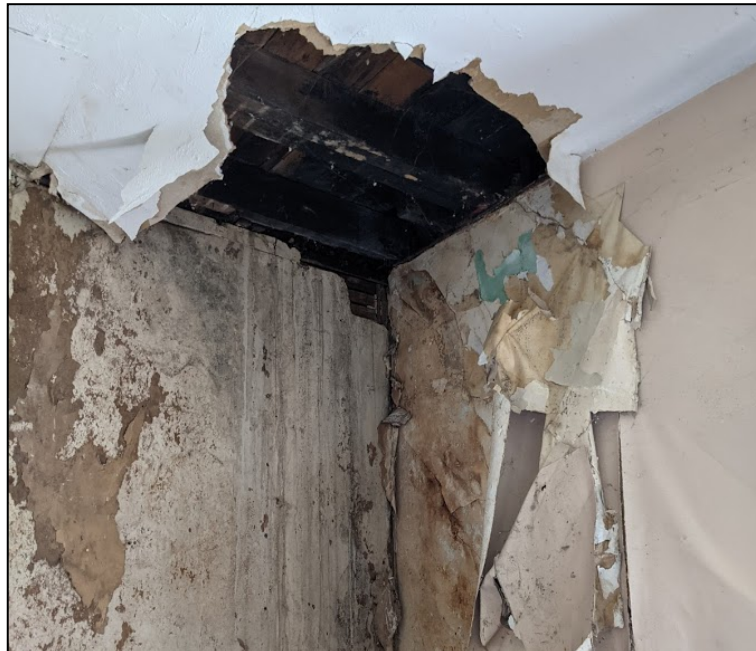
Photograph 1 - Interior finish damage

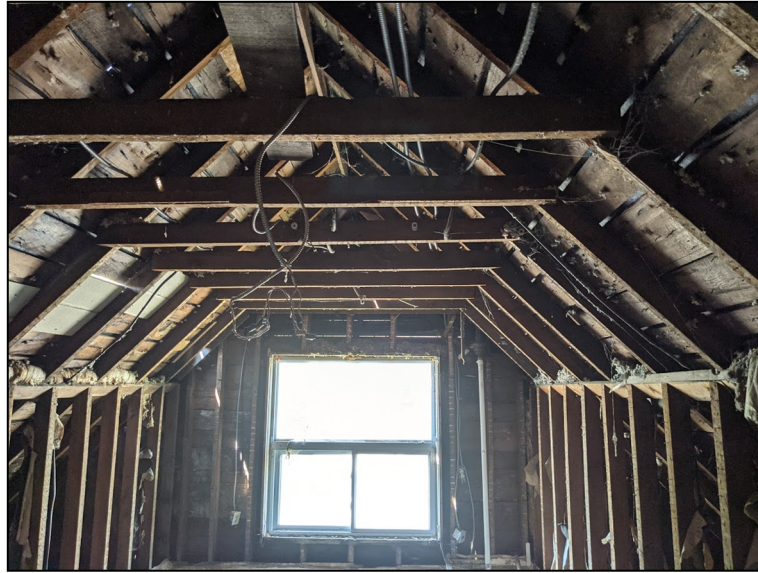
**Photograph 2 - Roof Framing**
