BRIGHT PAST

Cultural Heritage Evaluation Report

7056 Pack Road
City of London

Prepared for Old Oak Properties Inc.

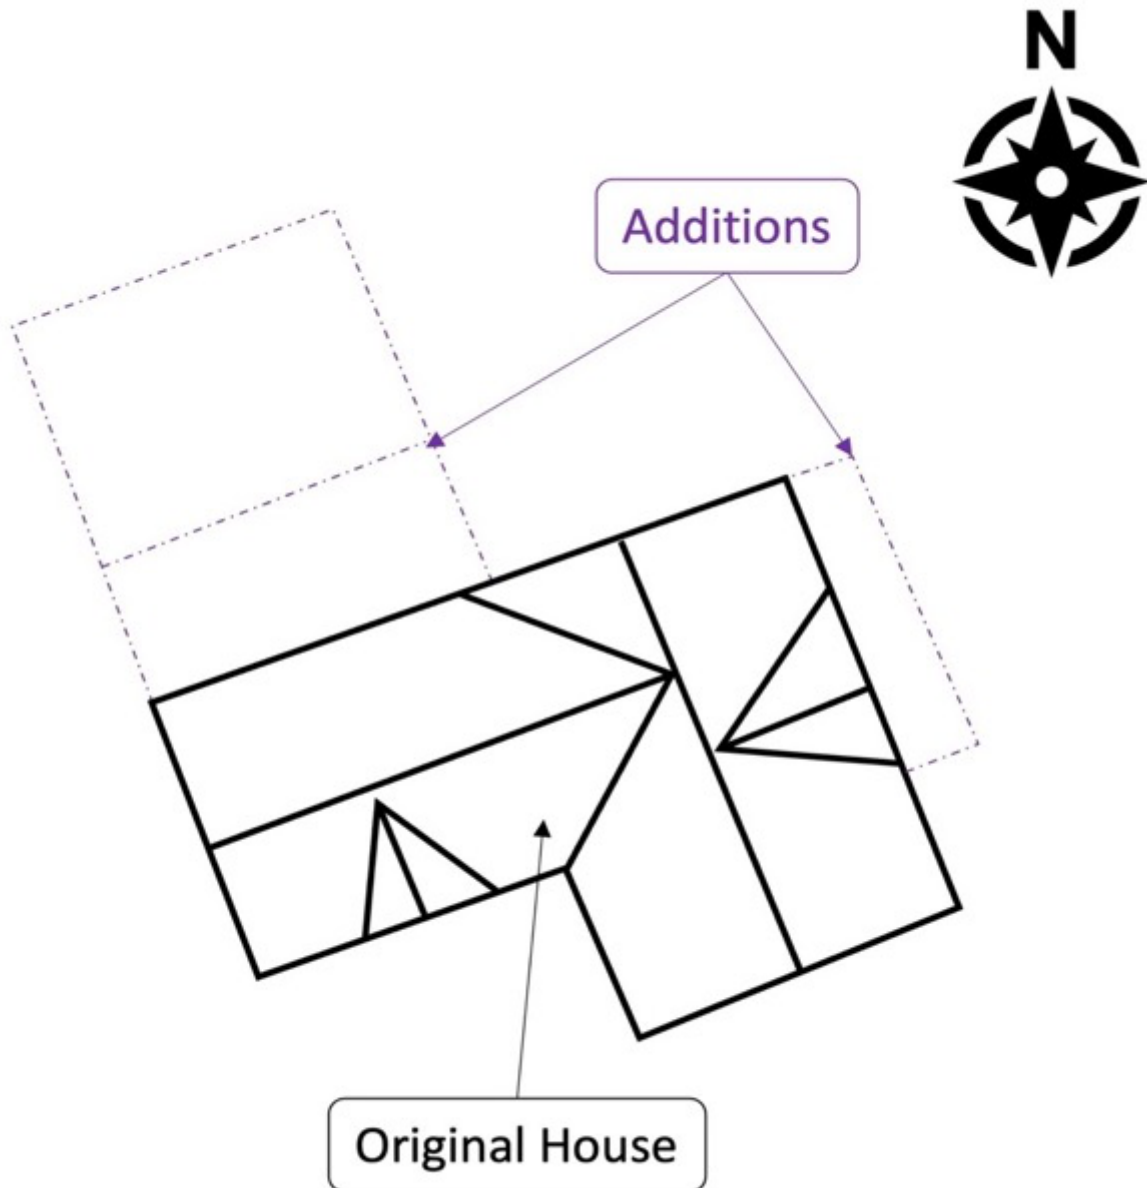
Figure 4 - Footprint Sketch

The main house appears to be constructed on a fieldstone foundation, with some areas covered or parged with concrete. According to the owner, the interior has been converted into two separate rental dwelling units, one on the ground floor and basement with access from the front main entrance, and the other on the upper level with access from the added mudroom on the east side. The south (front) and west elevations features trees or shrubs that are slightly overgrown abutting the house. The outline of the existing structure is illustrated below:

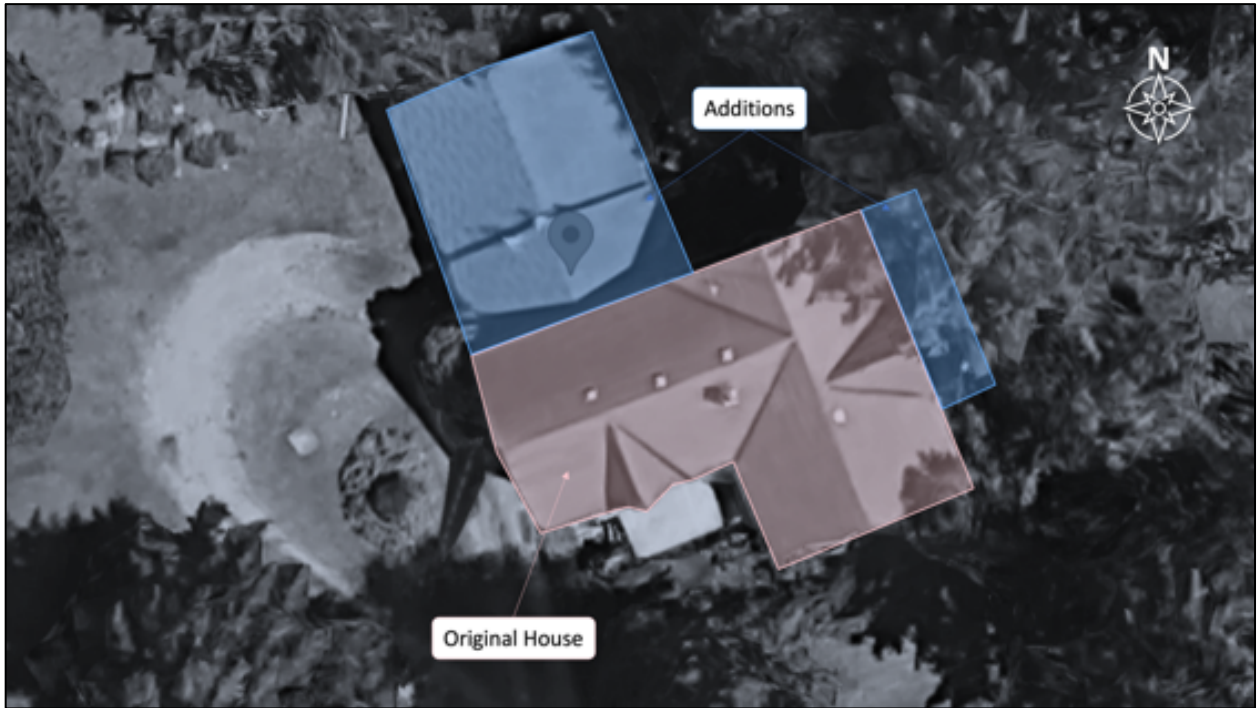
Figure 5 - Visual of Additions

The property at 7056 Pack Road features a 1.5-storey single-detached yellow brick house with an L-shaped floorplan and a gabled roof with steeply peaked dormers at the front and east sides. The roof is brown in colour, but during the site visit was under repair. It includes a 1-storey mudroom addition on the east façade and a 1-storey garage as a rear addition on the north side. There is also a small garden shed to the east of the house.

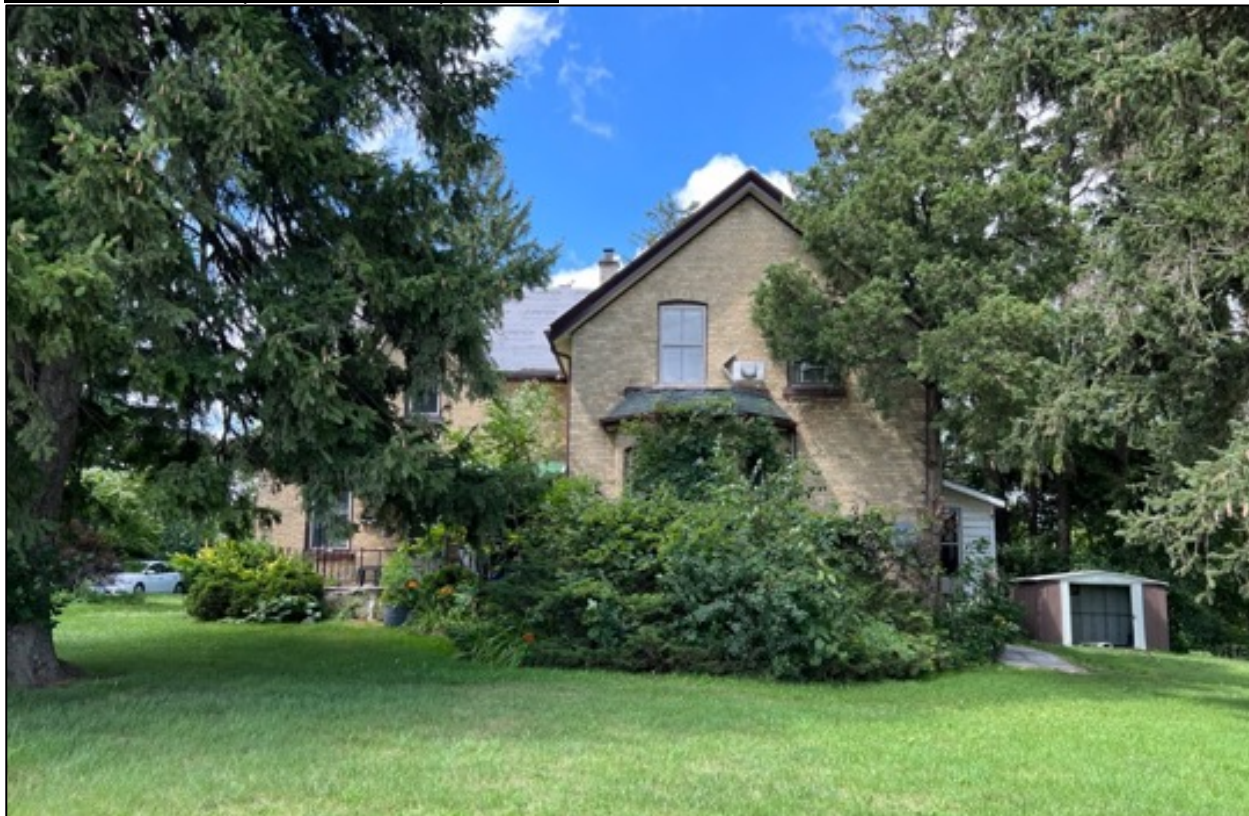
South Elevation (Front Façade) Overall

The south elevation (front façade) of the house at 7056 Pack Road consists of two sections: a front gable section and a side gable section both of which are made of yellow brick. The front gable section is positioned closest to the road and features a large offset bay window with three bays each with segmental arches. Each of the windows (central and flankers) are one-over-one rectangular vinyl inserts retrofit into their openings, and there is a shingled roof covering the bay.

Notably, the front gable portion incorporates a component from the Heating, Ventilation, and Air Conditioning (“HVAC”) system retrofitted into the façade between the upper level windows. On the right side of this front gable section, there is a window that includes an in-window Air Conditioning (“AC”) unit. On the lower level near the eastern corner of the house, a satellite dish has been mounted. At the ground level there is a basement window with a segmental arched opening, again retrofit with a modern rectangular window insert.

Some damage is evident in the bricks and mortar, particularly above the window openings, to the roof of the bay window, and in several small sections of the wall.

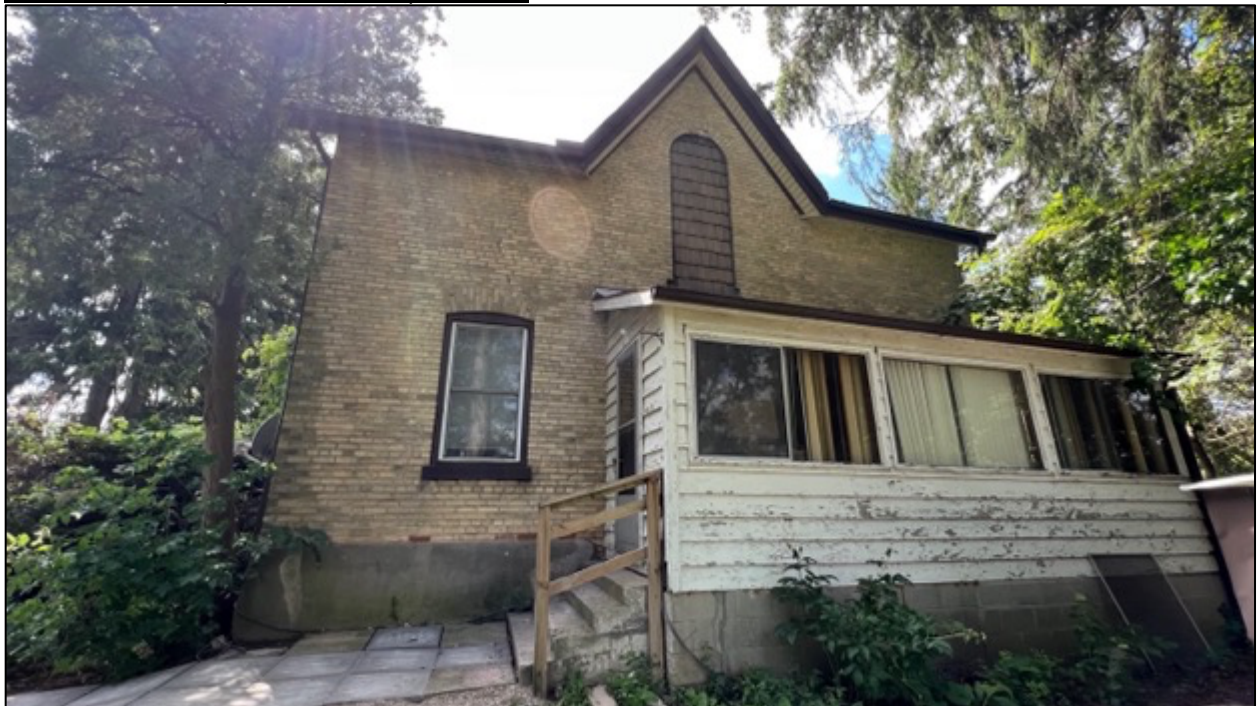
East Elevation (Side Façade) Overall

The east elevation (side façade) of the house at 7056 Pack Road features a generally square layout with two window openings. One window has been covered up, leaving a

Notably, there is some damage to the brick and mortar above the brick voussoirs of the main floor window. Overall, the yellow brick exterior generally appears uniform in size and construction and consistent in colour with the south elevation of the house.

On the upper level, a steeply pitched dormer with slightly projecting eaves can be observed. Below this dormer is a long, slender window opening that appears to be covered with cedar shakes. The window opening features a round arch that shows signs of brick and mortar damage.

Regarding the foundation on this side, it has been repaired with or parged over with concrete.

There is also a door to the rear of the mudroom (north side), but there are no steps projecting from it, suggesting that the door is not commonly or ever used. It is evident that the mudroom addition is a newer addition to the original structure as seen in its concrete block foundation versus the field stone foundation of the house and is a different material than the house itself (brick). This small addition provides access for the second rental unit, which occupies the upper level.

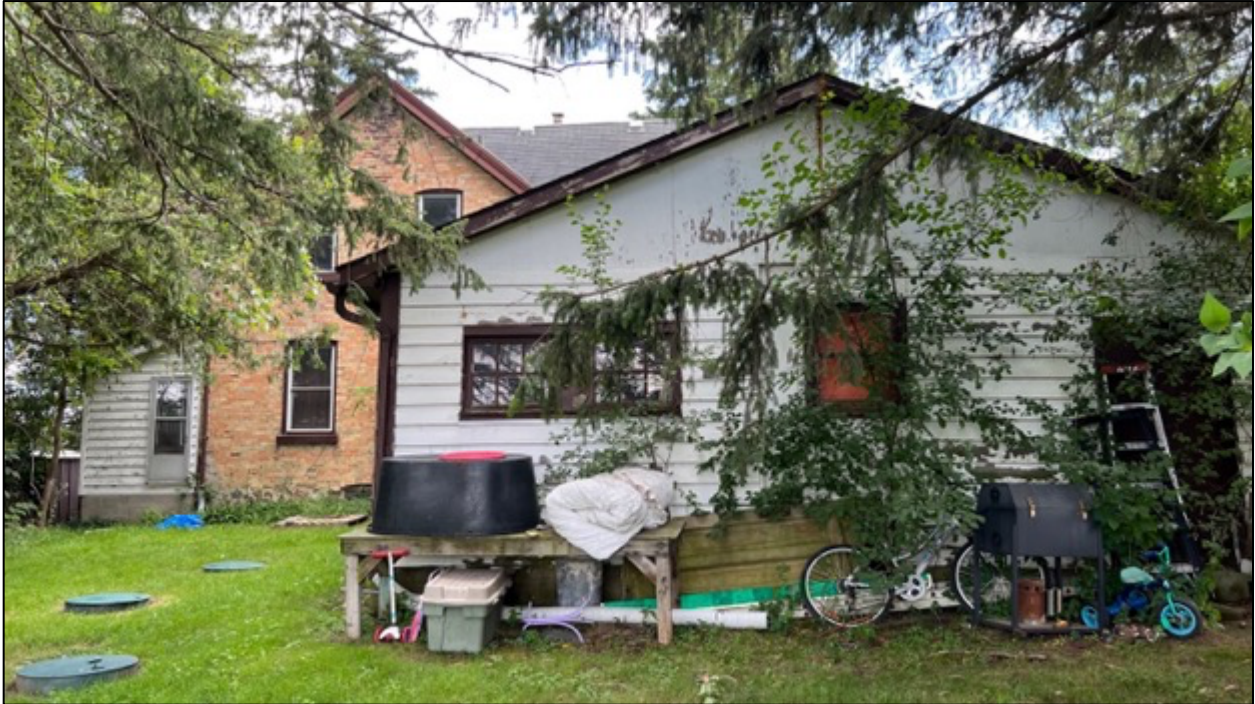
North Elevation (Rear Façade) Overall

The north elevation (rear façade) of the house at 7056 Pack Road presents some notable changes, including a different brick color and the presence of a 1-storey garage addition. Unlike the south (front) and east sides, this main exterior wall does not have any bends or corners and is the longest portion of the “L-Plan” featuring two sections - a

Along this façade, the fieldstone foundation is present before being interrupted by the garage addition.

Interestingly, the brick color on the rear differs from the yellow found on the front and east sides. The rear brickwork displays a polychromatic style with various hues of red and yellow and some brown. Typically, the north façade of buildings, especially rural ones, are better preserved from weather compared to the south façade due to differing exposure to elements. However, in this case, it is evident that different brick colors were intentionally used on the rear façade rather than a result of sun bleaching, because on the west elevation (discussed below) the change in brick is quite evident with a noticeable transition line in the brick.

A brick house may exhibit two different brick colors for various reasons. These include phased construction, where different sections were built at different times using materials available at the time; additions or expansions to accommodate growing families or changing needs; repairs or restoration work that involved using different bricks; brick sourcing, where locally available materials from various regions or quarries were used; or weathering and fading, although we do not believe weathering to be the case here.

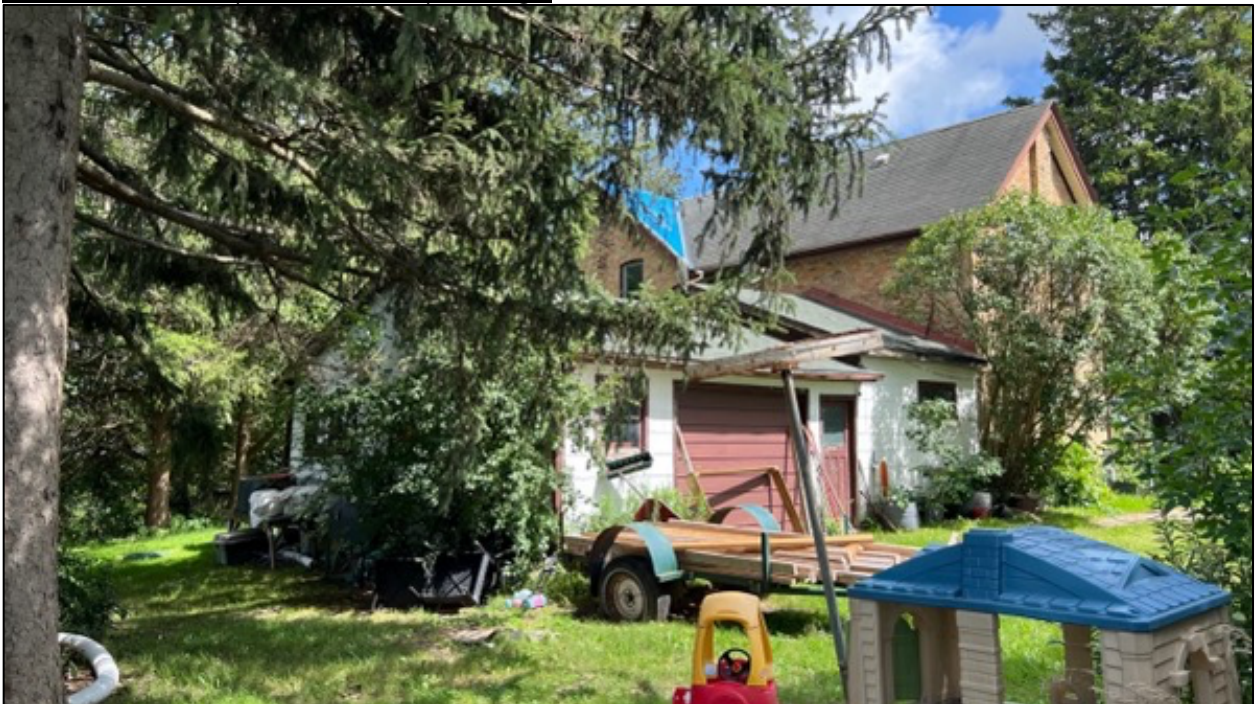
North Elevation (Rear Façade) Garage

The side gable section of the rear is mostly covered by the garage addition, which appears to be constructed of light timber with wood siding. Several windows of varying sizes and styles, some fixed and others operable, adorn each side of the garage. Most of these windows appear to be wood rather than vinyl, with one window on the rear closed off with plywood. The garage's white-painted wood siding is in need of repair, as it shows signs of flaking off.

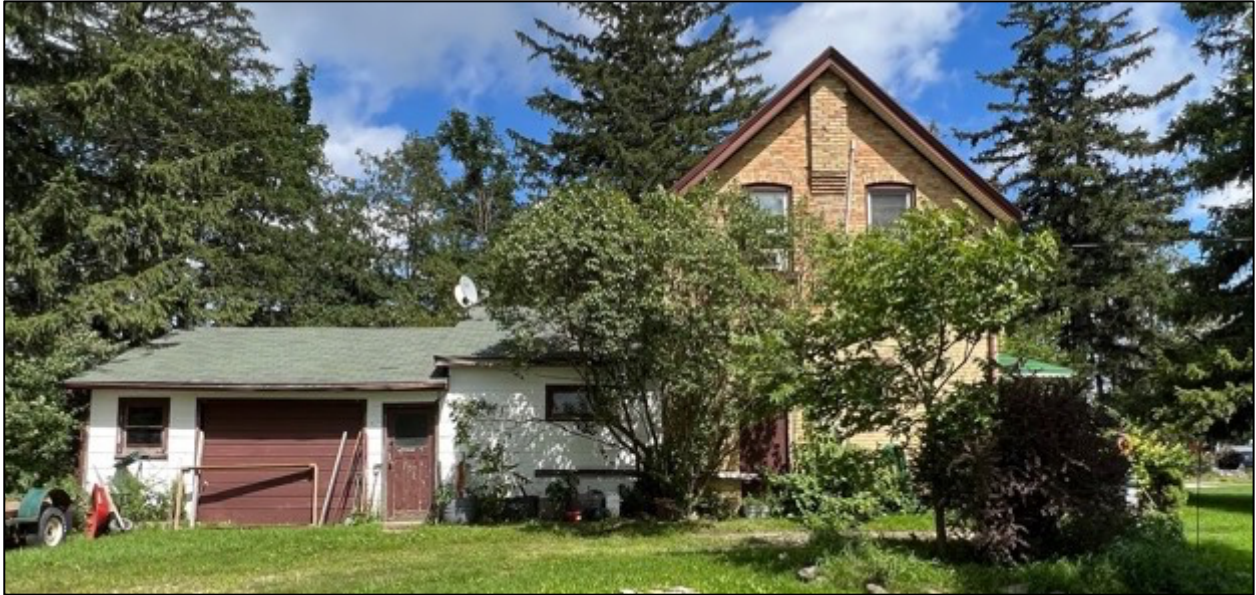
West Elevation Overall

The west elevation (side façade) of 7056 Pack Road is the side gable to the front elevation of the house. This part of the house boasts several windows, including a small rectangular window with wood framing on the ground floor level, featuring a single pane vinyl insert (potentially fixed or casement). It also houses the primary garage functions, such as the main entrance, garage doors, and windows. The upper portion of the brickwork displays the same polychrome style, showcasing various hues of red and yellow, similar to the rear façade. Yet, on the lower portion, the yellow brickwork from the front and east sides continues over, and the two brick styles can be seen just below the upper level windows.

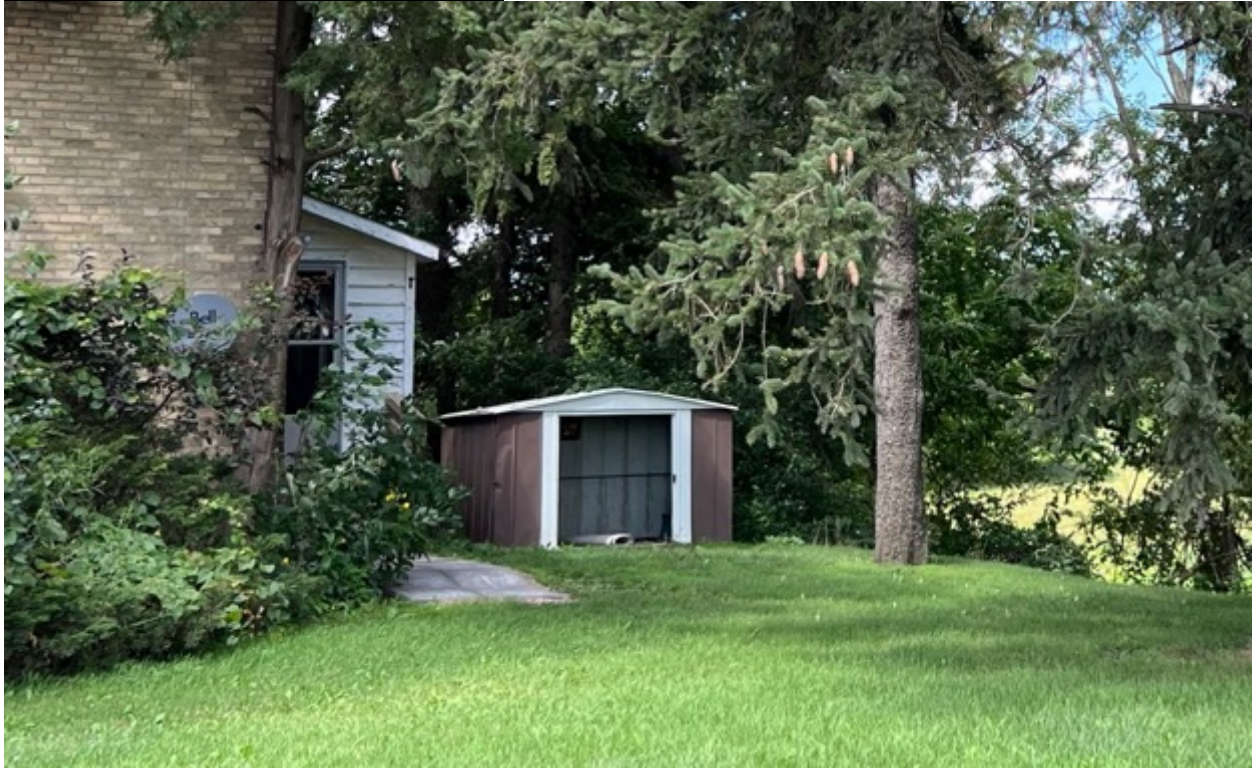
Garden Shed (East of Main House)

Located to the east side of the house is a small steel garden shed. The accessory structure is made of brown and white steel.

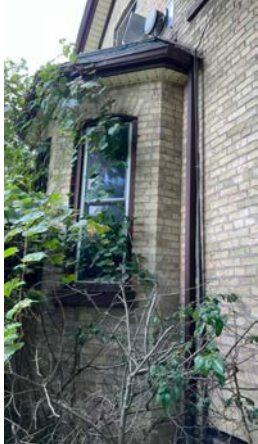
93. 7056 Pack Rd Stone Foundation.HEIC

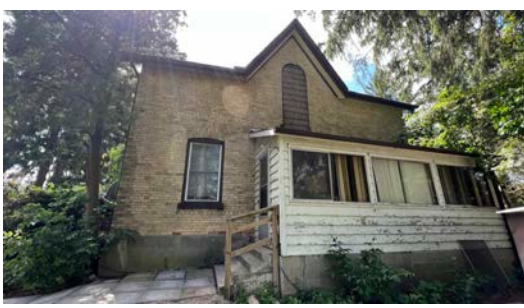
79. 7056 Pack Rd East Facade Mud Room Addition & Concrete Foundation Work.HEIC

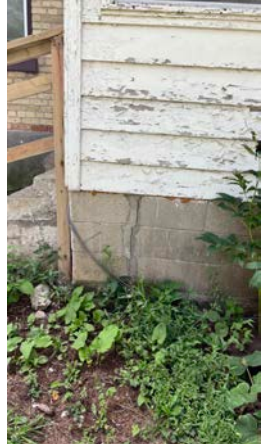
80. 7056 Pack Rd East Facade Boarded Over Window Opening.HEIC

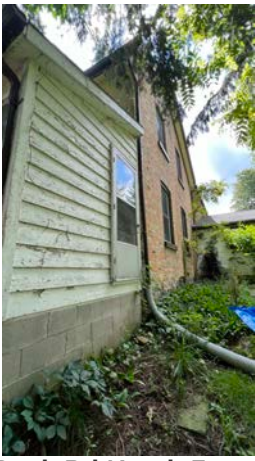
- Unsympathetic addition to the rear (north) for a garage, and a sympathetic mudroom / entrance to the east side.
- The mudroom addition to the east had cracks in its cinder block foundation.
- Removal of a chimney on the west side of the original brick house.

85. 7056 Pack Rd Cracked Cinder Block Mudroom Foundation.HEIC

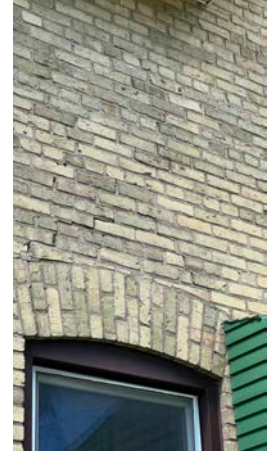
95. 7056 Pack Rd Mortar Damage 1.HEIC

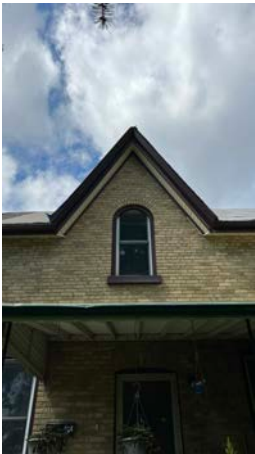
96. 7056 Pack Rd Mortar Damage 2.HEIC

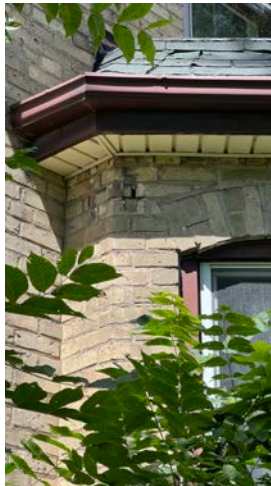
92. 7056 Pack Rd Peaked Dormer and Arched Window Opening.HEIC

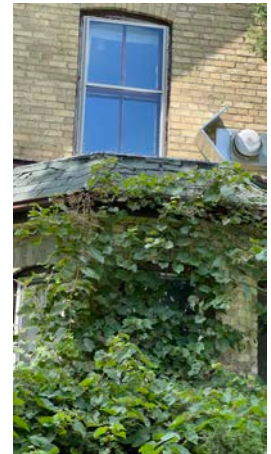
84. 7056 Pack Rd Brick Damage.HEIC
