*Heritage Impact Assessment for Proposed University Drive Student Residence
1151 & 1163 Richmond Street, London, ON*

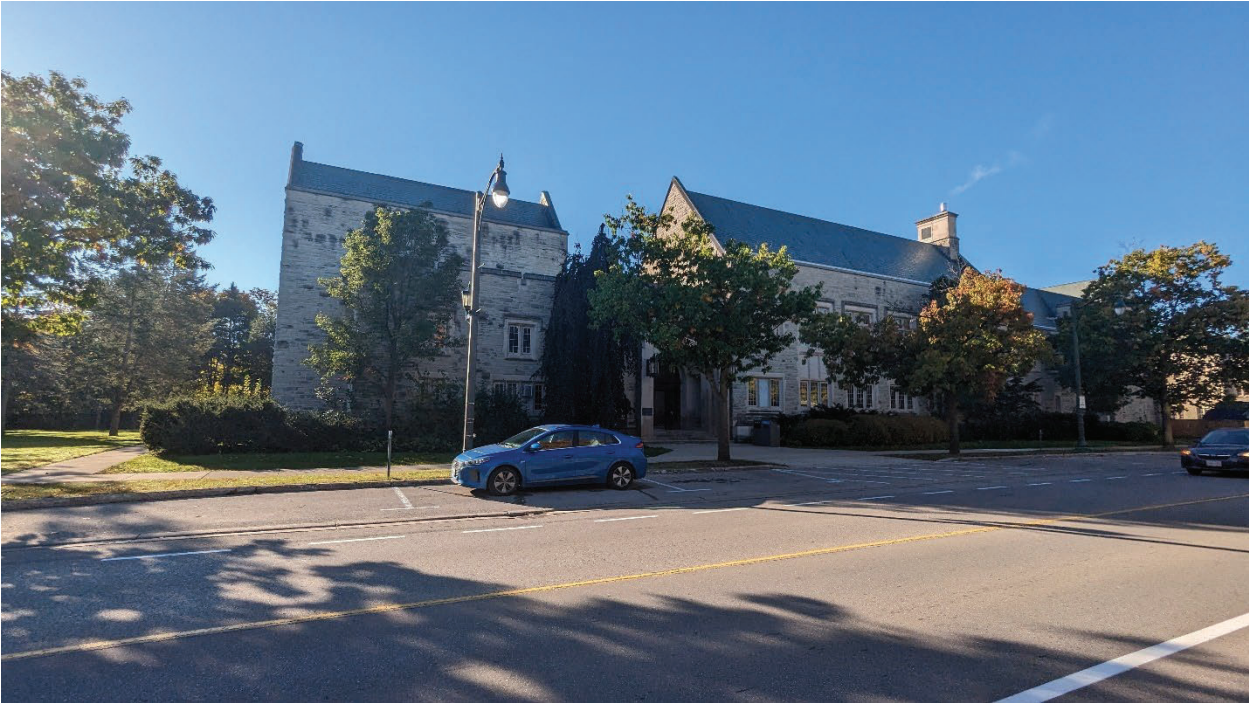
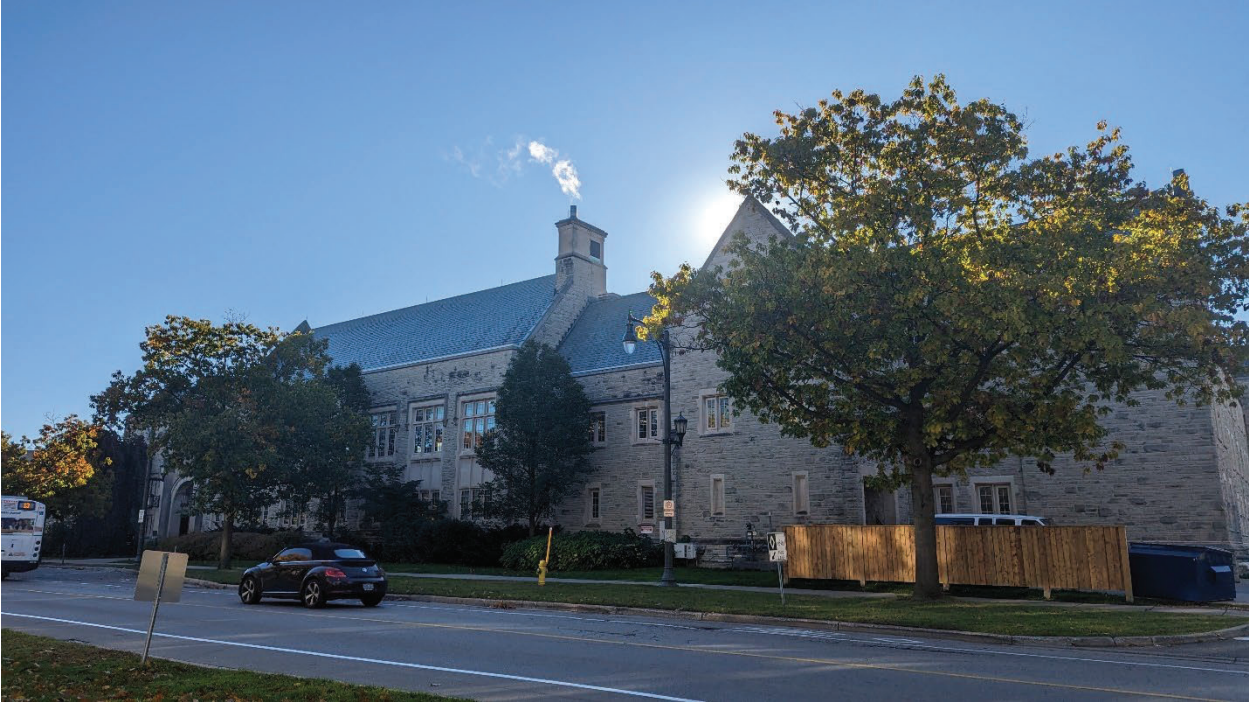
Photos 31 & 32: (above) View of Medway Hall north (front) elevation looking south-west; (below) View of north (front) elevation of Medway Hall looking south-east (MHBC, 2023).

Medway Hall is a three-storey sandstone masonry building and includes an internal courtyard. The main entryway is off University Drive through a semi-arched Gothic-inspired tunnel which is part of a lower two storey podium. The facades include a variety of Gothic inspired features including stone buttresses, pointed pilasters, door, and window surrounds. The main entryway, in particular, is flanked by pointed stone pilasters and above the lintel, a coat of arms inspired parapet which replicate the vertical form of the pilasters (see **Photo 33**). The building includes a variety of rooflines including platform and gabled with parapet gable ends and associated coping amongst prominent masonry chimneys.

The window placement and size are consistent throughout the building except for the central portion along the north (front) elevation which includes window galleries that span two stories adorned by heavy stone drip moulding and slit windows, inspired by the Gothic architecture. The stone surrounds for both window and door openings are key to the architectural style, however, appear to have resulted in some deterioration due to presumably poor water drainage which has led to the discolouration of masonry in various locations. Several features including the iron gates that accompany entrances into the courtyard and some fixtures remain and appear in good condition.

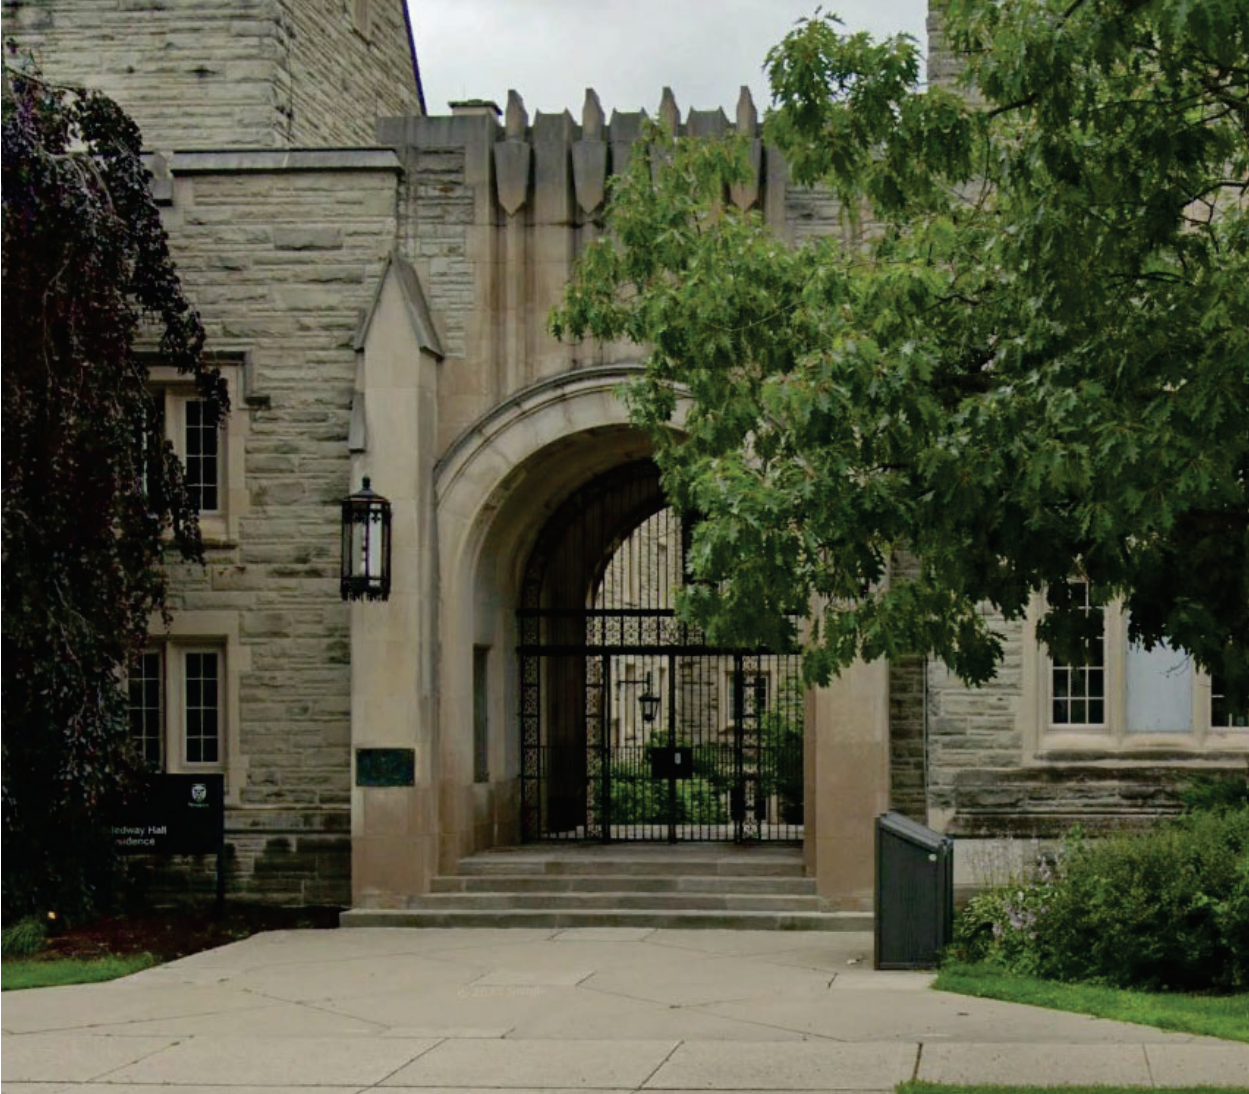
Photo 33: Main entryway of Medway Hall (MHBC, 2023).

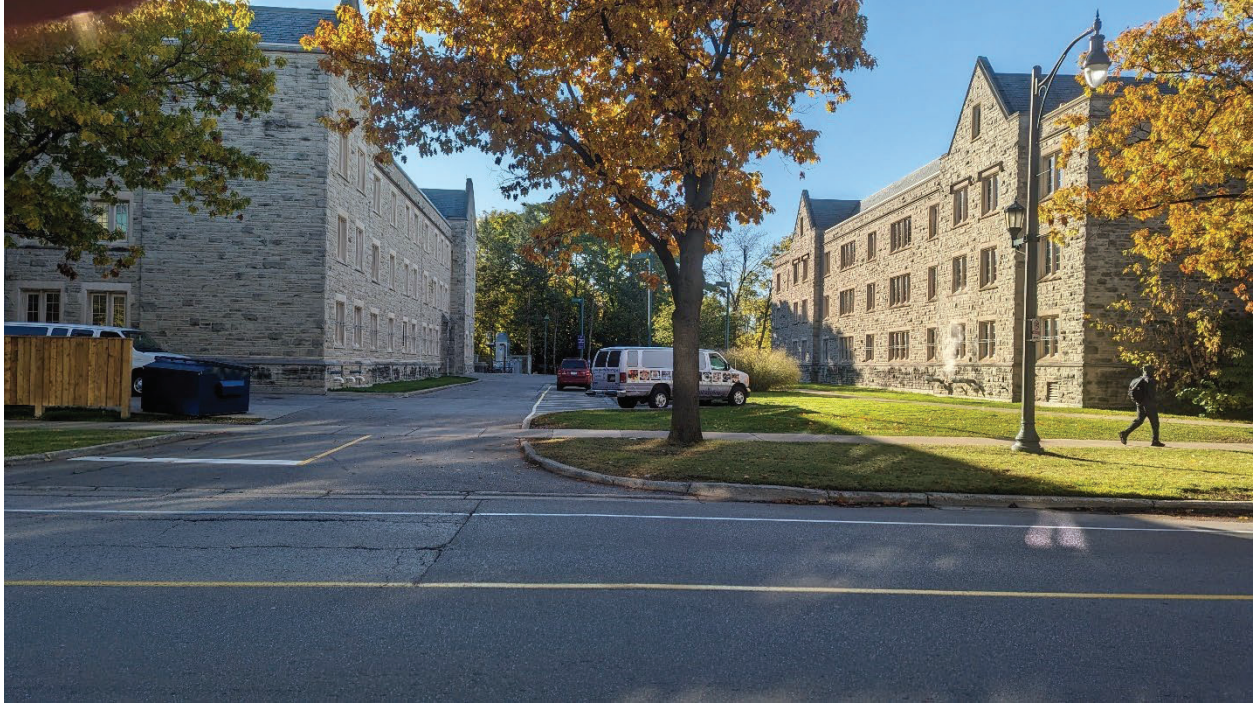
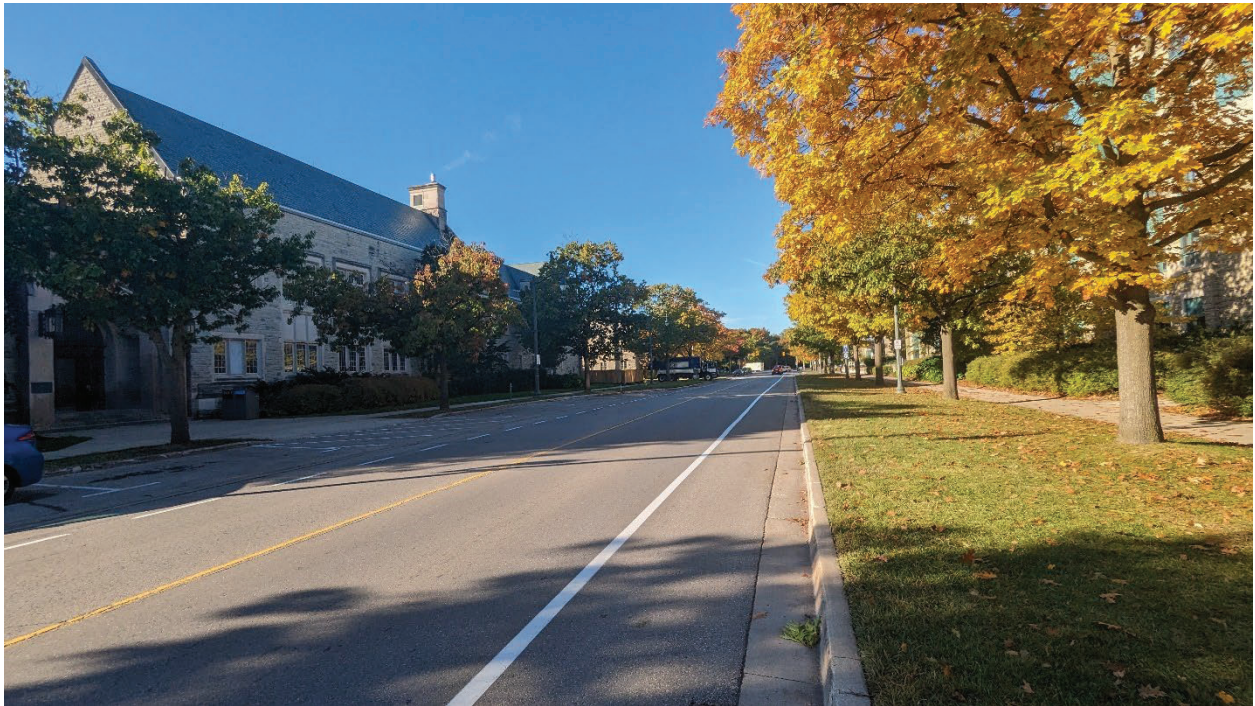
Photos 34 & 35: (above) View of Medway Hall west elevation and east elevation of Sydenham Hall looking southwards from north side of University Drive; (below) View of north (front) elevation of Medway Hall looking south-west along University Drive from approximate location of Project Site (MHBC, 2023).

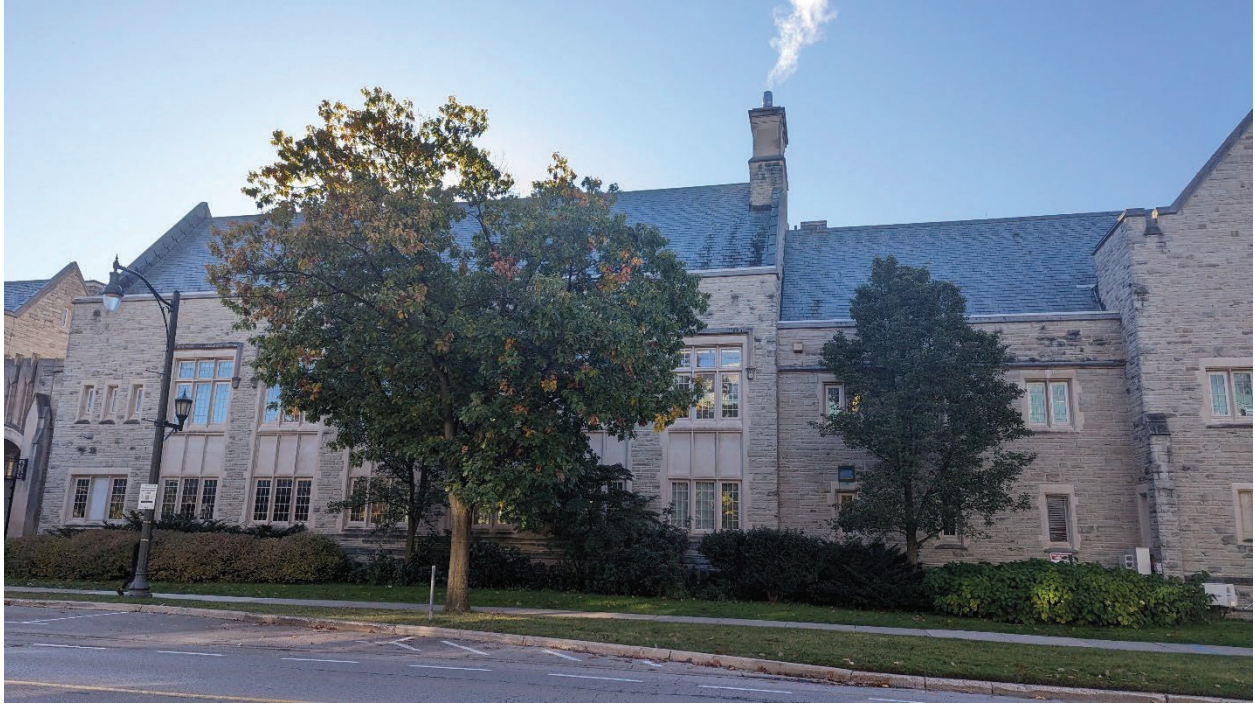
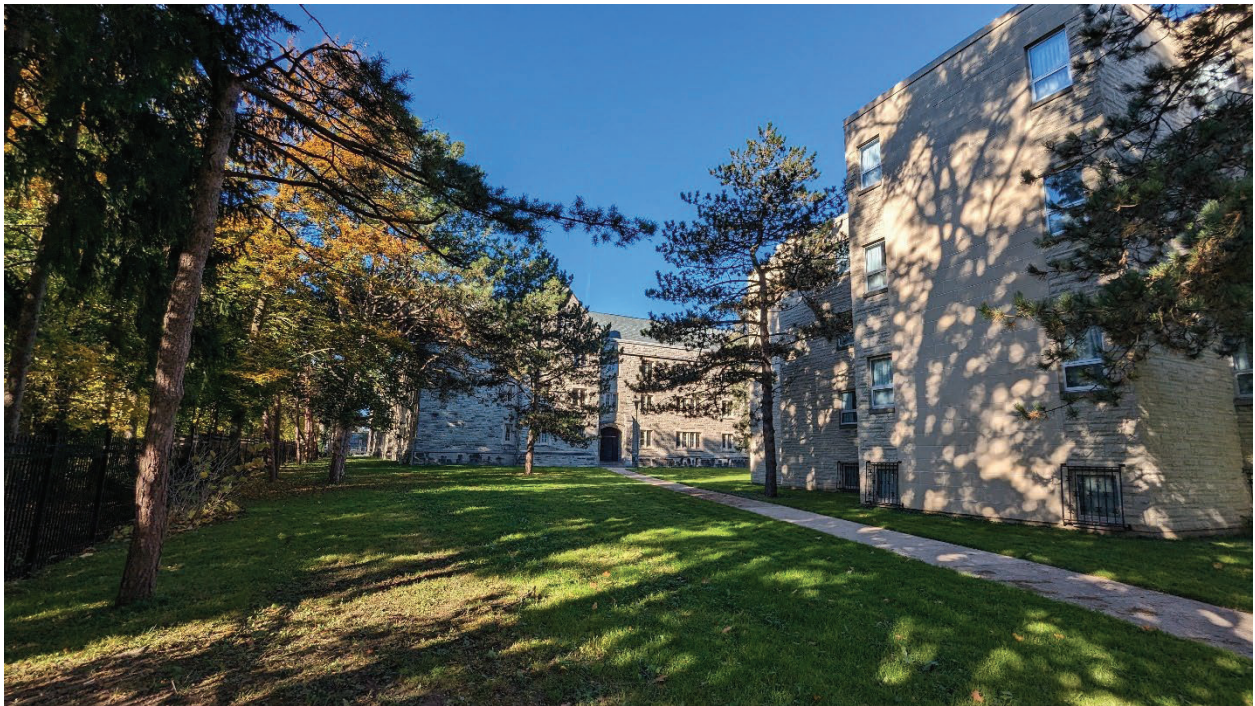
Photos 36 & 37: (above) View of north (front) elevation of Medway Hall looking southwards from north side of University Drive; (below) View of east elevation of Medway Hall and rear elevation of Alumni House looking westwards (MHBC, 2023).

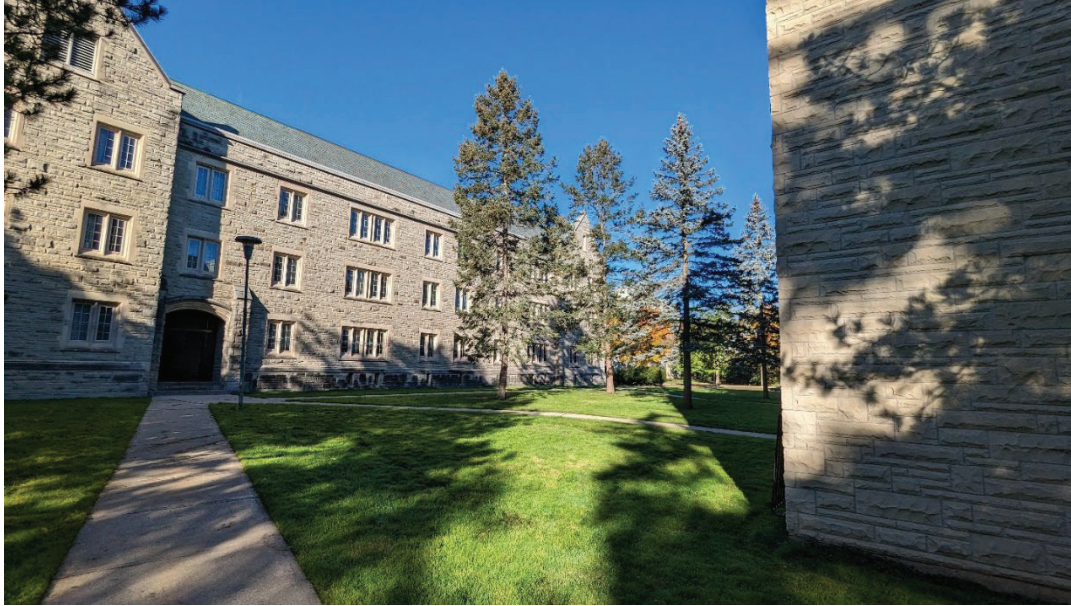
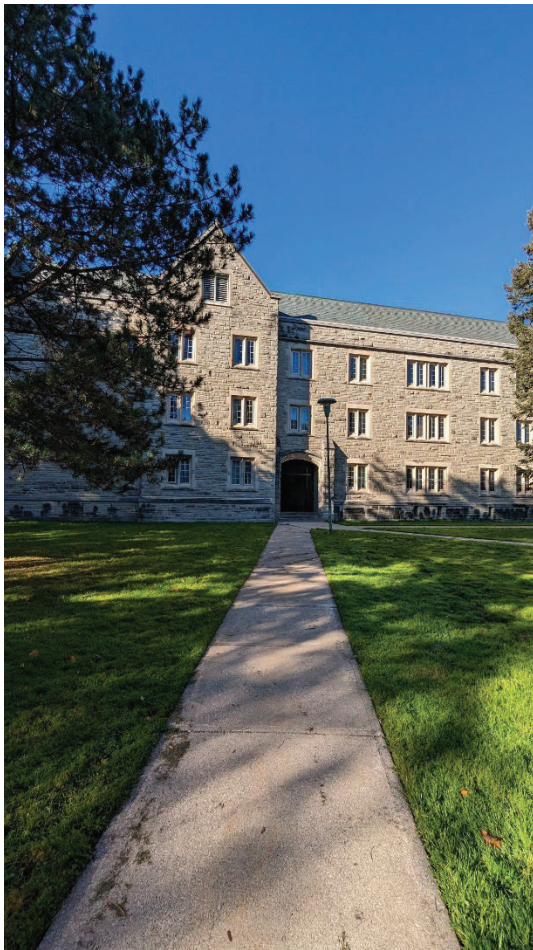
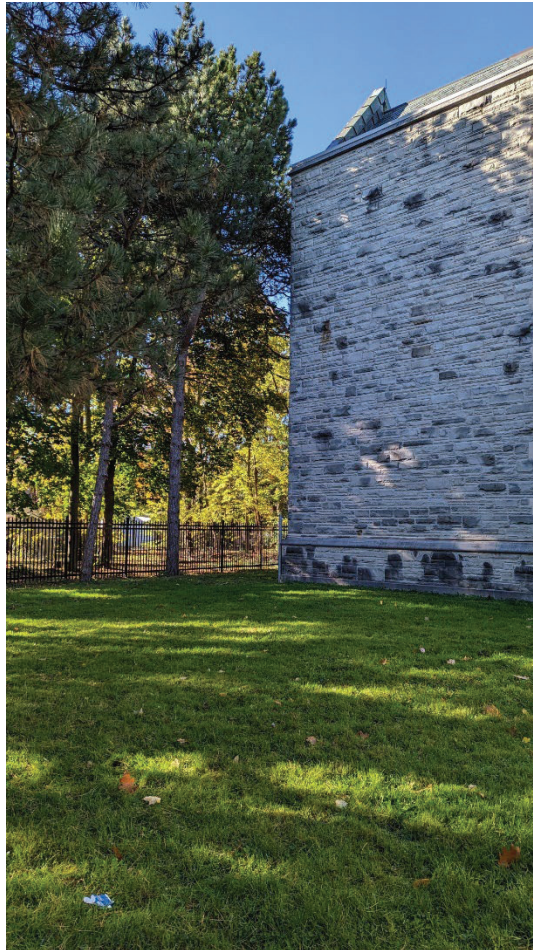
Photos 38-40: (above) View of east elevation of Medway Hall looking westwards; (below left) View of east elevation towards eastern entry to courtyard; (below right) View of southern portion of east elevation of Medway Hall (MHBC, 2023).

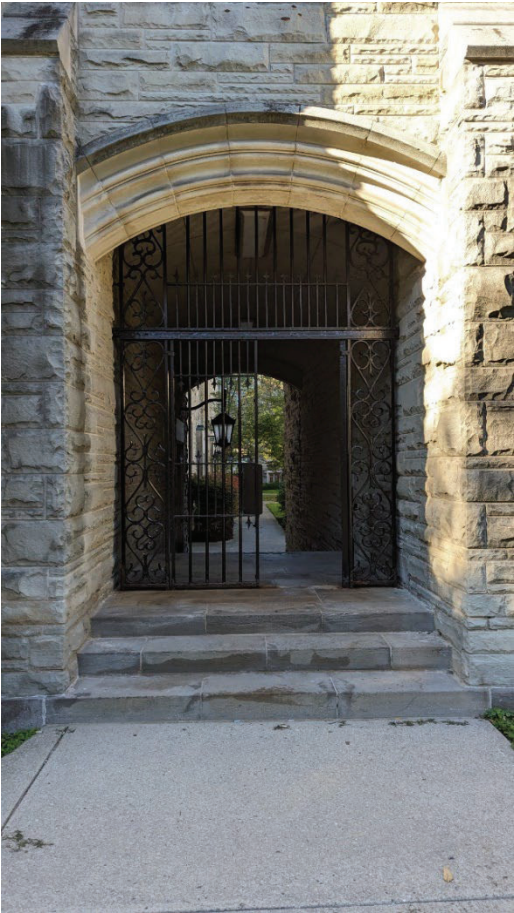
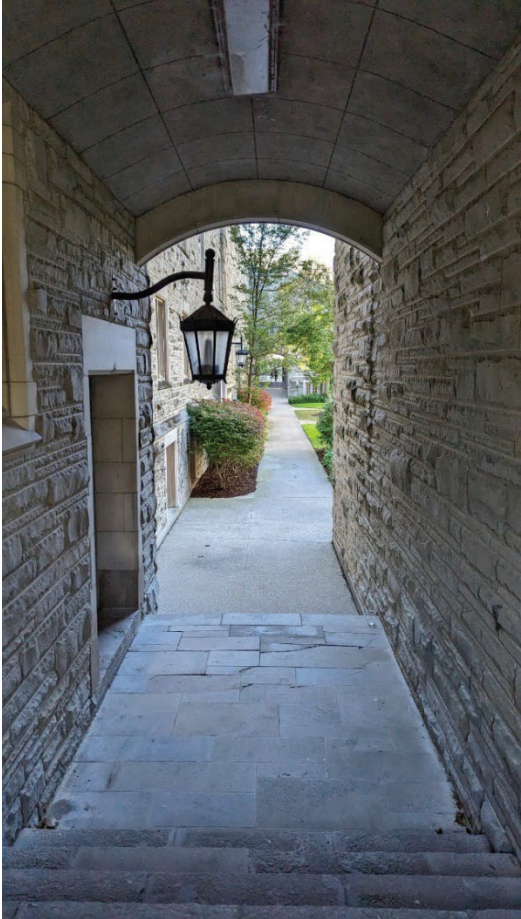
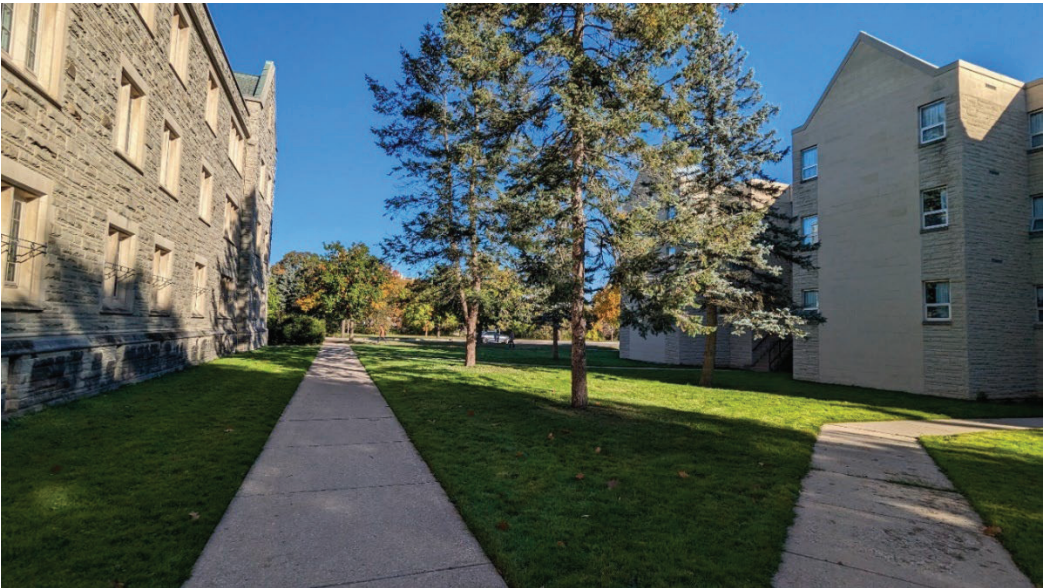
Photos 41-43: (above left) View of eastern entry into the courtyard including wrought-iron gates; (above right) View of tunnel to courtyard from east elevation; (below) View of east elevation of Medway Hall looking towards Project Site (MHBC, 2023).

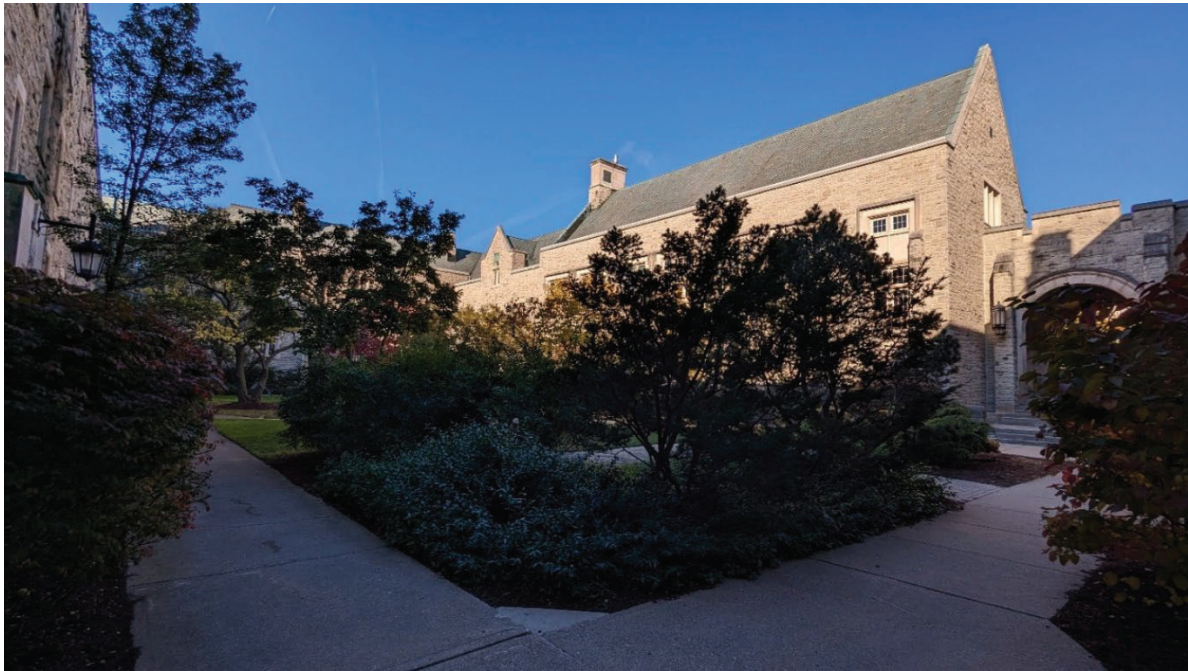
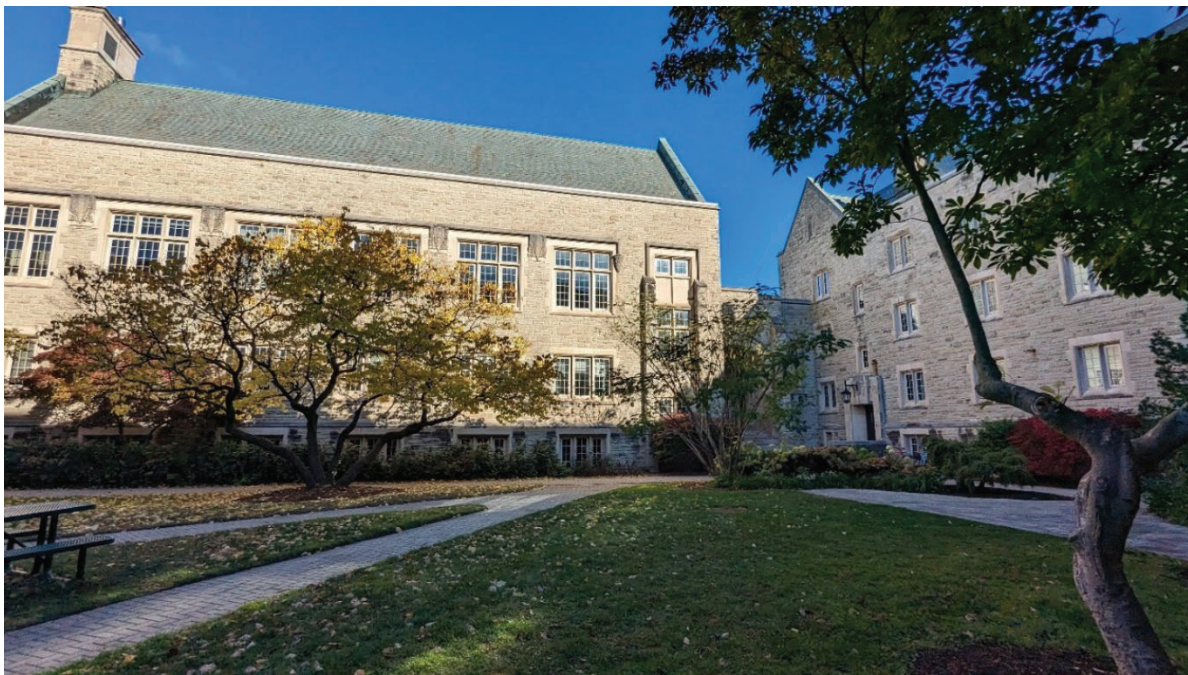
Photos 44-46: (above) View of front (north) elevation from the internal courtyard looking towards the front entryway; (below) View of internal courtyard looking towards front entryway (MHBC, 2023).

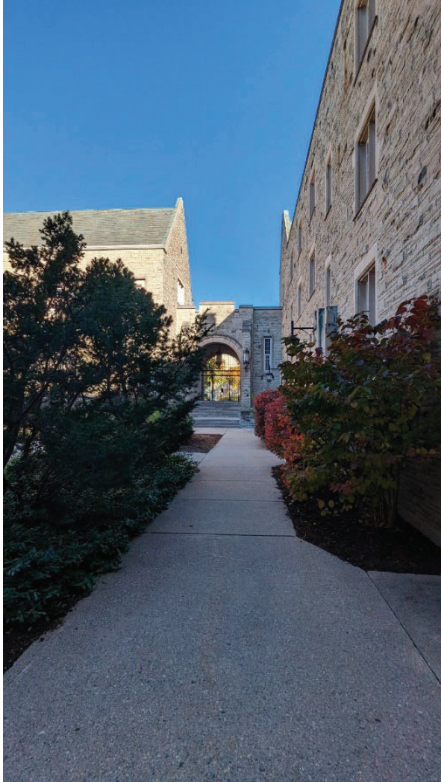
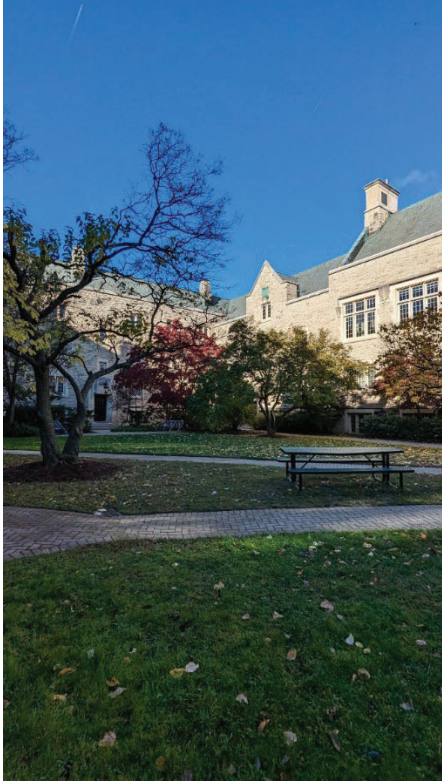
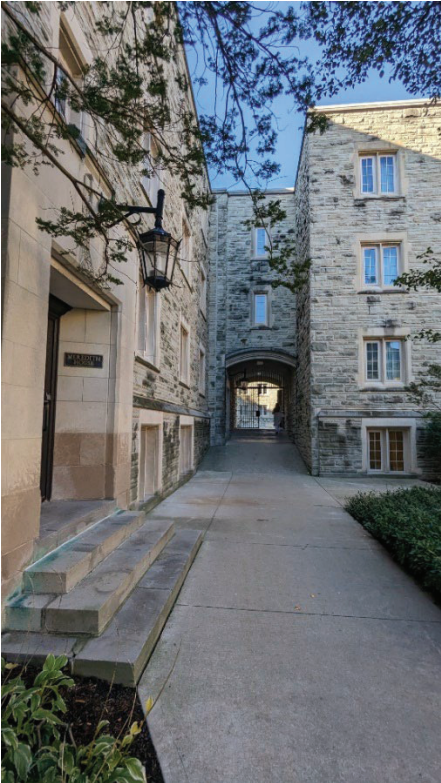
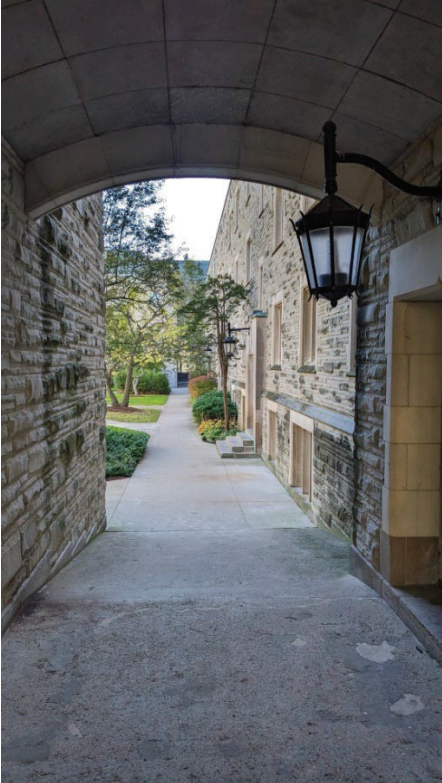
Photos 47-50: Various photographs of the internal courtyard and entryways (MHBC, 2023).

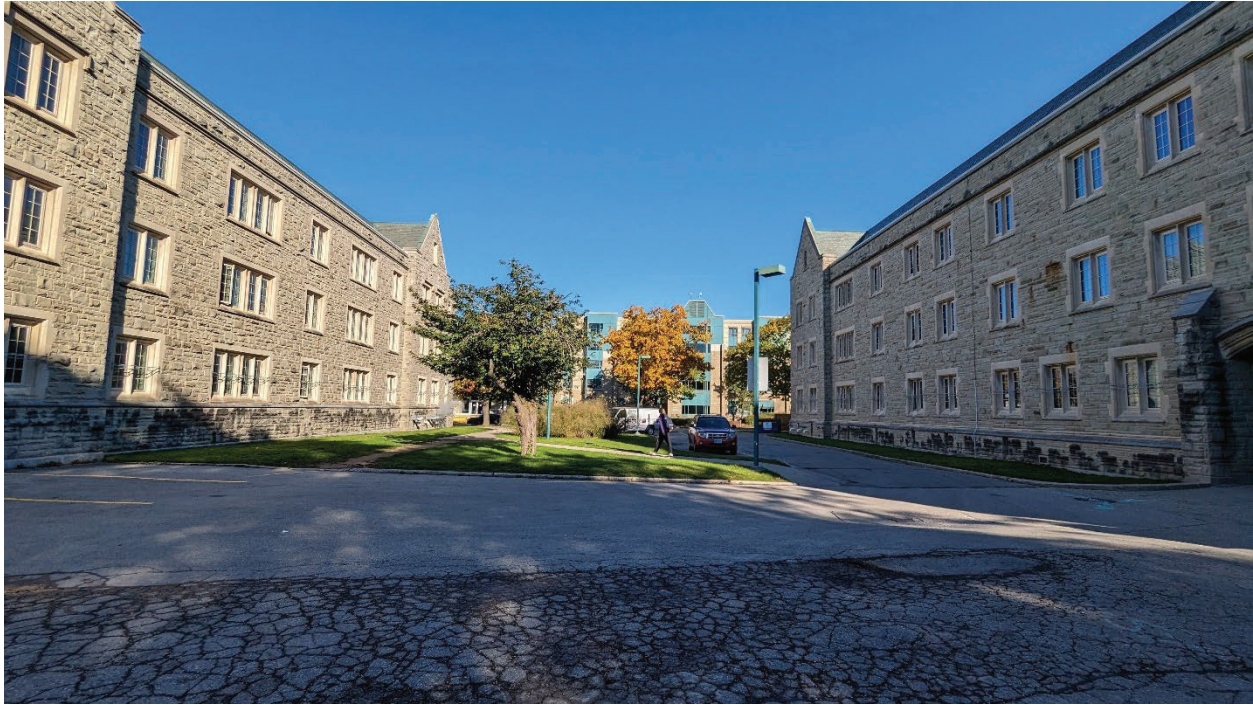
Photo 51: View of western elevation of Medway Hall (MHBC, 2023).

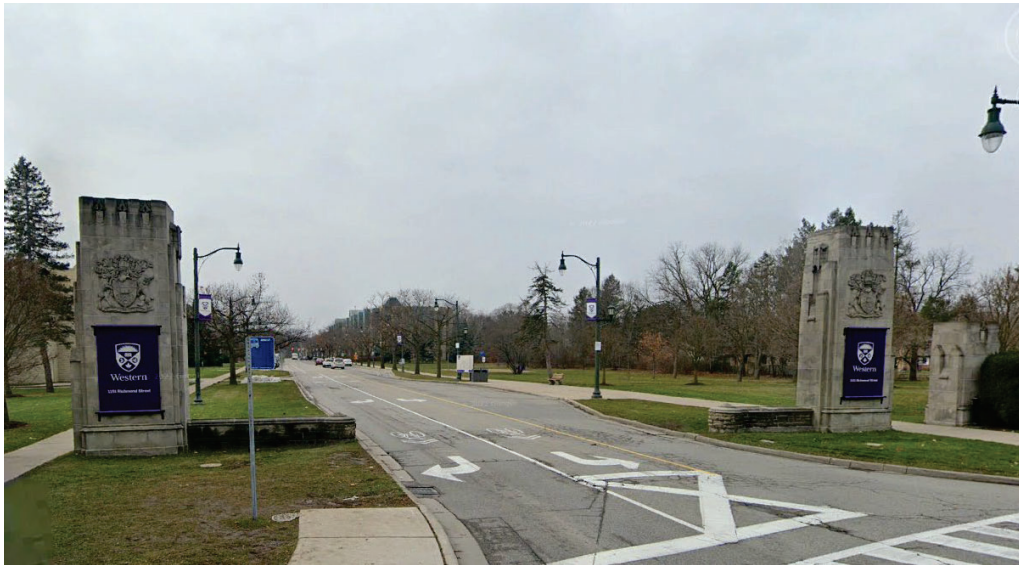
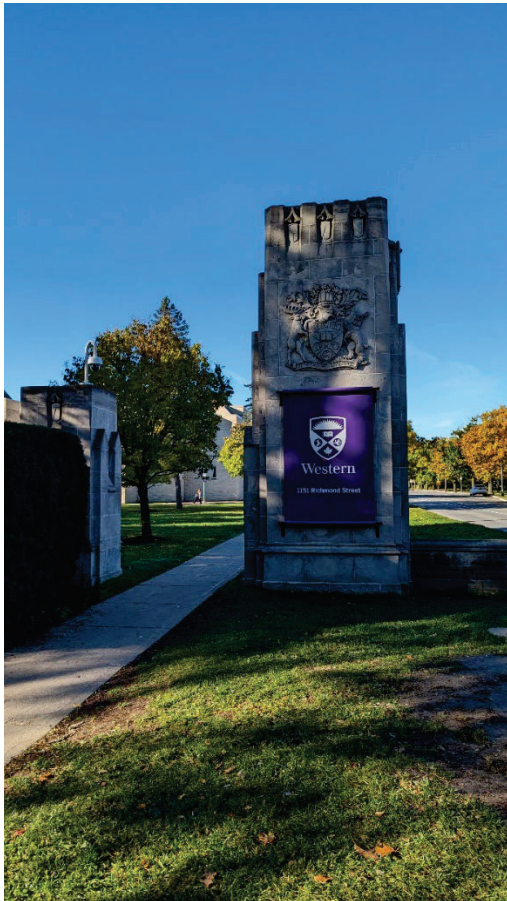
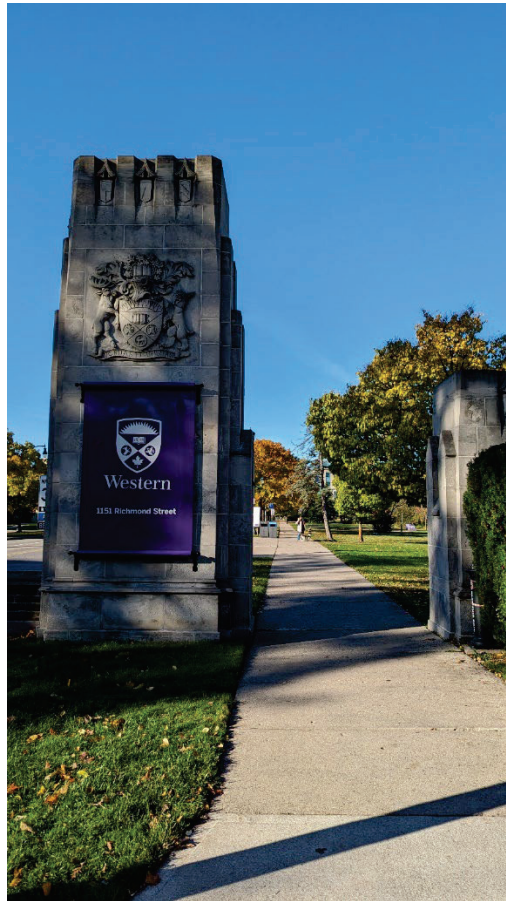
The University Gates (East) are comprised of two stone monuments that flank either side of University Drive. The main monuments are supported by smaller stone structures that flank the opposite side of the pedestrian walkway and there are also rusticated stone walls that connect the main monuments with the streetscape which have conical terminations and along the smaller counterparts on the opposite side of the pedestrian walkways. Architectural details include tiered pilasters and crenellation like indentations along the top of the main monuments. There appears to be some discolouration in both the monuments and stone walls likely due to poor water drainage along the masonry as well as signs of efflorescence. See **Photos 52-54**.

Photos 52-54: (above) View of University Gates (East) looking north-east towards University Drive from Richmond Street; (below left) View of west side of the entry; (below right) View of east side of entry (MHBC, 2023).

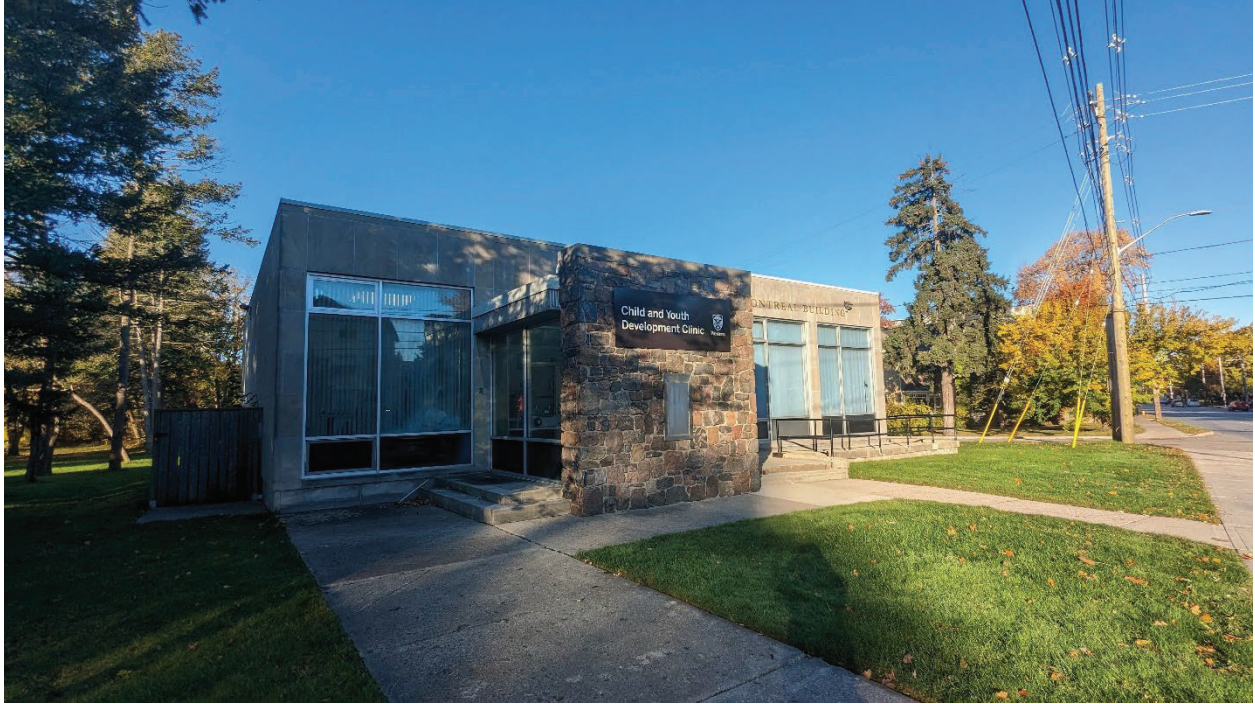
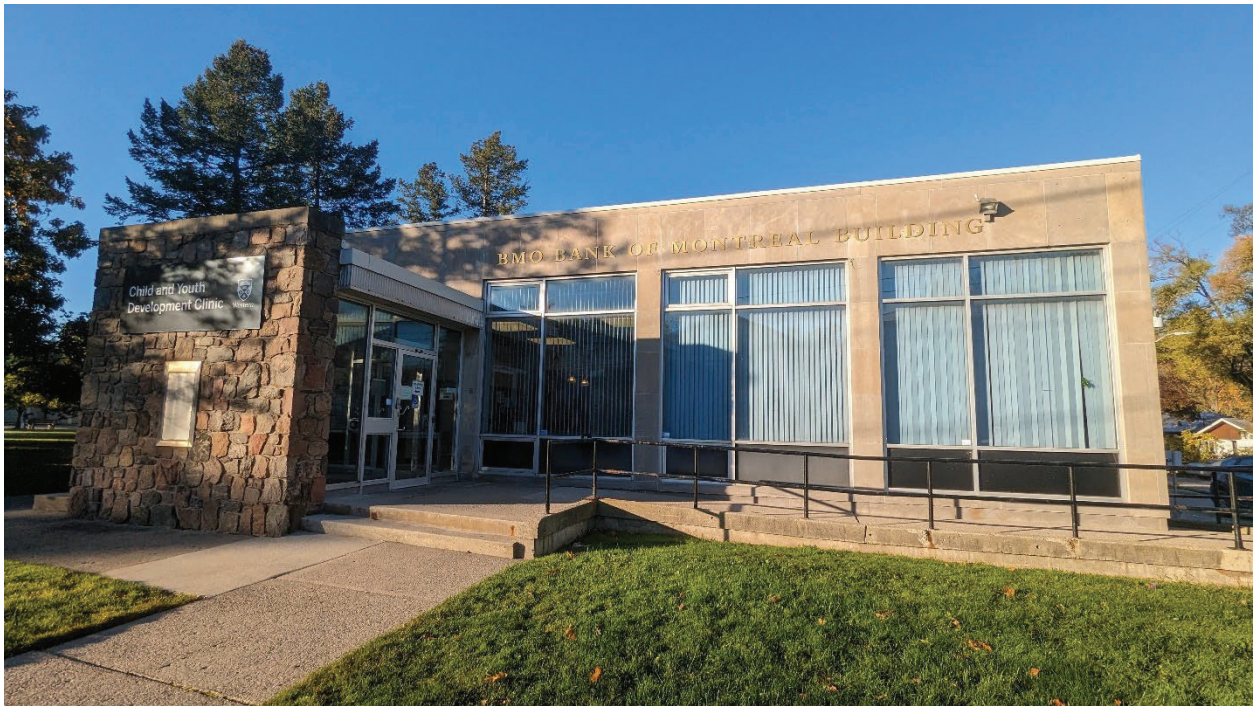
The property includes a one and a half storey building (BMO Bank of Montreal Building) with an 'L' shaped floor plan; the main building displays a stone veneer and a glass vestibule is located on the eastern elevation. The vestibule includes a feature wall along the east elevation which consists of fieldstone; this wall has a centrally placed panel. There is also a fieldstone wall that extends along the north elevation; the course fieldstone and smooth stone veneer creates a juxtaposition between textures. Large window openings are situated along the main (east) elevation and partly on the north elevation. The south and west elevations include single, narrow window openings that span the majority of the height of the facades. The main building and associated vestibule have a flat roof. The building appears to be in good condition except for discolouration along the foundation walls. See **Photos 55-60**.

Photos 55 & 56: (above) View of east (front) elevation of the building looking north-west; (below) View of east elevation of building looking westwards and towards vestibule entrance and feature stone wall (MHBC, 2023).

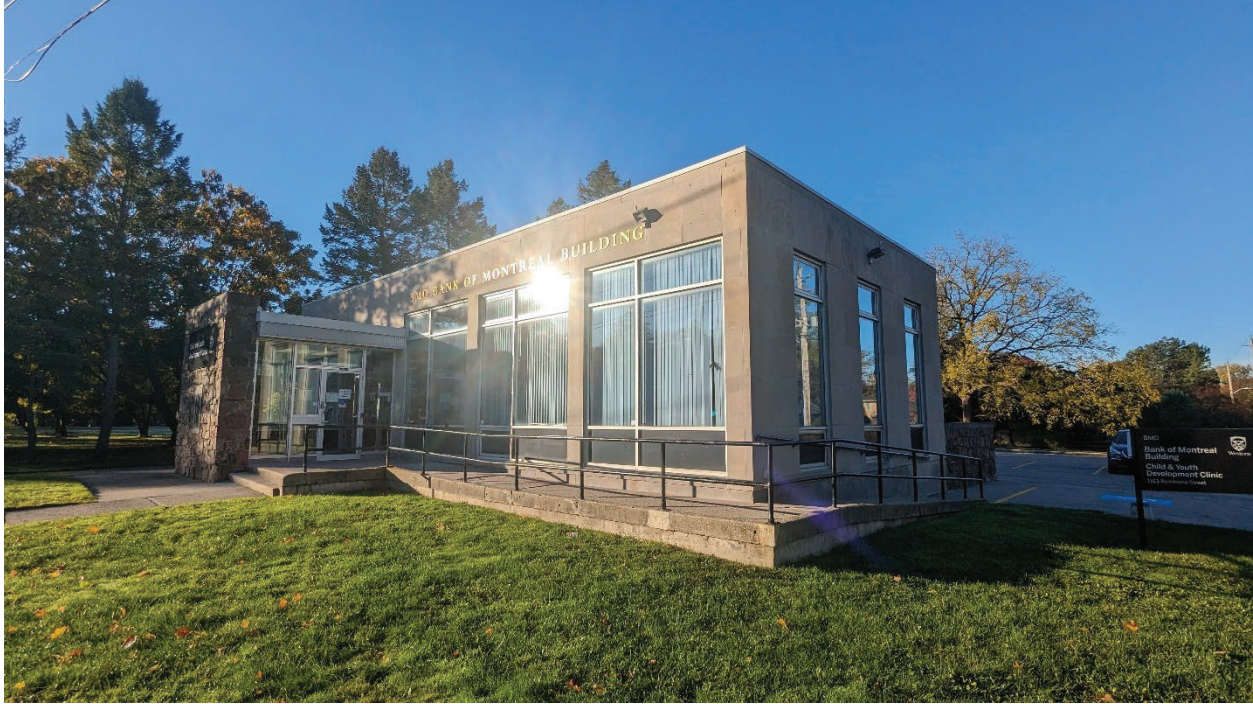
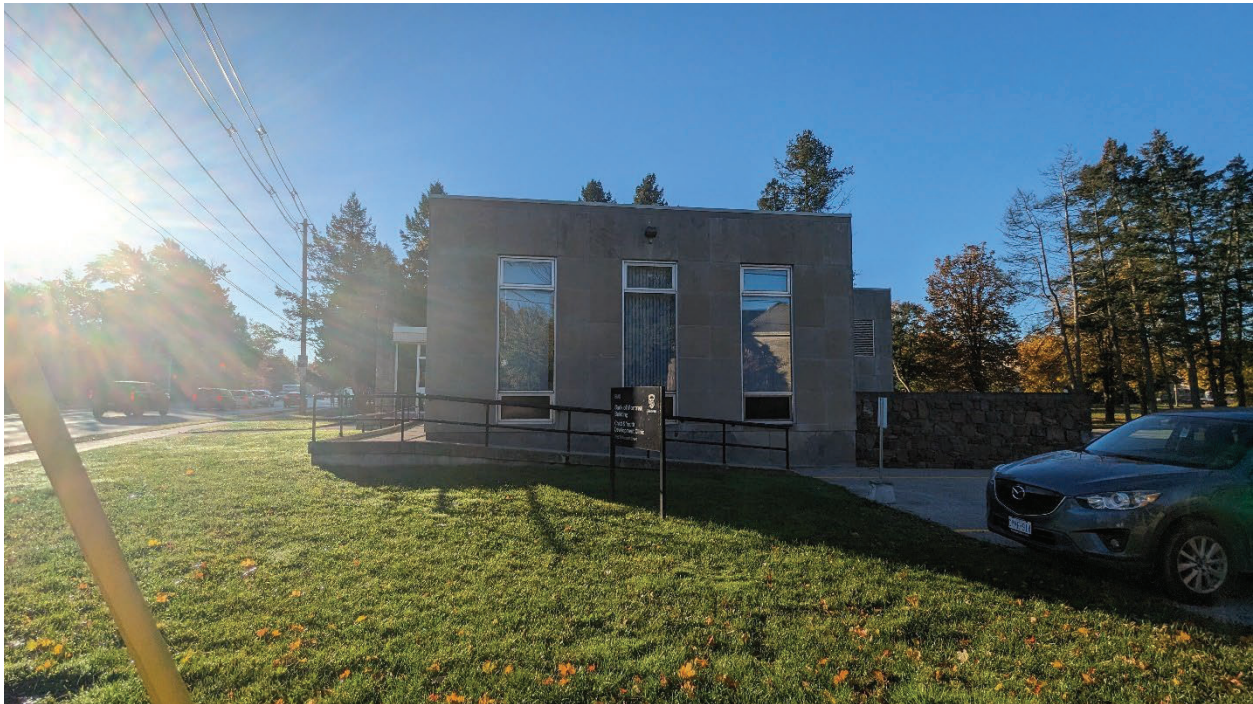
Photos 57 & 58: (above) Perspective view of east (front) elevation and north elevation of the building looking south-west; (below) View of north elevation of building looking southwards (MHBC, 2023).

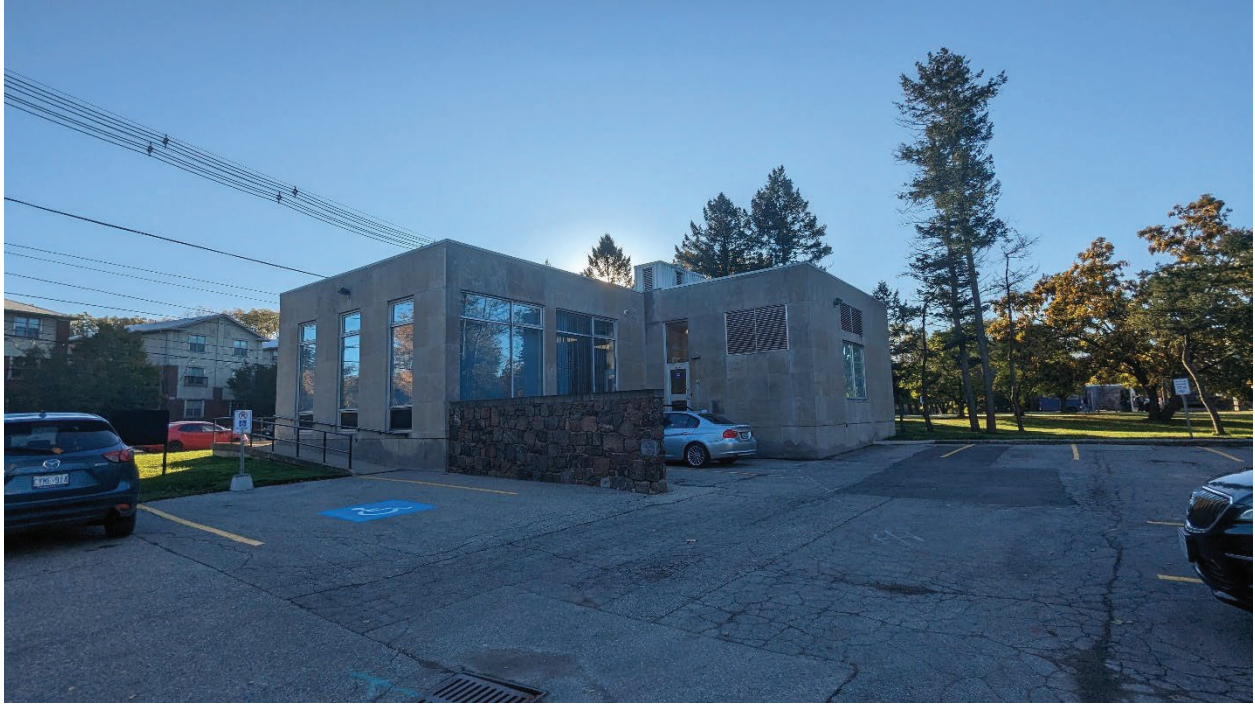
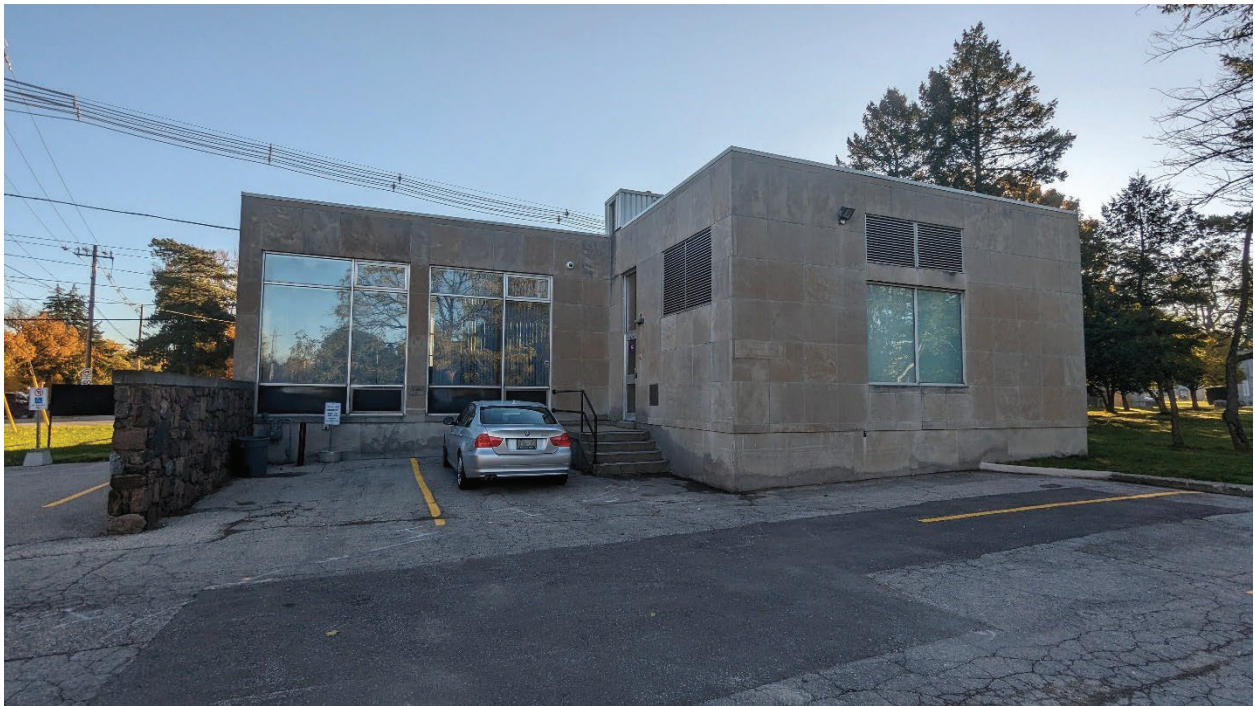
Photos 59 & 60: (above) Perspective view of north and west elevations of the building looking south-east; (below) View of west elevation of the building looking eastwards (MHBC, 2023).
