*Heritage Impact Assessment for Proposed University Drive Student Residence
1151 & 1163 Richmond Street, London, ON*

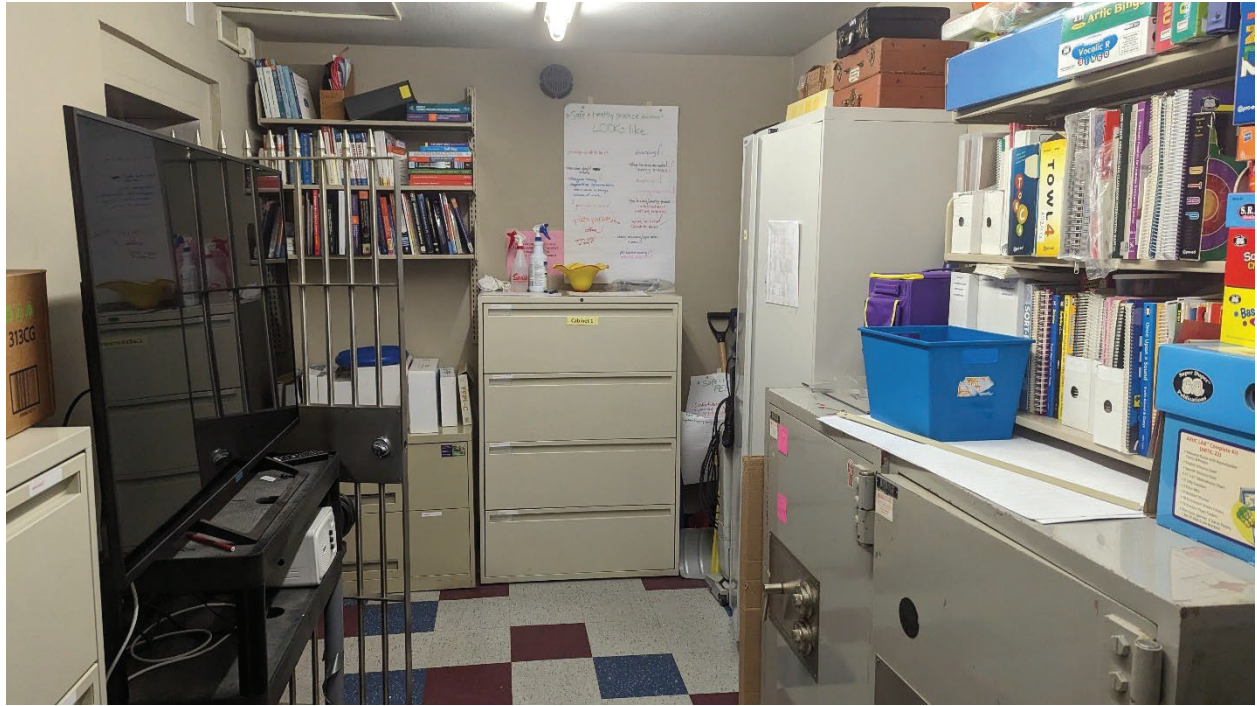
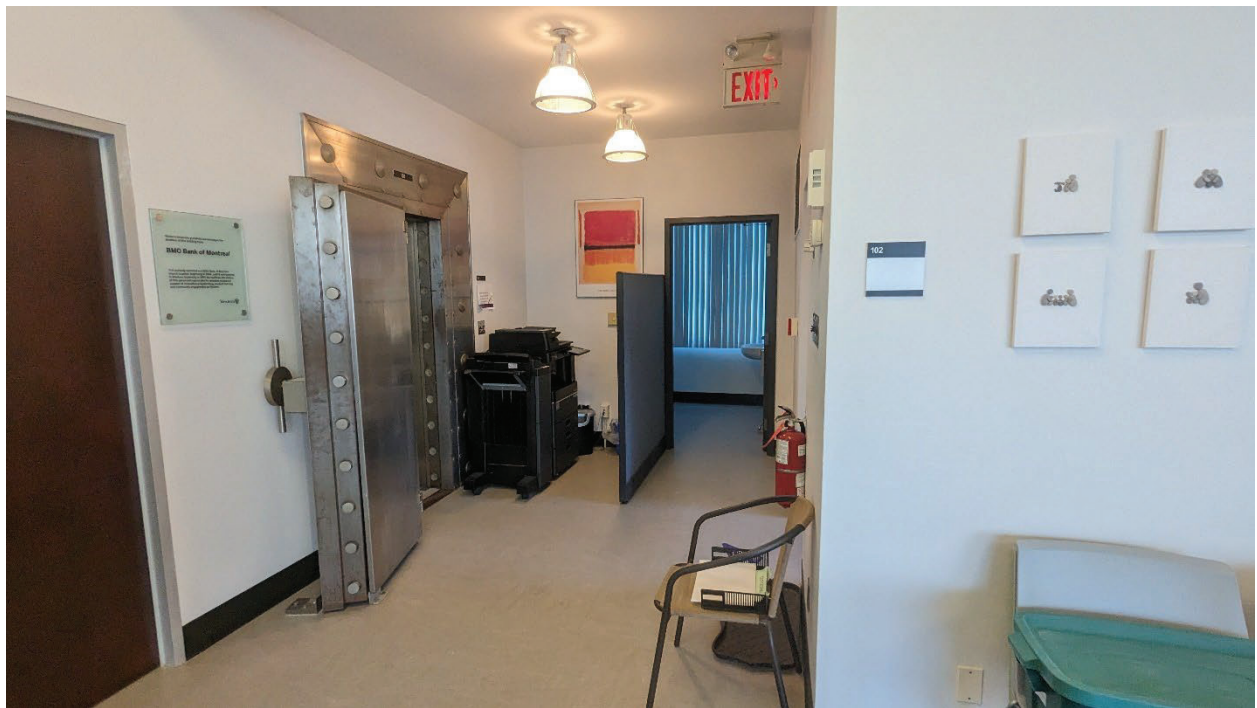
Photos 63 & 64: (above) View of office space on main floor; (below) View of vault off the primary room looking westwards (MHBC, 2023).

The building includes the main floor and basement (see **Photos 61-67**). The main floor is an open concept used as a general meeting area. There are some office rooms off of the primary room including a vault formerly used when the building operated as a bank (see **Photos 63 & 64**). The interior of the vestibule includes a stone wall which functioned partly as a vault for overnight deposits (see **Photo 65**). The basement includes several small meeting rooms.

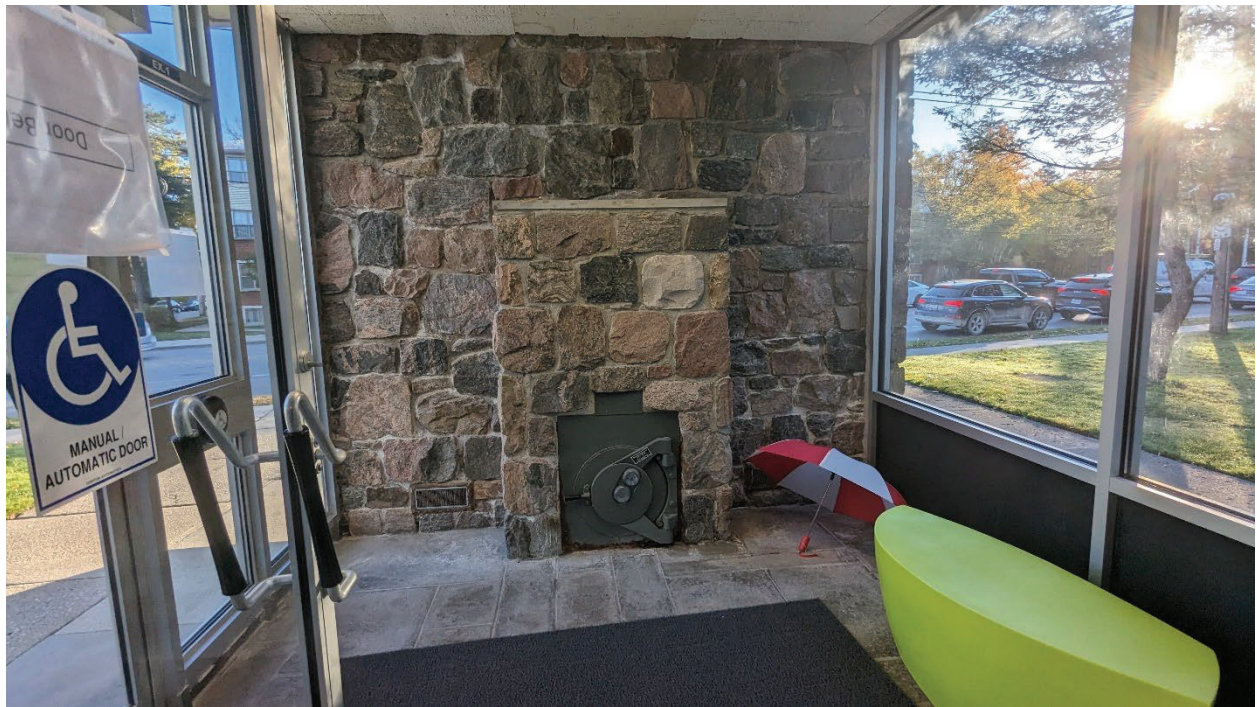
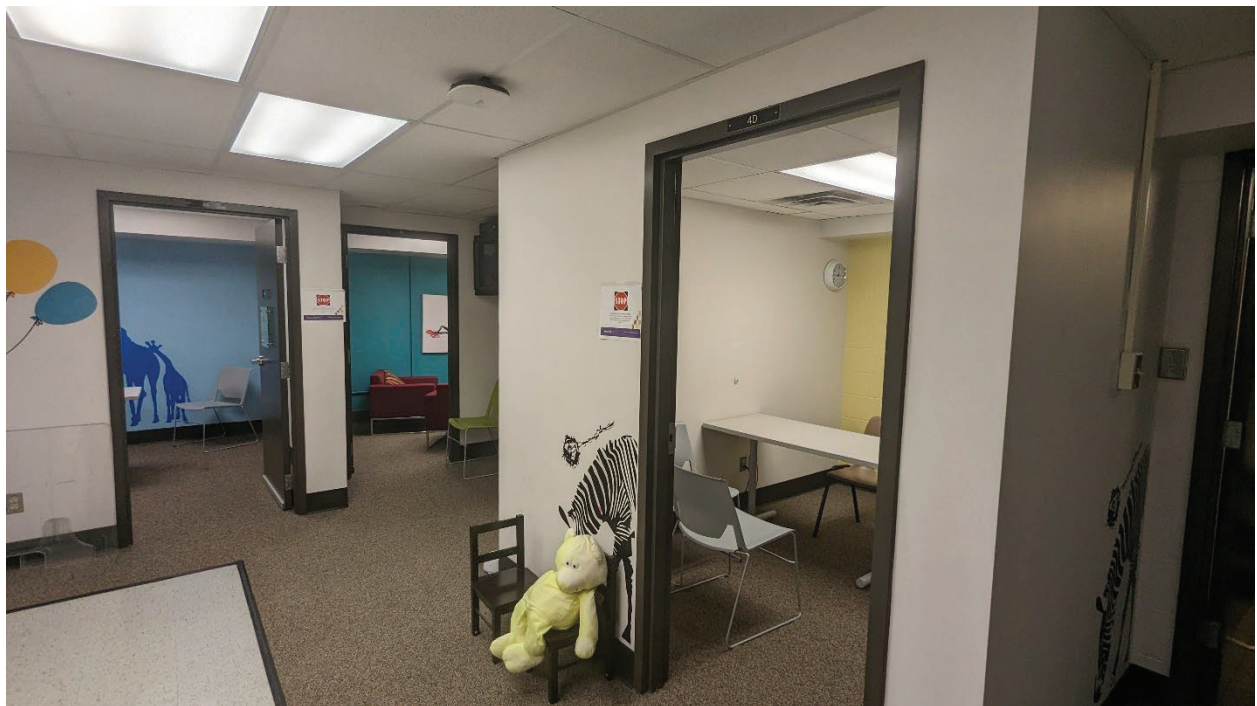
Photos 65 & 66: (above) View of stone feature wall in vestibule including vault; (below) View of office spaces in basement (MHBC, 2023).
