Talbot Village Phase 8

Subject Lands Status Report and Environmental Impact Study (SLSR/EIS)

3095 Bostwick Road, City of London, ON

MTE Consultants Inc.
123 St. George Street
London, ON N6A 3A1

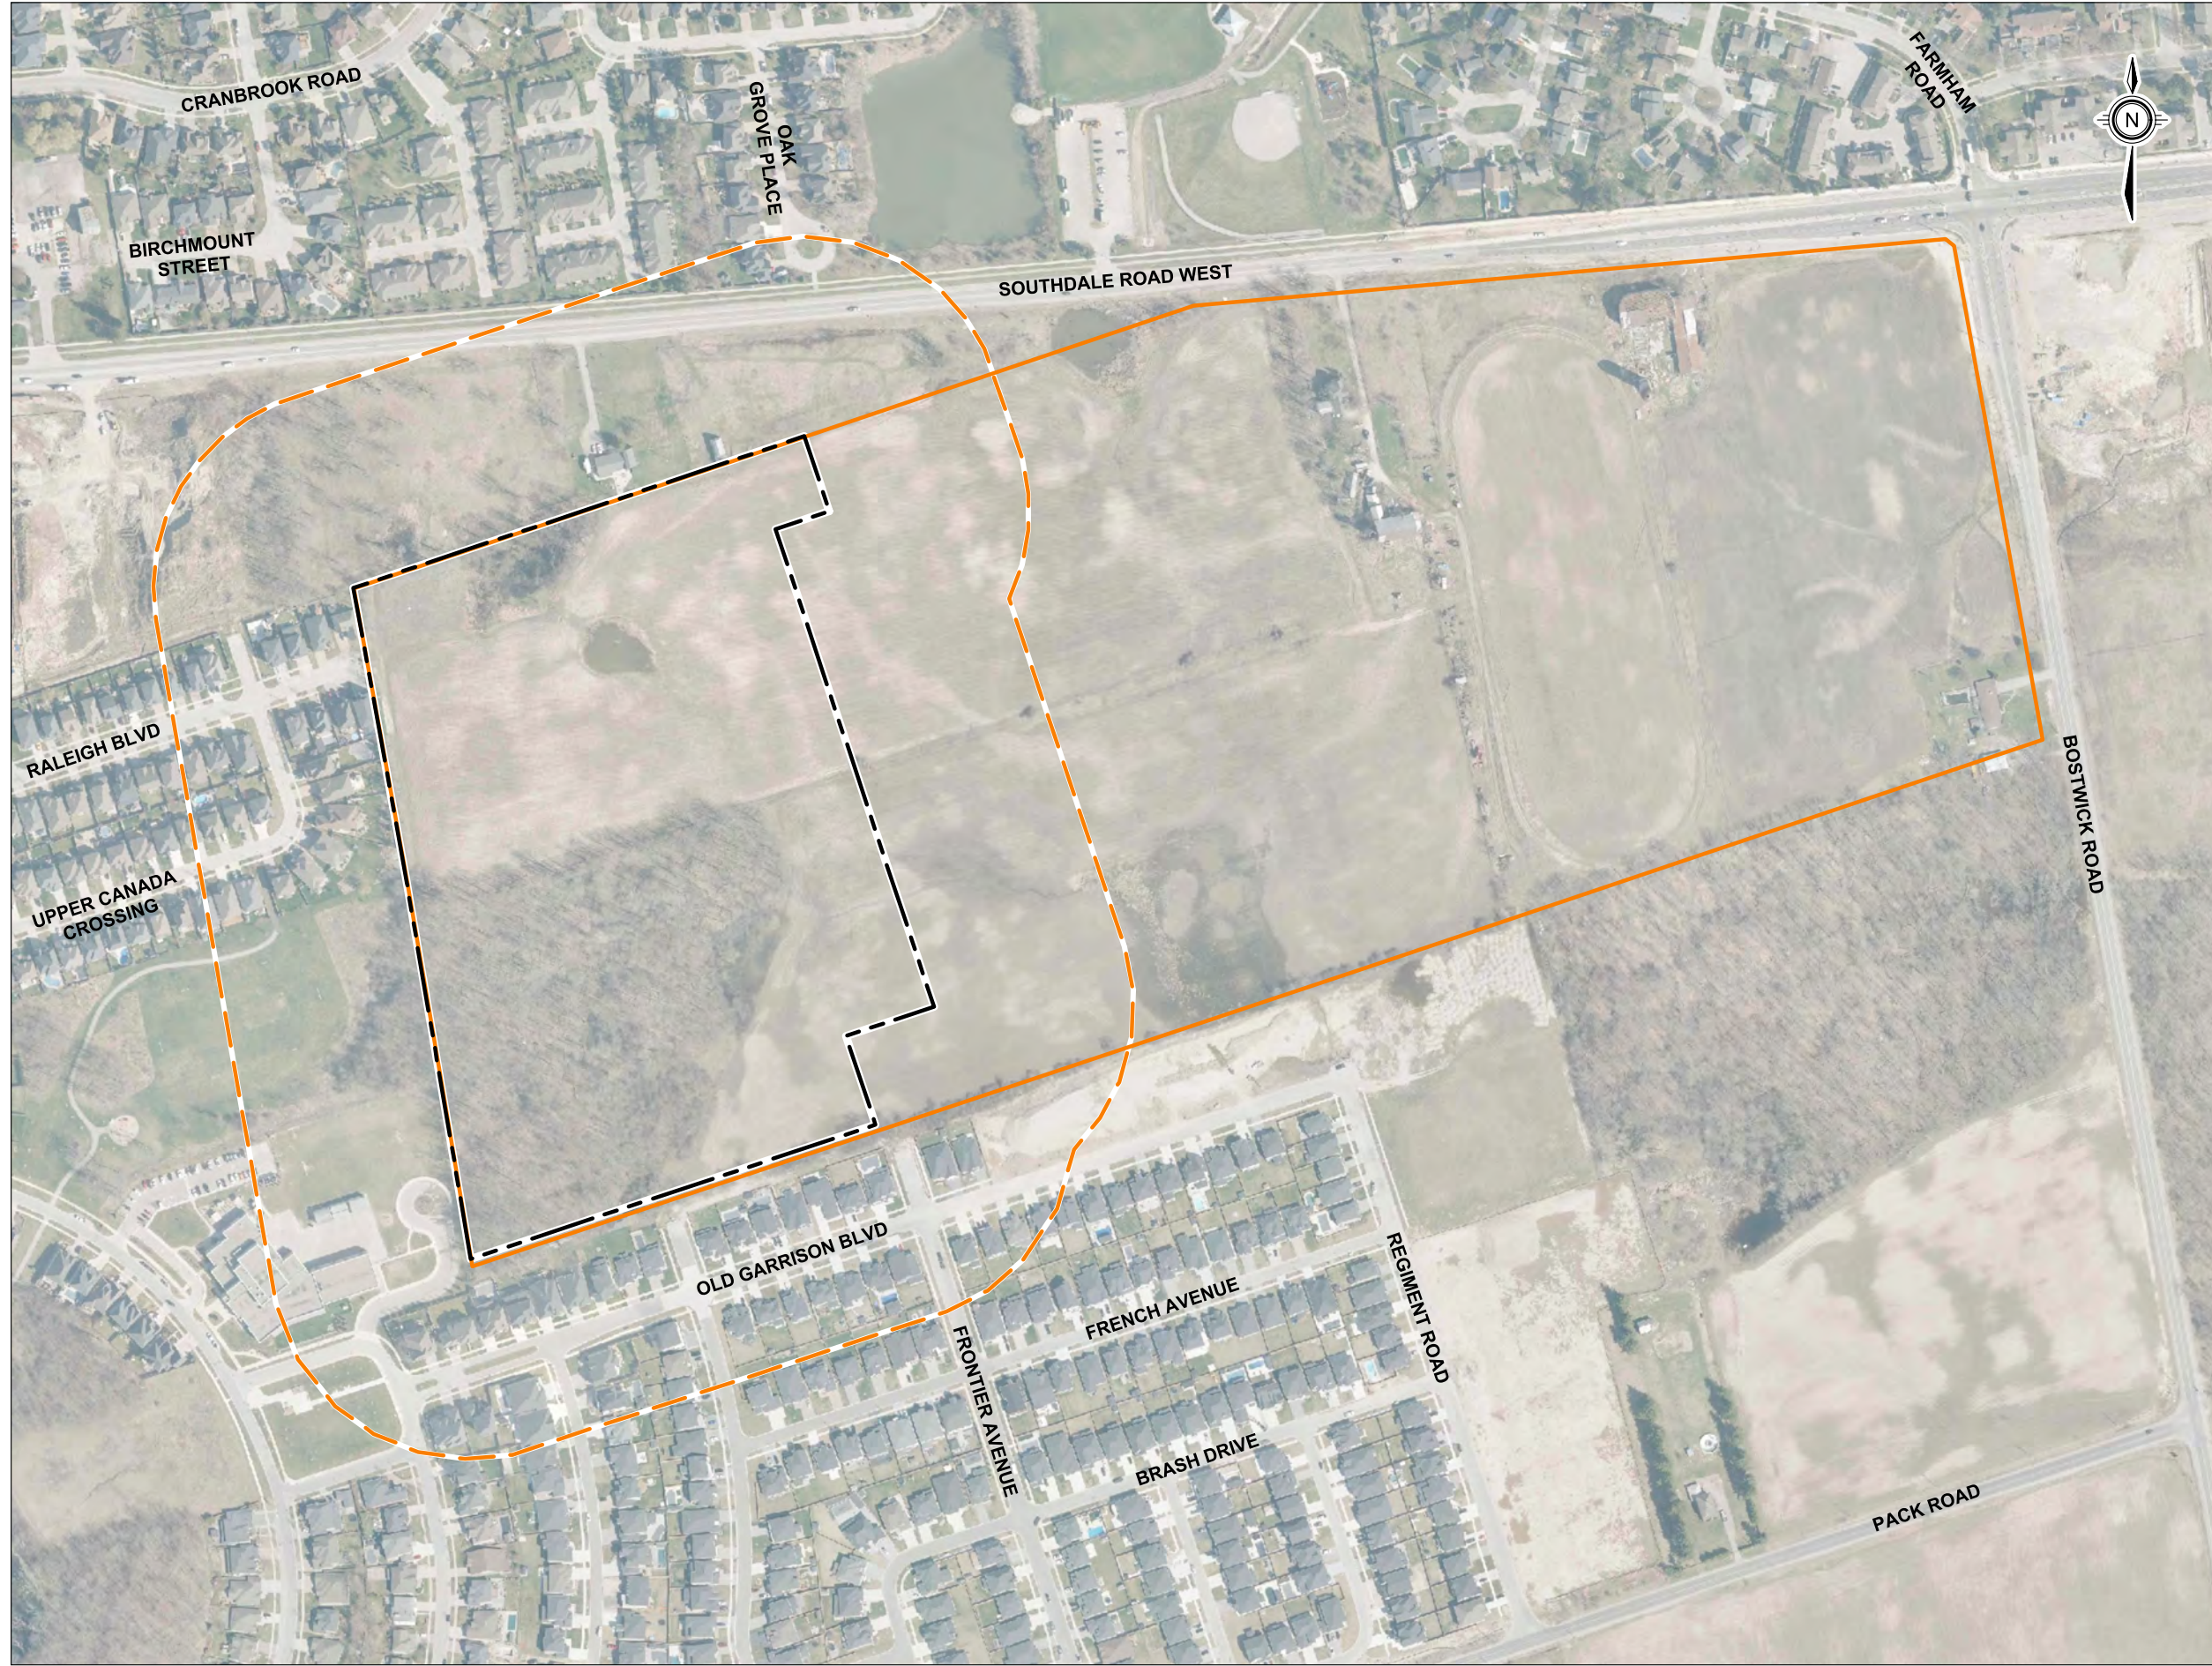
Drawn	DCH	Scale	1:4,000	Figure	1
Checked		Project No.	46666-100		
Date	2024-08-14	Rev No.	0

TITLE
PROJECT LOCATION

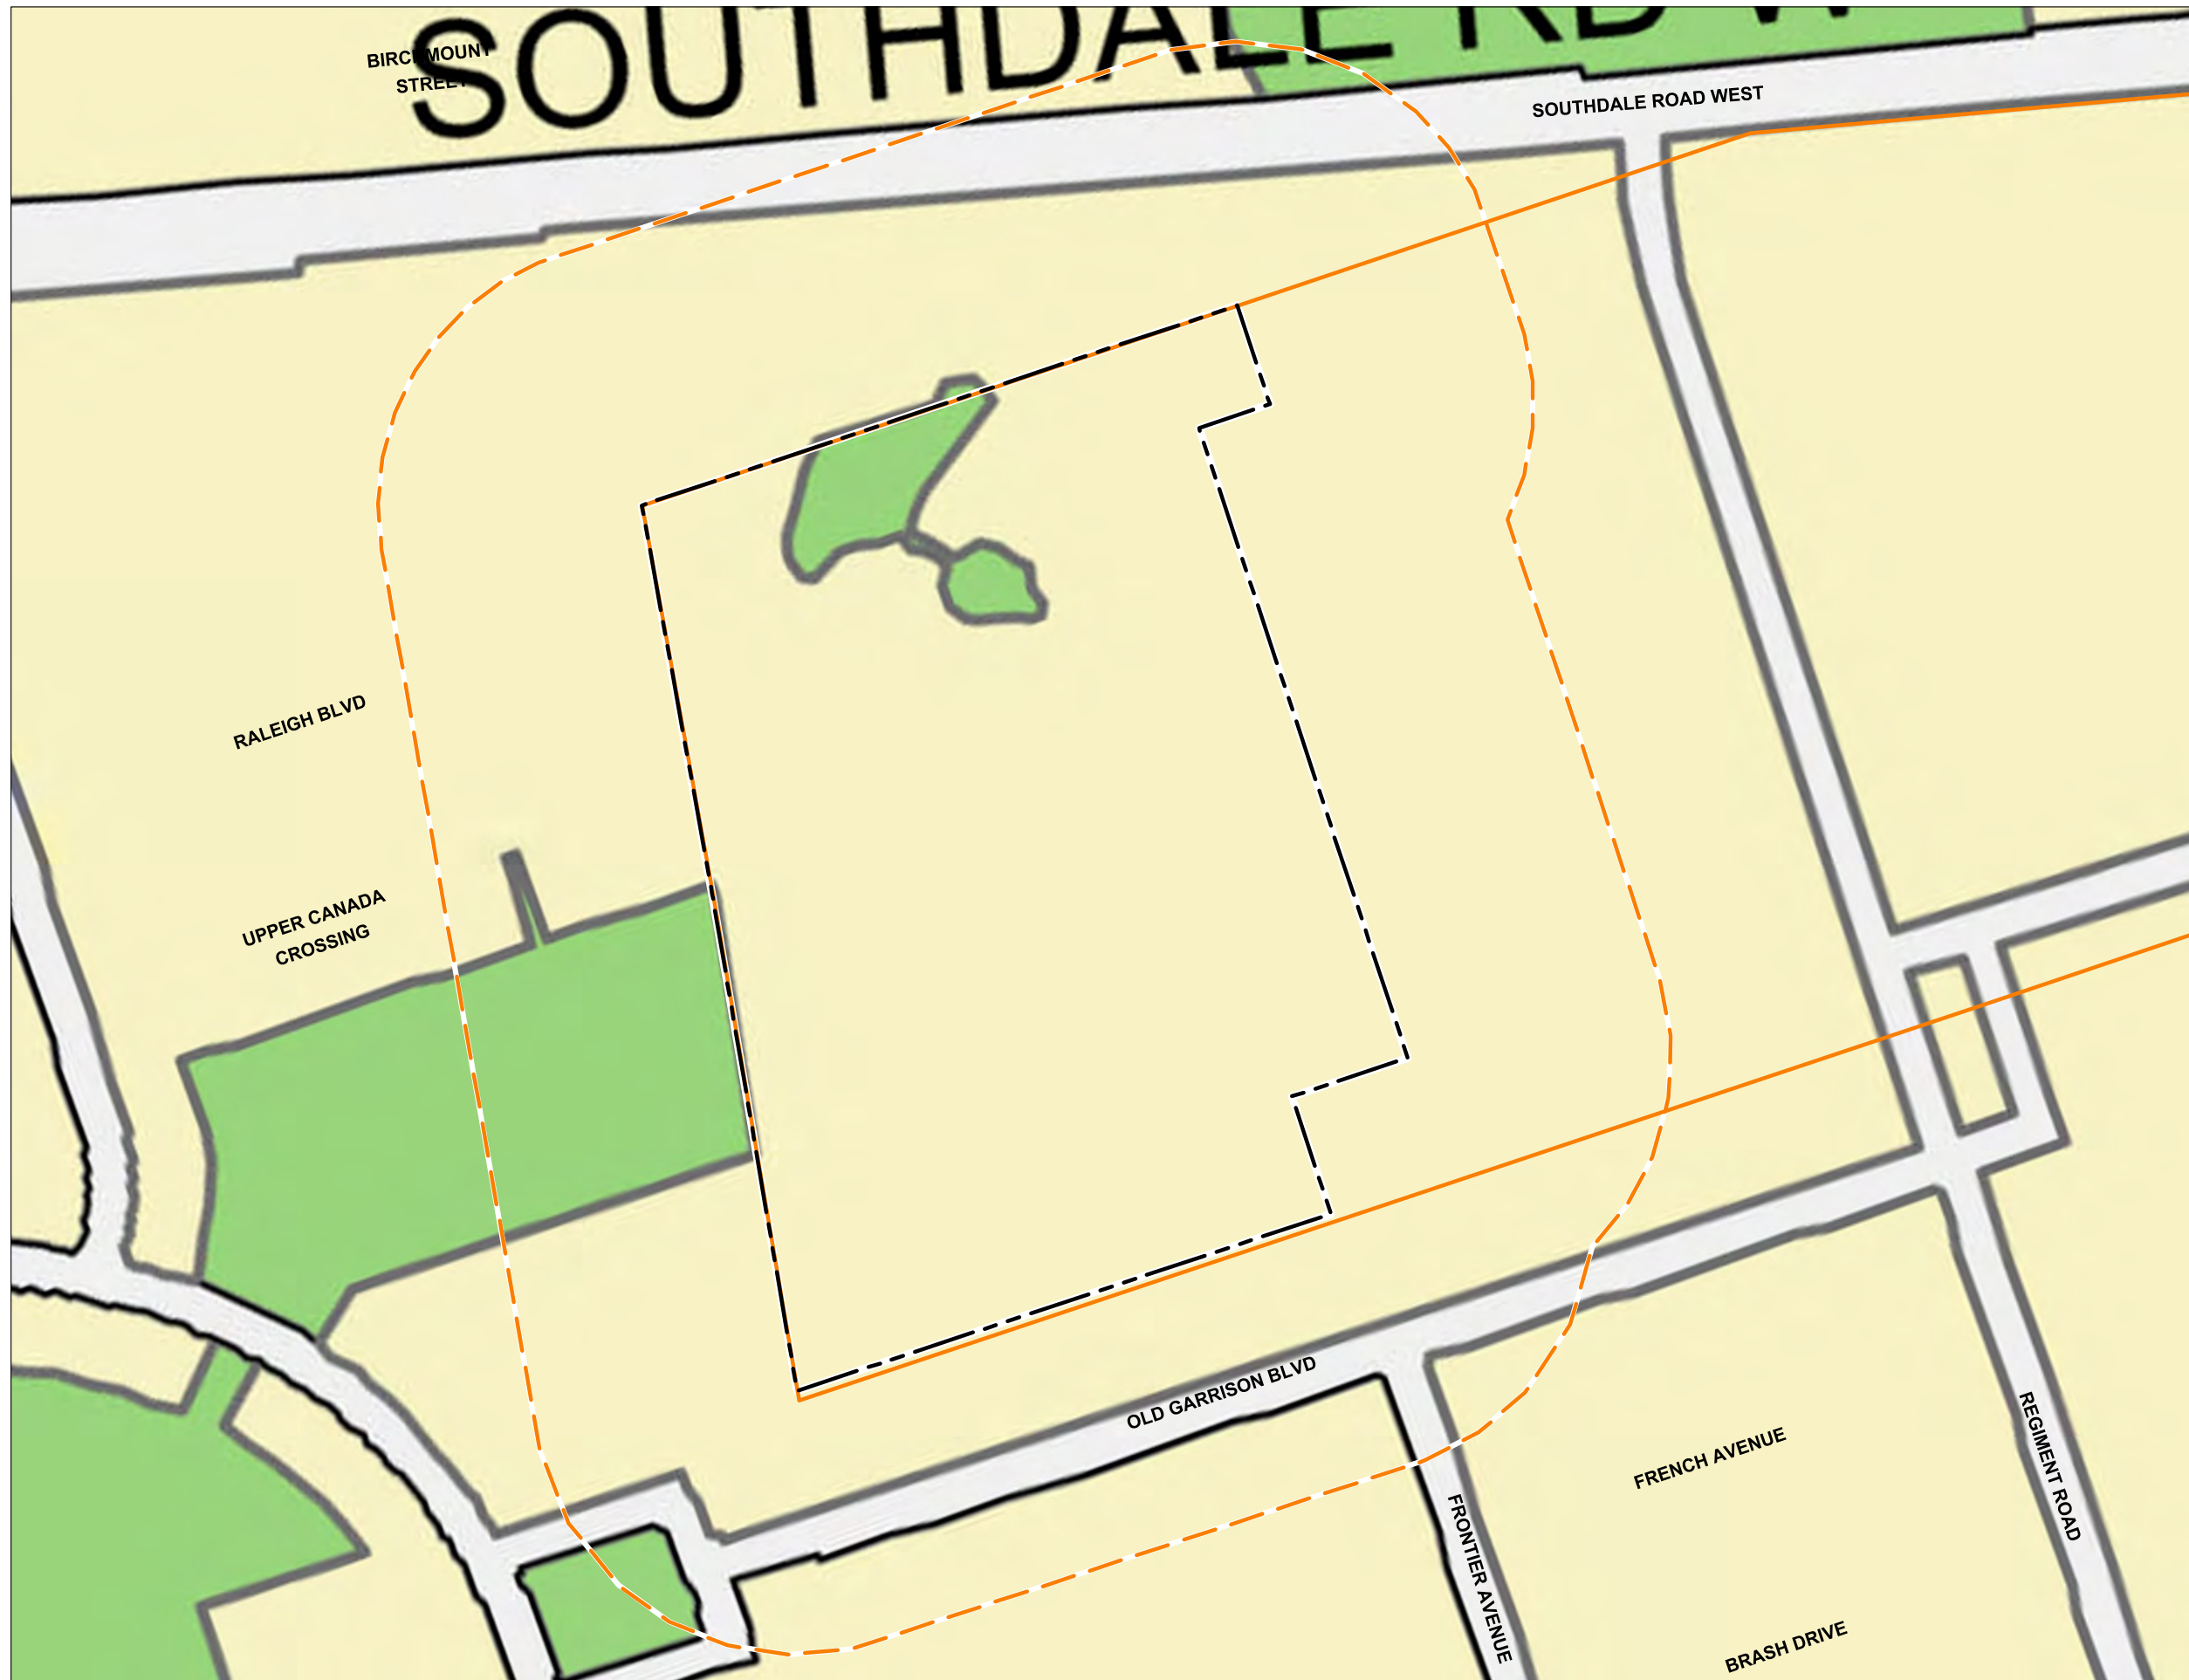
Drawn	DCH	Scale	1:3,000	Figure	2
Checked		Project No.	46666-100		
Date	2024-08-14	Rev No.	0

TITLE
PLACE TYPES
THE LONDON PLAN

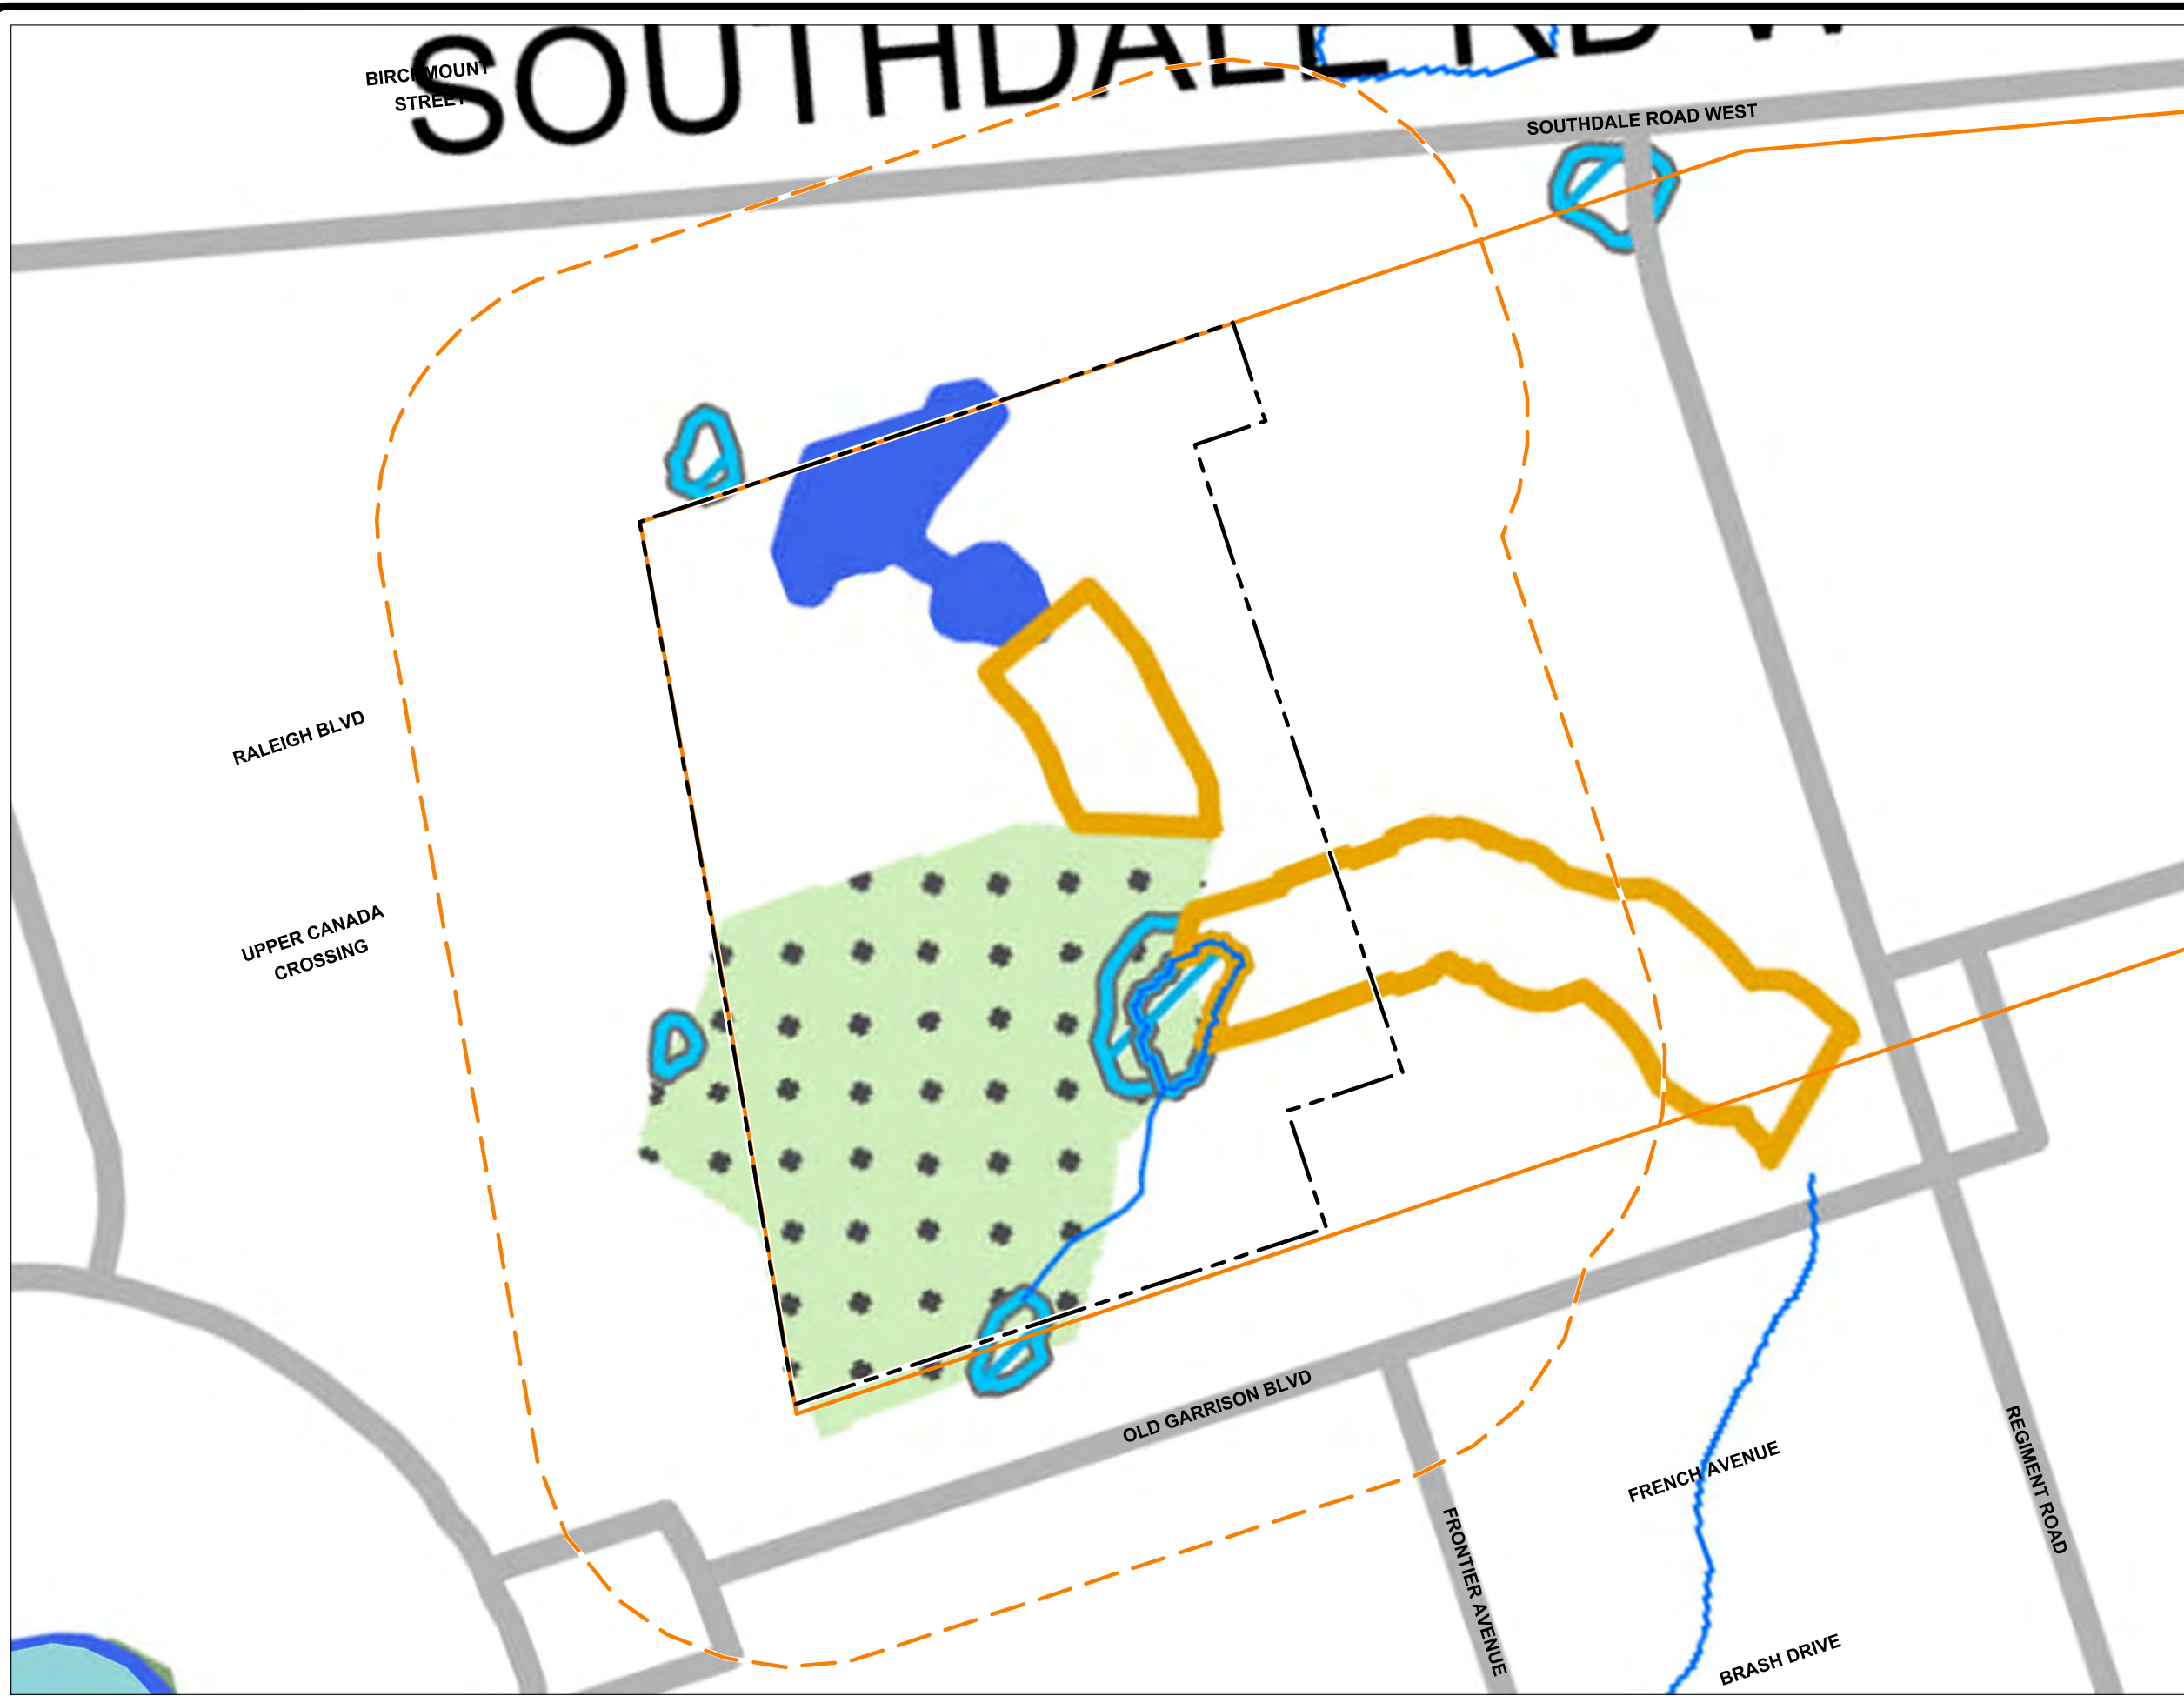
Drawn	DCH	Scale	1:3,000	Figure	3
Checked		Project No.	46666-100		
Date	2024-08-14	Rev No.	0

TITLE
**NATURAL HERITAGE
 THE LONDON PLAN**

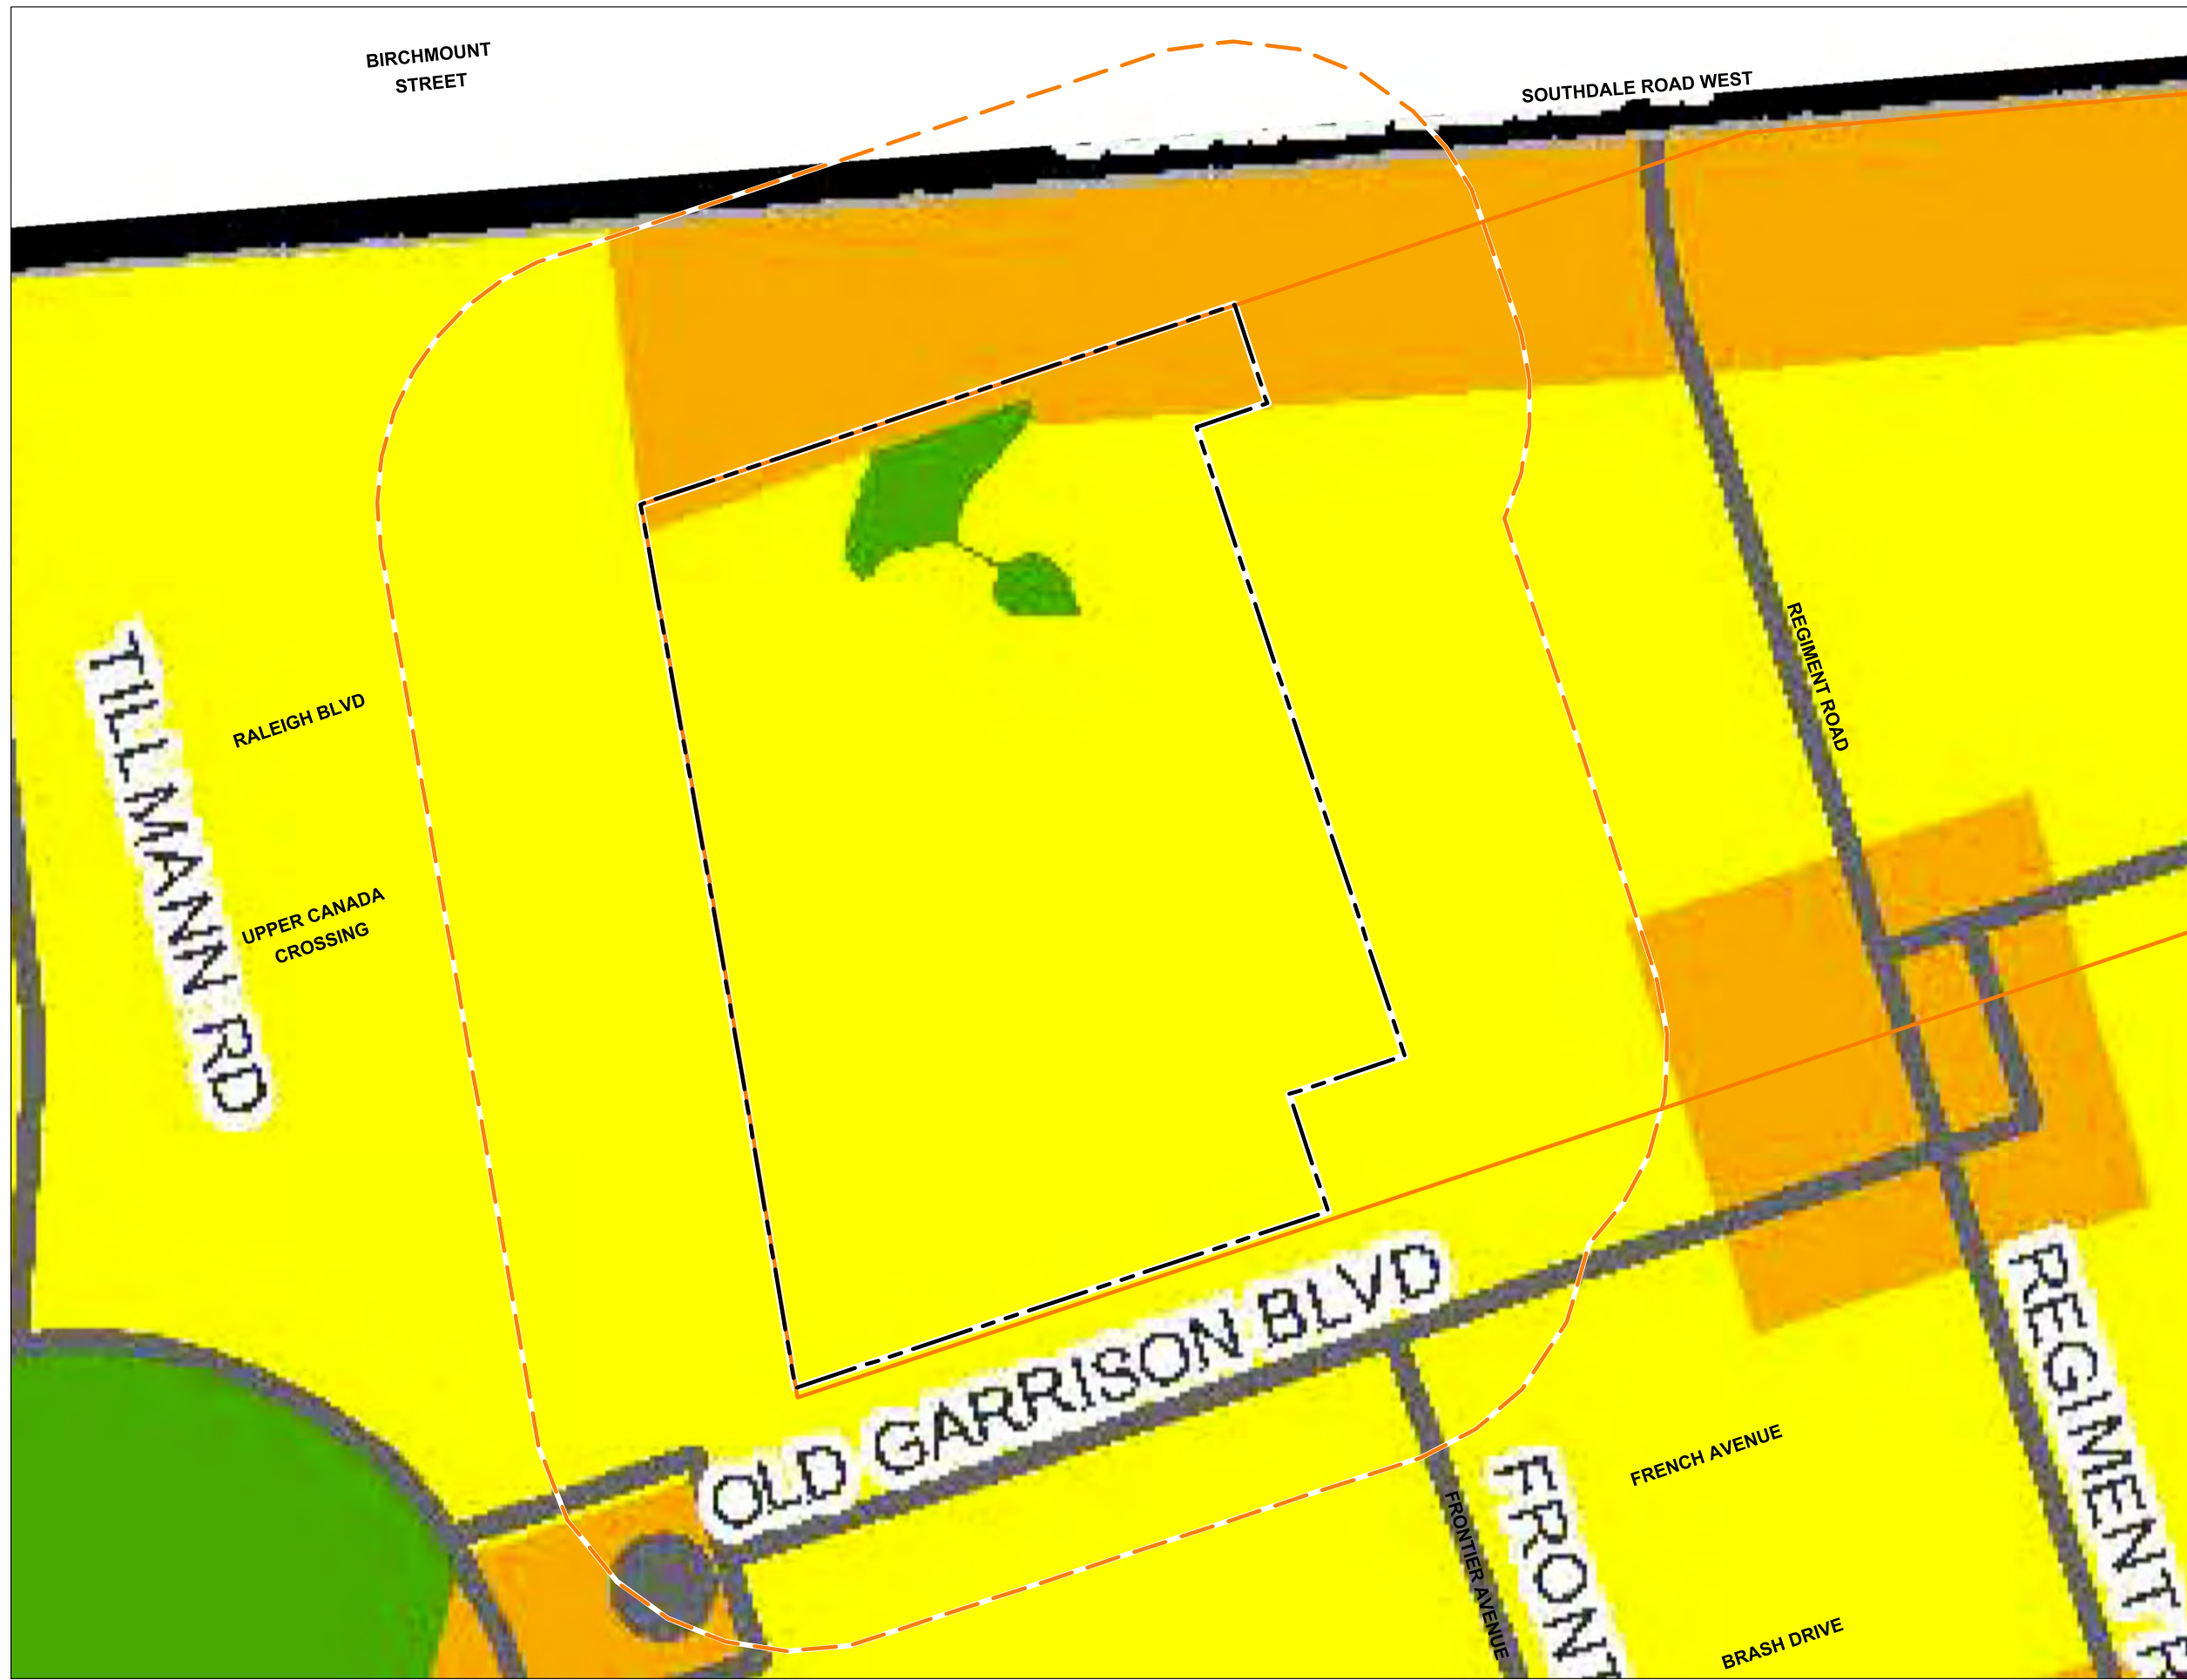
Drawn	DCH	Scale	1:3,000	Figure	4
Checked		Project No.	46666-100		
Date	2024-08-14	Rev No.	0

TITLE
LAND USE
SOUTHWEST AREA SECONDARY PLAN

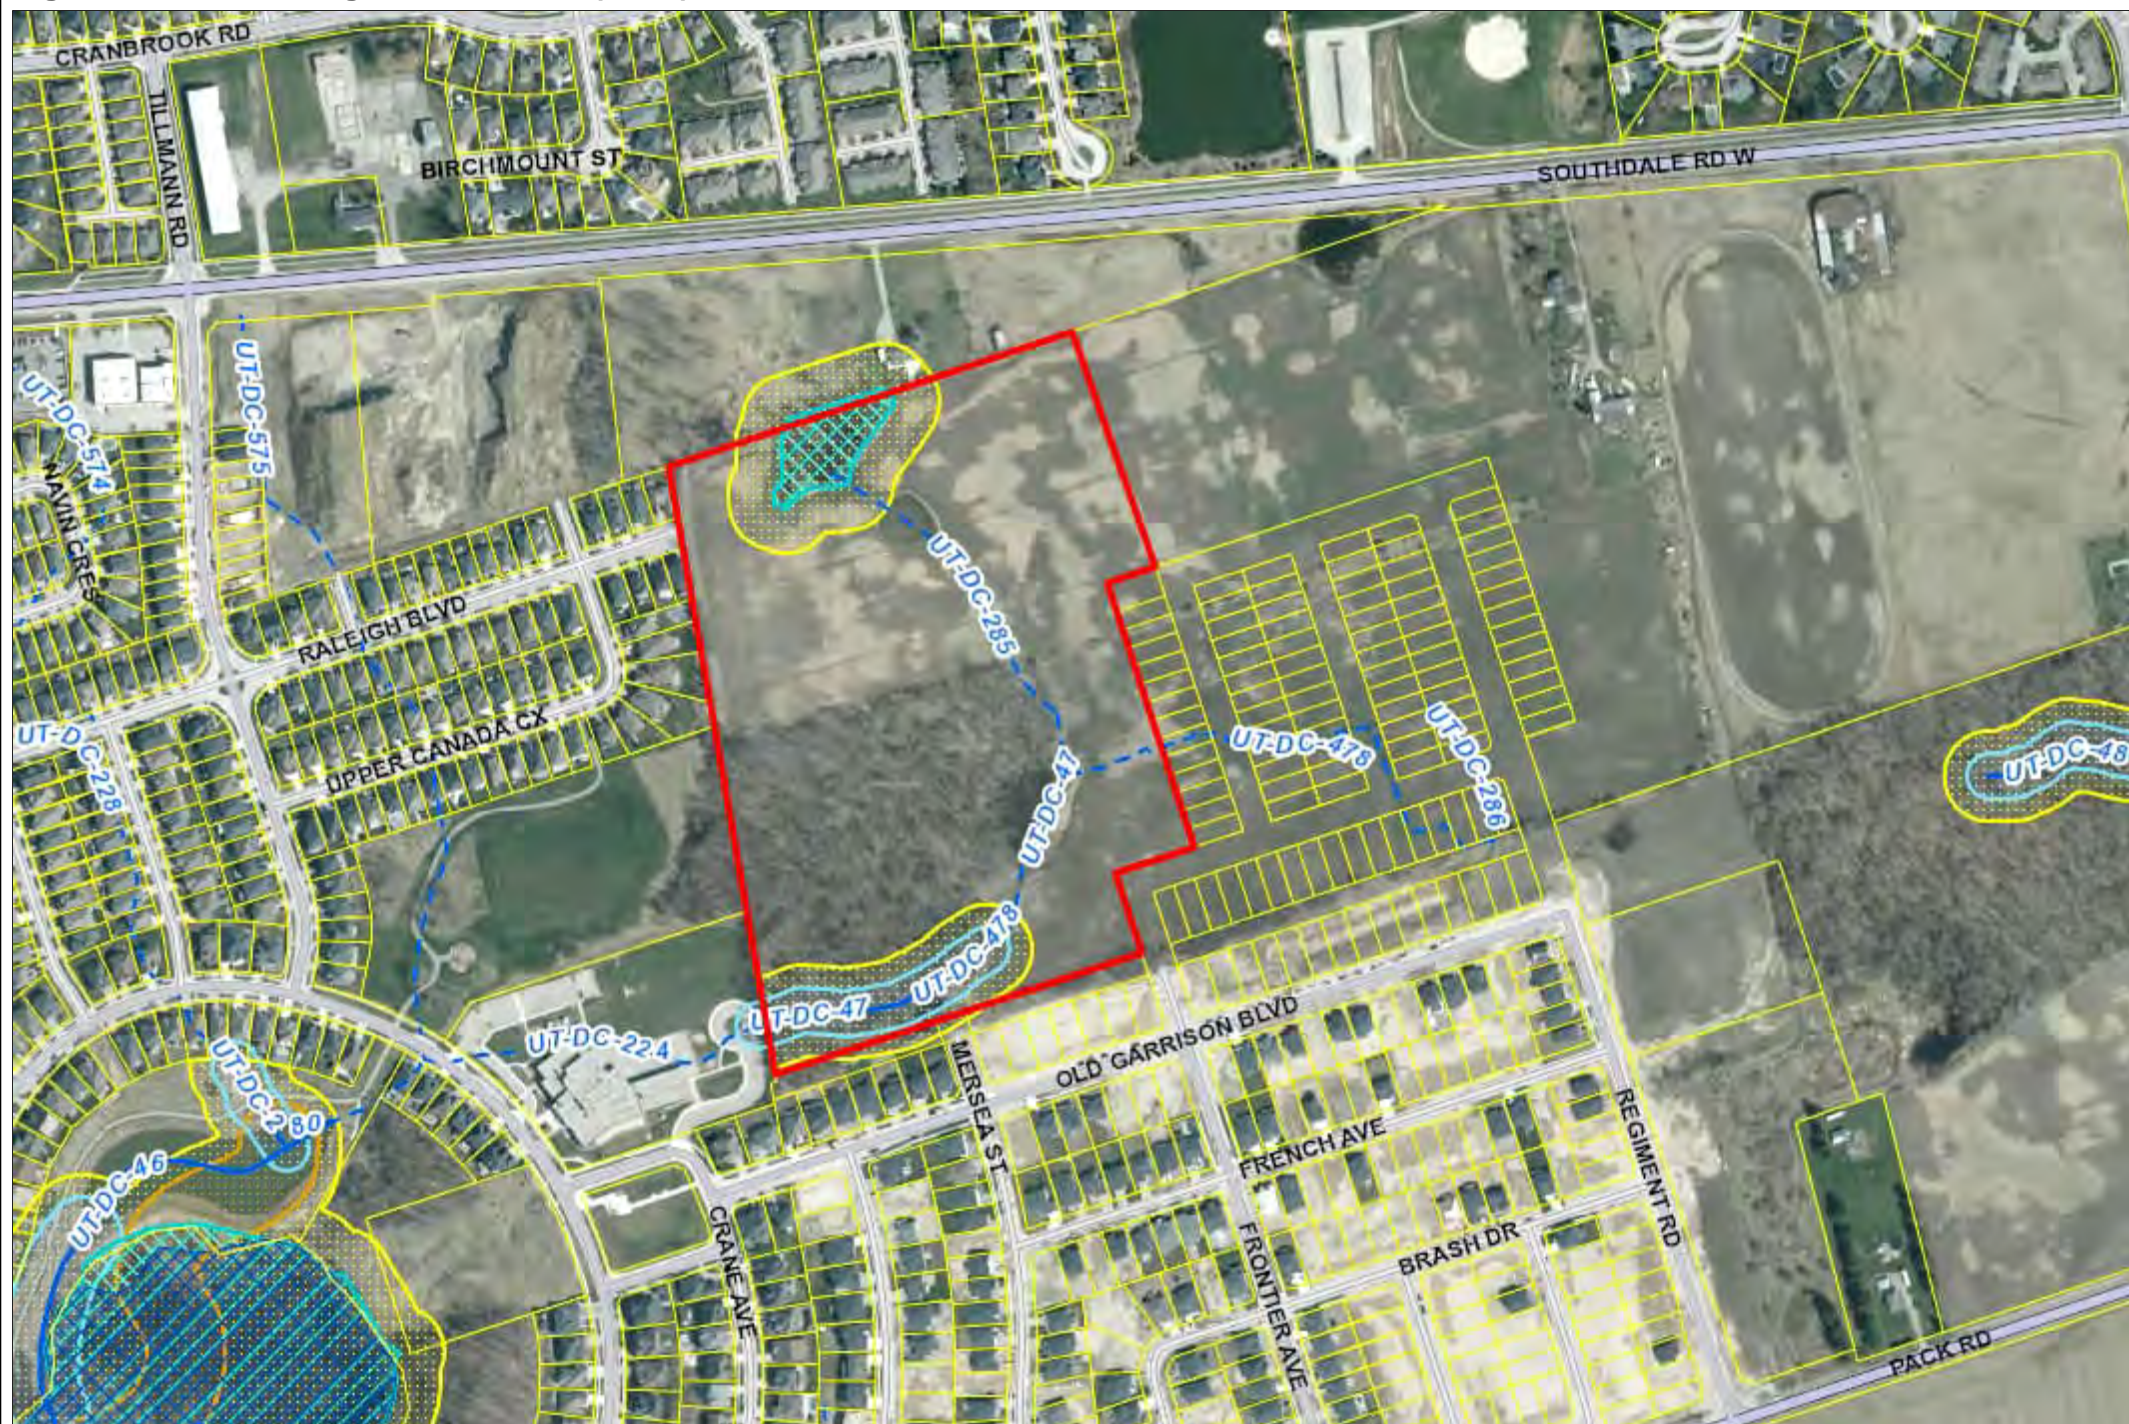
Figure 6: UTRCA Regulation Areas (2024)

Regulation under s.28 of the *Conservation Authorities Act*
Prohibited Activities, Exemptions and Permits.
O. Reg. 41/24.

As per UTRCA regulation mapping, the UTRCA considers the northern wetlands and wetland features with associated drainage features within the existing woodland to be within the UTRCA regulation area (**Figure 6**). The south surface drainage feature is shown as a flooding hazard although development has proceeded, and this flow does not appear to be present. This drainage feature is assumed to now be subsurface in the storm sewer system.

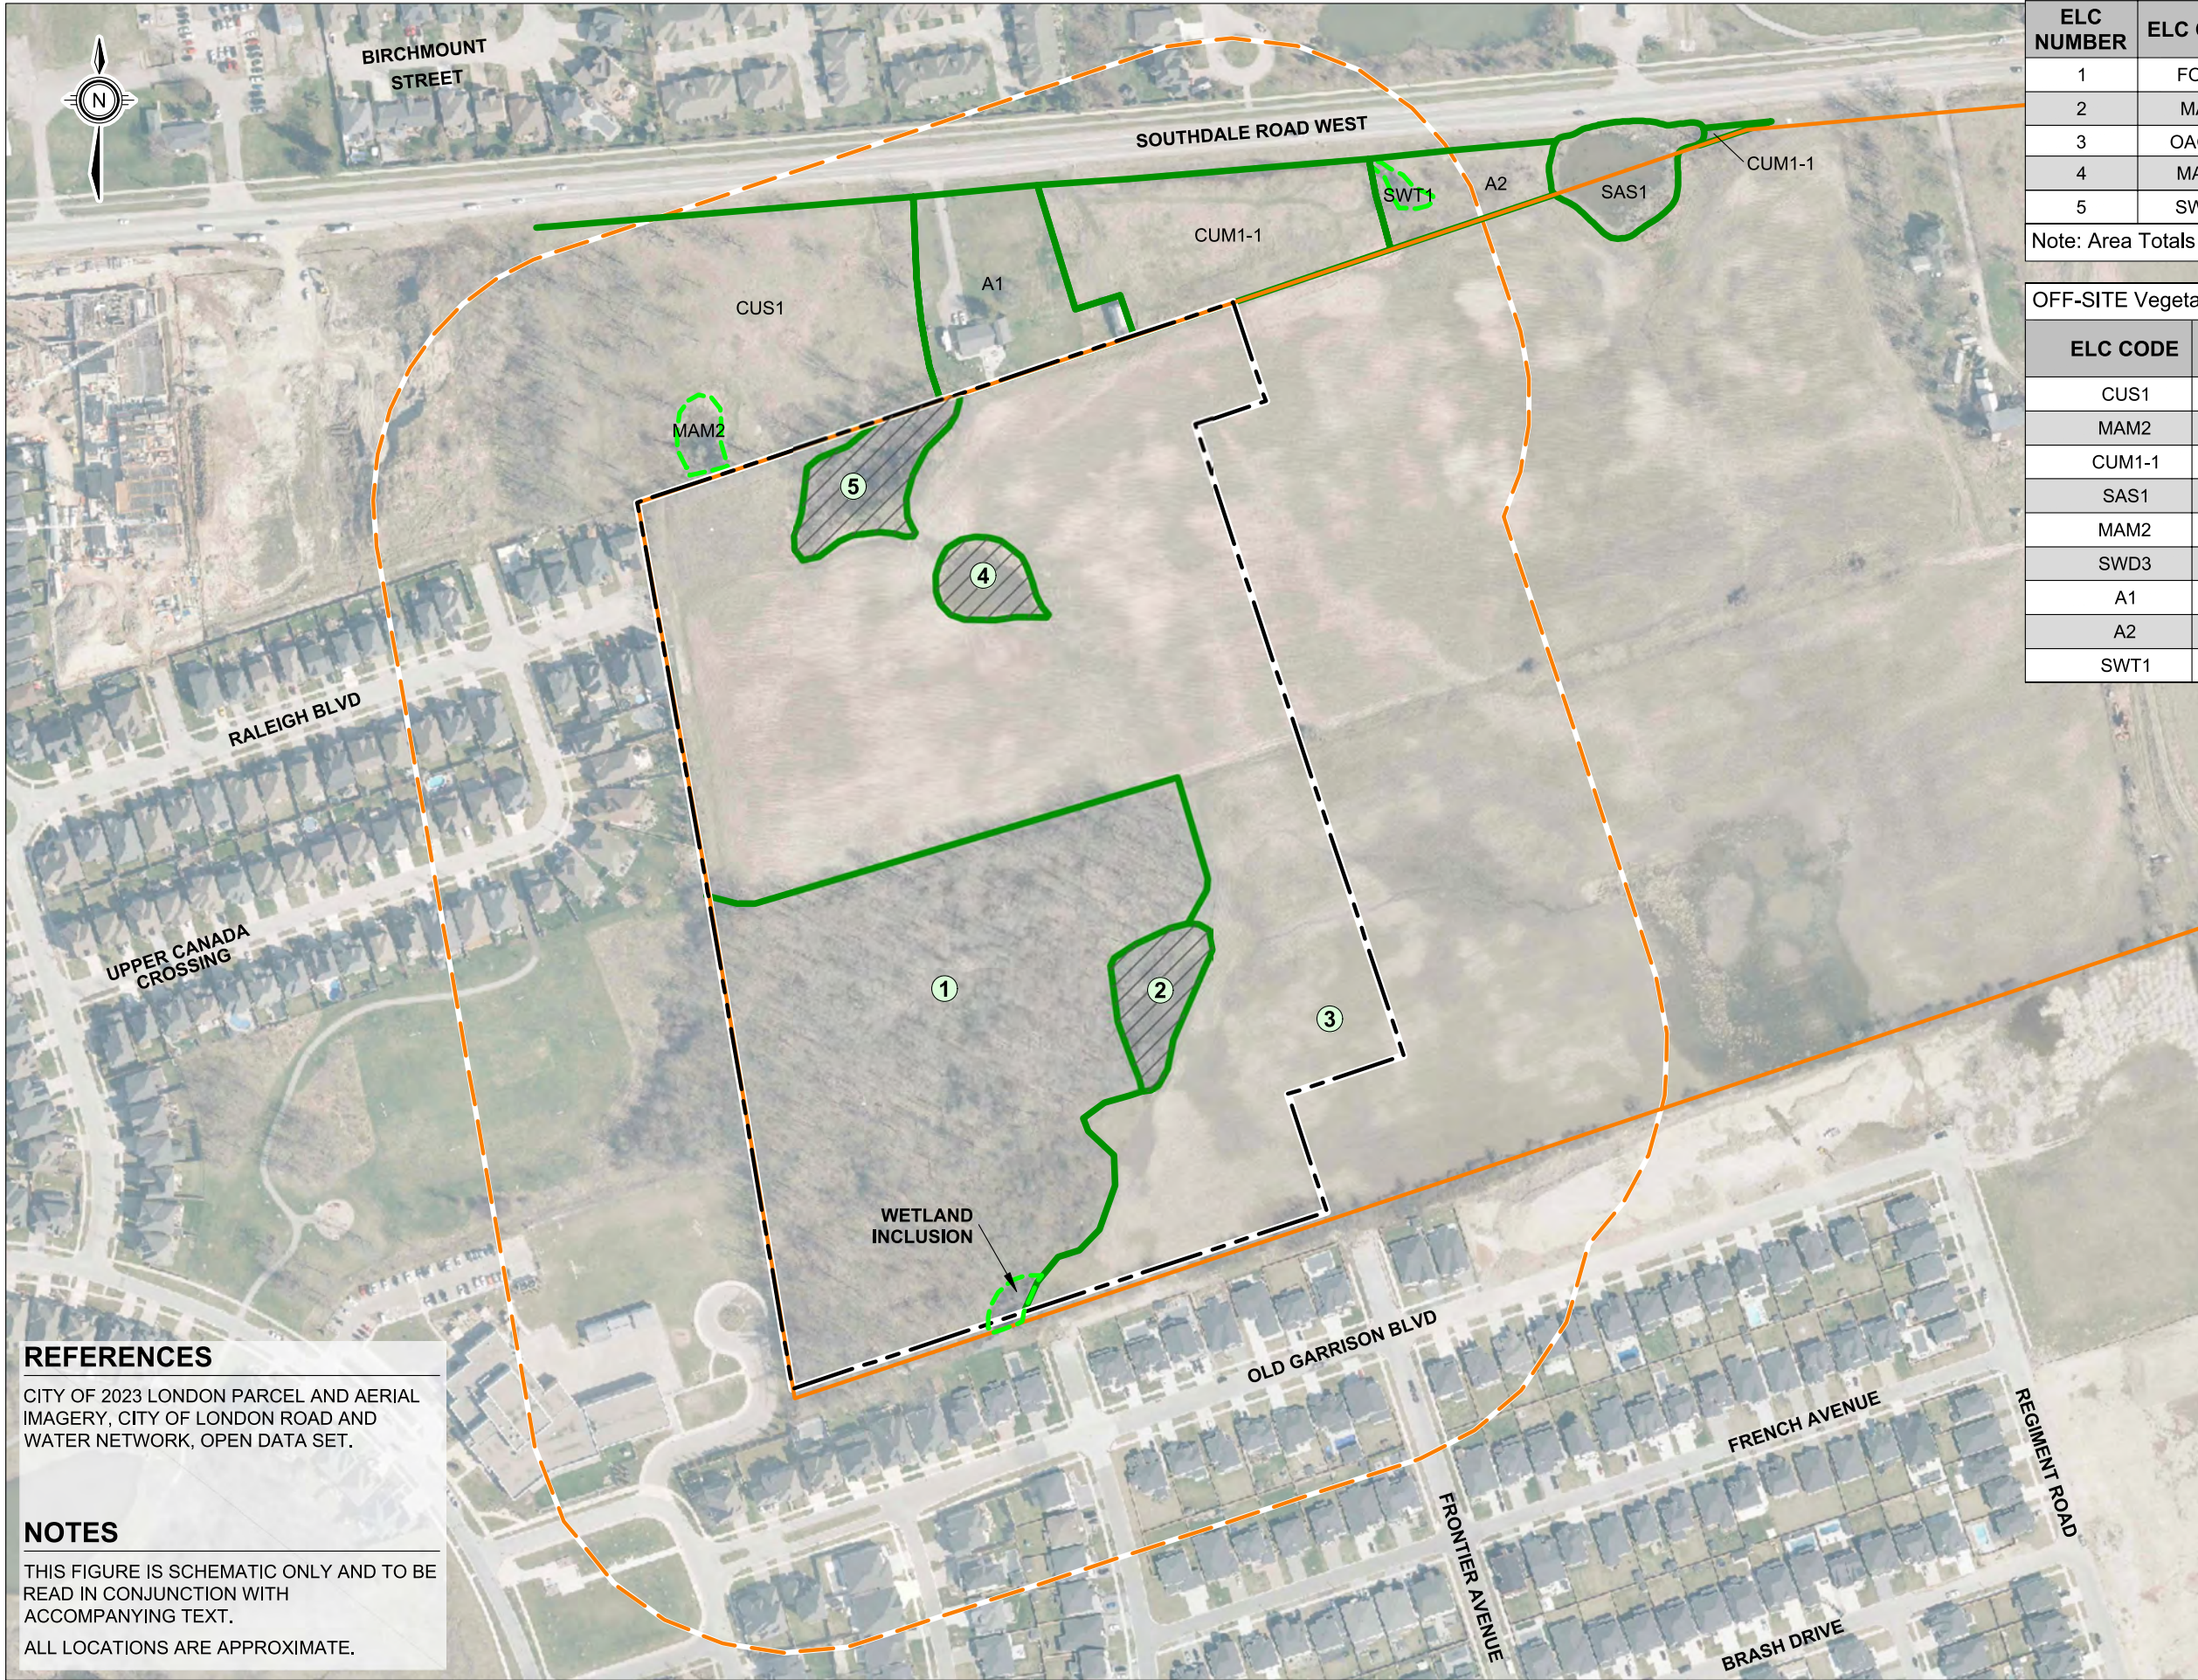
Drawn DCH	Scale 1:3,000	Figure 7
Checked	Project No. 46666-100	
Date 2024-08-14	Rev No. 0

ELC NUMBER	ELC CODE	Description
1	FOD7	Fresh-Moist Deciduous Lowland (3.86ha)
2	MAM	Mineral Meadow Marsh (0.21ha)
3	OAGM1	Annual Row Crops (7.14ha)
4	MAS2	Mineral Shallow Marsh (0.14ha)
5	SWD3	Maple Mineral Deciduous Swamp (0.27ha)

TITLE
VEGETATION COMMUNITIES

Polygon 1 is a Fresh-Moist Deciduous Lowland (FOD7) community dominated by American Basswood and Black Walnut in the canopy with Sugar Maple and Northern Red Oak to a lesser extent. Hawthorn species are dominant in the understorey along with Common Buckthorn, Gray Dogwood, and Tartarian Honeysuckle. Garlic Mustard, White Avens, Black Raspberry, and Common Burdock are frequently found in the ground layer. This community has a small (~0.03 ha) wetland inclusion in the south. Surface water was observed in parts of the woodland during spring freshet in 2021 and 2024 (EXP, 2024a).

Polygon 3 is active agricultural lands surrounding Polygons 1, 2, 4 and 5. A portion of Polygon 3, to the east of the existing woodland, was previously a Dry-Moist old Field Meadow (CUM1-1) used for pasture; however, it has been annexed into agricultural lands and has been farmed with rotational crops. A portion of the agricultural lands to the east has been developed as a part of Phase 7 of the residential subdivision.

Polygon 4 is a Mineral Shallow Marsh (MAS2) located to the north of the woodland within the agricultural field, south of Polygon 5. Polygon 4 is dominated by Narrow-leaved Cattails. A downward gradient is present, indicating surface infiltrating conditions (EXP, 2021). Polygon 4 was considered the same wetland unit as Polygon 5 during the original OWES assessment, although it should be noted that the two sections are not connected by wetland habitat (<50% wetland plant cover), and they do not have a permanent surface water connection.
