Talbot Village Phase 8

Subject Lands Status Report and Environmental Impact Study (SLSR/EIS)

3095 Bostwick Road, City of London, ON

MTE Consultants Inc.
123 St. George Street
London, ON N6A 3A1

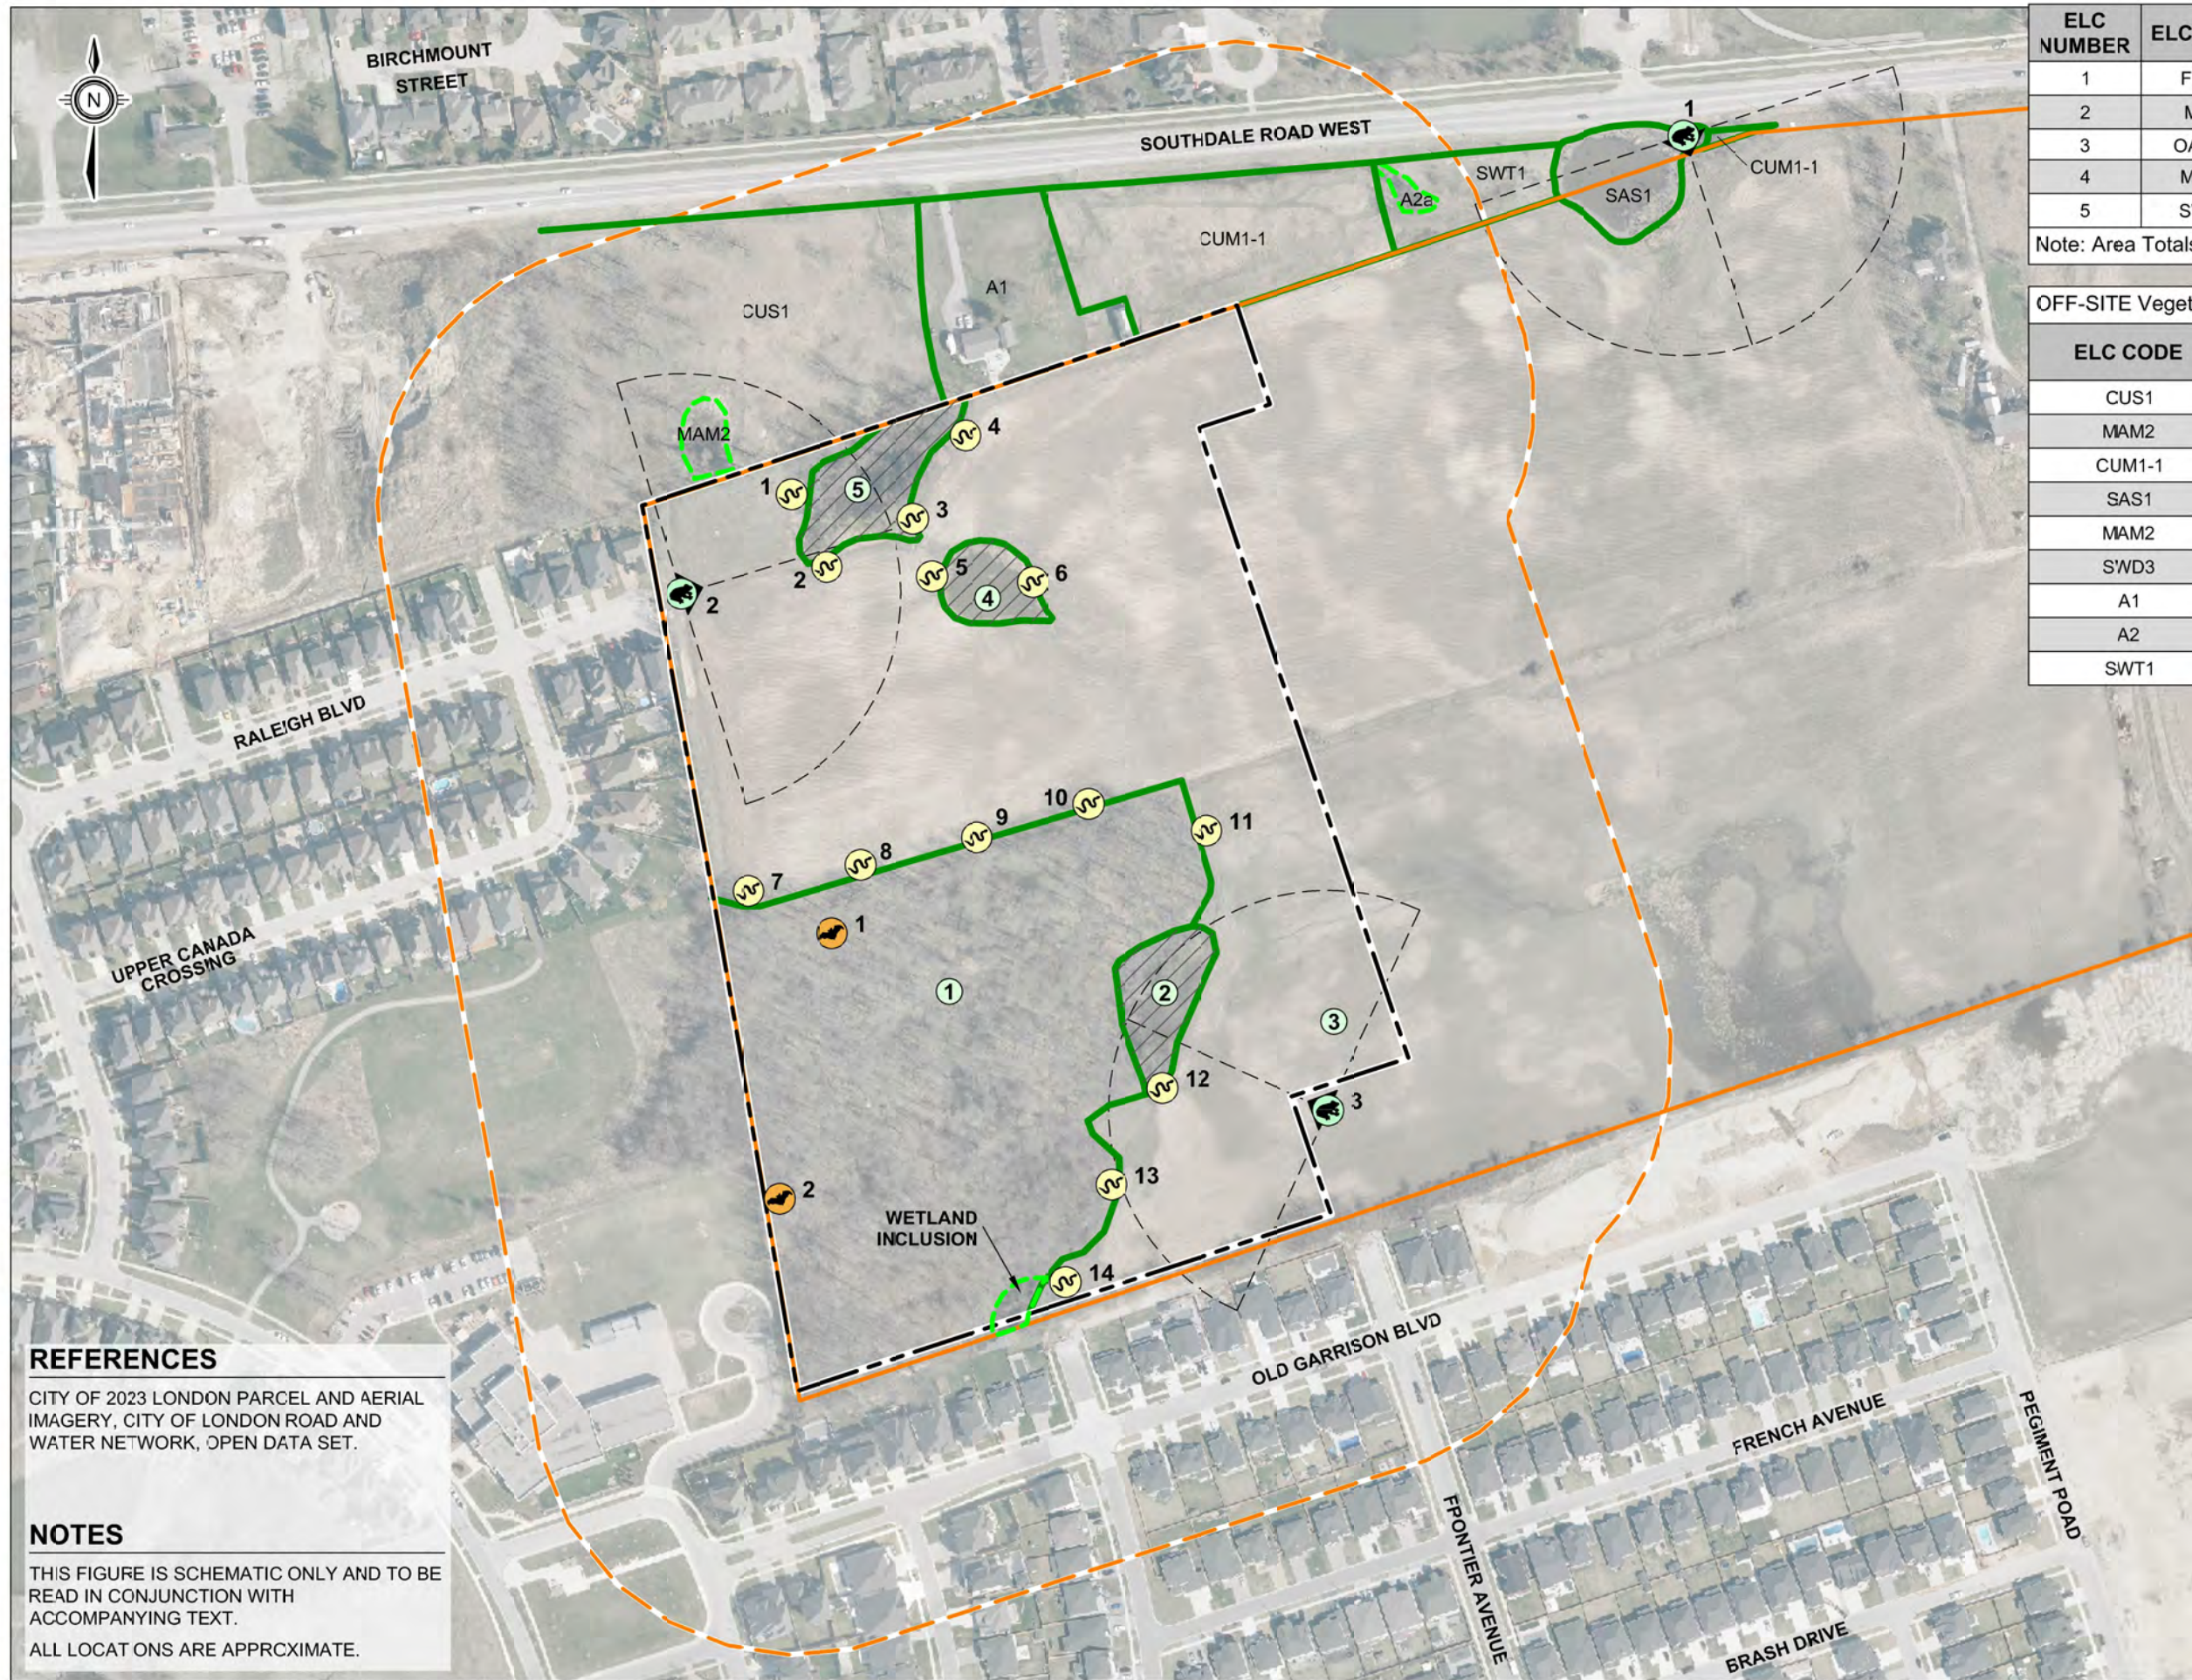
Drawn	DCH	Scale	1:3,000	Figure	8
Checked		Project No.	46666-100		
Date	2024-08-14	Rev No.	0

TITLE
SURVEY LOCATIONS

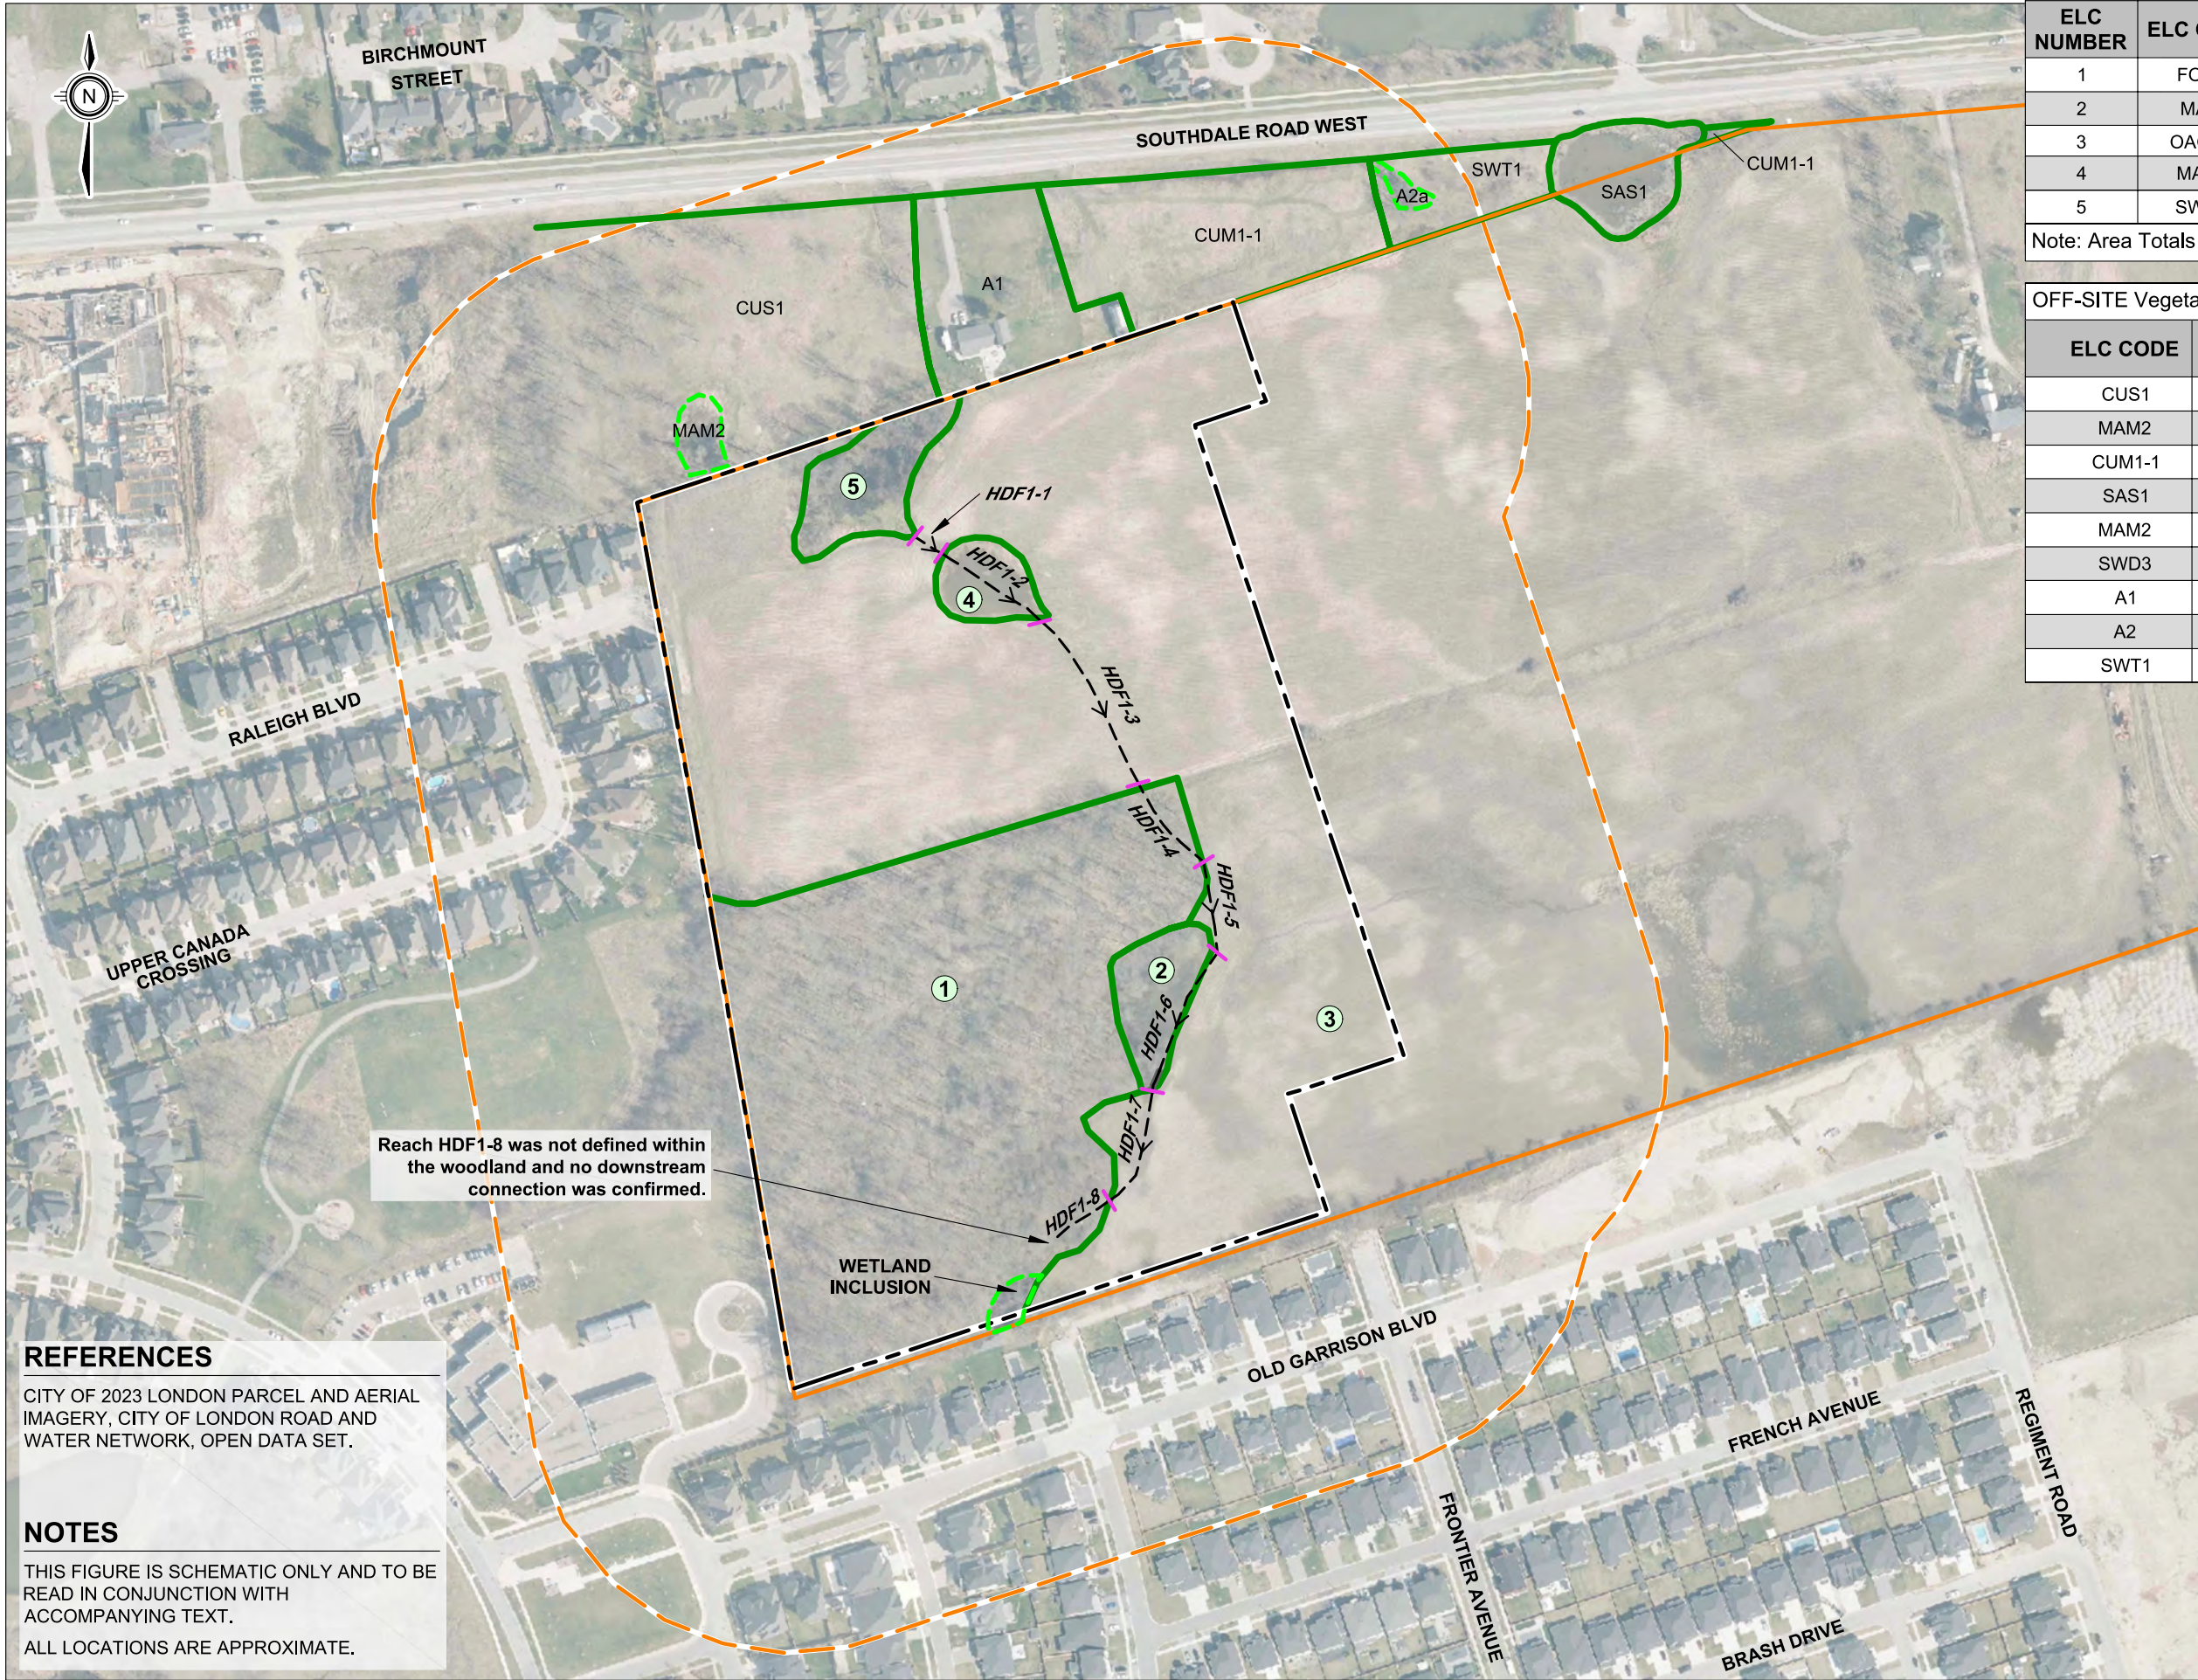
ELC NUMBER	ELC CODE	Description
1	FOD7	Fresh-Moist Deciduous Lowland (3.86ha)
2	MAM	Mineral Meadow Marsh (0.21ha)
3	OAGM1	Annual Row Crops (7.14ha)
4	MAS2	Mineral Shallow Marsh (0.14ha)
5	SWD3	Maple Mineral Deciduous Swamp (0.27ha)

Note: Area Totals (ha) are within the Subject Lands only.

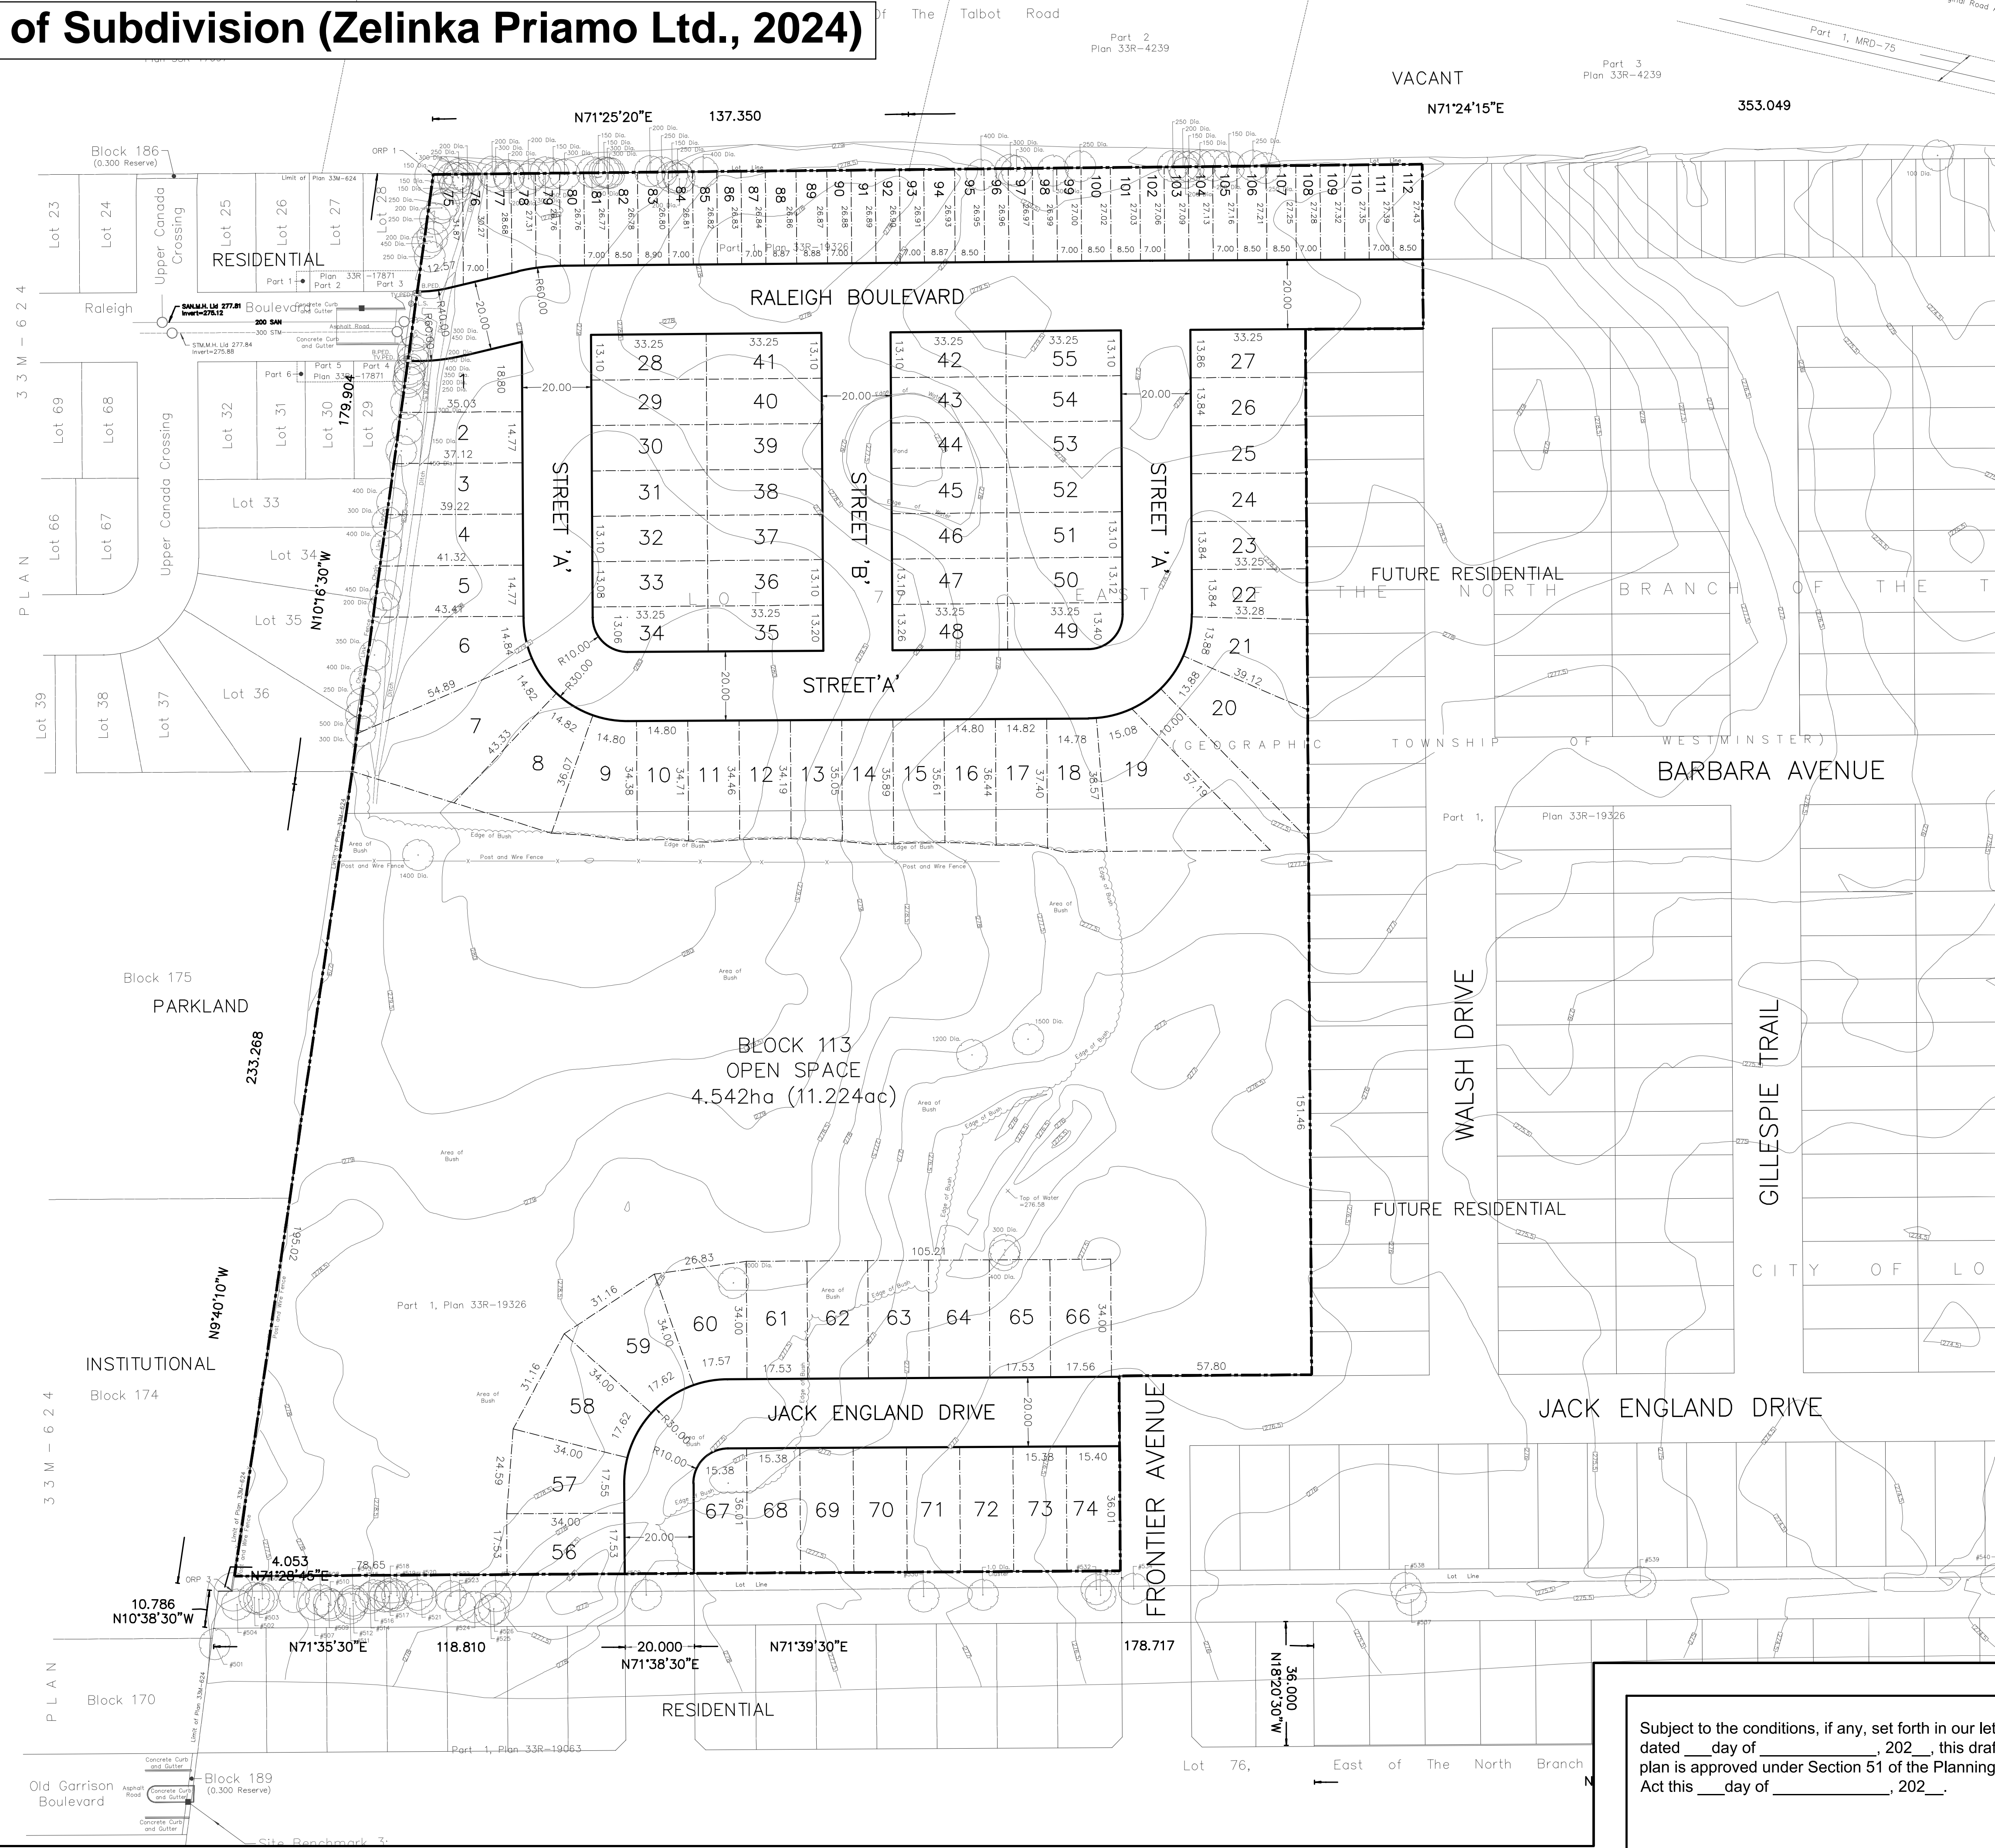
Figure 11: Draft Plan of Subdivision (Zelinka Priamo Ltd., 2024)

DRAFT PLAN OF SUBDIVISION
OF PART OF
LOT 76, CONCESSION EAST OF THE NORTH BRANCH OF THE TALBOT ROAD
(GEOGRAPHIC TOWNSHIP OF WESTMINSTER)
AND ALL OF
BLOCK 172, PLAN 33M-562
CITY OF LONDON
COUNTY OF MIDDLESEX

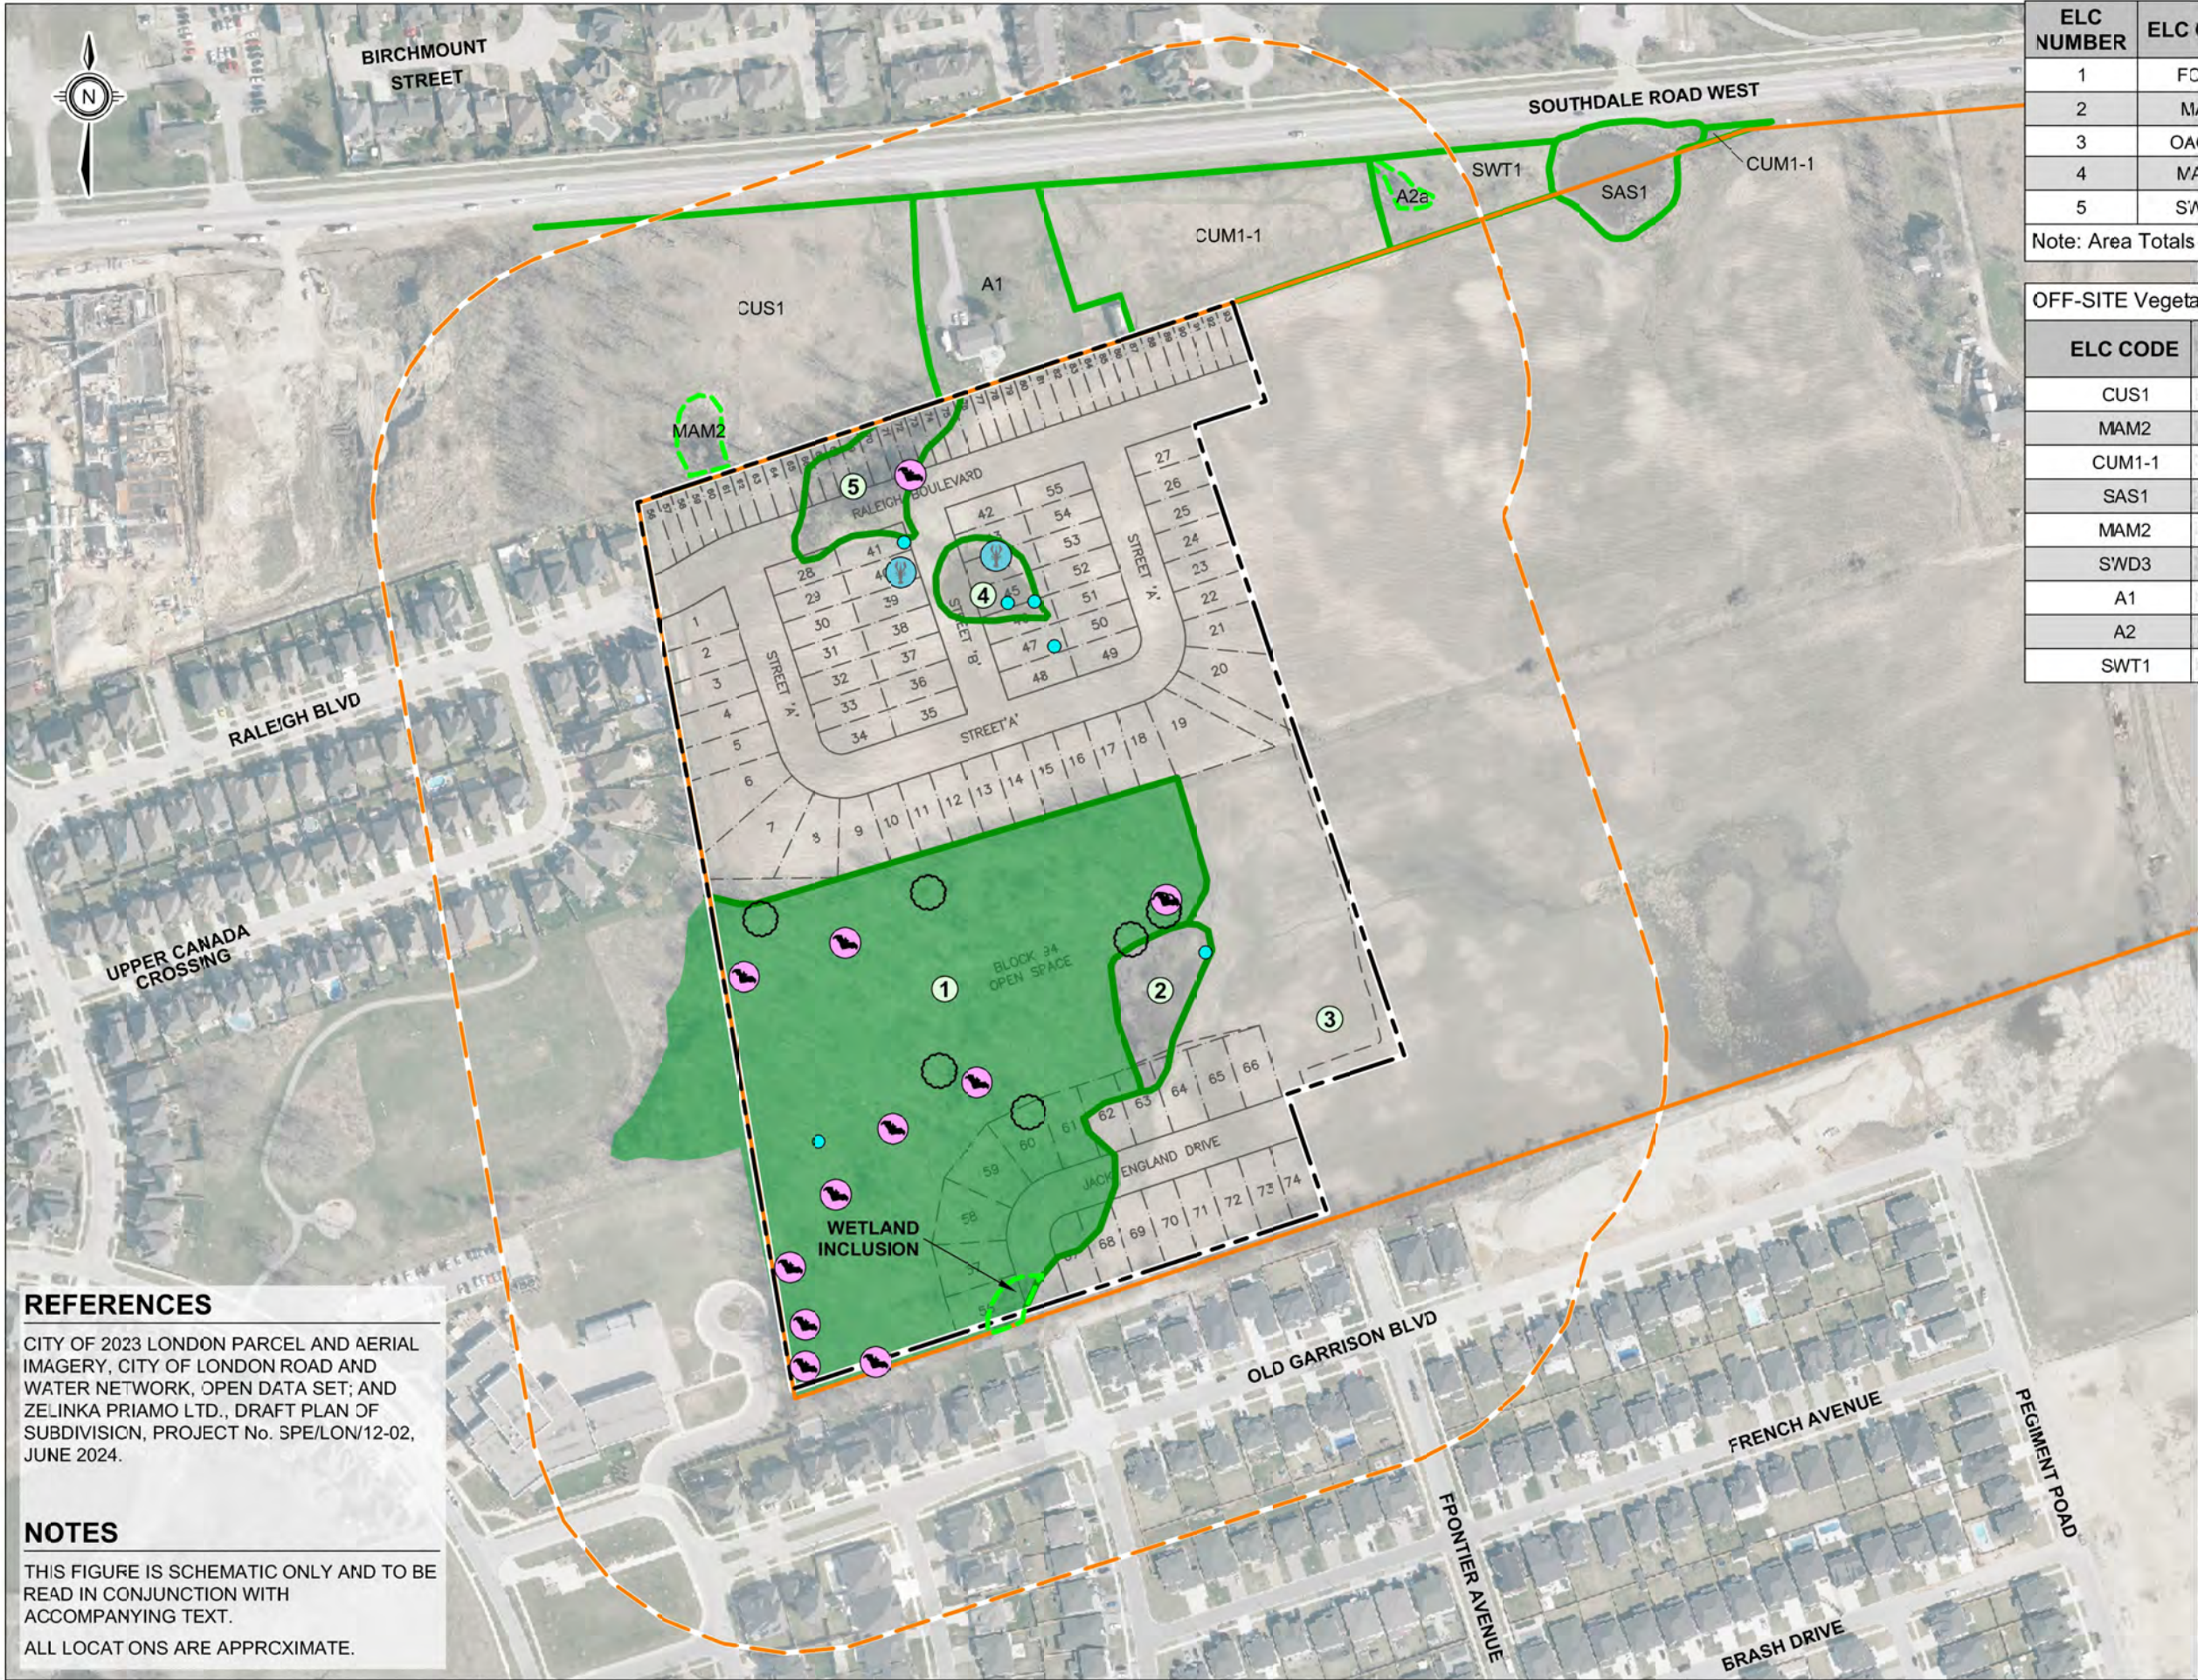
Drawn: DCH	Scale: 1:3,000	Figure: 12
Checked:	Project No.: 46666-100	
Date: 2024-08-16	Rev No.: 0

TITLE
DEVELOPMENT OVERLAY

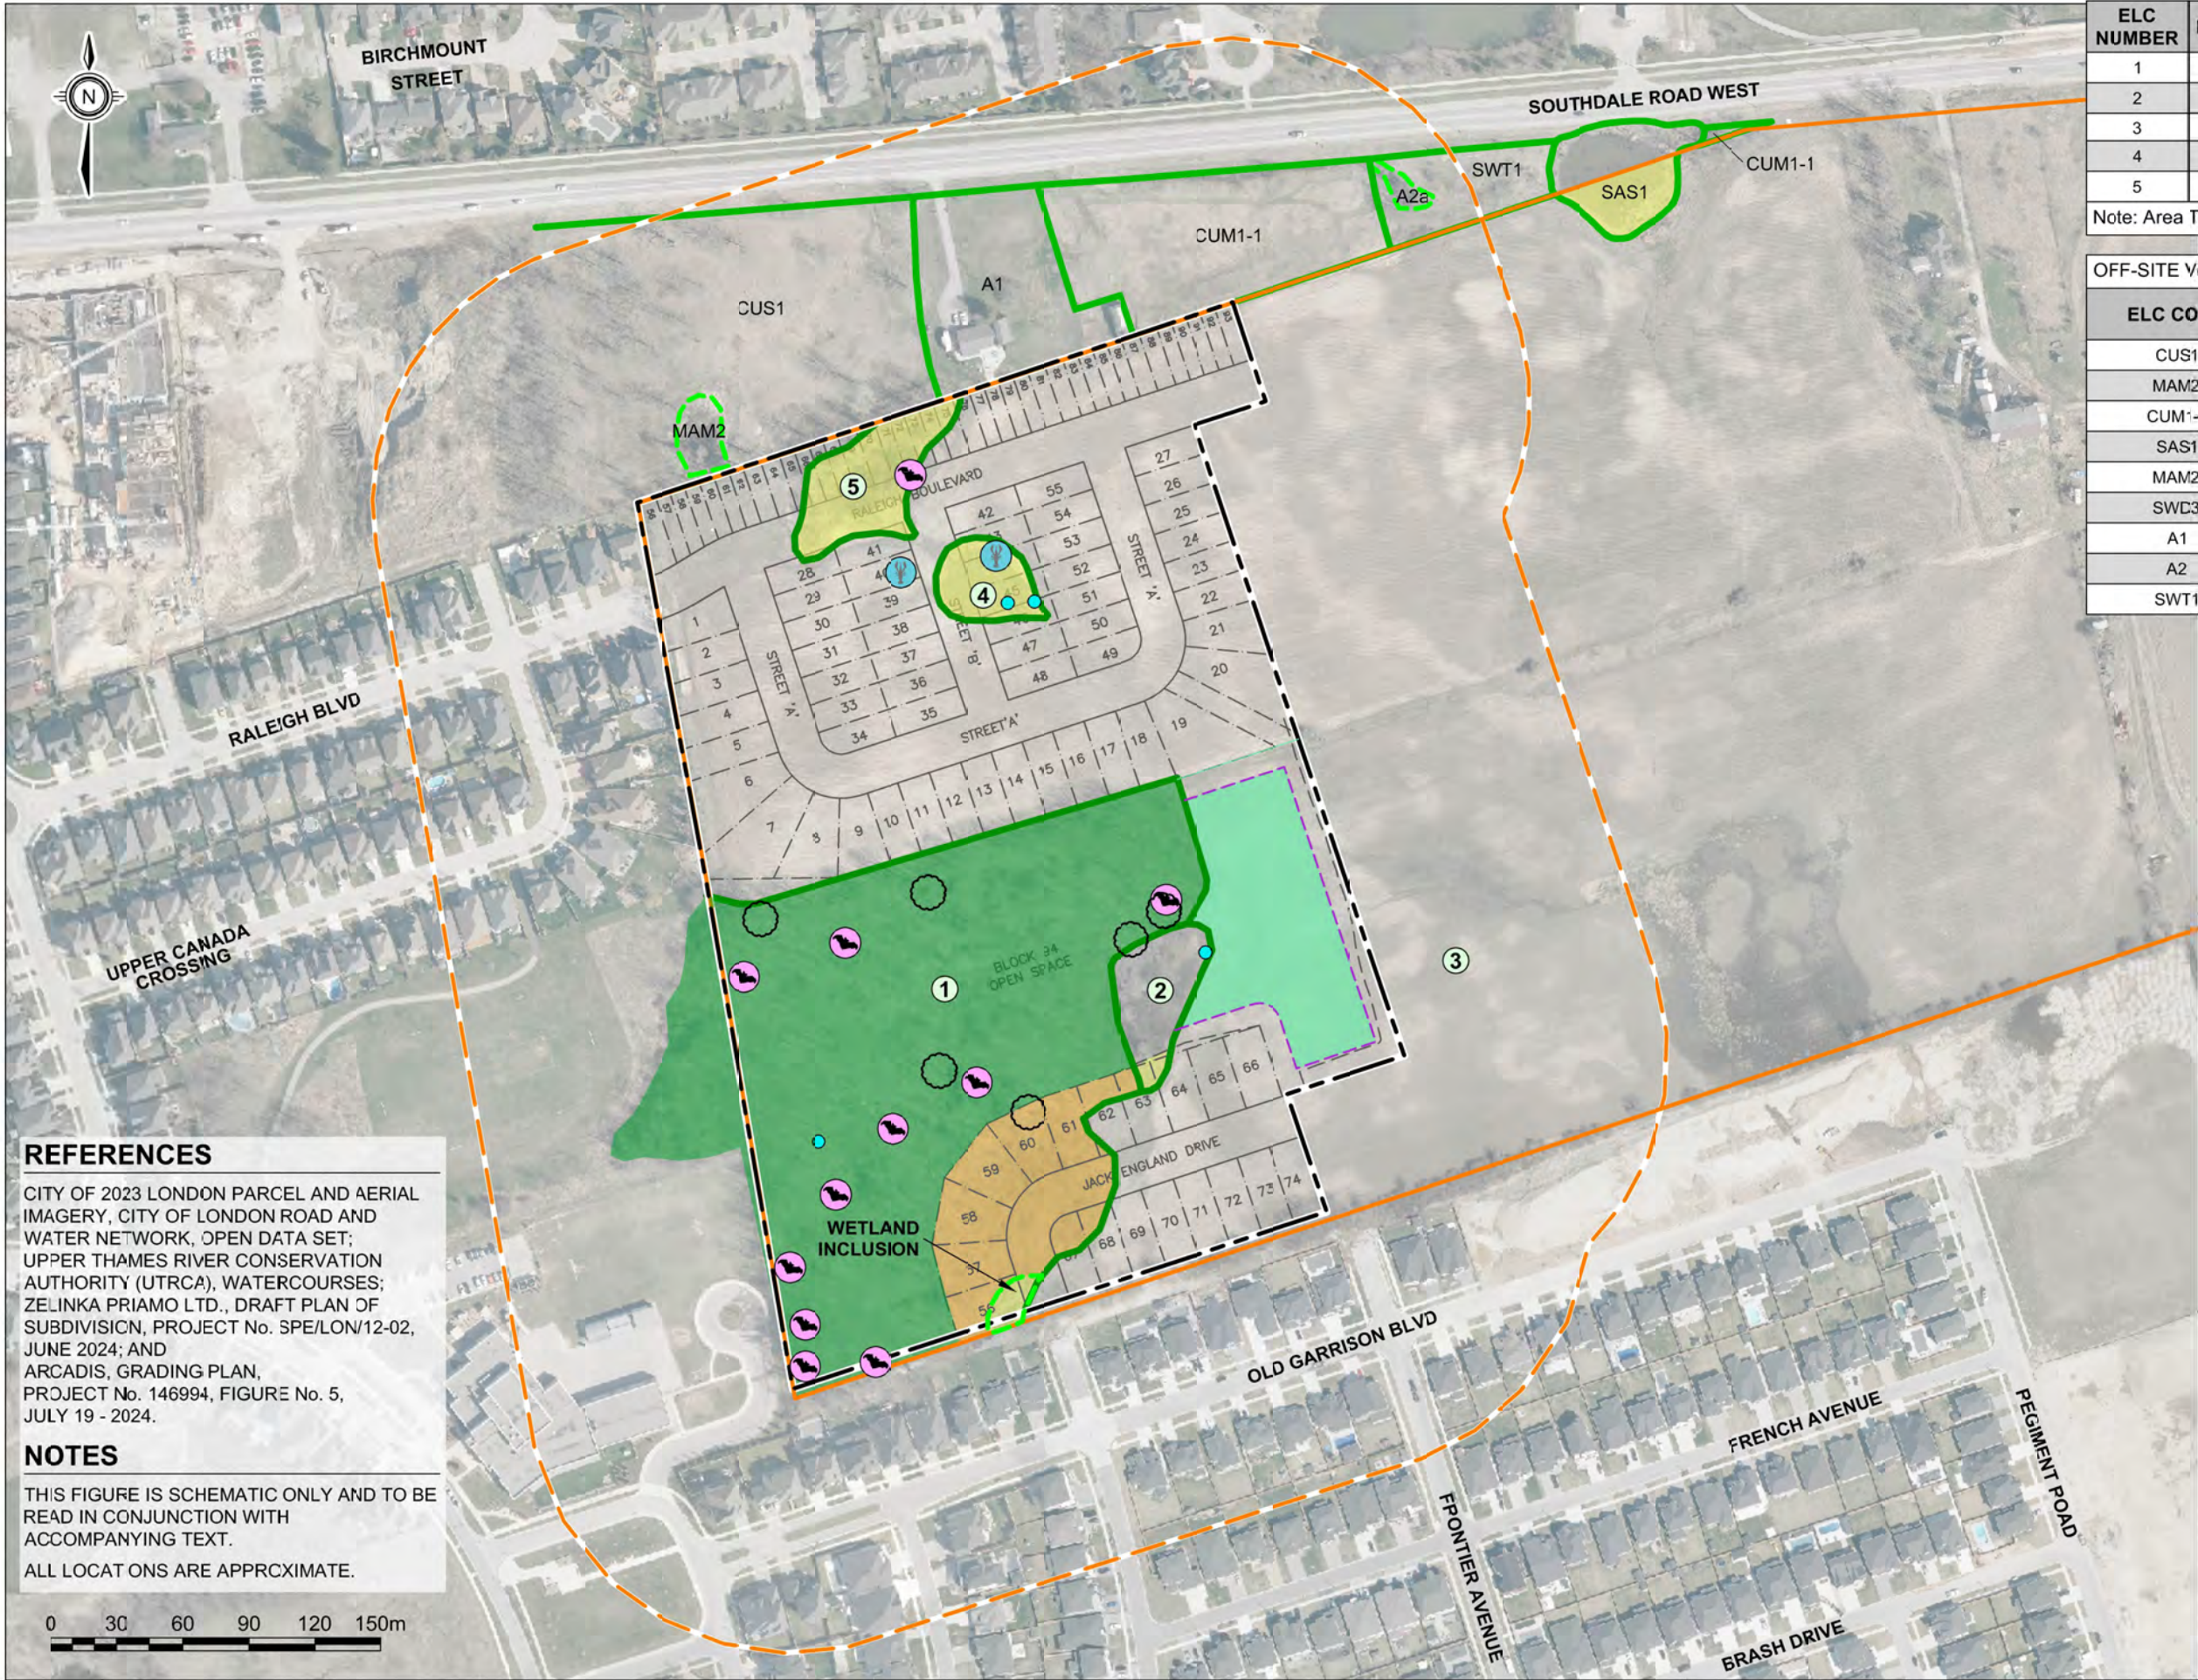
Drawn	DCH	Scale	1:3,000	Figure	13
Checked		Project No.	46666-100		
Date	2024-08-16	Rev No.	0

TITLE
MITIGATION AND COMPENSATION MEASURES
