Longworth Road Block 202

Scoped EIS Dated July 26 2013 Biologic

Site inspected 21 December 2013

January, 2014

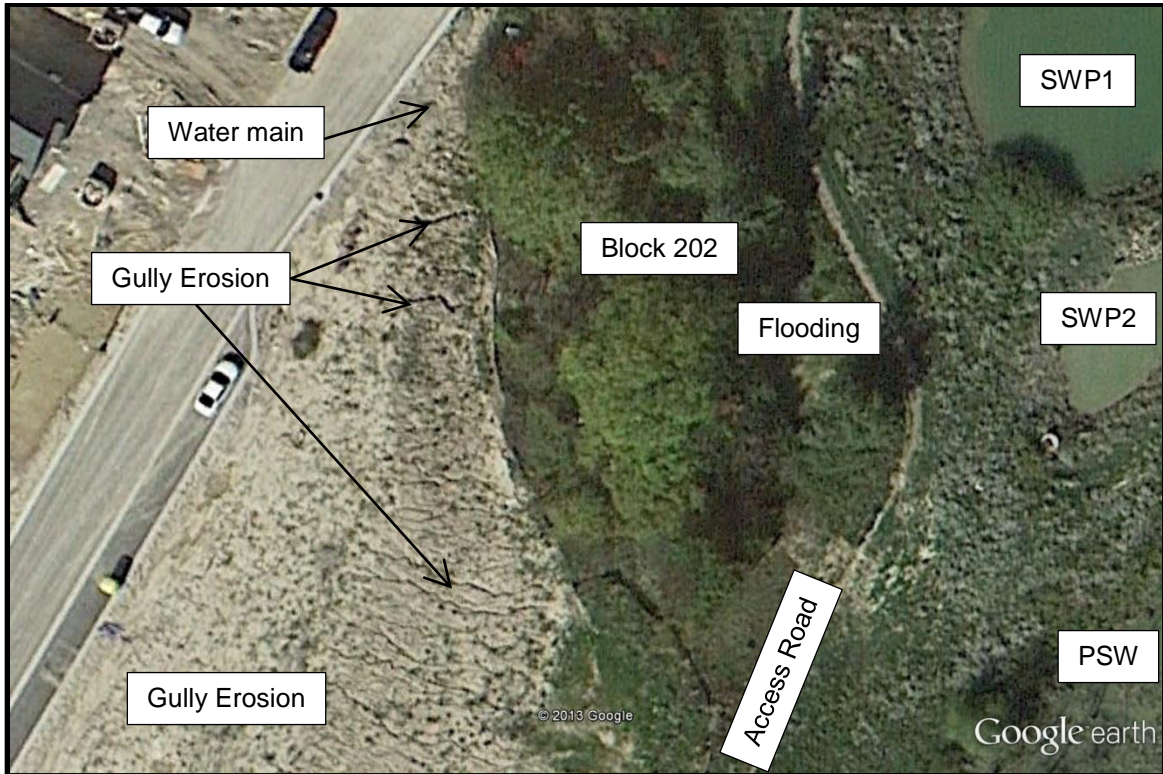
Figure 1 Longworth Road 27 September 2013

It may also be noted that the erosion control on the Longworth Road site (see Google earth image: Figure 1) is inadequate resulting in substantial siltation of the adjacent Provincially Significant Wetland. An earlier image captured by Google StreetView shows very poor erosion management immediately adjacent to the subject site. (Figure 2)

Figure 1. Longworth Road 27/9/13. Site analysis.

1. EEPAC recommends that the site should be retained as OS5 (Woodland) to provide a buffer to the PSW, to prevent risky development so close to a streamway feeding a PSW and to serve as a corridor linking the wetland to the adjacent forest patch.
2. EEPAC recommends that restorative work be undertaken to remediate the erosion upslope of the site and ponding below the site. Some additional work may be required to adequately protect the site and wetland from further degradation.
3. EEPAC recommends that a 30m buffer should be applied to the Buttonwood Wetland wherever possible.
4. UTRCA should be alerted to these concerns.

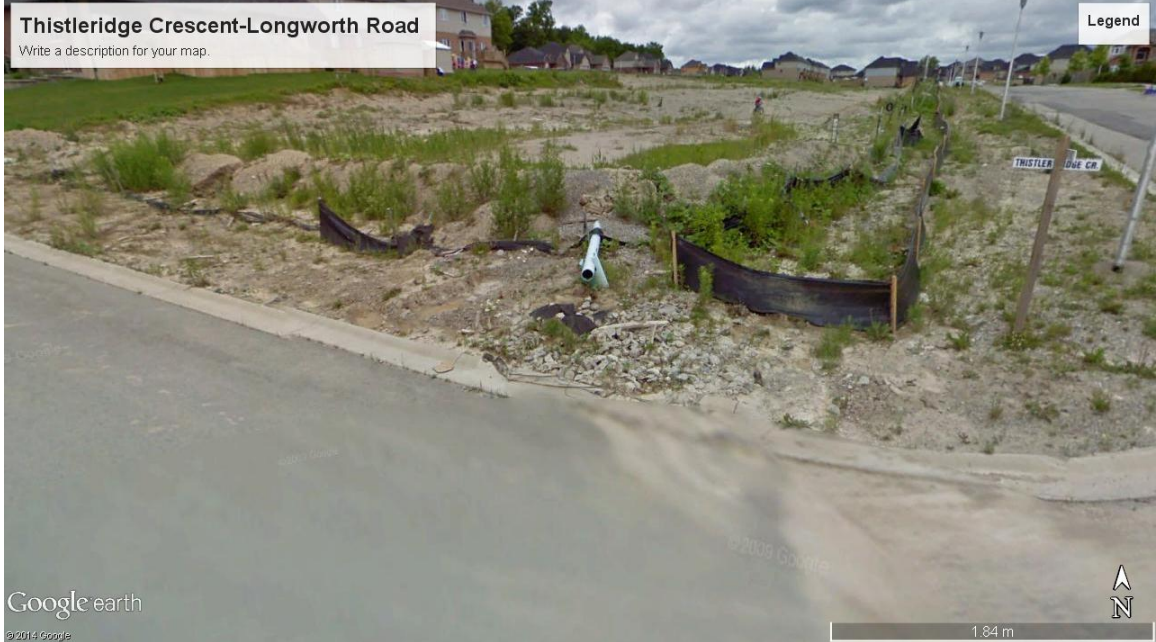
Figure 2. Longworth Road Thistleridge Cresc July 2009. Poor erosion and runoff control. Note: collapsed silt fence, breached berm and scour and sediment export from site (and into PSW).

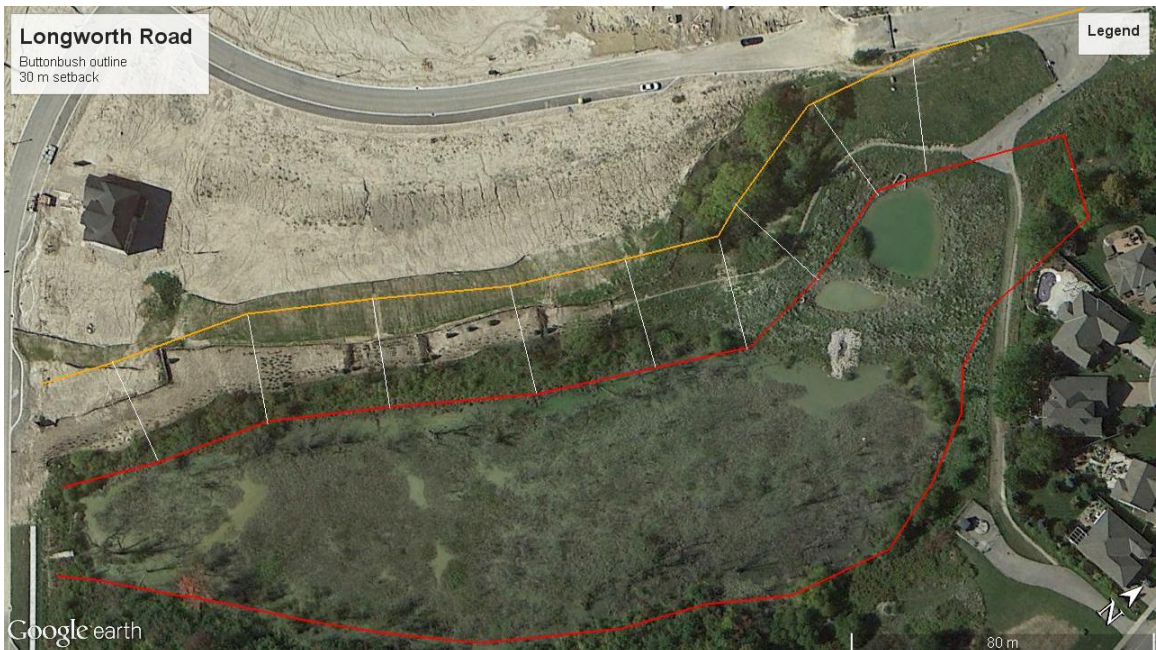
A guideline for wetland setback is 30m (City of London Environmental Management Guidelines p 122). Figure 3 illustrates approximately 30 m setback overlain on the 27 September 2013 Google Earth Image. It is clear that development has encroached significantly on the wetland although cleared, construction has not yet proceeded on the west side.

Figure 3. Buttonbush wetland 27/9/13 outline and ~30m buffer. The nature of the disturbance in the setback is indeterminate as it is currently buried beneath snow.
