# Proposed Adaptive Reuse of Kingsmill Building

by Kingsmill and Fanshawe College

**HERITAGE IMPACT ASSESSMENT FOR  
126, 128, 130, 132 DUNDAS STREET, AND  
129 CARLING STREET, CITY OF LONDON, ONTARIO  
(HISTORICALLY PART LOT 13 AND 14, CONCESSION I,  
TOWNSHIP OF LONDON, COUNTY OF MIDDLESEX)**

**EXECUTIVE SUMMARY  
COMPREHENSIVE BUILDING CONDITION STUDIES  
126-132 DUNDAS STREET AND 129 CARLING STREET  
LONDON, ONTARIO**

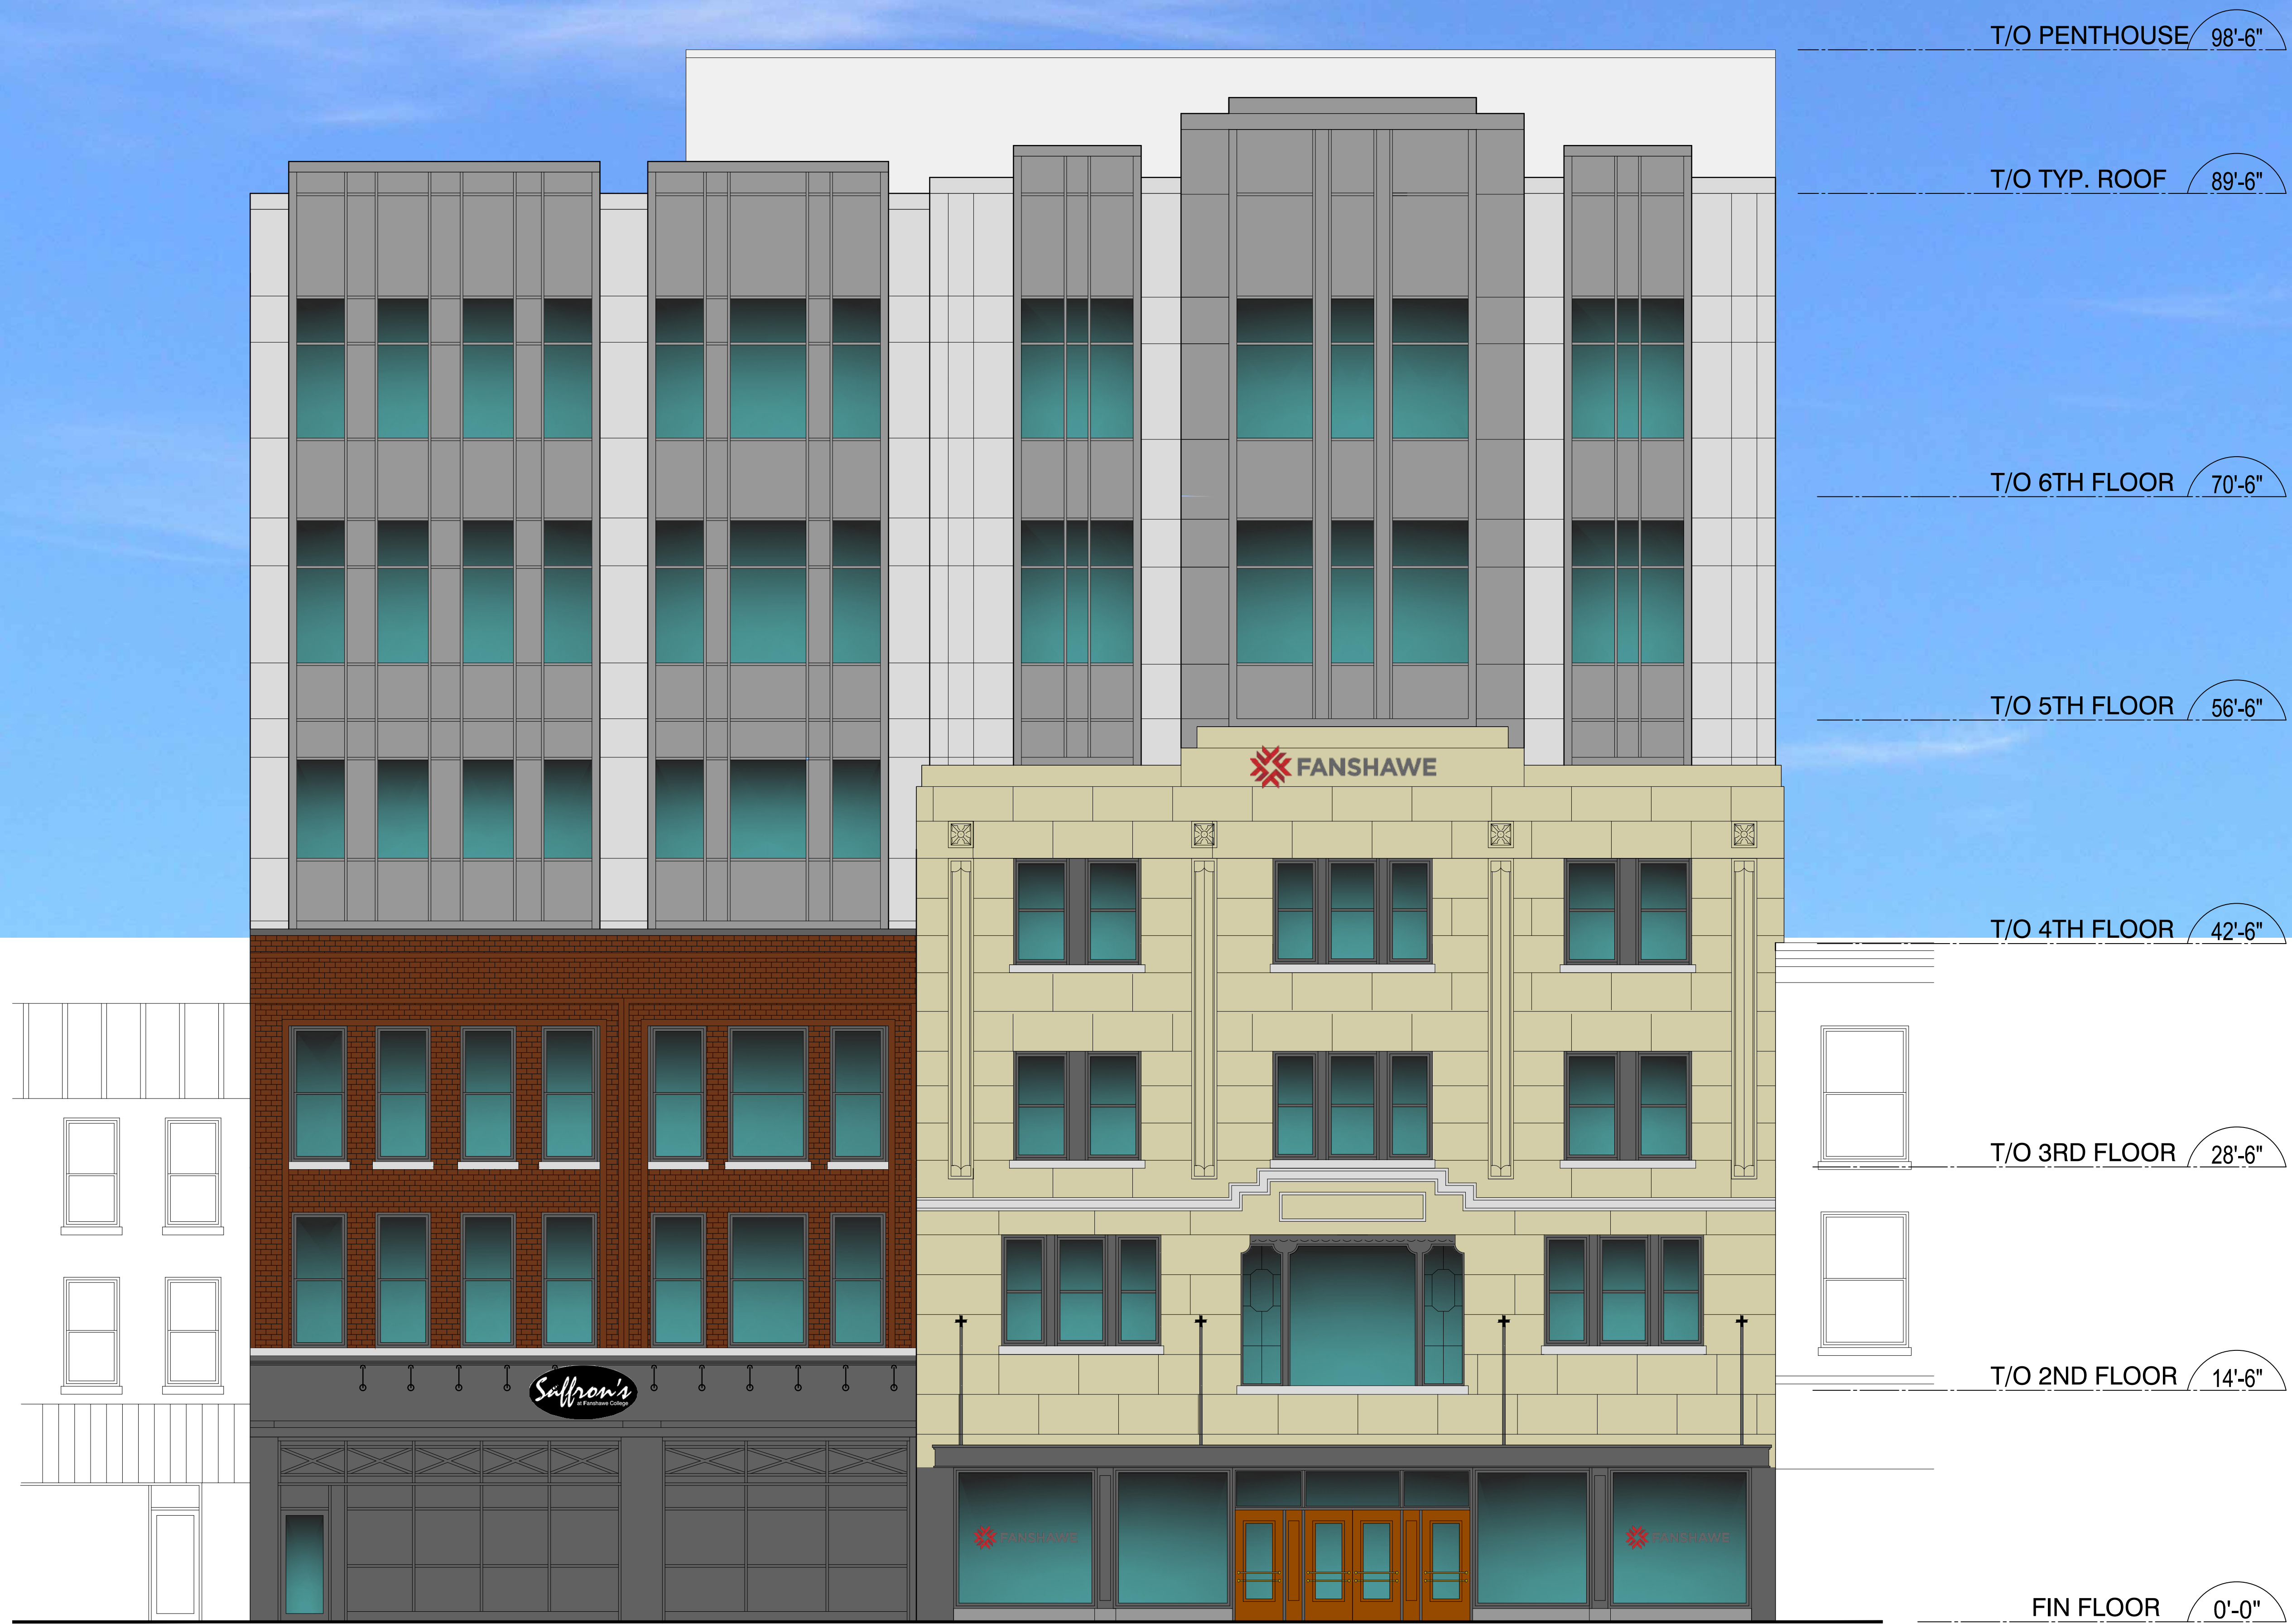
**dundas street - concept elevation**

T/O PENTHOUSE 98'-6"

T/O TYP. ROOF 89'-6"

T/O 6TH FLOOR 70'-6"

T/O 5TH FLOOR 56'-6"

T/O 4TH FLOOR 42'-6"

T/O 3RD FLOOR 28'-6"

T/O 2ND FLOOR 14'-6"

FIN FLOOR 0'-0"

- **South Elevation** – The existing façade will be preserved. Temporary shoring and bracing will be provided to stabilize the façade during construction until final incorporation into the new structural framing. The existing limestone and clay brick façade will be professionally restored using some of the materials salvaged from the demolition of the north Carling Street side. Existing wooden windows will be replaced with new energy efficient units that have a similar appearance to the existing windows. The south storefront will be brought forward to the sidewalk to showcase the existing set of doors. The ground floor storefront will incorporate windows set in frames with a bronze finish highlighted by granite accents. From the 4<sup>th</sup> and 5<sup>th</sup> floors up the façade will be traditional aluminum curtain wall with a 4.6 metre (15 foot) setback;

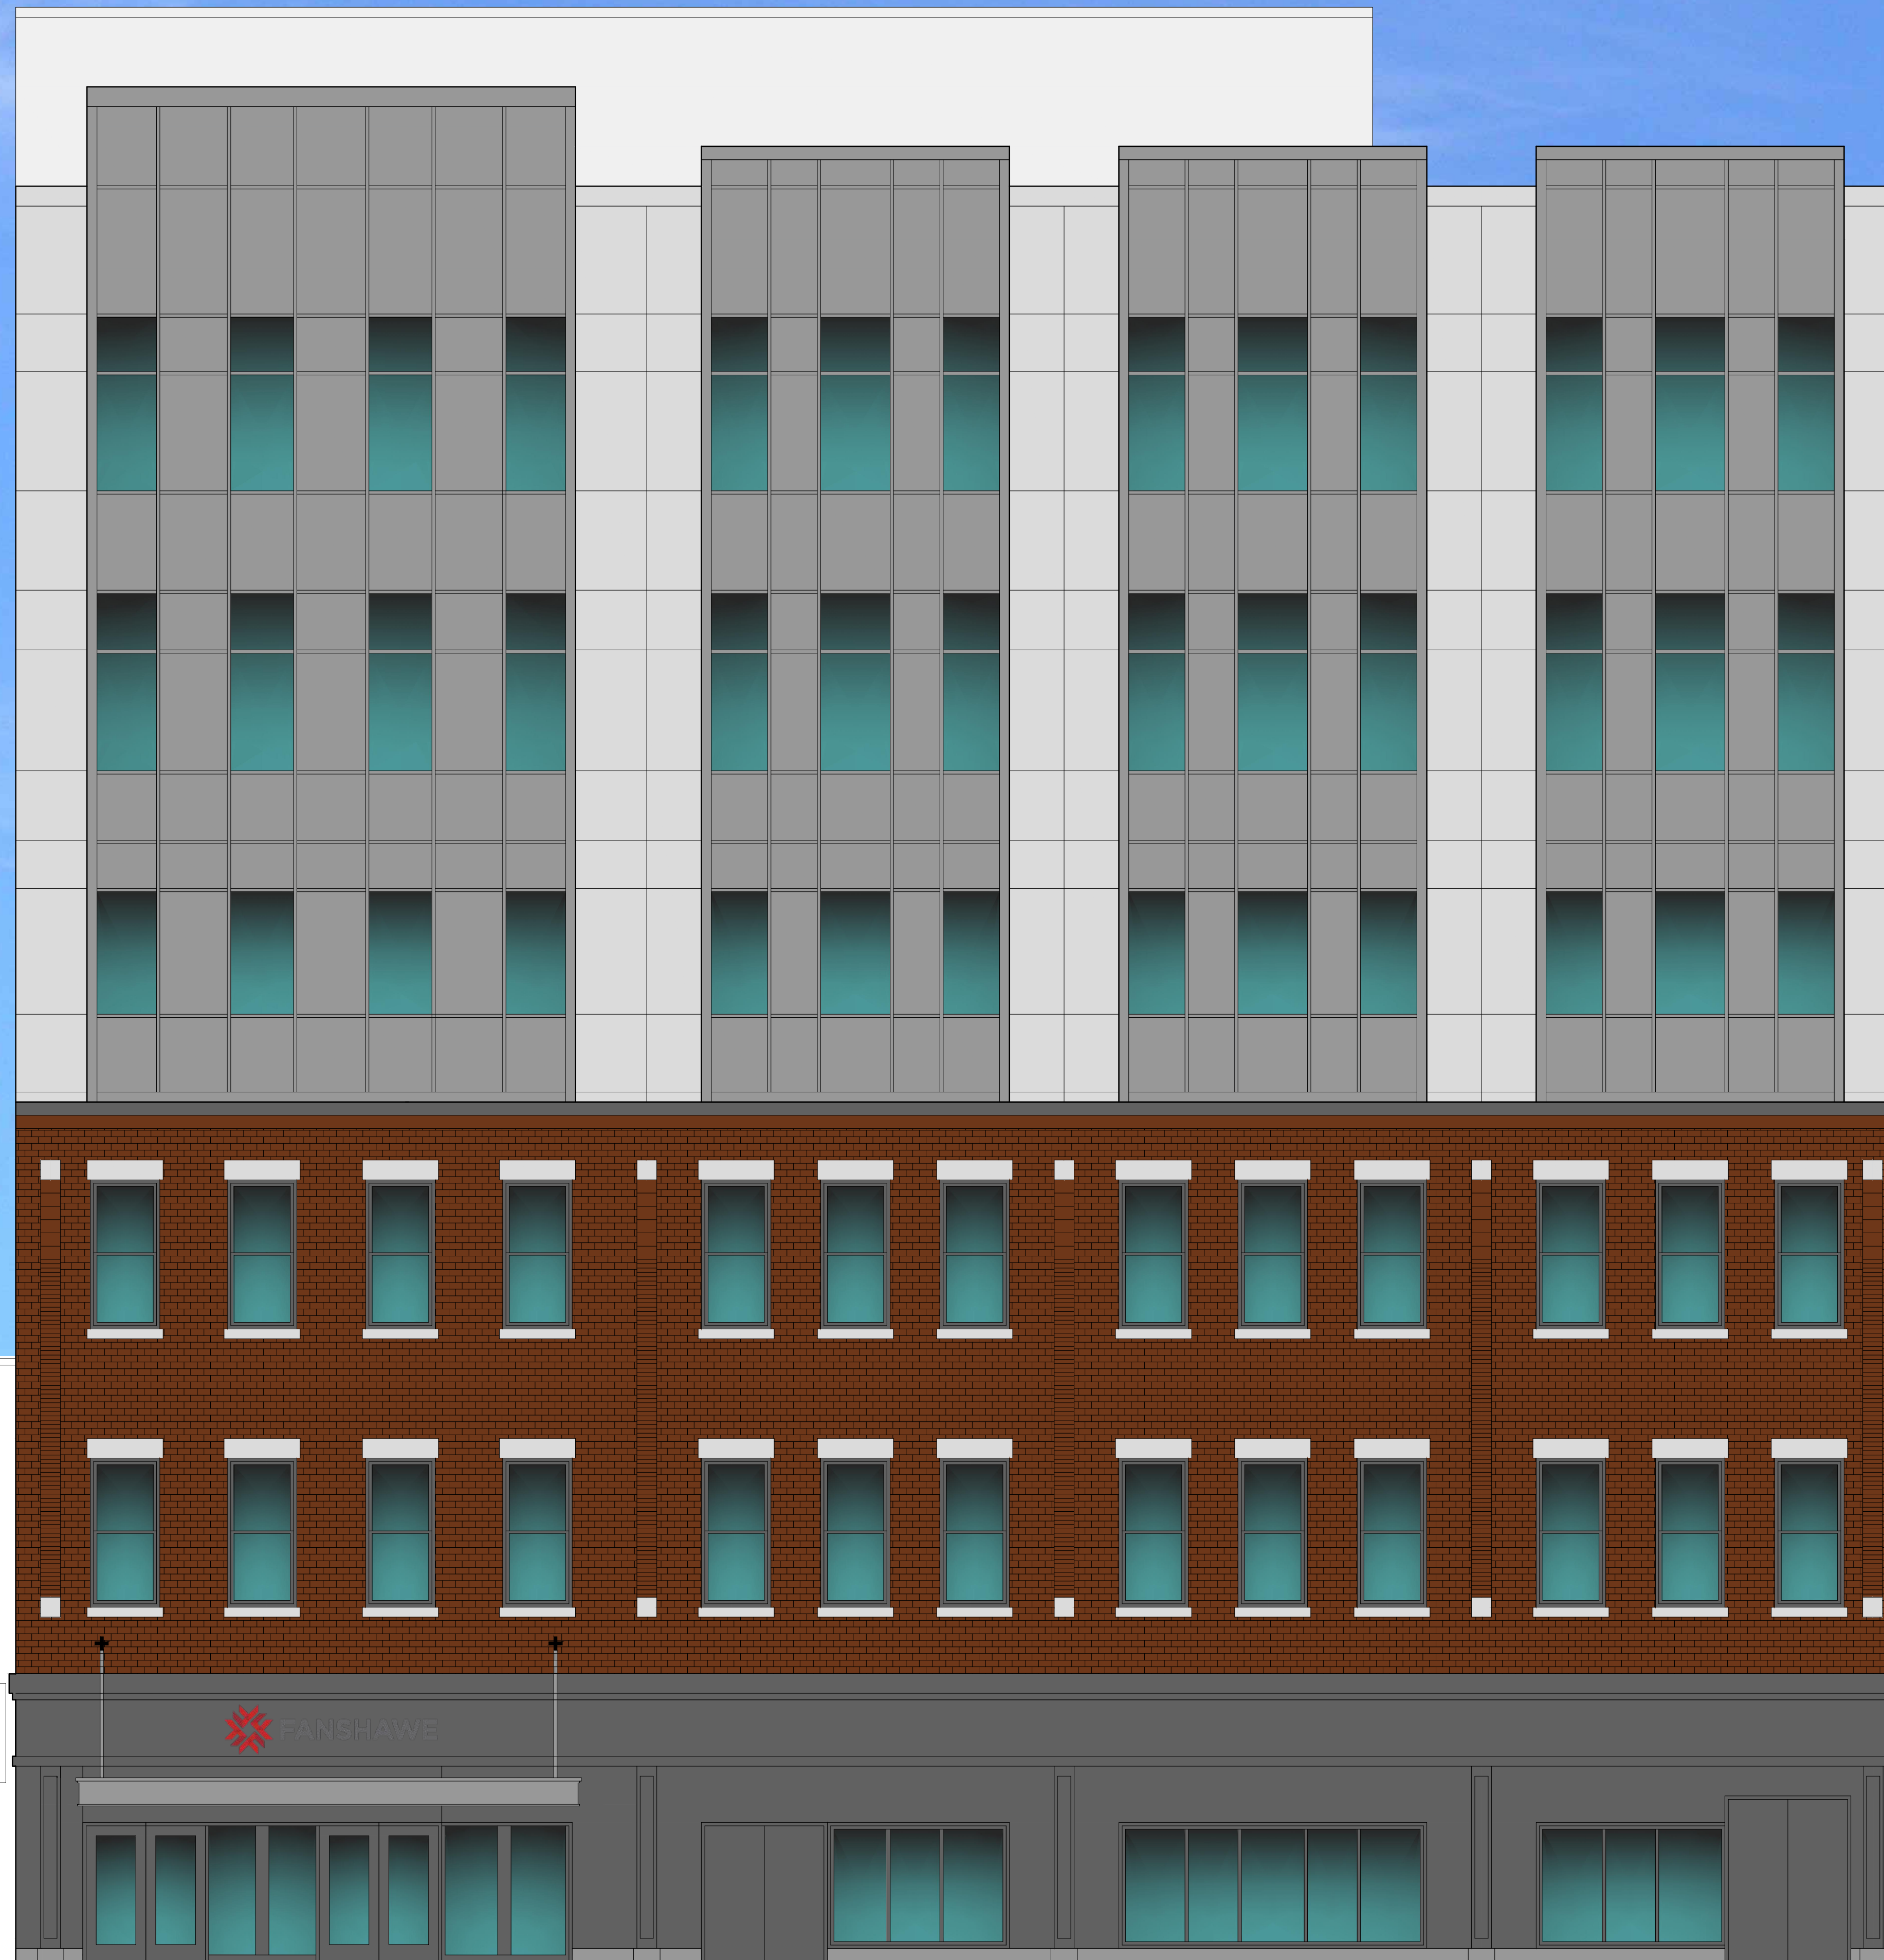
**carling street - concept elevation**

T/O PENTHOUSE 98'-6"

T/O ROOF 89'-6"

T/O 6TH FLOOR 70'-6"

T/O 5TH FLOOR 56'-6"

T/O 4TH FLOOR 42'-6"

T/O 3RD FLOOR 28'-6"

T/O 2ND FLOOR 14'-6"

FIN FLOOR 0'-0"

- **North Elevation** - Demolition of the Carling façade down to foundation level and complete re-construction utilizing appropriate historic reproductions of materials on the first 3 floors, including granite, clay and stone window sills and lintels to recreate an appearance similar to the existing (Appendix A:4b). Ground floor storefront will incorporate windows set in frames with a bronze finish highlighted by granite accents. From the 4<sup>th</sup> floor up the façade will be traditional aluminum curtain wall with a 4.6 metre (15 foot) setback;

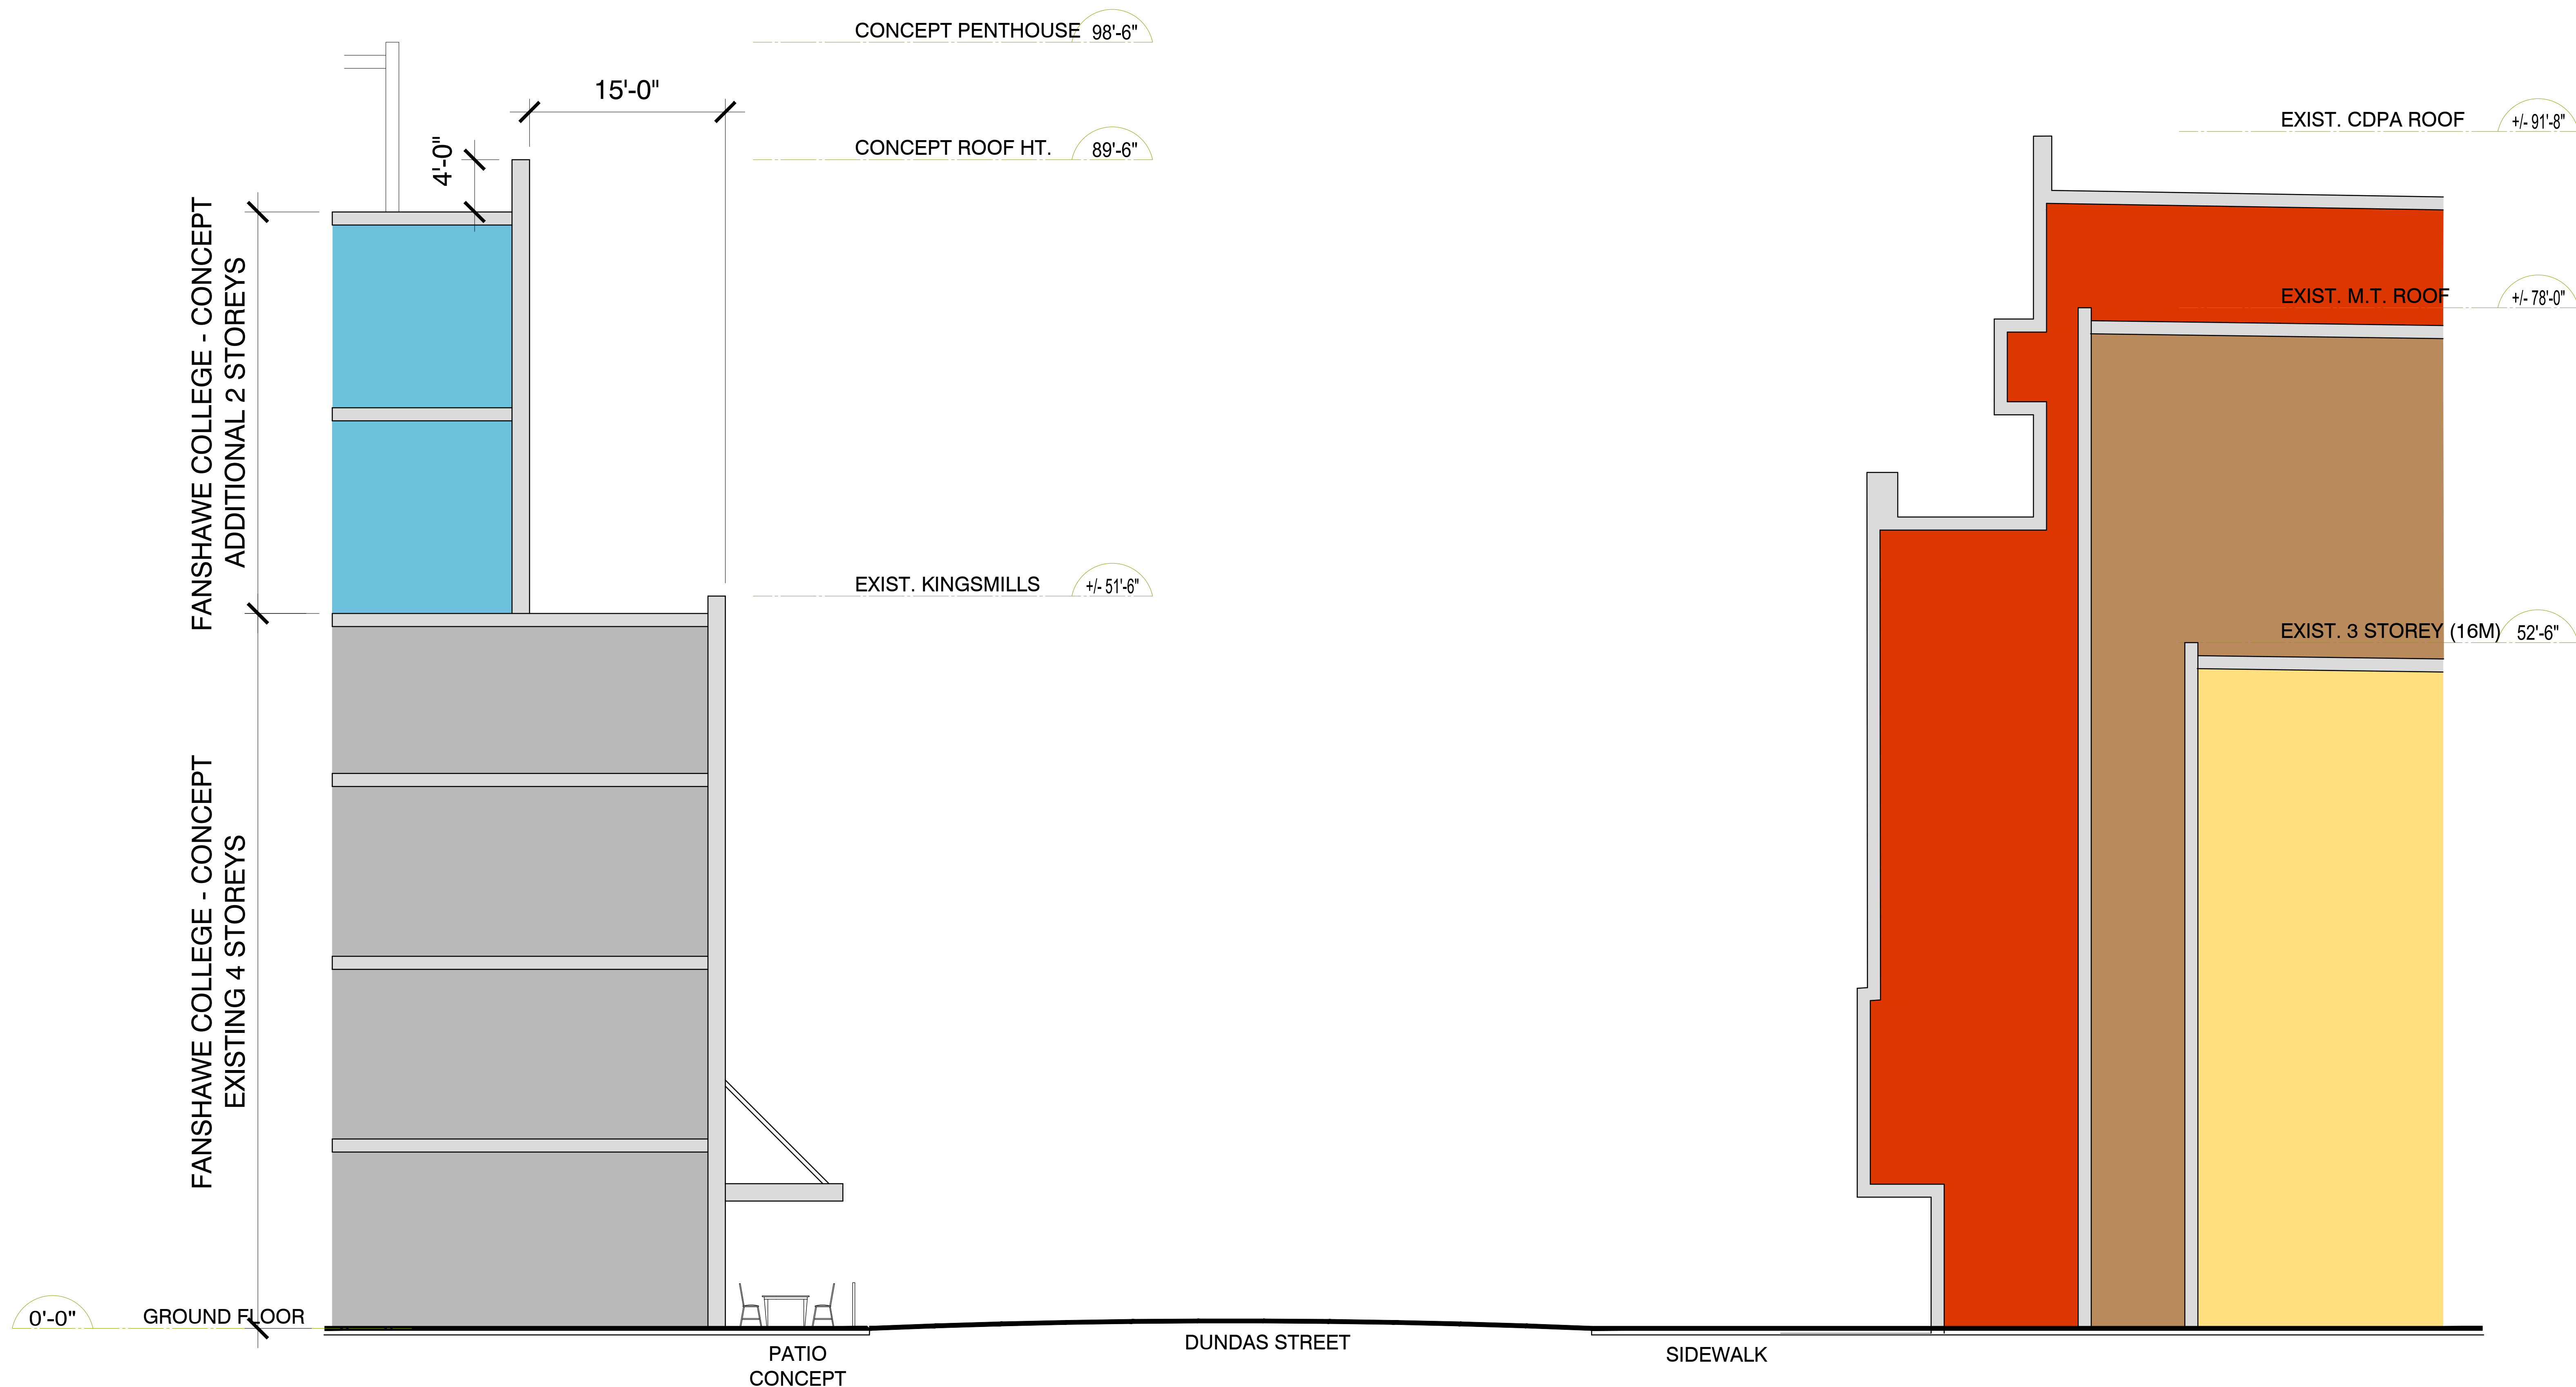
**dundas street - concept cross section**

- FANSHAWE COLLEGE - CENTRE FOR DIGITAL AND PERFORMANCE ARTS  
137 DUNDAS STREET
- MARKET TOWER  
151 DUNDAS STREET
- REPRESENTATIVE DUNDAS STREET THREE STOREY  
DOWNTOWN HERITAGE DISTRICT BUILDING

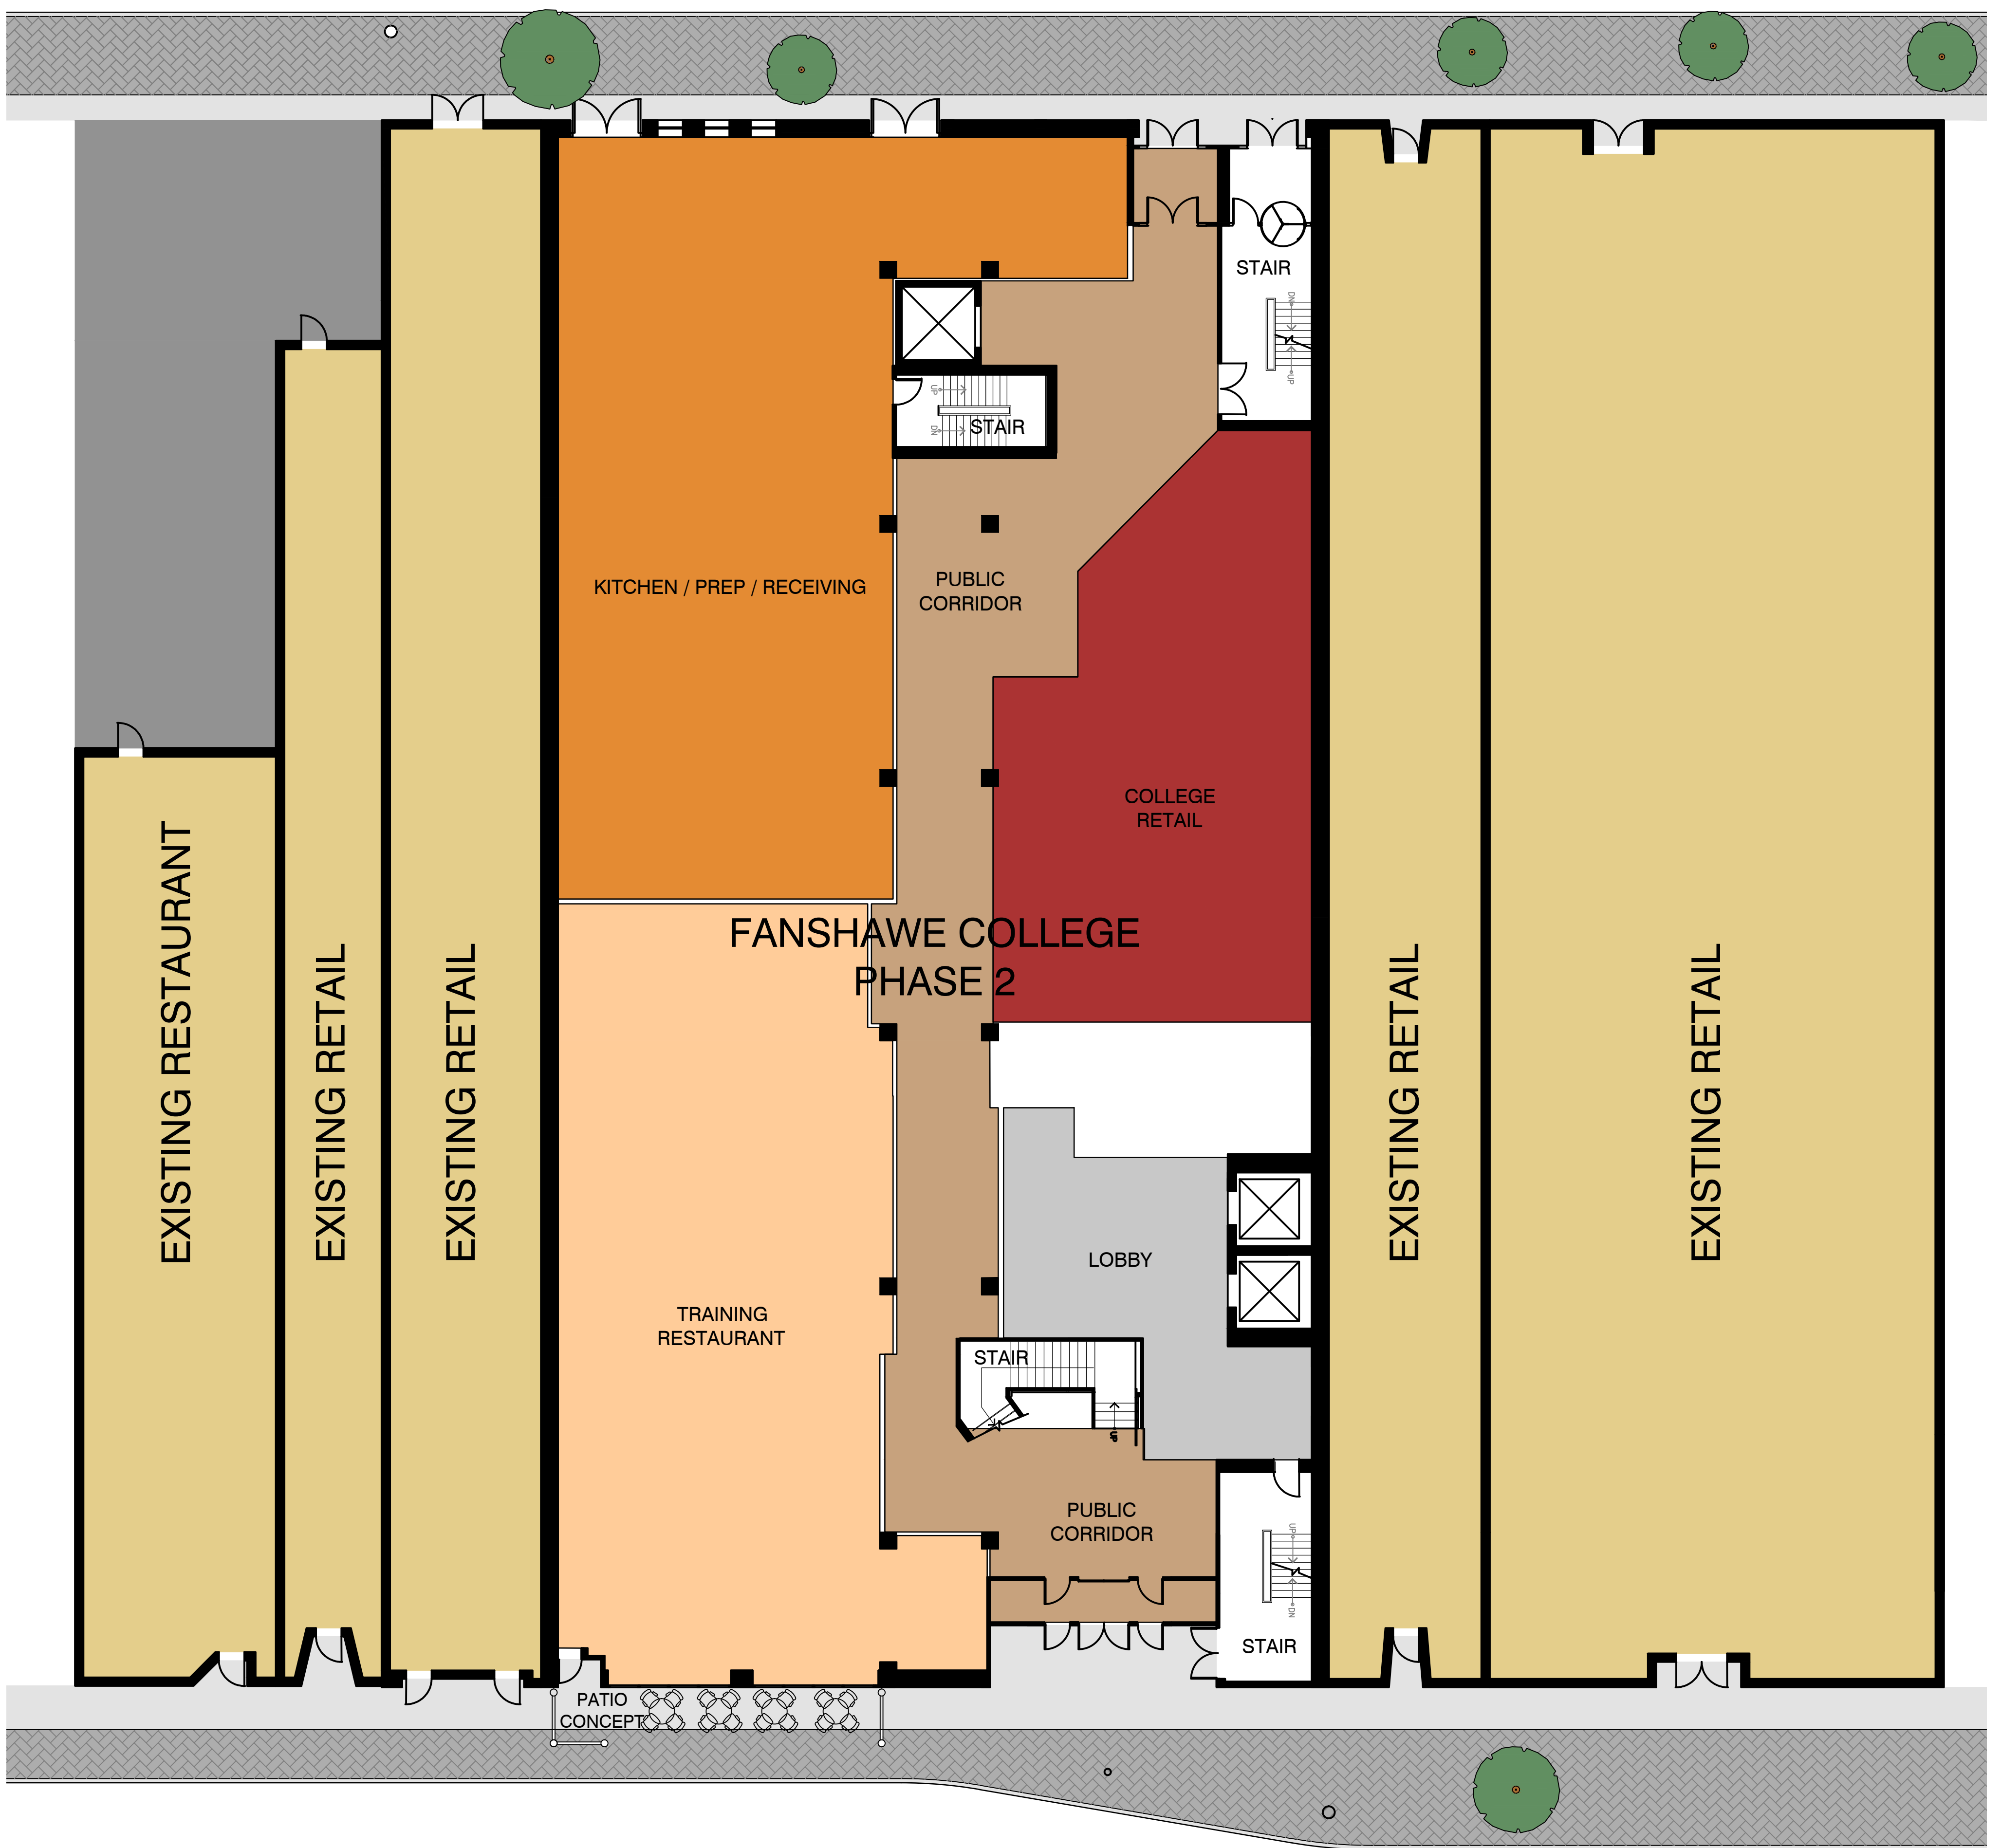
concept site plan

CARLING STREET

DUNDAS STREET
