Meadowlily Bridge

Presentation to the Civic Works Committee
March 5, 2012

Meadowlily Bridge Overview

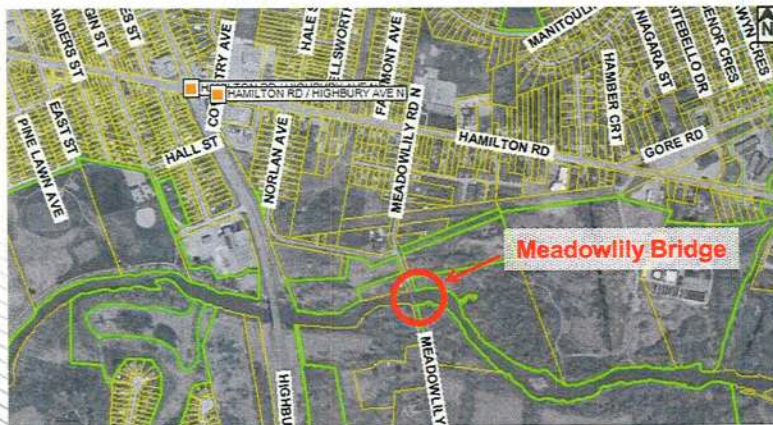
- Pedestrian Bridge crossing the Thames River in the vicinity of the Highbury Ave / Hamilton Rd intersection
- Originally opened in 1911

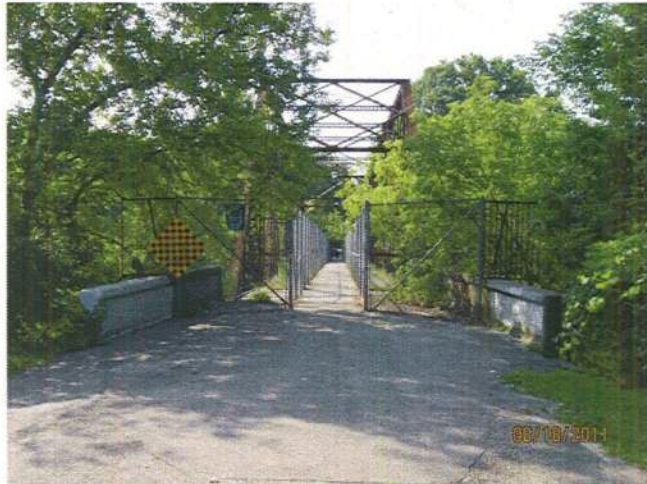
- Bridge deck is currently constrained by a chain link fence
- Structural deterioration means something must be done to maintain bridge link

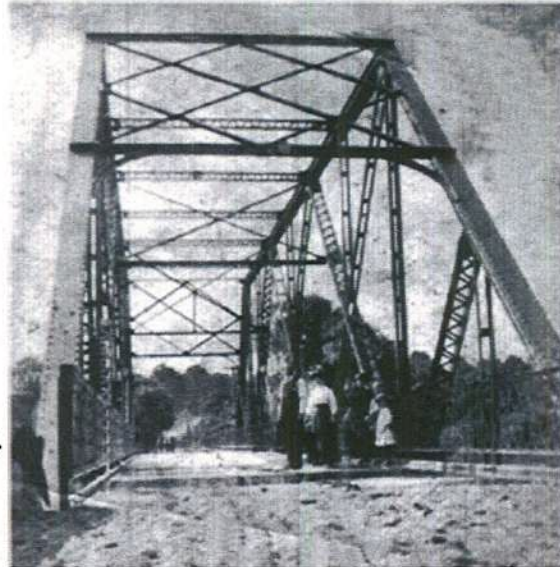
- Increasingly rare survivor of a metal truss bridge
- Eligible for designation under Part IV of the Ontario Heritage Bridge Act
- Eligible for listing in the Ontario Heritage Bridge List
- Scored 74 on the Ontario Heritage Bridge Evaluation (60+ is eligible for the list)
