**Heritage Impact Assessment  
78, 80, 82, 84, 86, 88 Oxford Street West  
London, Ontario**

AECOM

March 2016

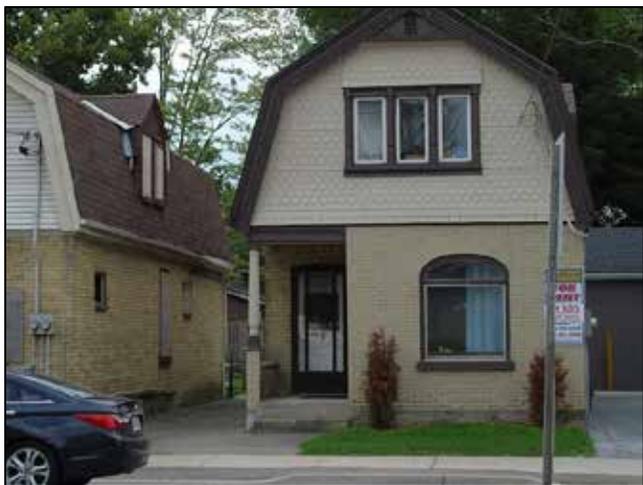
*Plate 2: 82 Oxford Street West*

A few houses were also built on the north side of Oxford Street West at the same time, notably the three buildings at 87, 89, and 99 Oxford Street West across from the subject properties. These buildings are architecturally similar to the subject properties and had been built prior to 1906. The structure at 99 Oxford Street West is significantly larger but 89 Oxford Street West is virtually identical in massing to the sixth house on the south side of the street. The house at 87 Oxford Street West differs from 89 Oxford Street West by having a projecting second storey over the ground floor. The architectural treatment of the gable end suggests that this second floor projection is original; however, it is possible that this could have been a later extension to the building. It is possible that these three houses were constructed by the same builder prior to the six subject properties across the street (Plates 2-5).

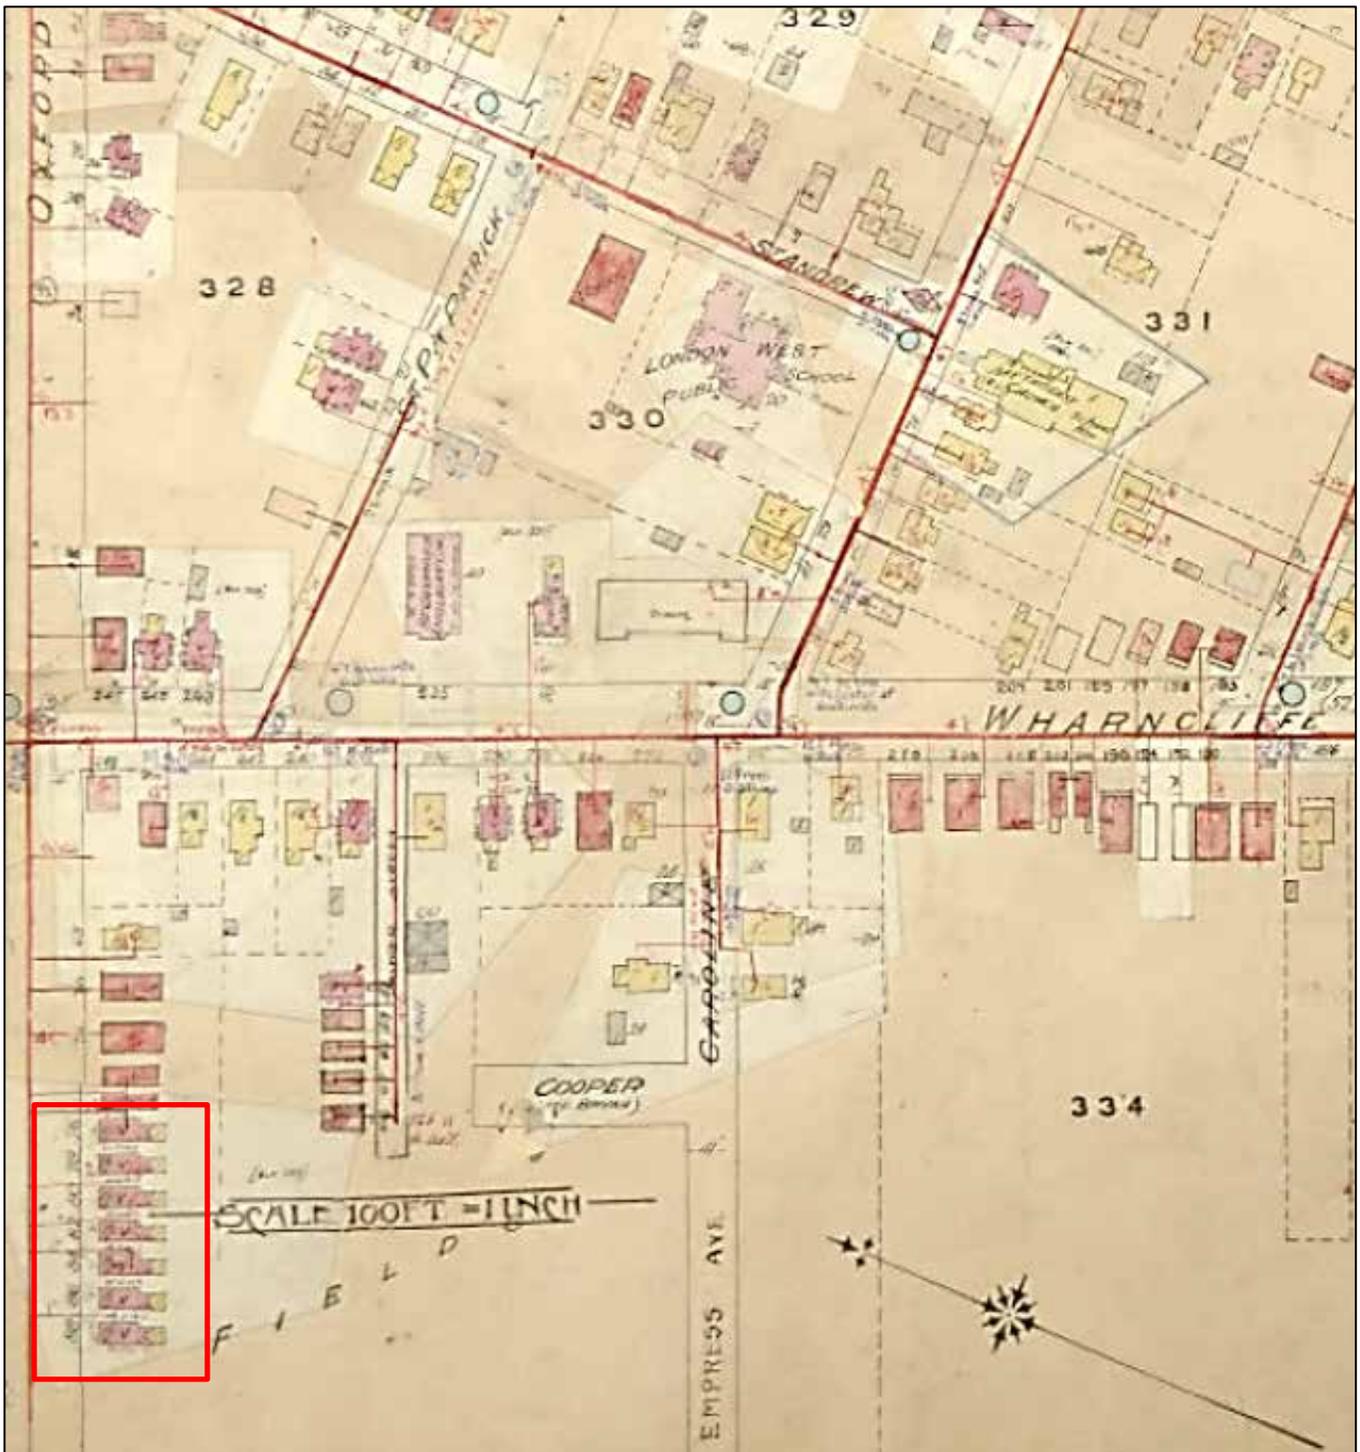
Figure 2: Portion of the 1892 Rev. 1907 Insurance Plans for the City of London

The properties located at 78-88 Oxford Street West were constructed between 1906 and 1907. In 1906, the *Vernon's Directory for the City of London* listed seven "unfinished houses" located between 78-88 Oxford Street. The 1892 Rev. 1907 Fire Insurance Plans for the City of London illustrated the structural footprints for these seven houses (Figure 1 Figure 2). A year later, the Directory lists six houses at 78, 80, 82, 84, 86, and 88 that were either occupied or "vacant" (which presumably means not yet rented/sold). No house at 76 Oxford was built at this time and only 6 houses are visible on the 1912 Rev. 1915 Insurance Plans (Figure 3 Figure 4).<sup>2</sup>

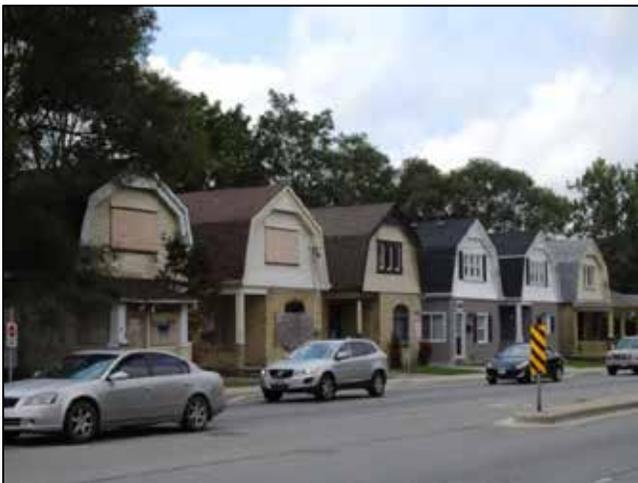
Plate 6: 78-88 Oxford Street West looking southwest

The six buildings at 78-88 Oxford Street West were built with a common foot print and orientation to create a streetscape of identical looking houses (Plate 6). The houses are located on deep, narrow lots. South and west of 88 Oxford Street West the land slopes steeply. The change in grade is particularly evident at the end of Palmer Street (Plate 7). The lot setbacks for the subject properties have been significantly reduced since the early 20<sup>th</sup> century due to the widening of Oxford Street which first began in 1973 (Figure 5). It appears that all of the road widenings have occurred on the south side. The north side of the street retains, what appear to be, the original house setbacks (Plates 7 and 8). The streetscape east of the subject properties and at the intersection with Wharncliffe has developed into a commercial and business area and is comprised of parking lots, professional buildings, and restaurant businesses.

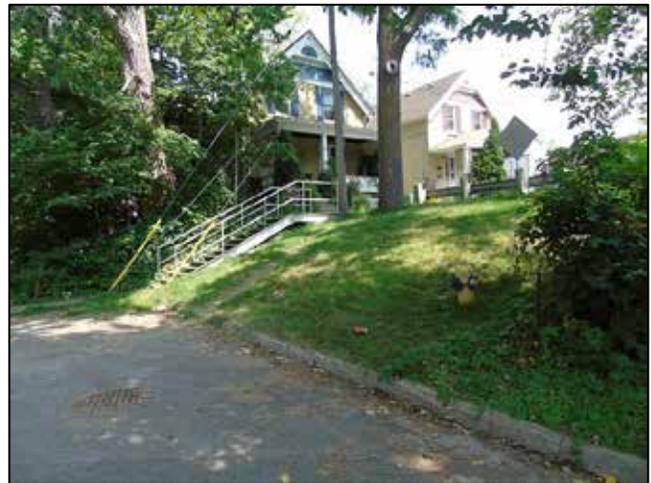
Plate 7: Original grade change at the end of Palmer Street, south of the subject properties

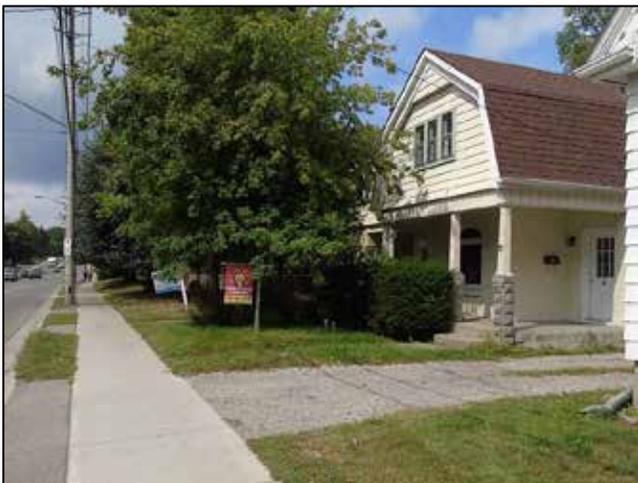
Plate 8: Original lot setbacks along the north side of Oxford Street

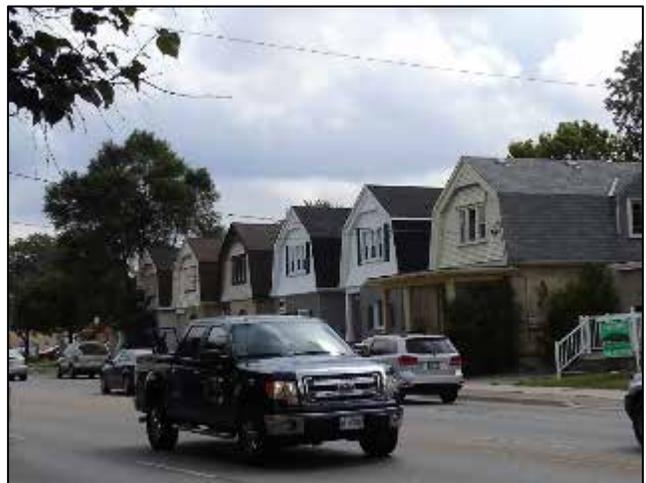
Plate 9: View looking southeast to the subject properties showing reduced setbacks.

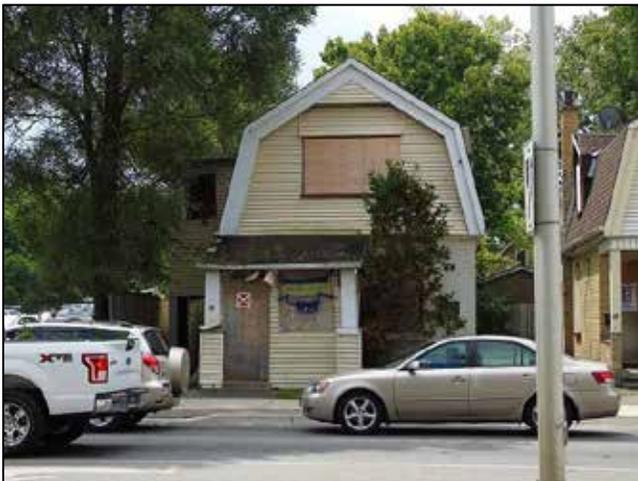
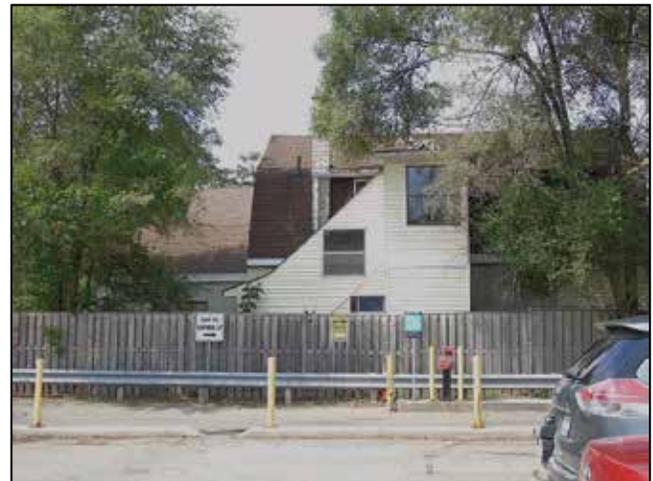
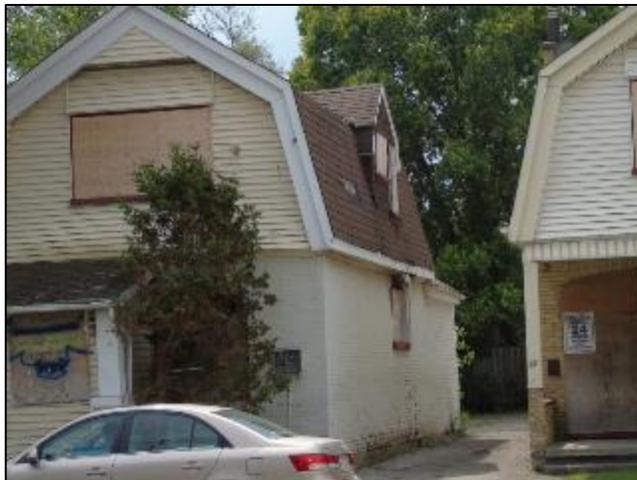
The exterior of this structure has been heavily modified with vinyl siding. The east (side) facade has been modified by the construction of a two-storey addition, clad with vinyl siding which covers the original roof dormer and part of the chimney. The original recessed front entrance porch façade appears to have been modified with the construction of a shed roof that extends out further than the neighbouring buildings. The gable end has been covered with vinyl and the remaining visible brick has been painted white. The grouping of second storey windows on the gable end has been boarded over but the lower level window retains its original attributes, including its arched brick voussoirs (Plates 10-12).

*Plate 10: Front façade of 78 Oxford Street West*

*Plate 11: East facade of 78 Oxford Street West showing modern addition*

Plate 12: West side of 78 Oxford Street West showing side dormer

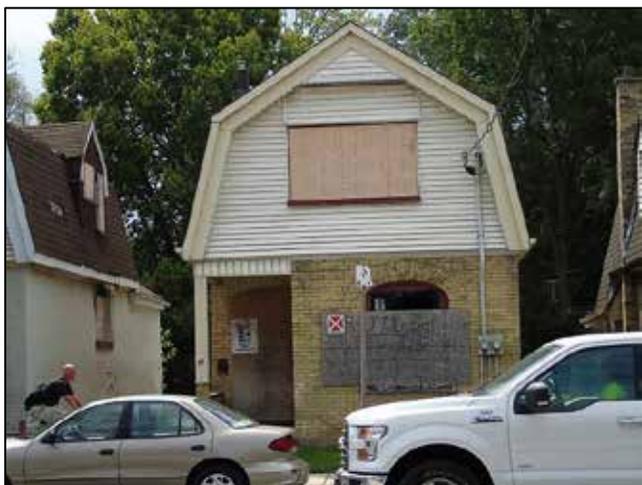
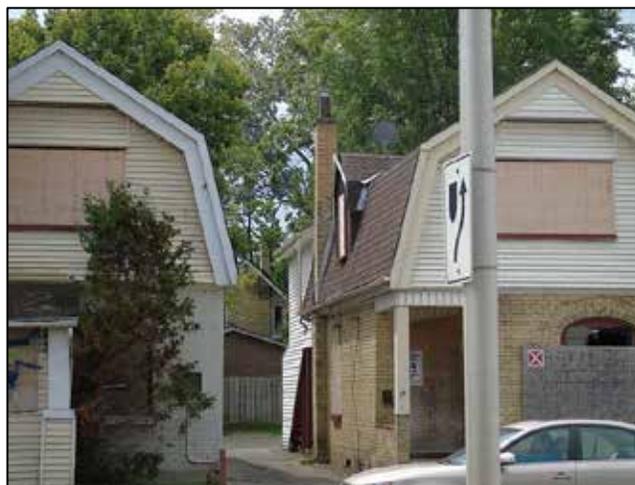
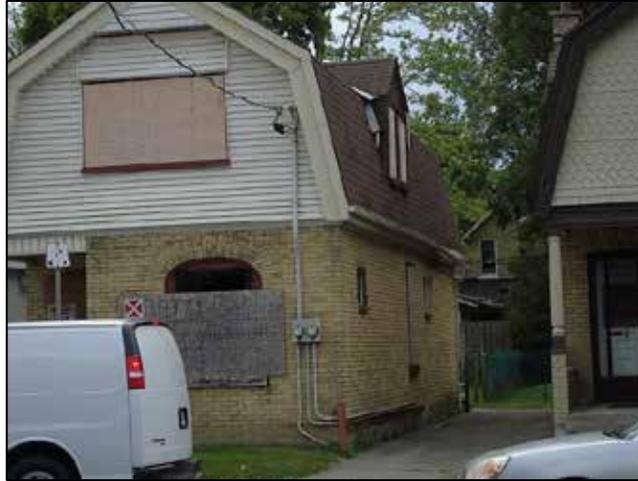
This structure has also undergone a series of modifications and currently appears to be vacant. The one-storey, rear brick addition has been rebuilt as a two-storey vinyl clad structure. The original pillar supporting the second storey over the recessed porch has been replaced or covered with a square aluminum clad pillar. The front gable end has been covered with vinyl siding and the second storey grouping of windows on the gable end has been boarded over. The original chimney has been rebuilt above the roofline. The first story window is also boarded over; however, the elliptical transom portion of the window opening and the brick arched lintel is still visible (Plates 13-15).

Plate 13: Front façade of 80 Oxford Street West

Plate 14: East facade of 80 Oxford Street West showing rear two-storey addition

*Plate 15: West facade of 80 Oxford Street West showing dormer*

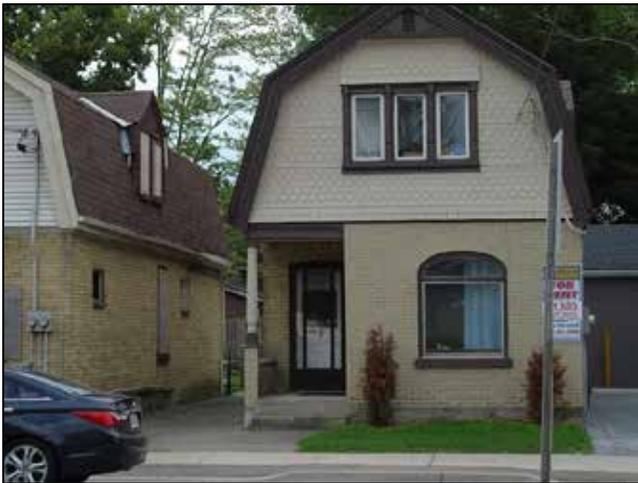
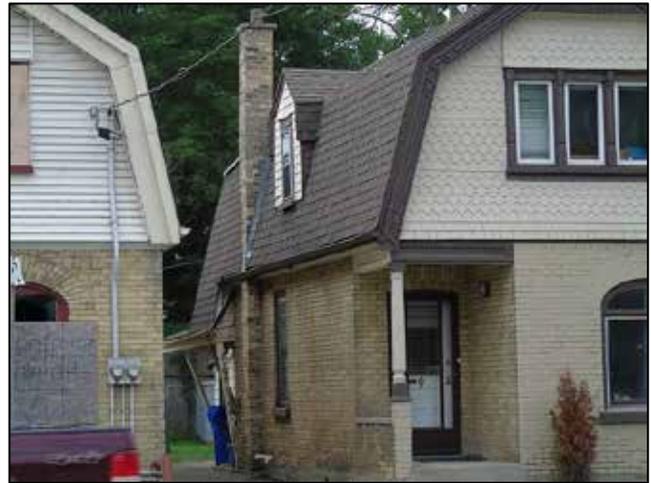
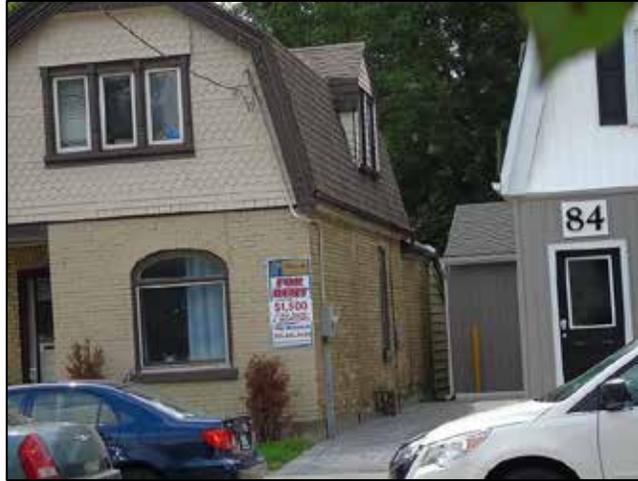
The building at 82 Oxford Street West is the least modified house of the six properties. The front façade is the least altered retaining its wood shingles in the gable end, detailed decorative bargeboards, wood mouldings around its second storey windows, and its porch post. The exception is a new front door and a small one storey vinyl sided addition at the rear that can be seen along the west side of the house (Plates 16-18).

*Plate 16: Front façade of 82 Oxford Street West*

*Plate 17: East facade of 82 Oxford Street West*

*Plate 18: West facade of 82 Oxford Street West showing portion of later rear addition*

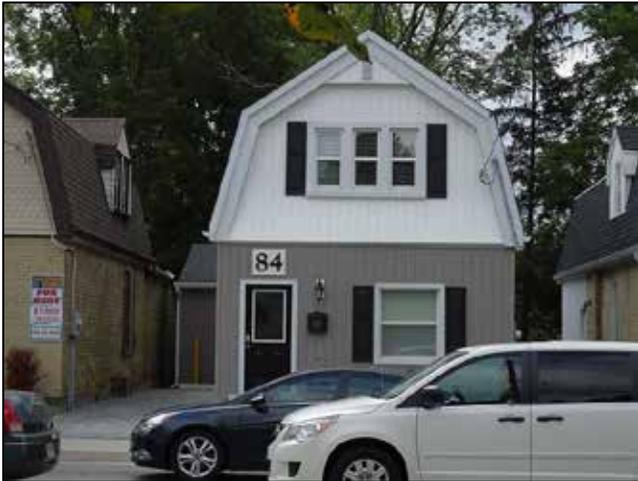
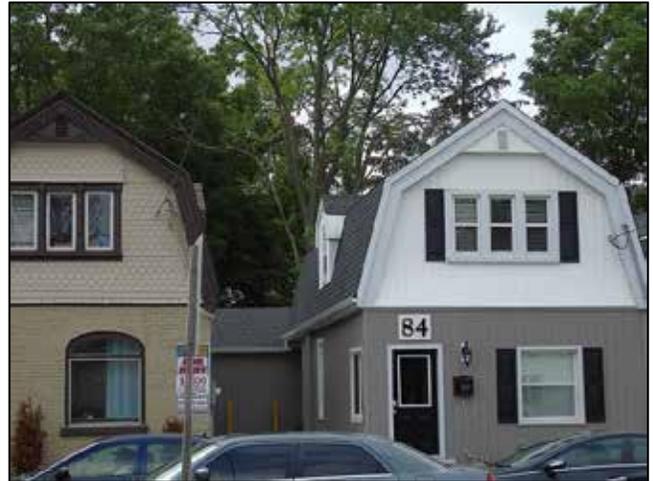
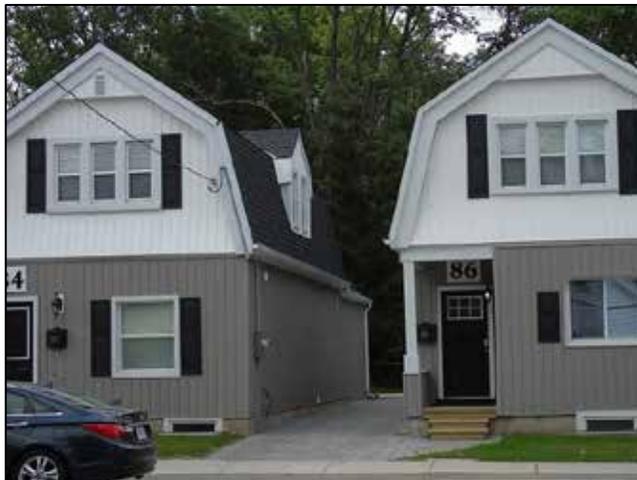
The buildings at 84 and 86 Oxford Street West have been significantly modified in similar manner by recent exterior renovations. The rear one-storey addition has been extended east into the laneway area and the original recessed porch has been filled in to create a consistent front façade depth. The house has been covered by with vinyl siding representative of board-and-batten wood siding on both first and second storeys. The second storey grouping of windows remains on the front facade, but its wood mouldings/pilasters and bargeboard have been replaced by vinyl. The elliptical transom of the ground floor window has been replaced with a vinyl one-over-one rectangular sash window with vinyl framing and the house’s chimney has been removed (Plates 19-21).

*Plate 19: Front facade of 84 Oxford Street West*

*Plate 20: East facade of 84 Oxford Street showing later addition at rear.*

Plate 21: West facade of 84 Oxford Street West

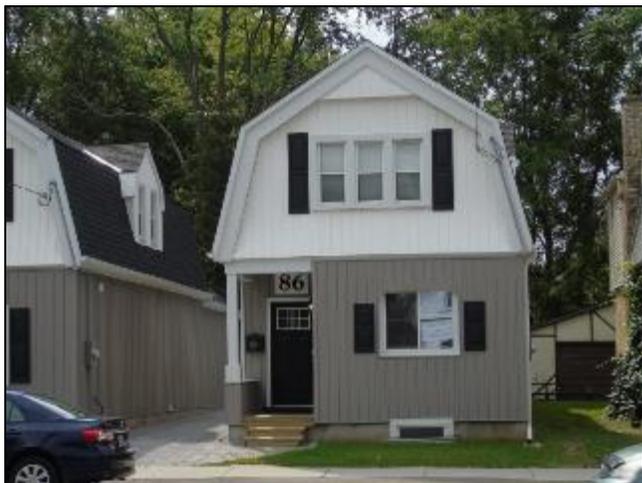
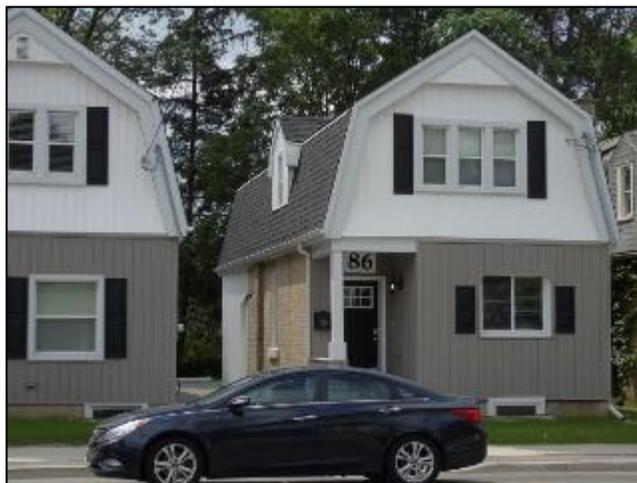
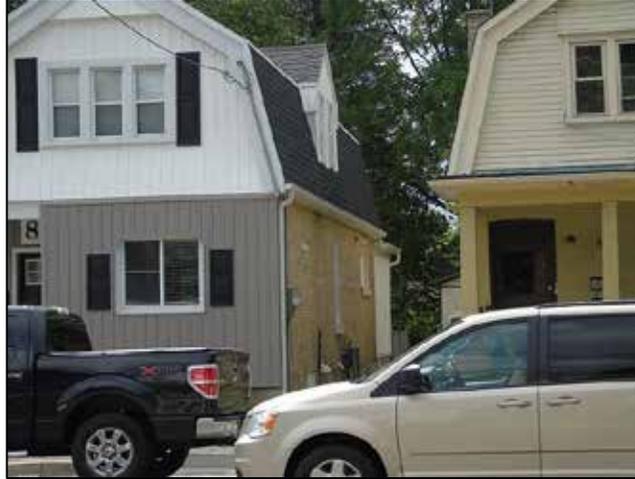
The buildings at 86 and 84 Oxford Street West have been significantly modified in similar manner by modern renovation. The original rear one-storey addition at the rear has been rebuilt as a two storey vinyl clad structure. The original recessed porch remains with the original pillar having been replaced with a square pillar. The front facade has been covered by vinyl siding representative of board-and-batten wood siding on both the first and second storeys. The east and west walls still retain the original, unpainted brick. The second storey grouping of windows remains in the front facade, but the original wood mouldings/pilasters and bargeboard have been replaced with vinyl. The chimney has been removed. The elliptical arch of the first storey window has been replaced with a sliding rectangular window with vinyl framing (Plates 22-24).

Plate 22: Front facade of 86 Oxford Street West

Plate 23: East facade of 86 Oxford Street West

*Plate 24: West facade of 86 Oxford Street West showing unpainted brick*

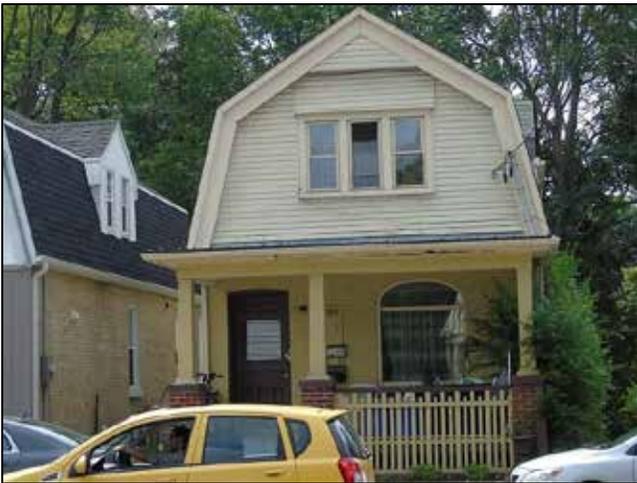
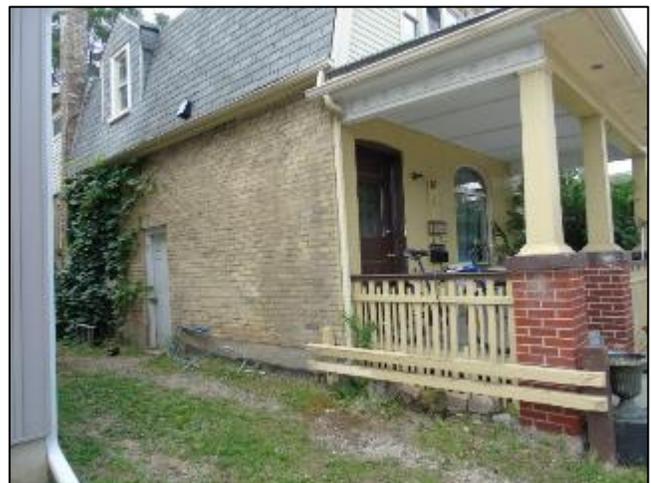
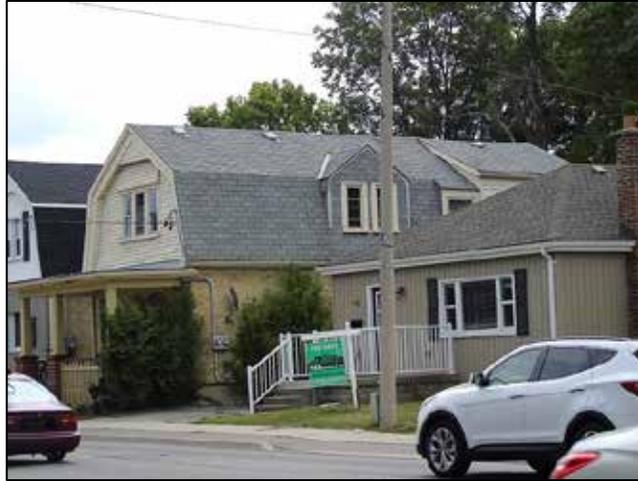
Architecturally, the property at 88 Oxford Street West is slightly different from the other five subject properties. The front façade no longer includes a recessed porch and the reconstruction of the brick on the front façade has hid any remnants hint of its reconstruction. In addition, a side entrance door was constructed on the east façade. The rear addition has been replaced with a two-storey, vinyl clad addition. A covered porch spans across the front of the building and appears to date from the mid-20<sup>th</sup> century based on its style and building materials, namely the brick posts. The brick on the first storey of the front façade has been painted, and the gable end covered with aluminum siding. The second storey grouping of windows remains on the front facade, but the original wood mouldings/pilasters and bargeboard have been replaced or covered by the siding (Plates 25-27).

*Plate 25: Front façade of 88 Oxford Street West*

*Plate 26: East facade of 88 Oxford Street West showing side door and brick-work where recessed front entrance may have been*

*Plate 27: West facade of 88 Oxford Street West showing roof line of rear addition.*
