TO:	CHAIR AND MEMBERS LONDON ADVISORY COMMITTEE ON HERITAGE MEETING ON WEDNESDAY OCTOBER 12, 2016
FROM:	JOHN M. FLEMING MANAGING DIRECTOR, PLANNING AND CITY PLANNER
SUBJECT:	HERITAGE ALTERATION PERMIT APPLICATION AT 40 BYRON AVENUE E., WORTLEY VILLAGE-OLD SOUTH HCD BY: M. EL-HOURANI

That, on the recommendation of the Managing Director, Planning & City Planner, with the advice of the Heritage Planner, the application under section 42 of the *Ontario Heritage Act* to partially rebuild the lower front porch of the building located at 40 Byron Avenue East, within the Wortley Village-Old South Heritage Conservation District, **BE PERMITTED** as described in this application (along with attached drawing) with the following terms and conditions:

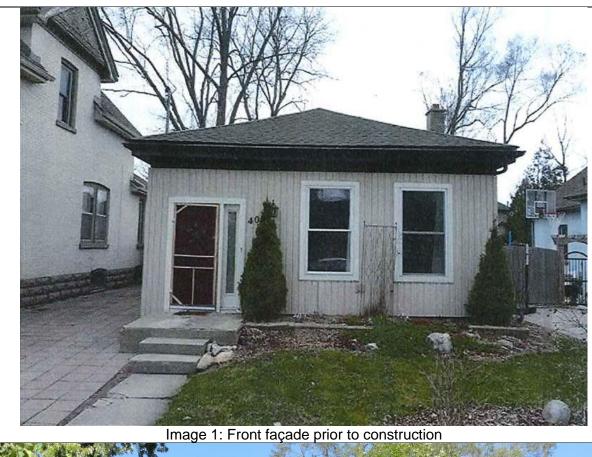
Image 2: Front façade post-construction

- replace the existing poured concrete stoop with an open, covered porch constructed of pressured treated lumber.
  - The porch balustrade is constructed of pressure treated posts with aluminium balusters capped with pressure treated handrails [Appendix B, image 2].

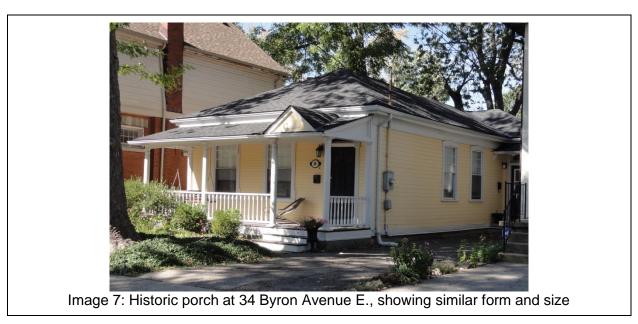
- is in keeping with the neighbourhood context with respect to overall form and massing, although it is articulated in non-historical materials and detailing [Appendix B, image 7].
- does not contribute, nor does it take away from the architectural character of the area.
